## **Appendix A Needs and Opportunities Assessment Report (March 2024)**

McCarthy Road Planning and Environmental Linkages (PEL) Study  
AK FLAP DOT 198(4)

**Needs and Opportunities Assessment Report**  
**March 2024**

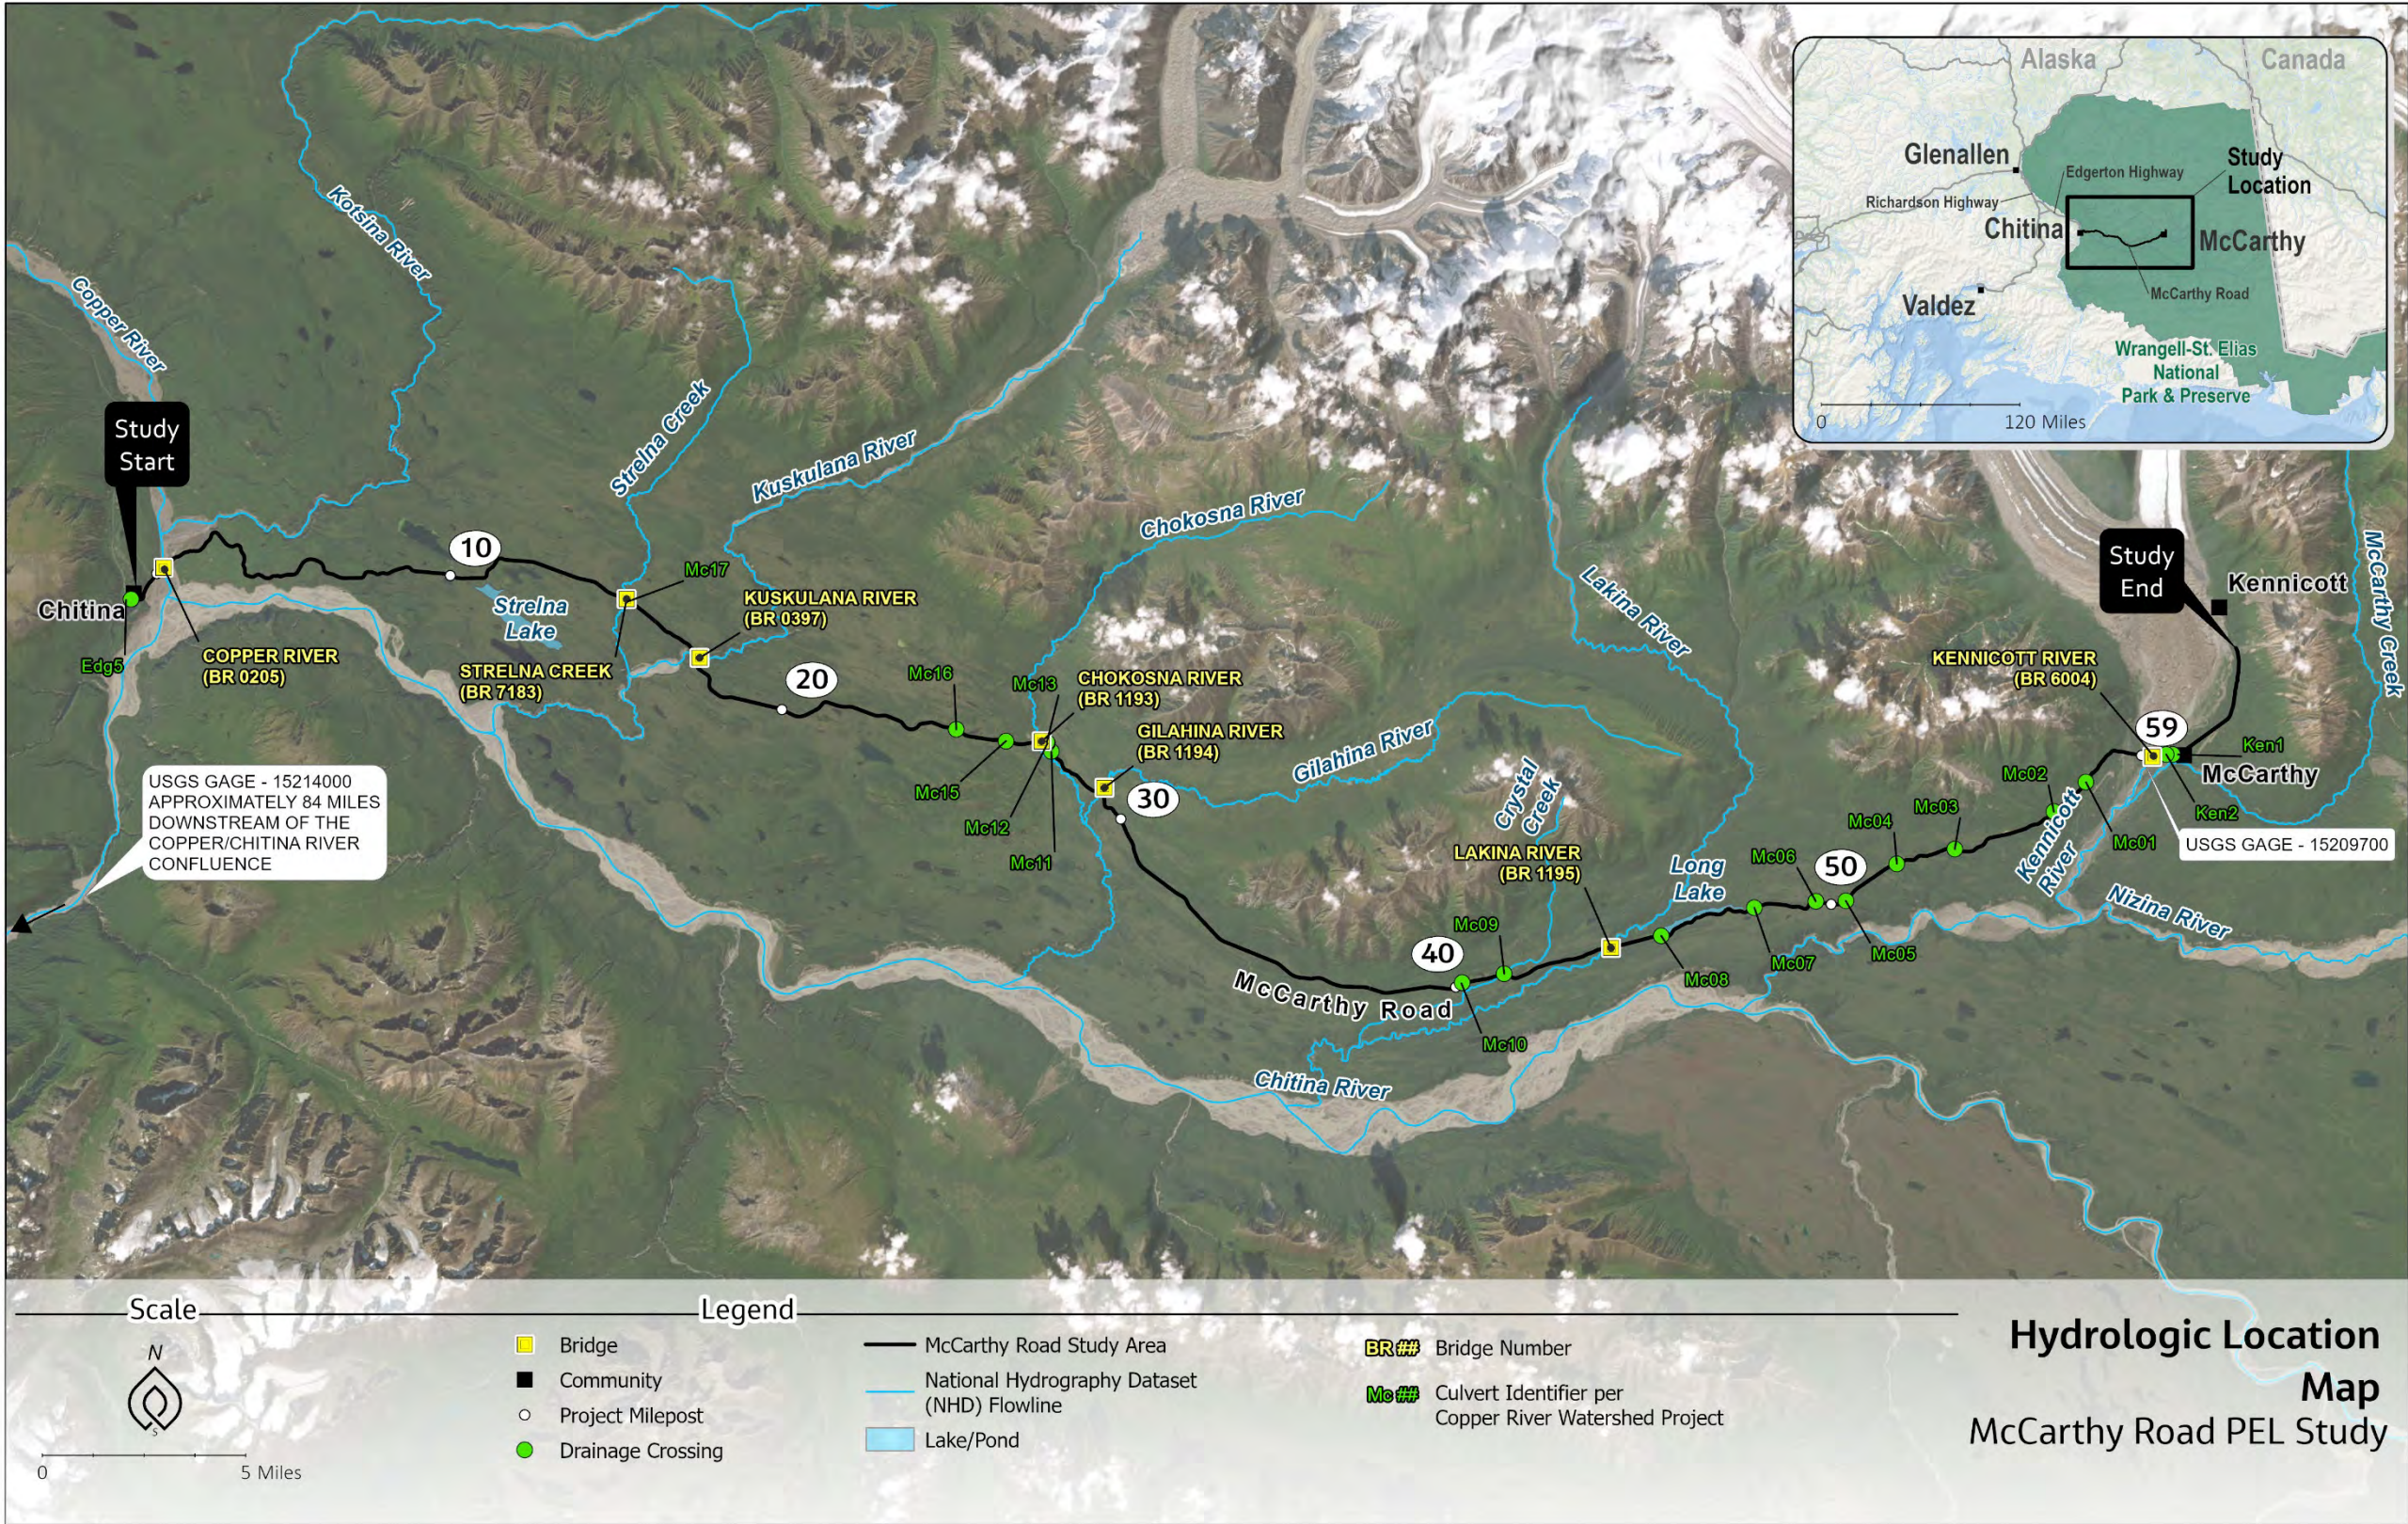
Figure 6-1. Known Drainage Crossings in the Study Corridor

Drainage crossings were identified based on the significance of each drainage crossing of the roadway corridor. Significant drainage crossings were identified based on a crossing structure size of a 48-inch-diameter culvert or larger, including all bridge crossings. This threshold meets criteria outlined in the *Alaska Highway Preconstruction Manual* sections 450.9.7 and 1120.5.1 (DOT&PF 2019). Significant streams were also identified where U.S. Geological Survey (USGS) topographic perennial streams were located as well as any streams that the ADF&G had identified as anadromous streams.

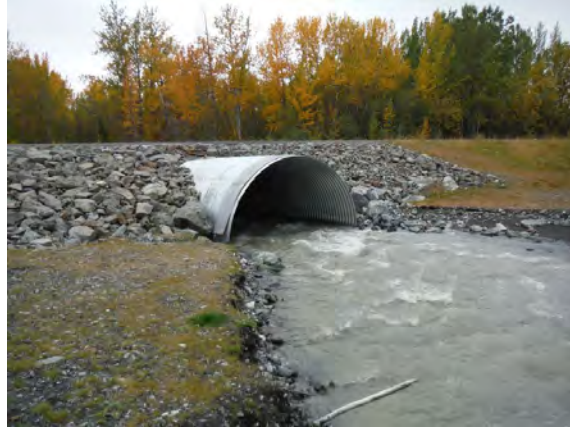
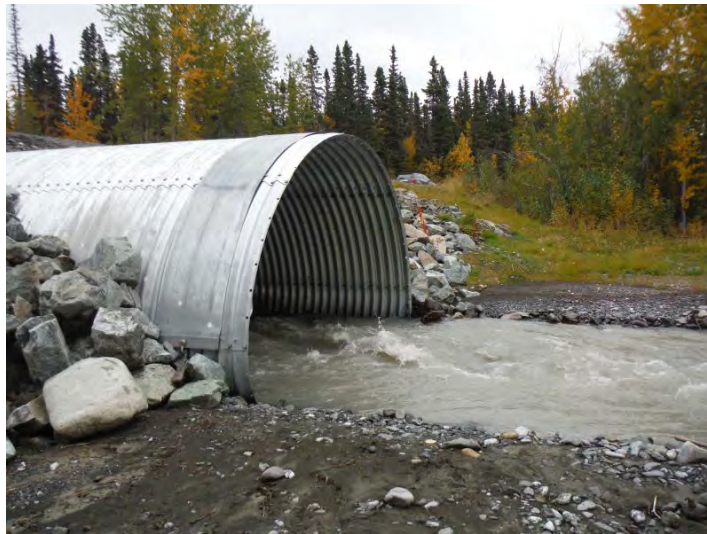
**Figure 6-3. Strelna Creek Culvert (BR 7183), Downstream Looking Upstream**

**Figure 6-4. Strelna Creek Culvert (BR 7183), Looking at Upstream End of Culvert**

This culvert was replaced in 2013 because the previous culvert was undersized. The CRWP data have identified this current culvert to include high velocities through the pipe. A major bank collapse and erosion has been identified approximately 300 feet upstream of this crossing (CRWP 2024).

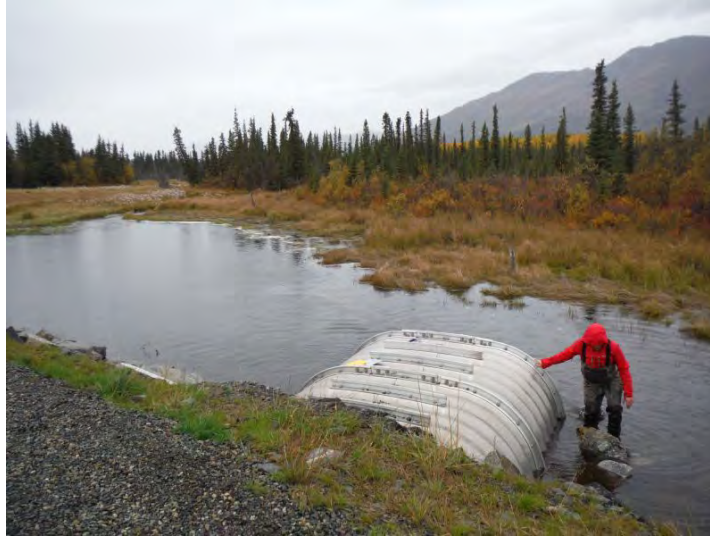
**Figure 6-7. Chokosna River Tributary (MC 15) Cross Culvert, Upstream Side Looking South**

As this Chokosna River Tributary approaches the McCarthy Road corridor, it ponds up on the northern side due to flat wetlands and beavers damming the water. The tributary downstream of the crossing is also ponded up because of flat wetlands.

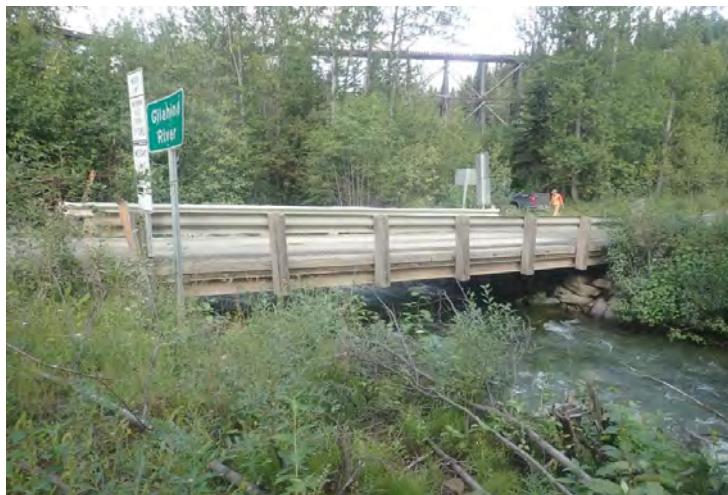
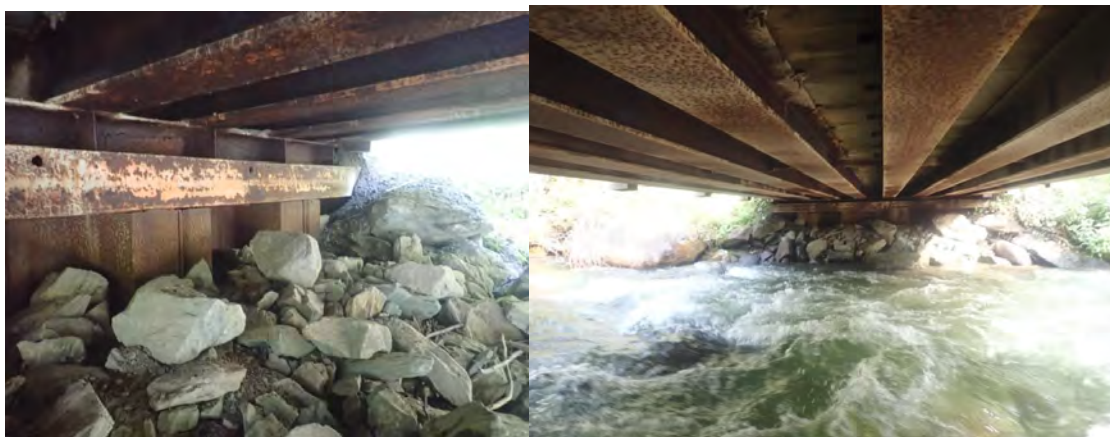
**Figure 6-17. Gilahina River Bridge (BR 1194), Downstream Looking Upstream**

The bridge abutments are armored with large-sized riprap. The river does not show signs of potential migration outside its existing banks. The river is moderately sloped, and the bed is made up of large cobbles and rock that do not appear to be aggregating. Small branches were observed around the abutments at the waterline that represents potential for driftwood impacts. The DOT&PF M&O staff has identified that this bridge needs to be replaced. It was observed that scour occurs at abutments, debris gets into girders, and a higher bridge clearance is needed. Throughout all of the vehicular bridges in this study corridor, the Gilahina River bridge (BR 1194) has the highest load restriction.

**Figure 6-18. Gilahina River Bridge (BR 1194), Looking Upstream, at Left and Right Abutment**

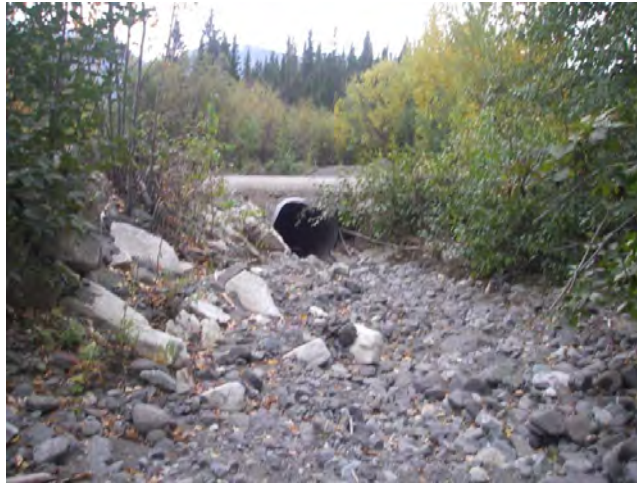
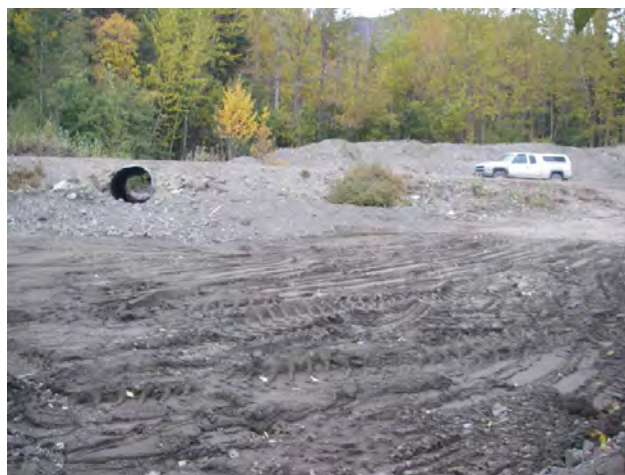
**Figure 6-19. Ruth Creek Cross Culvert (MC 10), Upstream Looking Downstream**

This creek appears to be a dry creek the majority of the year, only getting flow from spring snow melt. The creek does not show signs of potential migration outside its existing banks. The upstream creek bed is moderately sloped and is made up of medium-sized cobbles. Downstream of the cross culvert, there is an open area with about a 3-foot-tall berm to channel the creek south where it combines with Crystal Creek.

**Figure 6-20. Ruth Creek Cross Culvert (MC 10), Downstream Looking Upstream**

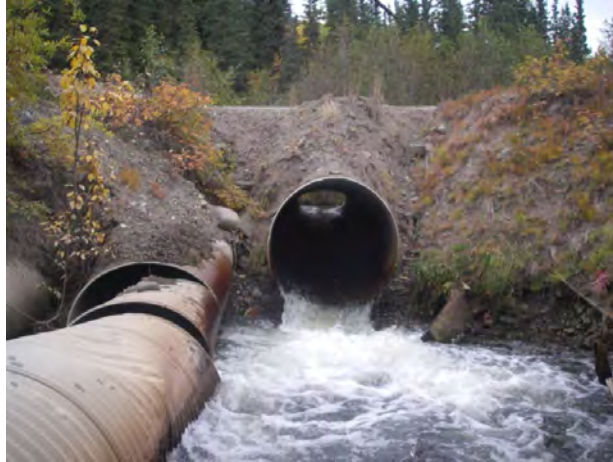
**Figure 6-21. Crystal Creek (MC 9), Downstream Looking Upstream (pre-improvement project)**

The upstream end of this crossing is a flat wetland with very low flow, causing ponding in the area. The roadway side slopes are armored with rock armor that was installed as part of the recently completed project. The area downstream has a moderate slope and conveys the water west of the corridor to the southwest to the Lakina River.

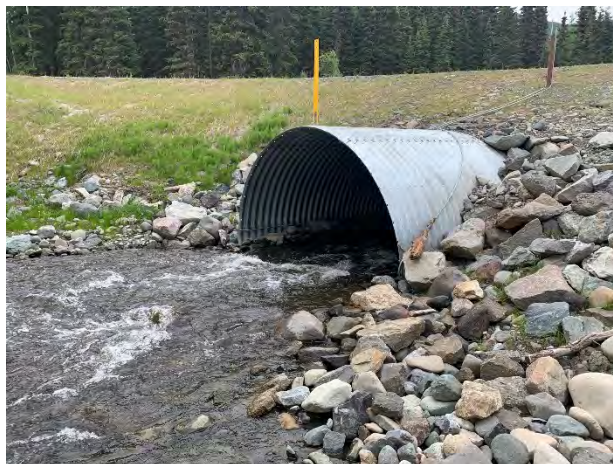
**Figure 6-22. Crystal Creek (MC 9), Looking Upstream (post-improvement project)**

The DOT&PF project (NFHWY00538/0850(029)) was completed in the summer of 2022, in partnership with the FHWA. The project reconstructed approximately 750 feet of the McCarthy Road at the Crystal Creek crossing. The project replaced three undersized and deteriorating culverts with a new 13.3-foot by 9.3-foot structural plate arch pipe culvert. The new culvert structure will improve the ability for fish, specifically coho salmon and trout, to pass through safely. The before and after photos show the resolution of the previously perched culvert, which was impeding fish passage. The roadway grade was also slightly raised and shifted to improve driver safety and comfort.

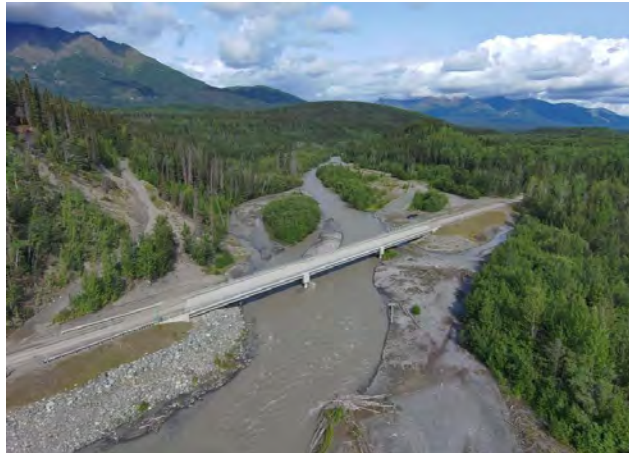
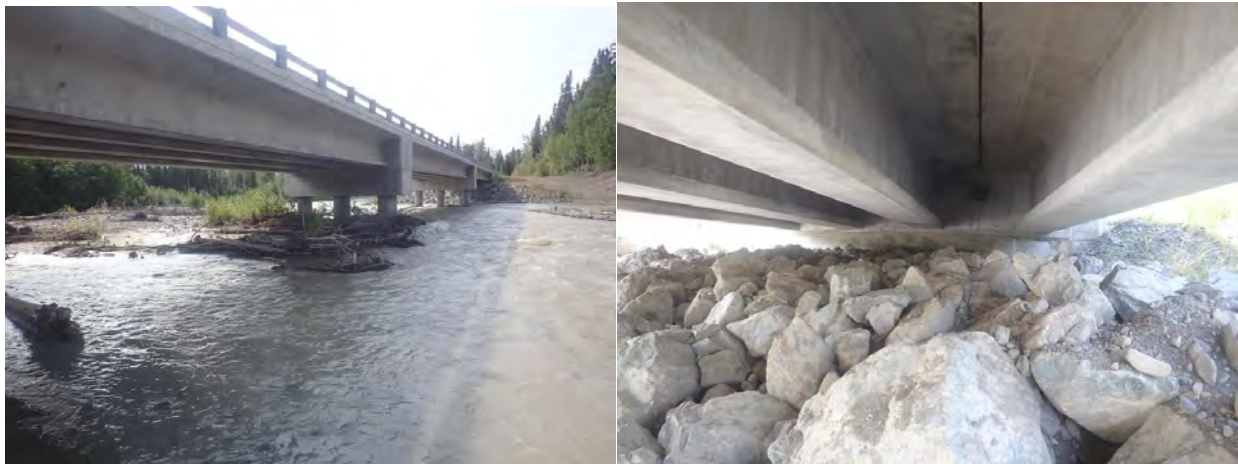
**Figure 6-23. Lakina River Bridge (BR 1195), Upstream Looking Downstream**

The Lakina River is a braided river upstream and downstream from the Lakina River bridge. The bridge abutments and piers are armored with moderately sized riprap. The river shows signs of migration outside its existing bank. The channel bed consists of cobbles and rock. It has been observed that tree-sized debris appear to frequently get caught along the banks and dried portions of the riverbed and floodplain approximately 3 feet above normal water level.

**Figure 6-24. Lakina River Bridge (BR 1195), Looking Upstream, Piers and Right Abutment**

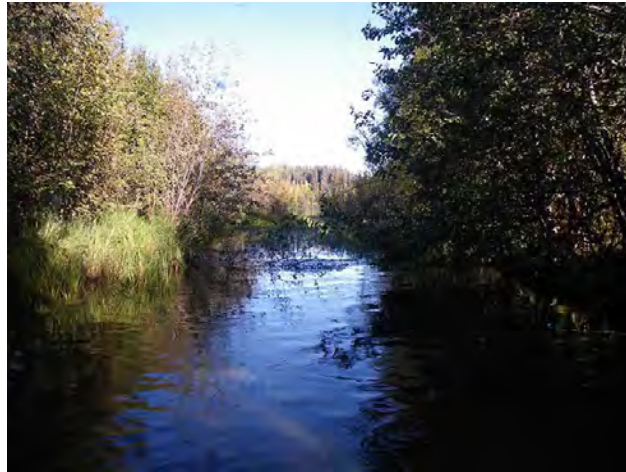
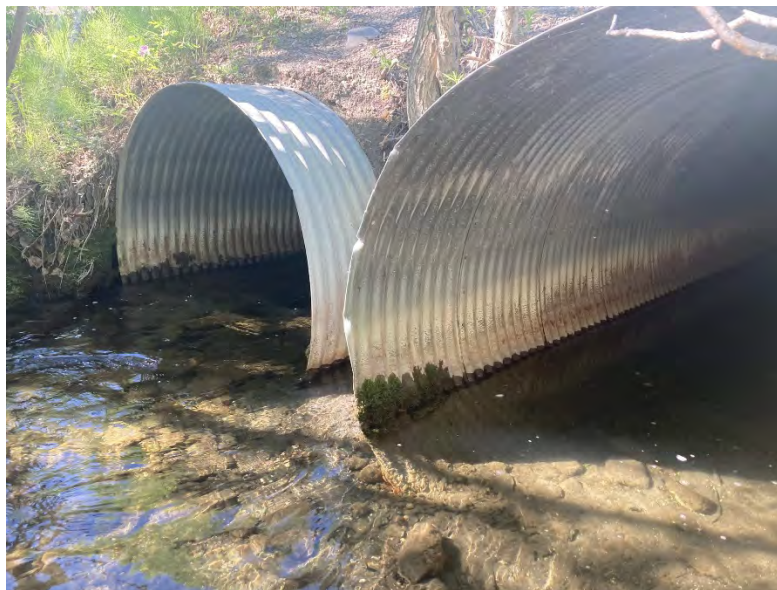
**Figure 6-25. Long Lake Creek Cross Culvert (MC 8), Looking Upstream**

Upstream from the corridor major crossing, Long Lake flows northeast to southwest to feed the Long Lake Creek. The creek does not show signs of potential migration outside its existing banks because these banks are heavily vegetated.

**Figure 6-26. Long Lake Creek Cross Culvert (MC 8), Downstream Looking Upstream**

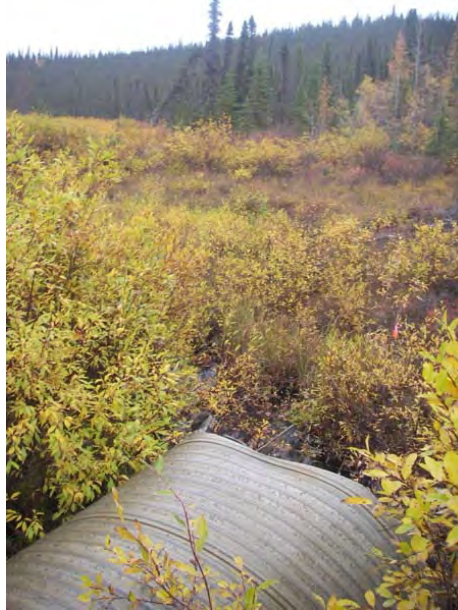
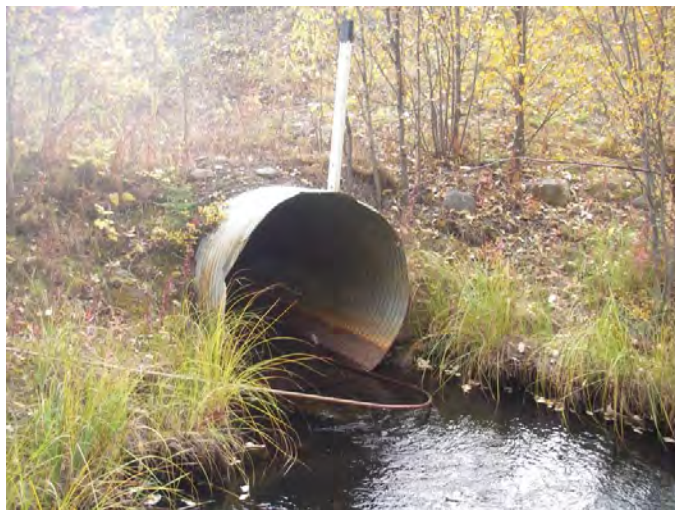
**Figure 6-27. Long Lake Creek Crossing (MC 7), Looking Upstream**

The upstream area is a somewhat flat vegetated wetland. Downstream of the corridor crossing, the creek does not show signs of potential migration outside its existing banks because the banks are relatively steep and somewhat vegetated.

**Figure 6-28. Long Lake Creek Crossing (MC 7), Downstream Looking Upstream**

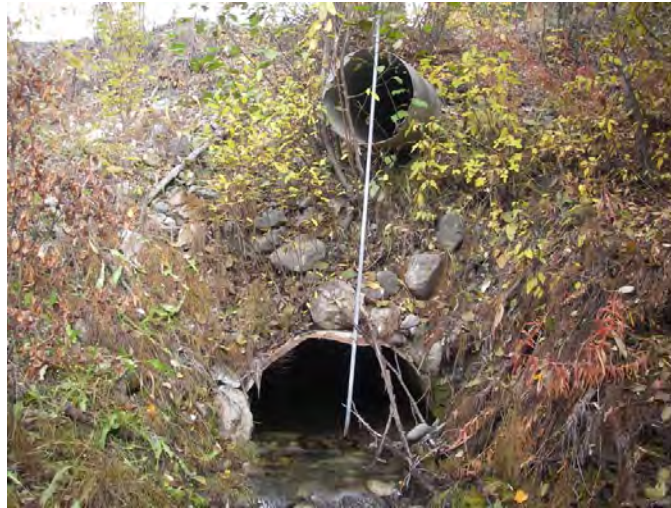
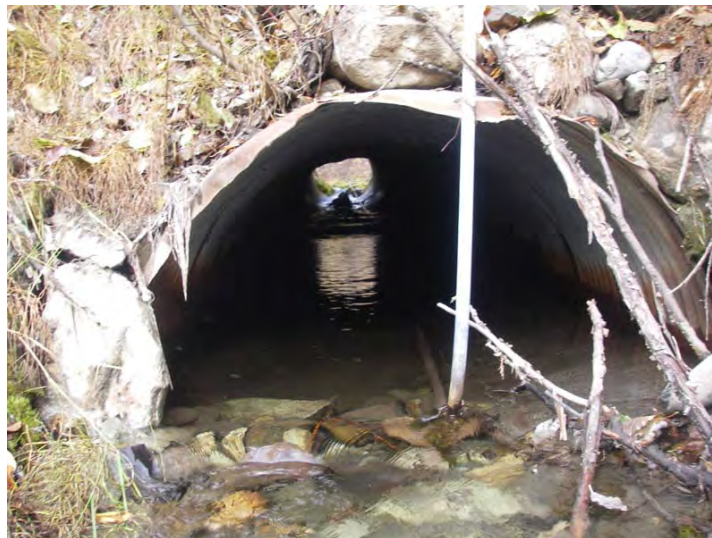
**Figure 6-29. Tractor Creek Cross Culvert (MC 3), Downstream Looking Upstream**

The condition of the existing cross culvert appears to be deteriorating. The upstream area is a somewhat flat, heavily vegetated area. The upstream and downstream roadway side slopes are armored with moderately sized riprap protecting the area around the culvert from erosion.

**Figure 6-30. Tractor Creek Cross Culvert (MC 3), Upstream Looking Downstream**

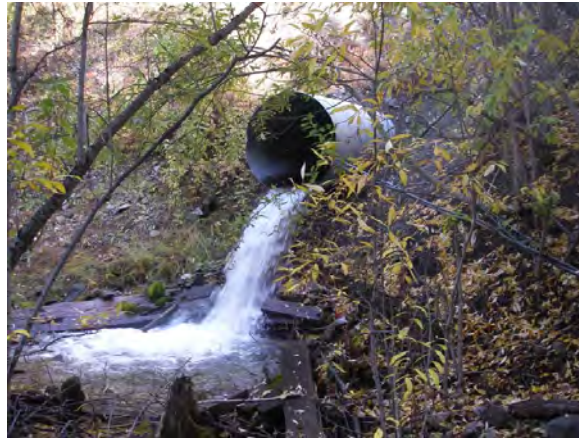
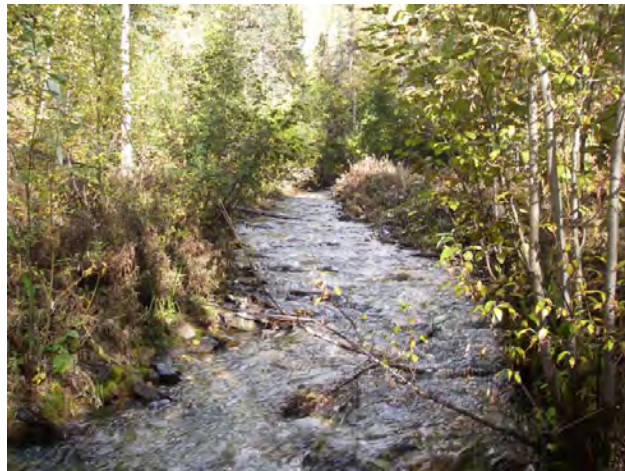
**Figure 6-31. Swift Creek Crossing (MC 2), Downstream Looking Upstream**

The cross culvert appears to be in great condition. Riprap armoring is not present on the roadway side slopes around the culvert inlet or outlet. Roadway side slopes are in danger of erosion around the culvert inlet and outlet. The DOT&PF M&O staff has recommended that this culvert be repaired.

**Figure 6-32. Swift Creek Crossing (MC 2), Looking Upstream**

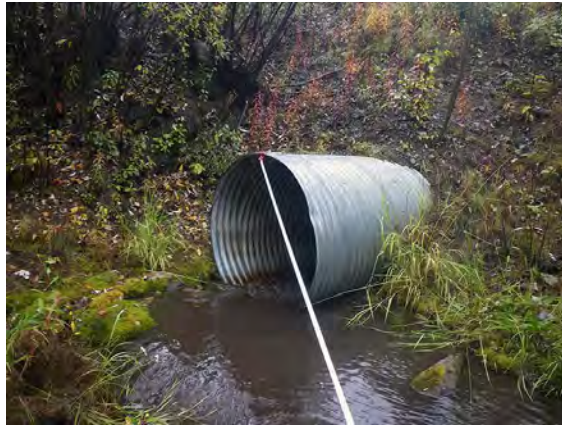
**Figure 6-33. Farm Creek Cross Culvert (MC 1), Upstream Looking Downstream**

The creek does not show signs of potential migration outside its existing banks because these banks are heavily vegetated. Farm Creek flows southeast to combine with the Kennicott River.

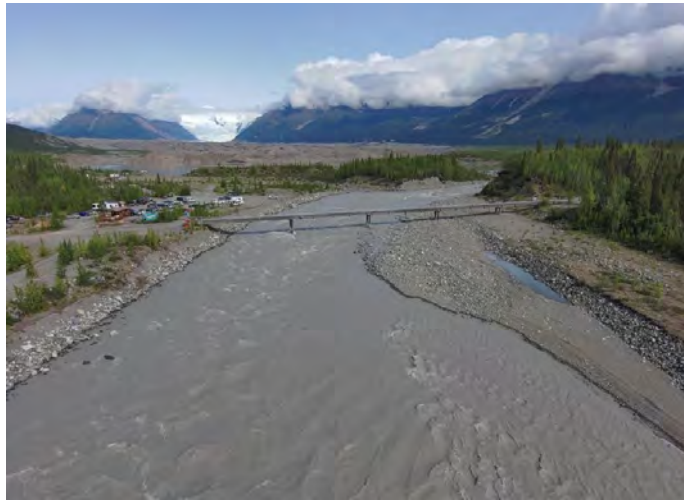
**Figure 6-35. Kennicott River Bridge (BR 6004), Downstream Looking Upstream**

The bridge abutments are armored with large-sized riprap. The river does not show signs of potential migration outside its existing banks because these banks are fairly steep. Erosion is observed to exist on the west bank where there now exists large riprap to protect the bank. The riverbed is composed of primarily silt, cobble, and boulder material.
