Re: Totchaket Road Geotechnical and Constructability Assessment - FINAL

RECON LLC has completed an initial field reconnaissance and geotechnical investigation of the proposed Totchaket Highway extension currently in the planning and engineering phase. The inspection was completed by Isaac Rowland, PE, and Mick Ewing, PLS, from November 1-4, 2013.

This report summarizes the reconnaissance geotechnical investigation, makes recommendations regarding engineering and construction methods, and identifies specific locations for sand borrow.

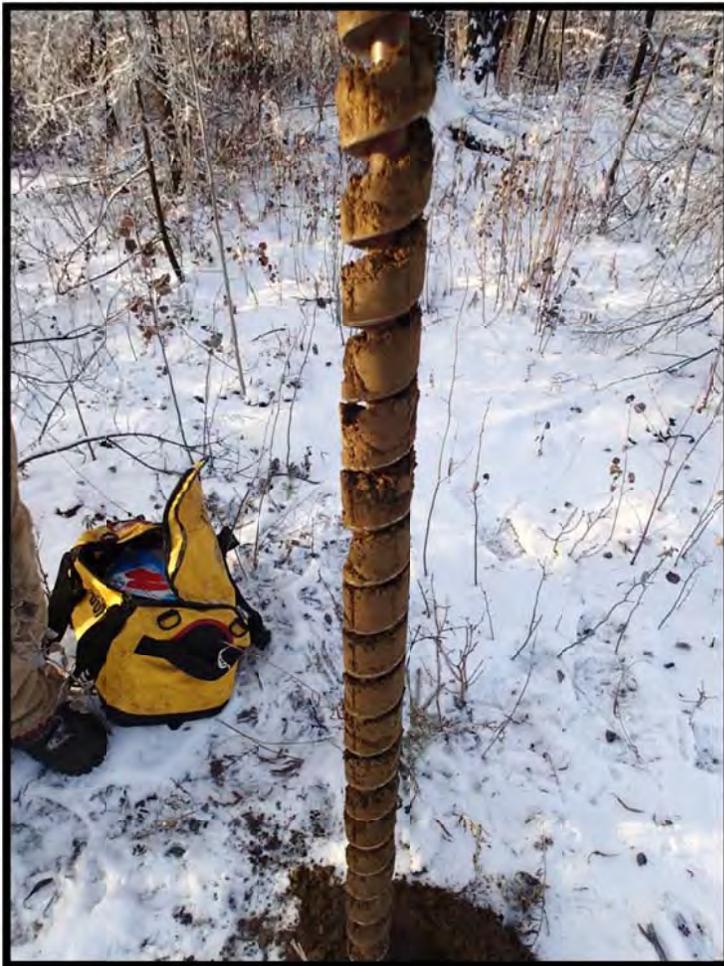
RECON found that the typical soil section along the entirety of the route consists of relatively clean sand overlain by varying thicknesses of silt or silt-heavy soils. The thickness of the silt overlay varied between 1.0 and 6.0 ft, with the majority at a thickness between 2.0 and 4.0 ft. This silt soil is generally deemed to be unsuitable for road construction and typically will be either removed or left undisturbed in the sub-grade.

*Photo 0038 – Typical Nenana silt loam found throughout project area.*

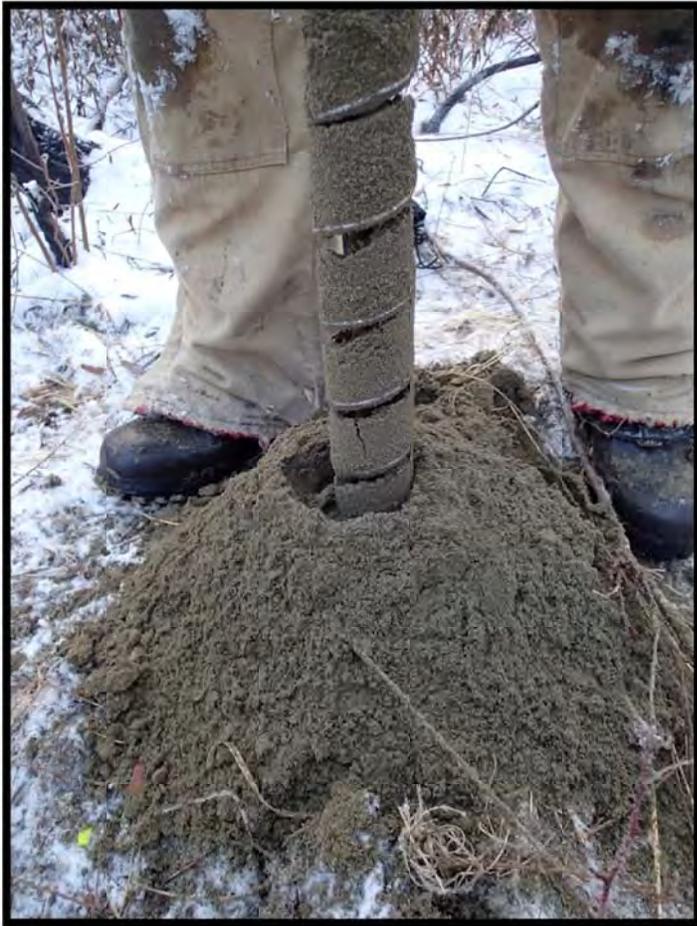
*Photo 0058 – Typical clean sand found underlying the silt layer.*

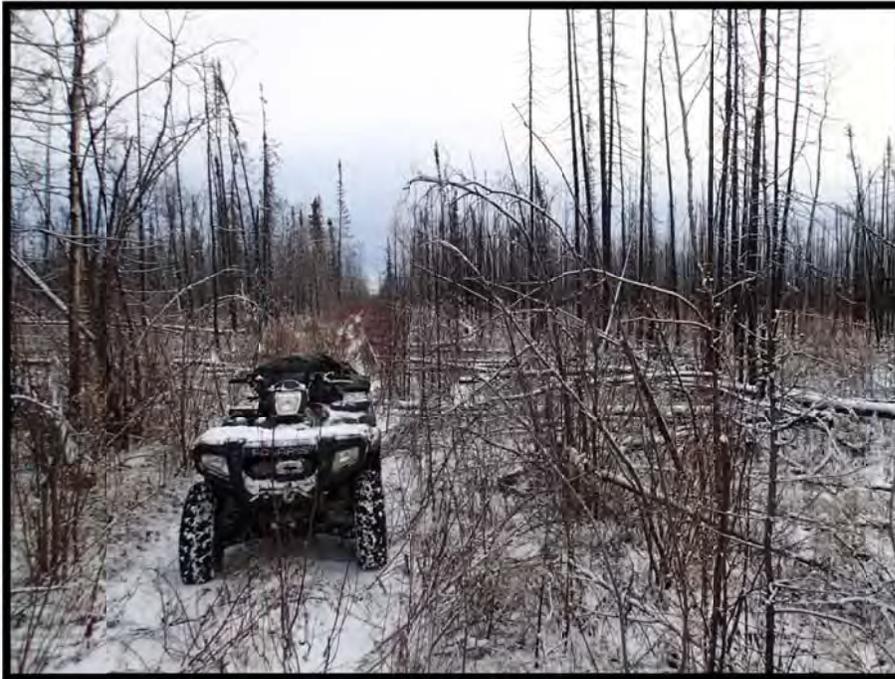
The entire project area has been burned over in the past several years. Nearly all of the proposed road alignment is through what was previously a very dense forest of black and white spruce with stands of aspen and some birch. At the time of this field investigation, much of the burned and dead timber was still standing. However, dead and down timber is also common and makes for difficult overland travel. Regrowth of aspen and willow is common with some young spruce and birch. Very little salvageable timber was noted.

*Photo 0004 – Typical vegetation and terrain along road alignment.*

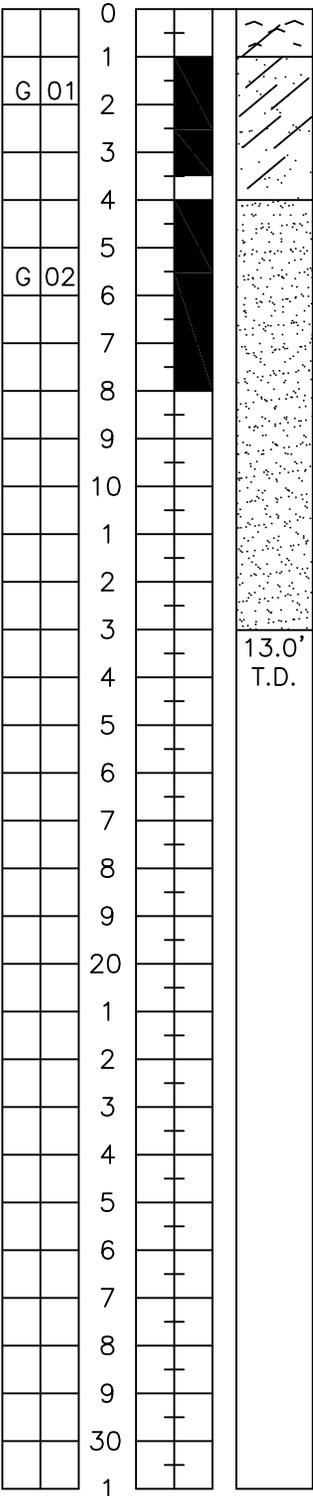
# GEOLOGIC LOG      TEST BORE: TB - 02

0.0-1.0'      SILT loam w/ some organics, brown, slightly moist

1.0-4.0'      Sandy-SILT loam, brown, slightly moist,

4.0-13.0'      Fine - Medium SAND, tan, slightly moist, moderately dense SM

13.0' T.D.

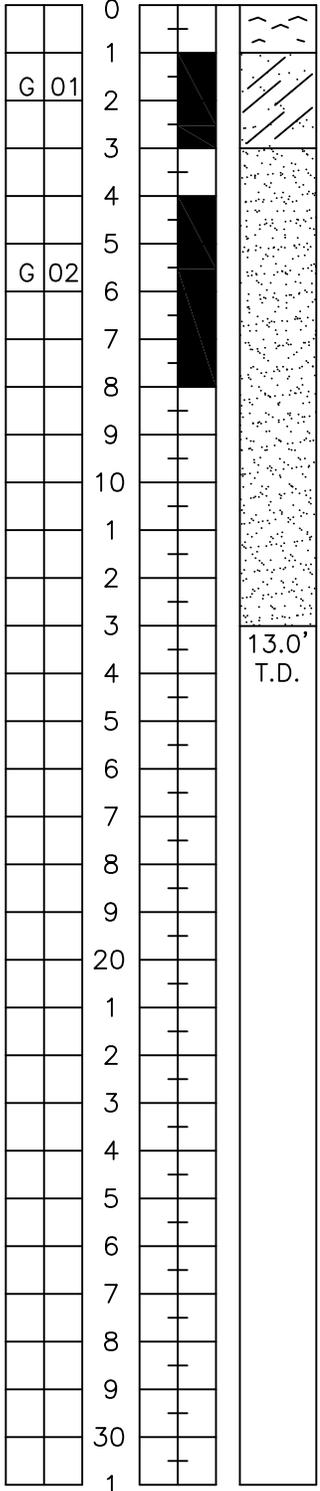
# GEOLOGIC LOG TEST BORE: TB - 03

0.0-1.0' PEAT, black, moist

1.0-3.0' Sandy-SILT loam, brown, moist,

3.0-13.0' Fine-Medium SAND, tan-brown, slightly moist, medium density, SM

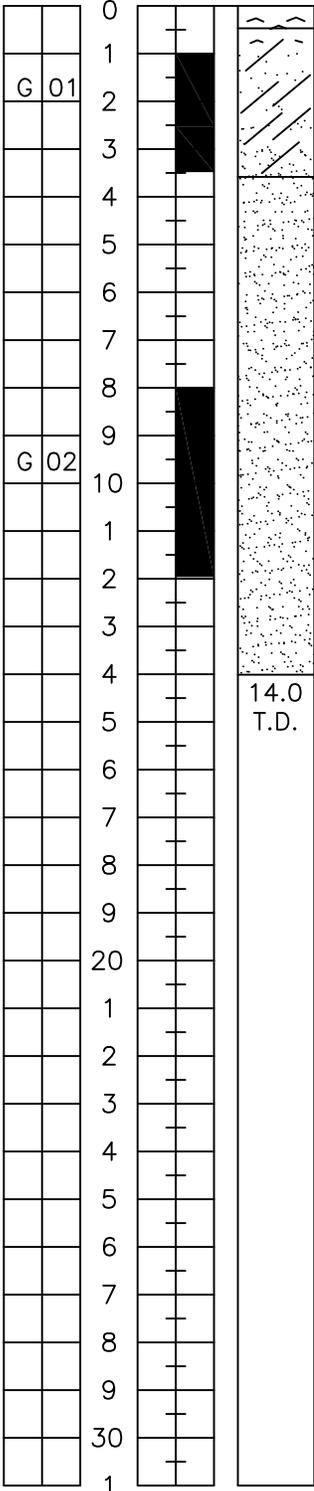
0.0-0.5' PEAT, w/ silt

0.5-3.5' Sandy-SILT loam, brown, moist,

3.5-14.0' Fine-Medium SAND, tan-brown, slightly moist, medium density, SM

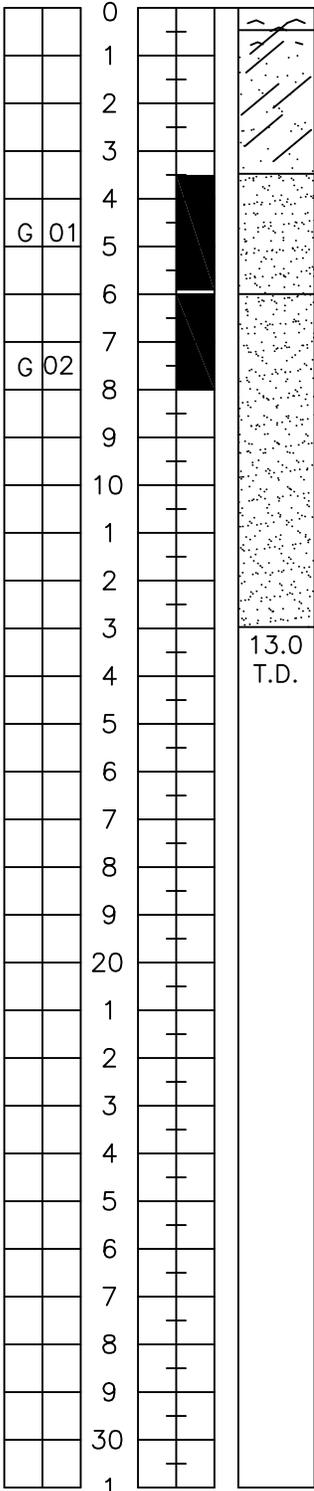
0.0-0.5' PEAT, w/ silt

1.0-3.5' Silty-SAND, dark gray, slightly moist

3.5-6.0' Fine-Medium SAND, red-brown, slightly moist, medium density, SM

6.0-13.0' Fine-Medium SAND, tan-gray, slightly moist, medium density, SM

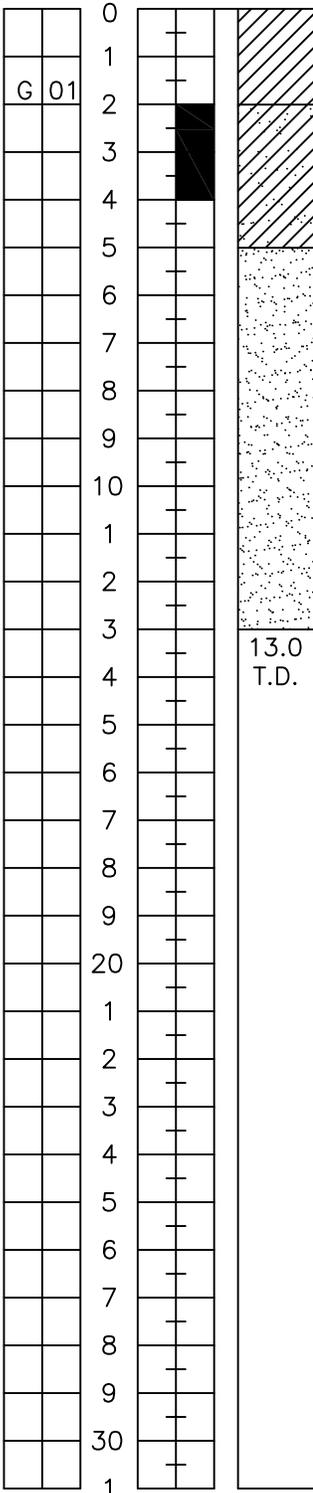
0.0–2.0' SILT loam, brown, slightly moist

2.0–5.0' SILT loam w/ some sand, gray, moist,

5.0–13.0 ft Fine–Medium SAND, red–brown, slightly moist, medium density, SM

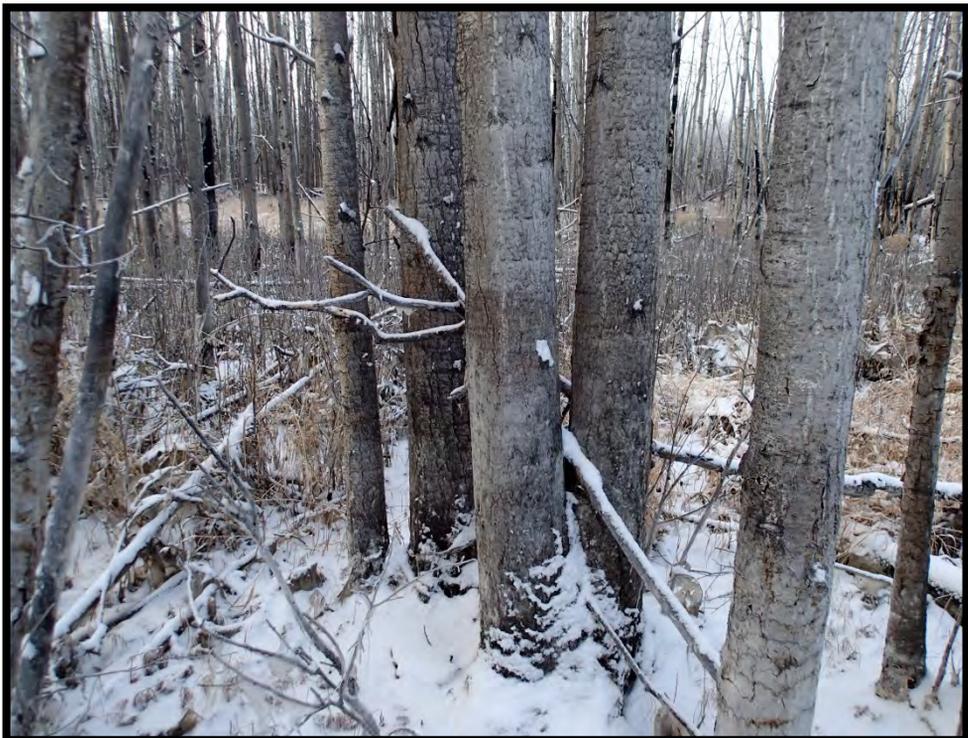
Of concern in this section are the numerous aspen “pothole” low areas that tend to fill with water in the spring. At least three such depressions will be crossed directly by the road, and it is likely that other, smaller low areas will also be crossed. One notable section at MP 10.9 (TB-09) showed high water marks on the trees of at least 4.5 ft above ground level. The use of a standard sand sub-base in these sections will result in road shoulder failure. Road re-alignment around these sections or a rock fill sub-base will be required for up to 20% of the road construction through this two-mile section.

0054: Watermark 4.5 up aspen trunk

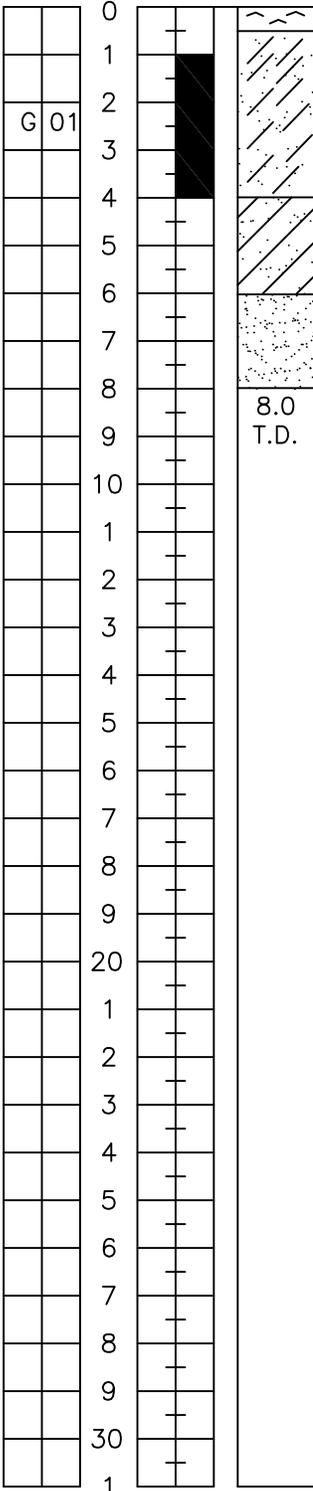
0.0-0.5' PEAT, black, PT

0.5-4.0 Sandy SILT loam, gray-brown, slightly moist.

4.0-6.0' SILT w/ sand, brown, slightly moist, somewhat plastic.  
very difficult to drill

6.0-8.0' Fine-Medium SAND, brown, slightly moist, medium density, SM

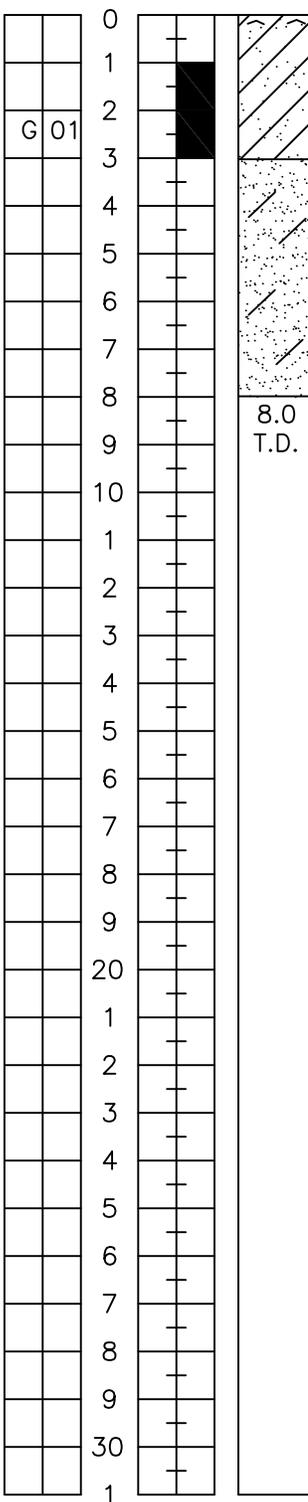
# GEOLOGIC LOG      TEST BORE: TB - 12

0.0-3.0'      SILT w/ some sand, brown, moist, somewhat plastic.

3.0-8.0'      Fine-Medium SAND w/ trace silt, tan-gray, slightly moist,  
 medium density, SM

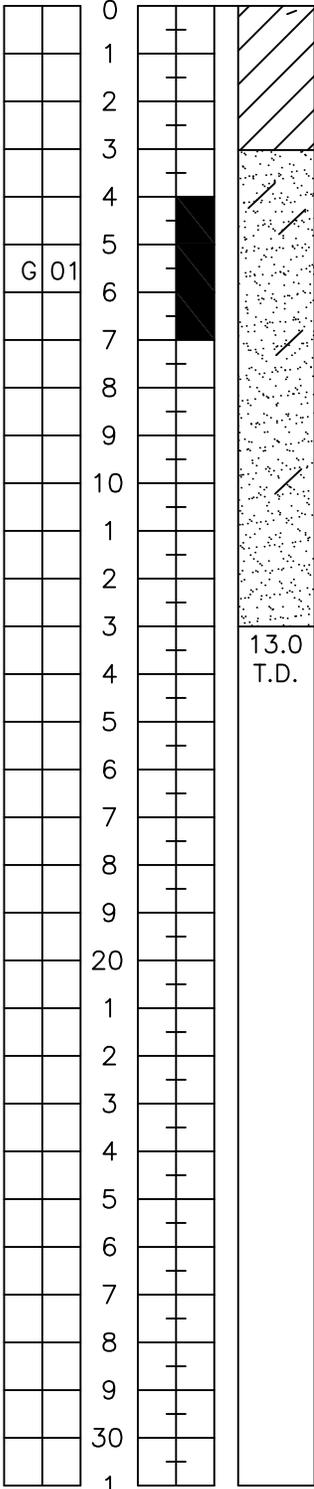
# GEOLOGIC LOG TEST BORE: TB - 13

0.0-3.0' SILT loam, brown, dry

3.0-13.0' Fine-Medium SAND w/ trace silt, tan-gray, slightly moist, medium density, SM

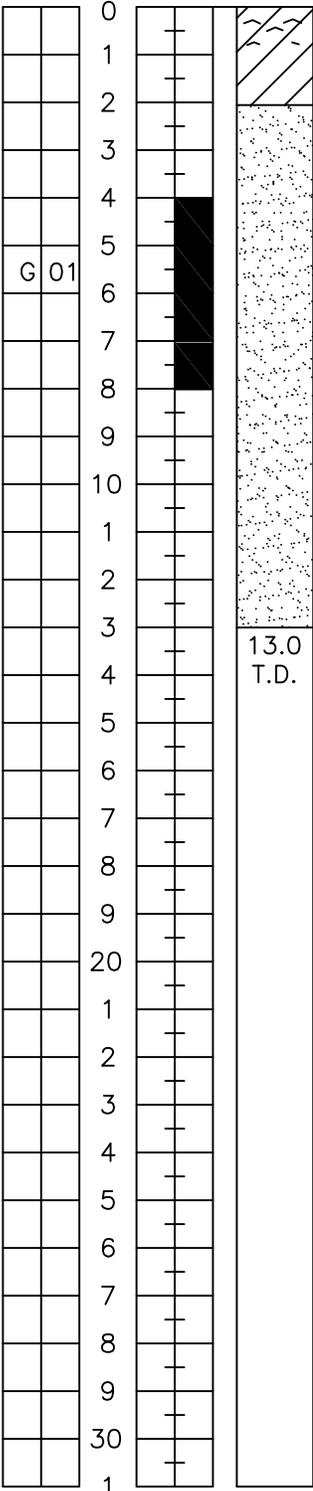
0.0–2.0'      SILT loam, dark brown, slightly moist

2.0–13.0'      Fine–Medium SAND, tan, dry, medium density, SM

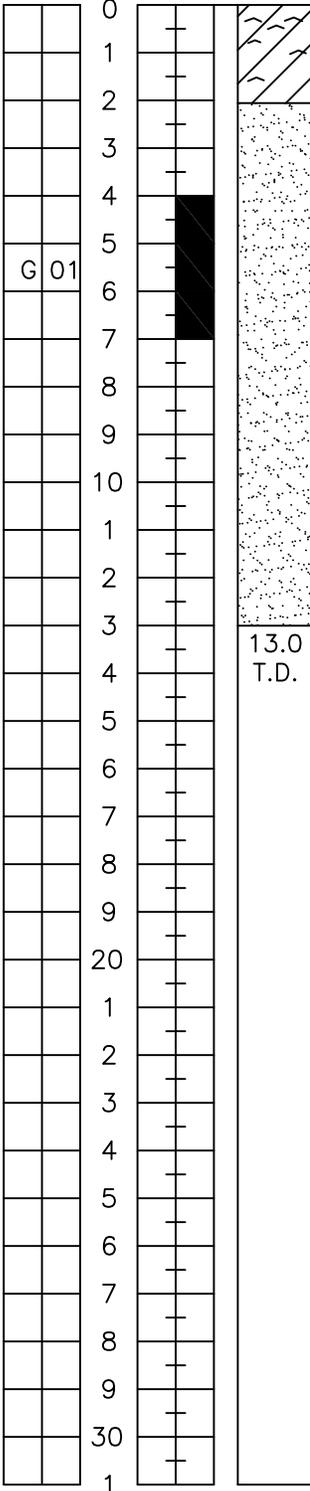
# GEOLOGIC LOG      TEST BORE: TB - 15

0.0-2.0'      SILT loam w some clay & organics, brown, moist, cohesive

2.0-13.0'      Fine-Medium SAND, tan-brown, slightly moist, medium density, SM

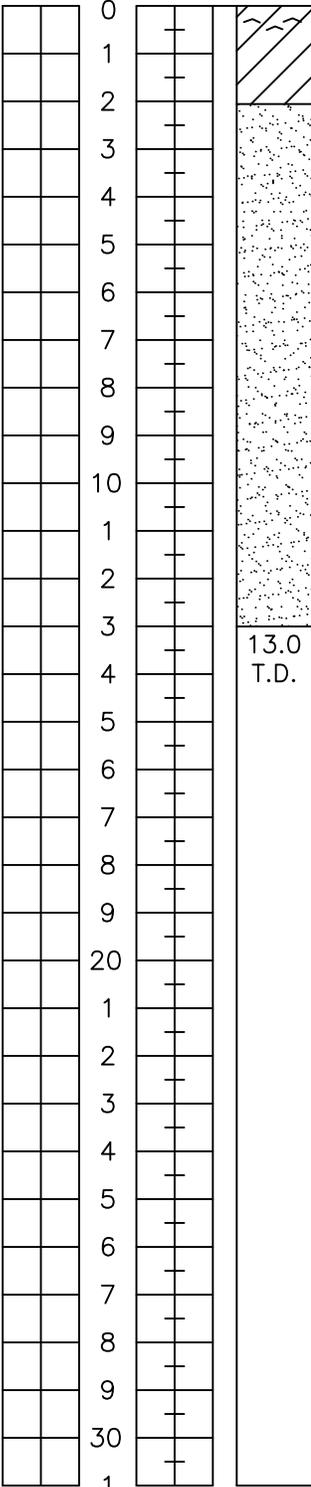
# GEOLOGIC LOG TEST BORE: TB - 16

0.0-2.0' SILT loam, brown, dry

2.0-13.0' Fine-Medium SAND, tan-brown, slightly moist, medium density, SM

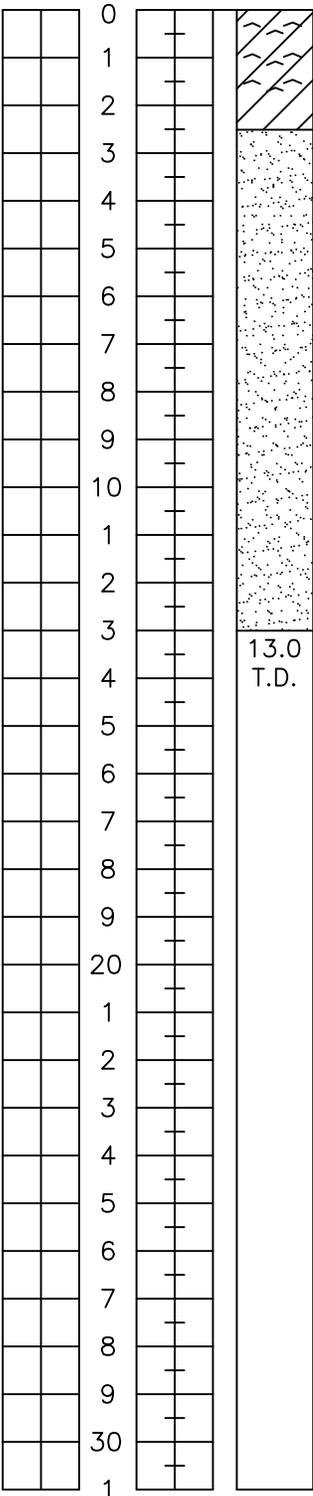
0.0-2.5'      SILT loam w some organics, brown, moist

2.5-13.0'      Fine-Medium SAND, tan-brown, slightly moist, medium density, SM

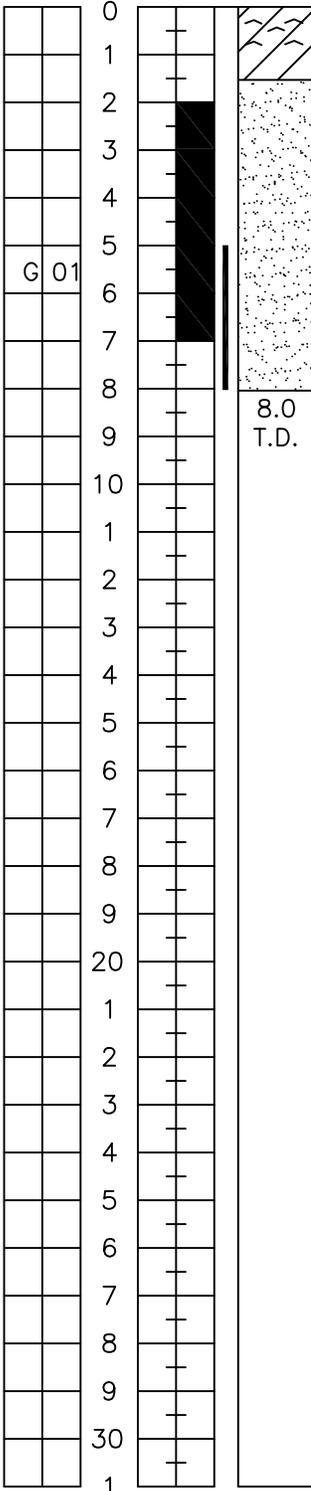
Permafrost was encountered in one test bore (TB-19) at a depth of 5 ft. RECON's experience in the project area is that permafrost may be encountered within the depth of road cut development at isolated locations with characteristic slope aspect and vegetative cover. However, it will be RECON's intent during design to avoid cuts in any area suspected to have shallow permafrost. Permafrost is likely pervasive at depths greater than 20 to 50 ft over much of the project area.

0.0–1.5'      SILT loam w some organics, brown, slightly moist

1.5–8.0'      Fine–Medium SAND, tan–brown, slightly moist, medium density, SM

Notes:         On a small flat near several small dunes.      Permafrost at 5'

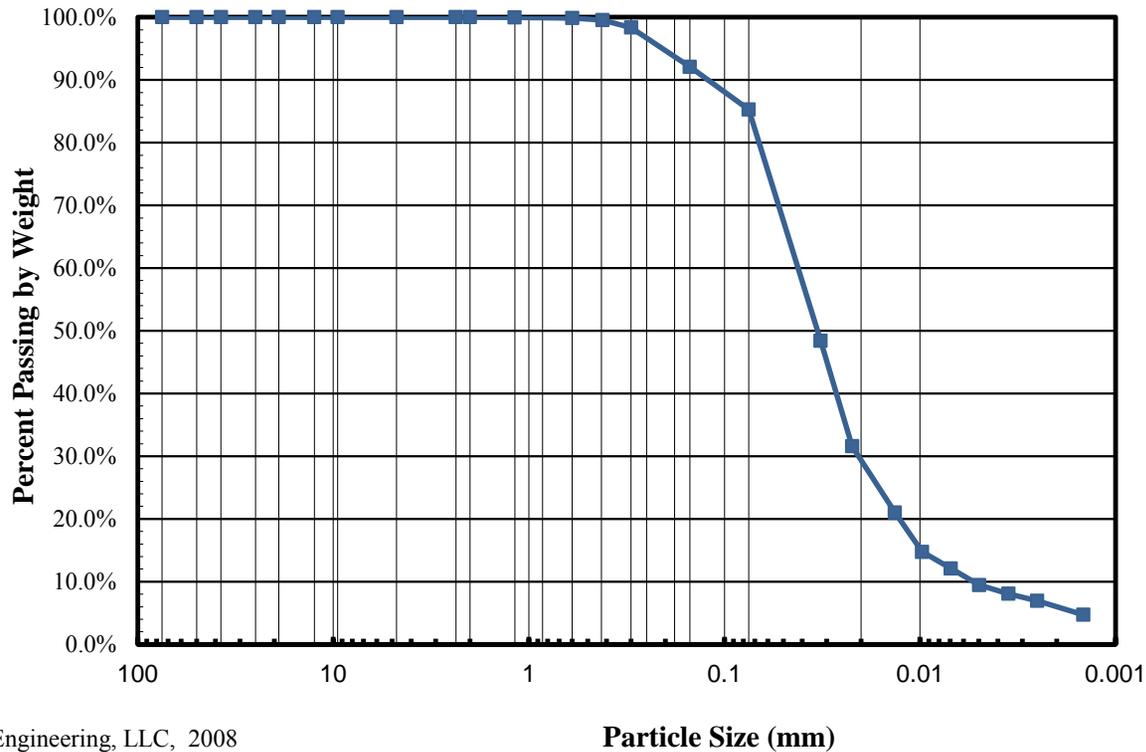
Client: Recon  
Project: Totchaket Silt  
Material Description: TB03-01 @ 1-3'  
Sample Location:

SIZE	PASSING	SPECIFICATION	
		Low	High
3"	100%		
2"	100%		
1 1/2"	100%		
1"	100%		
3/4"	100%		
1/2"	100%		
3/8"	100%		
No. 4	100%		
<b>Plasticity Index ASTM D4318</b>			
Non Plastic			
<b>Moisture Content As Received ASTM C 123</b>			
25.1%

A selection of 9 sand and overburden samples were submitted for sieve analysis to EMC Engineering in Palmer, AK. The results of the tests are included in Appendix C and confirm the visual observations of clean sand overlain by silt loam in most areas.

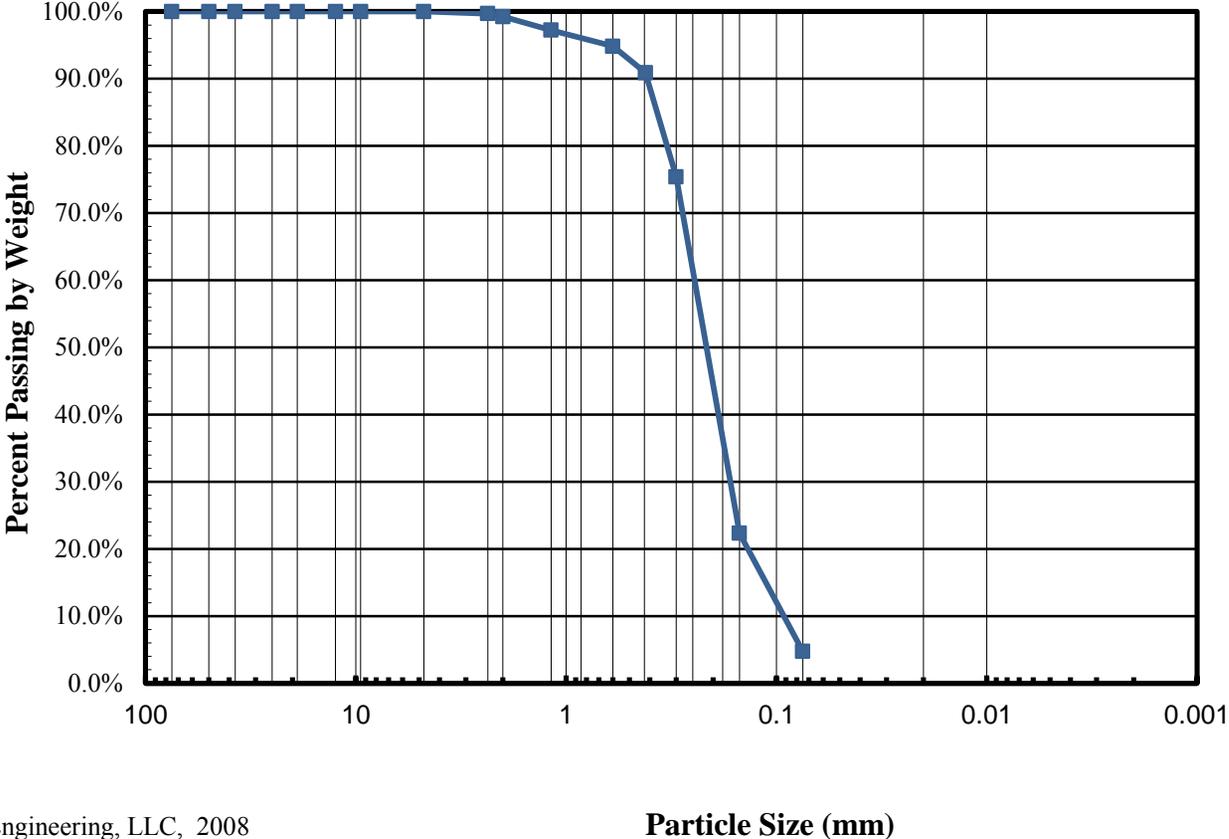
Client: Recon  
 Project: Totchaket  
 Material Description: Sand  
 Sample Location: TB05-02 @ 8-12'

SIZE	PASSING	SPECIFICATION	
		Low	High
3"	100%		
2"	100%		
1 1/2"	100%		
1"	100%		
3/4"	100%		
1/2"	100%		
3/8"	100%		
No. 4	100%		
<b>Moisture Content As Received</b>			
No. 8	100%		
No. 10	99%		
No. 16	97%		
No. 30	95%		
No. 40	91%		
No. 50	75%		
No. 100	22%		
No. 200	4.7%

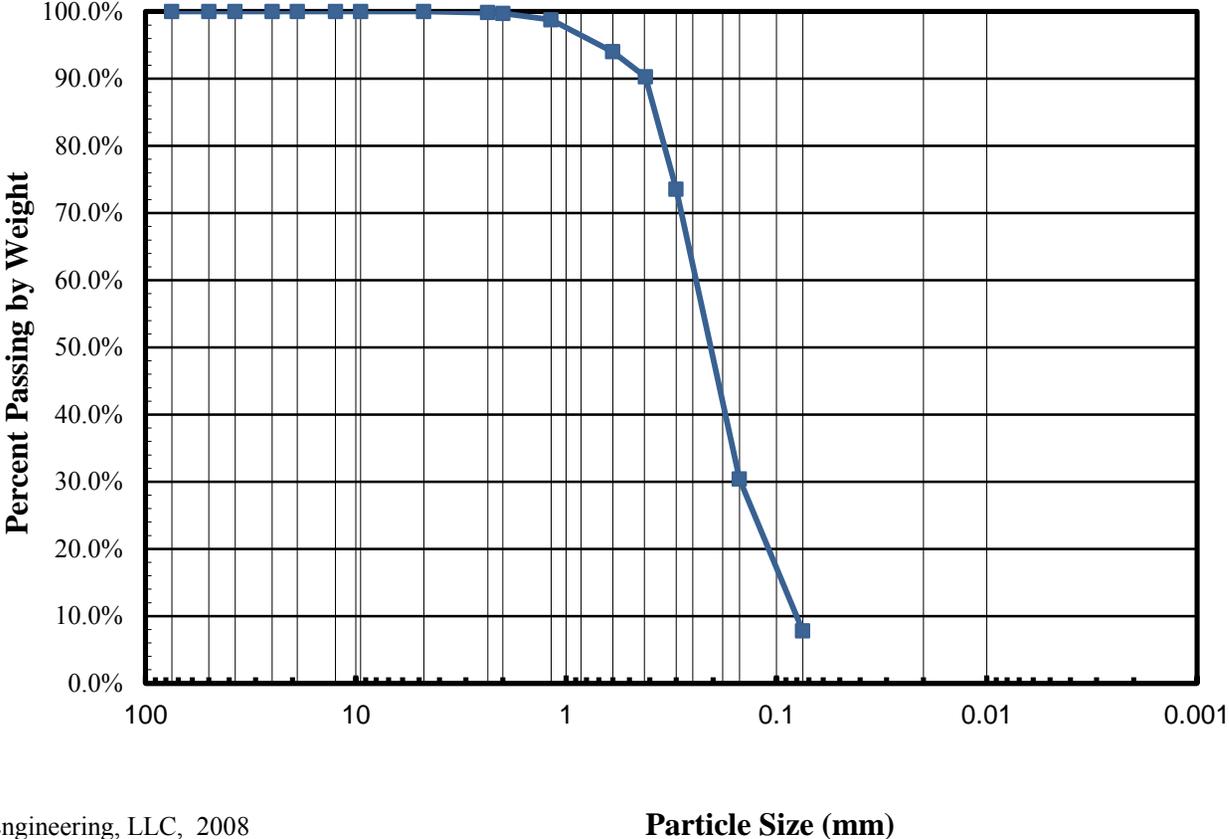
Client: Recon  
 Project: Totchaket  
 Material Description: Sand  
 Sample Location: TB08-01 @ 1.5-4.0'

SIZE	PASSING	SPECIFICATION	
		Low	High
3"	100%		
2"	100%		
1 1/2"	100%		
1"	100%		
3/4"	100%		
1/2"	100%		
3/8"	100%		
No. 4	100%		
<b>Moisture Content As Received</b>			
No. 8	100%		
No. 10	100%		
No. 16	99%		
No. 30	94%		
No. 40	90%		
No. 50	74%		
No. 100	30%		
No. 200	7.8%

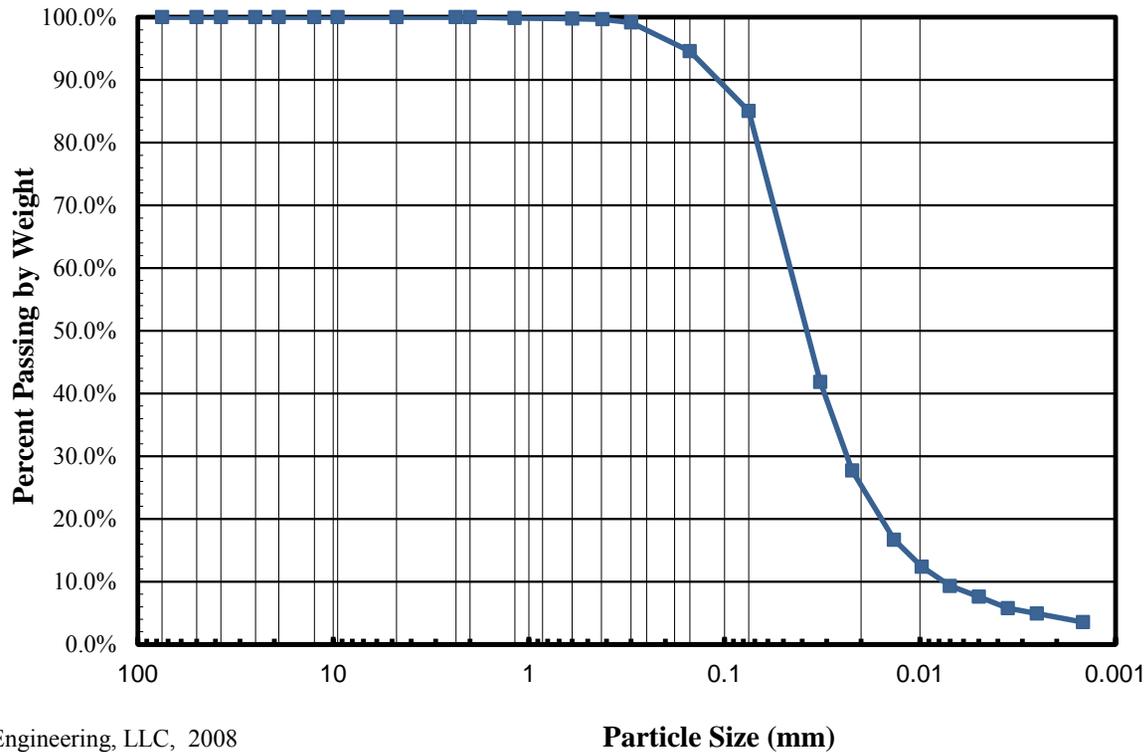
Client: Recon  
Project: Totchaket Silt  
Material Description: TB11-01 @ 1-4'  
Sample Location:

SIZE	PASSING	SPECIFICATION	
		Low	High
3"	100%		
2"	100%		
1 1/2"	100%		
1"	100%		
3/4"	100%		
1/2"	100%		
3/8"	100%		
No. 4	100%		
<b>Plasticity Index ASTM D4318</b>			
No. 8	100%		
No. 10	100%		
No. 16	100%		
No. 30	100%		
No. 40	100%		
No. 50	99%		
No. 100	95%		
No. 200	85.0%		
0.02mm	27.7%		
0.002 mm	4.9%		
0.001mm	3.6%		
<b>Moisture Content As Received ASTM C 123</b>			
21.6%

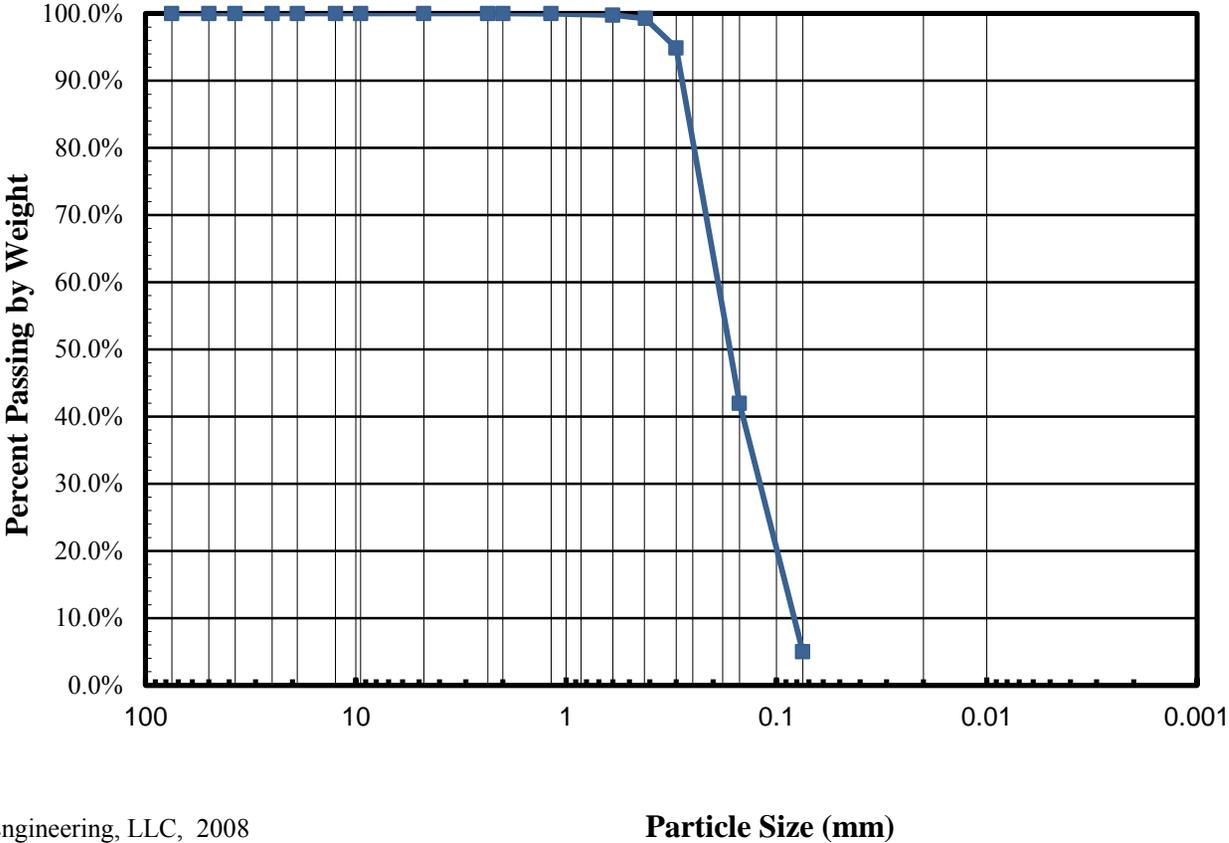
SIZE	PASSING	SPECIFICATION	
		Low	High
3"	100%		
2"	100%		
1 1/2"	100%		
1"	100%		
3/4"	100%		
1/2"	100%		
3/8"	100%		
No. 4	100%		
<b>Moisture Content As Received</b>			
No. 8	100%		
No. 10	100%		
No. 16	100%		
No. 30	100%		
No. 40	99%		
No. 50	95%		
No. 100	42%		
No. 200	5.0%

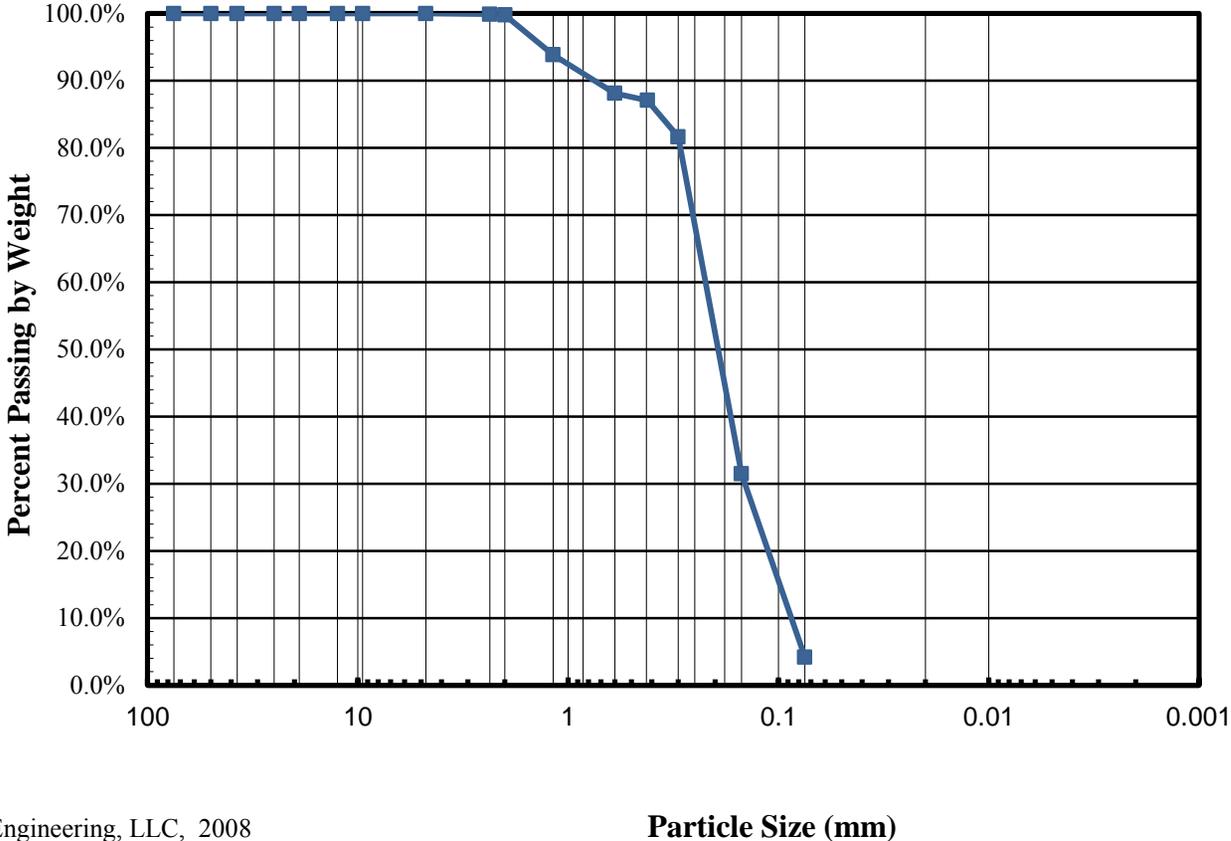
Client: Recon  
 Project: Totchaket  
 Material Description: Sand  
 Sample Location: TB18A-01 @ 4-8'

SIZE	PASSING	SPECIFICATION	
		Low	High
3"	100%		
2"	100%		
1 1/2"	100%		
1"	100%		
3/4"	100%		
1/2"	100%		
3/8"	100%		
No. 4	100%		
<b>Moisture Content As Received</b>			
No. 8	100%		
No. 10	100%		
No. 16	94%		
No. 30	88%		
No. 40	87%		
No. 50	82%		
No. 100	31%		
No. 200	4.2%

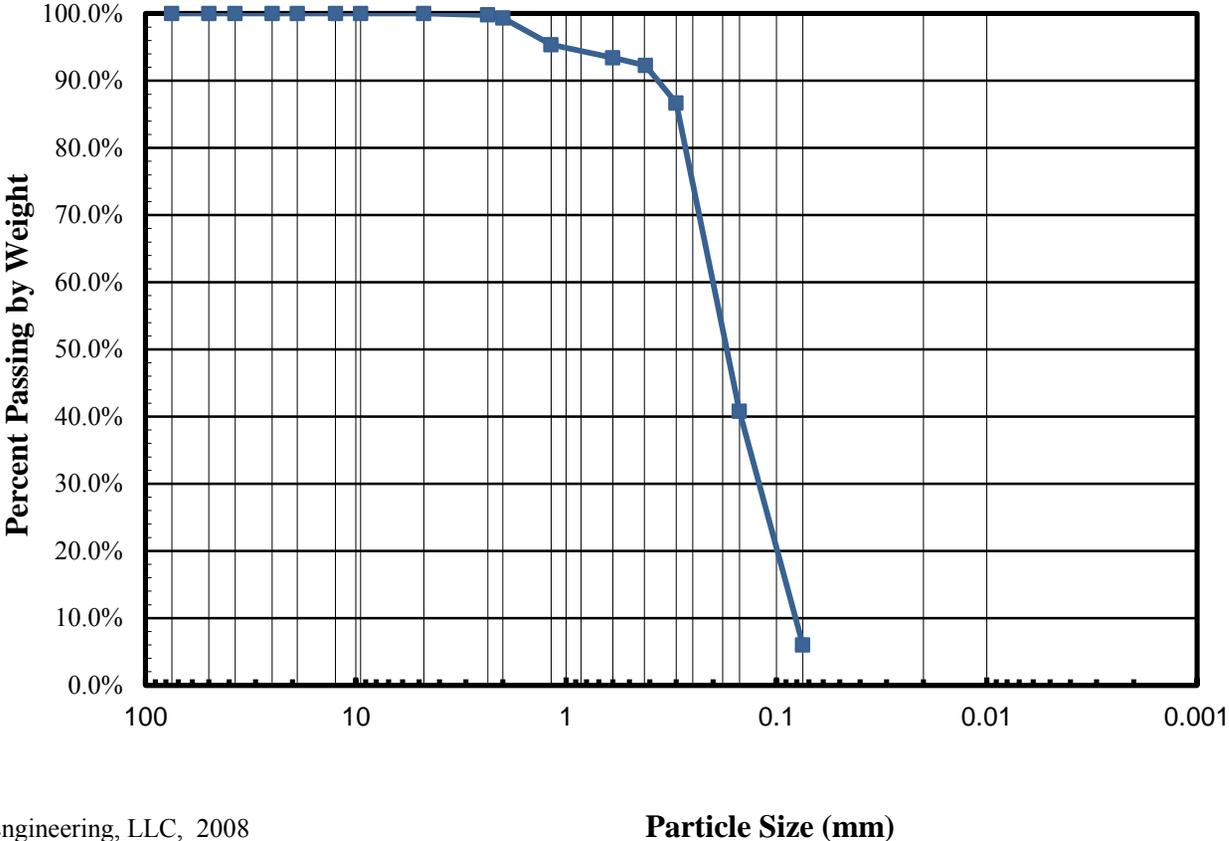
Client: Recon  
 Project: Totchaket  
 Material Description: Sand  
 Sample Location: TB21-01 @ 4-8'

SIZE	PASSING	SPECIFICATION	
		Low	High
3"	100%		
2"	100%		
1 1/2"	100%		
1"	100%		
3/4"	100%		
1/2"	100%		
3/8"	100%		
No. 4	100%		
No. 8	100%		
No. 10	99%		
No. 16	95%		
No. 30	93%		
No. 40	92%		
No. 50	87%		
No. 100	41%		
No. 200	6.0%
