CASCADE POINT
FERRY TERMINAL STAGE 1 DESIGN BUILD

Project No. HSHWY00015

REQUEST FOR PROPOSALS

PART IV – APPENDICES

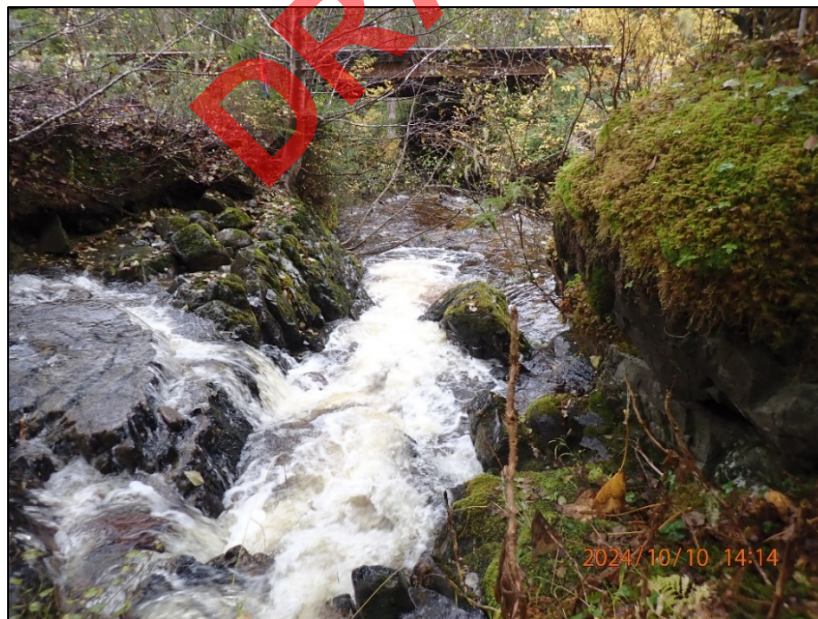
Figure 8: Looking downstream of a series of cascades between cross-sections 2+58.38 and 2+18.83.

Figure 8 A scour hole has developed at cross-section 2+18.83 due to the plunging flow across the cascades as shown in Figure 9. The scour hole was estimated to be approximately 2 feet deep. There are tall banks on both sides of the existing bridge between cascades, which facilitates channelized flow even during high flow conditions.

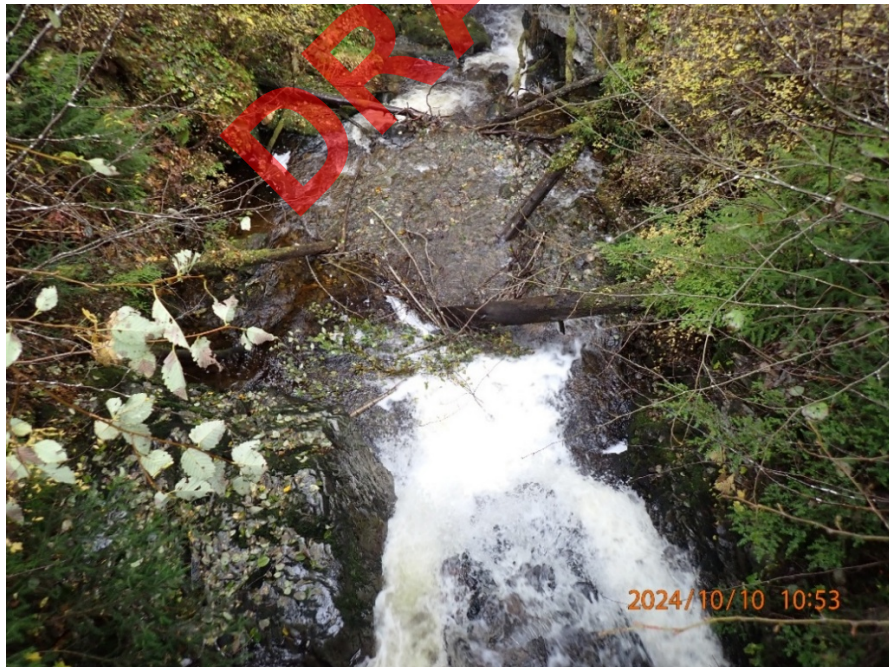
Figure 10: Looking downstream from the existing bridge across Cascade Creek.

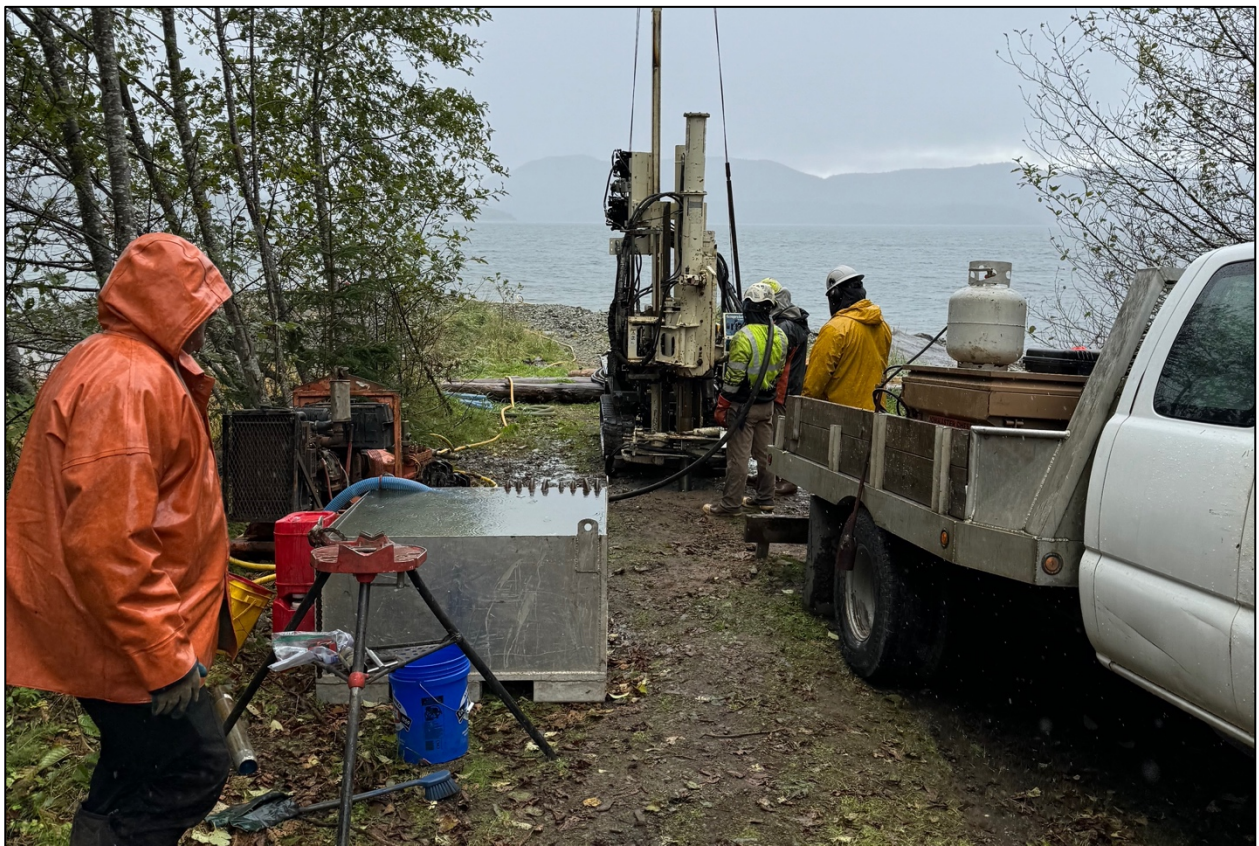
Figure 10. Borehole 21, showing the tracked drill rig utilized for all boreholes.
