### **Cultural Reconnaissance Report**

***Historical Review for the Gustavus Airport  
RSA Improvements Project (No. 68287),  
Gustavus, Alaska***

**December 2009**

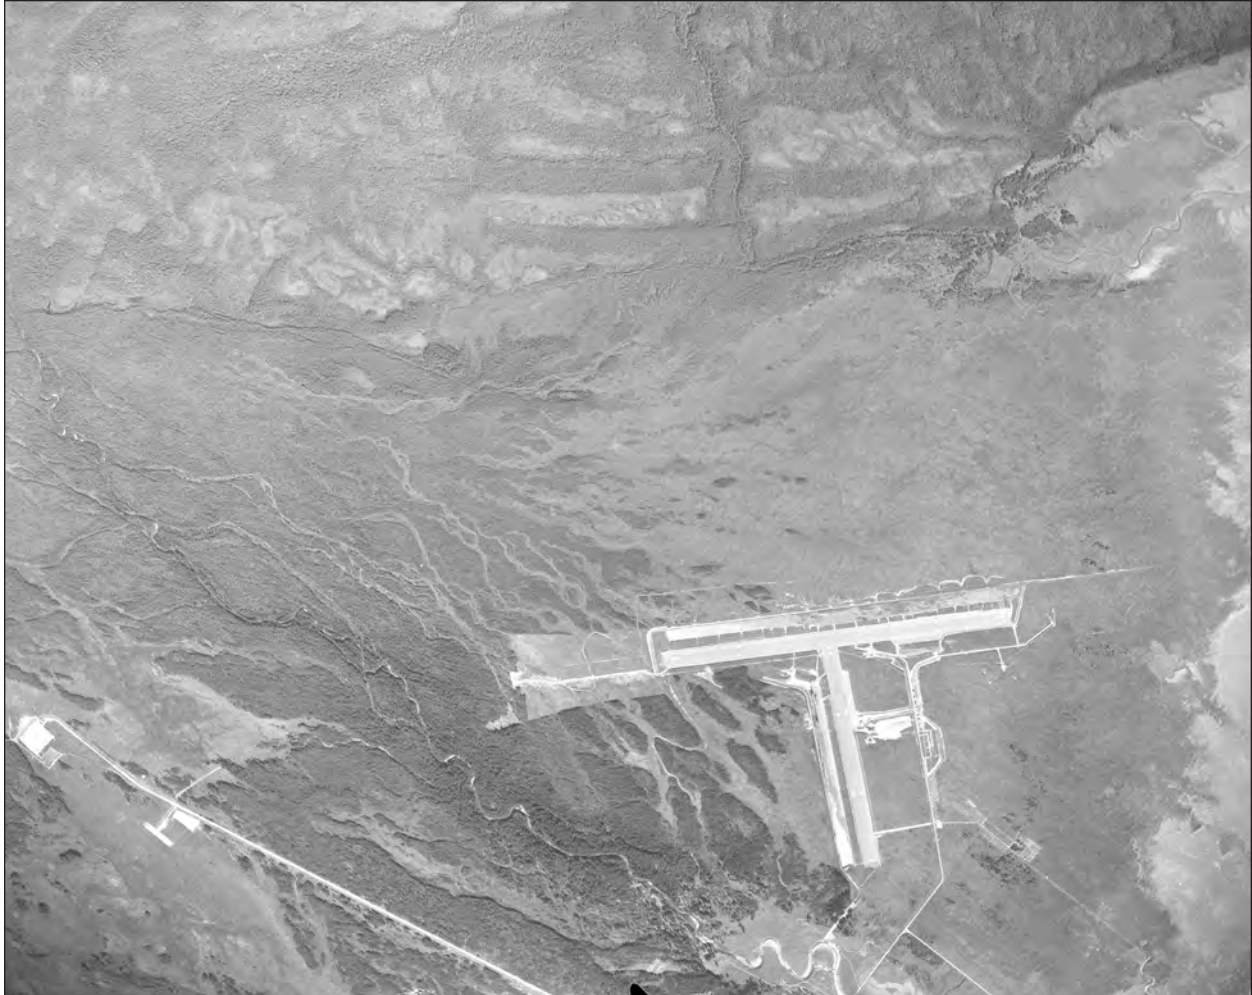
Figure 5. Gustavus Airfield in 1948.

How much of the complex associated with the airfield was constructed by 1945 when the CAA took over the over the facility remains unknown. The earliest discovered aerial photo of the facility is from 1948 and earlier, detailed construction data or inventories have yet to be found, even after several intensive searches (cf. Catton 1995, Chattey 1999, Howell and Johnson 2006; and Kurtz 1995). However, evidence suggests that the working facilities, such as the runways, of the airfield were already complete. Many of the buildings currently associated with the CAA district were built after 1948, but the general layout of the airfield changed little between 1948 and 1959 (compare Figures 5 and 6).

the facility's features have changed very little. A comparison of aerial photographs from 1948 and 1959 (see Figure 5 and 6) and a 2009 Google Earth image (Figure 7) show that the size, configuration, and spatial orientation of the runways and the majority of the roads and ditches near the airfield have remained the same.

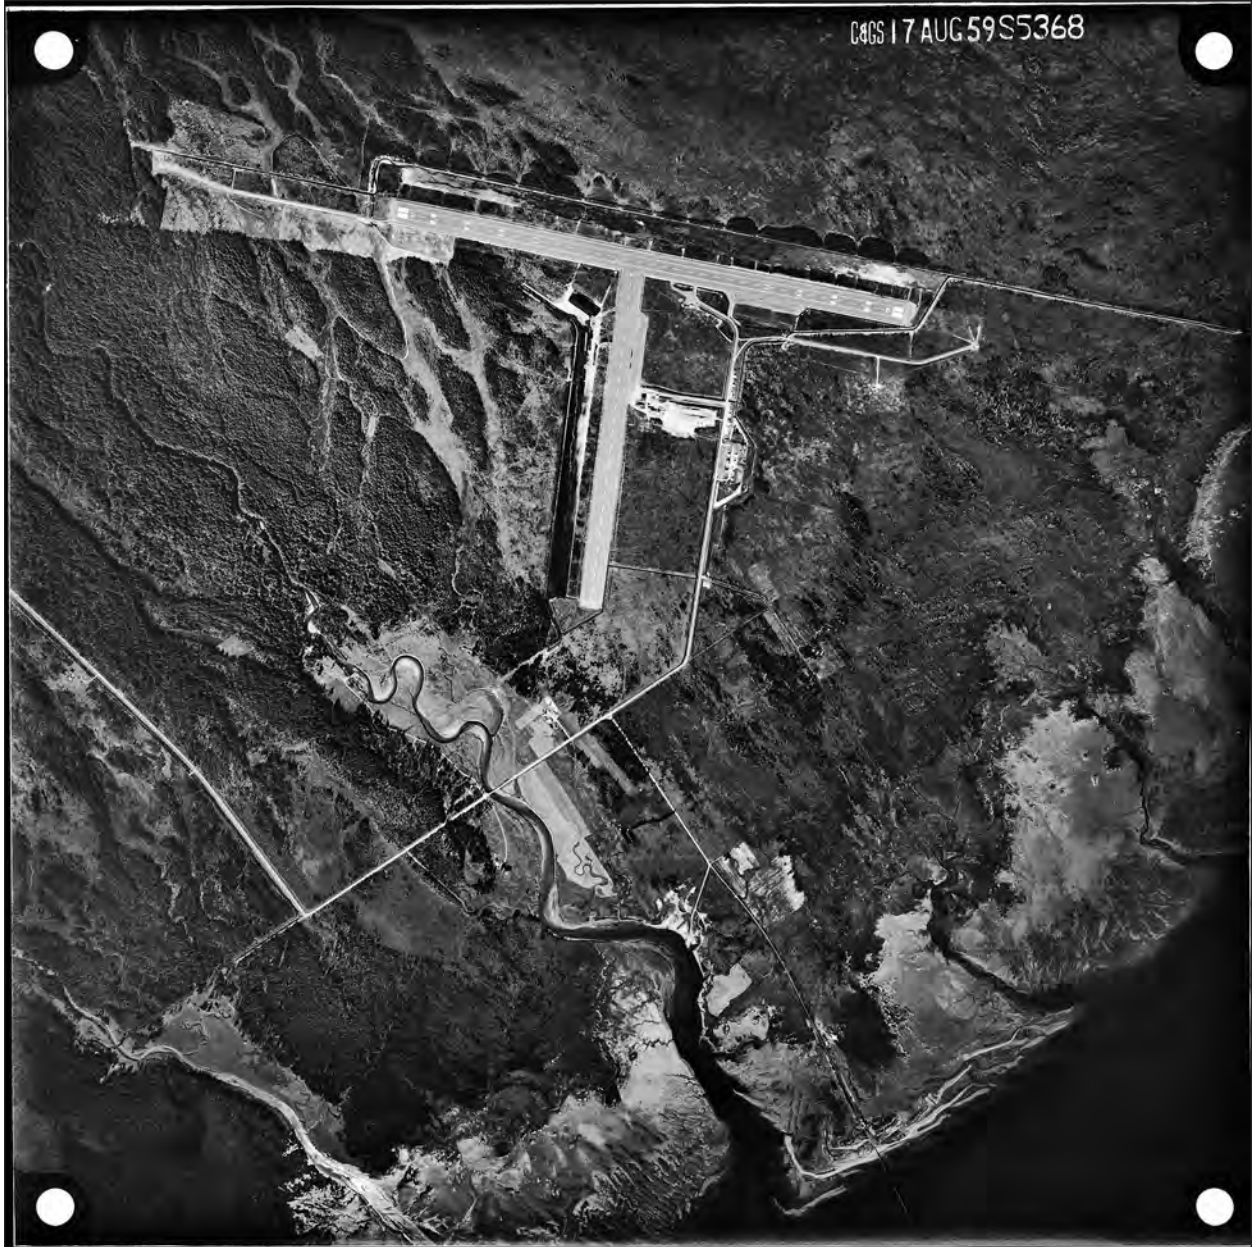
Figure 6. Gustavus Airport in 1959.

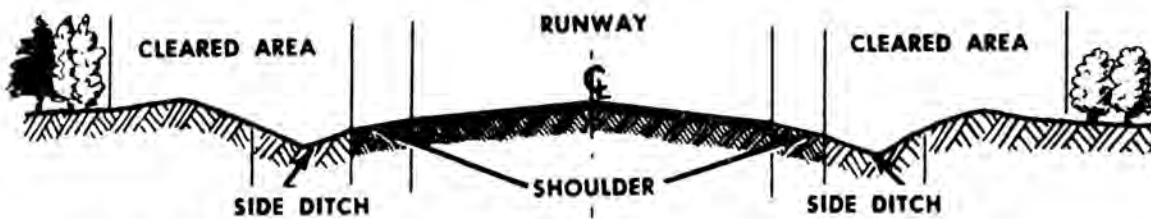
**(4) CROWNED CROSS SECTION (Vertical scale exaggerated)**

**(5) SLOPED CROSS SECTION (Vertical scale exaggerated)**

**(6) Required transverse slopes.**

Surface	% Slope	
	(min)	(max)
Mechanically stabilized soil and bituminous surface treatments, other than asphaltic concrete	1.5	2.0
Asphaltic and portland cement concrete	1.0 to	2.0
Shoulders	1.5	3.0
Side Ditches	1:12	1:8

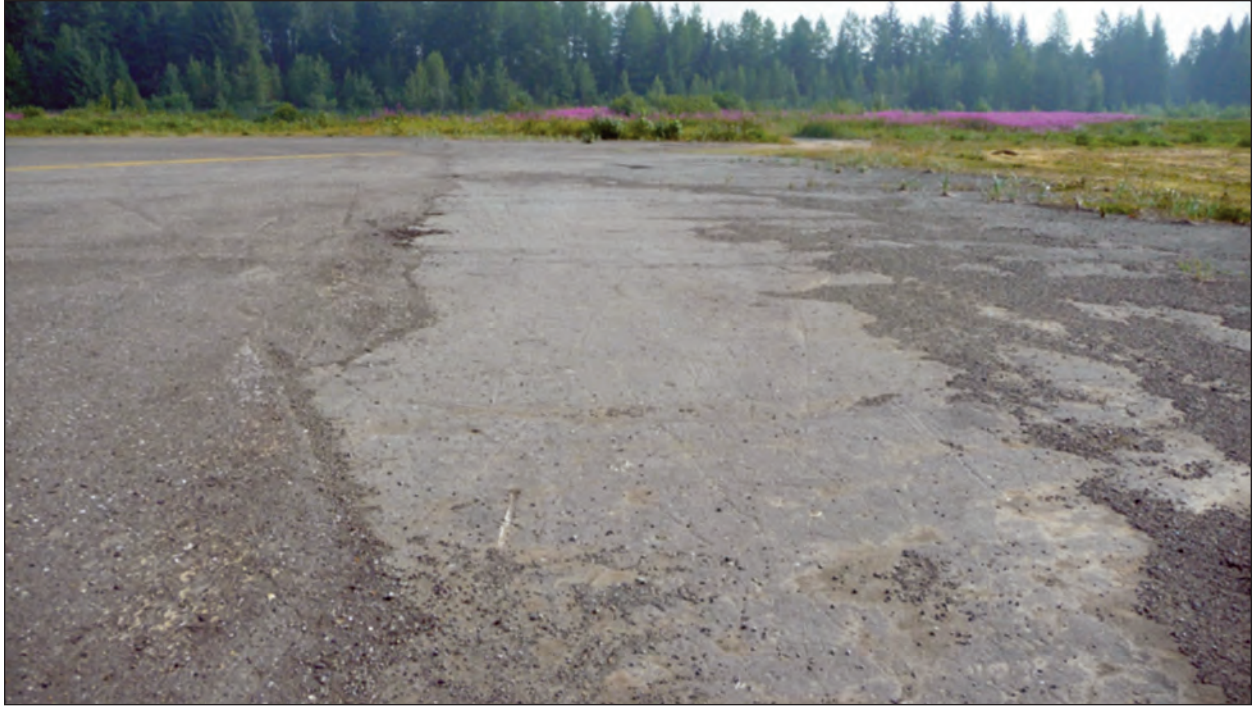
Figure 15. World War II-era pavement at the southern (29) end of the runway. From Tripp 2009a:2.

At the southern (29) end of the runway, World War II -era pavement extends approximately 50 feet beyond the end of the existing RSA (Figure 15). Some of the pavement is badly cracked and broken up into large pieces, especially where there has been vehicle traffic (Tripp 2009a:1-3). At the northern (11) end of the runway, there is what “looks like a fairly extensive area of World War II pavement [that is] fairly continuous near the edge of the RSA, less so as one moves away off the end of the RSA. It extends to as much as 60 feet off the RSA in one area. In another it extends only about 18 feet before it breaks up into chunks” (Tripp 2009a:21-22).

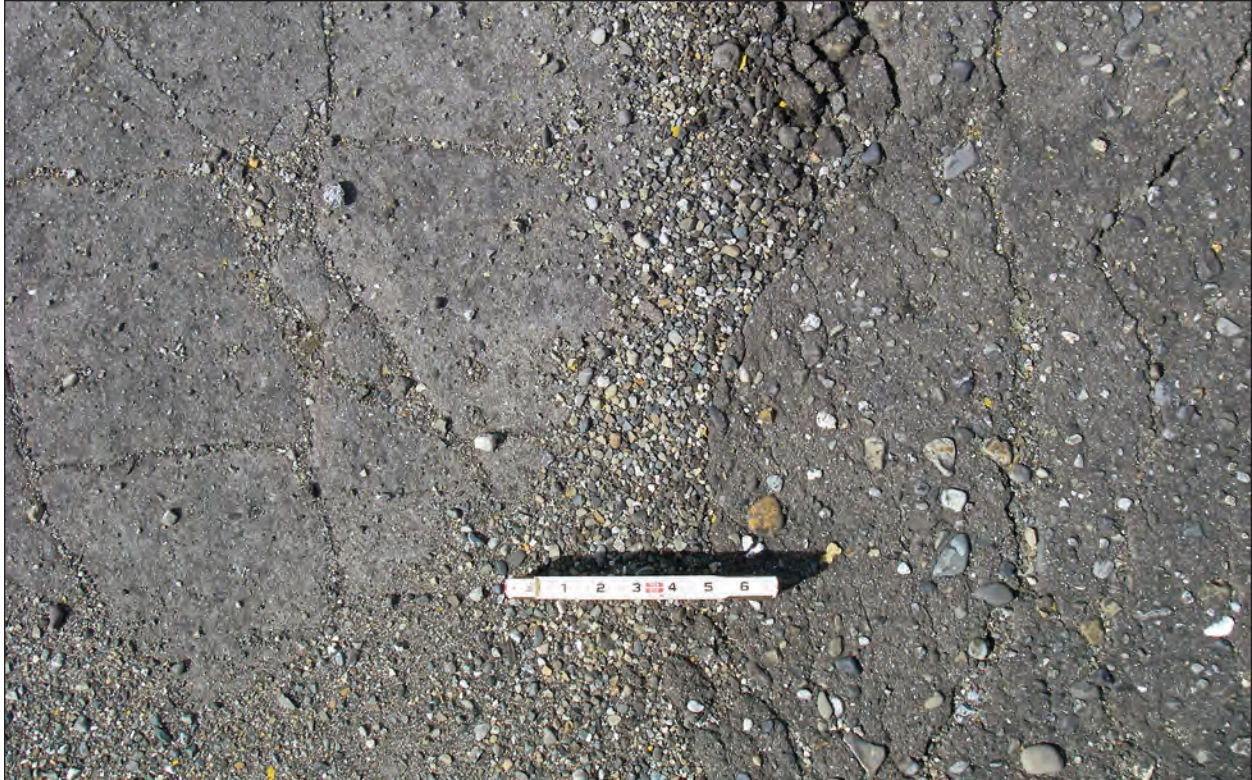
Figure 16. Layered pavement, with World War II-era pavement to the left. CRC LLC 2009.

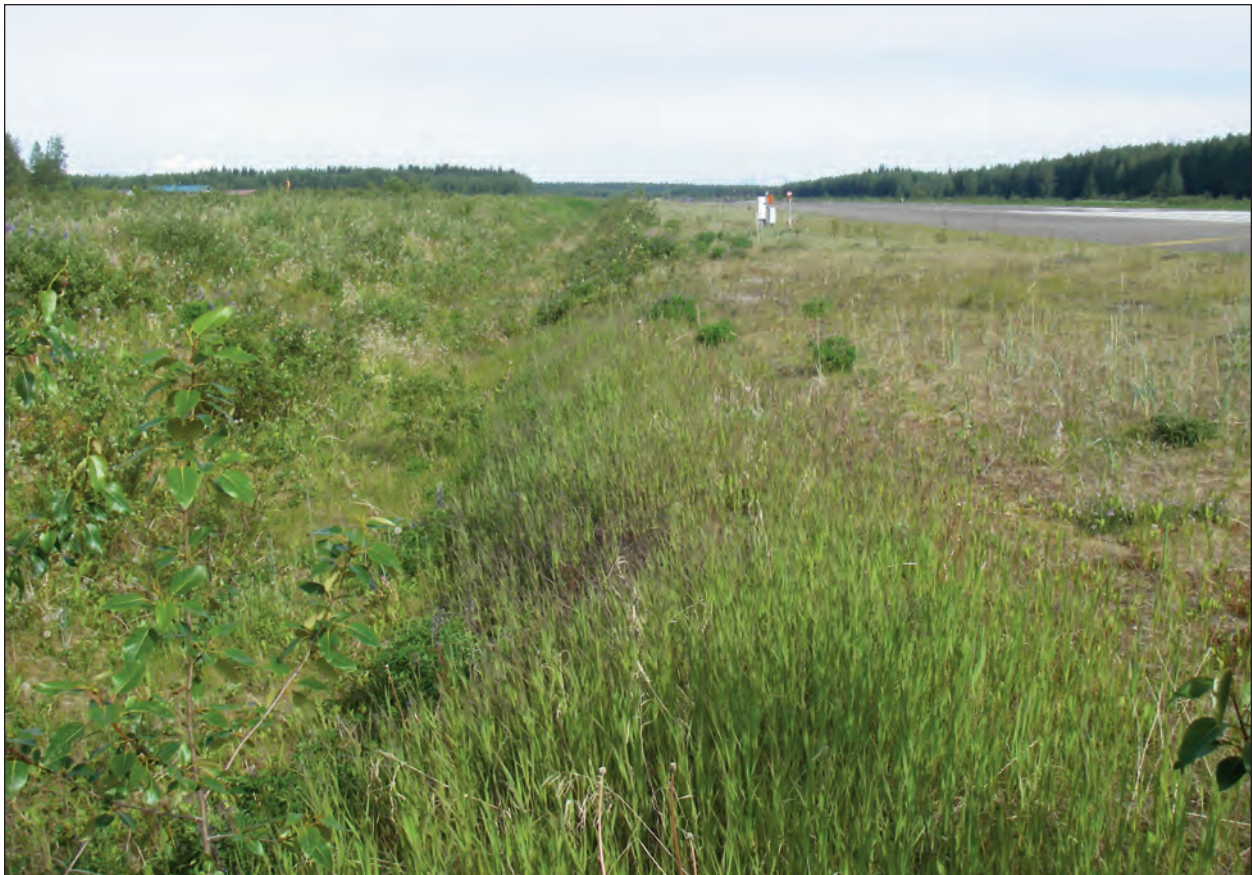
Figure 20. Feeder ditch paralleling the western edge of runway 11/29. View northwest. CRC LLC 2009.

The ditch paralleling the western edge of runway 11/29 (Figure 20) is a feeder ditch, similar to—but larger than—the trapezoidal ditch illustrated in Figure 21. This ditch is as much as 6 feet deep, 6 feet wide at the bottom, and 26 feet 6 inches wide at the top. Paralleling the runway to the east is another feeder ditch that is now generally u-shaped, although it, too, was likely originally trapezoidal. It is at most 5 feet deep and 22 feet wide, although vehicles traversing across, along side, and even in, the ditch have likely altered its shape and dimensions.

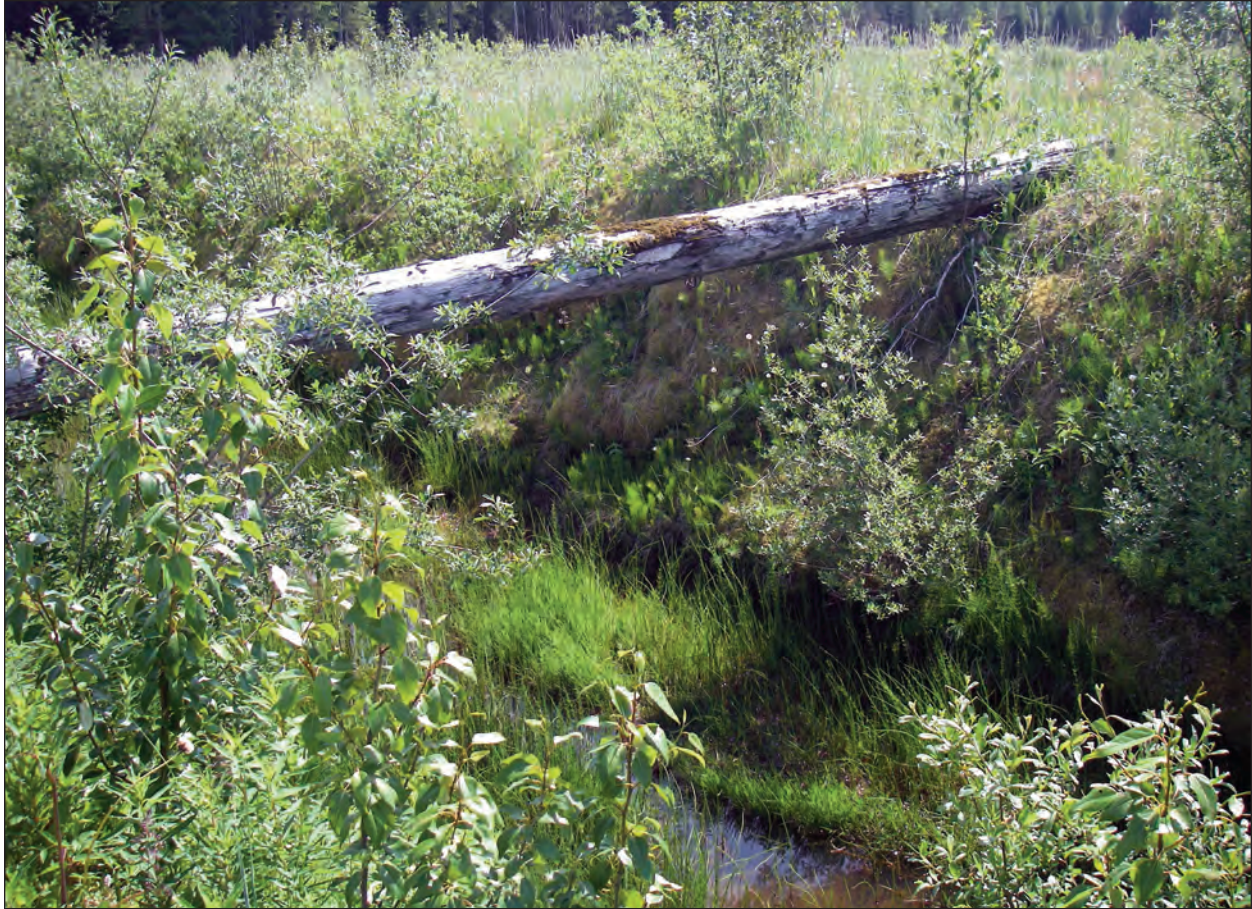
Figure 21. Collector ditch south of runway 11/29. CRC LLC 2009.

One collector ditch trends northwest to southeast along the western side of runway 11/29, then angles east-southeast of the runway to connect with a second collector (the “Existing Ditch” in Figures 2 and 3; Figure 21). A third collector ditch (the “Existing Stream” in Figures 2 and 3) is located just to the north of runway 11/29. It runs east-west, then makes a 90-degree turn to the south to parallel the eastern side of runway. It then connects with the other collector ditch just south of the runway and continues along a straight alignment to Icy Strait. The ditches are large and trapezoidal, measure between 8 and 17 feet deep and at least 12 feet across on the bottom, and—in places—contain several feet of flowing water.
