The Effects of Load History and Design Variables on Performance Limit States of Circular Bridge Columns Volume 2: Experimental Observations

Prepared By: Jason Chad Goodnight Yuhao Feng Mervyn J. Kowalsky James M. Nau North Carolina State University

January 2015

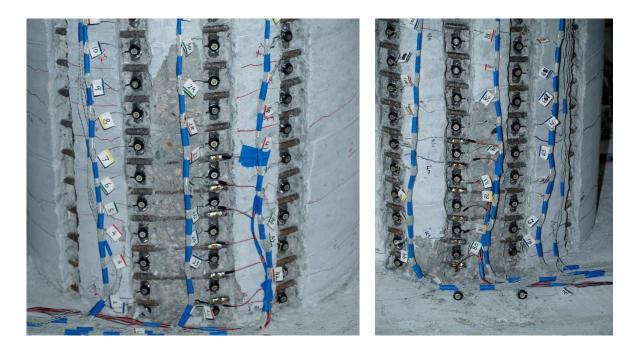
Figure 1.14 T9 – Cover Concrete Crushing (Left) South Side of the Specimen during $(\mu_3^{+1} = 2.51")$ and (Right) North Side of the Specimen during $(\mu_3^{-1} = -2.51")$

At $(\mu_1^{+1} = 0.84")$ the cracks on the North side of the specimen measured 0.35mm at approximate 6" spacing. The cracks on the South side of the specimen expanded to 0.4mm at 5" during $(\mu_1^{-1} = -0.84")$. During $(\mu_{1.5}^{+1} = 1.26")$, the cracks on the North measured 0.5mm at 6" spacing. The cracks on the South side of the specimen reached 0.75mm at 5" spacing during $(\mu_{1.5}^{-1} = -1.26")$. The North cracks expanded to 1.6mm at 5" spacing during $(\mu_2^{+1} =$ 1.69") as shown in Figure 1.13. The cracks on the South side of the specimen measured 1.7mm at 5" spacing during $(\mu_2^{-1} = -1.68")$. The cover concrete on both sides of the specimen showed signs of visible flaking, which precedes crushing, during $(\mu_2^{+2} = 1.69")$ and $(\mu_2^{-2} = -1.67")$ as shown in Figure 1.12. During $(\mu_3^{+1} = 2.51")$, the extent of crushing on the South side of the column reached 17" above the footing and 2.5mm crack widths were measured on the North side of the column. The extent of crushing on the North side of the specimen reached 13" above the footing during $(\mu_3^{-1} = -2.51")$, as shown in Figure 1.14.

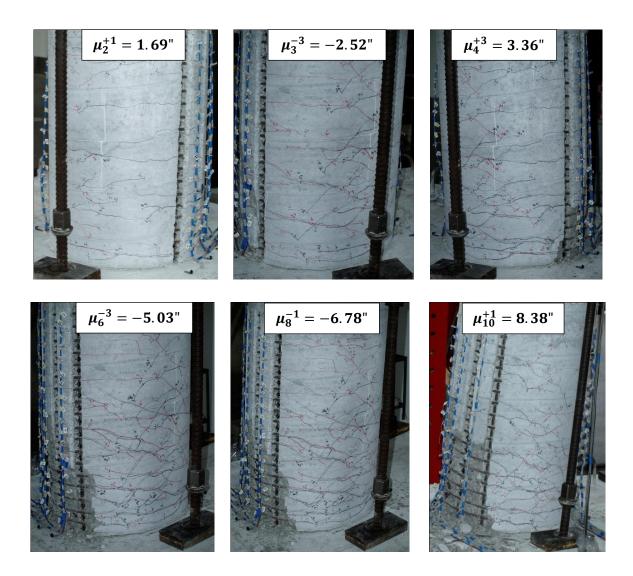
Figure 1.15 T9 – Crack Progression with Increasing Ductility Demands

The test progressed through $(\mu_8^{+1} = 6.72")$ without incident. The progression of cracking on the shear faces of the column appears in Figure 1.15. As the ductility level increased, the cracks became more numerous, increased in inclination, and linked up with cracks formed during loading in the opposite direction. The North extreme fiber reinforcing bar buckled after reversal from $(\mu_8^{+1} = 6.72")$, as shown in Figure 1.16. Additional North reinfrocing bars N2 and N4 buckled after reversal from $(\mu_8^{+2} = 6.71")$. The extreme fiber South reinforcing bar S3 buckled after reversal from $(\mu_8^{-2} = -6.70")$, as shown in Figure 1.17. During $(\mu_{10}^{+1} = 8.38")$, prevously buckled bars N3 and N4 ruptured and bar S2 buckled as shown in Figure 1.18. Two additional North reinforcing bars outside of the instrumented region buckled during $(\mu_{10}^{-1} = -8.48")$. During $(\mu_{10}^{+2} = 8.39")$, previously buckled. The test was concluded after the pull cycle to $(\mu_{10}^{-2} = -8.42")$ when previously buckled bars S3 and S2 ruptured. Rupture of previously buckled reinfrocing bars limited the displacement capacity of the bridge column as shown in Figure 1.20.

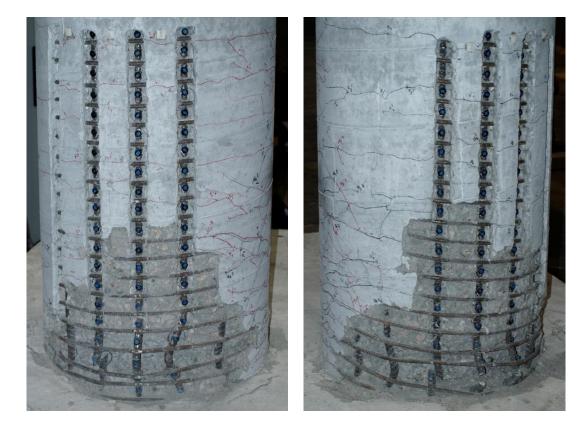
Figure 1.19 After the Test (Left) South Side and (Right) North Side

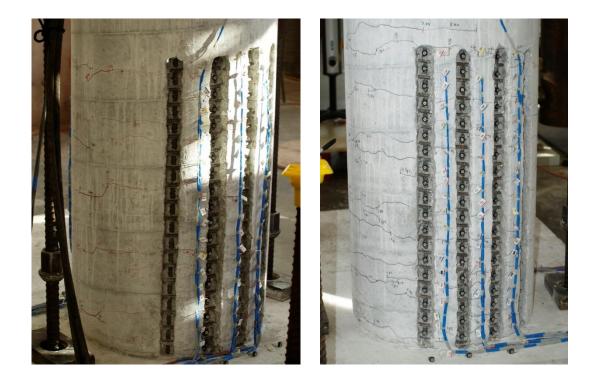
Figure 1.51 T8 – Crack Patterns on the (Left) South Side at $(\mu_{-1.2}^{8.12 \ sec} = -1.00")$ and (Right) North Side at $(\mu_{1.6}^{8.40 \ sec} = 1.35")$

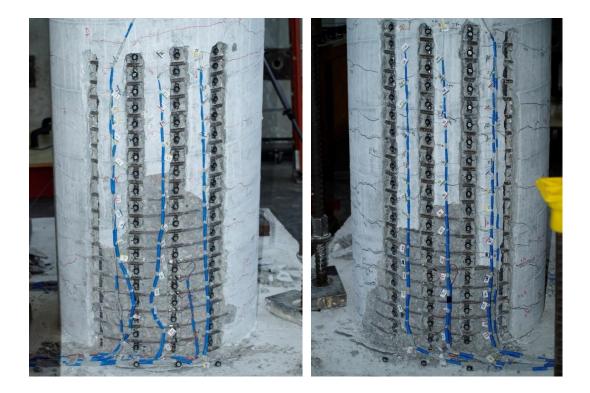
Figure 1.54 T8 – Peak Displacement ($\mu_{8.7}^{26.34 \, sec} = 7.25$ ") (Left) South & (Right) North

The peak displacement of ($\mu_{8.7}^{26.34 \, sec} = 7.25$ ") from the scaled Chile 2010 load history was reached with a lateral force of 69.18 kips. Photos of extreme fiber regions of the column at the peak displacement are shown in Figure 1.54. During subsequent reversals of loading the reinforcement remained visibly straight. Bar buckling or rupture did not occur, therefore, the load history was completed with degraded stiffness but no large losses in strength.

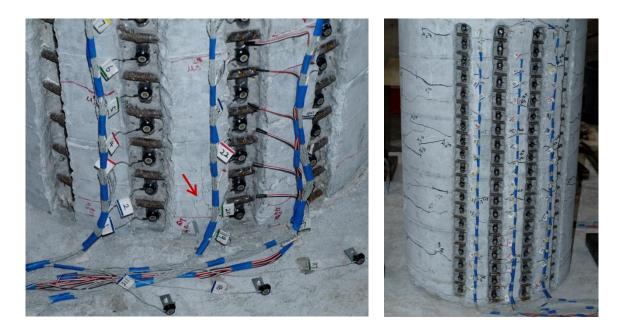
Figure 1.86 T10 – (Left) South Concrete Crushing ($\mu_{2.0}^{13.40 \, sec} = 1.70''$), (Right) North

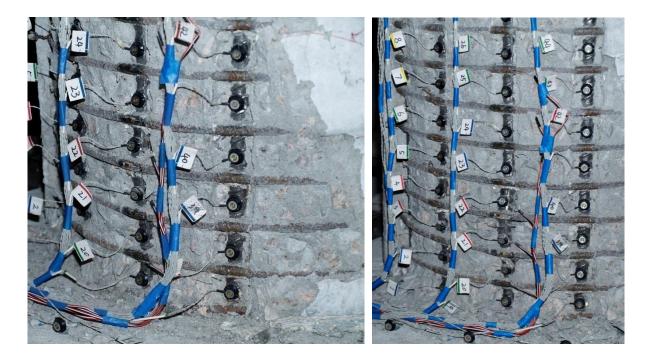
Figure 1.104 T10b – (Left) Buckling of Bar S3 after Reversal from $(\mu_6^{-1} = -5.01")$ and (Right) Buckling of S2 after Reversal from $(\mu_6^{-3} = -4.98")$

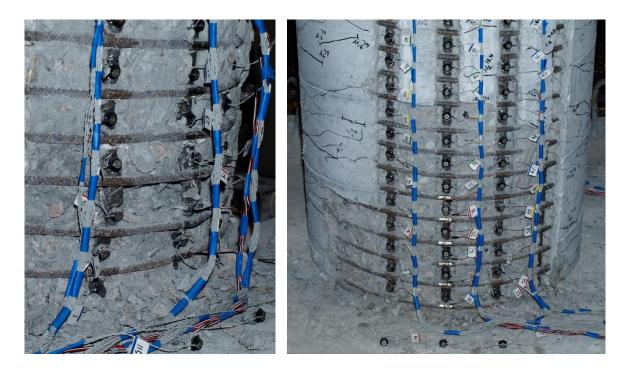
Figure 1.105 T10b – (Left) South at ($\mu_8^{+1} = 6.64''$) and (Right) North Side after Test

Since buckling did not occur during the Chichi load history, a second symmetric three cycle set load history was conducted on the specimen with degraded stiffness but no losses in strength, similar to Test 8b conducted after the Chile 2010 load history. The extreme fiber South reinforcement bar S3 buckled after reversal from ($\mu_6^{-1} = -5.01^{"}$), Figure 1.104. Due to the asymmetric nature of the Chichi load history, the South side of the specimen was subjected to low tensile demands but high compressive demands during the peak displacement cycle to ($\mu_{8.9}^{17.31 \, sec} = 7.40^{"}$). The purpose of the cyclic aftershock study shifted to determine if continued cycling at ductility six would rupture the previously buckled South reinforcement. After reversal from ($\mu_6^{-3} = -4.98^{"}$), bar S2 buckled as shown in Figure 1.104. Six complete cycles of ductility six where completed without rupturing previously buckled reinforcement on the South side of the specimen, so the load history continued to ductility eight as shown in Figure 1.82. As the load history progressed, visible deterioration of the core concrete on the South side of the specimen over the buckled region occurred due to loss of confinement, which is evident in the left photo in Figure 1.105 taken at ($\mu_8^{+1} = 6.64^{"}$).

Additionally, South reinforcement bar S4 buckled during $(\mu_8^{+1} = 6.64")$. Previously buckled reinforcing bar S3 ruptured in tension during $(\mu_8^{-1} = -6.63")$. Bar S1 buckled during $(\mu_8^{+2} = 6.62")$, and previously buckled Bar S2 ruptured during $(\mu_8^{-2} = -6.67")$. At $(\mu_8^{+3} = 6.63")$, the fifth reinforcing bar on the South side of the specimen buckled. Previously buckled reinforcing bar S4 ruptured during $(\mu_8^{-3} = -6.67")$. The test was concluded with five buckled bars on the South side of the specimen and intact reinforcing bars on the North side of the specimen, see Figure 1.106 and Figure 1.105 for photos of South and North sides of the specimen after testing.

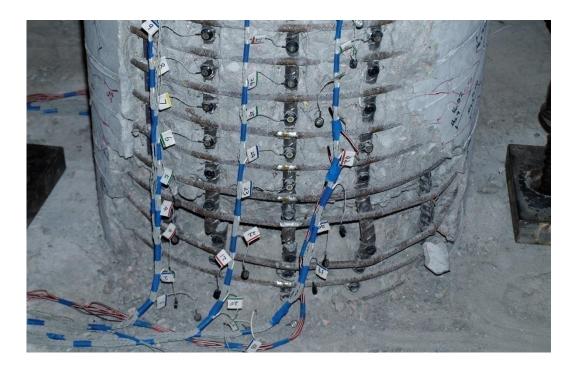
Figure 1.106 T10b – South Side after the Test (5 Buckled and 3 Ruptured Bars)

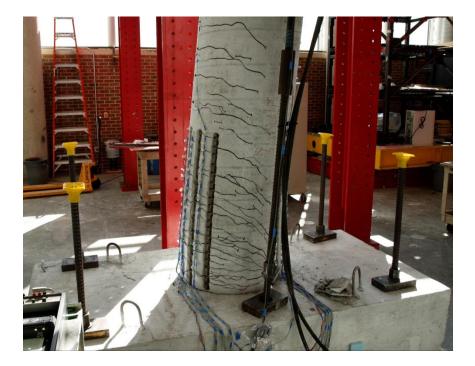
Figure 1.120 T12 – Crack Distribution at Peak Displacement ($\mu_{10}^{3.86 \, sec} = 8.28$ ")

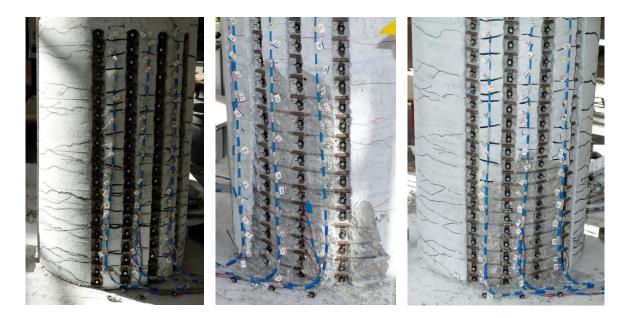
Figure 1.121 T11 – (Left and Middle) North and South Sides of Specimen during $(\mu_{10}^{3.86 \ sec} = 8.28")$ and (Right) North Side of the Specimen during $(\mu_{-6.1}^{4.42 \ sec} = -5.08")$

The first cycle of loading consisted a of small pull cycle to ductility 1.5, where cracks were measured at 0.75mm at approximate 5" spacing on the South side of the specimen. The Chile and Chichi records contained a cyclic ramp up to the peak cycle in contrast to the near monotonic push cycle to the peak displacement in the Kobe load history ($\mu_{10}^{3.86 \, sec} = 8.28$ "). The crack distribution on the North side of the specimen can be seen in the left photo of Figure 1.121, while the extent of crushing on the South side of the specimen appears in the middle photo. During the largest pull cycle at ($\mu_{-6.1}^{4.42 \, sec} = -5.08$ "), the concrete on the North side of the specimen crushed and the reinforcement did not show signs of visible buckling even though large tensile strains occurred during the near monotonic push cycle, Figure 1.121.

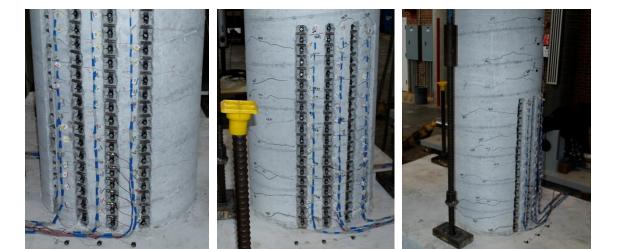
Figure 1.146 T12 – (Left) South Crack Distribution during $(\mu_{-1.3}^{47.53 \, sec} = -1.10")$ and (Middle & Right) North Crack Distribution during $(\mu_{2.1}^{48.83 \, sec} = 1.77")$

Cracks on the South side of the specimen were measured at 0.4mm during $(\mu_{-1.3}^{47.53 \, sec} = -1.10")$ as shown in Figure 1.146. The crack distribution on the North side of the specimen during $(\mu_{2.1}^{48.83 \, sec} = 1.77")$ appears in the middle and right photos of Figure 1.146. Crack widths on the North side of the specimen measured 2mm and the cover concrete on the South side of the specimen began to crush as shown in the left photo of Figure 1.147. Crushing on the South side of the specimen extended 10" above the footing during $(\mu_{2.4}^{61.36sec} = 2.02")$, while crack widths on the North side of the column measured 2.5mm. In previous tests, cover crushing began after visual flaking. This flaking was observed on the North side of the specimen during $(\mu_{-2.2}^{61.80 \, sec} = -1.85")$, as shown in the right photo of Figure 1.147. The extent of crushing on the North side of the specimen extended 7" above the footing during $(\mu_{-2.1}^{61.80 \, sec} = -1.71")$ as shown in the right photo of Figure 1.148.

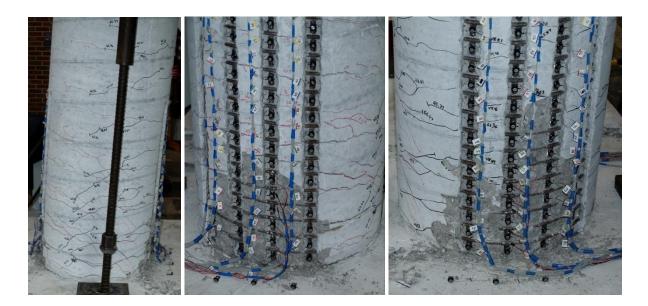
Figure 1.149 T12 – Peak Pull Cycle at $(\mu_{-7.9}^{66.88 \ sec} = -6.53") - (Left)$ Back Side of the Specimen, (Middle) South Side, and (Right) North Side

The largest cycle in the pull direction of loading occurred during ($\mu_{-7.9}^{66.88 \, sec} = -6.53$ ") with additional crushing on the North side of the specimen, see Figure 1.149. The peak cycle in the push direction at ($\mu_{9.9}^{68.62 \, sec} = -8.22$ ") was concluded without visible buckling on the South side of the specimen, Figure 1.150. A peak lateral load of 72.1 kips was recorded during the largest cycle of the Japan 2011 load history. Upon reversal of loading from

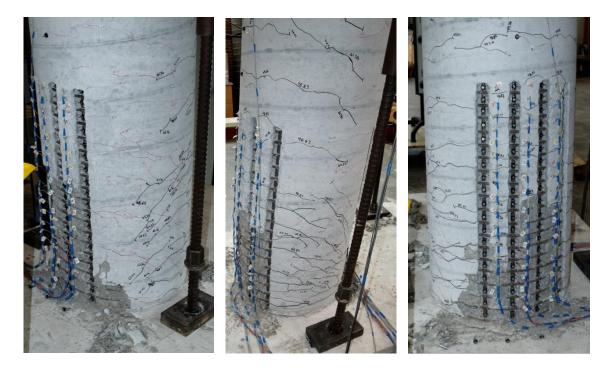
Figure 1.150 T12 – Peak Push Cycle in the Japan 2011 Load History ($\mu_{9.9}^{68.62sec} = 8.22$ ")

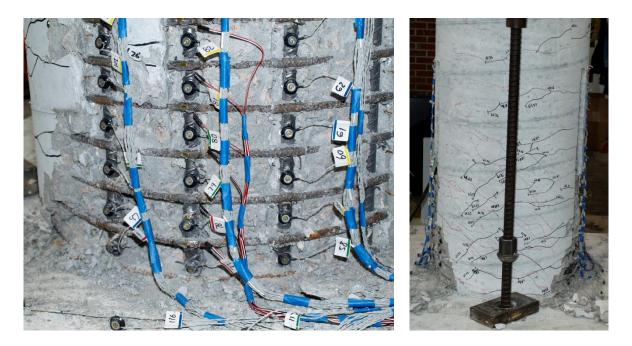
Figure 1.152 T12 – Increased Deformation in the Buckled bars toward the End of LH

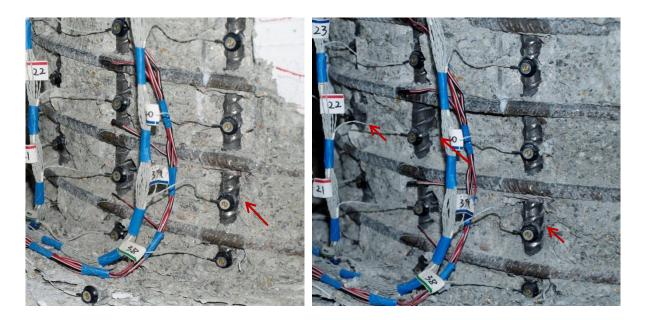
Figure 1.188 T13 – Buckling of South Reinforcing Bar S4 during $(\mu_8^{+2} = 6.46")$ and (Right) Buckling of Bar S2 and S3 during $(\mu_{10}^{+1} = 8.07")$

After reversal from ($\mu_8^{+1} = 6.46^{"}$), extreme fiber bar N3 and adjacent bar N2 buckled as shown in the left photo of Figure 1.187. During the second push cycle of ductility eight, South reinforcing bar S4 visibly buckled, see the left photo of Figure 1.188. The South extreme fiber bar S3 did not show signs of visible buckling while adjacent bar S4 deformed out of plane at the location where more prominent buckling later occurred. During the second and third pull cycles of ductility eight the deformation in the North buckled bars increased and an additional bar N4 buckled as shown in the right photo of Figure 1.187. The buckled deformation of both the North and South reinforcement occurred between layers of transverse steel (#4 at 2.75" spacing). Buckling over two to three layers of transverse steel was observed in previous tests with a #3 spiral at 2" spacing.

During $(\mu_{10}^{+1} = 8.07")$, two of the previously buckled North reinforcing bars ruptured and South reinforcing bars S2 and S3 buckled, see Figure 1.188 and Figure 1.189. Rupture of the North reinforcing bar N3 occurred before the bar straightened out in tension. While this has never been observed in previous tests, it is likely a consequence of the more severe buckled profile between layers of transverse reinforcement, see Figure 1.187. Losses in strength from reinforcement ruptures are shown in Figure 1.183 on the hysteretic response. Three additional North reinforcing bars ruptured during the $(\mu_{10}^{+2} = 8.06")$. Three previously buckled reinforcing bars on the South side of the specimen ruptured during $(\mu_{10}^{-2} = -8.12")$. The test was concluded with a total of eight ruptured reinforcing bars and a considerable loss of strength in each direction of loading.

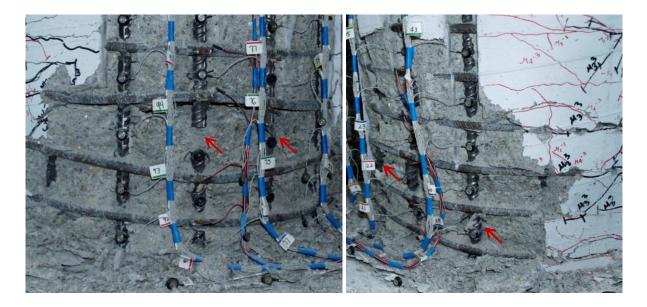
Figure 1.189 T13 – (Left) Rupture of North Reinforcement Bars N2 and N3 during $(\mu_{10}^{+1} = 8.07")$ and (Right) Additional Deformation in South Bars during $(\mu_{10}^{+2} = 8.06")$

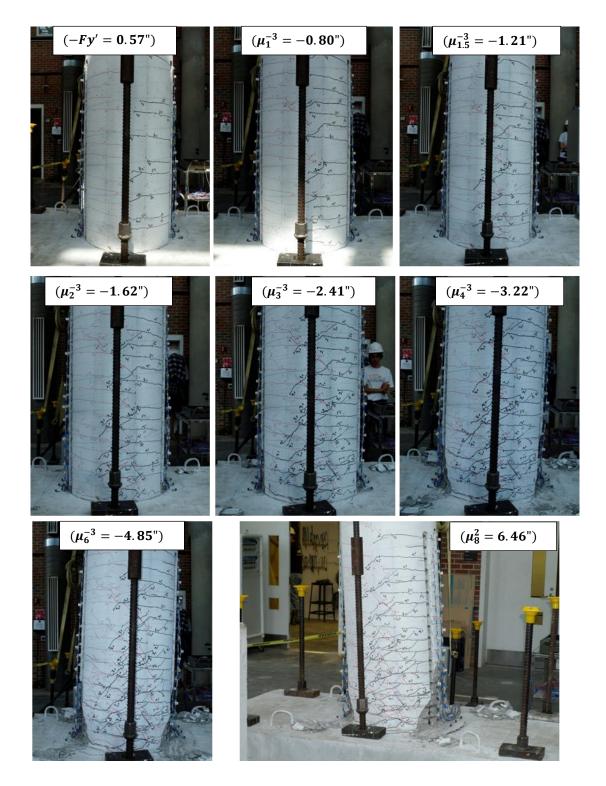
Figure 1.190 T13 – Crack Progression on the Back Side of the Specimen

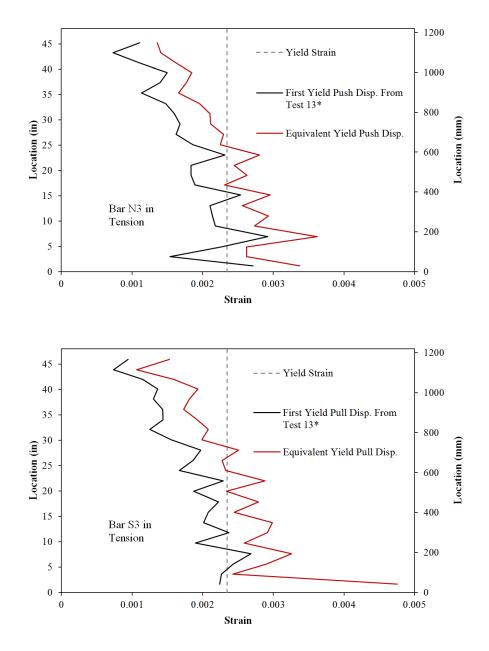
Figure 1.220 T14 – North and South Bar Strain Profiles during Δ'_{ν} (Test 13) and Δ_{ν}

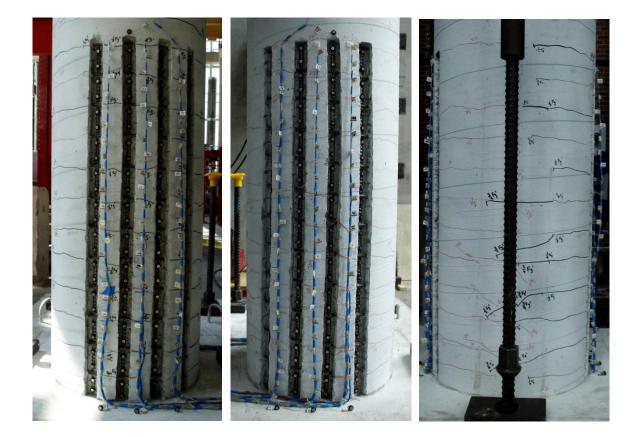
Figure 1.221 T14 – Crack Distribution after All Cycles with Actuator Load Cell Errors (No Notable Limit States Reached)

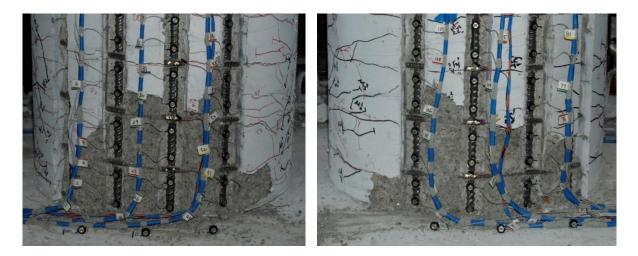
Figure 1.223 T14 – (Left) Extent of Crushing on the South Side of the Specimen during $(\mu_4^{+3} = 3.19")$ and (Right) Extent of Crushing on the North Side during $(\mu_4^{-3} = 3.20")$

The extent of crushing on the North and South sides of the specimen during the third cycle of ductility four is shown in Figure 1.223. Extreme fiber North reinforcing bar N3 buckled after reversal from ($\mu_6^{+1} = 4.80$ "), see the left photo of Figure 1.224. All three instrumented bars on the South side of the specimen (S2, S3, and S4) buckled after reversal from $(\mu_6^{-1} = -4.80")$, as shown in the right photo of Figure 1.224. During the reversal from $(\mu_6^{+2} = 4.82")$, additional North reinforcement bars N2 and N4 buckled, Figure 1.225. North reinforcing bars N1 and N5 buckled during ($\mu_6^{-3} = -4.80^{"}$). At the end of ductility six there was 9% strength loss in the push direction of loading and 12% strength loss in the pull direction due to buckled reinforcing bars and loss of confinement prior to rupture. On the way to $(\mu_8^{+1} = 6.40")$, South reinforcing bar S1 buckled. Separation of the deformed spiral North reinforcing bars, while they were in tension, is shown in Figure 1.226. During $(\mu_8^{-1} = -6.39")$, previously buckled South reinforcing bars S2, S3, and S4 ruptured causing a 48% loss in strength, Figure 1.227. On the way to $(\mu_8^{+2} = 6.40")$, previously buckled North reinforcing bars N2 and N3 ruptured causing a 45% loss in strength, as shown in the left photo of Figure 1.228. North reinforcement bars N4 and N5 ruptured on the way to $(\mu_8^{+2} = 6.40")$ causing a 67% loss in strength. The test was concluded at this time and photos which show the specimen after instrumentation and debris were removed appear in Figure 1.228. A photo progression of the crack propagation on the back side of the specimen is shown in Figure 1.229.

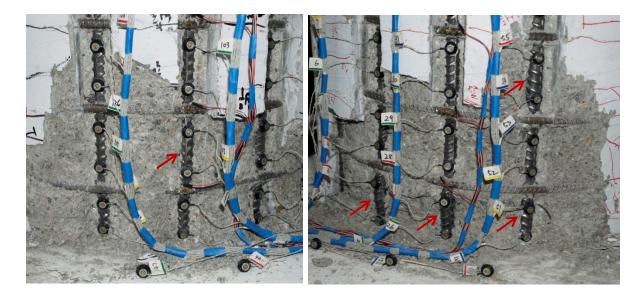
Figure 1.224 T14 – (Left) Buckling of Bar N3 during $(\mu_6^{-1} = -4.80")$ and (Right) Buckling of South Reinforcing Bars S2, S3, and S4 during $(\mu_6^{+2} = 4.82")$

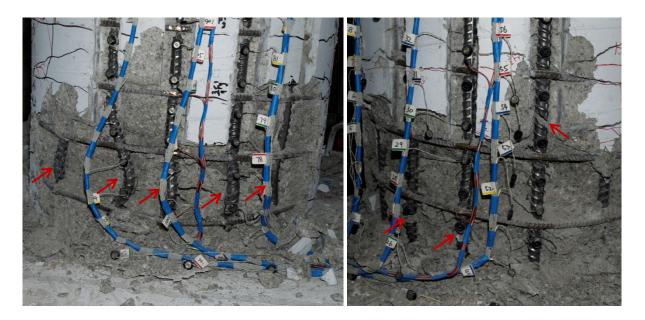
Figure 1.227 T14 – (Left) Deformation in North Buckled Bars during ($\mu_8^{-1} = -6.39$ ") and (Right) Rupture of South Buckled Bars S2, S3, and S4 during ($\mu_8^{-1} = -6.39$ ")

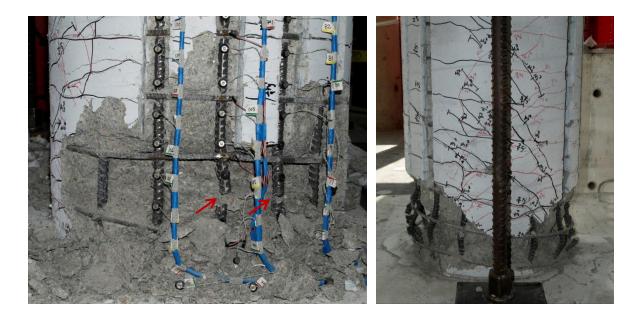
Figure 1.228 T14 – (Left) Rupture of North Buckled Bars N2 and N3 during ($\mu_8^{+2} = 6.40^{"}$) and (Right) Front of the Specimen after the Conclusion of the Test

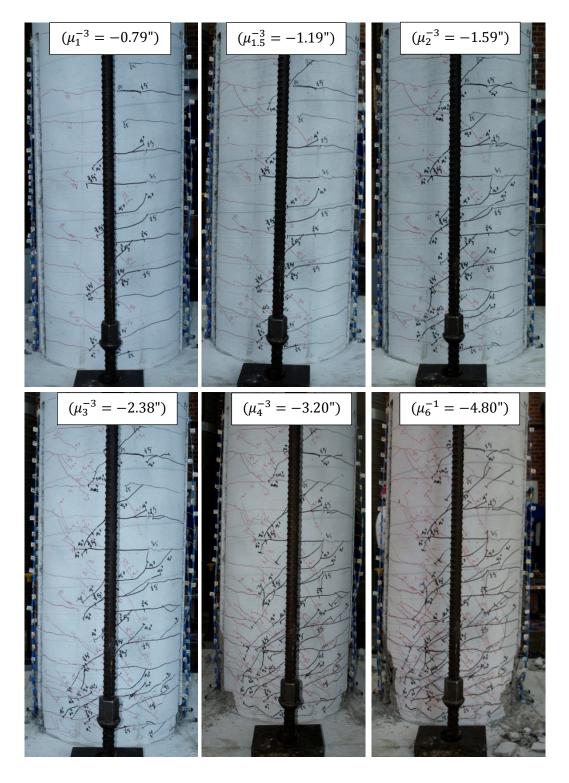
Figure 1.229 T14 – Crack Propagation and Orientation on the Back of the Specimen

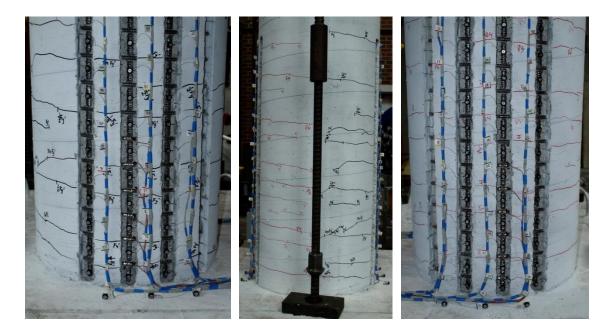
Figure 1.257 T15 – Crack Distribution at First Yield (Left) North and (Right) South

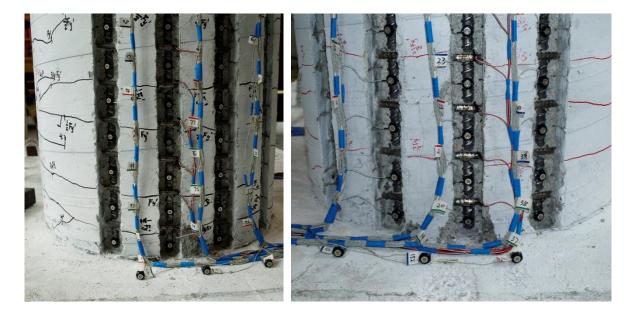
Figure 1.258 T15 – (Left) Crushing on the North Side of the Specimen during $(\mu_{1.5}^{-3} = -1.25")$ and (Right) Crushing on the South Side during $(\mu_2^{+1} = 1.68")$

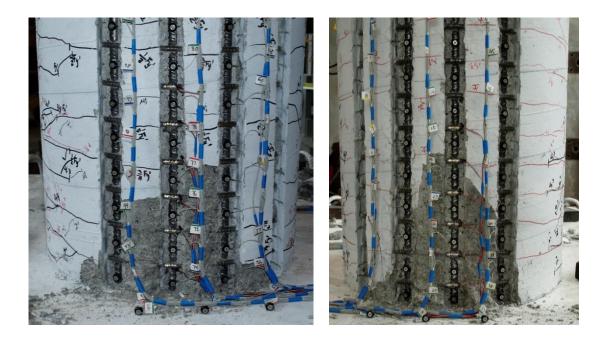
Figure 1.259 T15 – (Left) Crushing on the North Side of the Specimen during $(\mu_3^{-3} = -2.51")$ and (Left) Crushing on the South Side during $(\mu_3^{+3} = 2.49")$

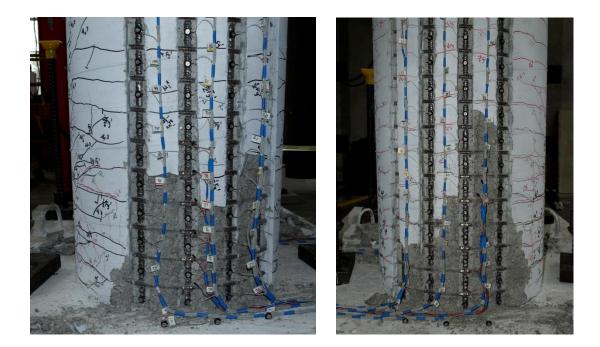
Figure 1.260 T15 – (Left) Extent of Crushing on the North Side of the Specimen during $(\mu_6^{-1} = -5.00")$ and (Right) Crushing on the South Side during $(\mu_6^{+1} = 5.01")$

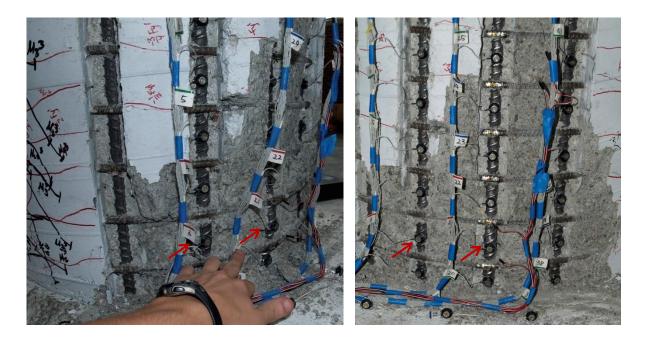
Figure 1.261 T15 – Buckling of Reinforcing Bars S2 and S3 during ($\mu_6^{+2} = 5.00"$)

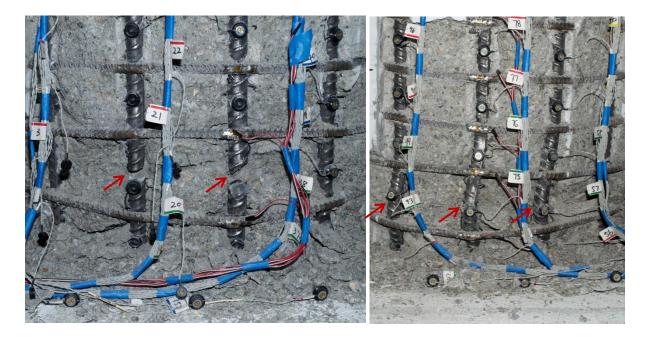
Figure 1.264 T15 – (Left) Rupture of Previously Buckled Bars S2 and S3 during $(\mu_8^{-1} = -6.69")$ and (Right) Deformation in Bars N2, N3, and N4 at $(\mu_8^{-1} = -6.69")$

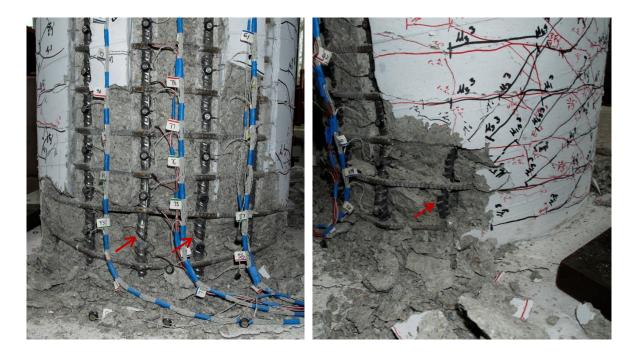
Figure 1.265 T15 – (Left) Rupture of Previously Buckled Bars N2 and N3 during $(\mu_8^{+2} = 6.67")$ and (Right) Buckling of Bar S1 and S5 during $(\mu_8^{+2} = 6.67")$

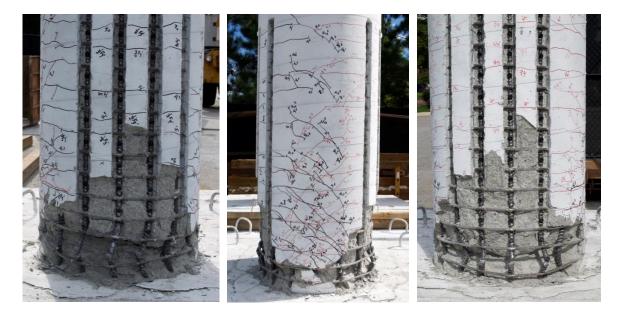
Figure 1.266 T15 – After the Test (Left) North, (Middle) Front, and (Right) South Side

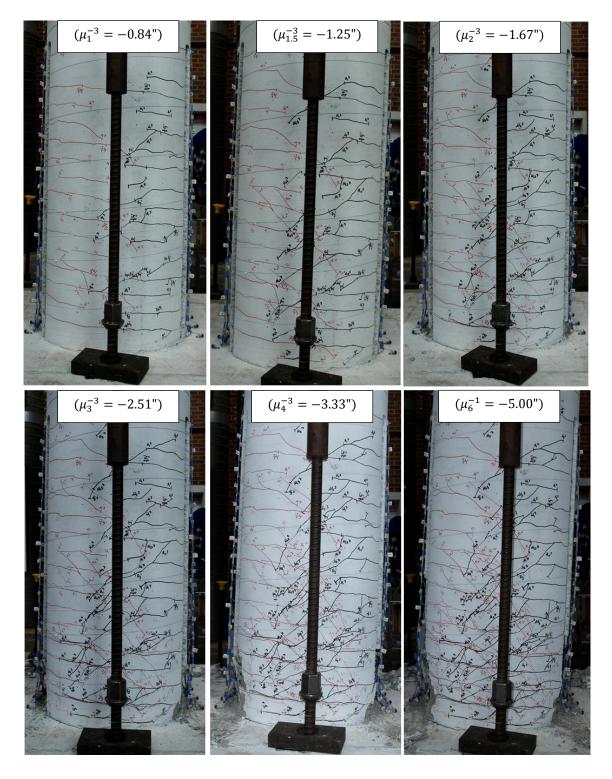
Figure 1.267 T15 – Crack Progression on the Back Side of the Specimen

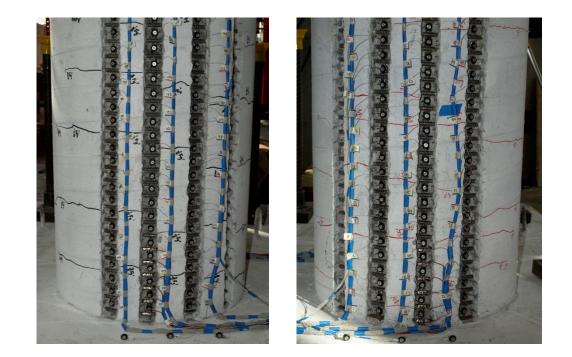
Figure 1.295 T16 – Crack Distribution at First Yield (Left) North and (Right) South

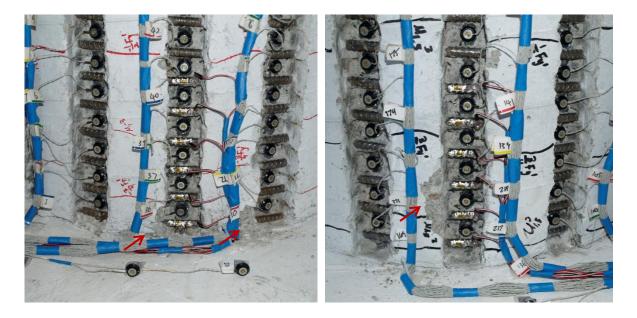
Figure 1.296 T16 – (Left) South Crushing during $(\mu_2^{+1} = 1.66")$ and (Right) North Crushing during $(\mu_2^{-3} = -1.65")$

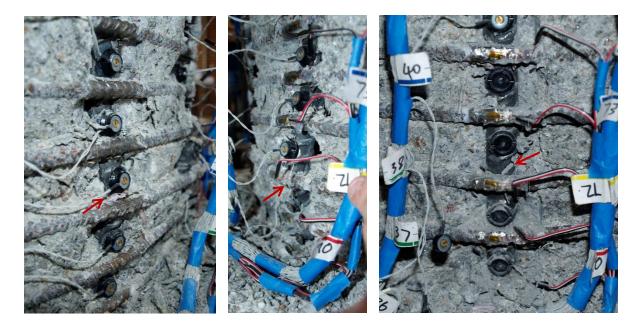
Figure 1.300 T16 – (Left) Buckling of Bar S2 during $(\mu_{10}^{+1} = 8.29")$, (Middle) Deformation in Bar S3 at $(\mu_{10}^{+1} = 8.29")$, and (Right) Rupture of Bar S3 during $(\mu_{10}^{-1} = -8.34")$

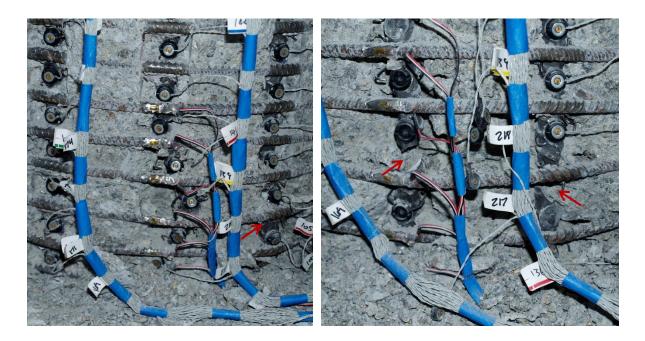
Figure 1.301 T16 – (Left) Buckling of N1 and N4 during $(\mu_{10}^{-1} = -8.34")$ and (Right) Rupture of N2 and N3 during $(\mu_{10}^{+2} = 8.32")$

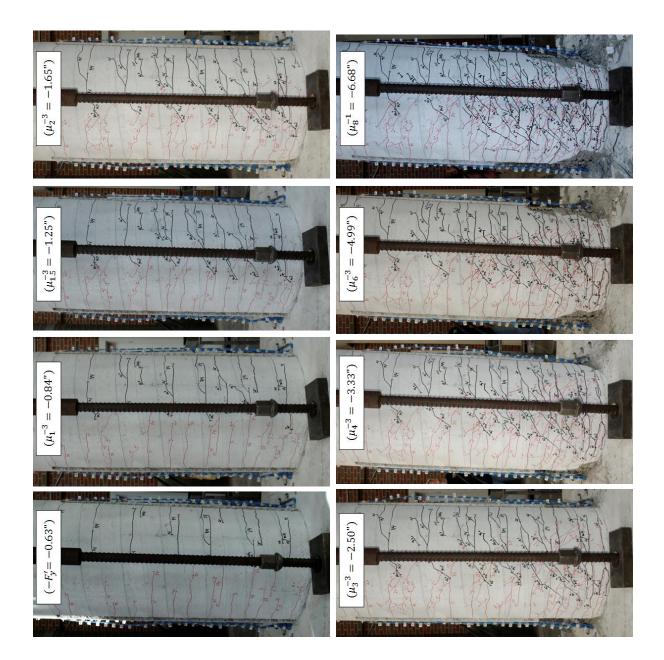
Figure 1.303 T16 – Crack Progression on the Back Side of the Specimen (North has Black Crack Markings while South has Red)

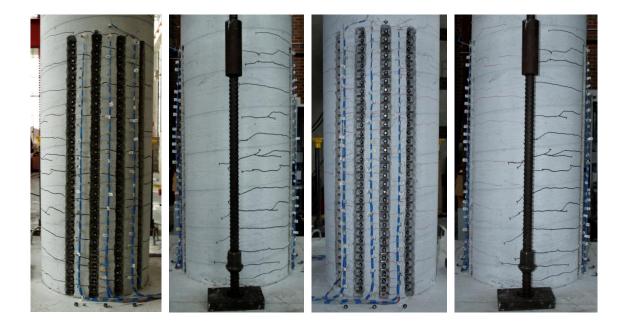
Figure 1.333 T17 – (Left) North Crack Distribution during $(\mu_{1.0}^{10.50 \, sec} = 0.84")$, (Mid-Left) Back Side during $(\mu_{1.5}^{11.91 \, sec} = 1.22")$, (Mid-Right) South Side during $(\mu_{-1.2}^{12.25 \, sec} = -0.96")$, and (Right) Back Side during $(\mu_{-1.2}^{12.25 \, sec} = -0.96")$

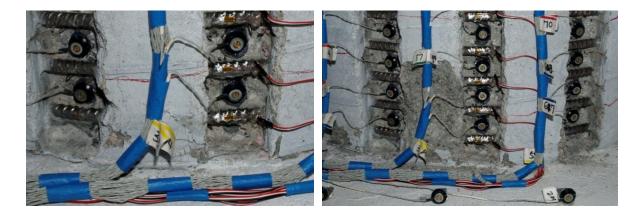
Figure 1.334 T17 – (Left) Cover Concrete Flaking Preceding Crushing on the South Side during ($\mu_{1.6}^{12.50 \, sec} = 1.32^{"}$), (Right) Cover Concrete Crushing on the South Side at $(\mu_{2.0}^{15.32 \, sec} = 1.67^{"})$

Visible flaking of cover concrete, which precedes crushing, was observed on the South side of the specimen during ($\mu_{1.6}^{12.50 \, sec} = 1.32^{"}$), as shown in the left photo of Figure 1.334. Cover concrete crushing over the lowest 5" of the South side of the column occurred during ($\mu_{2.0}^{15.32 \, sec} = 1.67^{"}$), see the right photo of Figure 1.334. Also during this cycle, crack widths on the North side of the specimen reached 1.5mm at approximate 6" spacing. Cover concrete crushing on the North side of the specimen over 3.5" occurred during ($\mu_{-1.9}^{16.27 \, sec} = -1.60^{"}$), see the left photo of Figure 1.335. The extent of crushing on the North side increased to 18.5" above the footing during ($\mu_{-3.5}^{17.66 \, sec} = -2.87^{"}$), as shown in the right photo of Figure 1.335. The extent of crushing on the specimen reached 24" above the footing during ($\mu_{-5.4}^{18.52 \, sec} = -4.49^{"}$), see the left photo of Figure 1.336. The extent of crushing on the South side of the specimen reached 21.5" above the footing during ($\mu_{3.5}^{21.36 \, sec} = 2.89^{"}$). The crack distribution on the South and back sides of the specimen appear in the middle and right photos of Figure 1.336.

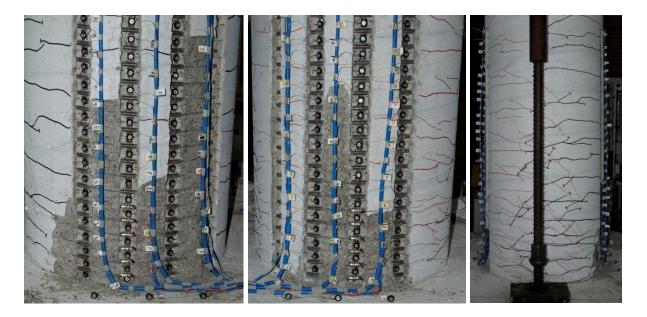
Figure 1.336 T17 – (Left) Extent of Crushing on the North Side during $(\mu_{-5.4}^{18.52 \, sec} = -4.49")$, (Middle) Extent of Crushing on the South Side during $(\mu_{3.5}^{21.36 \, sec} = 2.89")$, and (Right) Crack Distribution on the Back Side during $(\mu_{3.5}^{21.36 \, sec} = 2.89")$

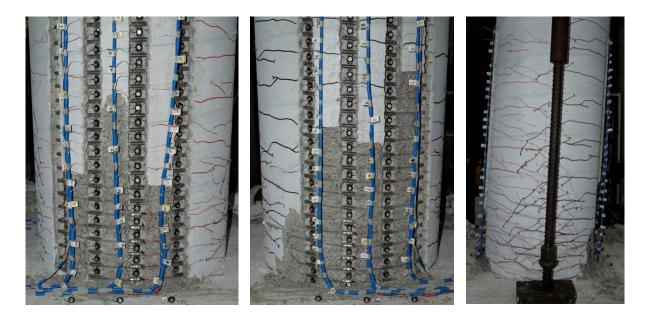
Figure 1.337 T17 – (Left) Extent of Crushing on the South during $(\mu_{4.7}^{30.52 \, sec} = 3.95")$, (Middle) Crushing on the North Side during $(\mu_{-6.0}^{31.34 \, sec} = -4.96")$, and (Right) Crack Distribution on the Back Side during $(\mu_{-6.0}^{31.34 \, sec} = -4.96")$

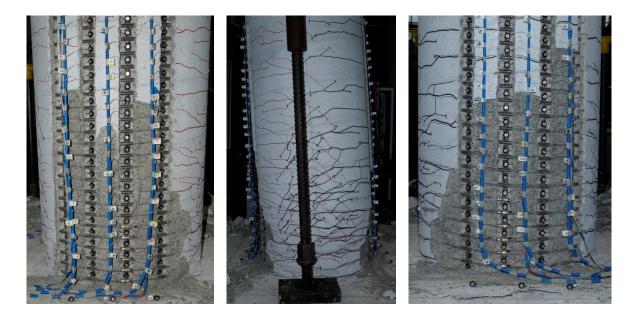
Figure 1.338 T17 – (Left, Middle, and Right) South, Back, and North Side of the Specimen during ($\mu_{9.0}^{32.76 \, sec} = 7.49$ ") Respectively

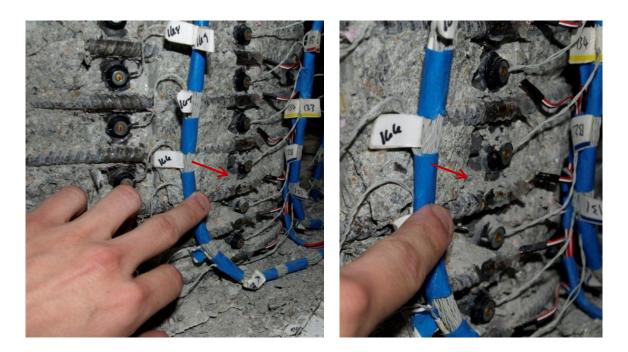
Figure 1.339 T17b – (Left and Right) Buckling of North Reinforcing Bar N3 during $(\mu_6^{-2} = -5.00")$ of the Cyclic Aftershock Load History

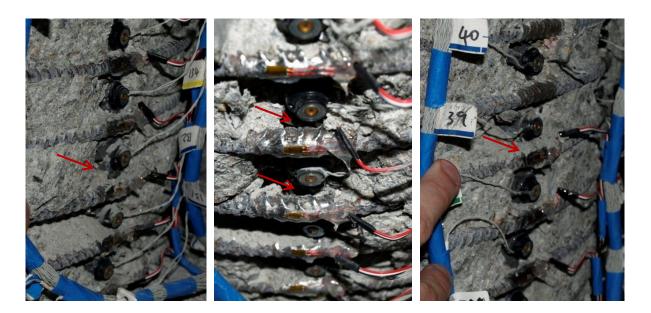
Figure 1.341 T17 – (Left) Additional Deformation in Buckled Bar N3 during ($\mu_6^{-3} = -5.00^{"}$), (Middle) Spiral Deformation over North Buckled Region at ($\mu_6^{+4} = 5.00^{"}$), and (Right) Additional Deformation in Buckled Bar S3 during ($\mu_6^{+4} = 5.00^{"}$)

During the subsequent push cycle to $(\mu_6^{+3} = 5.00^{"})$, the South extreme fiber bar S3 visibly buckled as shown in Figure 1.340. Outward deformation was observed 8" above the footing over the highest transverse steel layer instrumented with a strain gage. During the next pull cycle to $(\mu_6^{-3} = -5.00^{"})$, the deformation in buckled bar N3 increased as shown in the left photo of Figure 1.341. Permanent deformation in spiral layers overlaying bar N3 was observed during $(\mu_6^{+4} = 5.00^{"})$, see the middle photo of Figure 1.341. During this cycle, the outward deformation in buckled bar S3 increased as shown in the right photo of Figure 1.341. A fourth cycle at ductility six was conducted to verify that the outward deformation in bar S3 would increase over the same location giving a stronger indication of observable bar buckling during the previous cycle. After this cycle, the test was concluded with buckling of each extreme fiber bar, but without any strength loss or rupture of reinforcement. The specimen was saved as a repair candidate.

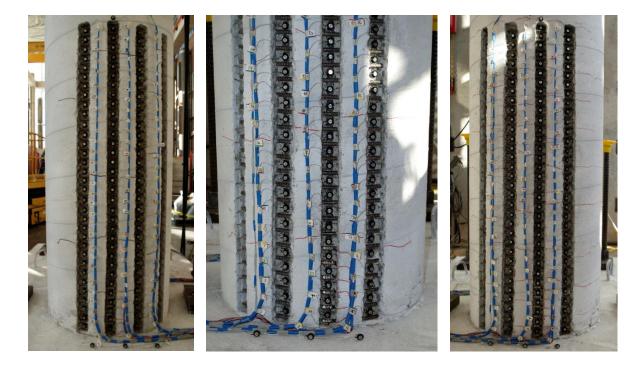
Figure 1.374 T18 – (Left) First Cracking on the North Side during $(\mu_{0.2}^{18.12 \, sec} = 0.17")$, (Middle) First Cracking on the South Side during $(\mu_{-0.3}^{18.30 \, sec} = -0.23")$, and (Right) South Crack Distribution during $(\mu_{-0.6}^{19.54 \, sec} = -0.50")$

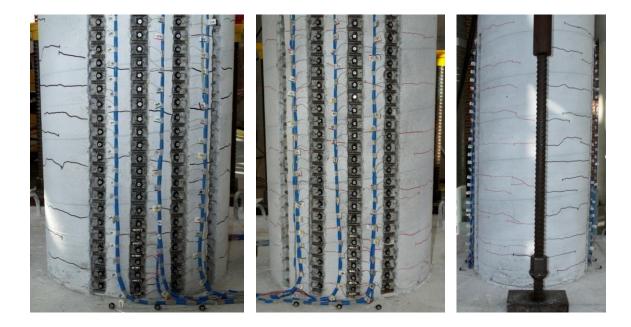
Figure 1.375 T18 – (Left) Cracks on the North Side at $(\mu_{0.6}^{19.74 \, sec} = 0.51")$, (Middle and Right) Crack Distribution on the South and Back Sides at $(\mu_{-0.8}^{22.02 \, sec} = -0.66")$

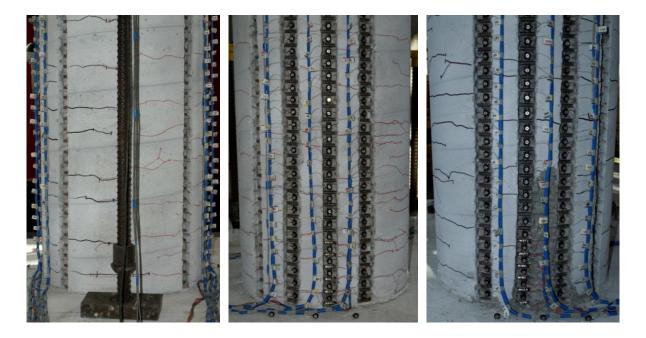
Figure 1.376 T18 – (Left) Crack Distribution on the Front Side during ($\mu_{1.3}^{22.78 \, sec} = 1.04$ "), (Middle) Cracking on the South Side during ($\mu_{-2.7}^{23.72 \, sec} = -2.21$ "), and (Right) Extent of Cover Concrete Crushing on the North Side at ($\mu_{-2.7}^{23.72 \, sec} = -2.21$ ")

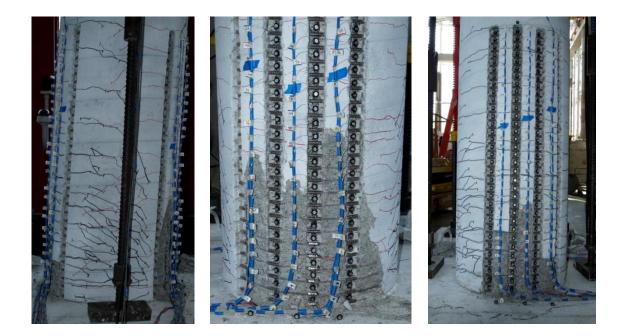
Figure 1.377 T18 – (Left) Crack Distribution on the Front Side during the Peak Cycle to $(\mu_{9.0}^{24.40 \, sec} = 7.46")$, (Middle) Crushing on the South Side, and (Right) Crack on the Top of the Footing on the North Side of the Column

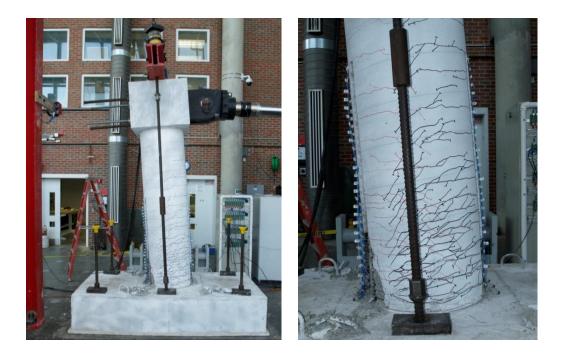
Figure 1.378 T18 – Crack Distribution at Peak Displacement ($\mu_{9.0}^{24.40 \, sec} = 7.46$ ")

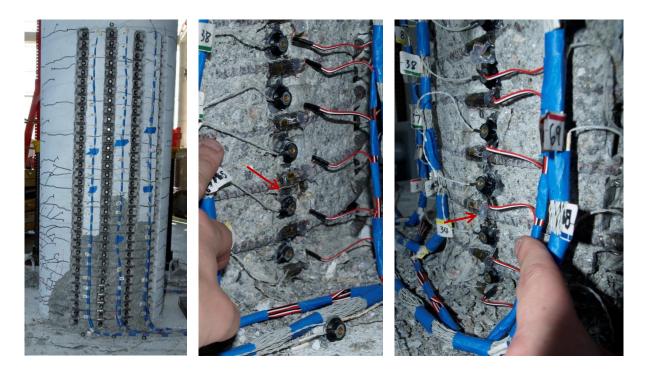
Figure 1.379 T18 – (Left) Extent of Crushing on the North Side during $(\mu_{-7.3}^{25.00 \ sec} = -6.05")$, (Middle and Right) Visible Buckling of Bar S3 at $(\mu_{4.0}^{25.58 \ sec} = 3.32")$

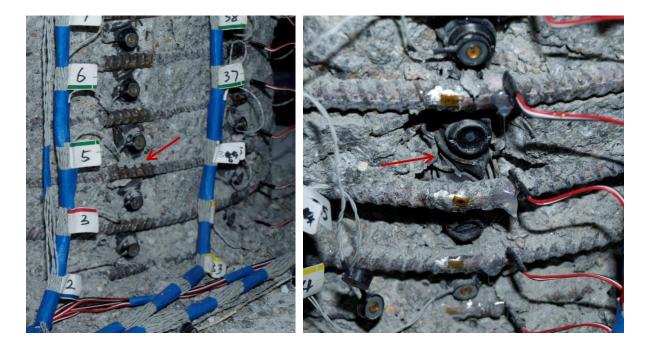
Figure 1.380 T18 – (Left) Buckling of Bars S2 and S4 during ($\mu_6^{+1} = 4.99$ ") and (Right) Rupture of Previously Buckled Bar S3 during ($\mu_6^{-2} = -4.99$ ")

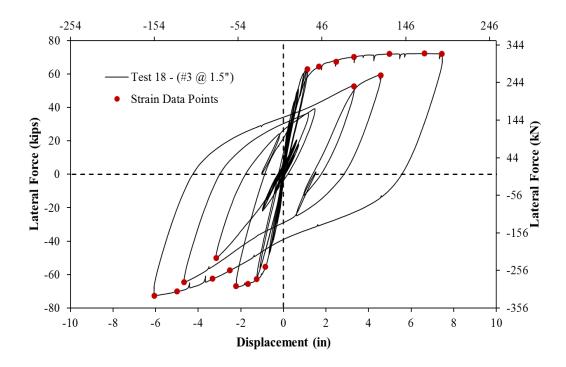
Figure 1.382 T18 – Strain Data Observation Points along the Backbone Curve

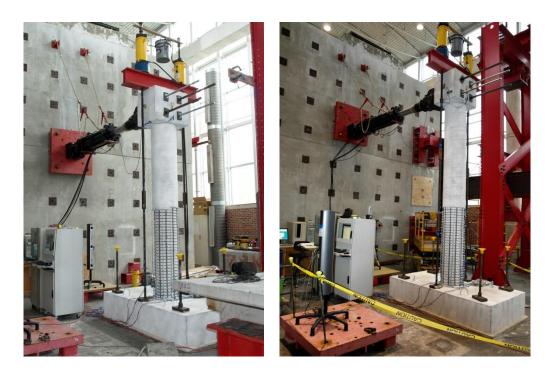
Figure 1.411 Test Setup for 11' and 13' Cantilever Length Specimens

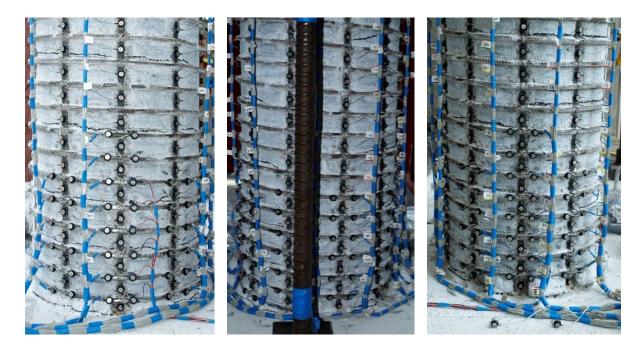
Figure 1.417 T19 – (Left) North at Fy', (Mid) Front at -Fy', and (Right) South at -Fy'

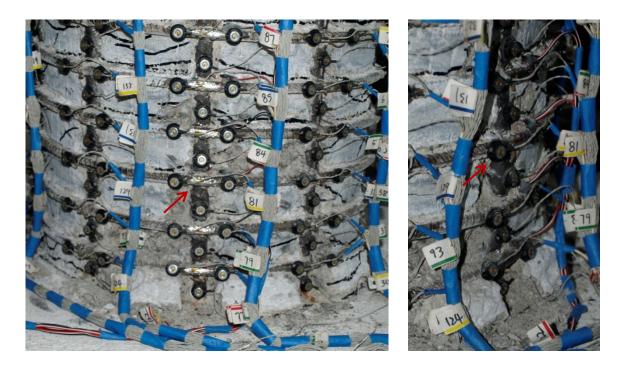
Figure 1.423 T19 – Buckling of the South Bar S3 after Reversal from (μ_5^{-2})

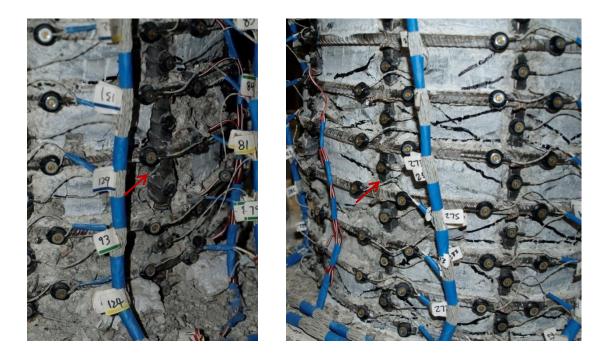
Figure 1.426 T19 – (Left) Rupture of Previously Buckled Bar S3 during (μ_6^{-3}) and (Right) Buckling of Bar N2 at (μ_6^{-3})

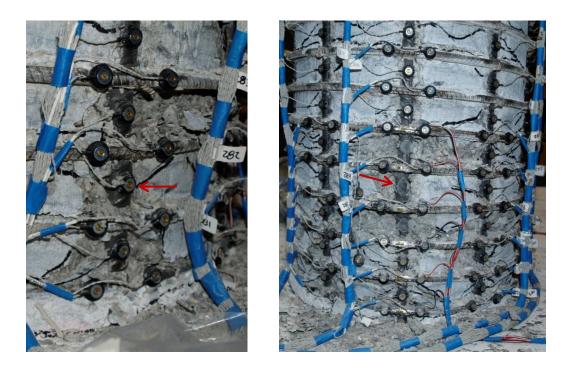
Figure 1.427 T19 – (Left) Buckling of Bar N4 at (μ_6^{-3}) and (Right) Rupture of Previously Buckled Bar N3 during (μ_6^{+4})

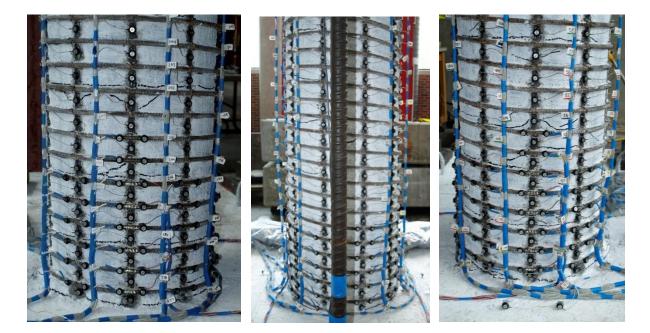
Figure 1.458 T19 – (Left) North at Fy', (Mid) Front at -Fy', and (Right) South at -Fy'

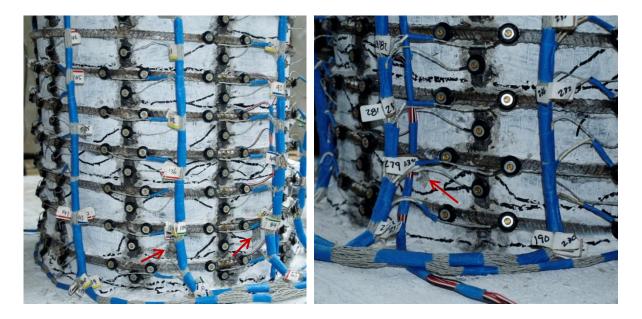
Figure 1.462 T20 – (Left) Cover Concrete Crushing on the South Side at μ_3^{+1} and (Right) Crushing on the North Side during μ_3^{-2}

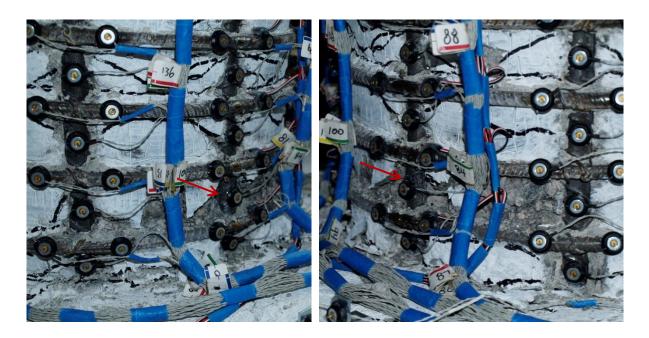
Figure 1.465 T20 – Buckling of Bar S3 after Reversal from ($\mu_5^{-2} = -5.93''$)

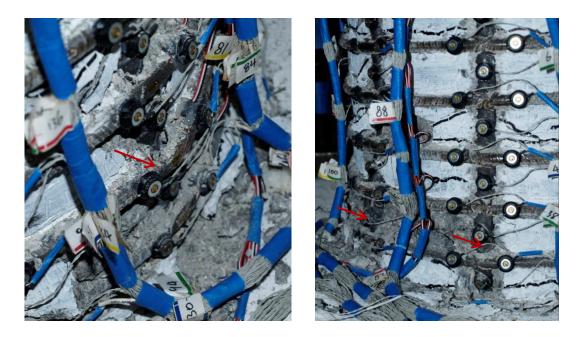
Figure 1.468 T20 – (Left) Deformation in Spiral Layers over Buckled Bar S3 during μ_6^{-2} and (Right) Buckling of Bar S4 after Reversal from μ_6^{-2}

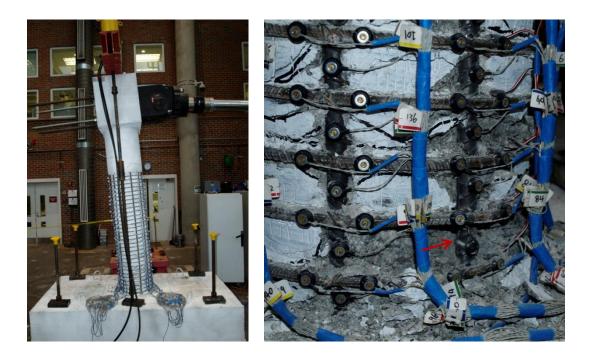
Figure 1.469 T20 – (Left) Lateral Displacement at $(\mu_6^{+3} = 7.01")$ and (Right) Fracture of Previously Buckled Bar S3 during μ_6^{-3}

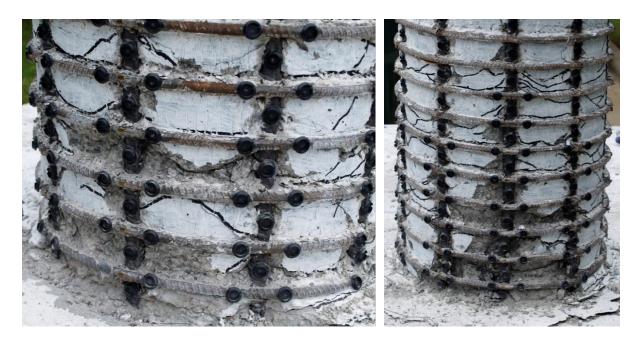
Figure 1.470 T20 – After Testing (Left) North Side and (Right) South Side

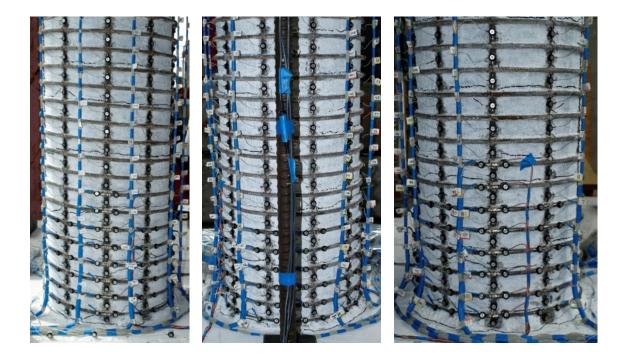
Figure 1.499 T21 – (Left) North at Fy', (Mid) Front at -Fy', and (Right) South at -Fy'

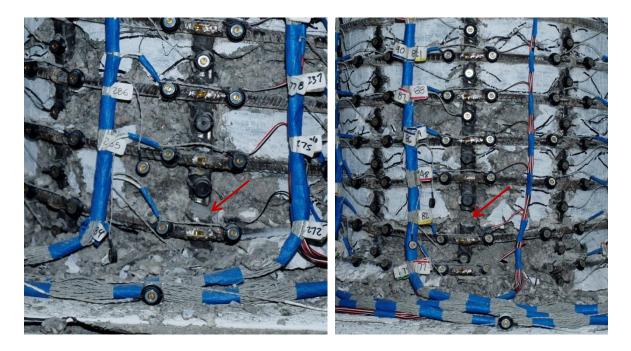
Figure 1.510 T21 – Fracture of (Left) Bar N3 at μ_6^{+4} and (Right) Bar S3 during at μ_6^{-4}

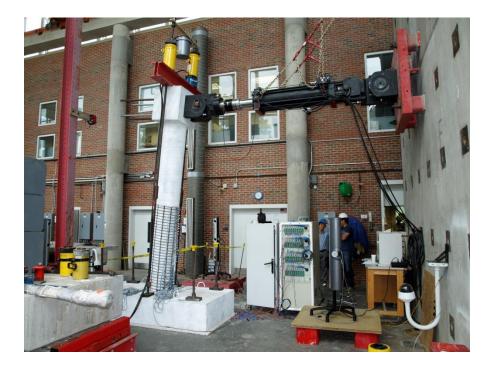
Figure 1.511 T21 – Lateral Displacement at ($\mu_6^{-4} = -11.86''$)

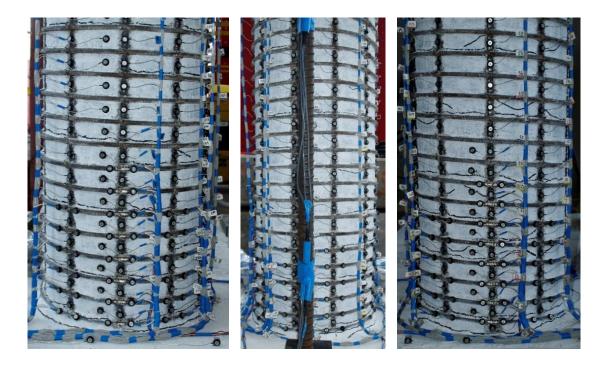
Figure 1.543 T22 – (Left) North at Fy', (Mid) Front at -Fy', and (Right) South at -Fy'

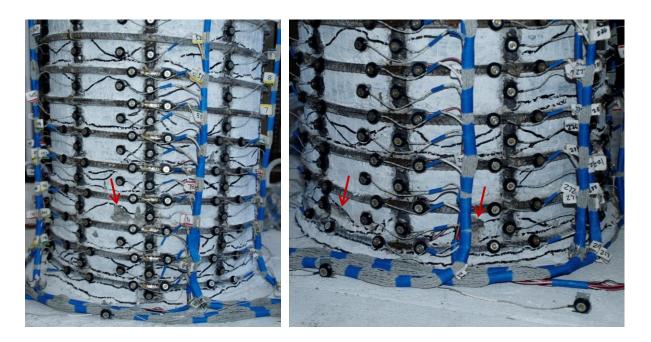
Figure 1.547 T22 – (Left) Concrete Crushing on the South Side at μ_3^{+1} and (Right) Concrete Crushing on the North Side at μ_3^{-1}
