The Effects of Load History and Design Variables on Performance Limit States of Circular Bridge Columns Volume 2: Experimental Observations

Prepared By: Jason Chad Goodnight Yuhao Feng Mervyn J. Kowalsky James M. Nau North Carolina State University

January 2015

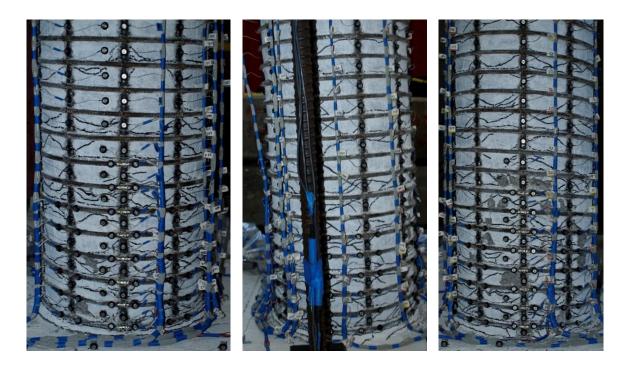
Figure 1.549 T22 – (Left) North at μ_4^{+3} , (Mid) Front at μ_4^{-3} , and (Right) South at μ_4^{-3}

The test began with cycles in ¹/₄ Fy' (first yield force) increments in each direction of loading until the first yield force was reached. The first cracks on the North and South sides of the specimen were observed during (3/4Fy' = 0.90") and (-1/2Fy' = -0.52") respectively. The crack distribution on all sides of the specimen at first yield, (Fy' = 1.48") and (-Fy' = -1.69"), appears in Figure 1.543. Similarly, the crack progression at displacement ductility 1, 1.5, and 2 appear in Figure 1.544, Figure 1.545, and Figure 1.546 respectively. During these cycles the cracks became more numerous and increased in inclination on the shear faces of the specimen. A small amount of core concrete crushed on the South side of the specimen during $(\mu_3^{+1} = 6.26")$, as shown in the left photo of Figure 1.547. A similar observation was made on the North side of the specimen during $(\mu_3^{-1} = -6.27")$, see the right photo of Figure 1.547. The crushing on each side of the specimen during ductility three was not severe, and it appeared that only a thin layer of concrete flaked off between spiral layers. Photos of the crack distributions during displacement ductility three and four appear in Figure 1.549 respectively.

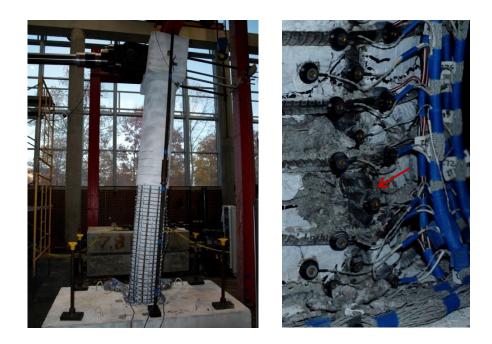
Figure 1.552 T22 – (Left) Specimen at $(\mu_6^{+1} = 12.54")$ and (Right) Additional Deformation in Buckled Bar N3 at $(\mu_6^{-1} = -12.53")$

The North extreme fiber bar N3 visibly buckled under compressive stress during the reversal from $(\mu_5^{+1} = 10.45")$, as shown in Figure 1.550. At this time the buckled deformation was small. Additional outward deformation was observed in buckled bar N3 at $(\mu_5^{-2} = -10.45")$, see the left photo of Figure 1.551. The South reinforcing bars remained intact during ductility five, and additional crushing of the core concrete was observed up to 20" above the footing (right photo of Figure 1.551). A photo of the specimen at $(\mu_6^{+1} = 12.54")$ and additional deformation in previously buckled bar N3 during $(\mu_6^{-1} = -12.53")$ appears in Figure 1.552. The previously buckled North extreme fiber bar N3 fractured at 4.81" during the push cycle to $(\mu_6^{+2} = 10.45")$, Figure 1.553. Visible buckling of the South extreme fiber bar was observed 17" above the footing at $(\mu_6^{+2} = 10.45")$, as shown in the right photo of Figure 1.553. Buckling of adjacent North reinforcing bars N2 and N4 was observed during the final pull cycle to $(\mu_6^{-2} = -12.53")$. Photos of the specimen after the test are shown in Figure 1.554.

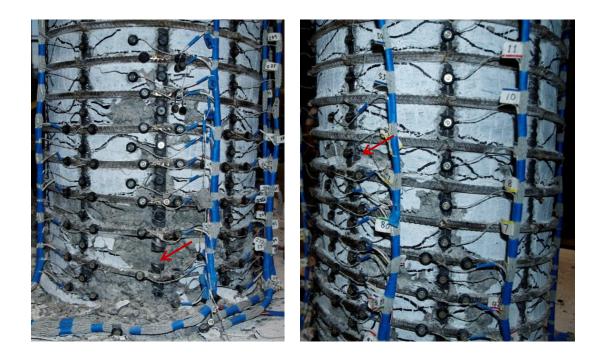
Figure 1.553 T22 – (Left) Fracture of Previously Buckled Bar N3 during ($\mu_6^{+2} = 12.56^{"}$) and (Right) Buckling of Extreme Fiber Bar S3 at ($\mu_6^{+2} = 12.56^{"}$)

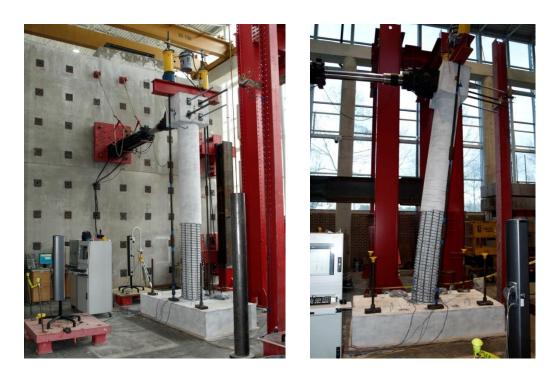
Figure 1.584 T23 – Test Setup for the Largest Aspect Ratio Specimens

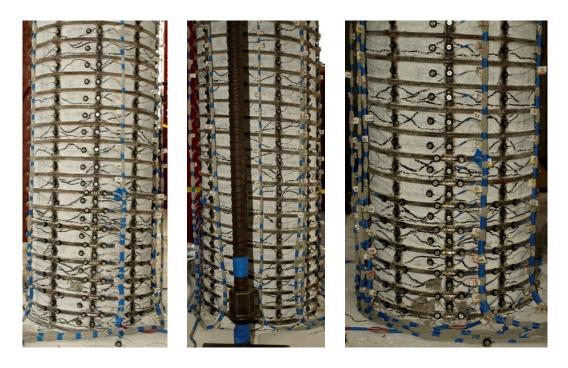
Figure 1.591 T23 – (Left) North at μ_3^{+3} , (Mid) Front at μ_3^{-3} , and (Right) South at μ_3^{-3}

The test began with cycles in ¹/₄ Fy' (first yield force) increments in each direction of loading until the first yield force was reached. The first cracks on the North and South sides of the specimen were observed during (1/2Fy' = 0.63") and (-1/2Fy' = -0.62") respectively. The crack distribution on all sides of the specimen at first yield, (Fy' = 2.00") and (-Fy' = -2.02"), appears in Figure 1.586. The crack progression at displacement ductility 1, 1.5, and 2 appear in Figure 1.587, Figure 1.588, and Figure 1.589 respectively. During these cycles the cracks became more numerous and increased in inclination on the shear faces of the specimen during $(\mu_3^{+1} = 8.31")$, Figure 1.590. A similar observation was made on the North side of the specimen during $(\mu_3^{-1} = -8.31")$, Figure 1.590. The crushing on each side of the specimen during ductility three was not severe, and it appeared that only a thin layer of concrete flaked off between spiral layers. Photos of the crack distributions during displacement ductility 3, 4, and 5 appear in Figure 1.591, Figure 1.592, and Figure 1.593 respectively.

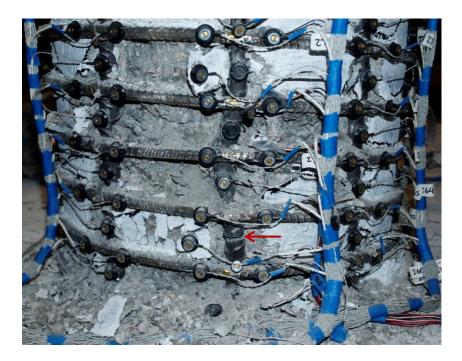
Figure 1.598 T23 – Fracture of Previously Buckled Bar N3 at 5.50" during μ_7^{+2}

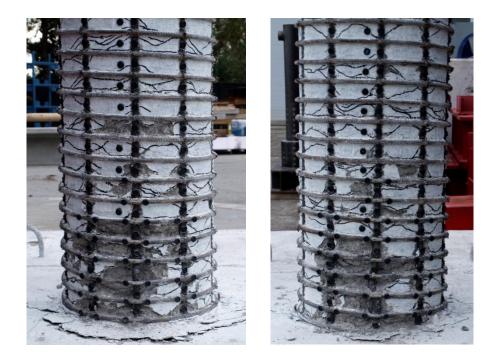
Figure 1.599 T23 – After the Test (Left) South Side and (Right) North Side

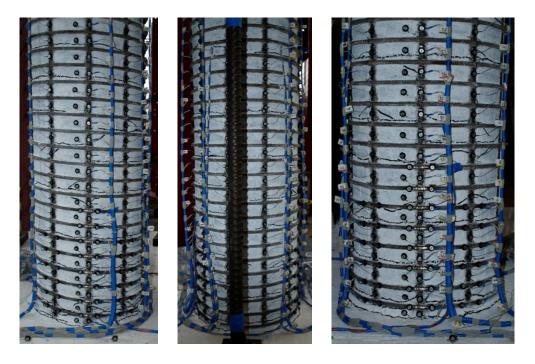
Figure 1.633 T24 – (Left) North at μ_1^{+3} , (Mid) Front at μ_1^{-3} , and (Right) South at μ_1^{-3}

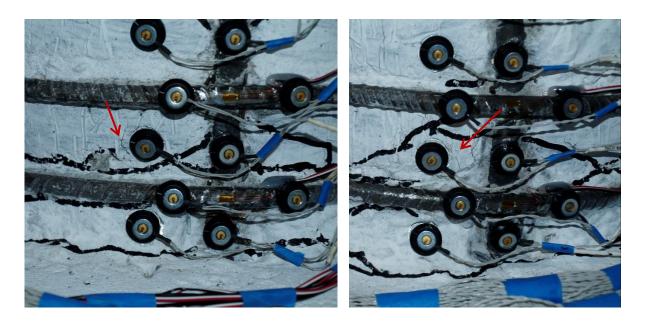
Figure 1.635 T24 – Visible Flaking of Cover Concrete which Precedes Crushing (Left) South Side during μ_2^{+1} and (Right) North Side during μ_2^{-1}

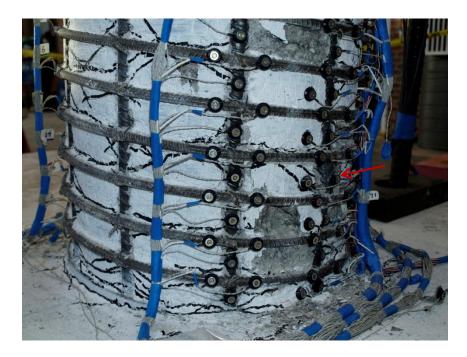
Figure 1.642 T24 – Additional Deformation in Previously Buckled Bar N3 during μ_5^{-2}

Additional deformation in the previously buckled bar N3 was observed during the subsequent pull cycle to $(\mu_5^{-2} = -14.33")$ in Figure 1.642. Similarly, additional deformation in buckled bar S3 was observed during $(\mu_5^{+3} = 14.33")$, see the right photo of Figure 1.641. The outward deformation in buckled bar N3 continued to increase during $(\mu_5^{-3} = -14.33")$, and the bar fractured in tension during the subsequent push cycle to $(\mu_5^{+4} = 14.33")$, as shown in Figure 1.643. Fracture of bar N3 lead to a 24% loss in strength measured at $(\mu_5^{+4} = 14.33")$ relative to the peak lateral force measured in the push direction of loading. Adjacent North reinforcing bar N4 buckled during $(\mu_5^{-4} = -14.32")$, see the left photo of Figure 1.644.

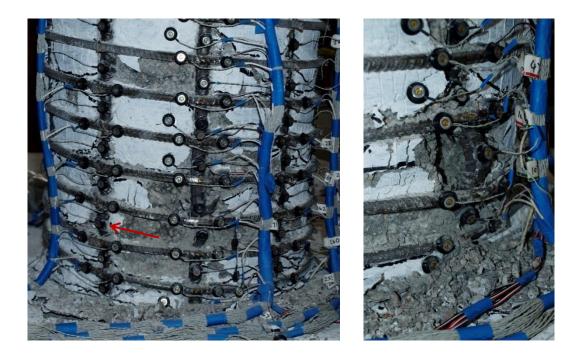
Figure 1.644 T24 – (Left) Buckling of Adjacent Bar N4 during μ_5^{-4} and (Right) Additional Deformation in Bar S3 during μ_5^{+6}

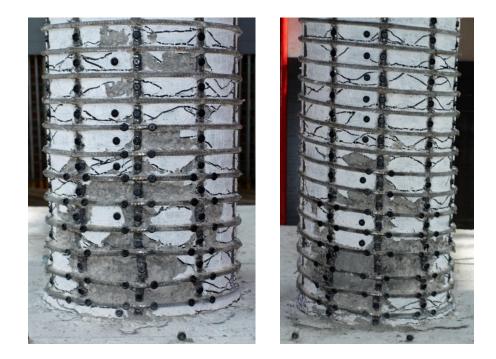
Figure 1.646 T24 – After the Test (Left) South Side and (Right) North Side

The deformation in previously buckled bar S3 became even more severe during ($\mu_5^{+6} = 14.34''$) as shown in the right photo of Figure 1.644. Bar S3 fractured in tension during the subsequent reversal to ($\mu_5^{-6} = -14.33''$), see Figure 1.645. Fracture of bar S3 lead to a 39% loss in strength measured at ($\mu_5^{-6} = -14.33''$) relative to the peak lateral force measured in the pull direction of loading. At this time the test was concluded with two buckled bars and one fractured bar on the North side of the specimen and one buckled and fractured bar on the South side of the specimen. Photos of all sides of the specimen after removal of the instrumentation appear in Figure 1.646.

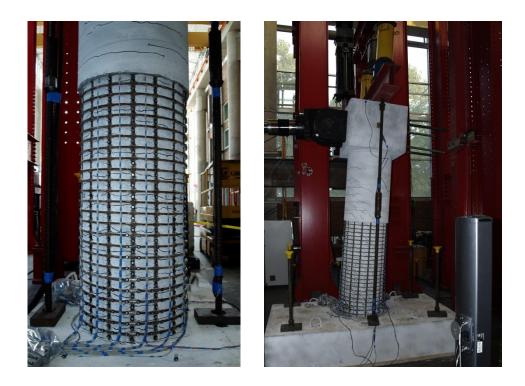
Figure 1.677 Complete Cover Concrete Blockout with Direct Application of Target Markers to Longitudinal and Transverse Steel

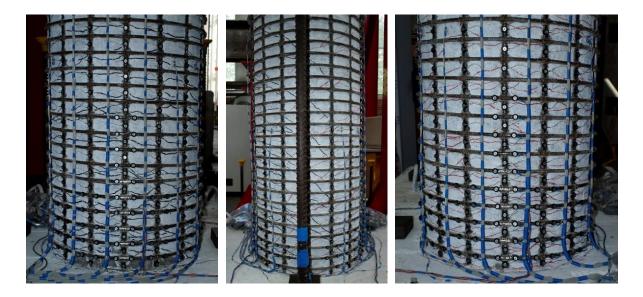
Figure 1.688 T25 – (Left) North Crack Distribution at $(\mu_2^{+3} = 2.04")$, (Middle and Right) Crack Distributions on the Front and Right Sides at $(\mu_2^{-3} = -2.04")$

The crack progression at displacement ductility 1, 1.5, 2, 3, 4, and 5 appear in Figure 1.685, Figure 1.687, Figure 1.688, Figure 1.689, Figure 1.690, and Figure 1.693 respectively. During these cycles the cracks became more numerous and increased in inclination on the shear faces of the specimen. The first signs of concrete crushing on the North side of the

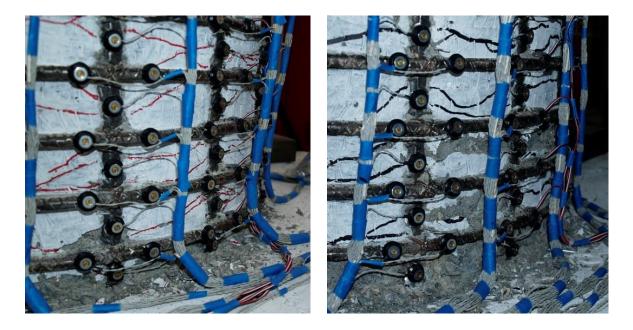
Figure 1.691 T25 – (Left) No Buckling of N3 during ($\mu_5^{+1} = 5.11$ "), (Right) No Buckling of S3 during ($\mu_5^{-1} = -5.12$ ")

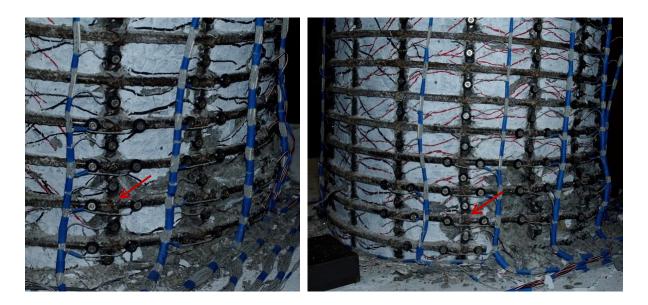
Figure 1.695 T25 – (Left) Buckling of N1 and N5 during ($\mu_6^{-3} = -6.15$ "), (Right) Buckling of S1 during ($\mu_7^{+1} = 7.16$ ")

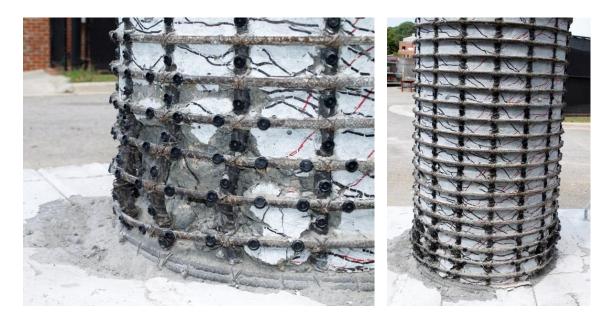
Figure 1.697 T25 – (Left) North Side of the Specimen after Test, (Right) Front Side

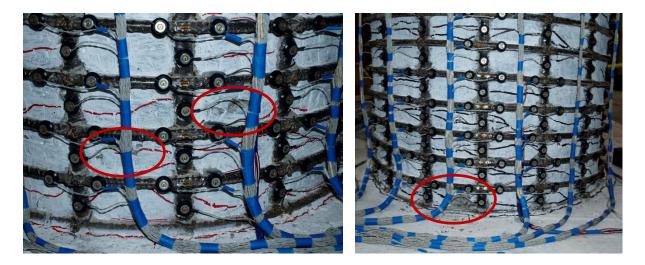
Figure 1.738 T26 – (Left) South Crushing during $(\mu_2^{+1} = 1.99")$, (Right) North Crushing during $(\mu_2^{-1} = -1.99")$

the specimen during $(\mu_{1.5}^{+1} = 1.49")$ and $(\mu_{1.5}^{-1} = -1.49")$, Figure 1.736. This visible flaking resulted in small amounts of concrete crushing during $(\mu_{1.5}^{+2} = 1.50")$ and $(\mu_{1.5}^{-2} = -1.49")$. Crushing on the south and north sides of the specimen increased at $(\mu_2^{+1} = 1.99")$ and $(\mu_2^{-1} = -1.99")$, Figure 1.738. As compressive demands increased during displacement ductility 1.5 to 4, crushing gradually increased on each side of the specimen without influencing the measured lateral forces. Compressive demand during $(\mu_3^{+1} = 2.97")$ and $(\mu_3^{-1} = -2.99")$ lead to spiral yielding in confinement regions. Spiral strains on each side of the specimen increased during each successive cycle of ductility four, but the extreme fiber reinforcement remained visibly straight, Figure 1.741.

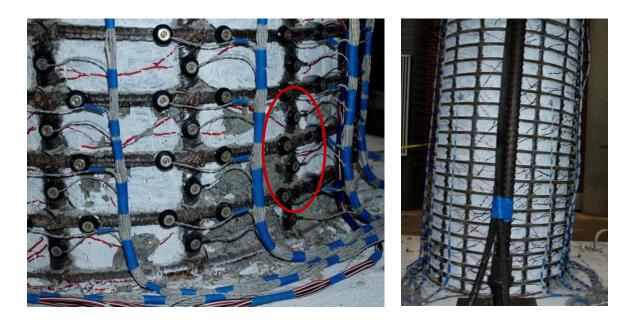
Figure 1.741 T26 – (Left) Bar S3 Remained Visibly Straight during ($\mu_4^{+3} = 3.98$ "), (Right) Crack Distribution on the Back Side

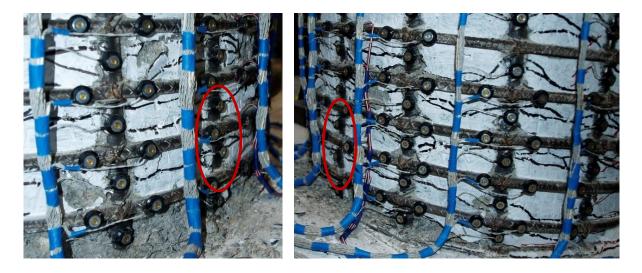
Figure 1.744 T26 – Slight Visible Buckling of Bar N3 during ($\mu_5^{-2} = -4.99$ ")

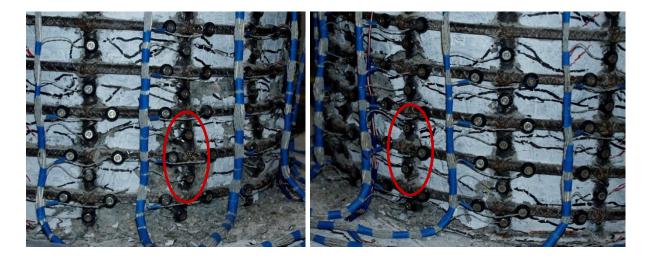
Figure 1.746 T26 – Buckling of North Bars N4 and N2 during ($\mu_6^{-1} = -5.97$ ")

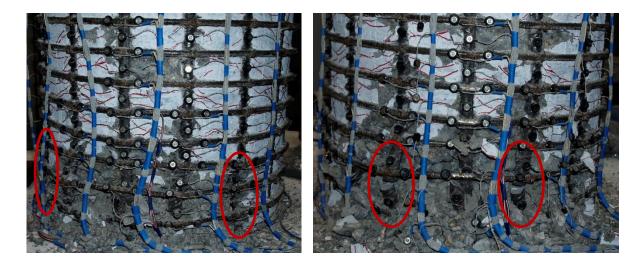
Figure 1.748 T26 – (Left) Buckling of South Bars S1 and S5 during ($\mu_6^{+3} = 5.97^{"}$), (Right) Fracture of Previously Buckled South Bars S2 and S4 during ($\mu_6^{-3} = -5.99^{"}$)

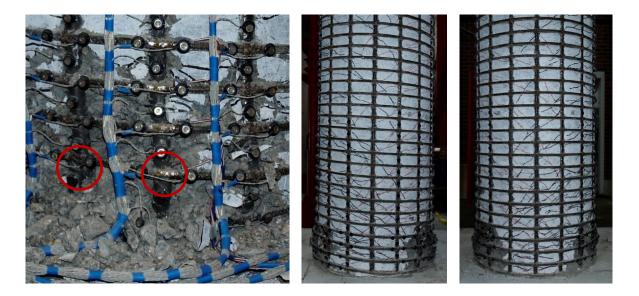
Figure 1.749 T26 – (Left) Fracture of Previously Buckled Bars N3 and N4 during $(\mu_6^{+4} = 5.97")$, Front (Middle) and Back (Right) After the Test

The south extreme fiber bar visibly buckled during ($\mu_5^{+1} = 4.98''$), as shown in the left photo of Figure 1.743. The outward buckled region occurred over the second gage length above the footing which encompassed the second spiral layer. The buckled deformation increased during ($\mu_5^{+2} = 4.98''$). The north extreme fiber bar visibly buckled during the reversal from tension strains sustained during ($\mu_5^{+2} = 4.98''$), Figure 1.744. Two adjacent south reinforcing bars, S2 and S4, buckled during ($\mu_5^{+3} = 4.97''$), Figure 1.745. Two adjacent north reinforcing bars, N2 and N4, buckled during ($\mu_6^{-1} = -5.97''$), Figure 1.746. Severe buckling of three bars on the south side of the specimen during ($\mu_6^{+2} = 5.97''$) led to significant crushing of core concrete, Figure 1.747. Previously buckled south extreme fiber bar S3 ruptured during ($\mu_6^{-2} = -5.98''$), Figure 1.747, resulting in the first significant loss in the strength. South reinforcing bars S1 and S5 buckled during ($\mu_6^{+3} = 5.97^{"}$), Figure 1.748. Two additional south bars, S2 and S4, ruptured during ($\mu_6^{-3} = -5.99''$), Figure 1.748. Previously buckled north reinforcing bars N3 and N4 ruptured during ($\mu_6^{+4} = 5.97$ "), Figure 1.749. The test was concluded with fractured bars on each side of the specimen, photos of the hinge region after removal of the instrumentation appear in Figure 1.749 and Figure 1.750.

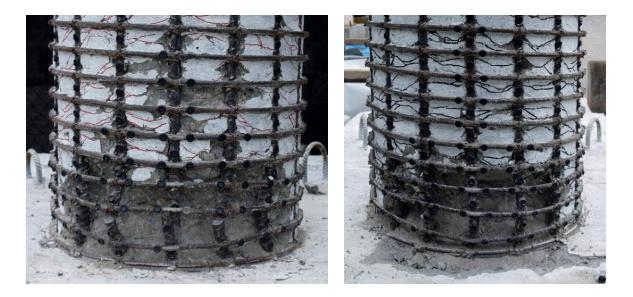
Figure 1.750 T26 – After the Test (Left) South Side and (Right) North Side

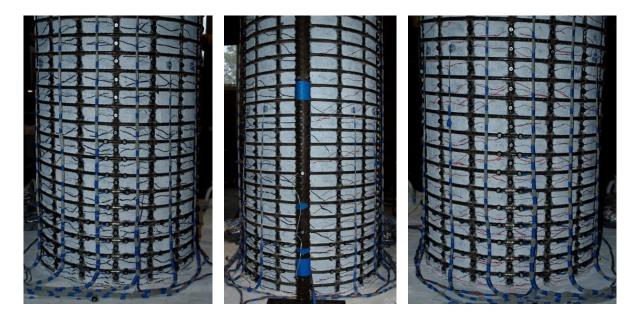
Figure 1.793 T27 – (Left) North Crack Distribution at $(\mu_{1.5}^{+3} = 1.38")$, (Middle and Right) Crack Distributions on the Front and Right Sides at $(\mu_{1.5}^{-3} = -1.38")$

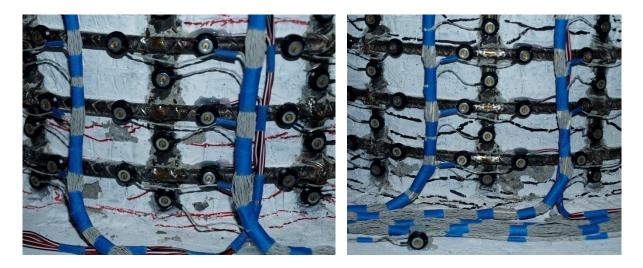
Figure 1.794 T27 – (Left) South Crushing during $(\mu_2^{+1} = 1.84")$, (Right) North Crushing during $(\mu_2^{-1} = -1.83")$

tests, this flaking leads to crushing during subsequent cycles, but crushing was not observed until displacement ductility two. Crushing on the south and north sides of the specimen occurred during ($\mu_2^{+1} = 1.84^{"}$) and ($\mu_2^{-1} = -1.83^{"}$), Figure 1.794. As compressive demands increased during displacement ductility 1.5 to 4, crushing gradually increased on each side of the specimen. Compressive demand during ($\mu_3^{+1} = 2.76^{"}$) and ($\mu_3^{-1} = -2.76^{"}$) lead to spiral yielding in confinement regions, Figure 1.796. Spiral strains on each side of the specimen increased during each successive cycle of ductility four, but the extreme fiber reinforcement remained visibly straight, Figure 1.798

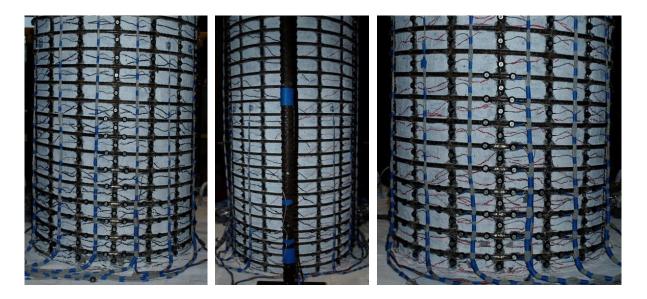
Figure 1.795 T27 – (Left) North Crack Distribution at $(\mu_2^{+3} = 1.84")$, (Middle and Right) Crack Distributions on the Front and Right Sides at $(\mu_2^{-3} = -1.84")$

The crack progression at displacement ductility 1, 1.5, 2, 3, and 4 appear in Figure 1.791, Figure 1.793, Figure 1.795, Figure 1.797, and Figure 1.799 respectively. During these cycles the cracks became more numerous and increased in inclination on the shear faces of the specimen. Small amounts concrete flaking was observed on the south and north sides of the specimen during ($\mu_{1.5}^{+2} = 1.38''$) and ($\mu_{1.5}^{-1} = -1.38''$), Figure 1.792. In previous

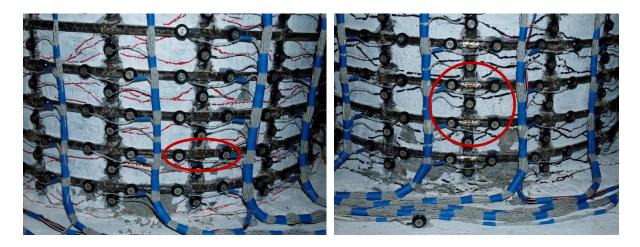
Figure 1.796 T27 – (Left) South Spiral Yield at $(\mu_3^{+1} = 2.76")$, (Right) North Spiral Yield at $(\mu_3^{-1} = -2.76")$

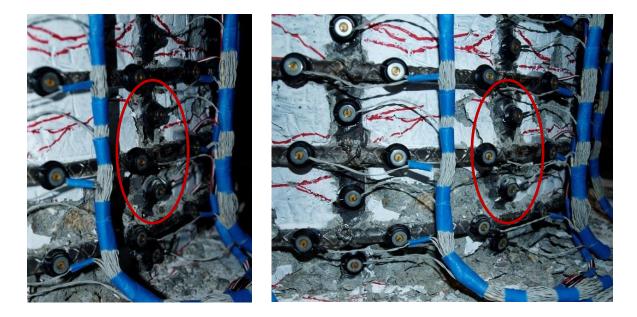
Figure 1.800 T27 – (Left) Very Slight Visible Buckling of Bar S3 during ($\mu_5^{+1} = 4.60^{"}$), (Right) Increased Deformation in Buckled Bar S3 during ($\mu_5^{+2} = 4.61^{"}$)

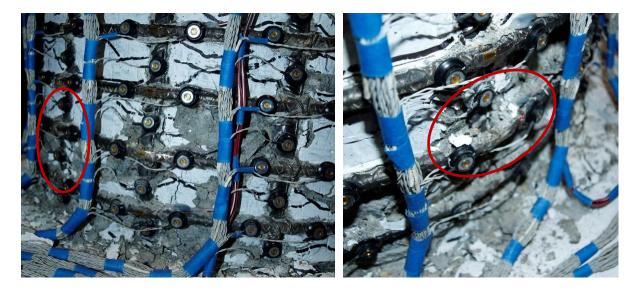
Figure 1.802 T27 – (Left) Buckling of Adjacent Bar N4 ($\mu_5^{-2} = -4.59^{"}$), (Right) North Spiral Deformation at ($\mu_5^{+3} = 4.60^{"}$)

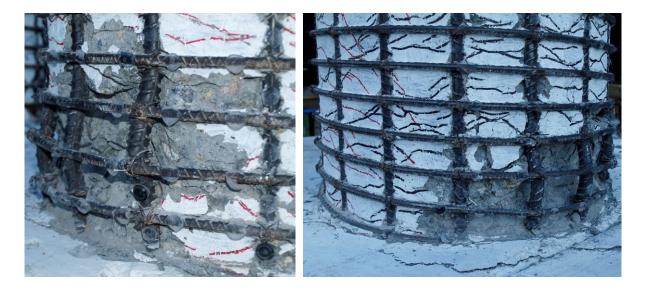
Figure 1.806 T27 – After the Test (Left) South Side and (Right) North Side

The south extreme fiber bar visibly buckled during ($\mu_5^{+1} = 4.60^{"}$), as shown in the left photo of Figure 1.800. The outward buckled region occurred over the second gage length above the footing which encompassed the second spiral layer. The buckled deformation increased during ($\mu_5^{+2} = 4.61''$), Figure 1.800. The north extreme fiber bar visibly buckled during the reversal from tension strains sustained during ($\mu_5^{+1} = 4.60^{"}$), Figure 1.801. An adjacent north reinforcing bar N4 buckled during ($\mu_5^{-2} = -4.59''$), Figure 1.802. Previously buckled north reinforcement placed into tension during ($\mu_5^{+3} = 4.60^{"}$) straightened out, showing large amounts of permanent deformation in spirals overlaying the outward buckled region, Figure 1.802. An adjacent north bar N2 buckled during ($\mu_5^{-3} = 4.60^{"}$), Figure 1.803. Two additional south reinforcing bars, S2 and S4, buckled during ($\mu_6^{+1} = 5.52''$), Figure 1.803 and Figure 1.804. Significant core concrete crushing behind three buckled north reinforcing occurred during ($\mu_6^{-1} = -5.54''$), Figure 1.804. The previously buckled extreme fiber south bar S3 ruptured during ($\mu_6^{-2} = -5.53^{"}$), Figure 1.805, leading to a significant loss in strength. Two previously buckled north bars N3 and N4 ruptured before straightening out in tension during the third push cycle of ductility six, Figure 1.805. Photos of the specimen after the instrumentation was removed appear in Figure 1.806 and Figure 1.807.

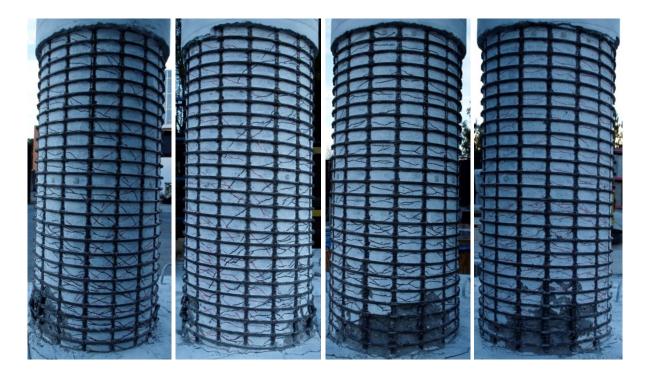
Figure 1.807 T27 – (Left to Right) Front, Back, North, and South Sides after the Test

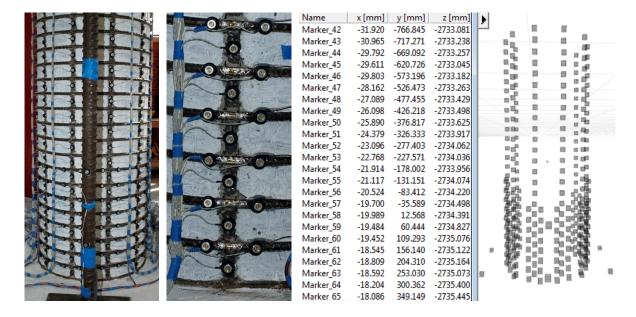
Figure 1.841 T28 – Target Marker Application and Optotrak Spatial Output

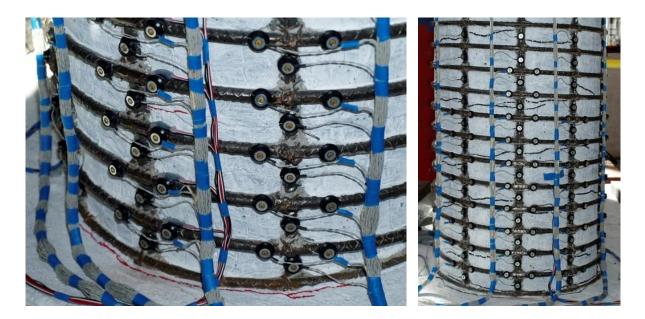
Figure 1.847 T28 – (Left) Cracking on the South Side during (-1/2Fy' = -0.33"), (Right) North Cracking (3/4Fy' = 0.60")

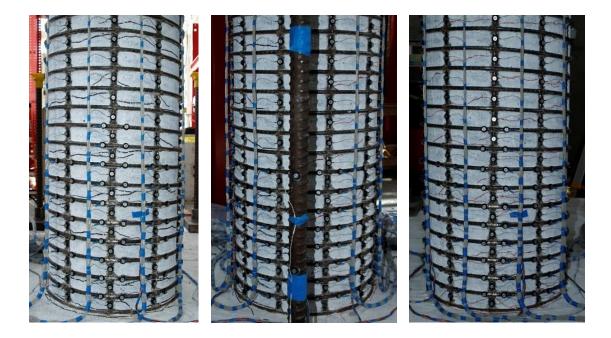
Figure 1.848 T28 – (Left) North Crack Distribution at (Fy' = 1.04"), (Middle and Right) Crack Distributions on the Front and Right Sides at (-Fy' = -1.07")

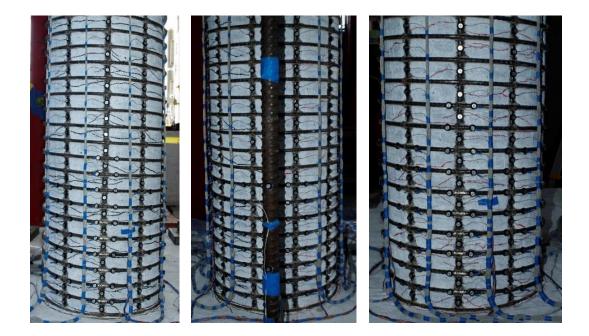
Figure 1.849 T28 – (Left) North Crack Distribution at $(\mu_1^{+3} = 1.34")$, (Middle and Right) Crack Distributions on the Front and Right Sides at $(\mu_1^{-3} = -1.34")$

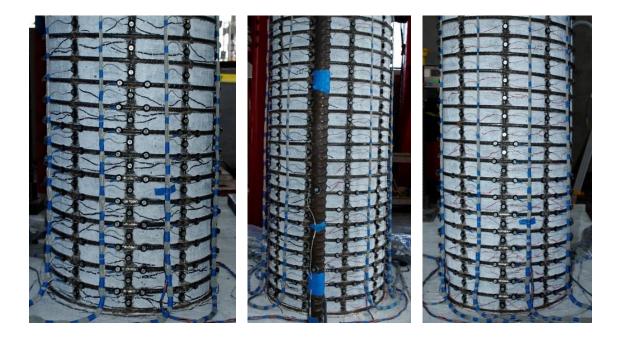
Figure 1.851 T28 – (Left) North Crack Distribution at ($\mu_{1.5}^{+3} = 2.00^{"}$), (Middle and Right) Crack Distributions on the Front and Right Sides at ($\mu_{1.5}^{-3} = -2.00^{"}$)

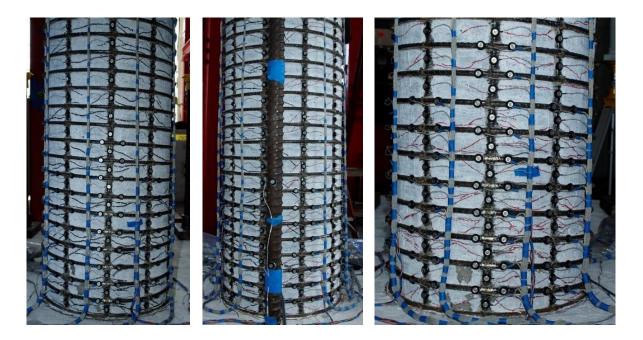
Figure 1.853 T28 – (Left) North Crack Distribution at $(\mu_2^{+3} = 2.67")$, (Middle and Right) Crack Distributions on the Front and Right Sides at $(\mu_2^{-3} = -2.66")$

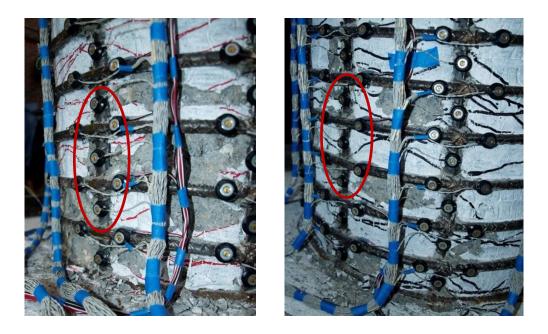
Figure 1.856 T28 – (Left) Bar S3 Remained Visibly Straight during ($\mu_4^{+3} = 5.34^{"}$), (Right) Bar N3 Remained Visibly Straight during ($\mu_4^{-3} = -5.34^{"}$)

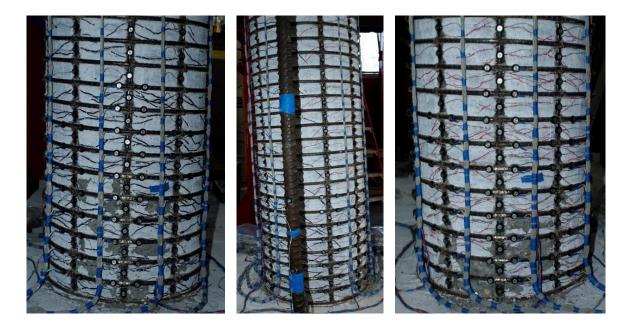
Figure 1.857 T28 – (Left) North Crack Distribution at ($\mu_4^{+3} = 5.34^{"}$), (Middle and Right) Crack Distributions on the Front and Right Sides at ($\mu_4^{-3} = -5.34^{"}$)

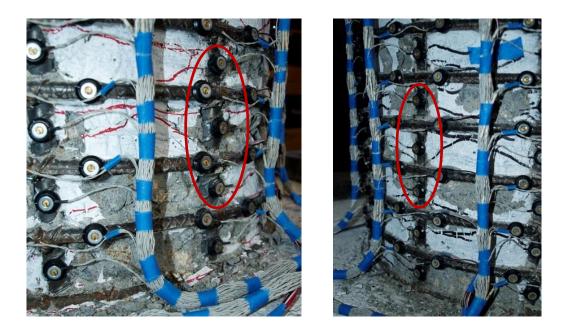
Figure 1.858 T28 – (Left) Visible Buckling of Bar S3 during ($\mu_5^{+1} = 6.68^{"}$), (Right) Bar N3 Remained Visibly Straight during ($\mu_5^{-1} = -6.68^{"}$)

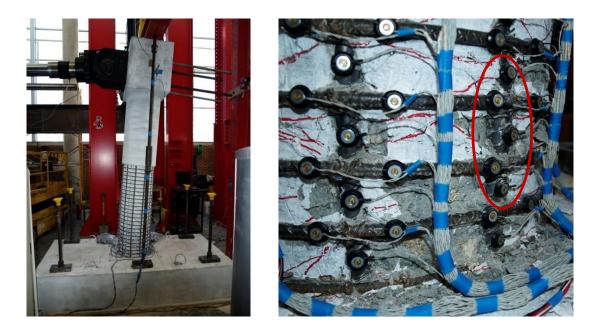
Figure 1.859 T28 – (Left) Lateral Deformation and (Right) Increased Deformation in Bar S3 during ($\mu_5^{+2} = 6.68$ ")

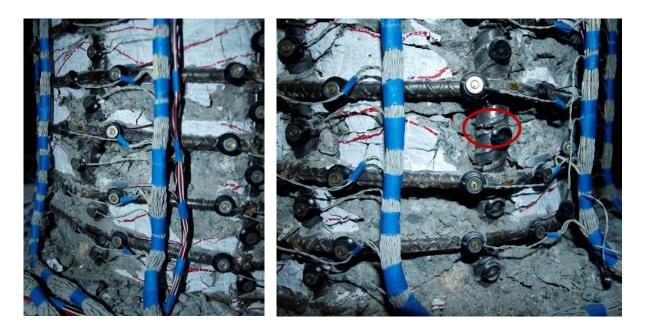
Figure 1.861 T28 – (Left) Increased Deformation in Bar S3 ($\mu_6^{+1} = 8.00^{"}$), (Right) Fracture of Bar S3 during ($\mu_6^{-1} = -8.01^{"}$)

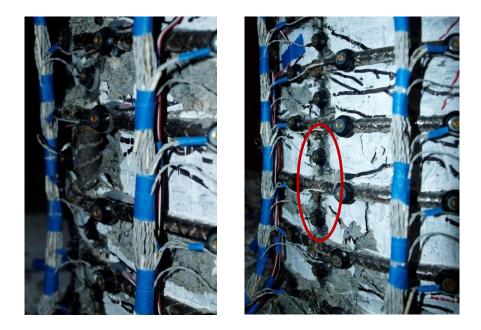
Figure 1.862 T28 – (Left) Increased Deformation in Bar N3 during ($\mu_6^{-1} = -8.01$ "), (Right) Buckling of Adjacent Bar N2 during ($\mu_6^{-1} = -8.01$ ")

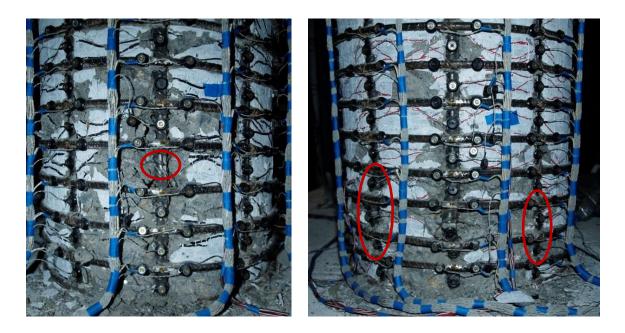
Figure 1.863 T28 – (Left) Fracture of Bar N3 during ($\mu_6^{+2} = 8.00^{"}$), (Right) Buckling of Adjacent Bars S2 and S4 during ($\mu_6^{+2} = 8.00^{"}$)

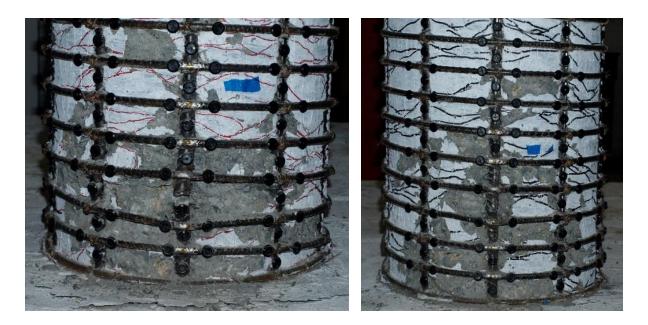
Figure 1.864 T28 – After the Test (Left) South Side and (Right) North Side

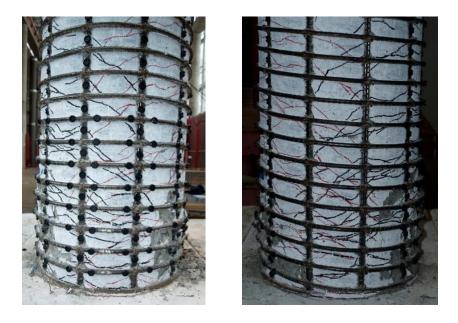
Figure 1.865 T28 – After the Test (Left) Front Side and (Right) Back Side

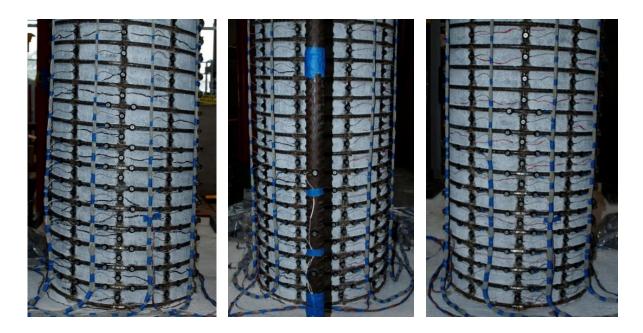
Figure 1.905 T29 – (Left) North Crack Distribution at (Fy' = 1.07"), (Middle and Right) Crack Distributions on the Front and Right Sides at (-Fy' = -1.10")

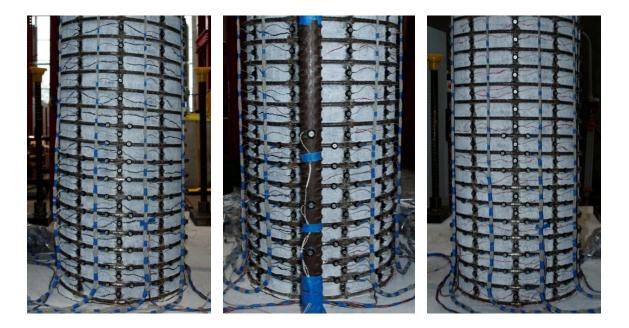
Figure 1.906 T29 – (Left) North Crack Distribution at ($\mu_1^{+3} = 1.35$ "), (Middle and Right) Crack Distributions on the Front and Right Sides at ($\mu_1^{-3} = -1.35$ ")

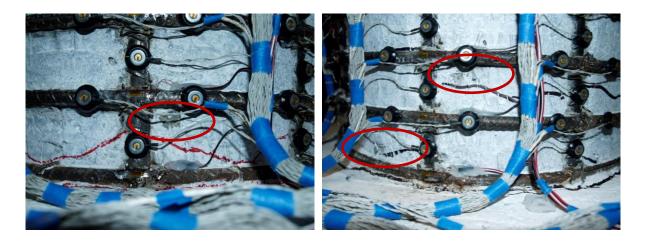
Figure 1.907 T29 – (Left) South Concrete Crushing during $(\mu_{1.5}^{+1} = 2.01")$, (Right) North Crushing during $(\mu_{1.5}^{-1} = -2.02")$

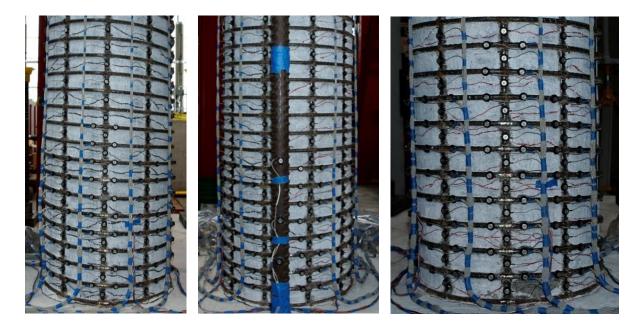
Figure 1.908 T29 – (Left) North Crack Distribution at $(\mu_{1.5}^{+3} = 2.01")$, (Middle and Right) Crack Distributions on the Front and Right Sides at $(\mu_{1.5}^{-3} = -2.01")$

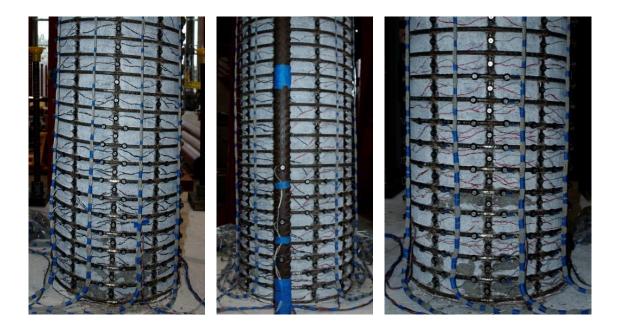
Figure 1.912 T29 – (Left) North Crack Distribution at $(\mu_3^{+3} = 4.02")$, (Middle and Right) Crack Distributions on the Front and Right Sides at $(\mu_3^{-3} = -4.03")$

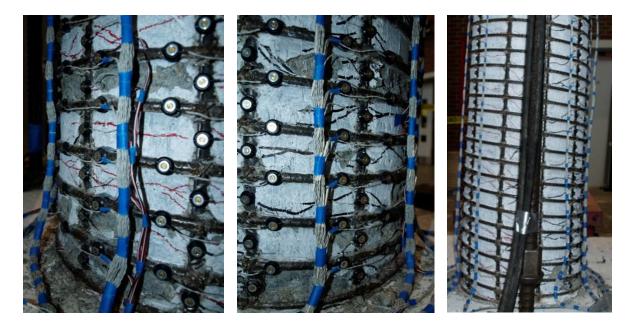
Figure 1.913 T29 – (Left) Bar S3 Remained Visibly Straight during ($\mu_4^{+3} = 5.37^{"}$), (Middle) Bar N3 Remained Visibly Straight during ($\mu_4^{-3} = -5.37^{"}$), (Right) Back of the Specimen at ($\mu_4^{-3} = -5.37^{"}$)

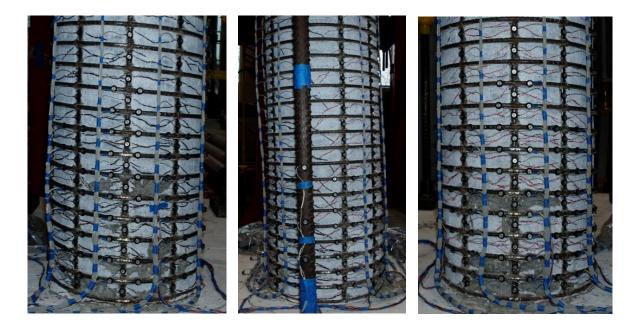
Figure 1.914 T29 – (Left) North Crack Distribution at ($\mu_4^{+3} = 5.37^{"}$), (Middle and Right) Crack Distributions on the Front and Right Sides at ($\mu_4^{-3} = -5.37^{"}$)

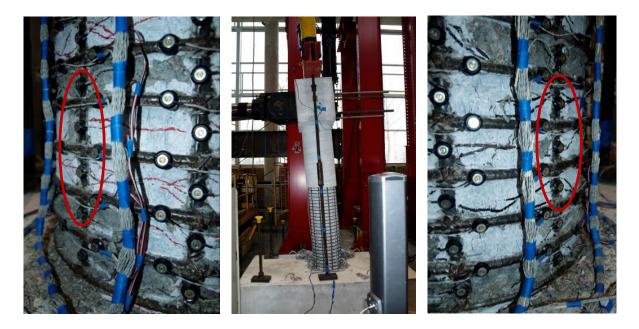
Figure 1.915 T29 – (Left) Bar S3 Remained Visibly Straight during ($\mu_5^{+1} = 6.72^{"}$), (Middle) Lateral Deformation at ($\mu_5^{-1} = -6.72^{"}$), (Right) Bar N3 Remained Visibly Straight during ($\mu_5^{-1} = -6.72^{"}$)

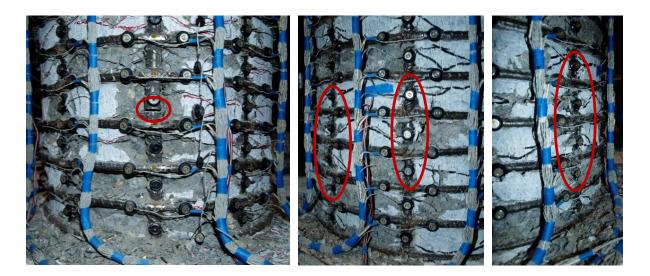
Figure 1.918 T29 – (Left) Fracture of Bar S3 during ($\mu_6^{-1} = -8.06$ "), (Middle and Right) Buckling of Bars N2 and N3 during ($\mu_6^{-1} = -8.06$ ")

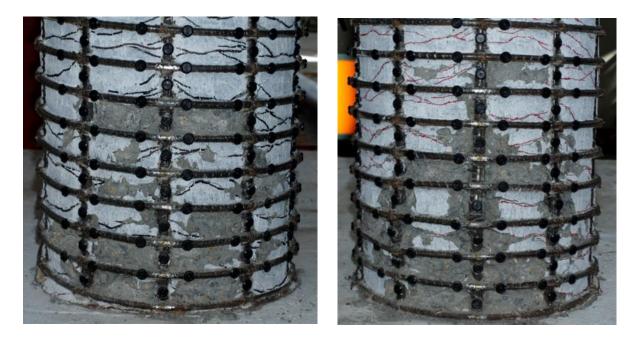
Figure 1.919 T29 – After the Test (Left) North Side and (Right) South Side

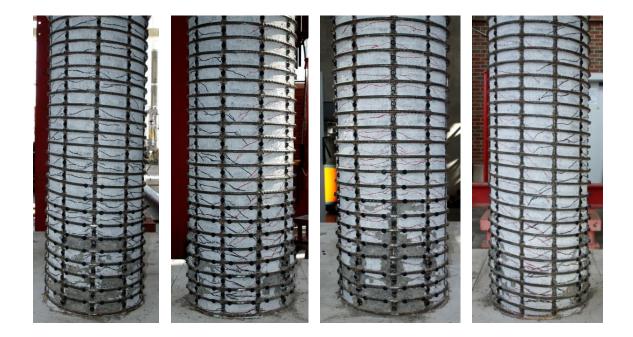
Figure 1.920 T29 – (Left to Right) North, Front, South, and Back Sides after the Test

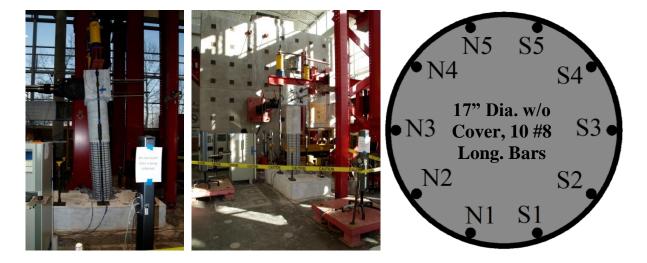
Figure 1.953 T30 – Test Setup and Cross Section Bar Designation

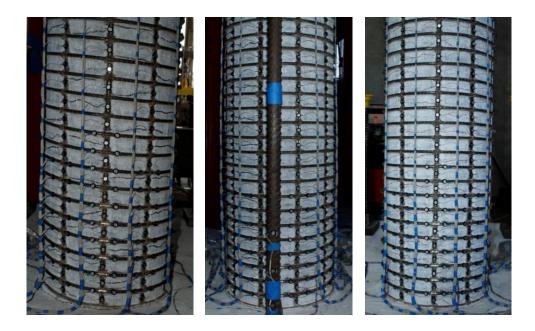
Figure 1.961 T30 – (Left) North Crack Distribution at (Fy' = 1.10"), (Middle and Right) Crack Distributions on the Front and Right Sides at (-Fy' = -1.20")

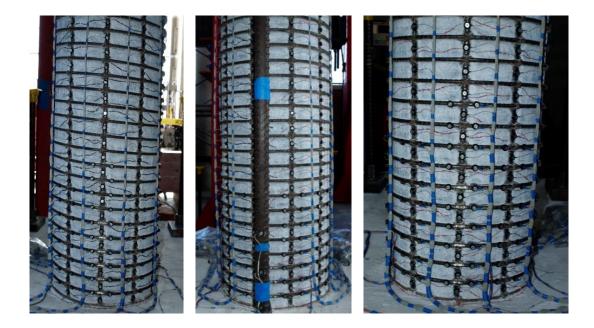
Figure 1.962 T30 – (Left) North Crack Distribution at $(\mu_1^{+3} = 1.48")$, (Middle and Right) Crack Distributions on the Front and Right Sides at $(\mu_1^{-3} = -1.48")$

The crack progression at displacement ductility 1, 1.5, 2, and 3 appear in Figure 1.962, Figure 1.964, Figure 1.966, and Figure 1.967 respectively. During these cycles the cracks

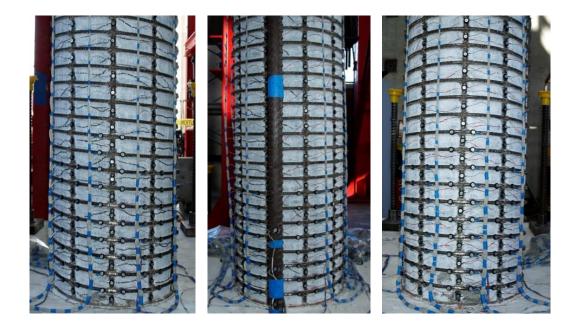
Figure 1.964 T30 – (Left) North Crack Distribution at ($\mu_{1.5}^{+3} = 2.01$ "), (Middle and Right) Crack Distributions on the Front and Right Sides at ($\mu_{1.5}^{-3} = -2.01$ ")

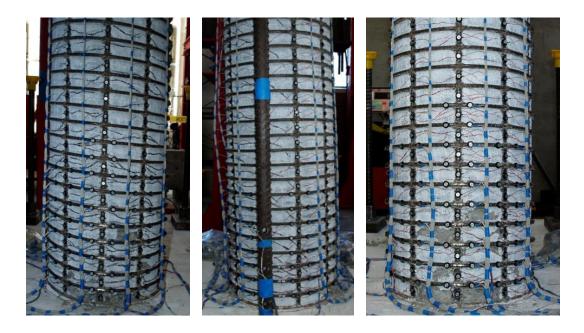
Figure 1.967 T30 – (Left) North Crack Distribution at $(\mu_3^{+3} = 4.43")$, (Middle and Right) Crack Distributions on the Front and Right Sides at $(\mu_3^{-3} = -4.43")$

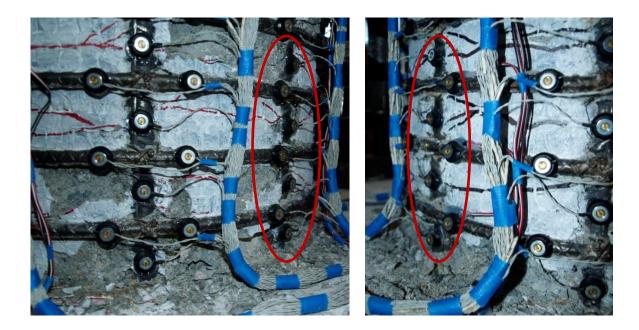
Figure 1.968 T30 – (Left) Bar S3 Remained Visibly Straight during ($\mu_4^{+3} = 5.92^{"}$) and (Right) Bar N3 Remained Visibly Straight during ($\mu_4^{-3} = -5.91^{"}$)

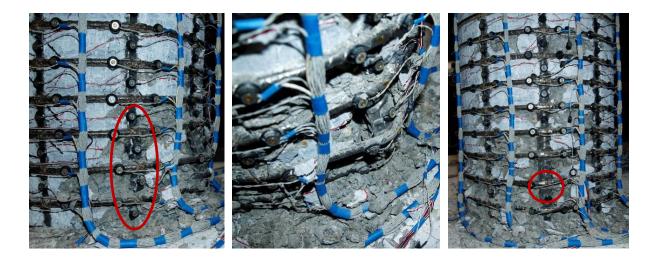
Figure 1.973 T30 – (Left) Buckling of Adjacent Bars S2 and S4 during ($\mu_6^{+2} = 8.87$), (Middle) South Spiral Deformation during ($\mu_6^{+2} = 8.87$), (Right) Fracture of Bar S3 during (μ_6^{-2})

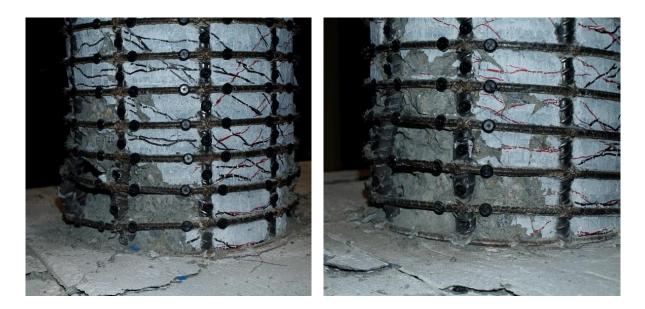
Figure 1.974 T30 – After the Test (Left) North and (Right) South Side of the Specimen

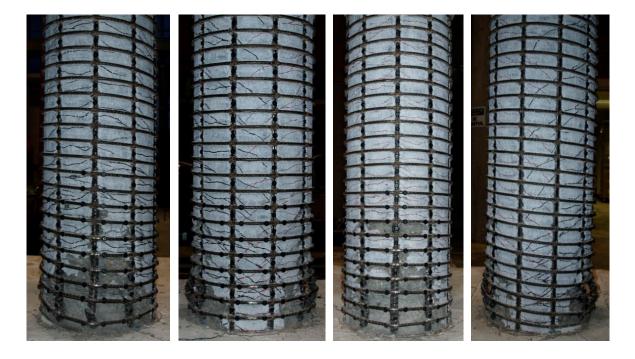
Figure 1.975 T30 – (Left to Right) North, Front, South, and Back Sides after the Test

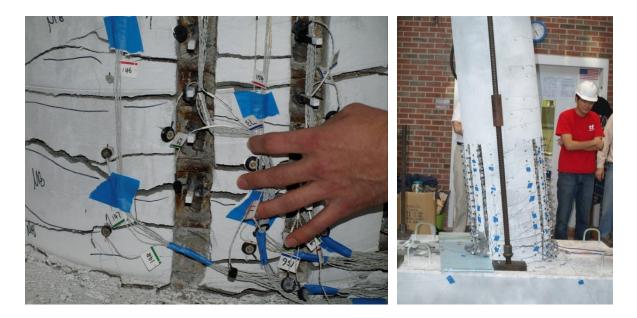
Figure 3.5 Test 1 – (Left) Fracture of Two North Bars at 12.5" and (Right) Lateral Displacement at $\mu_{\Delta 22} = 14.22$ "

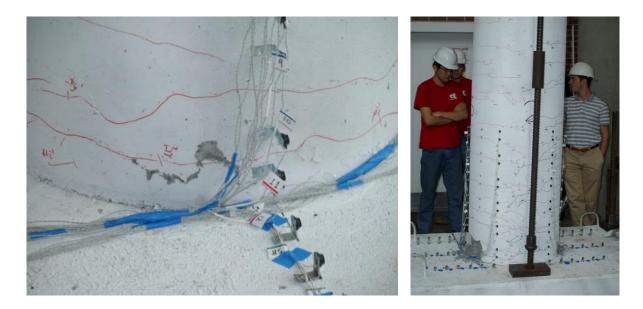
Figure 3.9 Test 2 – (Left) Initial Crushing on the South Side during $(\mu_3^{+1} = 1.72")$ and (Right) Crack Distribution at $(\mu_4^{-3} = -2.68")$

The first cracks on the north and south sides of the specimen were observed during ³/₄ Fy' push and pull cycles respectively. Cover concrete crushing was first observed on the south side of the specimen, Figure 3.9, during the first push cycle of displacement ductility three ($\mu_3^{+1} = 1.72^{"}$). The north extreme fiber bar buckled after reversal from ($\mu_8^{+1} = 5.27^{"}$), Figure 3.10. Buckled occurred over adjacent $\approx 2.5^{"}$ transverse steel spacings, which is larger than the specified 2" spacing in construction of the specimens. Adjacent north bars N2 and N4 buckled during ductility eight, resulting in the buckled deformation shown in Figure 3.10. The previously buckled north extreme fiber bar N3 ruptured during ($\mu_{10}^{+1} = 6.60^{"}$), resulting in the first notable loss in strength.

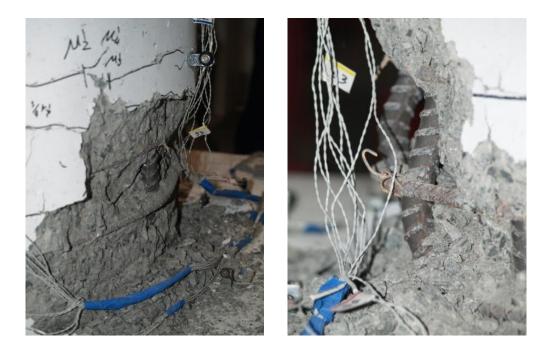
Figure 3.10 Test 2 – (Left) Buckling of Bar N3 during $(\mu_8^{-1} = -5.39")$ and (Right) Deformation in Multiple Buckled North Bars at $(\mu_8^{-3} = -5.36")$

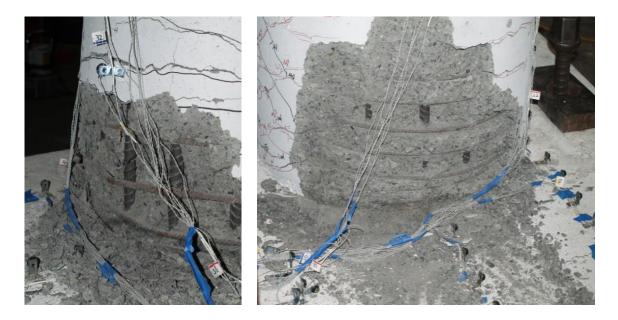
Figure 3.11 Test 2 – (Left) Fracture of Previously Buckled Bar N3 during $(\mu_{10}^{+1} = 6.60")$ and (Right) Buckling of South Extreme Fiber Bar S3 during $(\mu_{10}^{+2} = 6.59")$

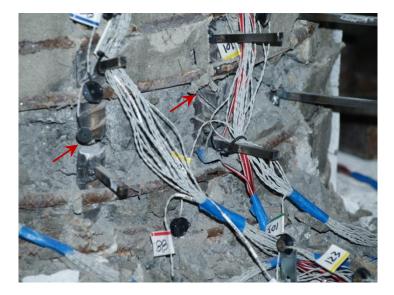
Figure 3.17 Test 3 – Fracture of Bars N2 and N3 during ($\mu_8^{+3} = 5.37^{"}$)

The first cracks on the south side of the specimen were observed during the -½ Fy' pull cycle. Cover concrete crushing was observed on the north side of the specimen during $(\mu_3^{-1} = -2.05")$, Figure 3.15. The crack distribution on the front of the specimen during $(\mu_3^{-3} = -2.02")$ is also shown in Figure 3.15. A bar on the north side fo the specimen visibly buckled duirng $(\mu_6^{-1} = -4.07")$, Figure 3.16, at the location of the largest transverse steel sapcing of 3" above the column base. Since the specified transverse steel spacing was only 2", the detailing error led to a reduction in the deformation capacity of the column. Three additional north reinforcing bars buckled during $(\mu_8^{-1} = -5.45")$, before any south reinforcement showed signs of buckling. Two perviously buckled north reinforcing bars fratured during $(\mu_8^{+3} = 5.37")$, Figure 3.17, resulting in the first significant loss in strength. A third north bar fractured during $(\mu_{10}^{+1} = 6.67")$, followed by a fourth during $(\mu_{10}^{+2} = 6.65")$.

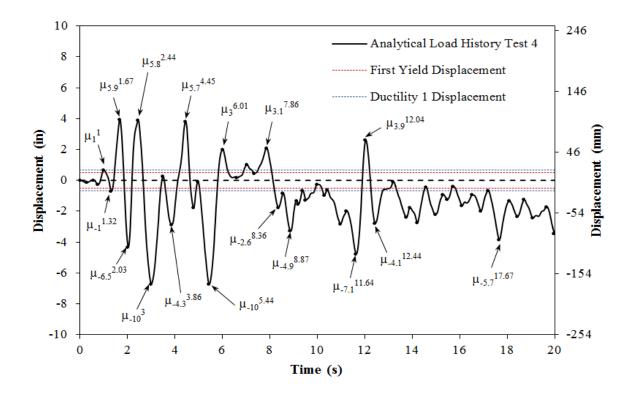
Figure 3.18 Test 4 – Analytical Lateral Displacement History for 1940 El Centro EQ

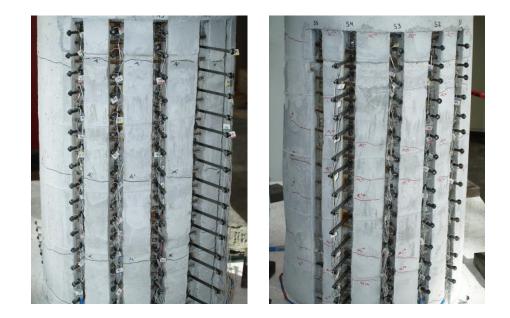
Figure 3.22 Test 4 – (Left) Crack distribution at $(\mu_{1.0}^{1.00sec} = 0.67")$ and (Right) Crack Distribution at $(\mu_{-1.0}^{1.32sec} = -0.66")$

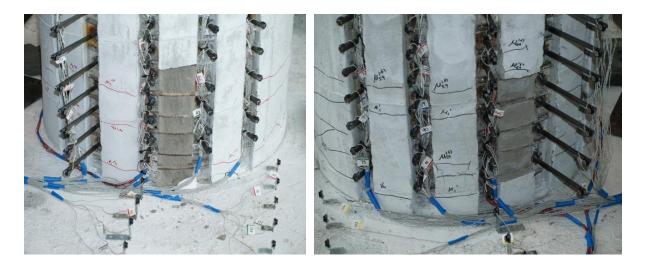
Figure 3.23 Test 4 – (Left) Crushing on the South during $(\mu_{5.9}^{1.67sec} = 3.96")$ and (Right) Crushing on the North during $(\mu_{-6.4}^{2.03sec} = -4.40")$

The fourth test began with the application of 170 kips of axial load, which is an axial load ratio of 5% for the tested cylinder strength ($f'_c = 7.93ksi$). During the fourth half cycle of load the specimen was held at the analytical first yield force of 44.02 kips to determine the first yield displacement for ductility calculations ($\Delta'_y = 0.50^{"}$). The push cycle then resumed until the target displacement of ($\mu_{1.00}^{1.00 \ sec} = 0.67^{"}$) was readed. The crack distribution on the north side of the specimen during this cycle, and the south side during the subsequent cycle to ($\mu_{-1.0}^{1.32 \ sec} = -0.66^{"}$) is shown in Figure 3.22. Concrete crushing was observed on the south side of the specimen during the push cycle to ($\mu_{5.9}^{1.67 \ sec} = 3.96^{"}$), Figure 3.23. Crushing on the north side of the specimen was observed during ($\mu_{-6.4}^{2.03 \ sec} = -4.40^{"}$).

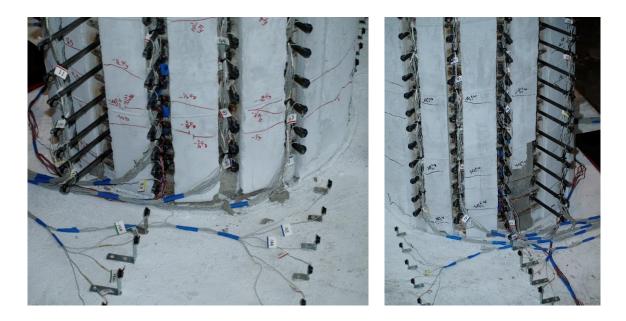
Figure 3.27 Test 5 – (Left) North Concrete Crushing at $(\mu_{2.4}^{5.08 \ sec} = 1.59")$ and (Right) South Concrete Crushing at $(\mu_{-2.1}^{5.4 \ sec} = -1.57")$

The fifth test began with the application of 170 kips of axial load, which is an axial load ratio of 5% for the tested cylinder strength ($f'_c = 8.4 \text{ ksi}$). During the first half cycle of load the specimen was held at the analytical first yield force of 44 kips to determine the first yield displacement for ductility calculations ($\Delta'_y = 0.55^{"}$). To allow for direct comparison to previous tests, the ductility levels for Test 5 were based on a first yield displacement of 0.50" and corresponding ductility one displacement of 0.67". Previous tests results with a maximum transverse steel spacing of 3" (north) and 2" (south) in the plastic hinge region have shown that buckling occurs upon reversal from ($\mu_{\Delta 6} = 4.04^{"}$) and ($\mu_{\Delta 10} = 6.72^{"}$) accordingly. In Figure 3.25, the peak displacements from the analytical load history are highlighted, ($\mu_{7.7}^{11.38 \text{ sec}} = 5.20^{"}$) or ($\mu_{7.5}^{11.98 \text{ sec}} = 5.07^{"}$) to buckle the North reinforcement upon reversal and ($\mu_{-10.0}^{14.26 \text{ sec}} = -6.68^{"}$) for the South. First crushing of cover concrete on the north and south sides of the specimen were observed at ($\mu_{2.4}^{5.08 \text{ sec}} = 1.59^{"}$) and ($\mu_{-2.1}^{5.4 \text{ sec}} = -1.57^{"}$) respectfully, Figure 3.27. In the physical test, bar buckling was not observed during the Tabas load history appear in Figure 3.28.

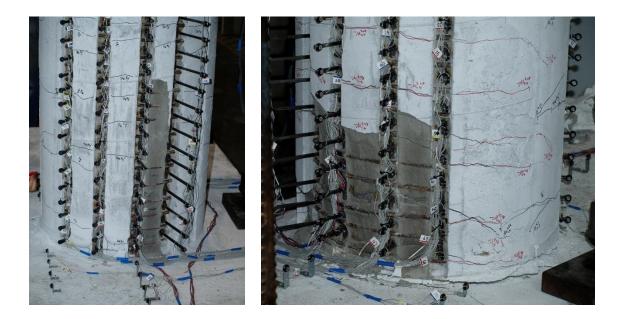
Figure 3.38 Test 6 – (Left) North Crushing observed during $(\mu_{-2.4}^{5.08 \, sec} = -1.59")$ and (Right) Extent of South Crushing at $(\mu_{4.6}^{10.32 \, sec} = 3.11")$

The sixth test began with the application of 170 kips of axial load, which is an axial load ratio of 3.7% for the tested cylinder strength ($f'_c = 10.2 \text{ ksi}$). During the first half cycle of load the specimen was held at the analytical first yield force of 44 kips to determine the first yield displacement for ductility calculations ($\Delta'_y = 0.53^{"}$). To allow for direct comparison to previous tests, the ductility levels for Test 6 were based on a first yield displacement of 0.50" and corresponding ductility one displacement of 0.67". Cover concrete crushing was observed on the north side of the specimen during ($\mu^{5.08 \text{ sec}}_{-2.4} = -1.59^{"}$), Figure 3.38. A photo depicting crushing on the south side of the specimen at ($\mu^{10.32 \text{ sec}}_{4.6} = 3.11^{"}$) appears in Figure 3.38.
