Phase II: Chulitna River Bridge Structurally Health Monitoring

Alaska Bridge 255 – Chulitna River Bridge

January 2015

INE/ AUTC 14.04

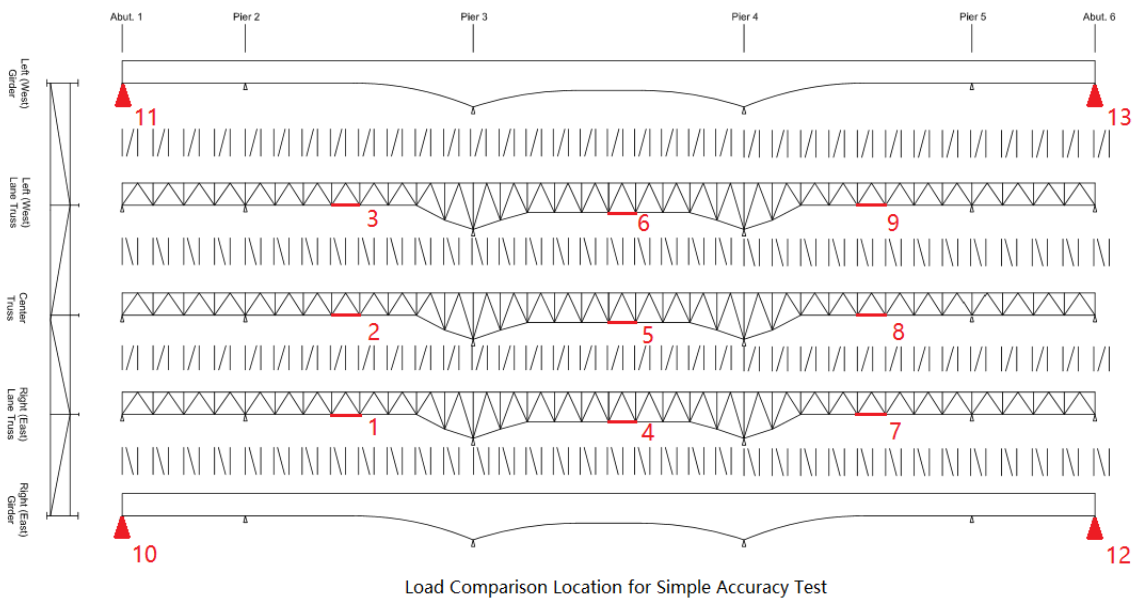
Figure A.1 Locations where the influence of mesh refinement was checked (see Table A.1).

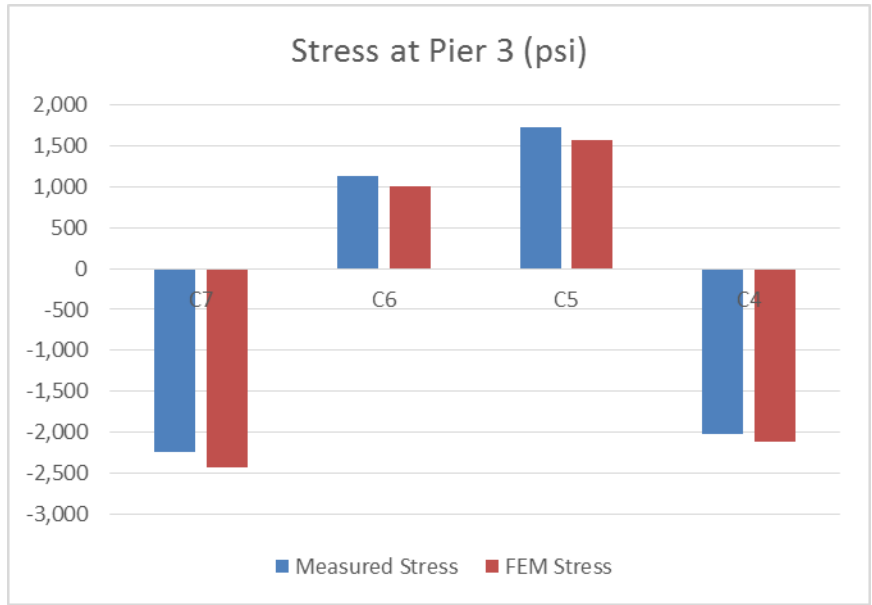
Figure E.1 Two trucks at Pier 3 stress results after model modifications

Following modification of the model, the largest error in the transverse direction decreased from -512.3% to -19.9%. Initially, five support bearings did not support the bridge (i.e., the superstructure was not in contact with the bearings). After the model was modified, bridge response was simulated with two bearings (Bearings 2 and 4) that were not in contact with the structure. At the other three bearing locations, the superstructure is modeled with vertical springs between the bearing support and the structure. The cross frames were found to be too stiff compared with the as-is condition (Xiao, Hulsey and Chen, 2015).

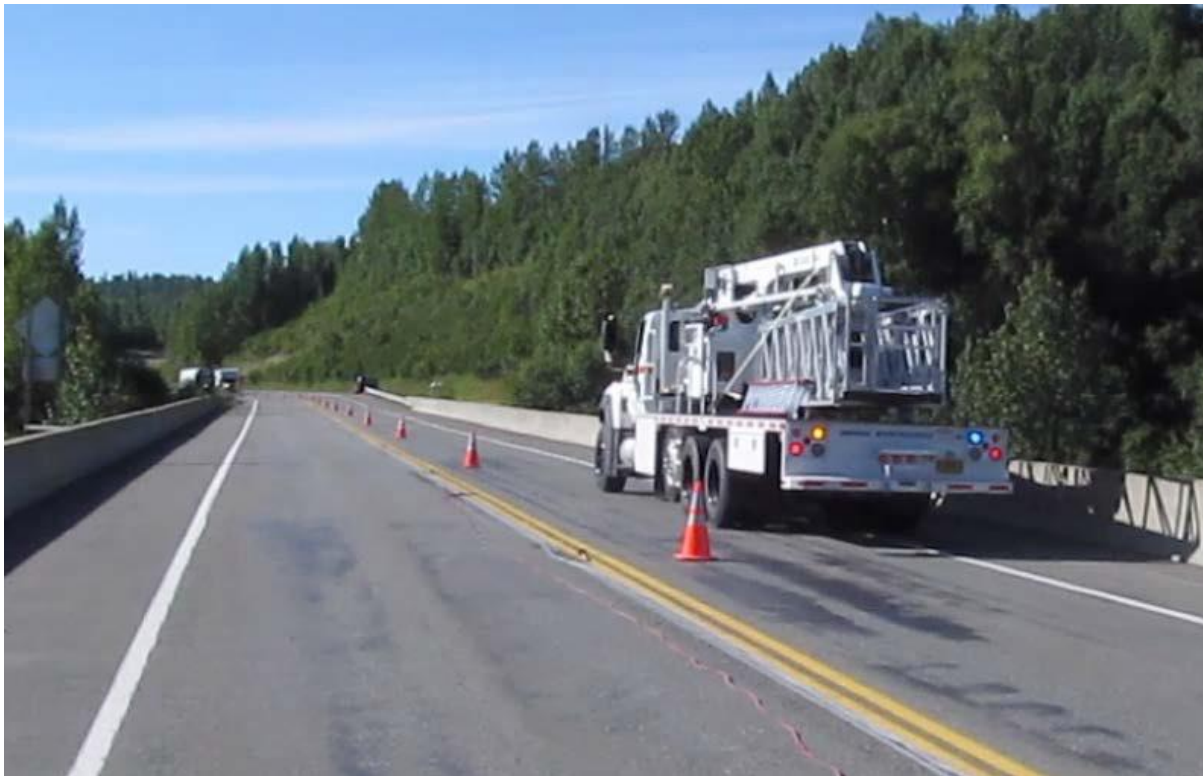
Figure I.3 A-30 boom truck traveling north for the dynamic ambient test

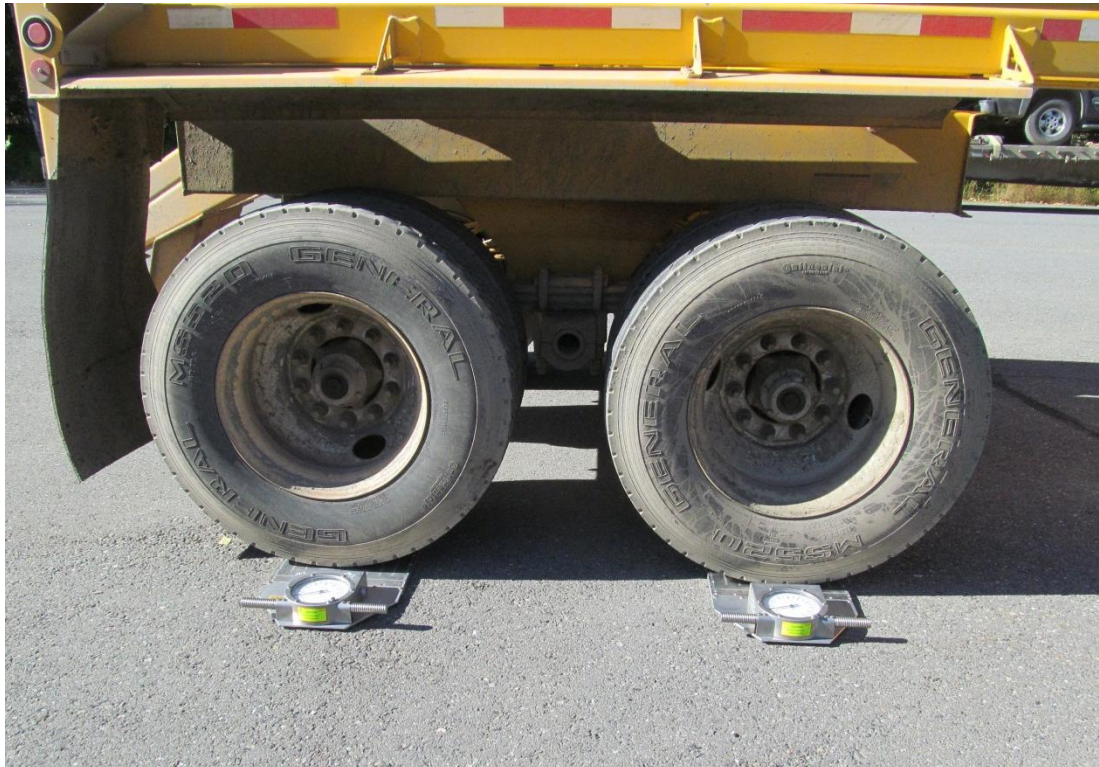
Figure I.6 Axle weight measured by the wheel load scales

for testing the bridge. Each truck-trailer was weighed and measured. Then, the trailers were loaded with sand and the truck-trailers were weighed (this is the load prior to testing). At the end of the day on September 10, after the load test, the three loaded ADOT&PF dump trucks were again weighed. This data provided the researchers with a record of the change in weight over the 8-hour test period. Axle weights were measured with calibrated portable scales provided by the ADOT&PF (see Figs. I.6 and I.7).

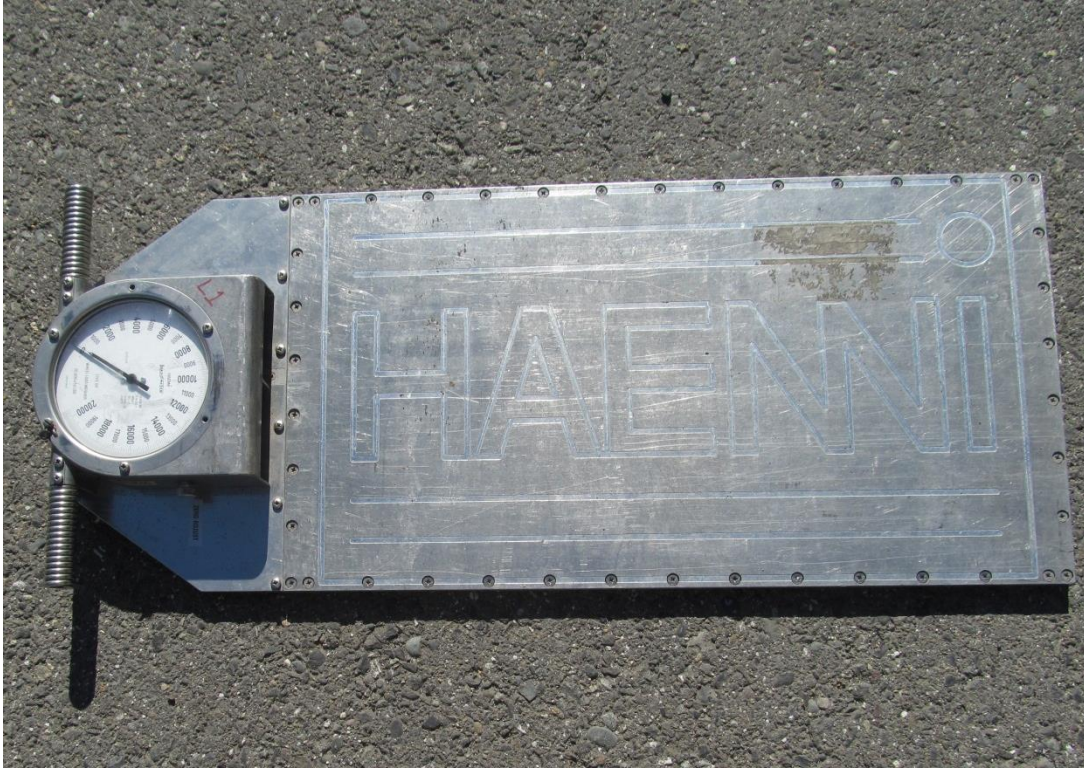
Figure I.7 Wheel load scales WL 101

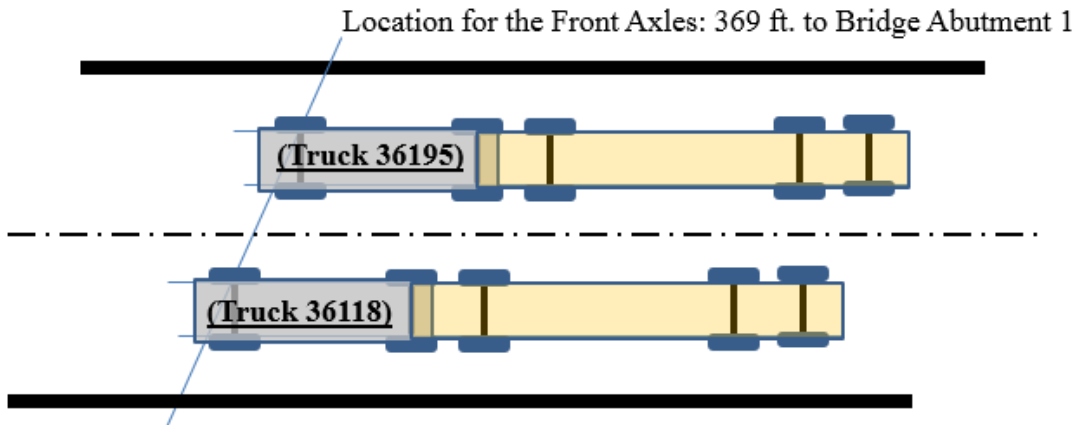
Figure I.10 Plan view of two trucks at mid-Span 3 southbound

In Trial 1, the ADOT&PF trucks used for testing were stopped and positioned in the middle of Span 3 (between Piers 3 and 4). The front axles were located 369 feet from the south abutment (Abutment 1) (see Figs. I.10 and I.11). A finite element analysis for these same load conditions was conducted. The local calculated strains and displacements were compared with the experimental SHMS response data

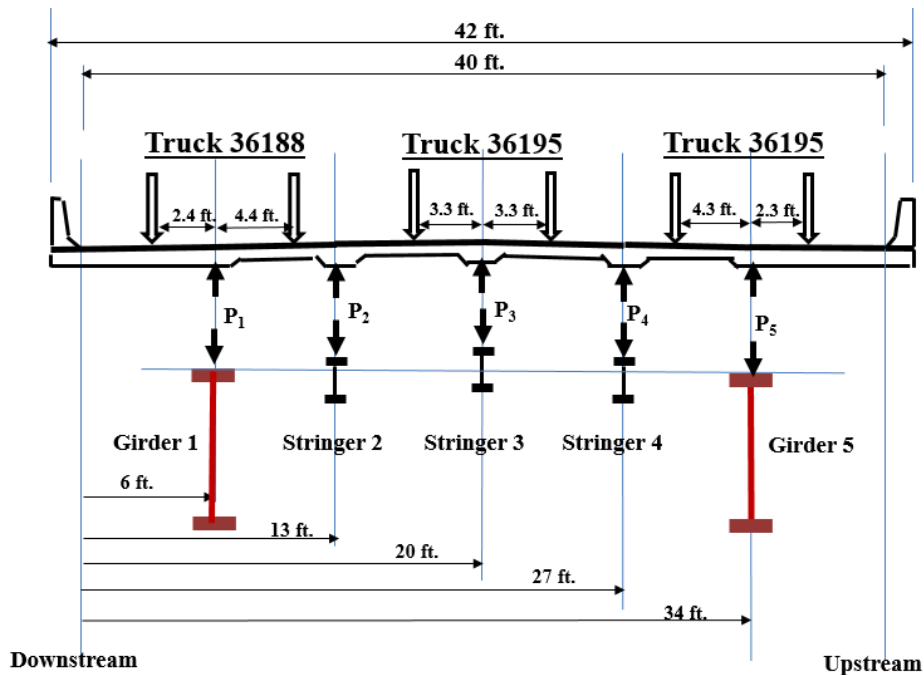
Figure I.14 Vertical view of three trucks at mid-span

Three trucks traveled parallel to the 22-degree skew angle of the bridge. Truck No. 36195 was on the upstream side of the bridge (Fig. I.12). The ADOT&PF loaded trucks moved southbound at 1 mph. Static tests were conducted by stopping the trucks for no less than 30 seconds at several pre-determined locations along the length of the bridge. In Trial 17, three trucks were positioned at mid-span of Span 3 (see Figs. I.13 and I.14). The FEM calculated values were compared with local SHMS data. Truck No. 36188 was on the middle of the bridge, and Truck No. 35752 was on the downstream side of the bridge (see Figs. I.13 and I.14).
