Use of Steel Fiber-Reinforced Rubberized Concrete in Cold Regions – Phase II: Monitoring

**HFHWY00049 and FHWA-AK-RD-4000(165)
December 2020**

13. ABSTRACT (Maximum 200 words) This report documents the real-world performance of a new pavement product for use in cold regions—steel fiber-reinforced rubberized concrete (SFRRRC). During the previous phase of this research project, Phase I: Use of Steel Fiber-Reinforced Concrete in Cold Regions, SFRRRC underwent laboratory testing and then pre-cast panels were designed and installed on Abbott Road in the Municipality of Anchorage in the summer of 2017. During the current phase, Phase II, SFRRRC was monitored in the field using visual inspection, continuous collection of strain gauge data, deflection measurements, rut depth, skid resistance, and other measures. SFRRRC was also investigated on high-traffic urban arterials/intersections to analyze rutting, freeze-thaw resistance and other possible rigid pavement properties, falling weight deflection, skid resistance, and life-cycle cost. A comparative analysis was conducted using the same measuring techniques on hot mix asphalt (HMA) on an adjacent road section. The results show that the

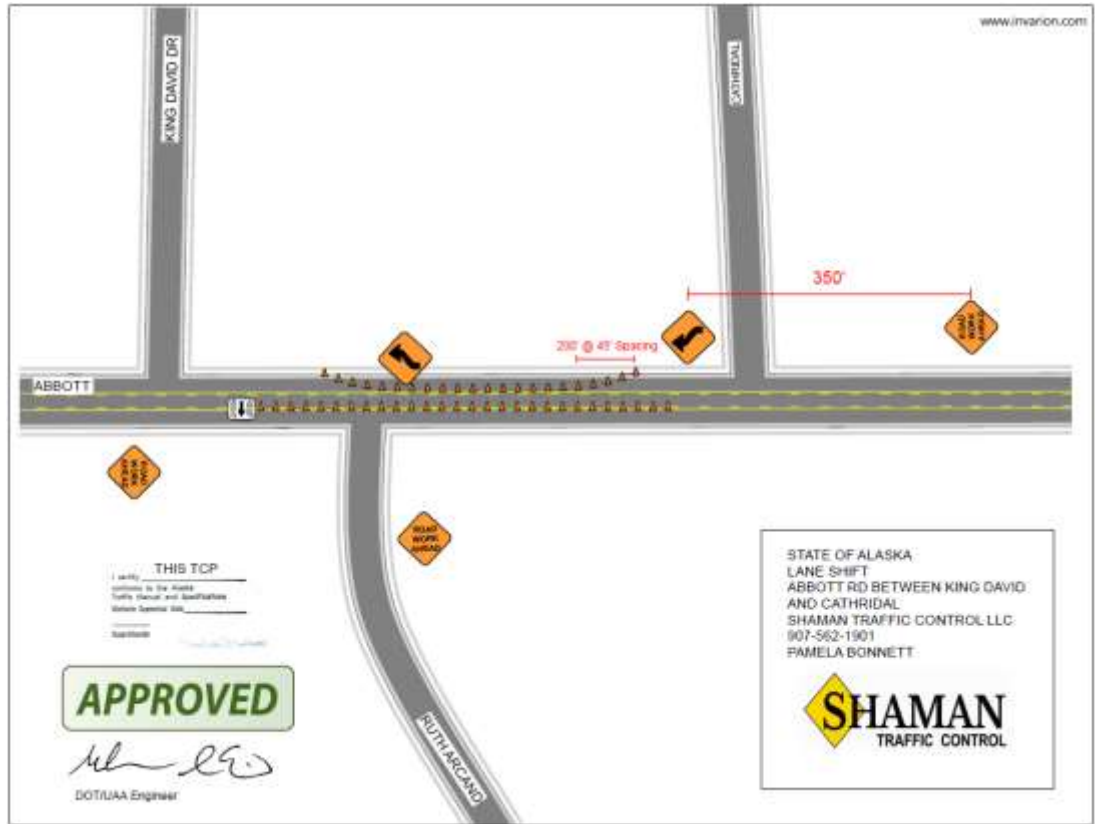
Figure 1: Traffic control plan during physical on-site testing (SHAMAN, Inc., 2018).

Data were collected through on-site physical testing, sensors embedded in the SFRRC slabs, and traffic sensors. On-site testing was conducted twice a year, and a traffic plan was developed and approved for that purpose, as shown in Figure 1. Shaman Traffic Control provided the services for lane shifting during the physical testing.

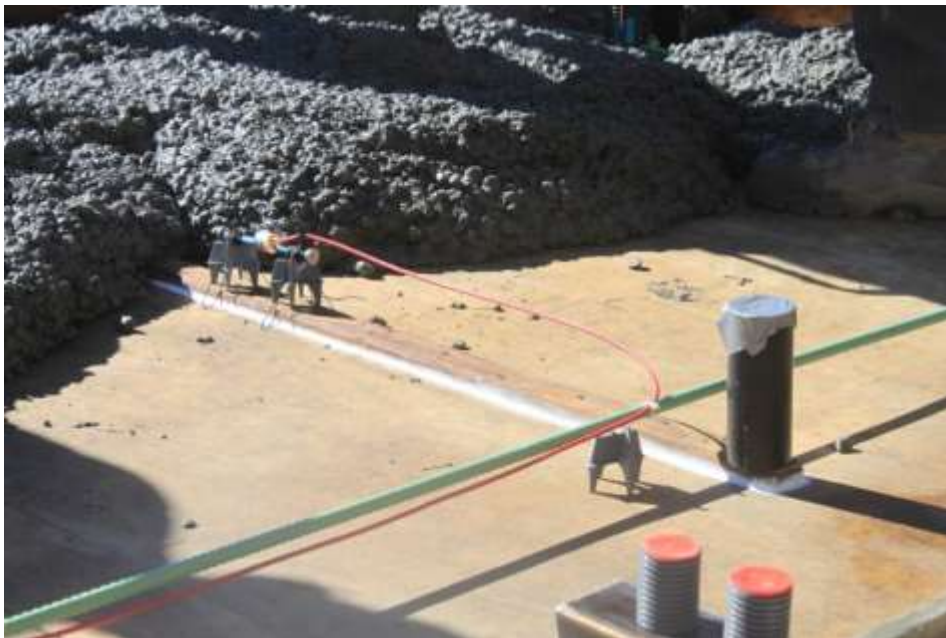
Figure 4: Strain gauge sensor placed in the precast SFRRRC slabs (Abaza, 2016).

- Of the three slabs embedded with strain gauges, sensors in slabs four and eight provided a more reliable outcome than slab thirteen.
- It was determined that each slab has its own characteristics with regard to strain values depending on conditions of basin and placement of the slabs, and can be analyzed separately, but still follows the general trends in rigid pavements.

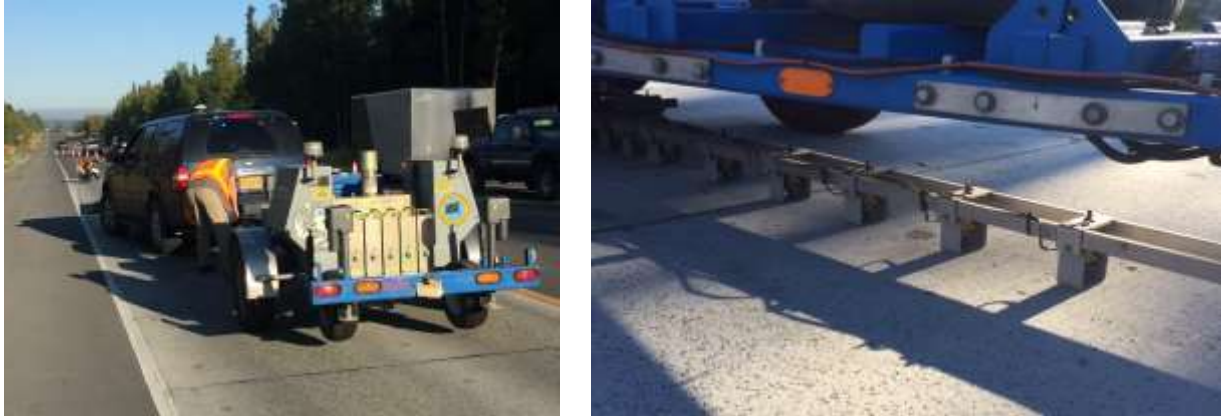
Figure 5: Falling weight deflectometer testing device used (Abaza, 2018).

The FWD data were collected by the Alaska DOT&PF Pavement Management System (PMS) team. The PMS team depends on the Dynatest (FWD) RSP 5051 Mark II, which applies a dynamic load that simulates the loading of a moving wheel as shown in Figure 5. Data were collected every 6 months when possible and compiled to measure the deflection at specified locations. Figure 6 shows locations of FWD testing for each site visit.

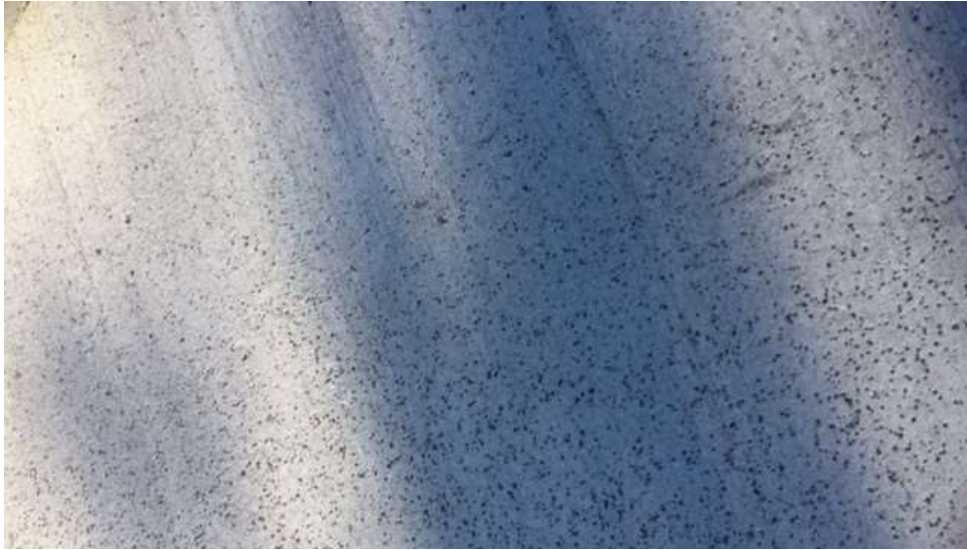
For each testing cycle of the SFRRRC section, a visual inspection was conducted to detect cracking or heaving due to freeze-thaw stresses. This visual inspection included any signs of joint filling failure, erosion or scaling of the concrete surface, the presence of steel fibers on the surface (embedment and geometry), striping damage, etc. Figure 7 shows a typical close-up view of the slab. Figure 8 shows a typical view of crack filling, edge striping, and the slab shoulder joint.

Figure 7: Typical close-up view of the SFRRRC surface (Abaza, 2018).

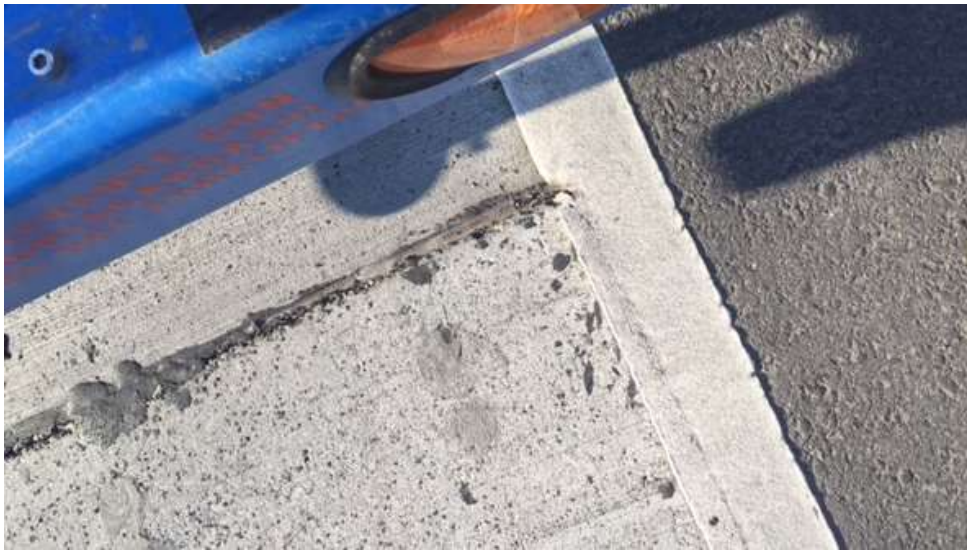
Figure 8: Typical view of crack filling, edge striping, and the slab shoulder joint (Abaza, 2018).

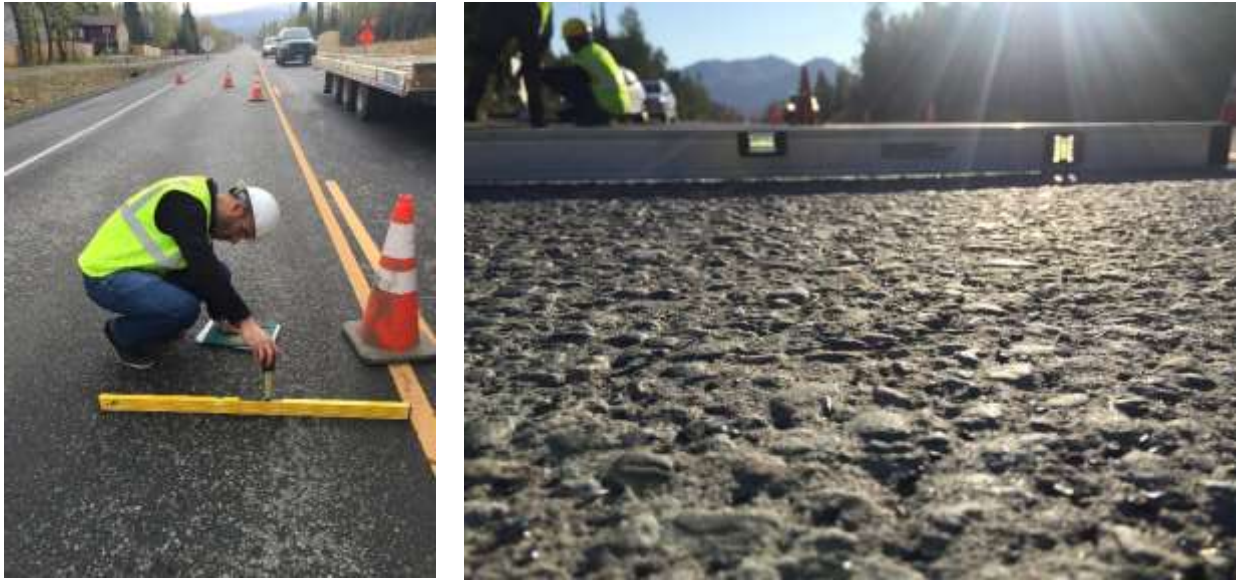
Rut measurements to determine abrasion resistance to studded tires were conducted on the test section and adjacent HMA. Figure 2 shows the locations of rut measurements on the SFRRRC and HMA sections during the monitoring period. Figure 9 shows a typical rut measurement using a straight edge in accordance with ASTM E1703 / E1703M – 10 (2015). In addition, Alaska DOT&PF PMS database rut data will be used in the analysis utilizing Mandlii LCMS, which was used until the end of 2017 and Fugro LCMS Road Surface Profiling (RSP) equipment, in use since 2018, which consists of distance measuring lasers and accelerometers and the Laser Crack Measurement System (LCMS) that provides high-definition 3D profiles and 2D images of the road surface (PMS, ADOT&PF). Figure 10 shows a typical rut profiler system. A comparative analysis of rut development on the two pavement sections was conducted for use as a criterion for life expectancy of each material, and life-cycle cost analysis was developed based on the outcome.

Figure 9: Rut measurements using a straight edge of adjacent HMA (Abaza, 2018).

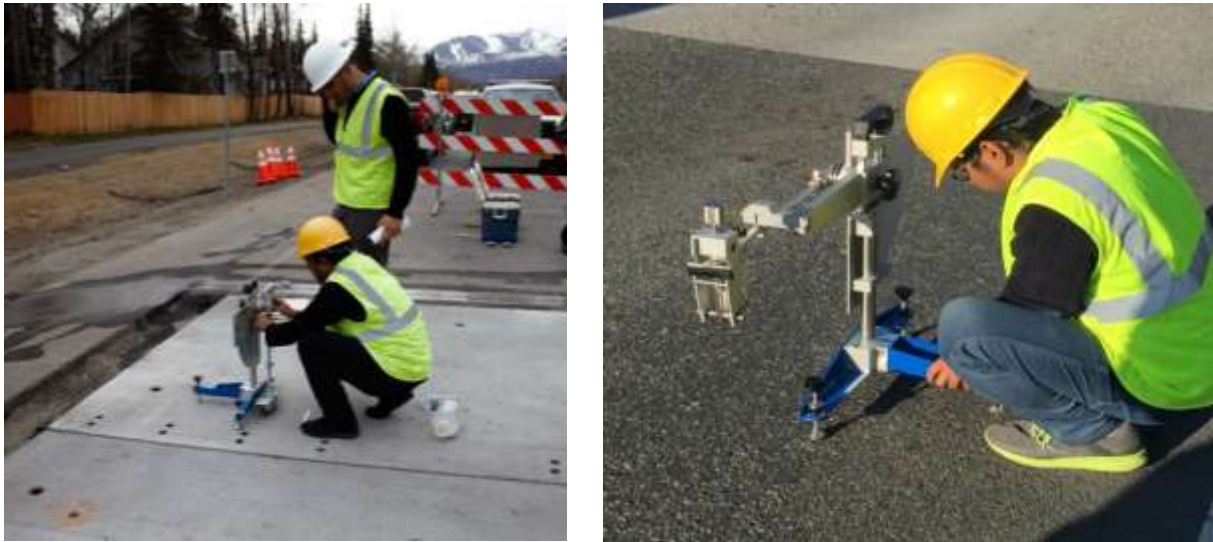
Skid resistance tests were conducted at each of the on-site testing locations following the American Society for Testing and Materials (ASTM) E303 – 93, “Standard Test Method for Measuring Surface Frictional Properties Using the British Pendulum Tester.” This step represents the safety aspect of the comparative analysis. The locations of the road section tests are shown in Figure 2. Figure 11 shows typical testing done on SFRRC and HMA at the Abbott Road test section.

Figure 11: Skid resistance testing for SFRR and HMA (Abaza, 2017).

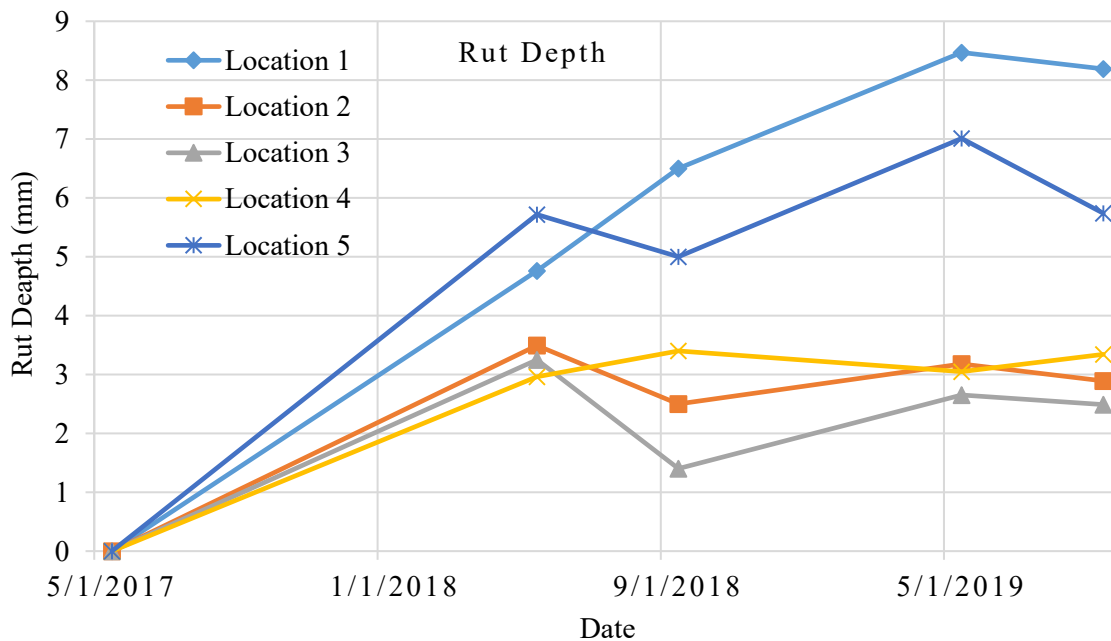
Rut depth readings were collected over the project’s duration to provide a comparative analysis of rut development in SFRRRC and HMA paving materials on Abbott Road. Locations of rut measurement are shown in Figure 2. Figure 12 gives the actual readings over the study period. Locations 1 and 5 are on the HMA surface located before and after the SFRRRC test section, and Locations 2, 3, and 4 are on slab numbers four, seven, and eleven of the SFRRRC surface test section. HMA rut development follows the normal trend in the area for arterial roads per the findings of the DOT&PF report titled “Survey and Economic Analysis of Pavement Impacts from Studded Tire Use in Alaska” (Abaza, 2019). SFRRRC showed very mild rut development compared to HMA before and after the test section. Concrete does not rut under wheel loads (Halsted, 2009). The rut readings measured on SFRRRC are due to studded tire use during wintertime and normal wear as a result of traction between wheel and surface.

Figure 12: Actual rut readings on Abbott Road over the study period.

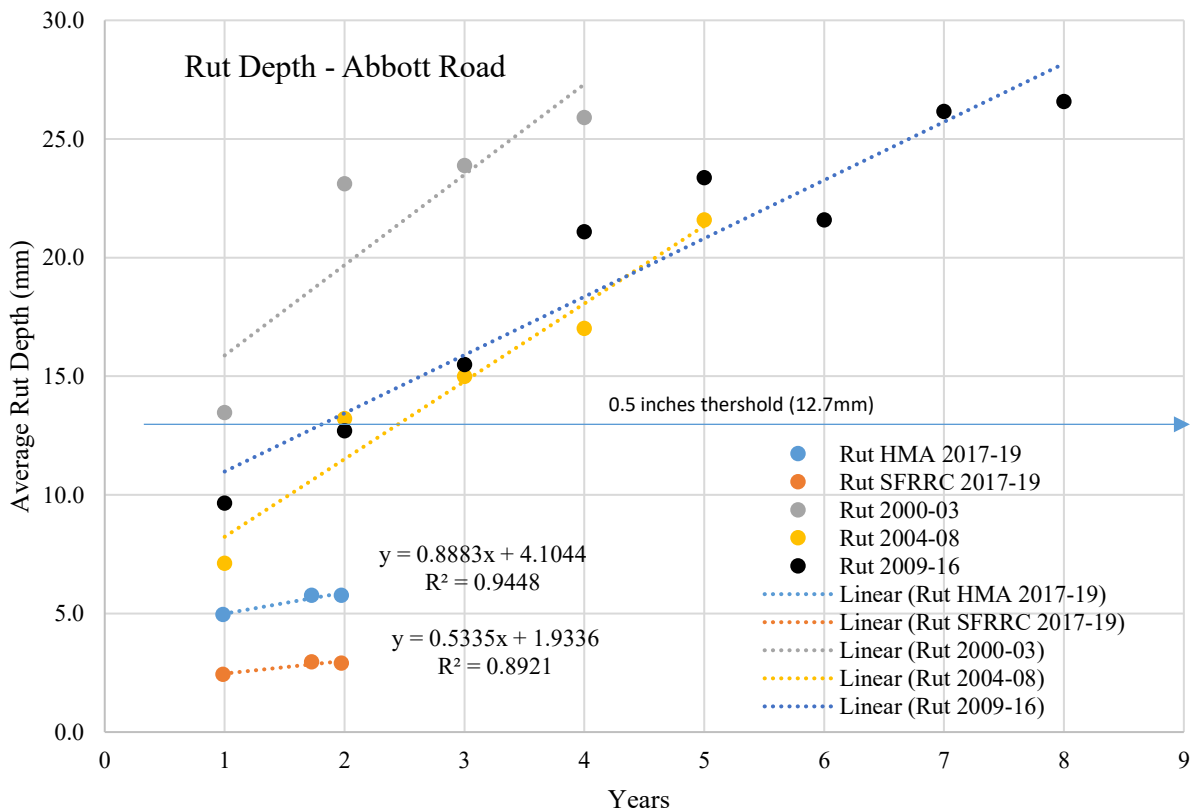
Based on the three historic cycles, the actual average overall rut depth at the time of maintenance was 0.97 in., which suggests that the next maintenance for HMA should occur in about the year 2030, with an overall service life of about 13 years. Comparative performance analysis of HMA and SFRRC shows that SFRRC can have a maintenance cycle that is about three times (3.28) longer than HMA. Appendix D gives a more detailed analysis on the rut development and rut rates of HMA and SFRRC on Abbott Road.

Figure 13: Average rut depth for HMA, SFRRC, and historic HMA rut on Abbott Road between Lake Otis and Elmore Road.

- Comparative analysis of HMA and SFRRRC rut resistance performance shows that SFRRRC can have a maintenance cycle that is about three times (3.28) longer than HMA under the same traffic conditions.
- The rut rate of SFRRRC is about 44% that of HMA based on the current mix design used on Abbott Road, and the rut rate is expected to decrease with time, as SFRRRC does not rut under wheel loads.
- Historic data on the same road section showed an improvement in HMA mix design as reflected in rut development over several cycles of rehabilitation/maintenance on Abbott Road.
- Rut performance measurement of the SFRRRC test section over the coming years is highly recommended, as the latest readings showed mild change and flattening of the curve, indicating very slow rut development compared with HMA. The overall future rut rate might be significantly lower than the measured value to date.

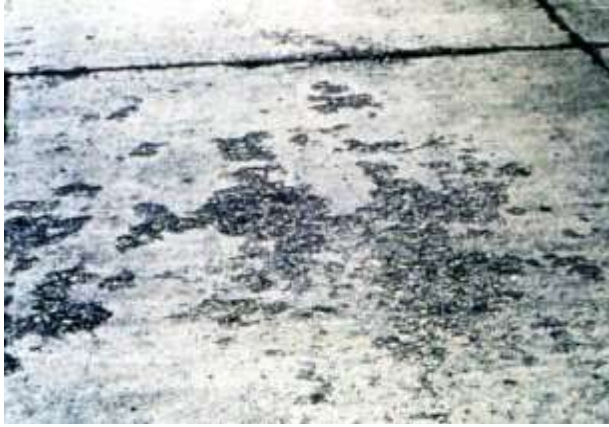
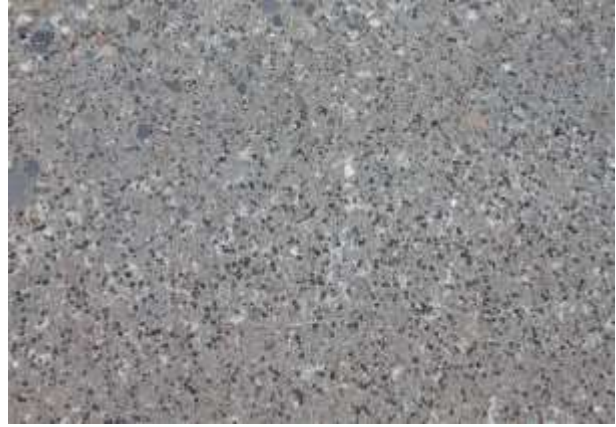
Figure 14: (a) Freeze-thaw scaling of concrete slabs, (b) SFRRC surface on Abbott Road.

When water/moisture freezes in concrete, it produces pressure in the capillaries and pores of the concrete. If the pressure exceeds the tensile strength of the concrete, the cavity will dilate and rupture. The cumulative effect of successive freeze-thaw cycles and disruption of paste and aggregate can eventually cause significant expansion and cracking, scaling, and crumbling of the concrete (PCA). Alaska is categorized as having greater frequency of exposure to freeze-thaw cycles than most regions in the United States. Freeze-thaw testing in Phase I showed no signs of damage in the SFRRRC in the lab environment as well as in the UAA trial slab. The field observations added crucial data for future use of this material. Typical signs of freeze-thaw can be noticed in the form of scaling of the concrete surface as shown in Figure 14a. No signs of scaling were noticed on the SFRRRC test section over the project period as shown in Figure 14b. In addition to steel fiber and crumbed rubber in the SFRRRC, air entrainment helped prevent freeze-thaw deterioration.

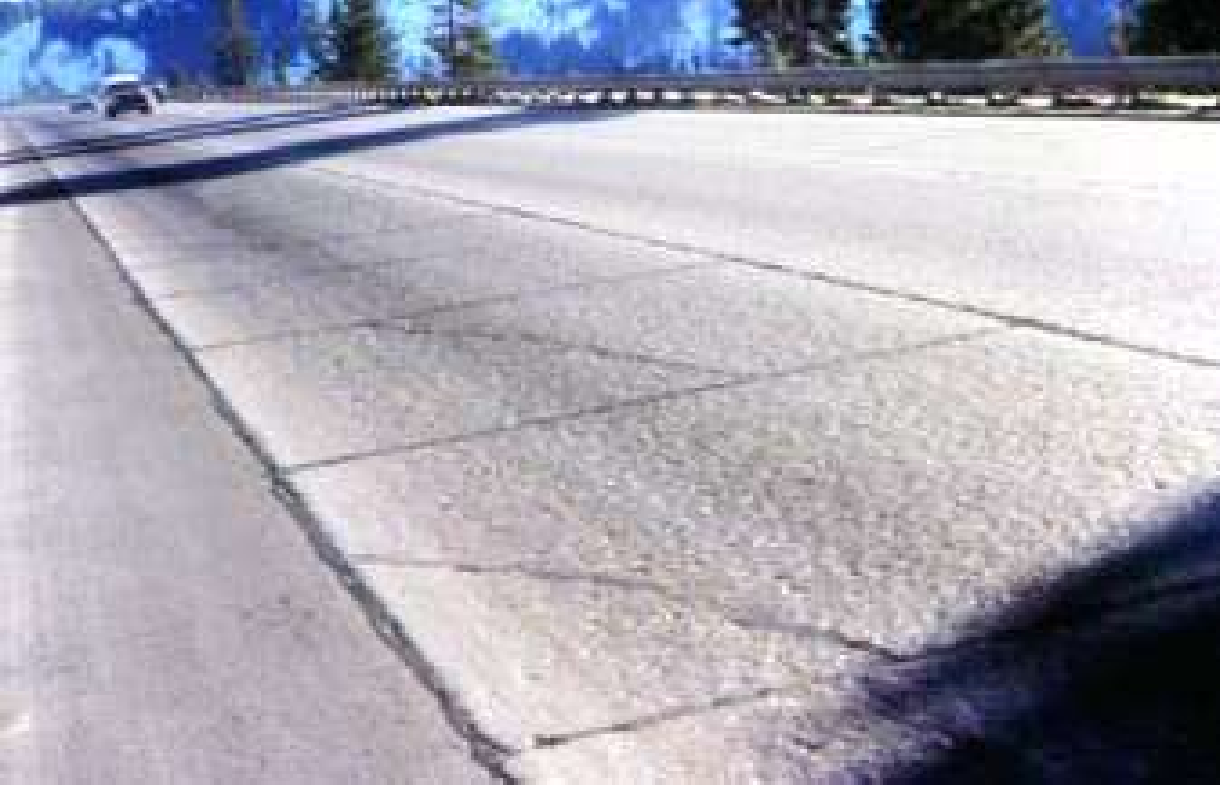
Figure 15: Typical rigid pavement rut (PCA [70156]).

Abrasion damage in PCC occurs when the surface of concrete is unable to resist wear caused by rubbing and friction. As the outer paste of concrete wears, fine aggregate and coarse aggregate are exposed, and abrasion and impact will cause additional degradation related to aggregate-to-paste bond strength and hardness of the aggregate. Tire chains and studded snow tires cause considerable wear to concrete surfaces. In the case of tire chains, wear is caused by flailing and scuffing as the rotating tire brings the metal in contact with the concrete surface (PCA). One of the main objectives in developing SFRRC is its use as a pavement material in cold region environments. In Alaska, the use of studded tires to improve traction is common, but this practice creates a challenge for building an abrasion-resistant surface that will withstand such aggressive action. Roadway rutting is a visible sign of studded tire use. Abrasion of floors and pavements may result from production operations or vehicular traffic. Many industrial floors as well are subjected to abrasion by steel or hard rubber wheeled traffic, which can cause significant rutting. Figure 15 shows an example of visible signs of rutting on typical rigid pavement. Figure 16 shows the developed rut on HMA adjacent to the test slabs 1 year after construction. Figure 17 shows a snapshot of SFRRC on Abbott Road. No notable signs of rut are visible on the SFRRC test section. Appendix E provides further details on measured rut depth of HMA and SFRRC.

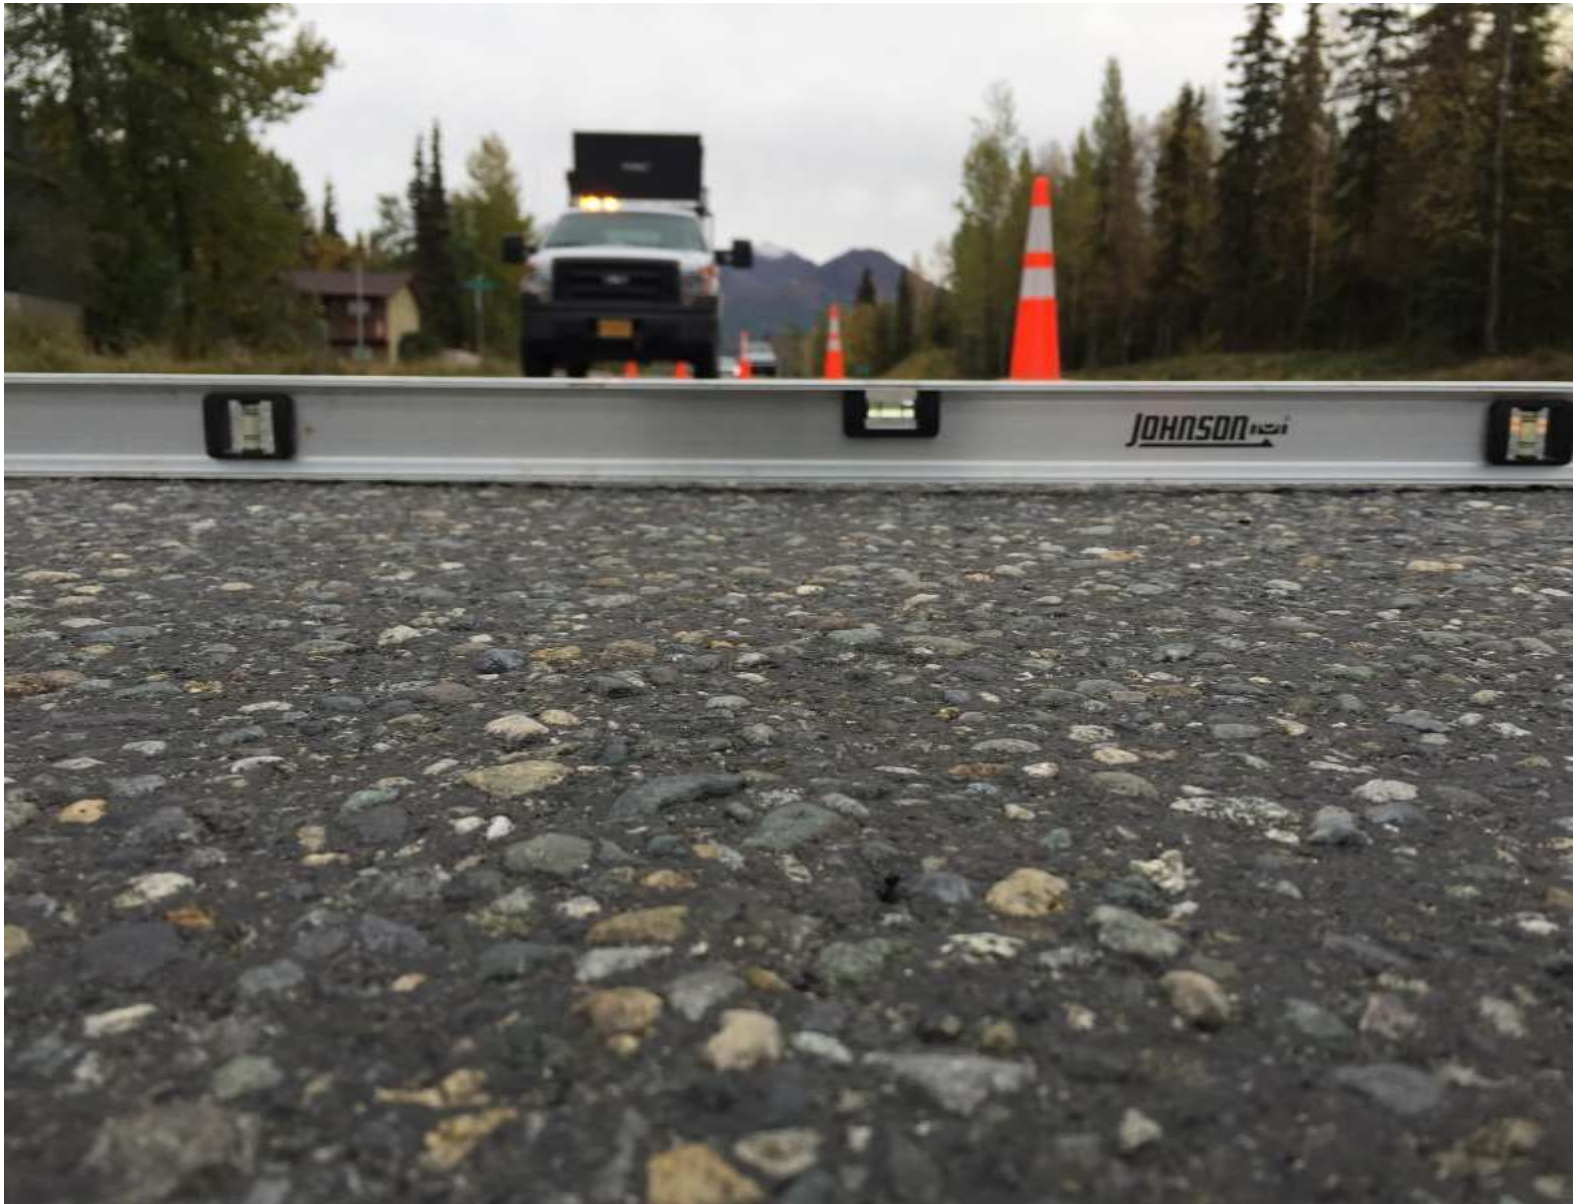
Figure 16: HMA rut on Abbott Road (Abaza, 2018).

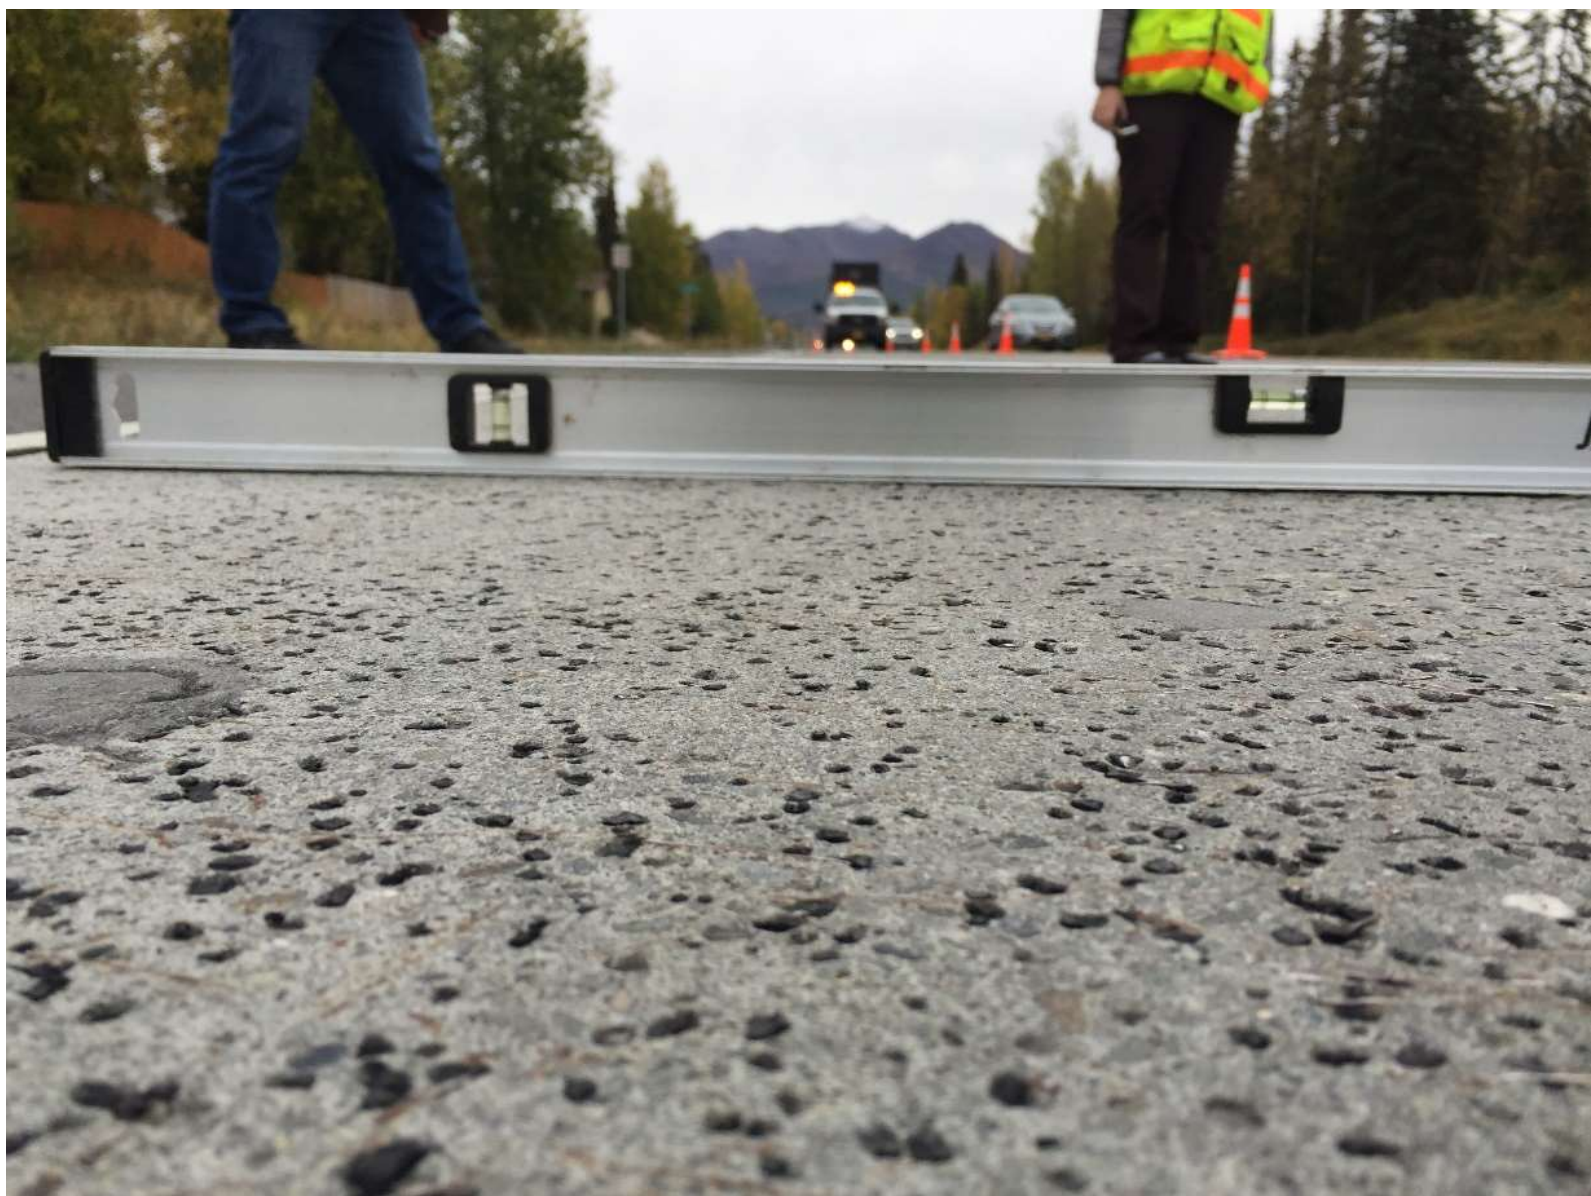
Figure 17: SFRRR Abbott Road (Abaza, 2018).

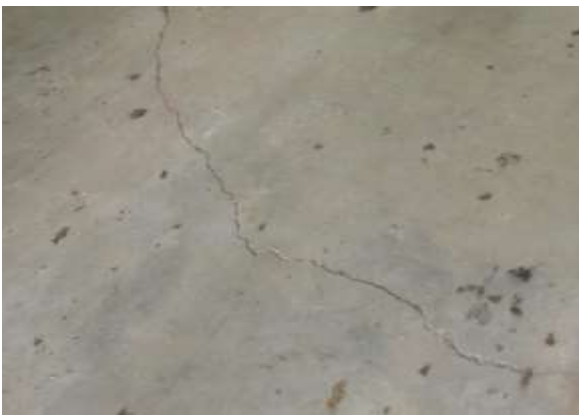
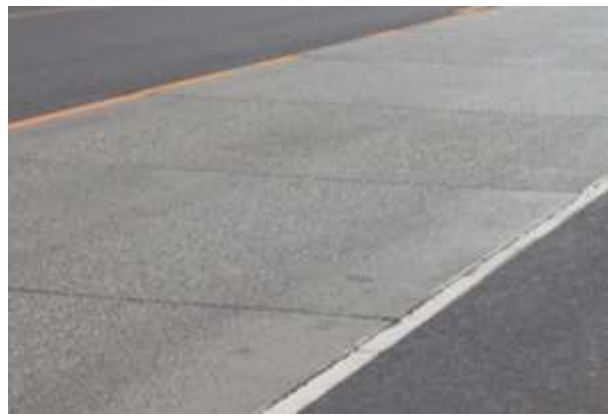
Concrete expands when heated and contracts when cooled. An average value for the thermal expansion of concrete is about 10 millionths per degree Celsius (5.5 millionths per degree Fahrenheit) (PCA). This amounts to a length change of 5 mm for 10 m of concrete (2/3 in. for 100 ft of concrete) subjected to a rise or fall of 50°C (90°F). Thermal expansion and contraction of concrete varies with factors such as aggregate type, cement content, water-cement ratio, temperature range, concrete age, and relative humidity. Allowing for movement by using properly designed expansion or isolation joints will help minimize the effects of temperature variations. In the case of SFRRC, the inclusion of steel fiber significantly reduces expansion and contraction, eventually reducing the effect of thermal cracking (see Appendix D for field strain gauge measurements). In addition, expansion joints were considered in the design of the SFRRC test section. No signs of thermal cracking are visible in the SFRRC test section, as shown in Figure 18.

Figure 18: (a) Typical thermal cracking in concrete slabs, (b) SFRCC.

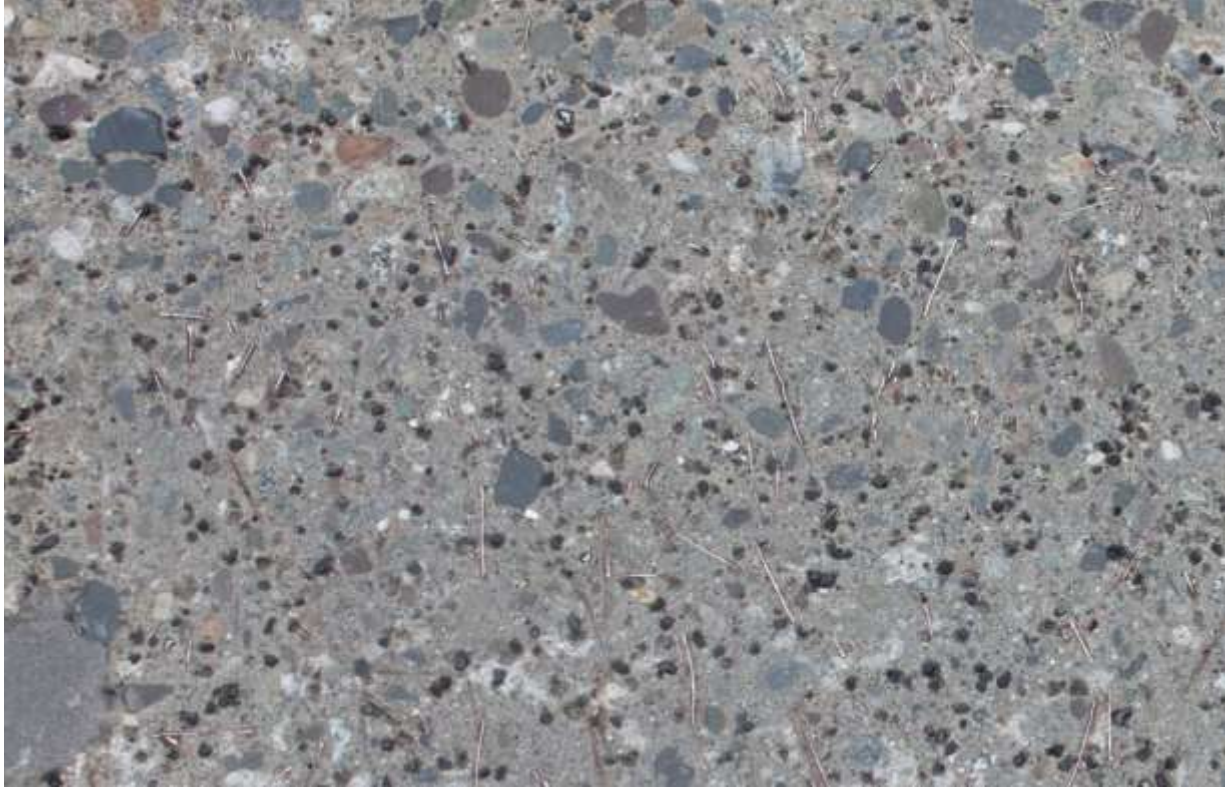
Corrosion of reinforcing steel and other embedded metals is the leading cause of deterioration in concrete. When steel corrodes, the resulting rust occupies a greater volume than steel. This expansion creates tensile stresses in the concrete, which can eventually cause cracking, delamination, and spalling. In the case of the test section on Abbott Road, steel fibers were used to enhance the material characteristics for cold region environments. The steel fibers showed no signs of corrosion, and no signs of damage to the concrete material were noted. Figure 19 shows an example of visible steel fiber on-site.

Figure 19: Steel fiber in the test section (Abaza, July 2020).

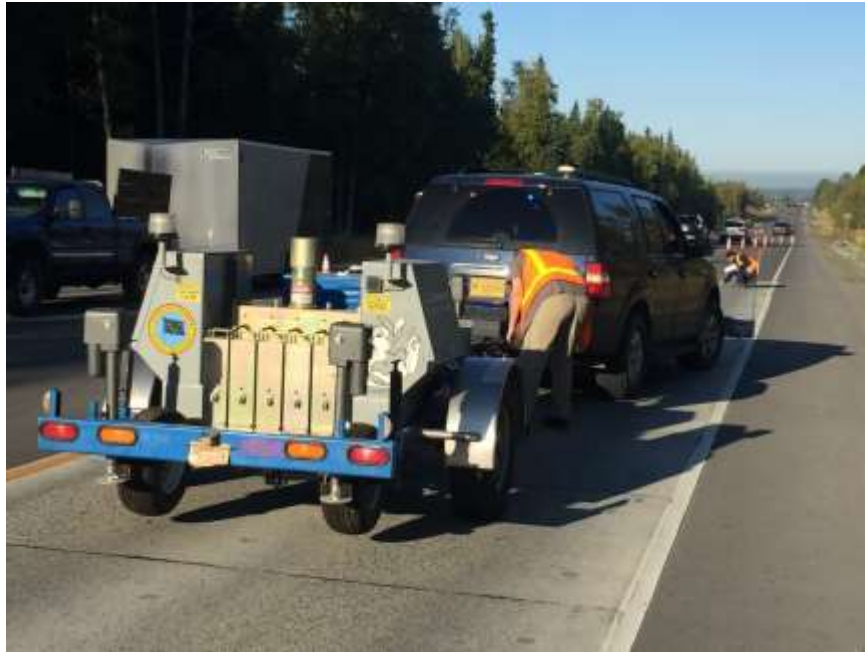
Figure A2: FWD testing on Abbott Road (Abaza, 2018)

county roads, municipal streets, and parking lots. Finally, deflection can be measured using impact (impulse) load response; all impact load devices deliver a transient impulse load to the pavement surface. The subsequent pavement response (deflection basin) is measured by a series of sensors. The most common type of impact load response equipment is the FWD. Figure A2 shows the FWD machine used in measuring deflections by Alaska DOT&PF at the SFRRRC test section on Abbott Road.

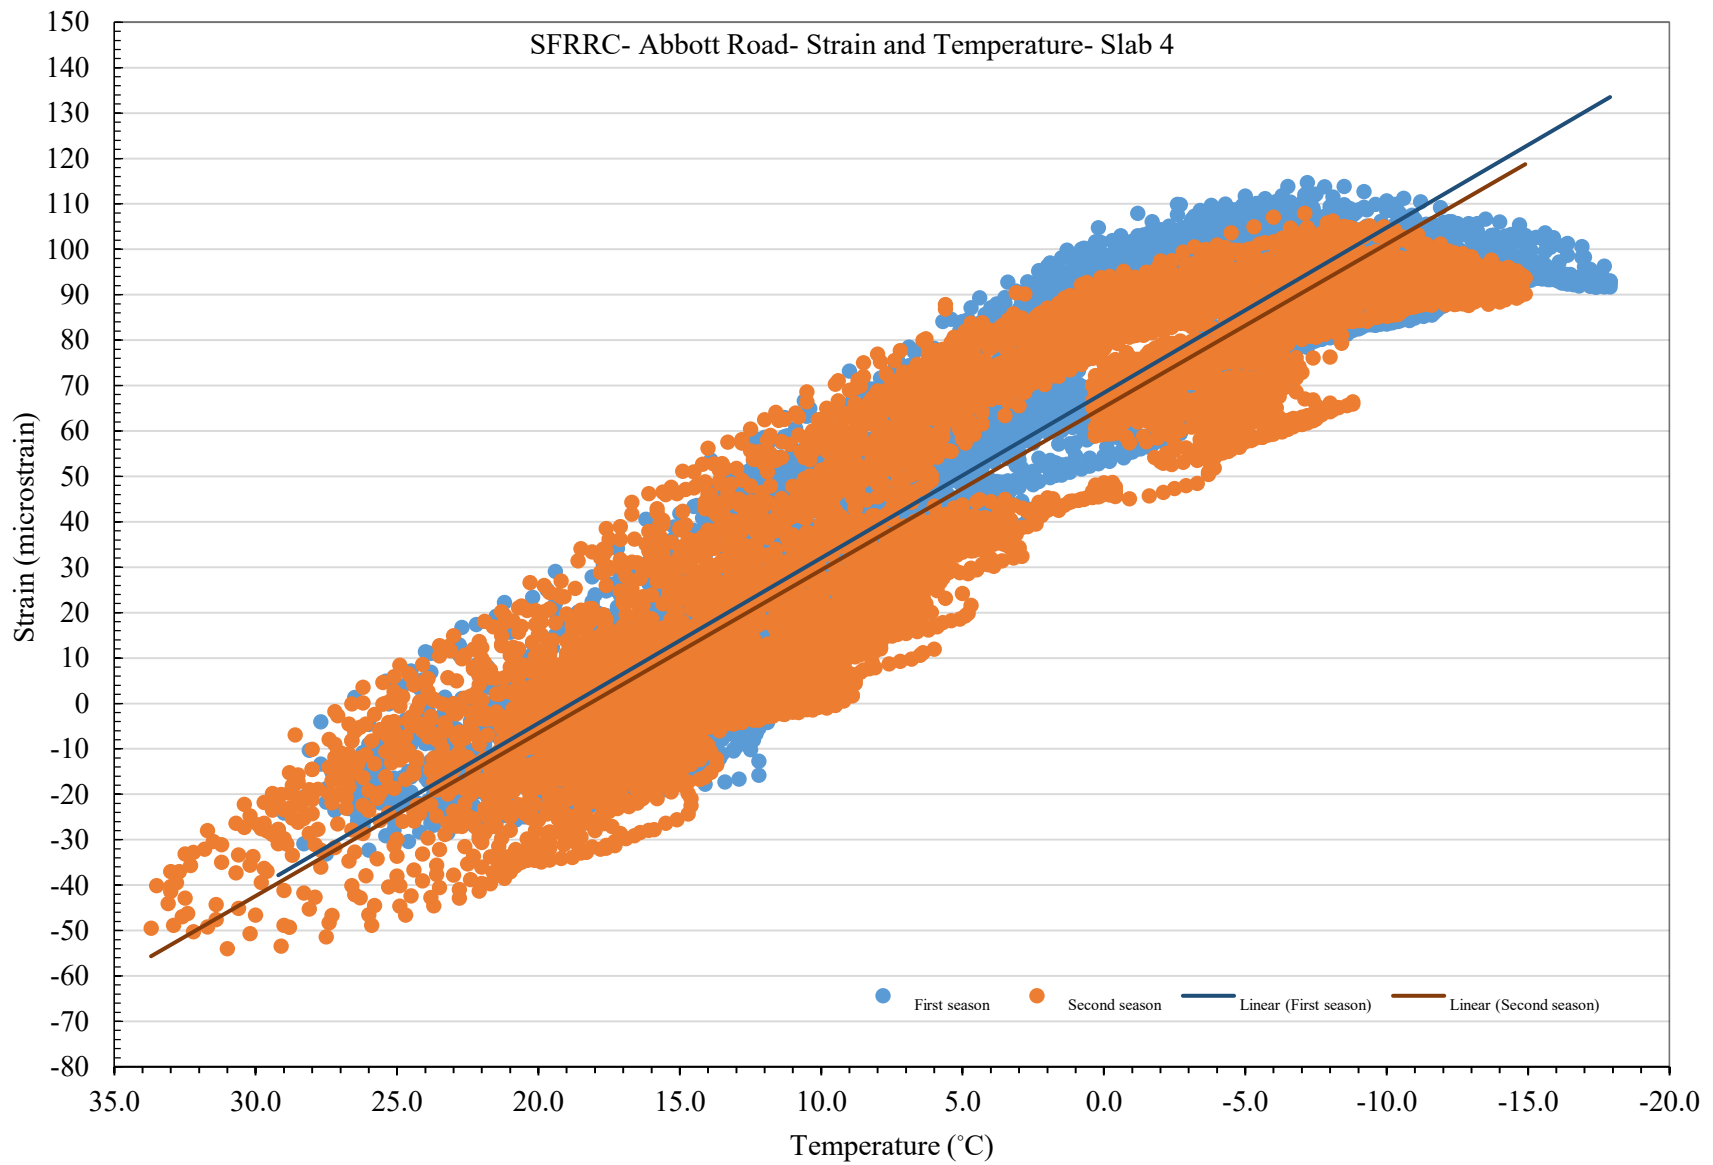
Figure B6: Strain-temperature data for the center of slab number four for SFRRC test section.

- The coefficient of thermal expansion (CTE) for SFRRRC was reported to be $3.60 \times 10^{-6} / ^\circ\text{C}$ ($6.48 \times 10^{-6} / ^\circ\text{F}$) reflecting 38% of the mechanistic-empirical pavement design guide (MEPDG) American Association of State Highway and Transportation Officials (AASHTO) recommended value.

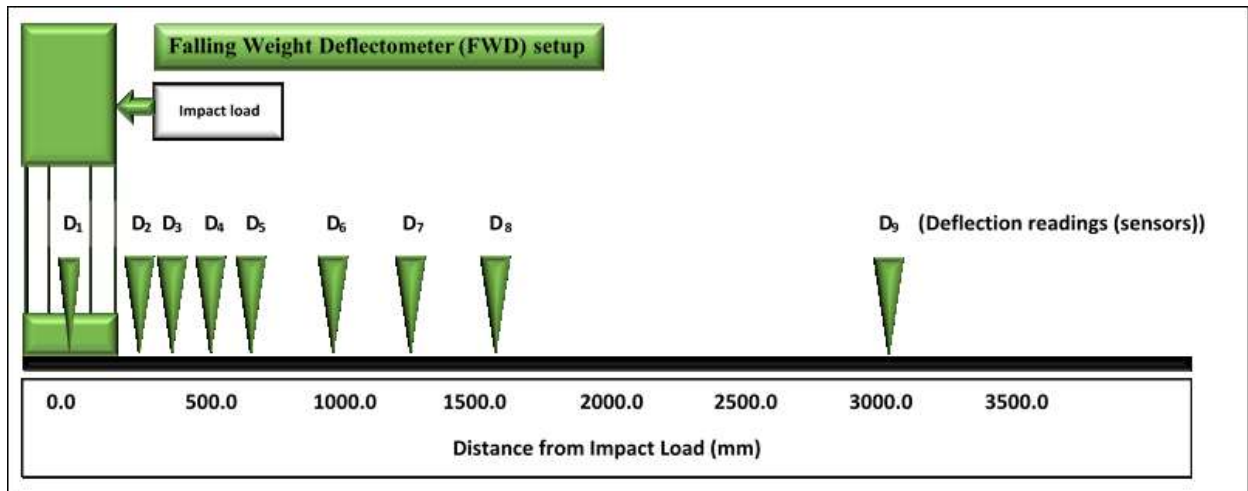
Falling weight deflectometer (FWD) testing was used to evaluate the structural condition of existing pavements in the SFRRRC slabs and the adjacent HMA. For PCC, FWD testing is used to detect voids, monitor joints and crack performance, and back-calculate the modulus of elasticity of PCC and the k-value of all supporting layers. For HMA pavements, FWD testing is used to back-calculate the stiffness of each layer and to estimate the amount of damage in the existing asphalt. In this project analysis, deflections in the slabs and load transfer efficiency (LTE) across the joints were evaluated for SFRRRC, and deflections in HMA were evaluated. The data were collected by the Alaska DOT&PF PMS team using Dynatest (FWD) RSP 5051 Mark II, which applies a dynamic load that simulates the loading of a moving wheel. The advantage of FWD testing is that it gives the deflection characteristics of pavement and the deflection basin. Data for this project were collected every 6 months when possible and compiled to measure the deflection at the center, edge, corner, and panel joint. Figure C1 shows the testing locations 1 through 16 (1 through 15 on the SFRRRC slabs and location 16 on the HMA), and Figure C2 shows the FWD deflection readings per location away from the center of the impact load of the FWD device. D₁ is at zero distance from the standard impact load (10,000 pounds), and D₉ is the farthest from D₁ at 3000 mm. The rest of the readings are recorded at distances shown in the figure.

Figure C2: Location of deflection readings from sensors in the FWD device (Abaza, 2020).

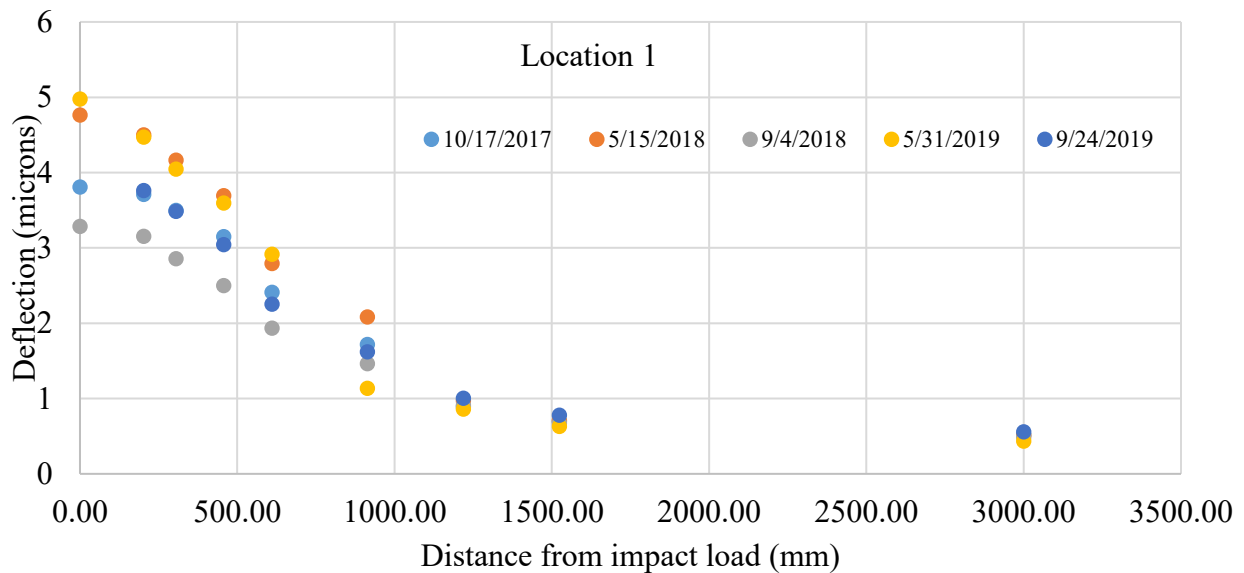
Figure C3: Readings of deflections taken from location 1 at the center of SFRRRC slab number two.

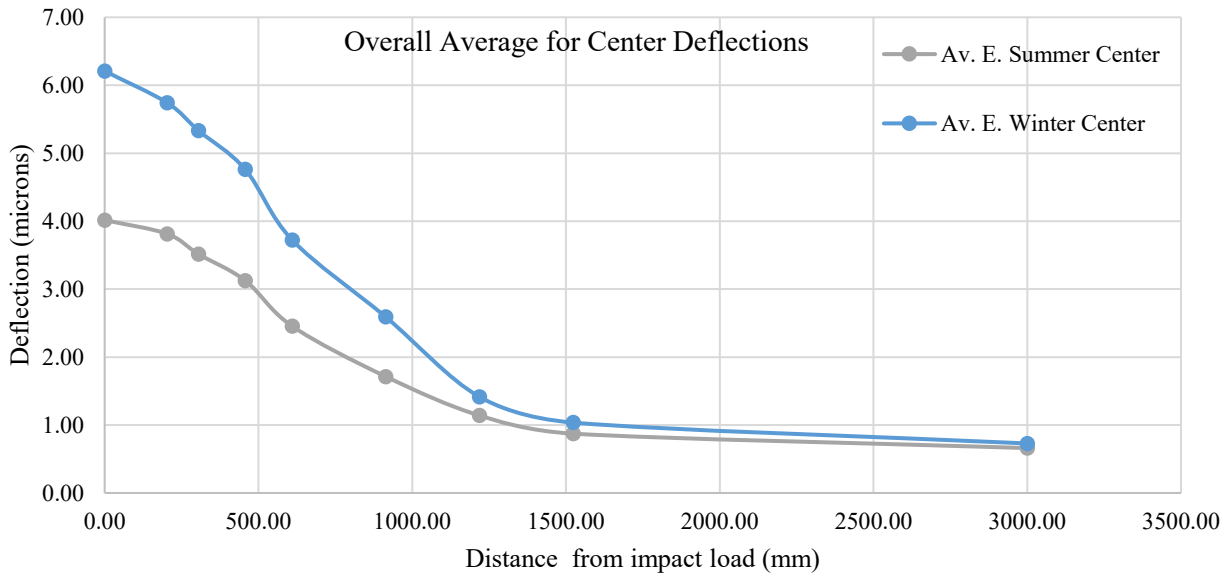
Figure C7: Overall average center deflections for locations 1, 2, and 3 at the end of winter and summer seasons.
