Use of Steel Fiber-Reinforced Rubberized Concrete in Cold Regions – Phase II: Monitoring

**HFHWY00049 and FHWA-AK-RD-4000(165)
December 2020**

13. ABSTRACT (Maximum 200 words) This report documents the real-world performance of a new pavement product for use in cold regions—steel fiber-reinforced rubberized concrete (SFRRRC). During the previous phase of this research project, Phase I: Use of Steel Fiber-Reinforced Concrete in Cold Regions, SFRRRC underwent laboratory testing and then pre-cast panels were designed and installed on Abbott Road in the Municipality of Anchorage in the summer of 2017. During the current phase, Phase II, SFRRRC was monitored in the field using visual inspection, continuous collection of strain gauge data, deflection measurements, rut depth, skid resistance, and other measures. SFRRRC was also investigated on high-traffic urban arterials/intersections to analyze rutting, freeze-thaw resistance and other possible rigid pavement properties, falling weight deflection, skid resistance, and life-cycle cost. A comparative analysis was conducted using the same measuring techniques on hot mix asphalt (HMA) on an adjacent road section. The results show that the

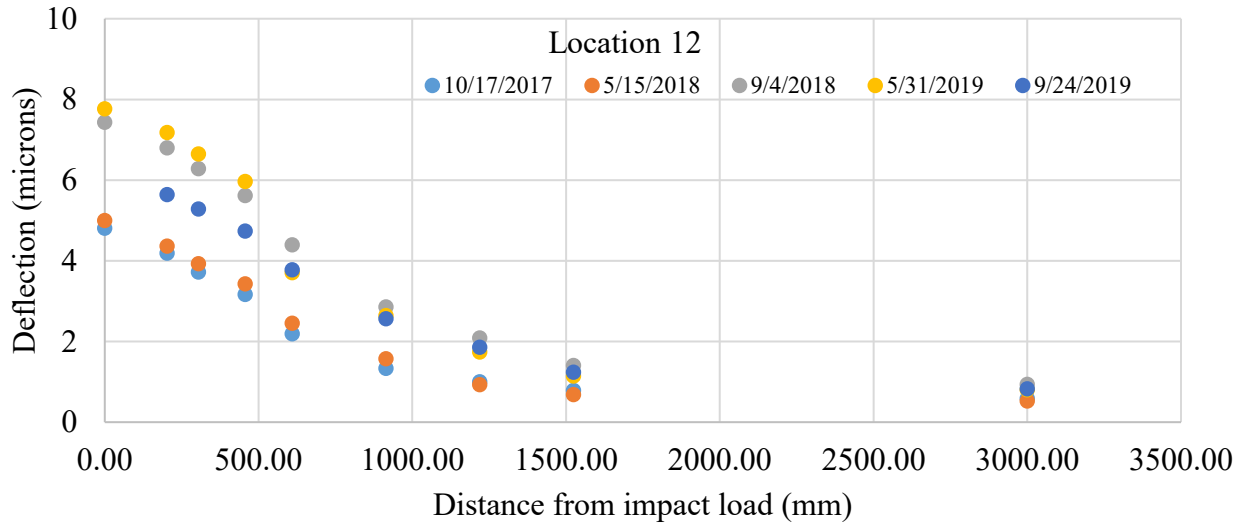
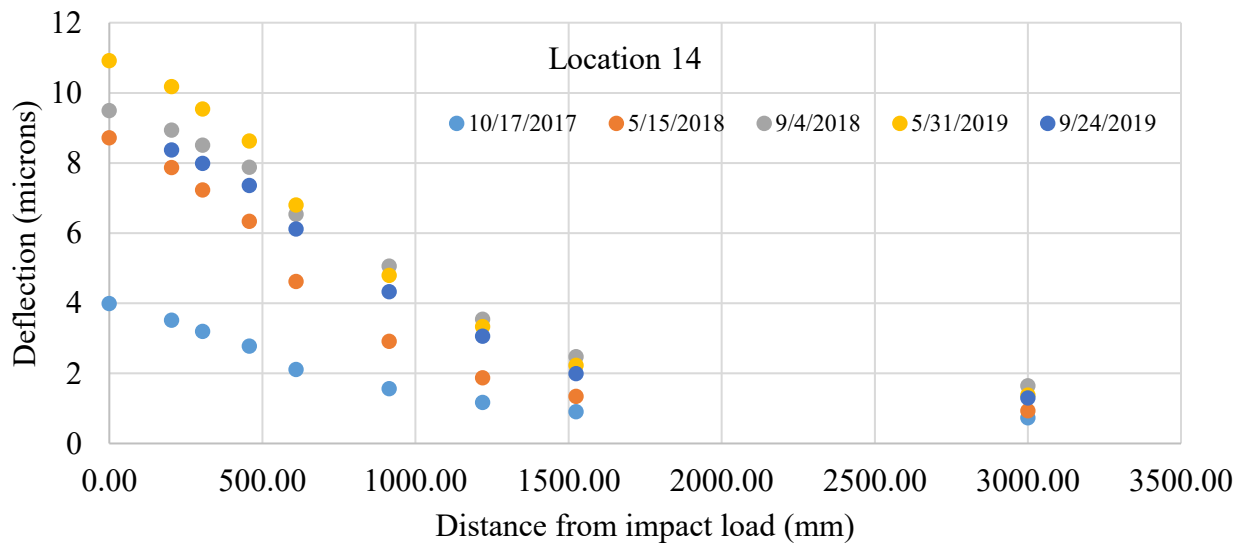
Deflection readings at the edge of slab numbers two, eight, and fourteen or locations 10, 12, and 14 are shown in Figure C1. No seasonal trends are observed from individual data per Figure D8, but the overall average in Figure C9 depicted such a trend as observed in the center loading. Figure C10 shows overall average deflection at the edge for locations 10, 12, and 14 at the end of the winter and summer seasons. In addition, a comparison of center and edge loading for the same locations per Figure C11 shows higher deflection at the edges as expected and as documented in the literature (Huang, 2004, and others).

Figure C8: Deflections readings at the edge of slabs two, eight and thirteen, locations 10, 12, and 14.

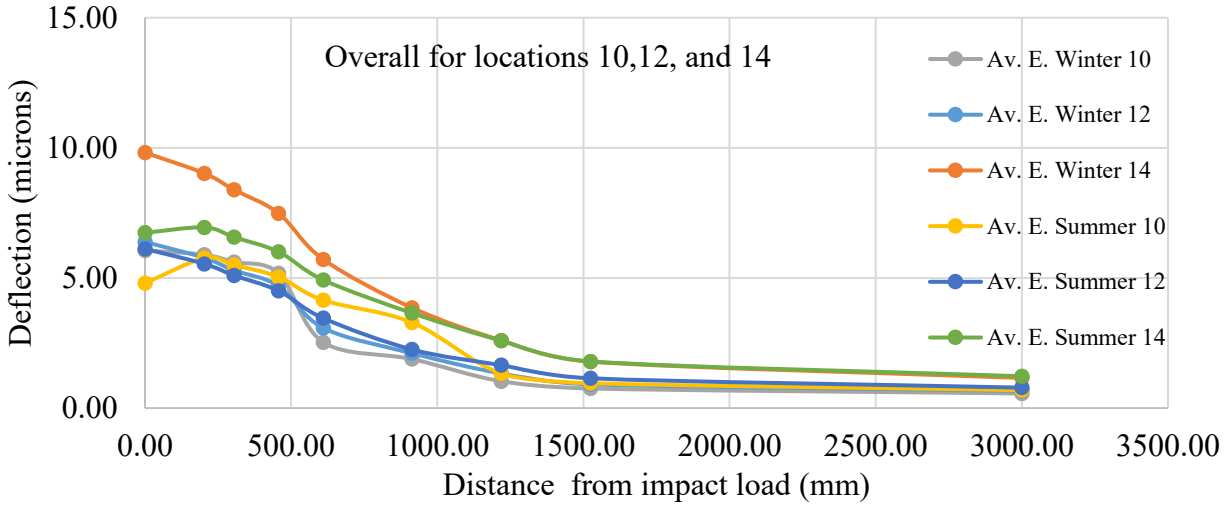
Figure C9: Graphical representation of deflections on the three locations at the edge of the slabs for end of winter and summer seasons

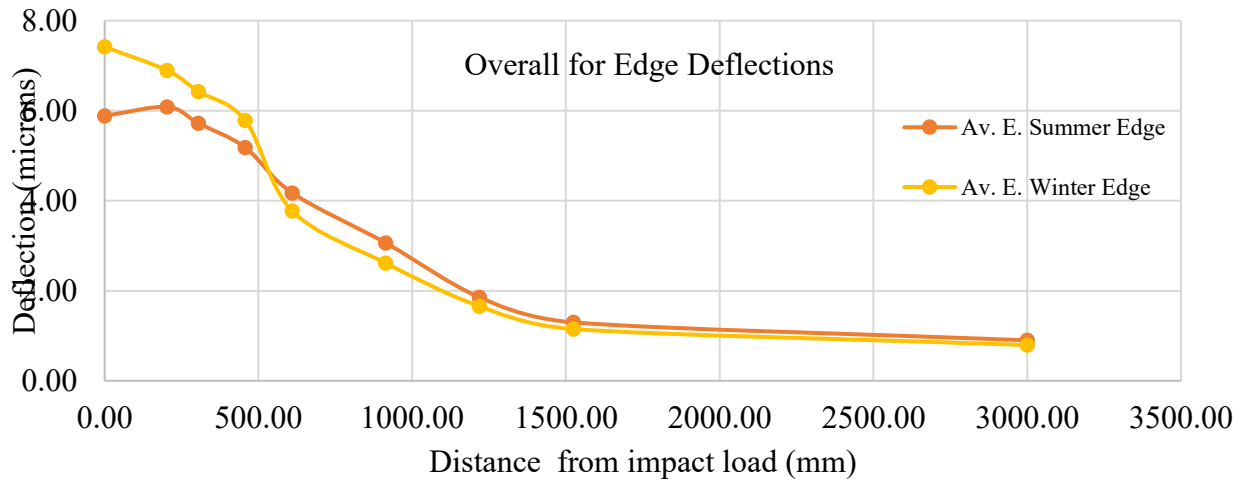
Figure C10: Overall average edge deflection for locations 10, 12, and 14 at the end of winter and summer seasons.

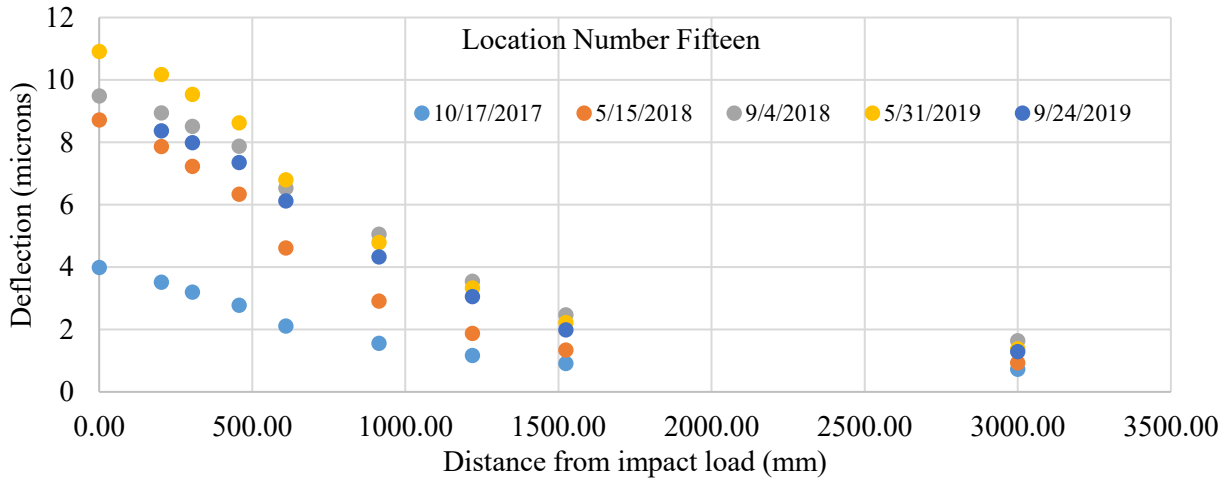
For the analysis of deflections at the corner of slabs two, eight, and fourteen or locations 11, 13, and 15, Figure C12 shows a summary of the readings. No seasonal trends are observed from individual data per Figure C13, as the main support of the slab at the corner are dowel bars (Huang, 2004) transferring load to the adjacent slab and not totally dependent on conditions of the basin. Figure C14 shows the overall average corner deflection at the end of the winter and summer seasons, where the end of summer deflection readings are higher near the joint/corner, after which they are about equal to that of the end-of-winter deflection. In other words, at about 400 mm from the joint/corner, the corner deflection resembles that of the edge deflection. Furthermore, the shape of the curve is dependent on the point of loading and the existence of a dowel bar at that location. Figure C15 gives an overall summary of the center, edge, and corner deflections. The highest deflection occurs at the corner, followed by edge and center, respectively. The deflection at these three locations follows the trend reported in the literature (Huang, 2004, and others).

Figure C12: Deflection readings at the edge of slabs two, eight and thirteen, locations 11, 13, and 15.

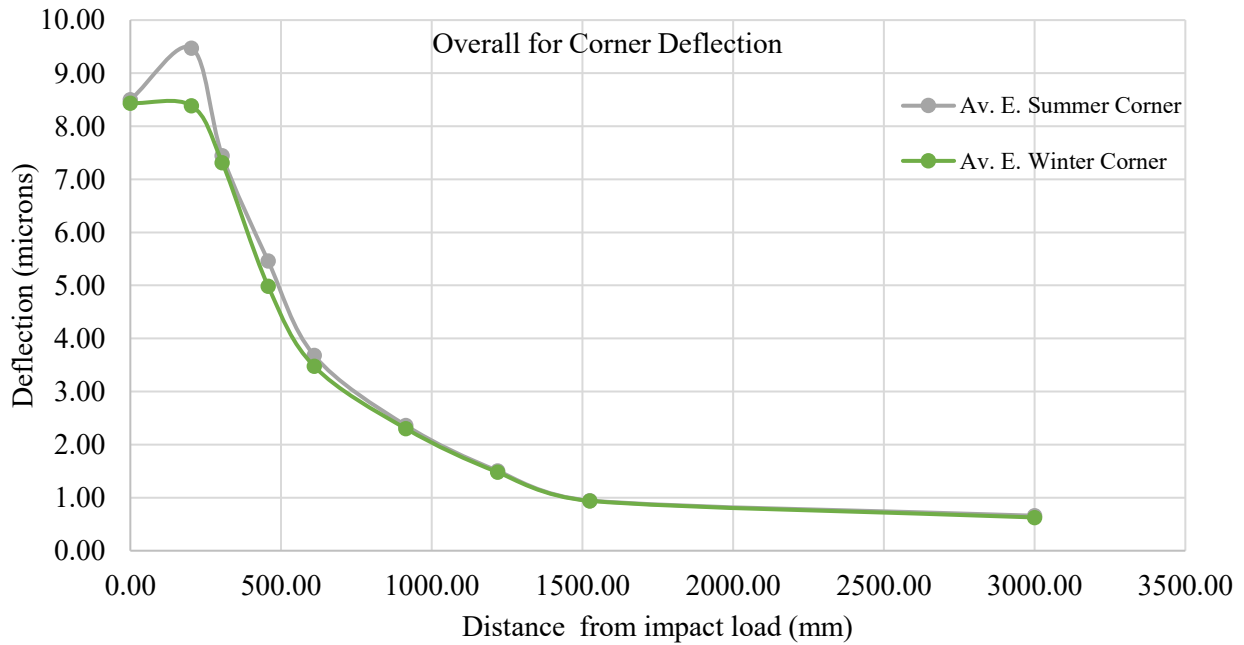
Figure C14: Overall average corner deflection for locations 11, 13, and 15 at the end of winter and summer seasons.

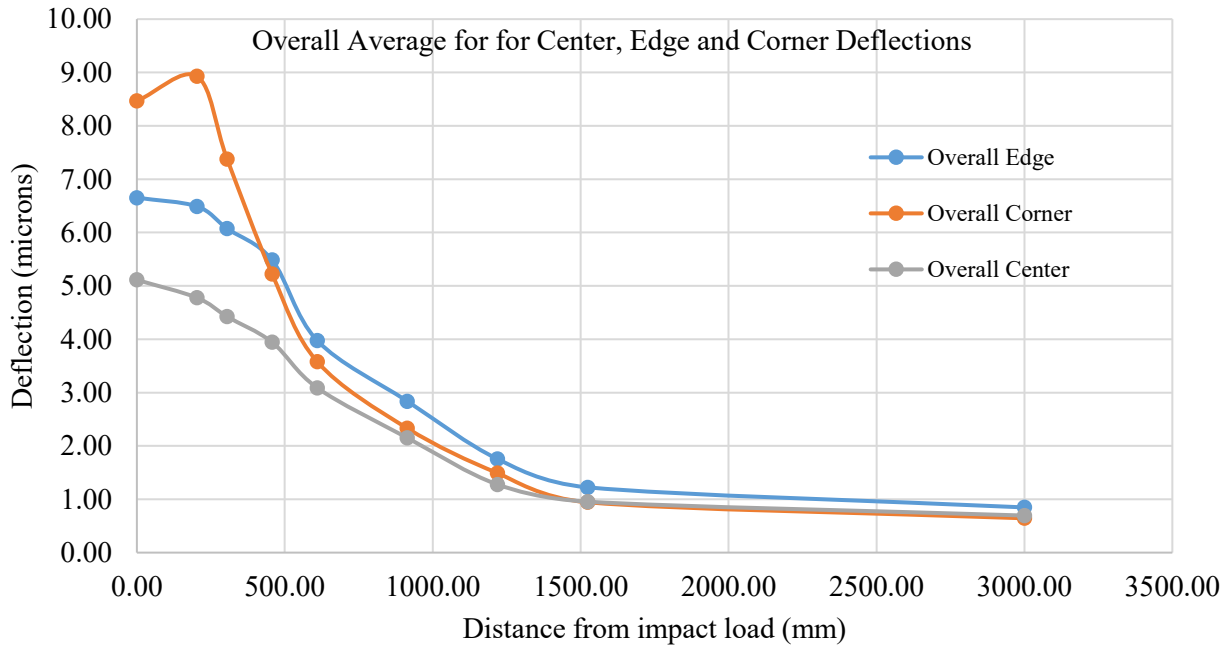
Figure C15: Overall average center, edge, and corner deflections.

- Cases of deflections in SFRRRC follow normal trends in rigid pavements, where maximum deflections were reported at the corner of the slab followed by the edge and the center, respectively.
- The FWD testing performed on the SFRRRC test section showed seasonal deflection behaviors based on the conditions of the base/subgrade (basin). Deflections reported for the three loading cases were higher at the end of the winter season than at the end of the summer season.

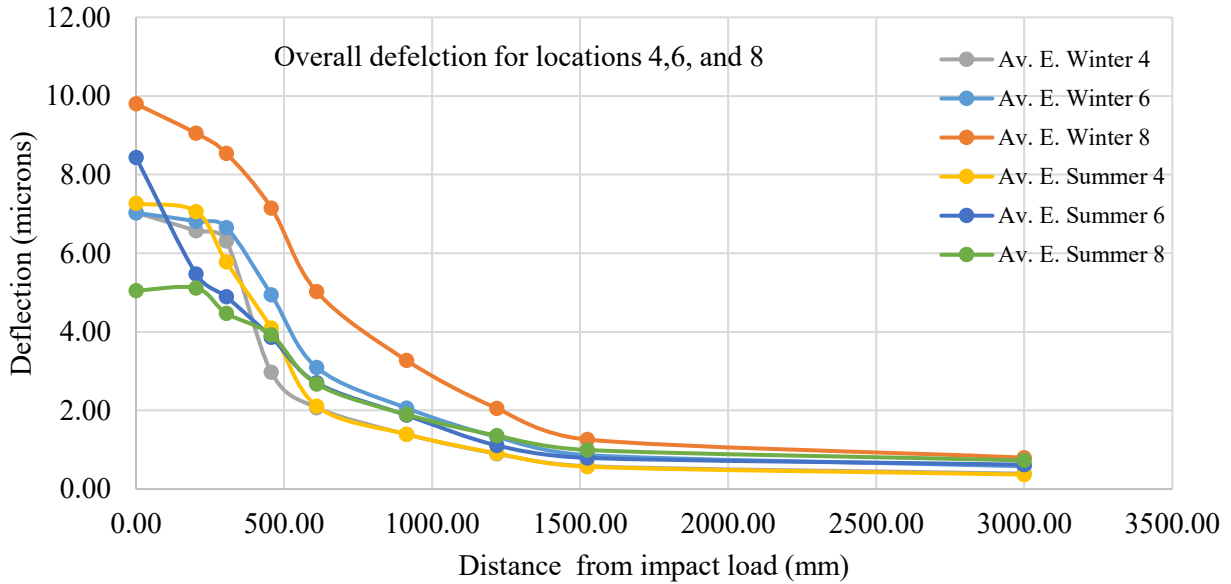
Figure C17: Graphical representation of joint deflections for locations 4, 6, and 8 at the end of winter and summer seasons.

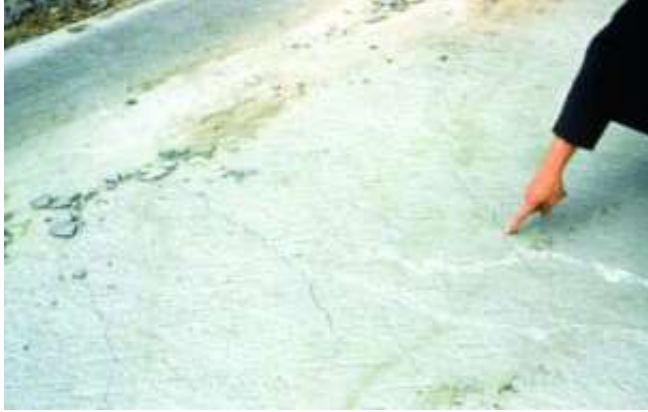
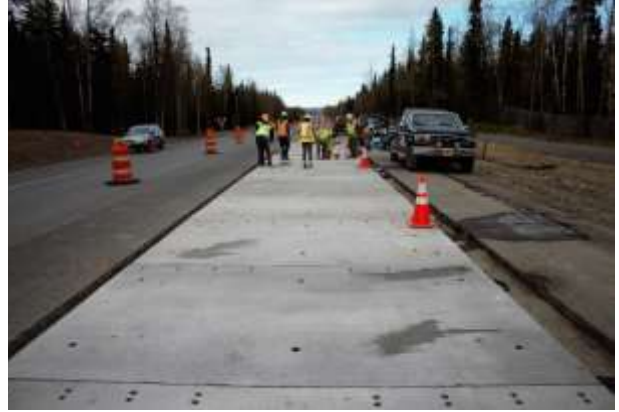
Figure E1: (a) Typical plastic shrinkage cracks, (b) SFRRC test section.

Cracking occurs due to plastic shrinkage when water evaporates from the surface of freshly placed concrete faster than it is replaced by bleed water; the surface concrete shrinks. Due to the restraint provided by concrete below the drying surface layer, tensile stresses develop in the weak, stiffening plastic concrete, resulting in shallow cracks of varying depth (Figure E1a). These cracks are often fairly wide at the surface. SFRRC slabs were cured under a controlled environment in the plant. No signs of any plastic shrinkage were seen on the test section in the short-term or long-term (Figure E1b).

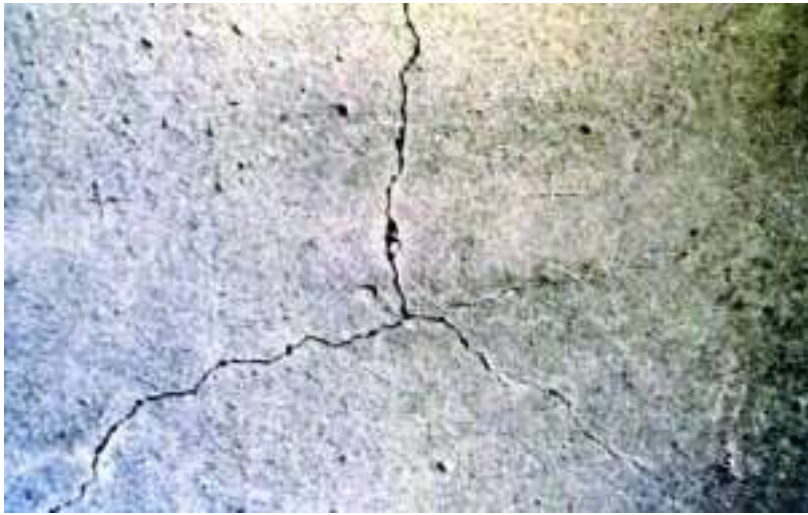
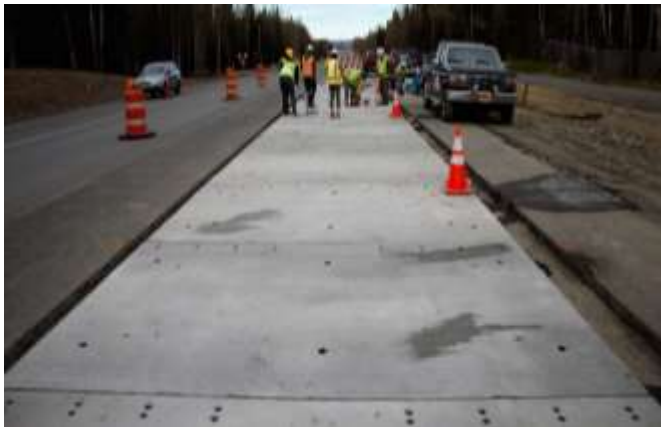
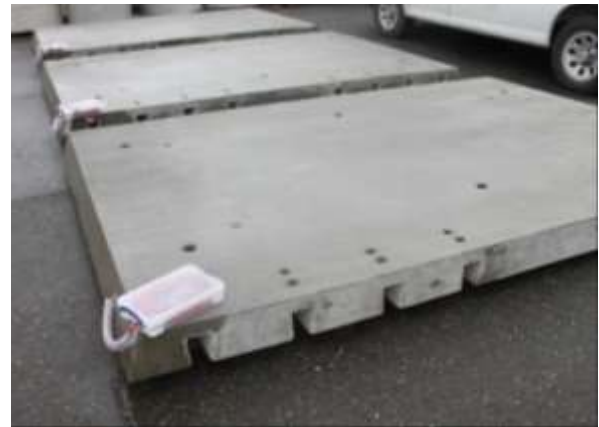
Cracking also occurs because of drying shrinkage when concrete is mixed with more water than is needed to hydrate the cement. Much of the remaining water evaporates, causing the concrete to shrink. Restraint of shrinkage, provided by the subgrade, reinforcement, or another part of the structure, causes tensile stresses to develop in the hardened concrete. Restraint of drying shrinkage is the most common cause of concrete cracking (Figure E2a). In the case of SFRRC, steel fibers act as the ultimate restraint of the drying shrinkage. No signs of drying shrinkage cracks are visible on the SFRRC test section in place or in the plant (Figure E2b, c).

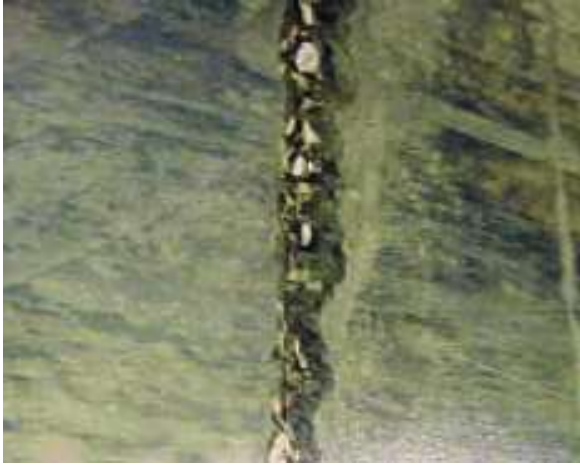
Figure E3: Typical overload crack (PCA 70151).

Properly designed and constructed concrete members are usually strong enough to support the loads for which they are intended. But overloading can occur for a variety of reasons: a change in use of a structure without proper structural upgrades, unintentional overloading, and other unusual circumstances. Earthquake damage is a classic example of the overloading of concrete structures. No signs of overload damage on the SFRRRC test section were noticed or reported after a magnitude 7.0 earthquake occurred north of Anchorage, Alaska, on November 30, 2018. In addition, in the case of SFRRRC precast slabs, a common error occurs when precast members are not properly supported during transport and erection. No signs of damage resulted from transporting or erecting the SFRRRC precast slabs. Damage caused by impact is another form of overload. A common form of impact overload occurs at slab edges of joints on vehicular traffic surfaces (Figure E3). No such signs are visible on the SFRRRC test section.

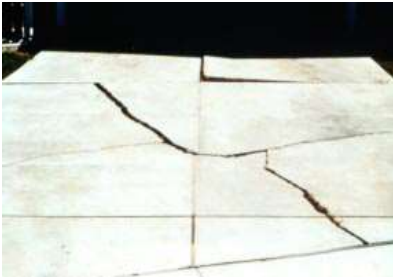
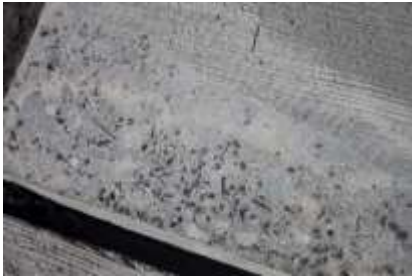
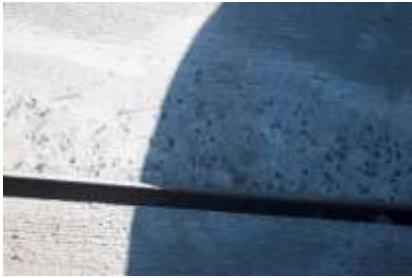
Figure E4 (a) Cracking and structural failure resulted from loss of support, (b) corner grinding, (c) edge grinding.

Loss of support beneath concrete structures, usually caused by settling or washout of soils and subbase materials, can cause a variety of problems in concrete structures, from cracking and performance problems to structural failure (Figure E4). A common problem related to loss of support is slab curling. Curling is the rise of a slab’s edges and corners caused by differences in moisture content or temperature between the top and bottom of a slab. No signs of any loss of support were detected in the SFRRC precast slabs. Minor corner bumps in some of the slabs were noticed, caused by leveling during construction with no crack or structural damage. This problem was treated by shaving and grinding these areas of concern. No recurrence of this issue was noted during the monitoring period.

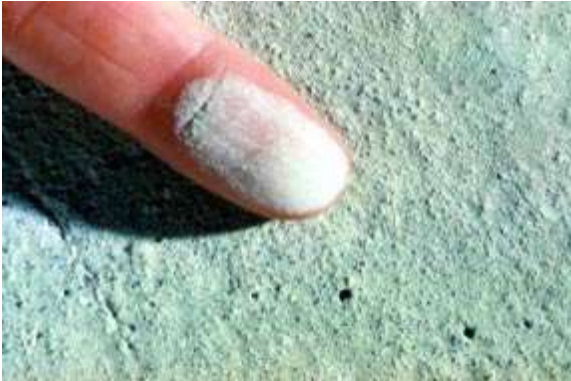
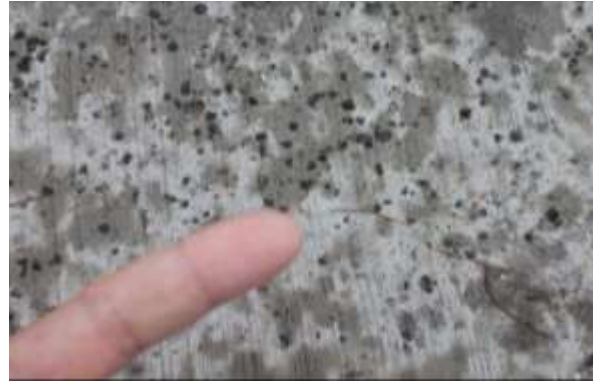
Figure E5: Surface finish, (a) typical dusting occurs on concrete surface (PCA 1297), (b) exposed crumbed rubber on SFRRRC.

Dusting is the development of a fine, powdery material that easily rubs off the surface of hardened concrete (Figure E5a). Dusting is the result of a thin, weak surface layer, called laitance, which is composed of water, cement, and fine particles. Though no signs of dusting were apparent on the surface, the thin cover over some mixed crumbed rubber was removed by traffic (Figure E5b). Dusting does not pose any surface or structural issues.

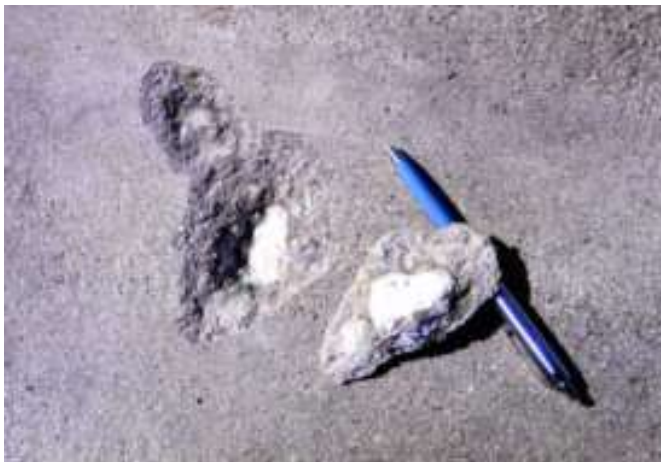
Figure E6: Example of a pop-out on concrete surface (PCA 0113).

A pop-out is a fragment that breaks out of the surface of concrete, leaving a hole that is usually 6 to 50 mm (1/4 to 2 in.) in diameter (Figure E6) (PCA). No such holes were visible on the SFRRRC test section.

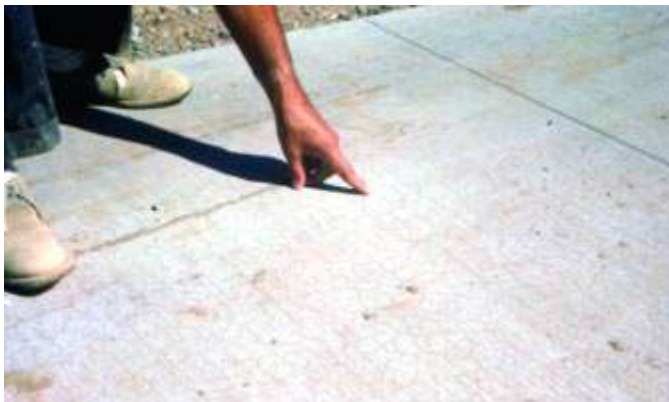
Figure E8: Typical crazing cracks on a concrete surface.

Finally, the last possible surface finish damage for typical concrete is crazing, which is a pattern of fine cracks that do not penetrate much below the surface and are usually a cosmetic problem only (Figure E8). Crazing is barely visible, except when the concrete is drying after the surface has been wet. Preventing excessive evaporation during placement and proper curing can prevent crazing. No sign of crazing was noticed on the SFRRRC in wet or dry conditions. Steel fiber embedded in the concrete mix controls all types of cracks throughout the concrete volume.

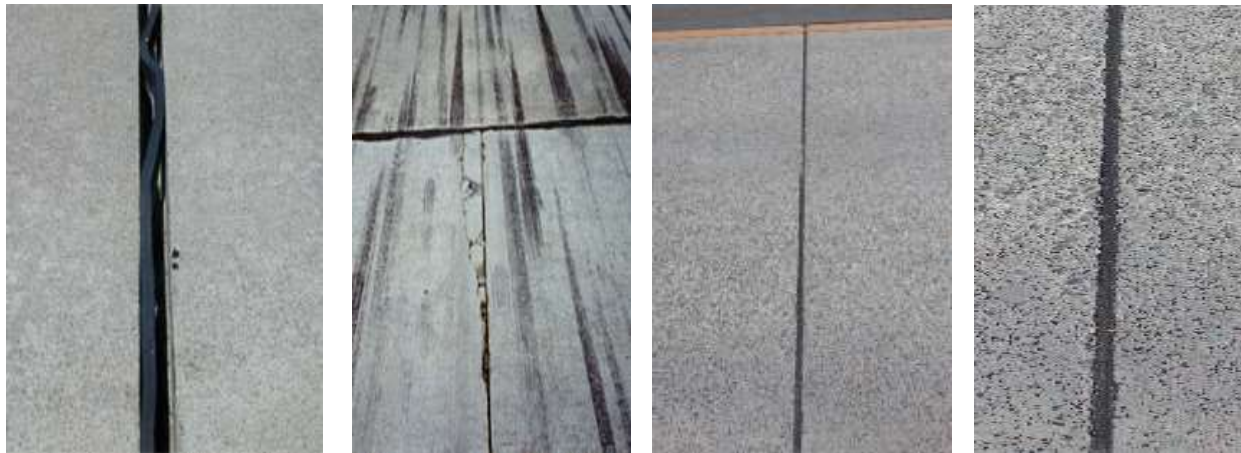
Joint sealant damage is any condition that enables soil or rocks to accumulate in the joints or allows significant infiltration of water. Accumulation of incompressible materials prevents the slabs from expanding and may result in buckling, shattering, or spalling. A pliable joint filler bonded to the edges of the slabs protects joints from accumulation of materials, and prevents water from seeping down and softening the foundation that supports the slab (Iowa DOT). No signs of damage were noticed in the sealant between the sides of the slabs or in any opening in the joints that might allow

foreign debris to enter the joint or allow ejection of base material through the joint. Furthermore, no signs of joint spalling (breakdown of the slab edges within 2 ft of the side of the joint) were detected. Minor crystallization of the joint material was noticed with no damage to the joint. Figure E9 shows typical damage to the joints and the conditions of the sealant and material on Abbott Road.

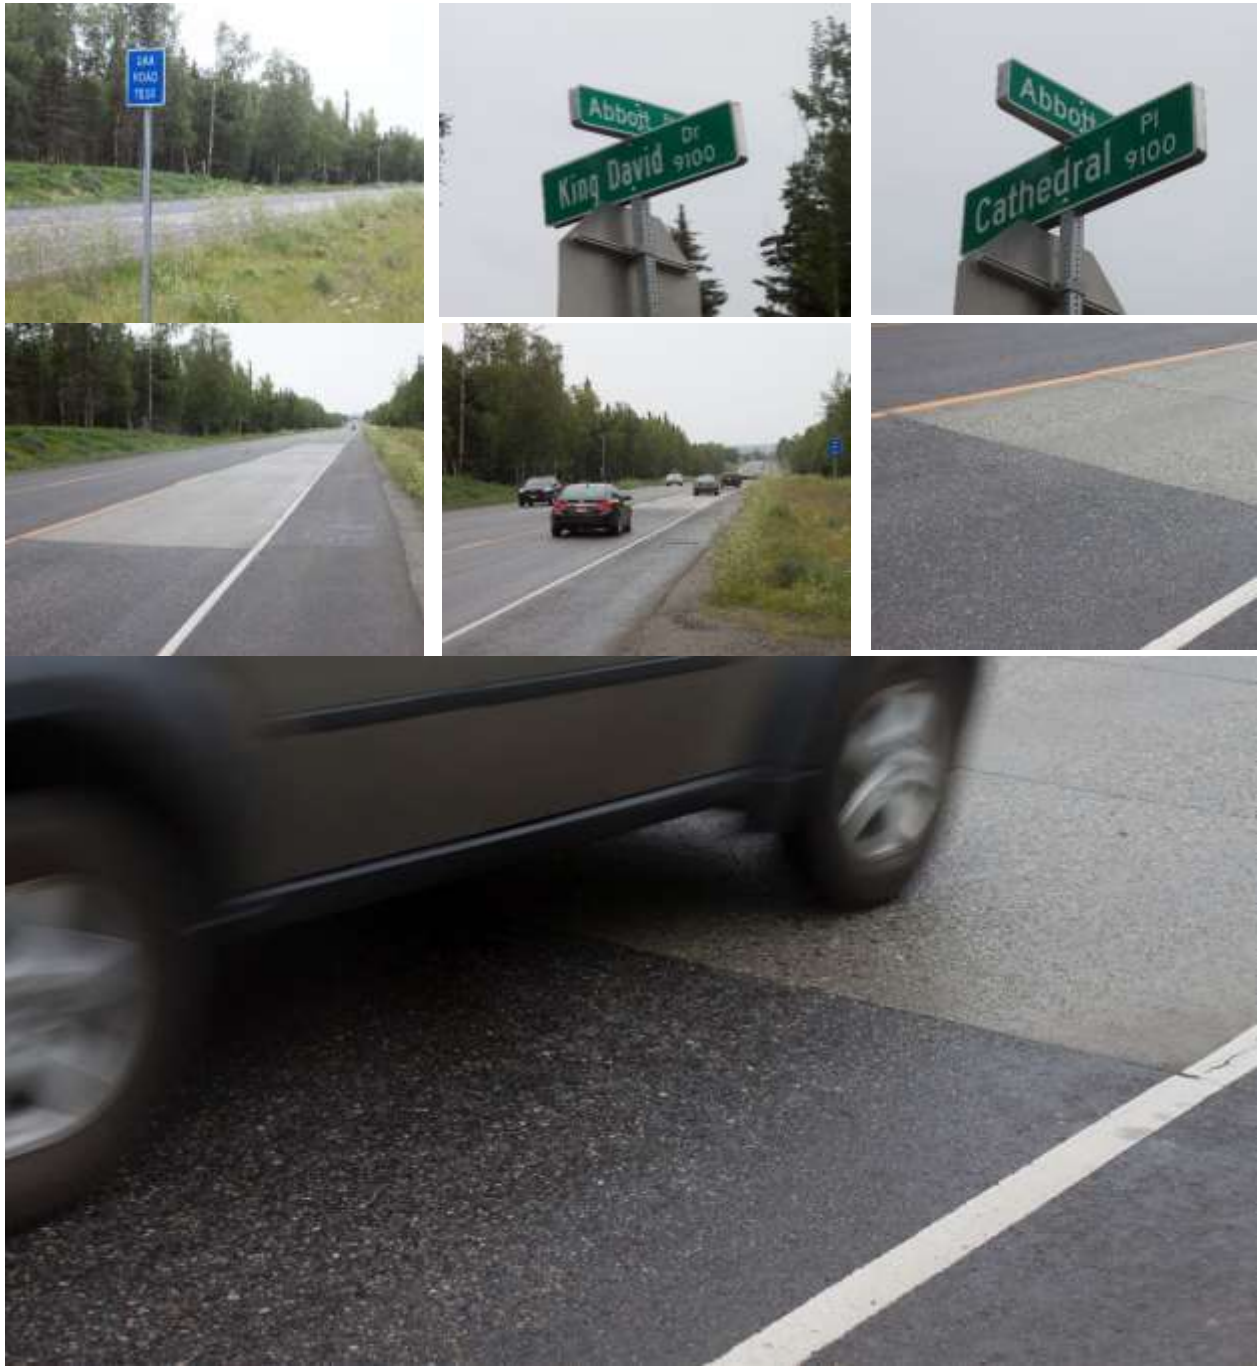
Figure E10: Snapshots of the SFRRRC test section and HMA after about 3 years of service.

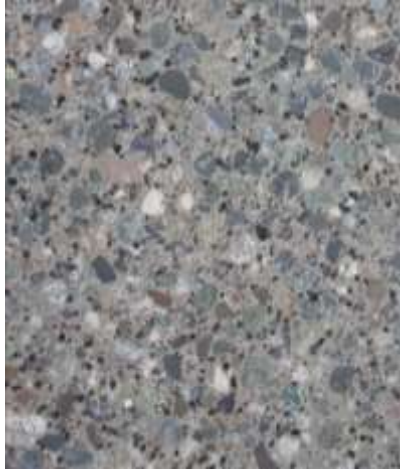
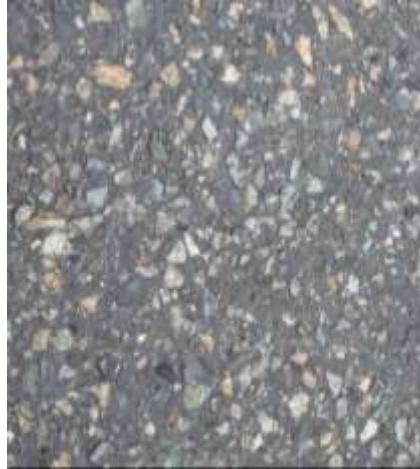
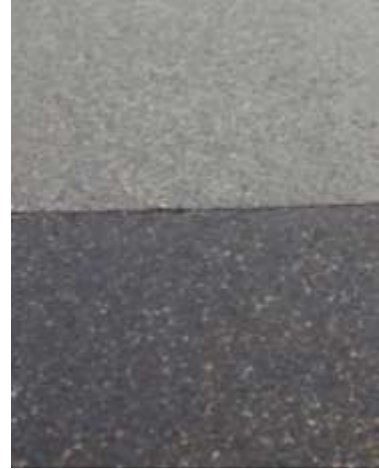
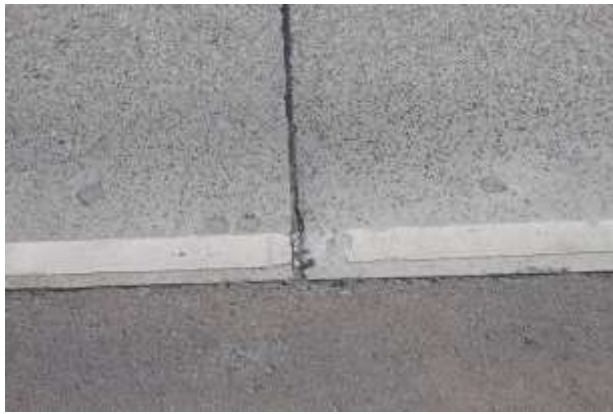
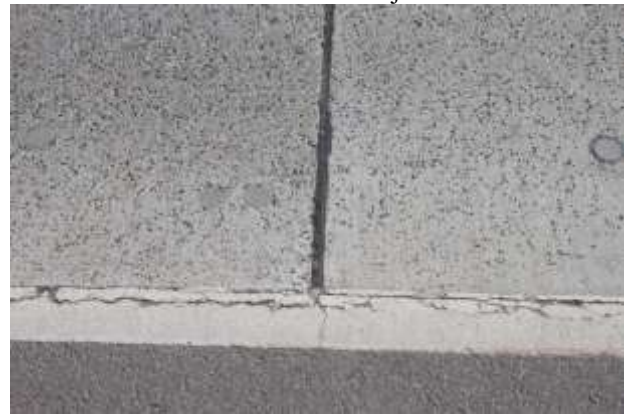
Figure E10 (continued).

SFRRRC surface

HMA surface

HMA-SFRRRC joint

Slab corners
