## Survey and Economic Analysis of Pavement Impacts from Studded Tire Use in Alaska

May 2019

Alaska Department of Transportation and Public Facilities  
Statewide Research Office  
3132 Channel Drive  
Juneau, AK 99801-7898

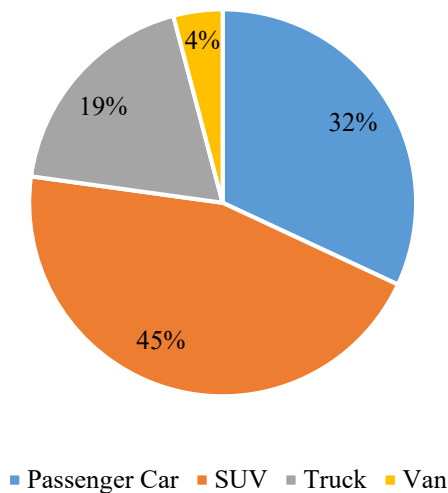
A total of 1226 vehicles were surveyed. A majority of the surveyed vehicles were SUVs (45%), followed by passenger cars (32%), then trucks (19%), and then vans (4%) (Figure B.2). Overall, 65% of the vehicles were all-wheel drive (Figure B.3). 35% percent of vehicles had studded tires (Figure B.4). The percentage of vehicles with studded tires, differentiated by location, are shown in Figure B.5. The figure indicates that the range of results between two visits are not significantly different, except that of Providence Hospital, DOT, and Walmart. The state owned vehicles at the DOT&PF Aviation Building might have biased the results because most state vehicles have studded tires. Further discussion is provided in the next section.

Figure B.2 Vehicle type

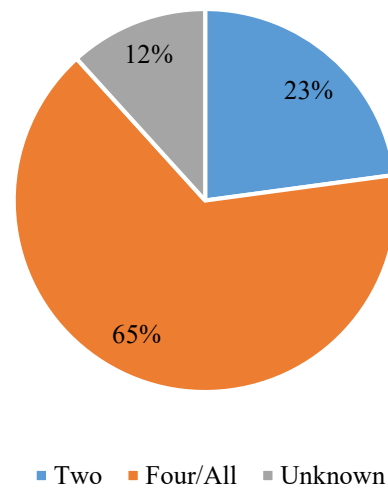
Figure B.3 Drive type of the surveyed vehicles

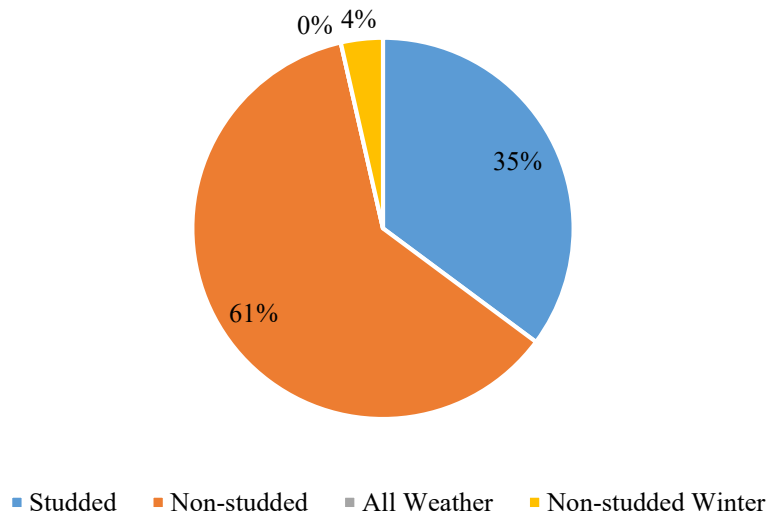
Figure B.4 Tire type of the surveyed vehicle

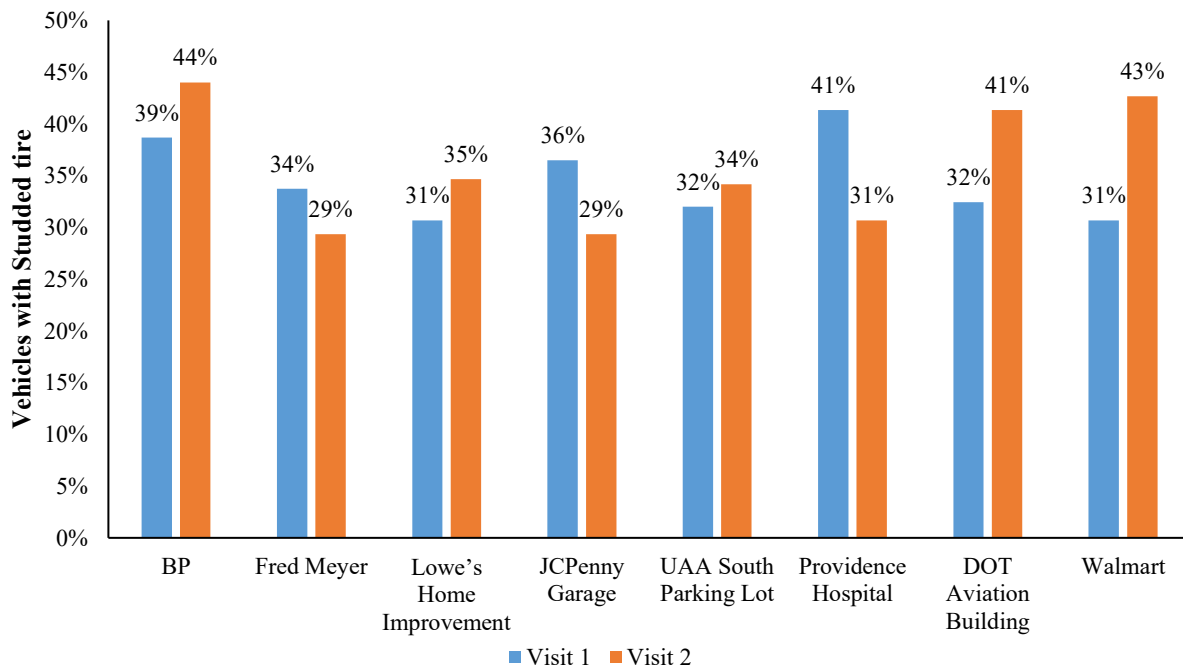
Figure B.5 Studded tire use in different parking lots

Descriptive statistics of the parking survey are given in Table B.2. On the first visit, the average studded tire use was 34% with a standard deviation of 4%, whereas the average was 36% with a standard deviation of 6% for the second visit. Overall, the average studded tire use was 35% with a standard deviation of 5%.

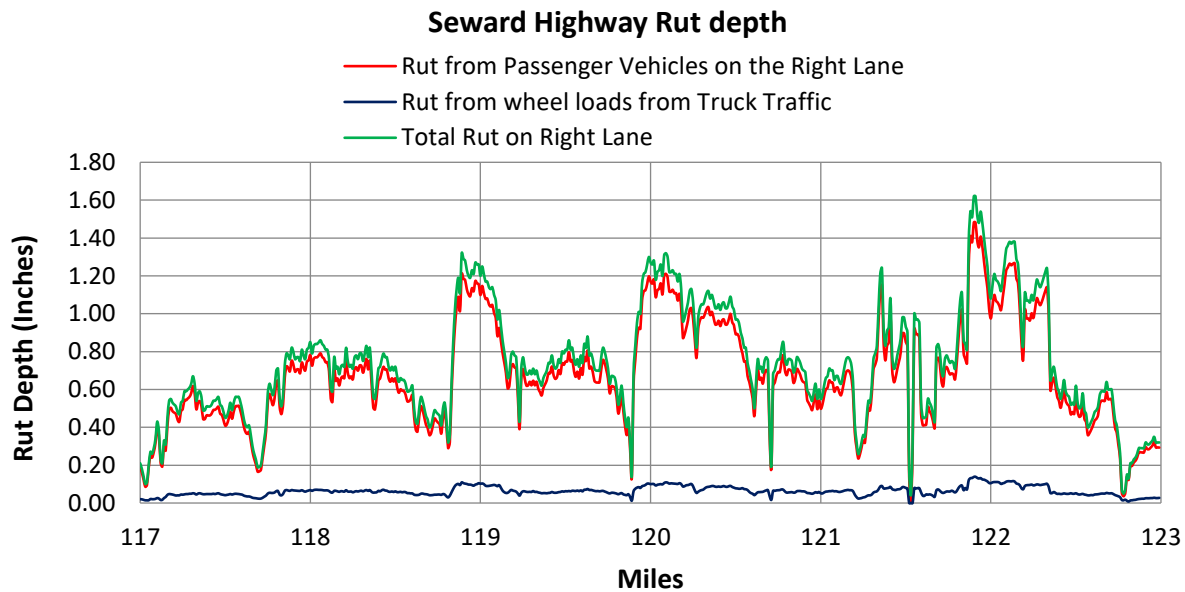
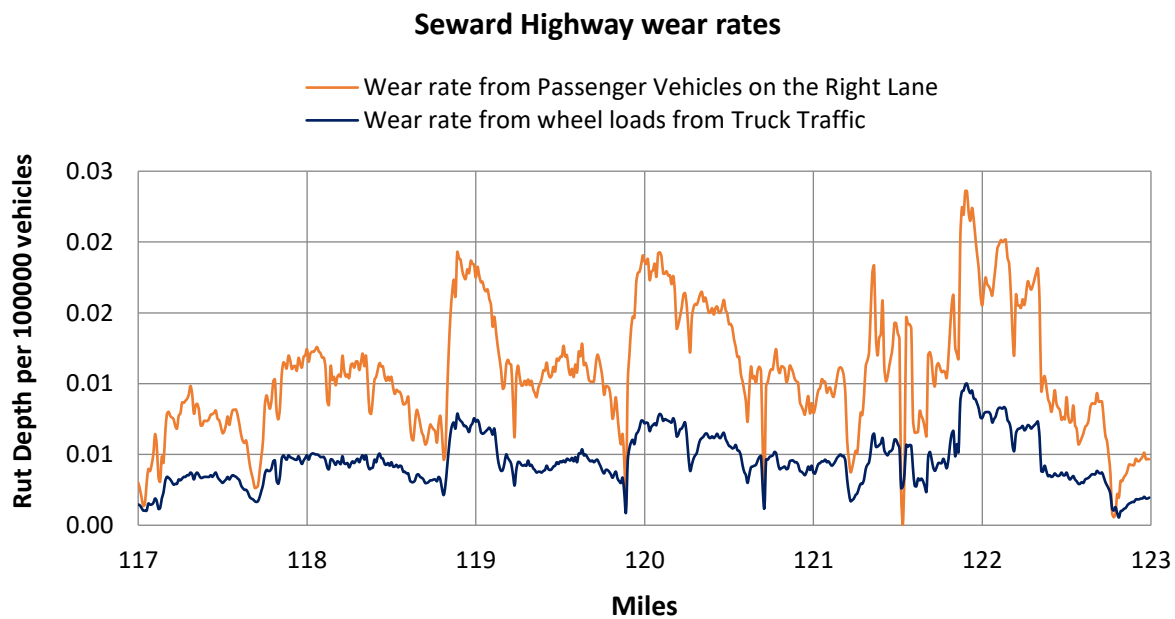
The freeway samples showed significant wear rates as a result of studded tires on the right lane, higher than the wear caused by wheel loads. Figures D.1, D.2, and D.3 show the distribution of wear rates for the freeway samples.

Figure D.2 Distribution of wear rates for the Seward Highway

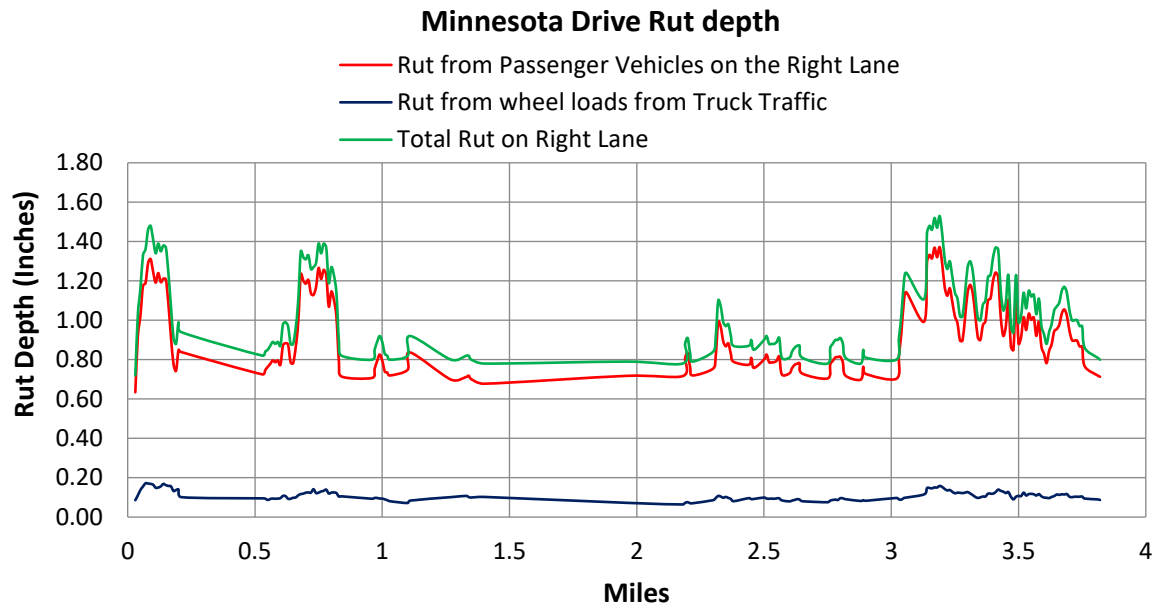
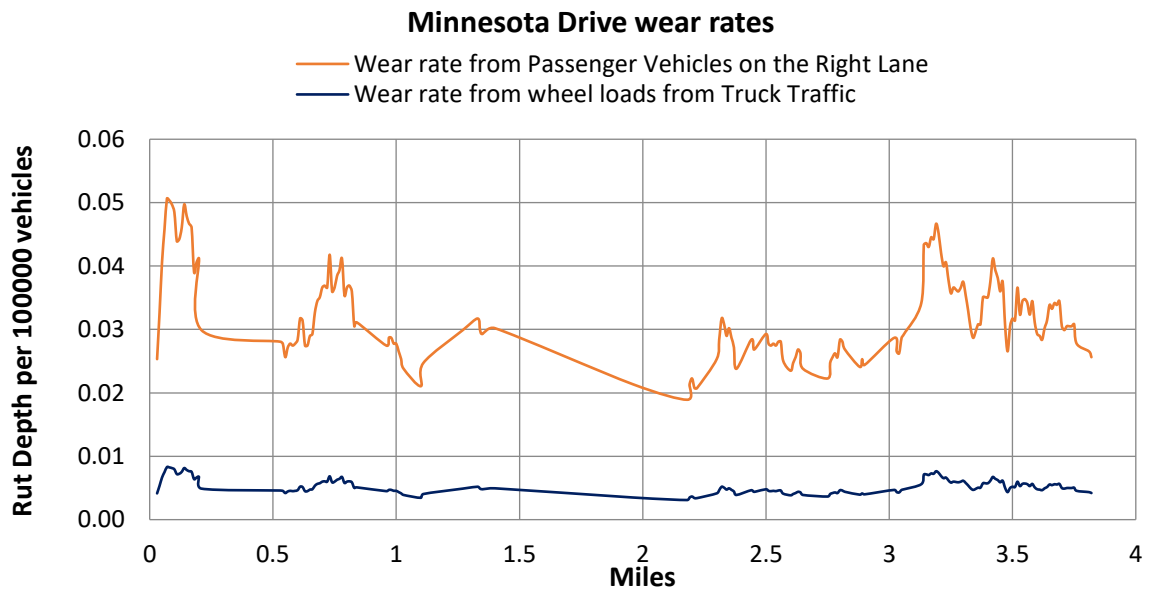
Figure D.3 Distribution of wear rates for Minnesota Drive

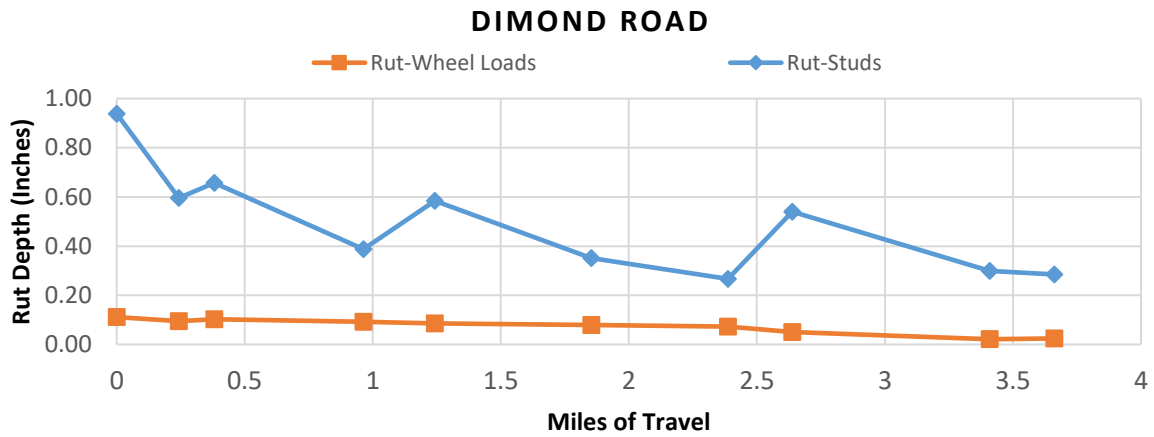
An average truck rut rate of 0.0049 in./100,000 trucks was assumed for arterial samples. Then, rut measurements due to percentage of truck traffic were calculated for each arterial segment. Rut measurements as a result of passenger vehicles were estimated by subtracting the rutting caused by truck traffic from the total rut depth. Finally, wear rates due to passenger vehicles were generated for each arterial segment. Figures D.4 to D.9 show the distribution of rut rates for the arterial samples. Figures D.10 to D.18 show the distribution of rut rates for the collector samples. Results showed a significant lower average wear rate due to studded passenger vehicles on arterial roads, reaching 0.0062 in./100,000 studded vehicles, compared with an average wear rate of 0.0116 in./100,000 on freeway segments. Moreover, results showed a significantly lower average wear rate due to studded passenger vehicles on collector roads, reaching 0.0045 in./100,000 studded vehicles.

Figure D.4 Distribution of rut rates for Dimond Road

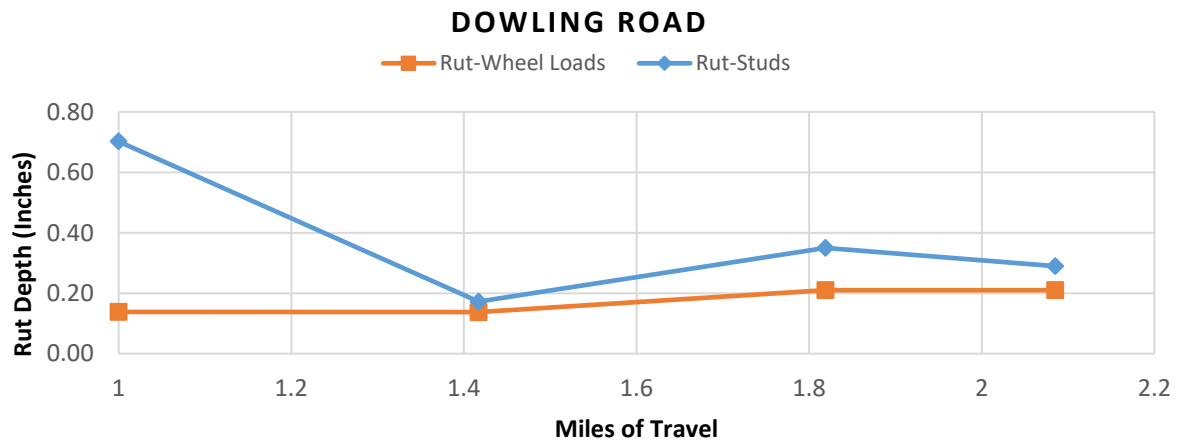
Figure D.5 Distribution of rut rates for Dowling Road

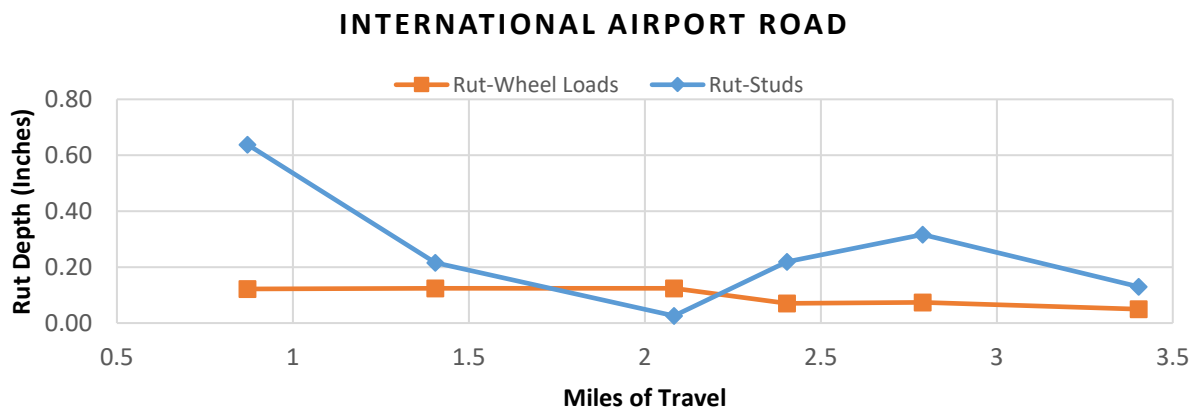
Figure D.6 Distribution of rut rates for International Airport Road

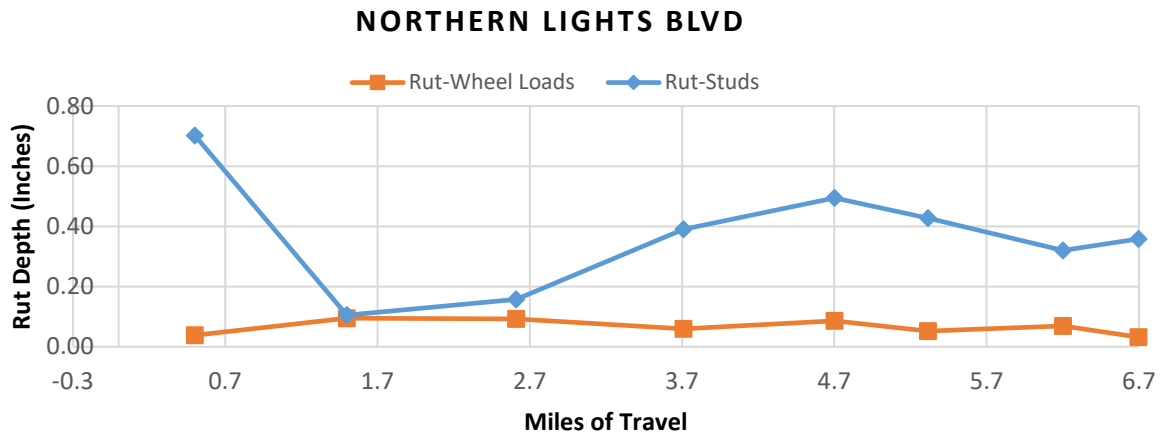
Figure D.7 Distribution of rut rates for Northern Lights Boulevard

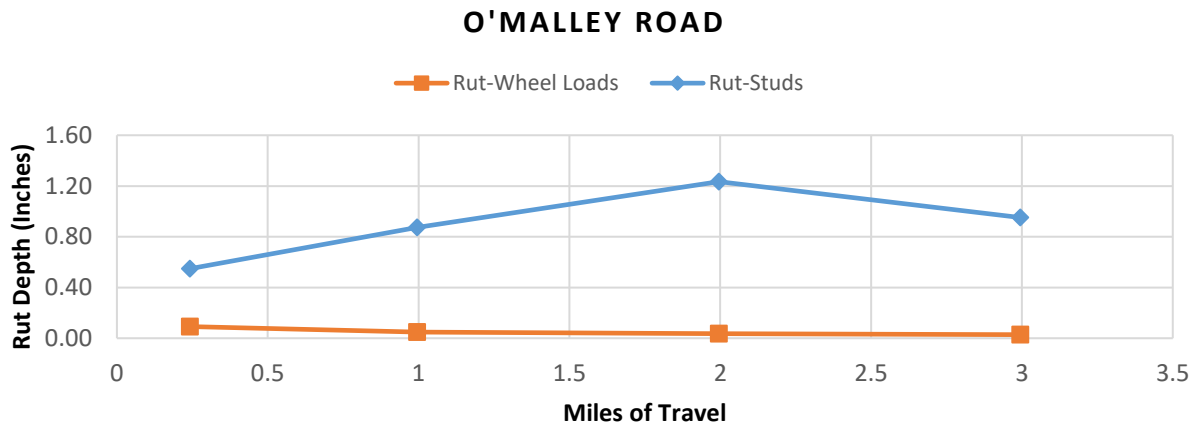
Figure D.8 Distribution of rut rates for O'Malley Road

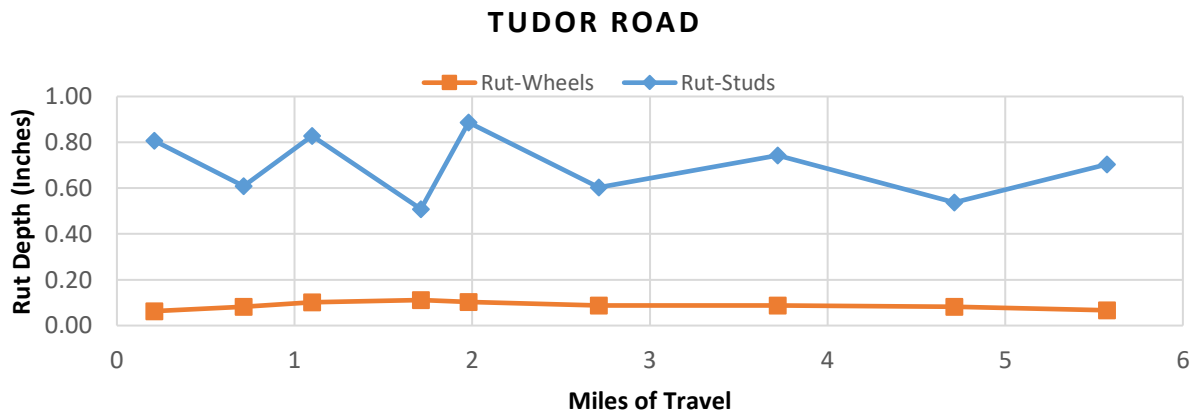
Figure D.9 Distribution of rut rates for Tudor Road

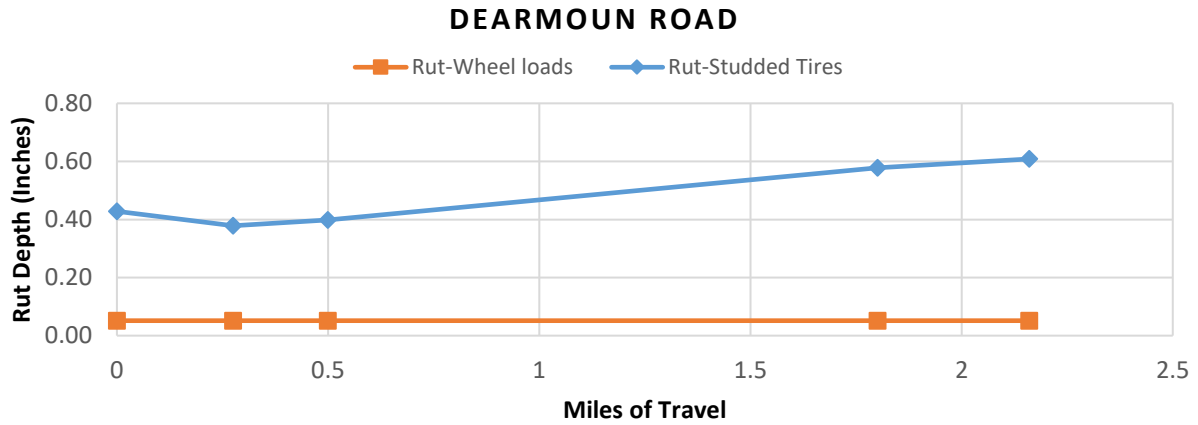
Figure D.10 Distribution of rut rates for DeArmoun Road

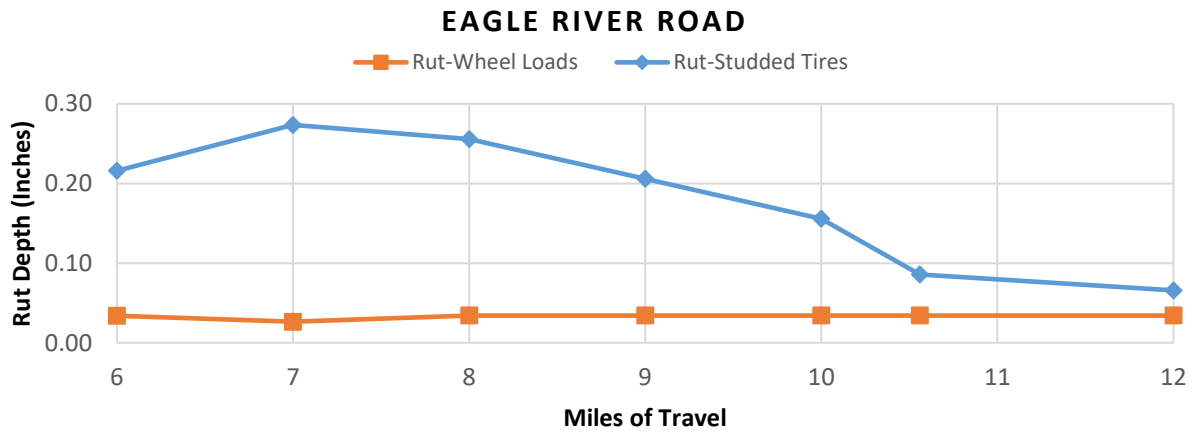
Figure D.11 Distribution of rut rates for Eagle River Road

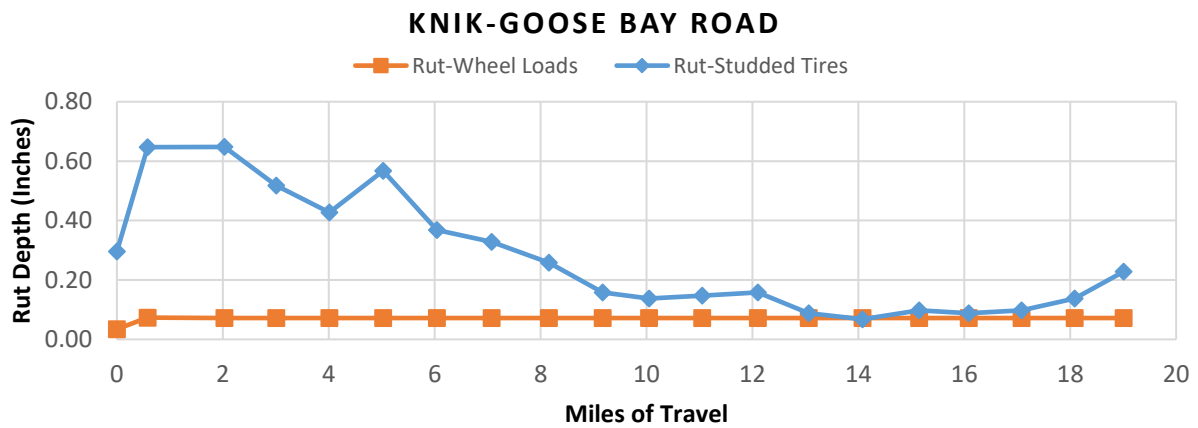
Figure D.12 Distribution of rut rates for Kink-Goose Bay Road

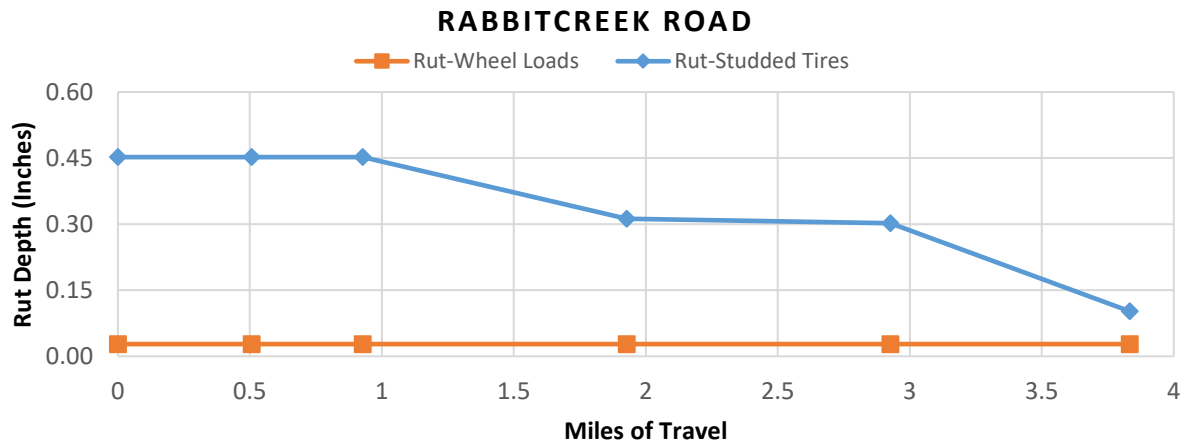
Figure D.13 Distribution of rut rates for Rabbit Creek Road

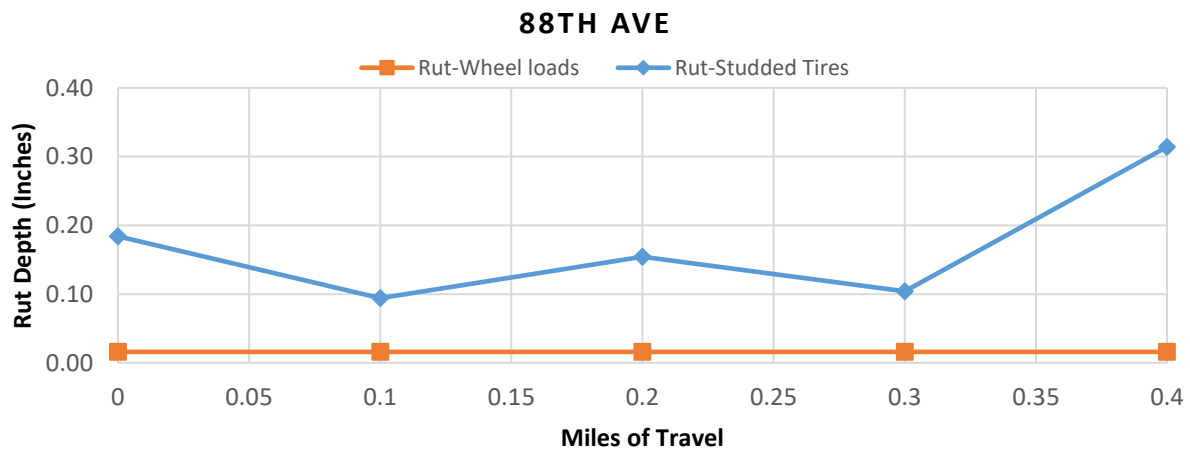
Figure D.14 Distribution of rut rates for 88th Avenue

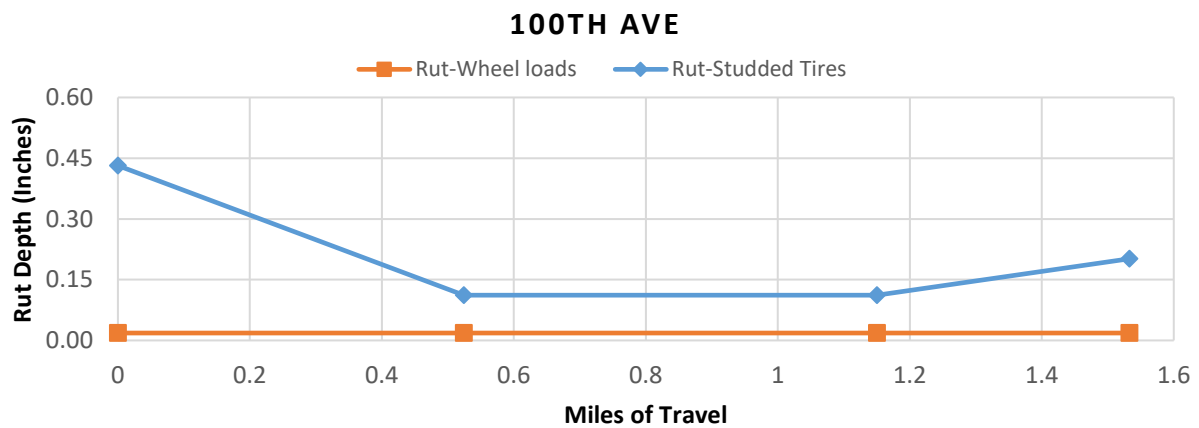
Figure D.15 Distribution of rut rates for 100th Avenue

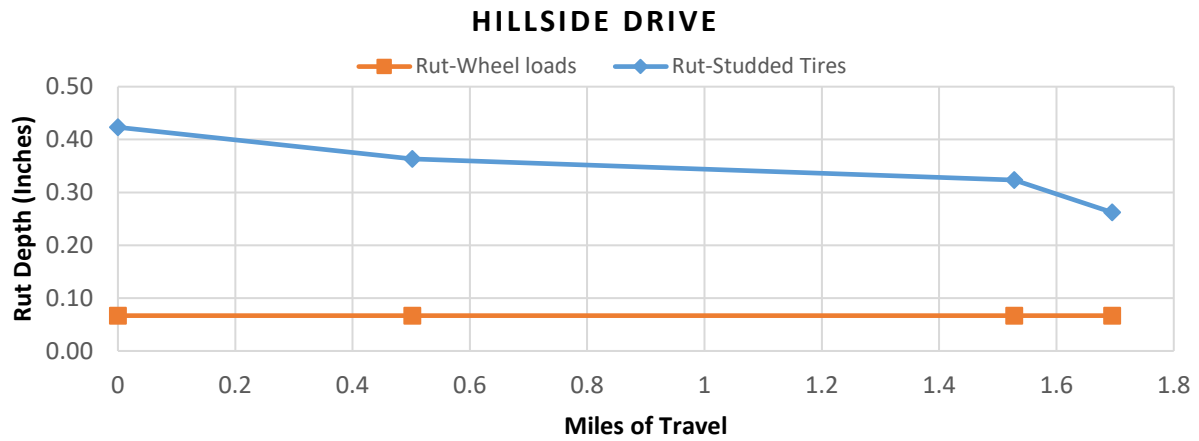
Figure D.16 Distribution of rut rates for Hillside Road

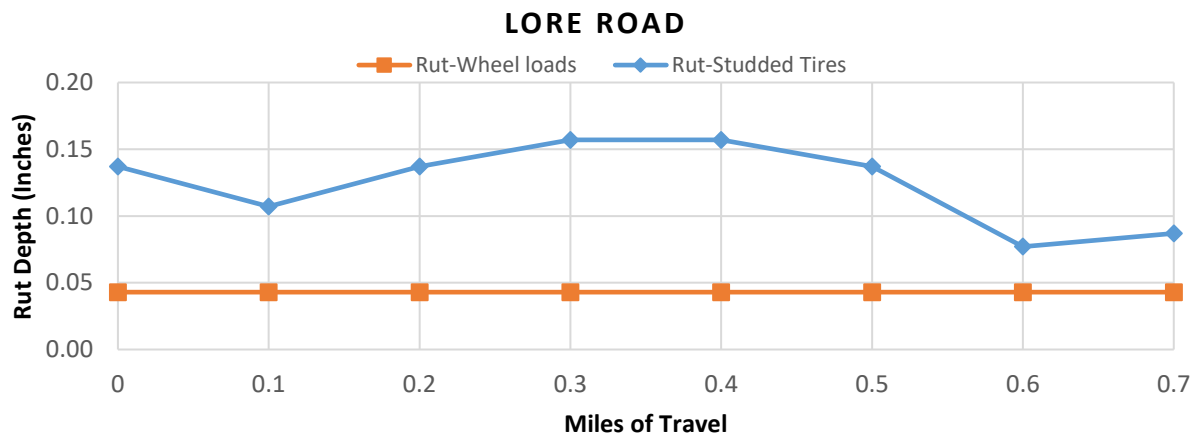
Figure D.17 Distribution of rut rates for Lore Road

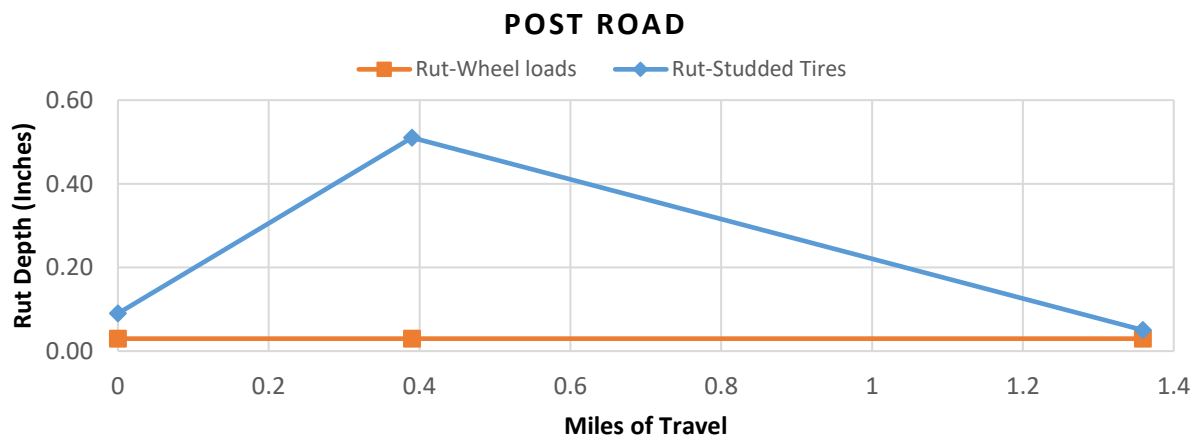
Figure D.18 Distribution of rut rates for Post Road
