# Improved Permafrost Protection Using Air Convection and Ventilated Shoulder Cooling Systems — Final Project Report

**Date:** November 2022

**Publication Number:** FHWA-AK-RD-4000(185)

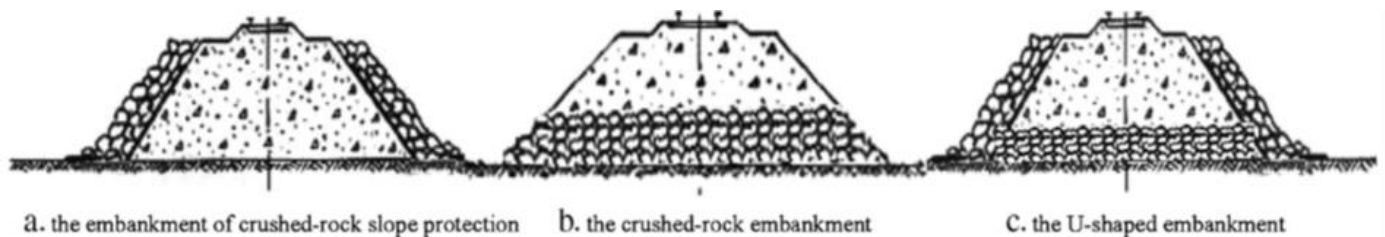
Figure 2-1 Crushed rock configurations used in the QTR project (Ma et al. [15])

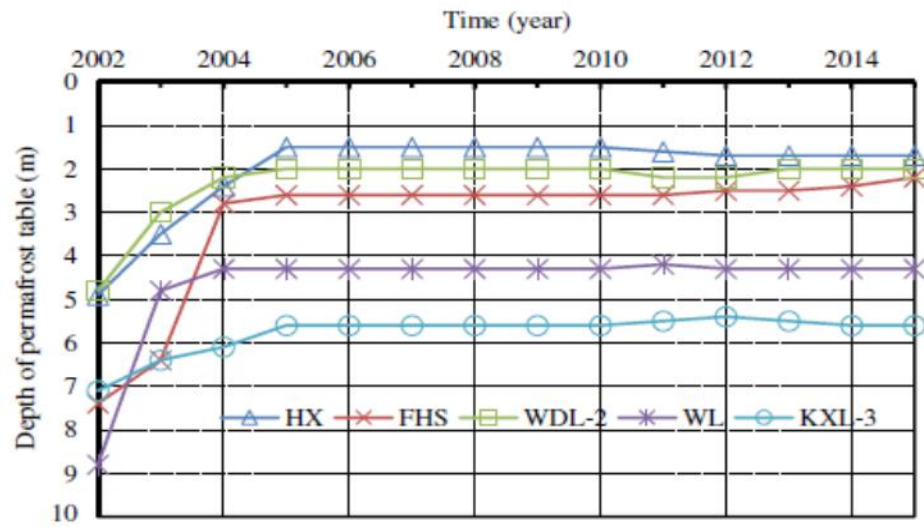
Figure 2-2 Variations in permafrost table depth over time beneath the centerline of five ACE monitoring sites (labelled HX, FHS, WDL-2, WL, and KXL-3), along the QTR. See Mu et al. [16] for details.

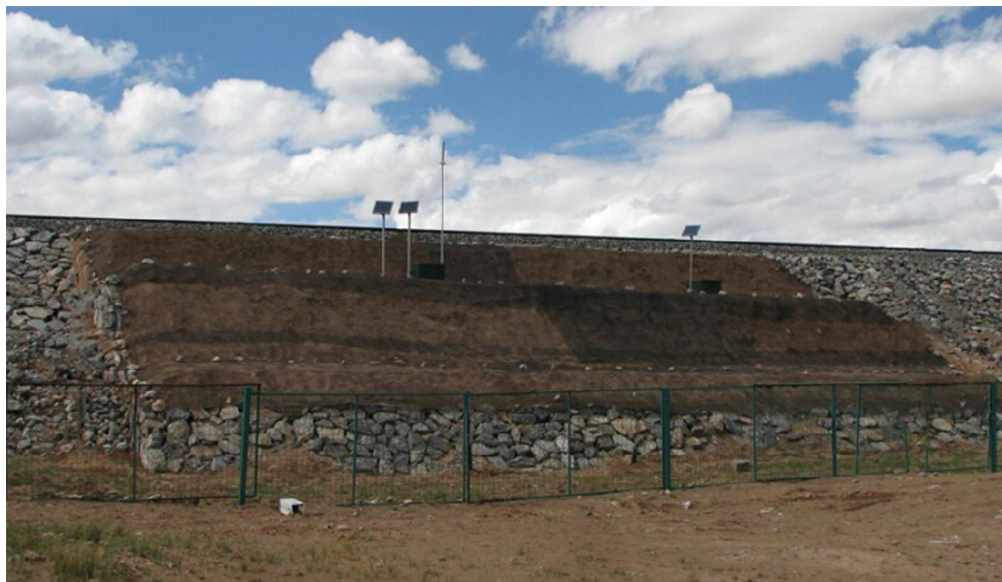
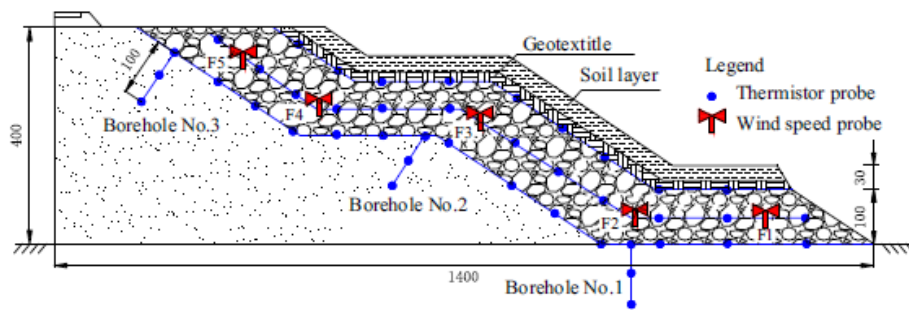
Figure 2-3 QTR test section with covered ventilated shoulder (Liu et al. [13])

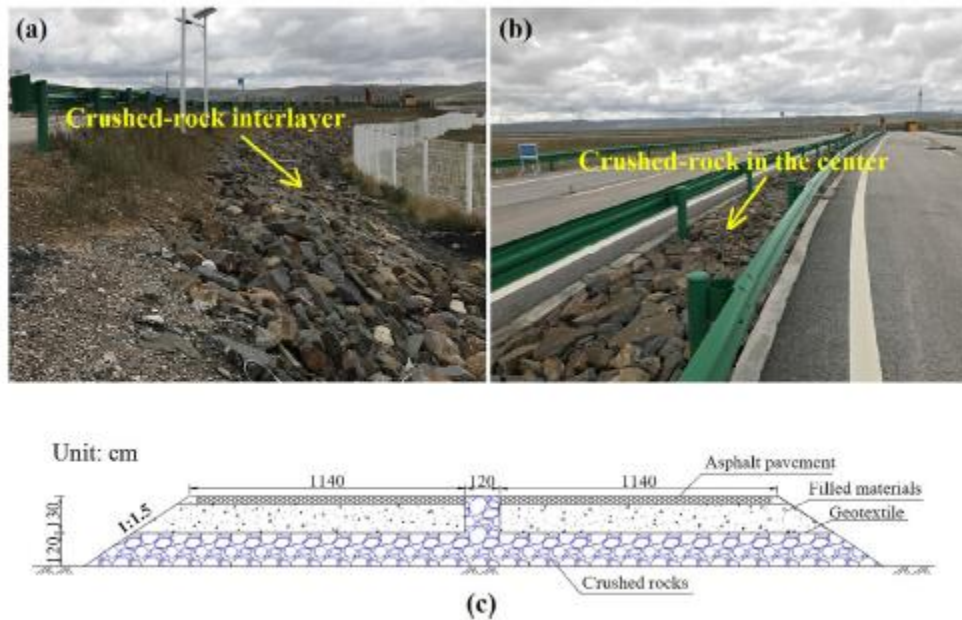
Figure 2-4 ACE layer with center vent designed for use in a wide expressway (Liu et al. [21])

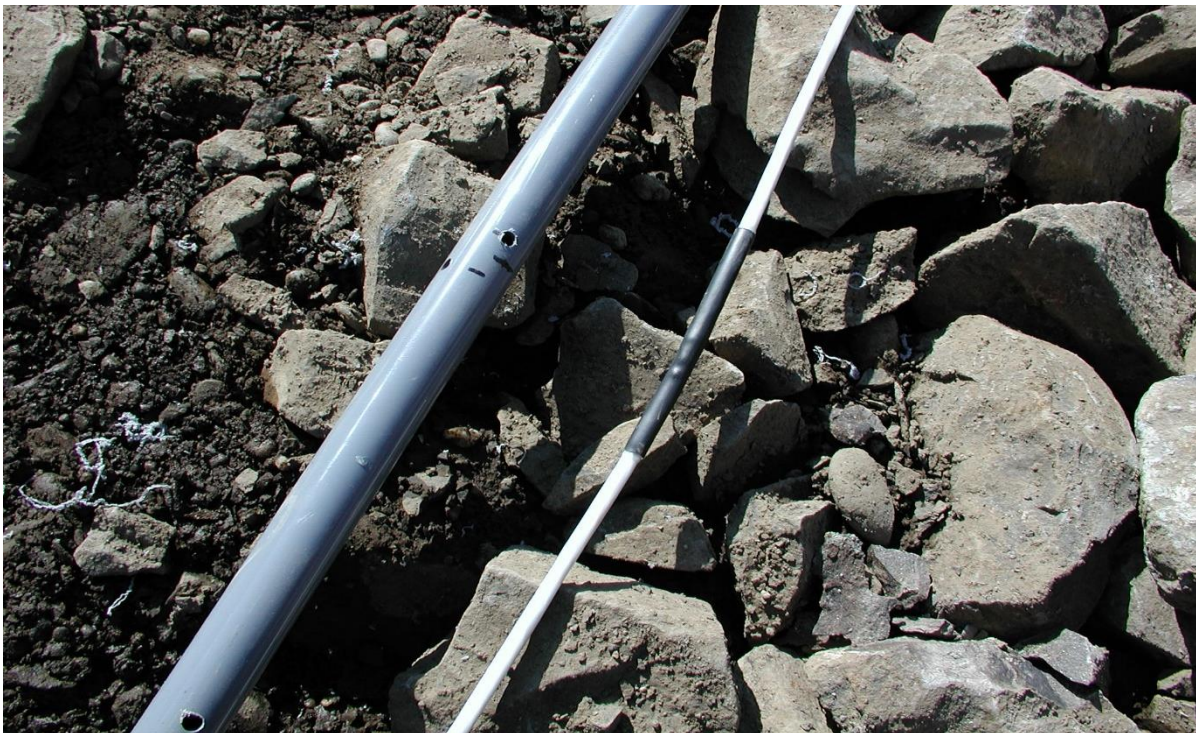
Figure 3-2 Thermistor sensor wire and vented PVC armoring tube as used in ACE areas

Figure 3-2. After drilling, the cable was pulled into the proper position within the shielding tube and silicone was injected at the intermediate points to hold the cable in place and block air motion. For the thermistor strings run vertically into the foundation soil, unshielded cables were used inside a sealed PVC casing with the annulus filled with silicon oil.

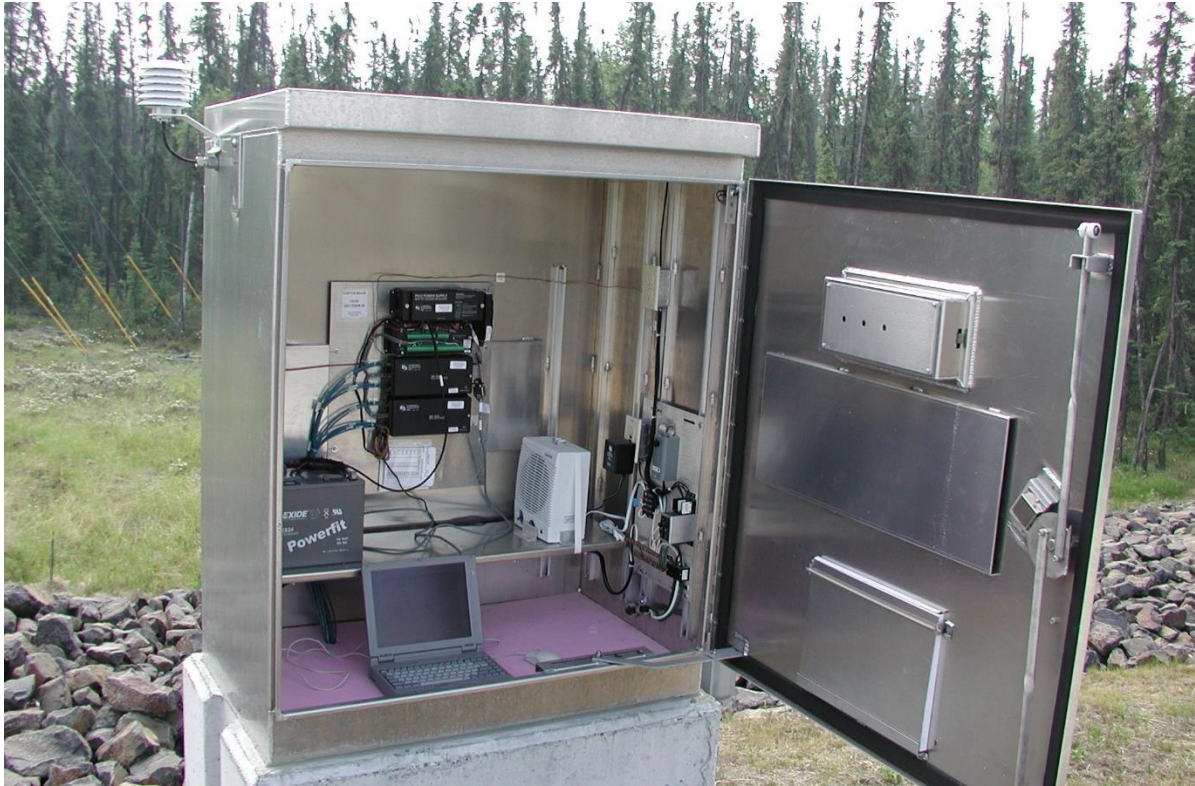
Figure 3-3 Data logging station for test section #1

Data acquisition equipment consists of Campbell CR10XT data loggers connected to AM416 multiplexers. Because of the distance separating the three test sections, three separate data logging stations were utilized. Each station is connected to AC power with 12 VDC backup, and contains one CR10XT data logger, and the appropriate number of multiplexers (see paragraphs below for details). AC power was unavailable for the first year of the project, so deep cycle 12 VDC batteries were used for the first year. Each of the three data acquisition stations are housed in permanent traffic controller electrical boxes (see Figure 3-3 for a photo of data acquisition station for test section #1).

Figure 3-3. Air temperature data is collected on the same schedule as the rest of the embankment temperatures resulting in hourly temperature readings extending from late 2004 to the present time. While this temperature record includes the details of daily temperature fluctuations, it is the annually averaged value of air temperature that has an impact on deeper embankment and foundation soil temperatures.

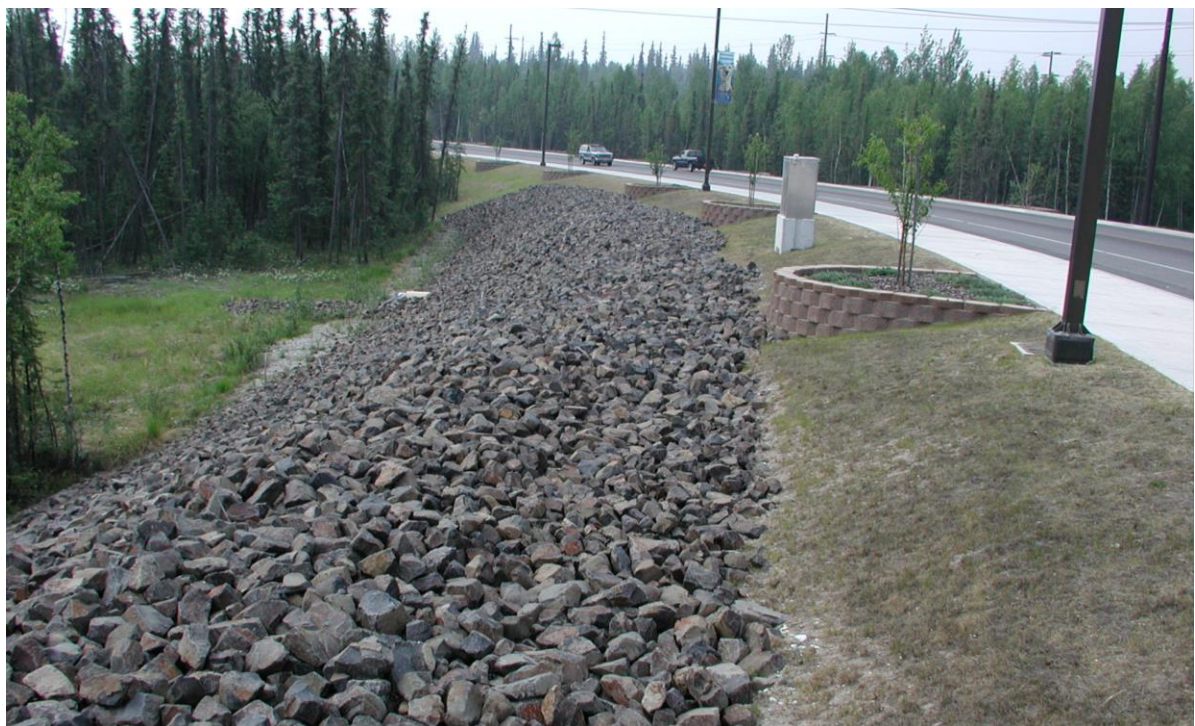
Figure 3-4 Photo Showing Test Section #1 and Ventilated Shoulder on Thompson Drive

The following paragraphs give a brief description of the instrumentation strings included at each test section. A photo showing test section #1, including the ventilated shoulder, is shown in Figure 3-4 while the thermistor sensor layout is shown in Figure 3-6. Note that in Figure 3-6 through Figure 3-8 the slope

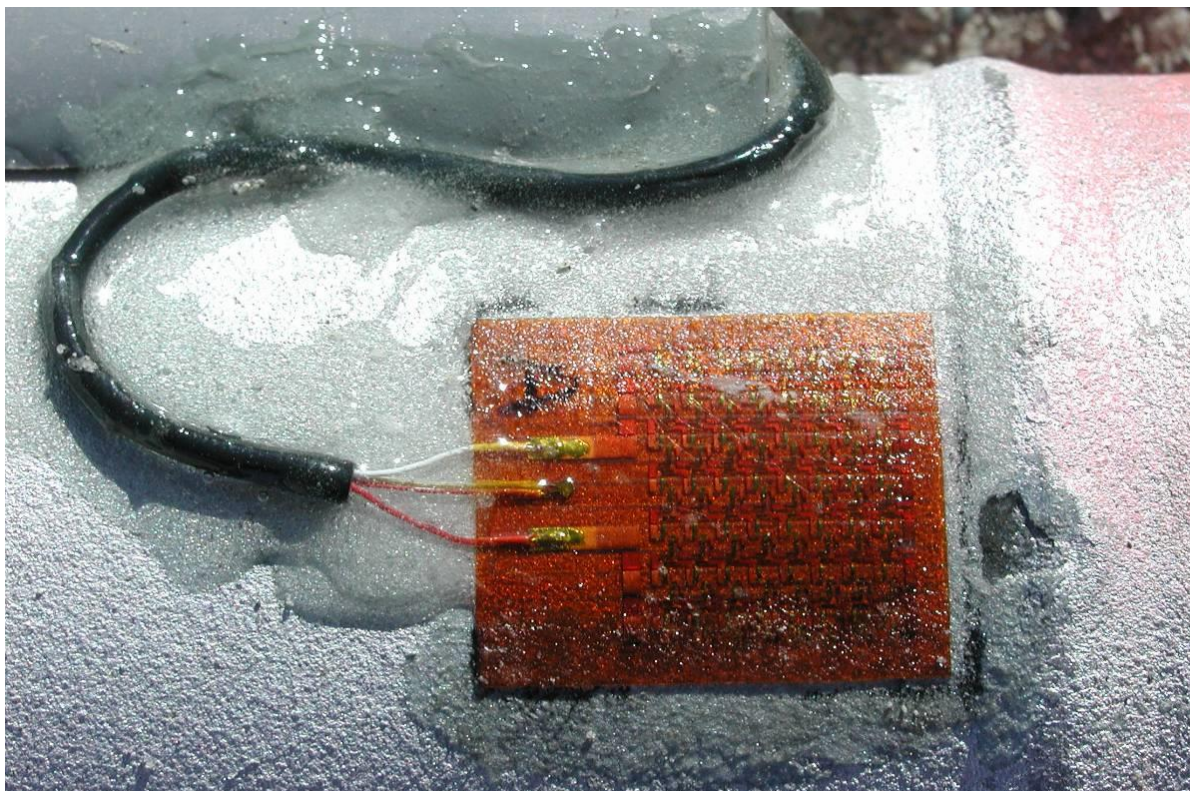
Figure 3-5 Installation of heat flux sensor on condenser tube

epoxy/carbon powder mix was placed over the top of the sensors to shield them from impact. Also, a thick layer of silicone rubber was placed over the lead wires to help avoid damage due to compaction around the thermosyphons. The carbon powder was added in an attempt to better match the thermal conductivity of the epoxy sensor coating with that of the surrounding bedding material. In addition, the heat flux sensors were fastened to the side of the thermosyphon tubes (as opposed to the top or the bottom) in an effort to average out any peripheral heat flux variation.

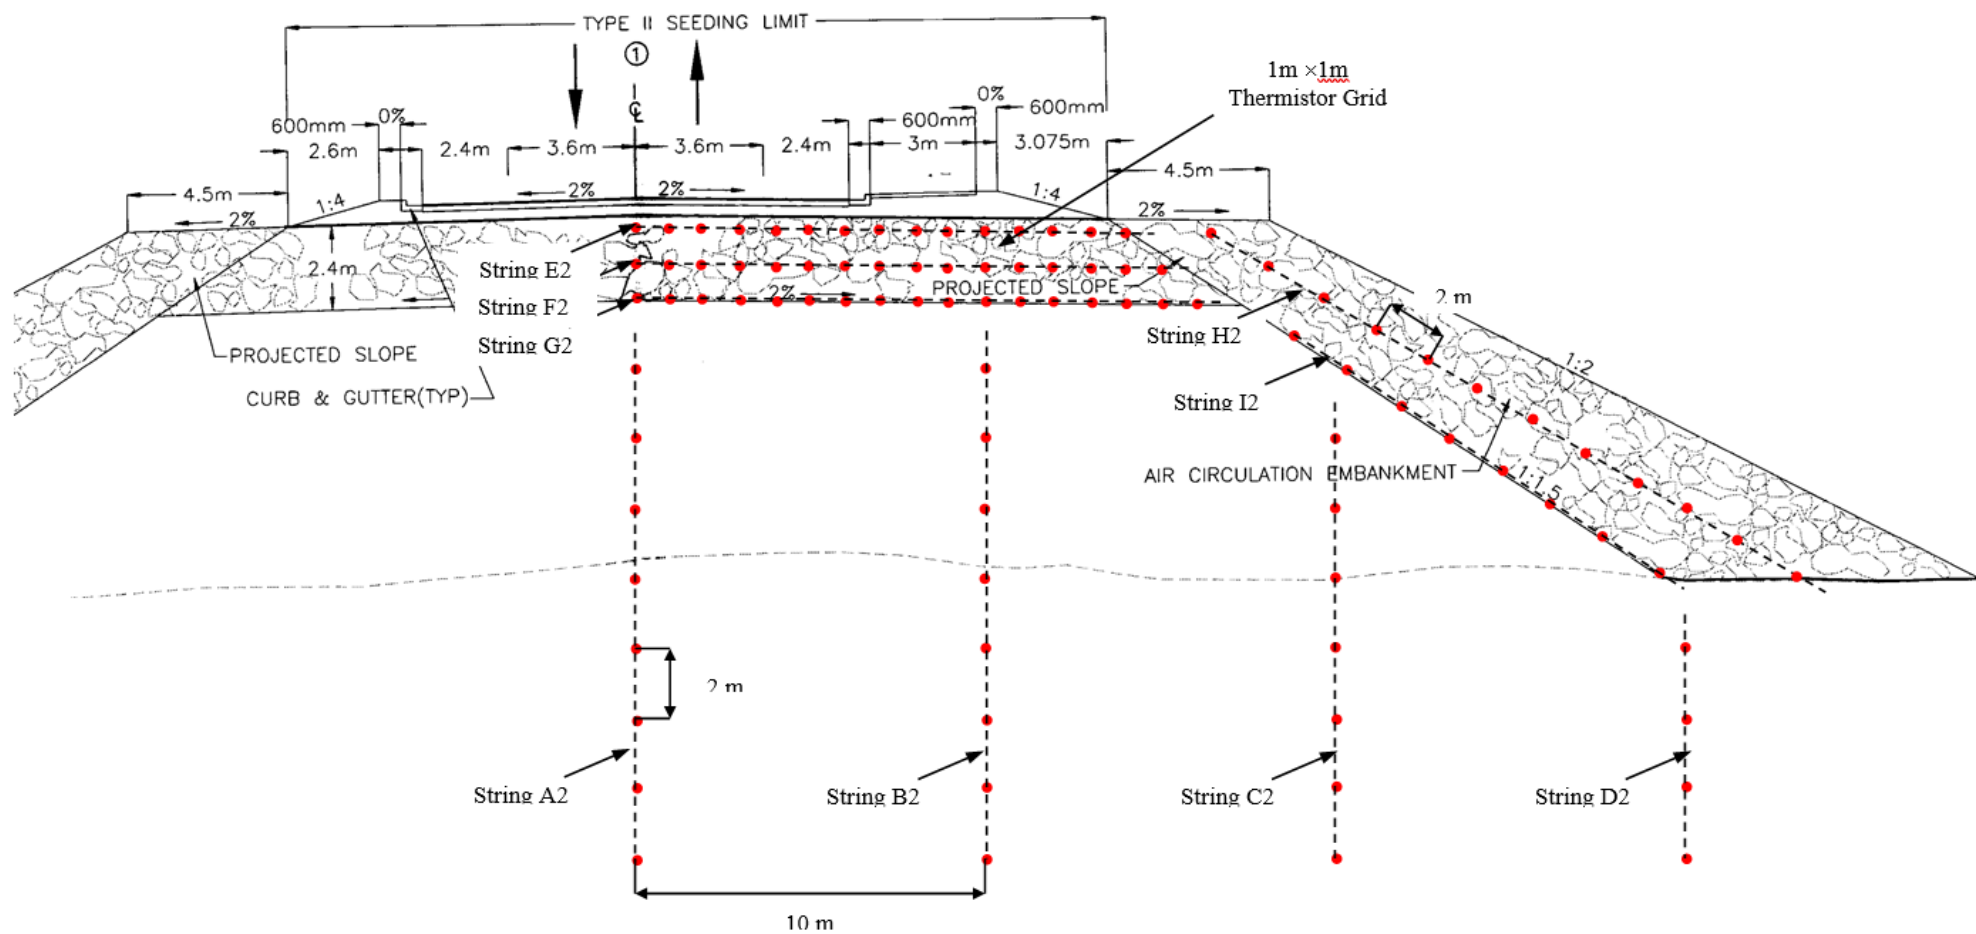
Figure 3-7 Instrumentation for test section #2 consisting of 9 thermistor strings with a total of 95 thermistor temperature sensors

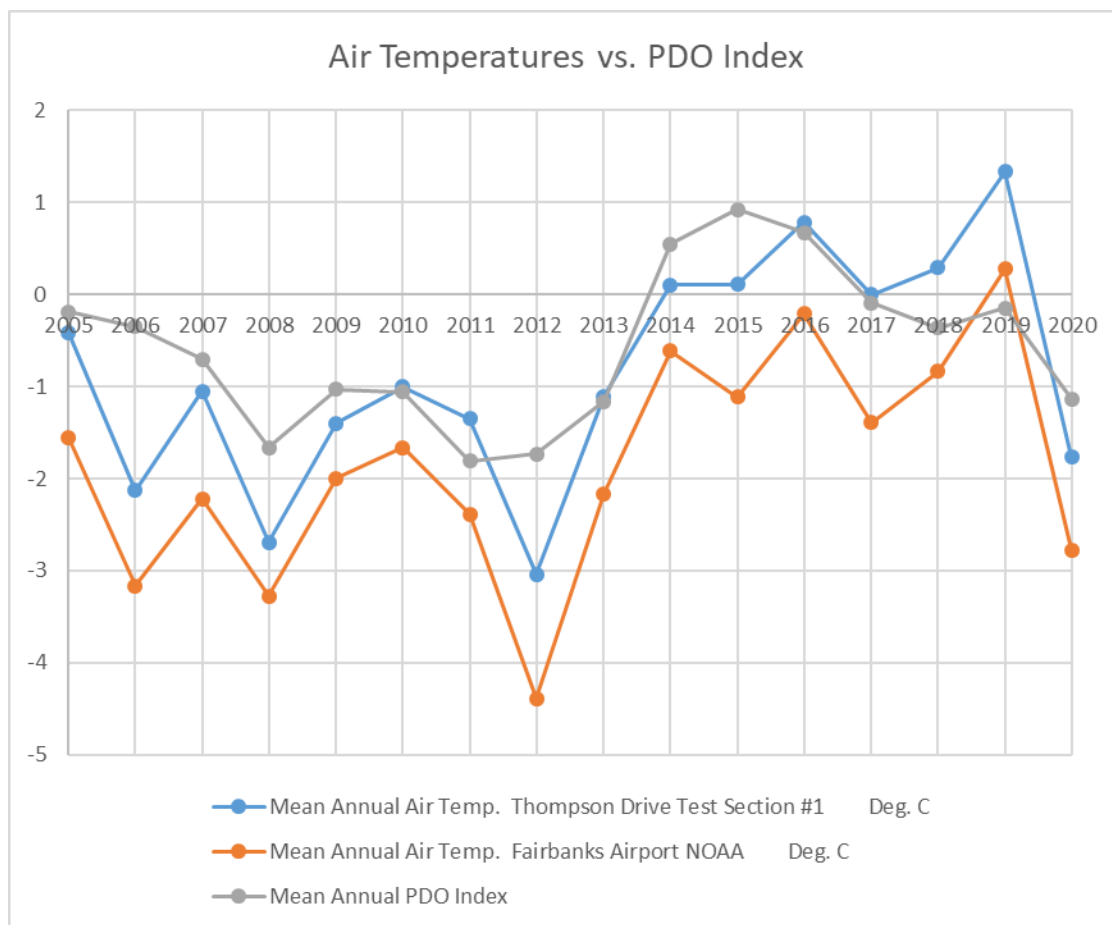
Figure 3-9 Thompson Drive and Fairbanks Airport Mean Annual Air Temperatures vs. PDO Index

during periods of relatively high PDO index values. This correlation can be seen clearly in Figure 3-9 which shows annual average values of Thompson Drive air temperature, Fairbanks airport air temperature, and PDO index. Fairbanks airport temperatures averaged  $-2.54^{\circ}\text{C}$  ( $27.4^{\circ}\text{F}$ ) for the years 2005 through 2013, close to the long-term mean for Fairbanks air temperature. Average temperatures at Thompson Drive were generally about  $1^{\circ}\text{C}$  warmer than those reported at the airport, which is likely due to differences in elevation and the location of Thompson Drive at the base of College Hill. The years 2014 through 2019 corresponded to a period of relatively high PDO values and warm air temperatures. During those five years, air temperatures averaged  $-0.65^{\circ}\text{C}$  at the airport and  $+0.44^{\circ}\text{C}$  at Thompson Drive, substantially warmer than long-term average air temperatures for Fairbanks. In 2020 the PDO index dropped and air temperatures returned to values more in line with long-term average values for Fairbanks.

For the years 2006 through 2013, annual air temperatures at Thompson Drive remained relatively cold, as shown in Figure 3-9. Mean annual temperature contours for test section #1 during this time period can be found in Figures Figure A-2 through Figure A-9. As shown in these figures, every year provided additional cooling in the foundation soils beneath the test section. Temperature depressions in the vicinity of the thermosyphon evaporator increased to roughly 2°C while temperature depressions beneath the VS side-slope increased to roughly 3°C. The zone of cooling produced by the VS and that produced by the thermosyphon have merged to a certain extent and effectively cooled the entire foundation base from the centerline out to the edge of the toe. During the same time, temperatures within the VS rock layer remained similar or slightly cooler than they were during 2005, with mean annual temperatures of -5 to -6°C at the base of the shoulder layer and +1 to +2°C in the upper portions of the shoulder.

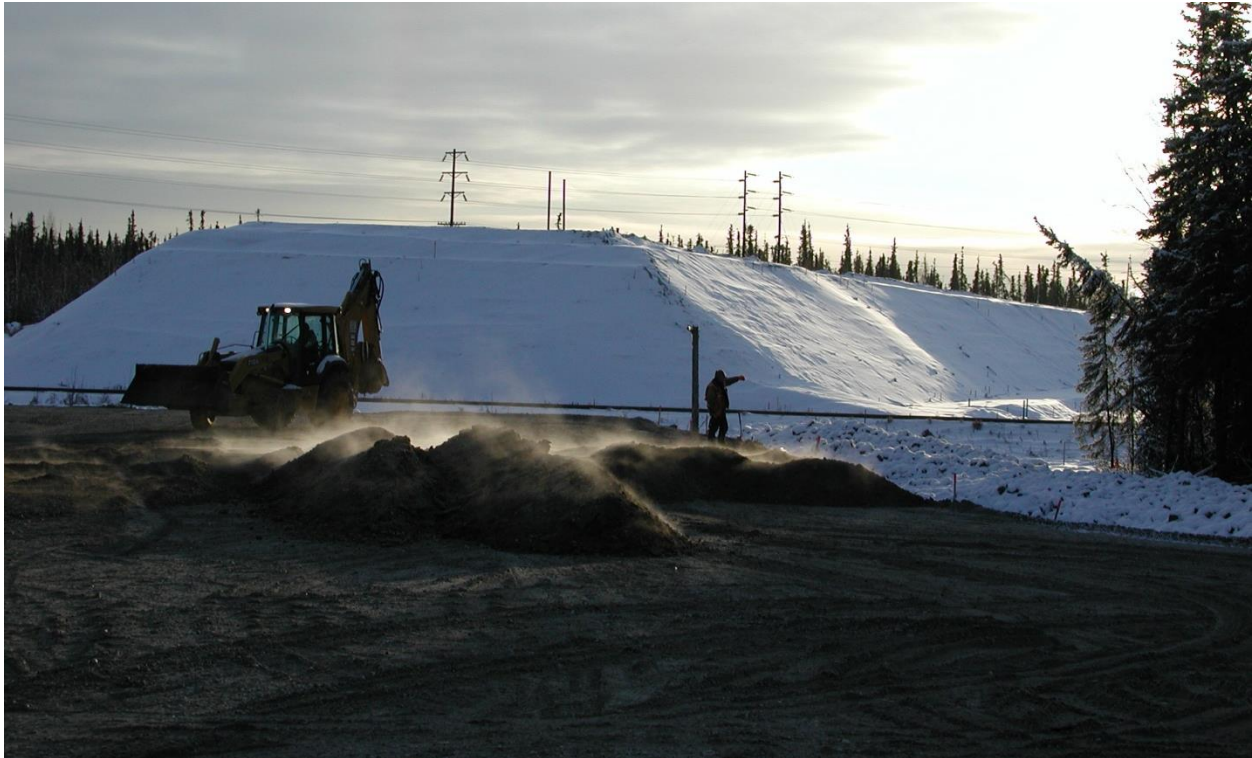
Figure 3-10 Winter Construction of Test Section #2

Beneath the ACE layer is roughly 8 m of select material, resulting in a total embankment height of about 10 m. The test section includes a thermistor array with a total of 95 sensors, 48 of which are located in a 1 m x 1 m grid spanning the right half of the ACE layer and 20 of which are located in two separate thermistor strings placed in the righthand VS structure. Thermistor locations are indicated by red dots in Figure 3-7. In an effort to reduce warming of underlying foundation soils, this section of the project was completed during winter, see Figure 3-10.

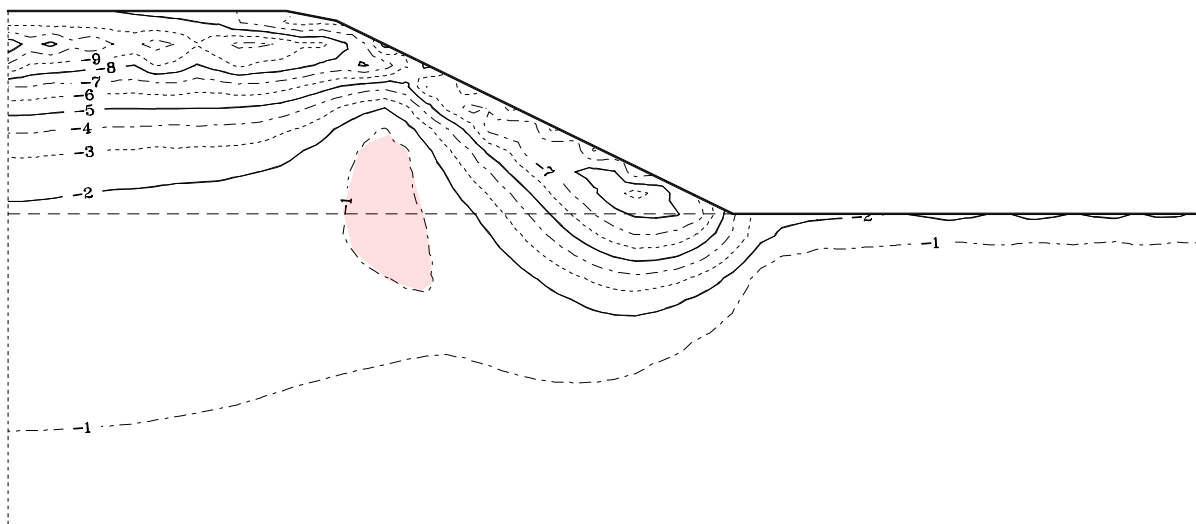
Figure 3-12 Calculated Temperature Isotherms for Test Section #2 for April, (Goering [11])

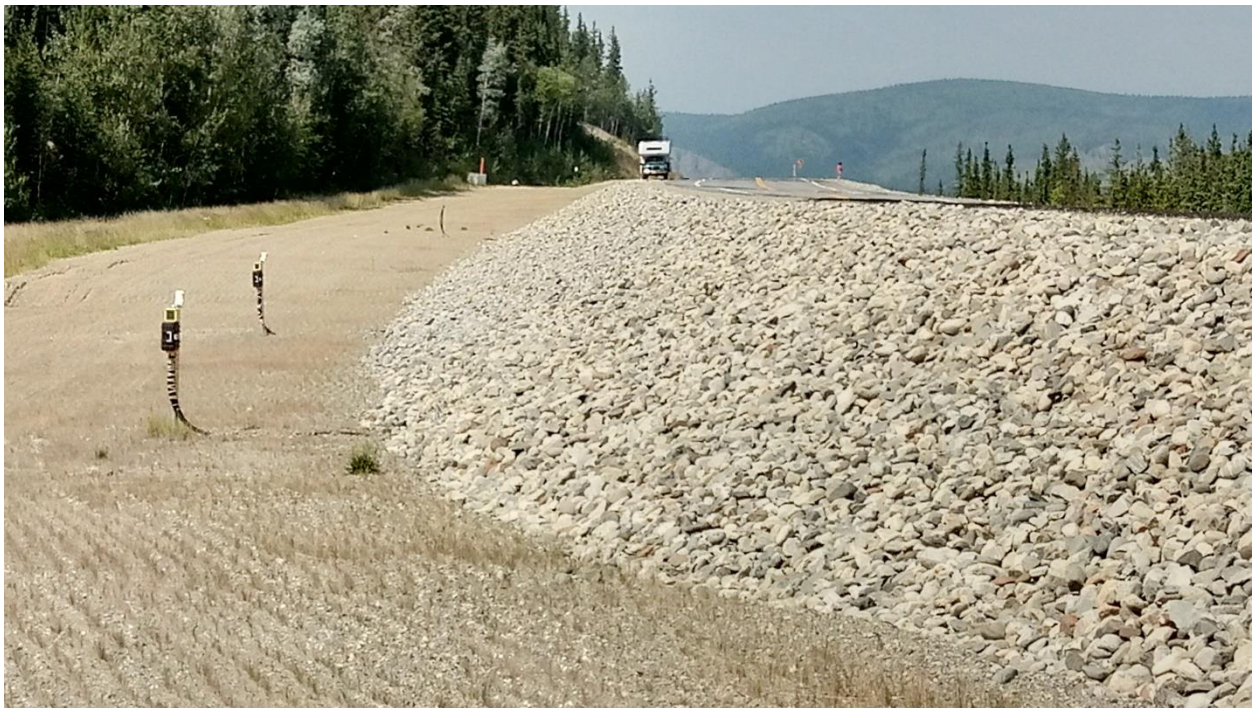
Figure 3-27 Alaska Highway Dot Lake Test Section, Looking North

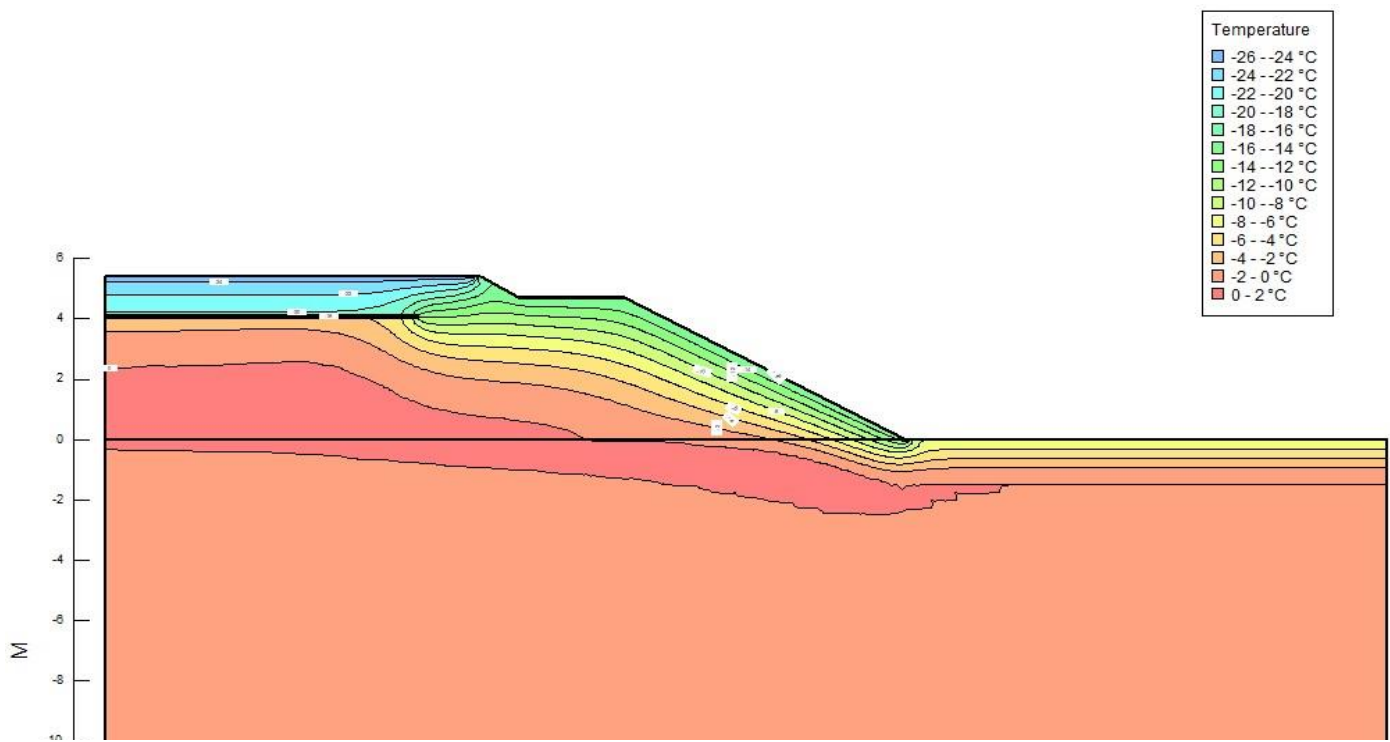
Figure 4-2 Simulation Results for Case 1 for January 1 of Year 1

Figure 4-2 through Figure 4-4 show the results of the Case 1 simulation on January 1 of the 1<sup>st</sup>, 6<sup>th</sup>, and 12<sup>th</sup> year of simulation. These figures show that a thawed region develops beneath the roadway and grows over time, achieving maximum depth of thaw in the region beneath the shoulder of the embankment. After twelve years the maximum depth of the thaw zone extends down nearly six meters below the original grade. In a real-world situation where the embankment is located on permafrost with excess ice content, we would expect that this thaw behavior would cause significant deformation of the embankment and outward rotation of the shoulders due to the exacerbated thaw beneath the toe.

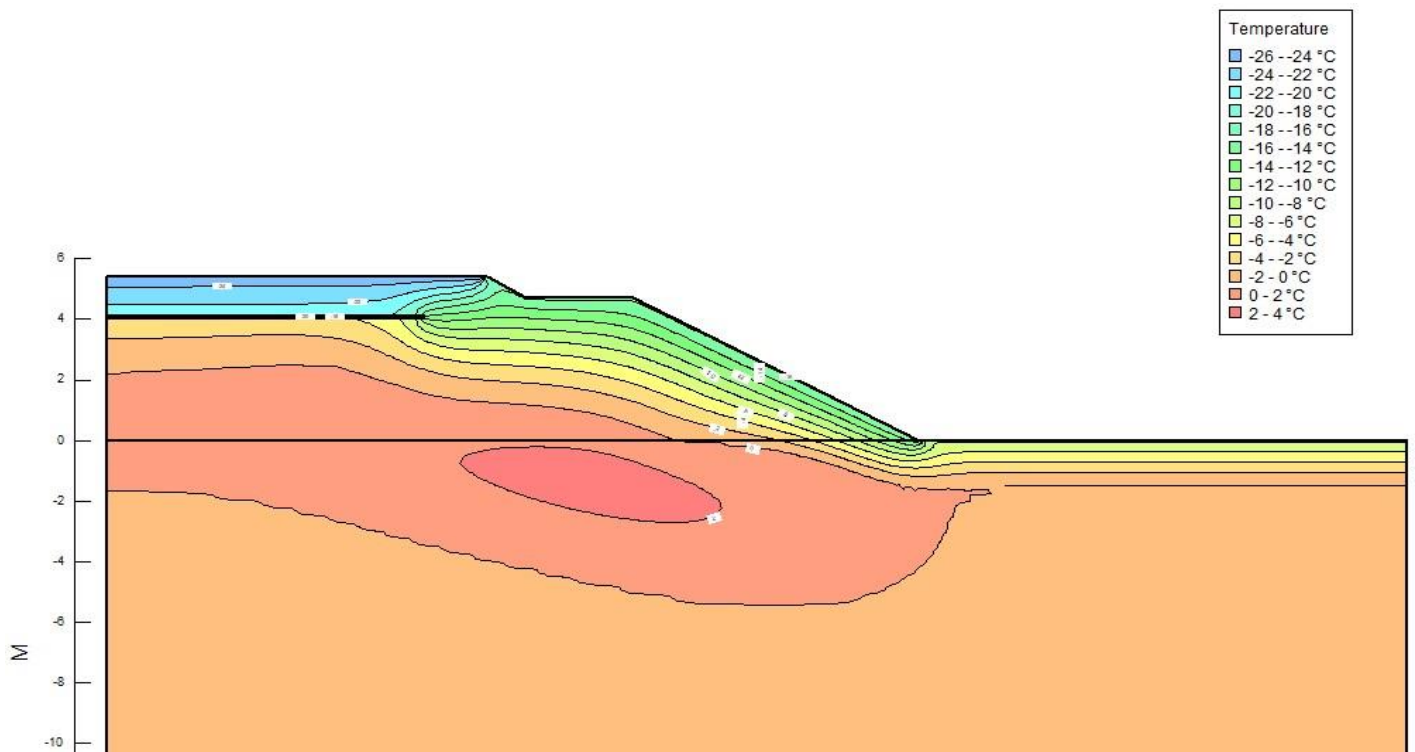
Figure 4-4 Simulation Results for Case 1 for January 1 of Year 12

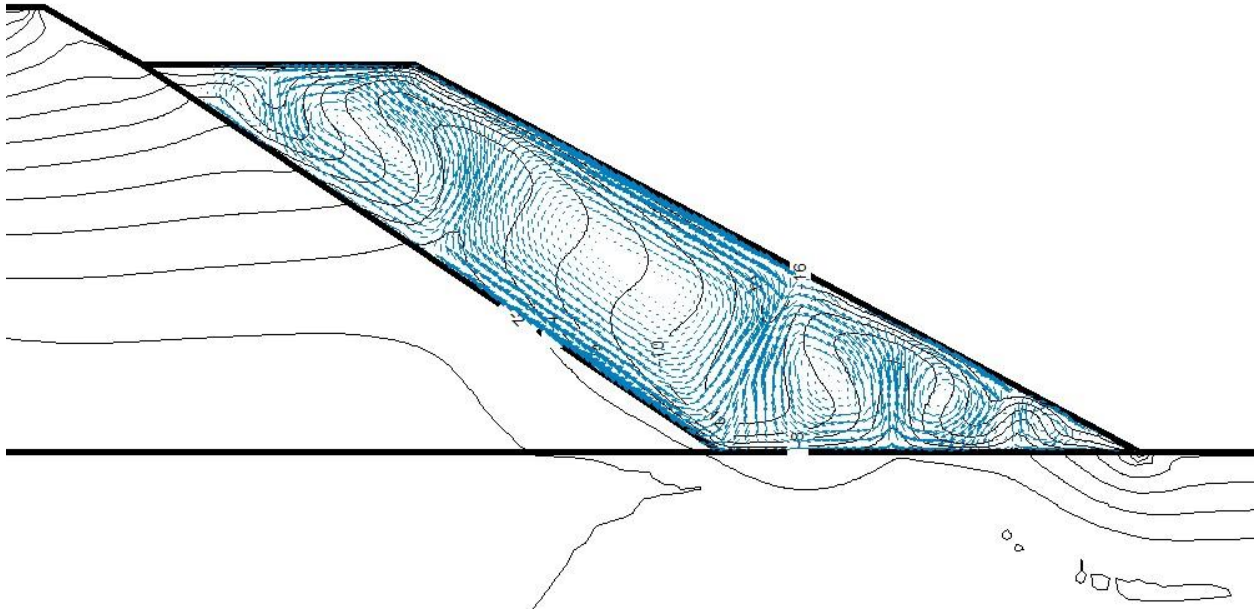
Figure 4-5 Convective Airflow Pattern in the Ventilated Shoulder on January 1 for Case 2

evidenced in the figure. As a result, the convective airflow is less effective at enhancing summer warming of the embankment core and foundation soils.

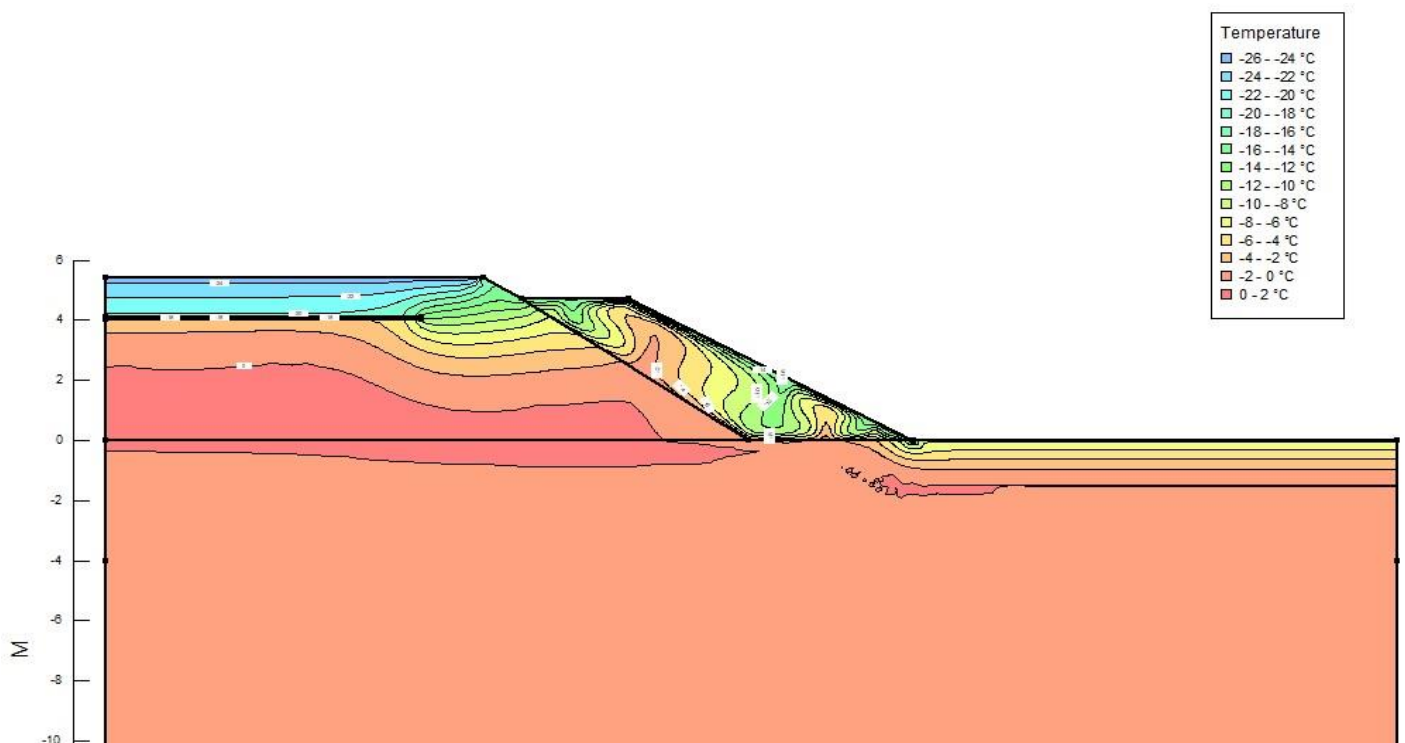
Figure 4-7 Simulation Results for Case 2 for January 1 of Year 1

As was the case for Case 1, these results for Case 2 do not bear a strong resemblance to the field data for test section #1 on Thompson Drive, although they are closer to field observations than those for Case 1. In particular, it appears that the air convection in the shoulder is able to counteract the warm thermal boundary condition at the surface of the shoulder and maintain frozen conditions at least in the foundation soil immediately below the base of the shoulder.

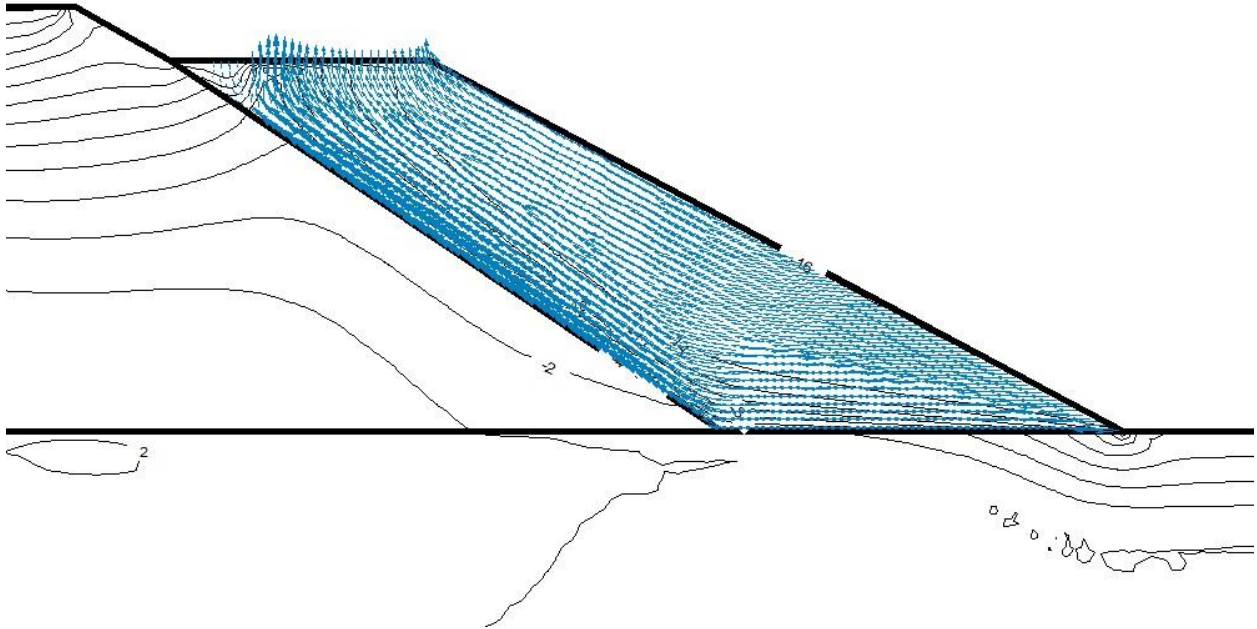
Figure 4-12 Convective Airflow Pattern in the Ventilated Shoulder on January 1 for Case 3

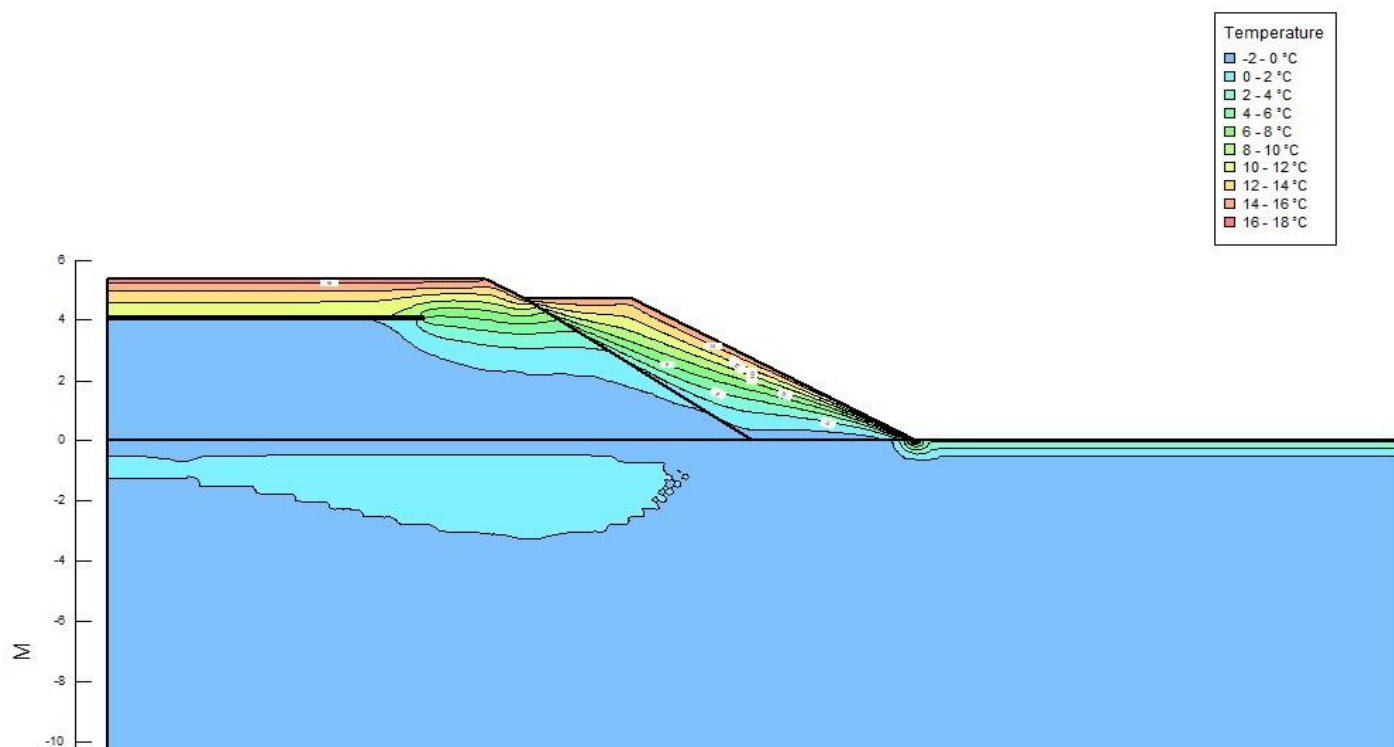
Figure 4-17 Simulation Results for Case 3 for May 15 of Year 12

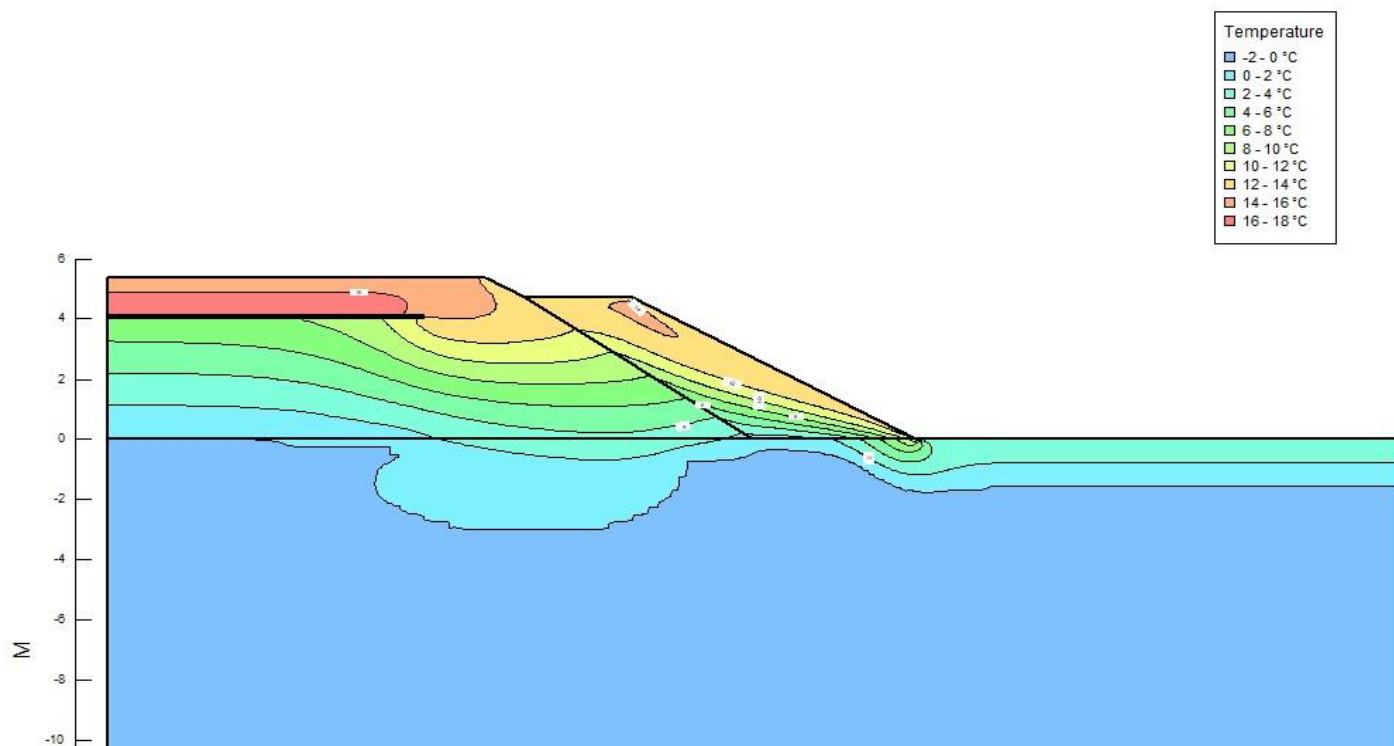
Figure 4-18 Simulation Results for Case 3 for September 15 of Year 12

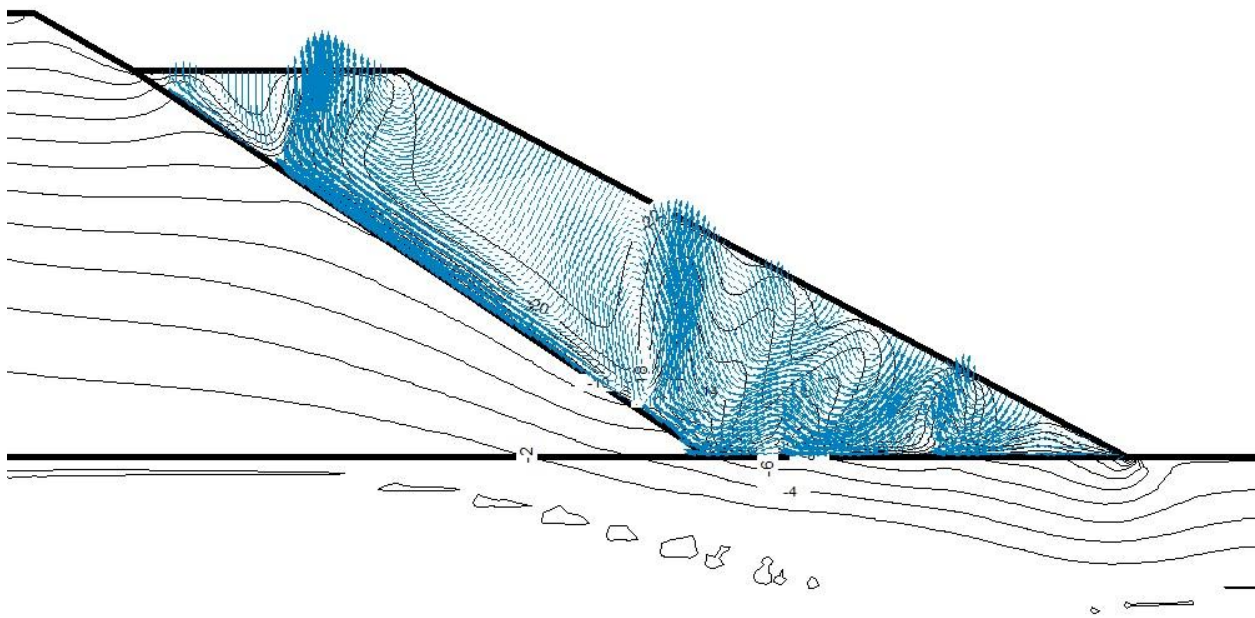
Figure 4-19 Convective Airflow Pattern in the Ventilated Shoulder on January 1 for Case 4

Interestingly, the convective airflow patterns shown in Figure 4-19 for Case 4 on January 1 display characteristics that could be considered a mixture of the airflow patterns observed for Case 2 and Case 3. On the one hand, it is clear that ambient air is entering and exiting the embankment surface at multiple locations as was the situation for Case 3, however, the internal airflow is organized into a series of circulatory patterns similar to that observed for Case 2. These circulation cells result in five or more sections of the upper ventilated shoulder boundary where airflow is entering or leaving the shoulder surface. This type of behavior was also seen in the numerical simulations performed during the design phase of the Thompson Drive project, Goering [11]. The more complex airflow patterns shown in the figure for January are likely the result of stronger temperature gradients in the shoulder region due to the imposition of ambient air temperatures directly on the upper boundary of the shoulder.

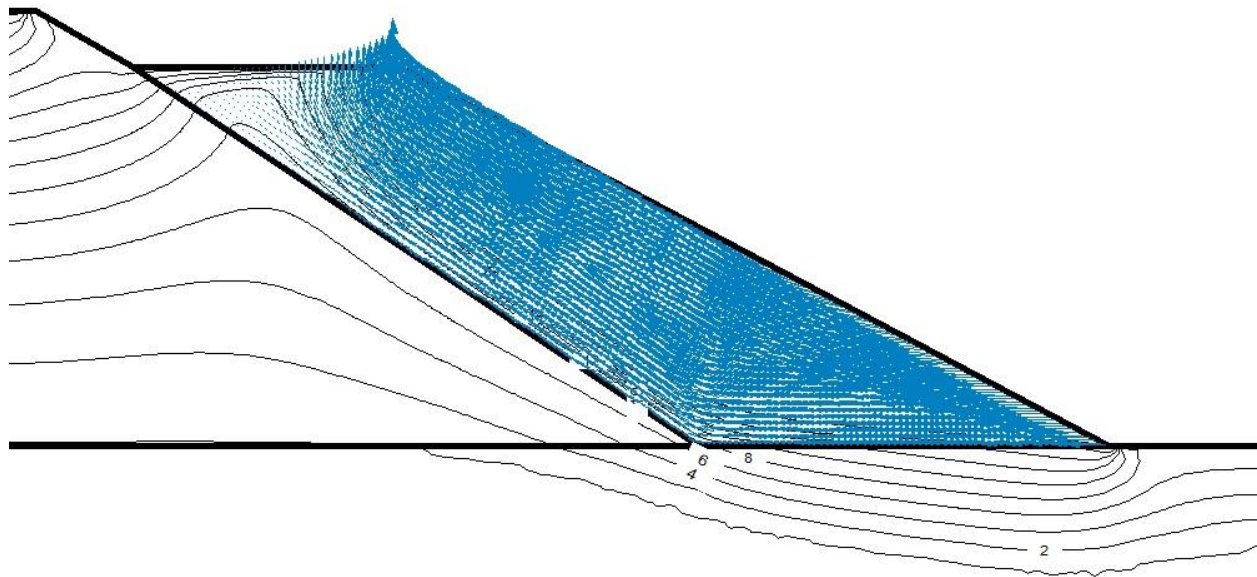
Figure 4-20 Convective Airflow Pattern in the Ventilated Shoulder on July 1 for Case 4

shoulder is much cooler for Case 4 than it is for Case 2 or 3. This is a result of the thermal boundary condition used for Case 4 which imposes ambient air temperature on the shoulder boundary as opposed to cases 2 and 3 which use the side-slope boundary condition that has a thawing N-factor of 1.4. The rather surprising result is that Case 4 produces greater summer heating of the foundation soil beneath the shoulder even though it has a colder boundary temperature than Case 2 or 3. This is an example of the effectiveness of convective heat transfer in that the airflow pattern has more influence on the temperatures beneath the side-slope than the actual surface boundary temperature.
