# Improved Permafrost Protection Using Air Convection and Ventilated Shoulder Cooling Systems — Final Project Report

**Date:** November 2022

**Publication Number:** FHWA-AK-RD-4000(185)

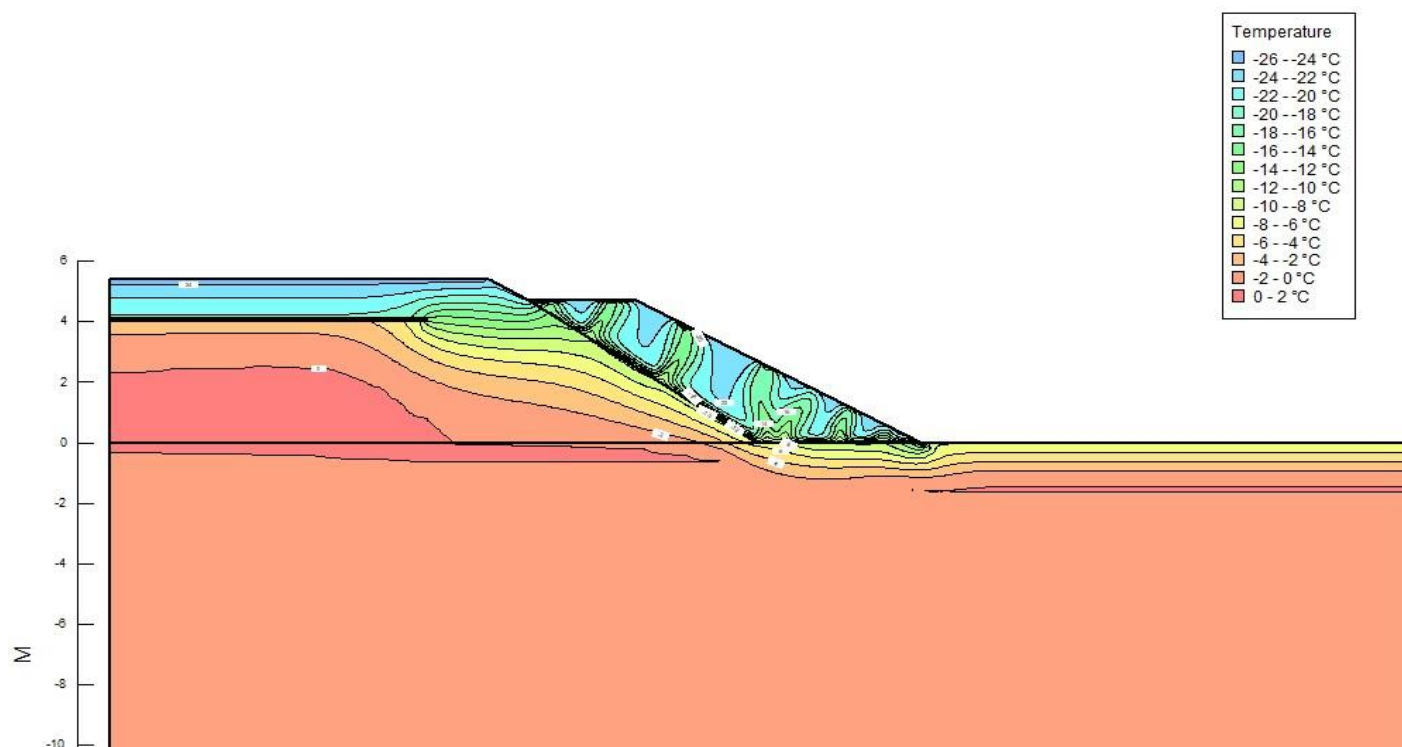
Figure 4-21 Simulation Results for Case 4 for January of Year 1

Figure 4-21 through Figure 4-23 show temperature isotherm profiles for the Case 4 simulation after one, six, and twelve years. The isotherm patterns displayed in these figures show significantly improved cooling as compared to any of the earlier results. This is, no doubt, due to the influence of the relatively colder thermal boundary condition used at the surface of the ventilated shoulder for this case (i.e. freezing N-factor of 1 rather than 0.6 as used for Cases 1, 2, and 3). These figures show a thawed zone beneath the center of the embankment, but the foundation soil beneath the side-slope and the shoulder region is nearly completely re-frozen by January 1. The size of the thawed region is significantly smaller than in any of the prior cases and is limited to the region of the embankment beneath the insulation sheet. Also note that the depth of the thawed material beneath the embankment extends to a depth of only about 1.5 m beneath the original ground surface, roughly the same depth as the original active layer beneath the undisturbed surface. As such, it is unlikely that the thaw zone shown in these figures would result in any thaw settlement of the embankment.

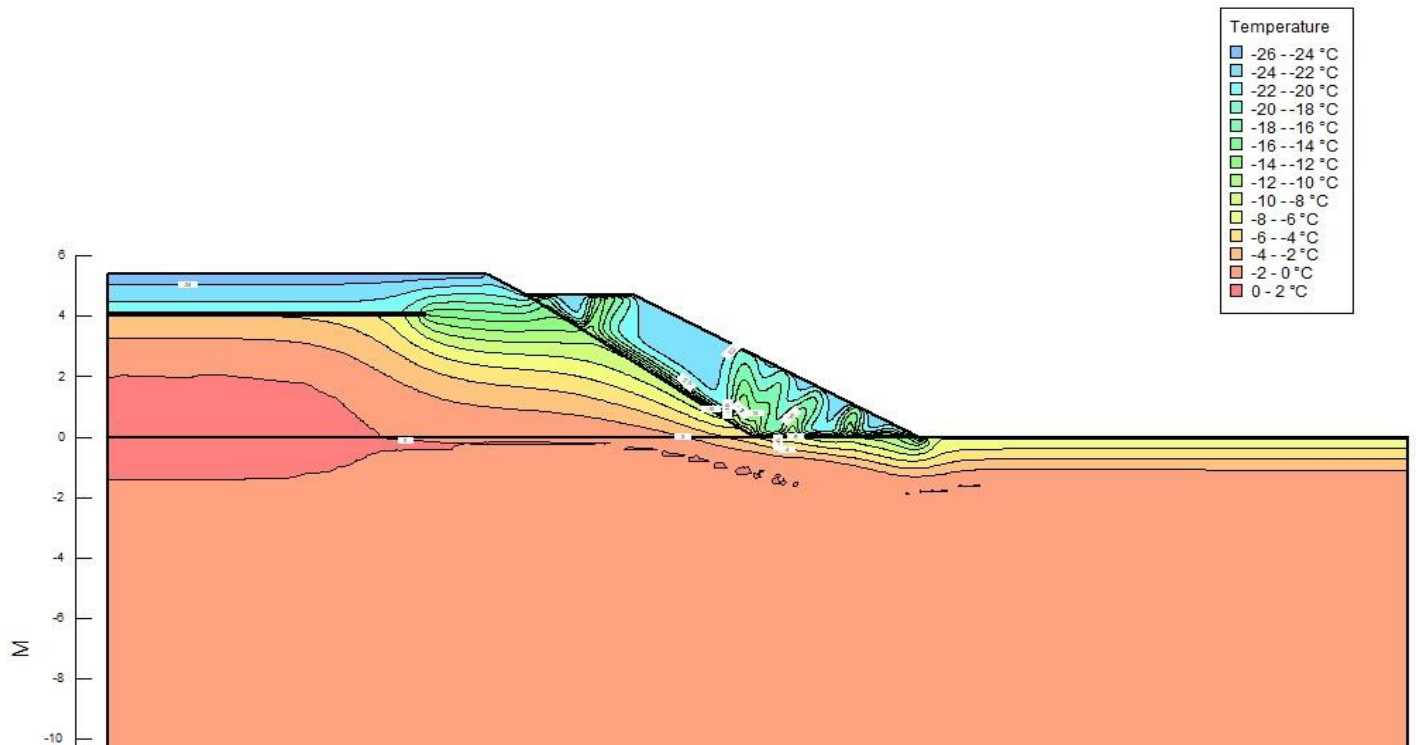
Figure 4-23 Simulation Results for Case 4 for January of Year 12

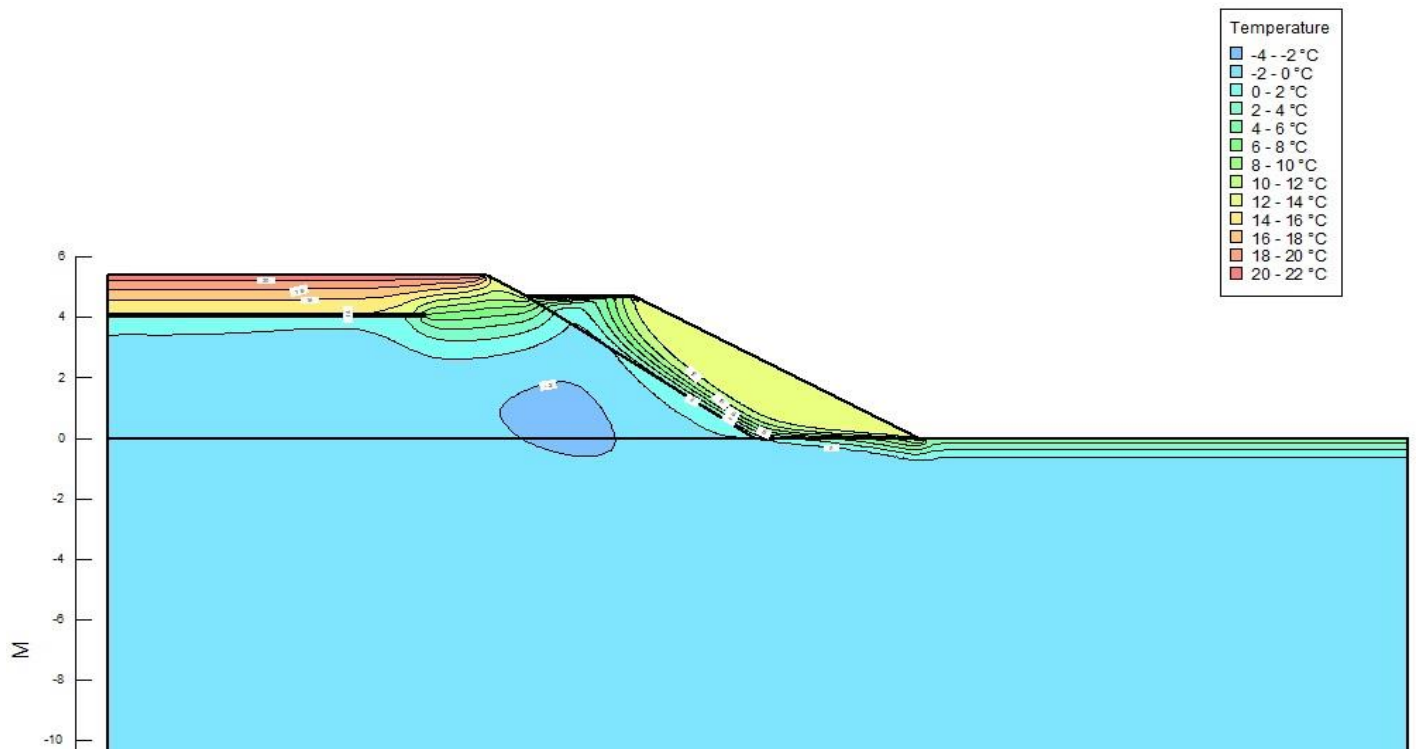
Figure 4-24 Simulation Results for Case 4 for May 15 of Year 12

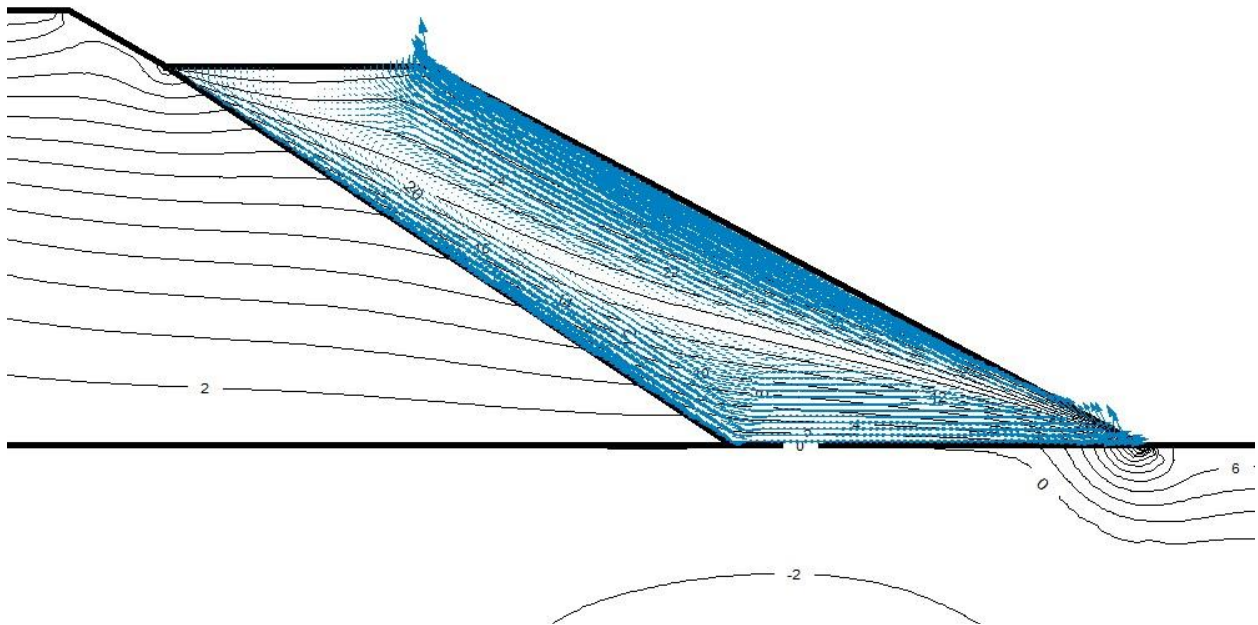
Figure 4-27 Convective Airflow Pattern in the Ventilated Shoulder for July 1 for Case 5

Figure 4-26 and Figure 4-27 show the airflow patterns for Case 5 on January 1 and July 1, respectively. Not surprisingly the January 1 airflow pattern is nearly identical to that obtained for the Case 4 simulation as shown in Figure 4-19. This makes sense since the winter boundary condition at the surface of the ventilated shoulder is the same for Case 4 and Case 5. However, the summer airflow pattern shown in Figure 4-27 is much more similar to the cellular flow pattern obtained for Case 2 and Case 3, as opposed to that obtained for Case 4. As a result, summer heating of the foundation soil beneath the ventilated shoulder is reduced for Case 5 as compared to Case 4.

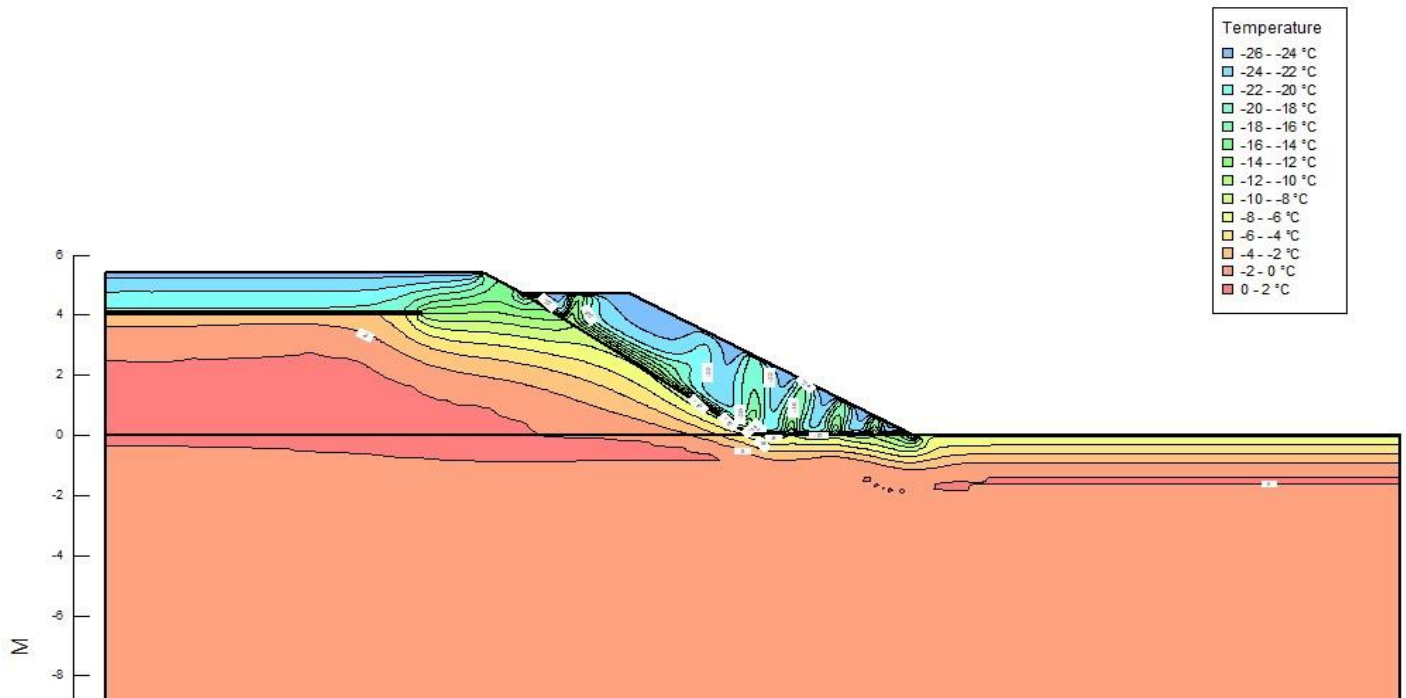
Figure 4-28 Simulation Results for Case 5 for January 1 of Year 1

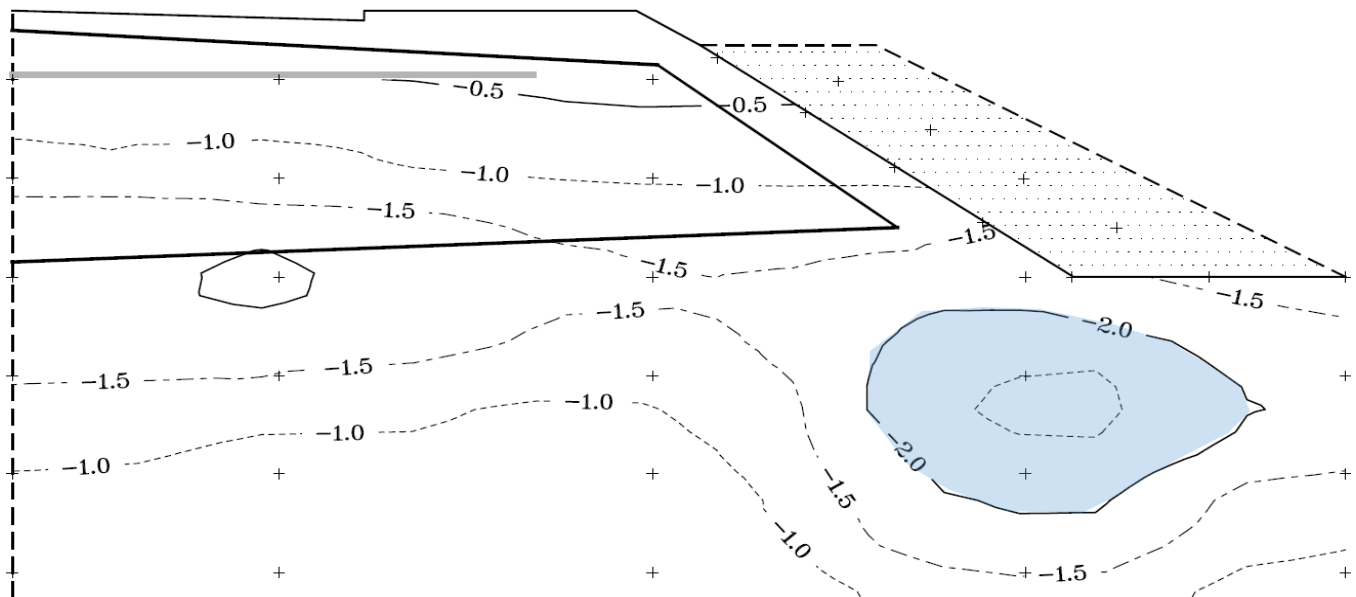
Figure 4-33 Temperature Contours for Thompson Drive Test Section #1 on May 15, 2015

Field data from Thompson Drive test section #1 is shown in Figure 4-33 for May 15, 2015, roughly ten years after construction of Thompson Drive. As shown in this figure, the field data shows a zone of reduced temperature centered beneath the ventilated shoulder. The data indicates a minimum temperature of somewhat less than  $-2.5^{\circ}\text{C}$  at the center of the cooled area, substantially colder than any other portion of the foundation soil layers.

The shape and position of the low temperature zone shown in Figure 4-33 matches quite well with the results from the Case 5 numerical simulation which are repeated in greater detail in Figure 4-34. As shown in this figure the size and position of the chilled foundation soil zone matches well with the field data, although the minimum temperature achieved at the center of the zone was somewhat colder than  $-4^{\circ}\text{C}$ , roughly  $1.5^{\circ}\text{C}$  colder than observed in the Thompson Drive data. Despite this mis-match in temperature magnitude, other aspects of the numerical simulation results match the field data quite well and this match is taken as an indication that the boundary conditions used for the Case 5 simulation were likely the best match for the actual thermal behavior in the field. Note that there are some discrepancies in the position of the  $-1^{\circ}\text{C}$  isotherm when comparing the two figures, but this is likely due to the fact that the simulation did not include the hairpin thermosyphon which was effective at cooling the Borrow A material closer to the embankment centerline, thus the cooler temperatures shown in the field data.

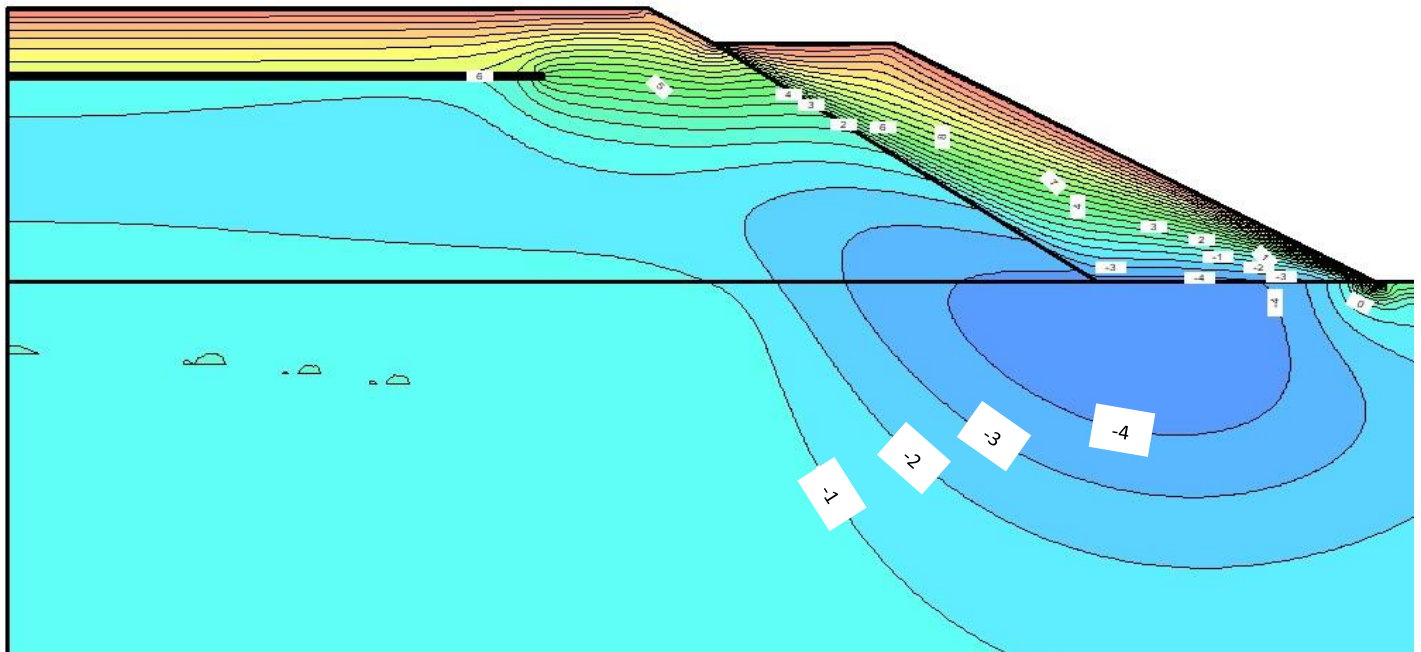
Figure 4-34 Detailed Simulation Results for Case 5 for May 15 of Year 12

While the aspects of these comparisons between the field results and the Case 5 simulation are quite good, the comparison is clearly not perfect. Remaining discrepancies are likely resulting from material property assumptions used in the simulations as compared to the actual field values, as well as remaining uncertainty in the thermal and hydraulic boundary condition used at the surface of the ventilated shoulder.

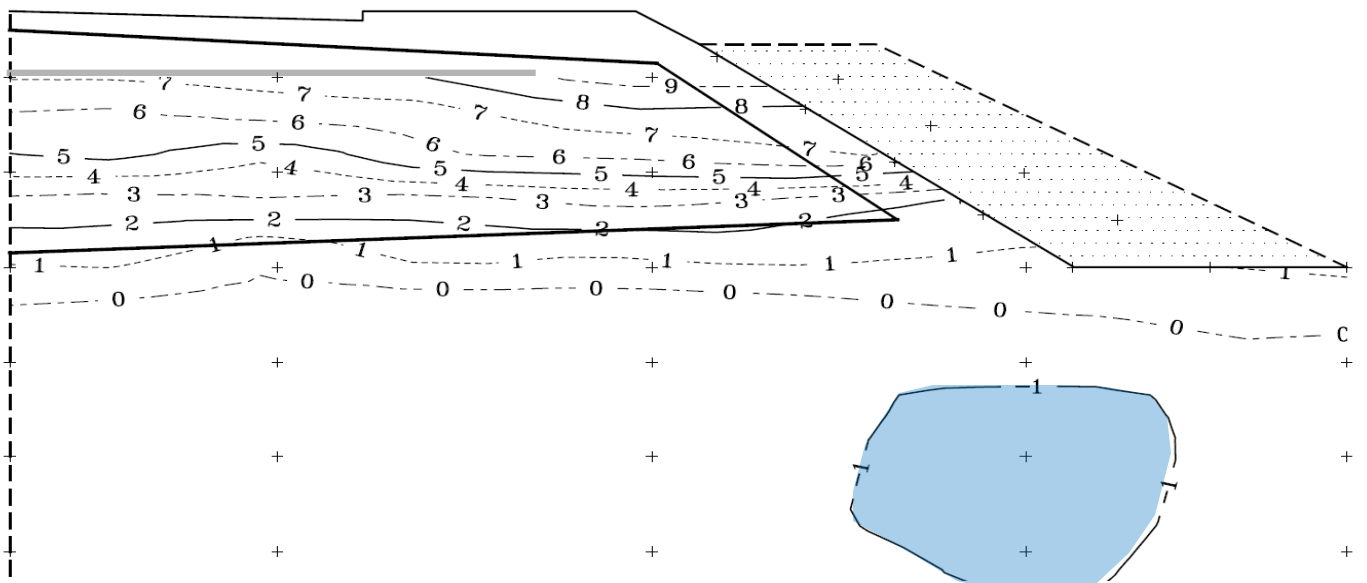
Figure 4-35 Temperature Contours for Thompson Drive Test Section #1 on September 15, 2015

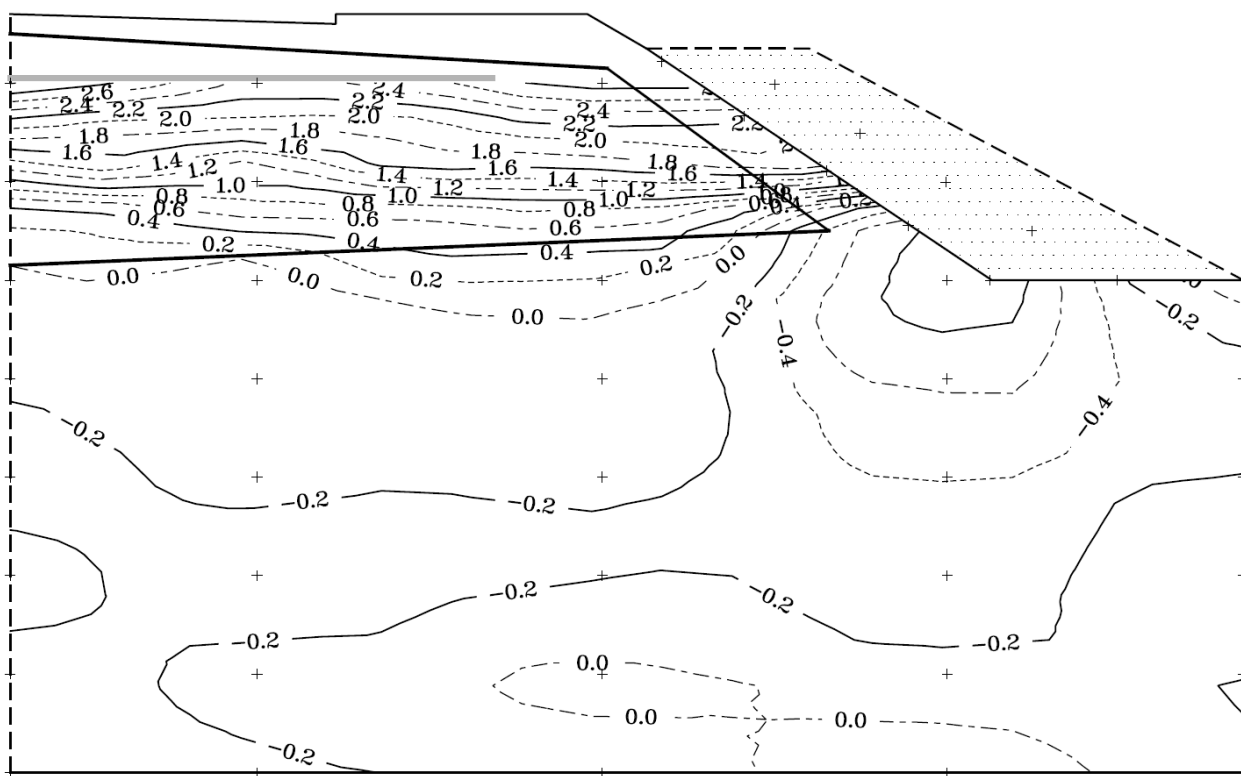
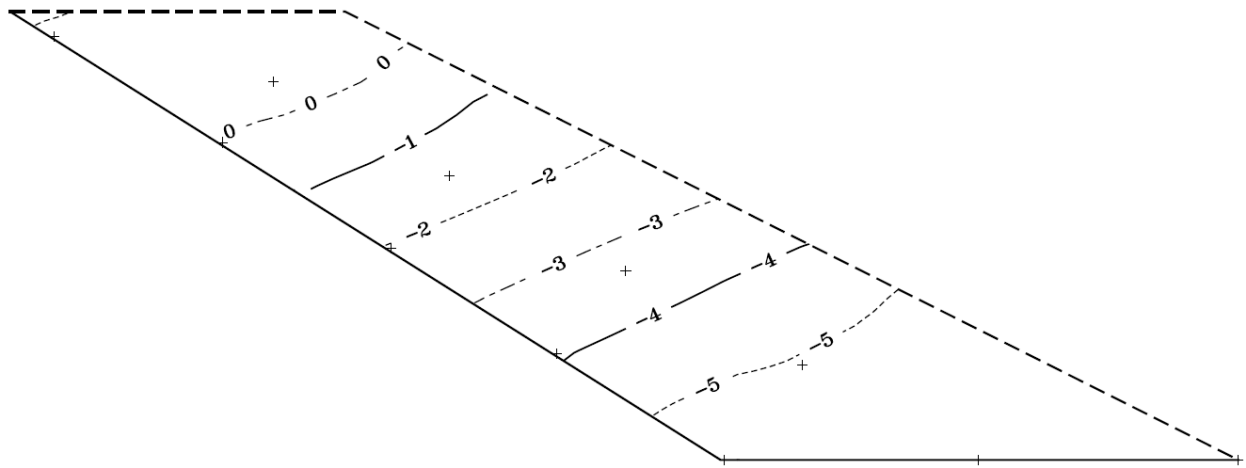
Figure A-1 Mean annual temperature contours for test section 1 in 2005, (a) ventilated shoulder, (b) embankment core and foundation soils

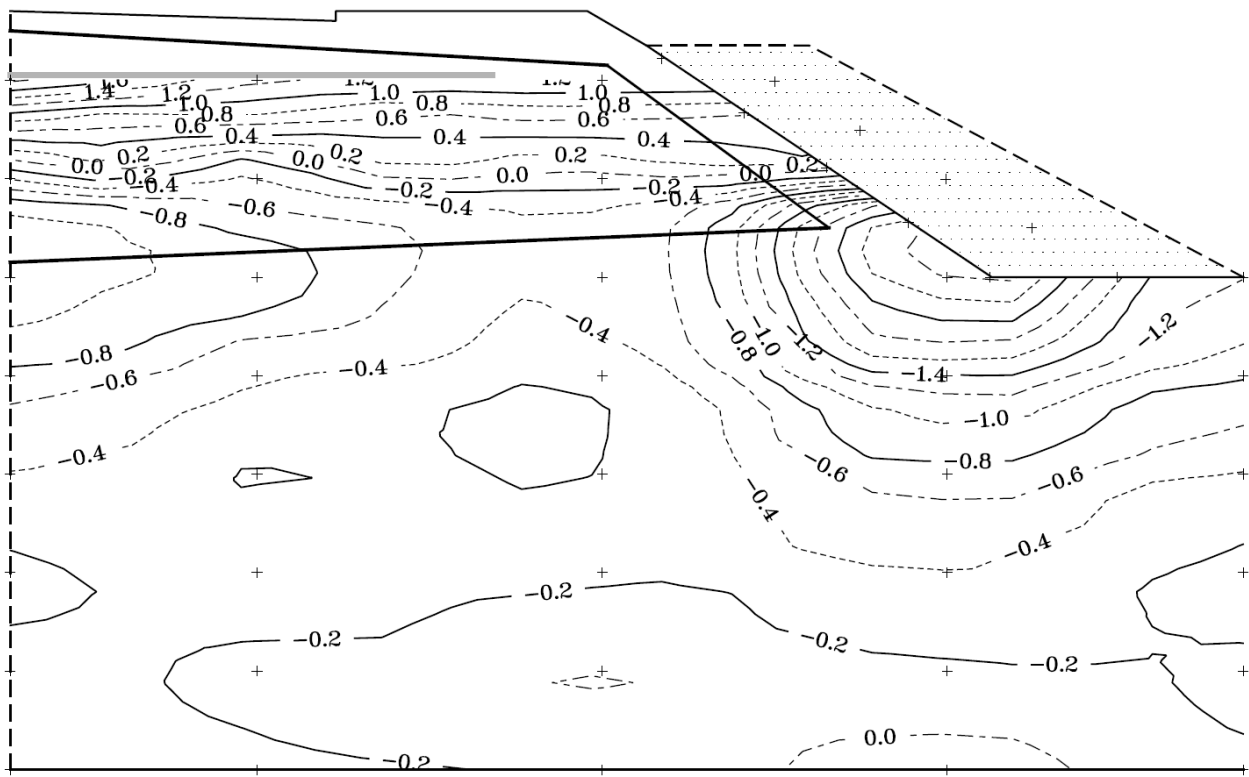
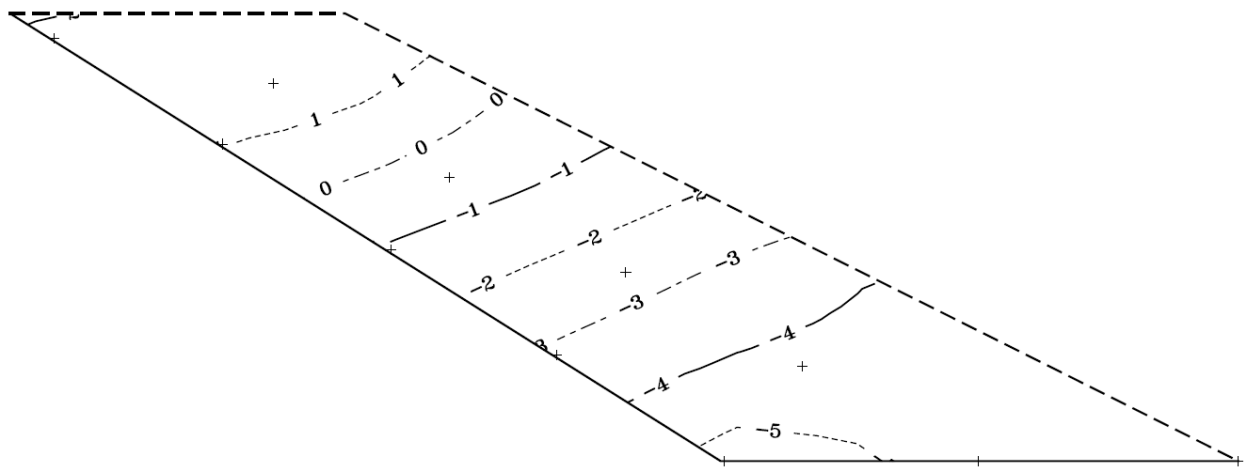
Figure A-2 Mean annual temperature contours for test section 1 in 2006, (a) ventilated shoulder, (b) embankment core and foundation soils

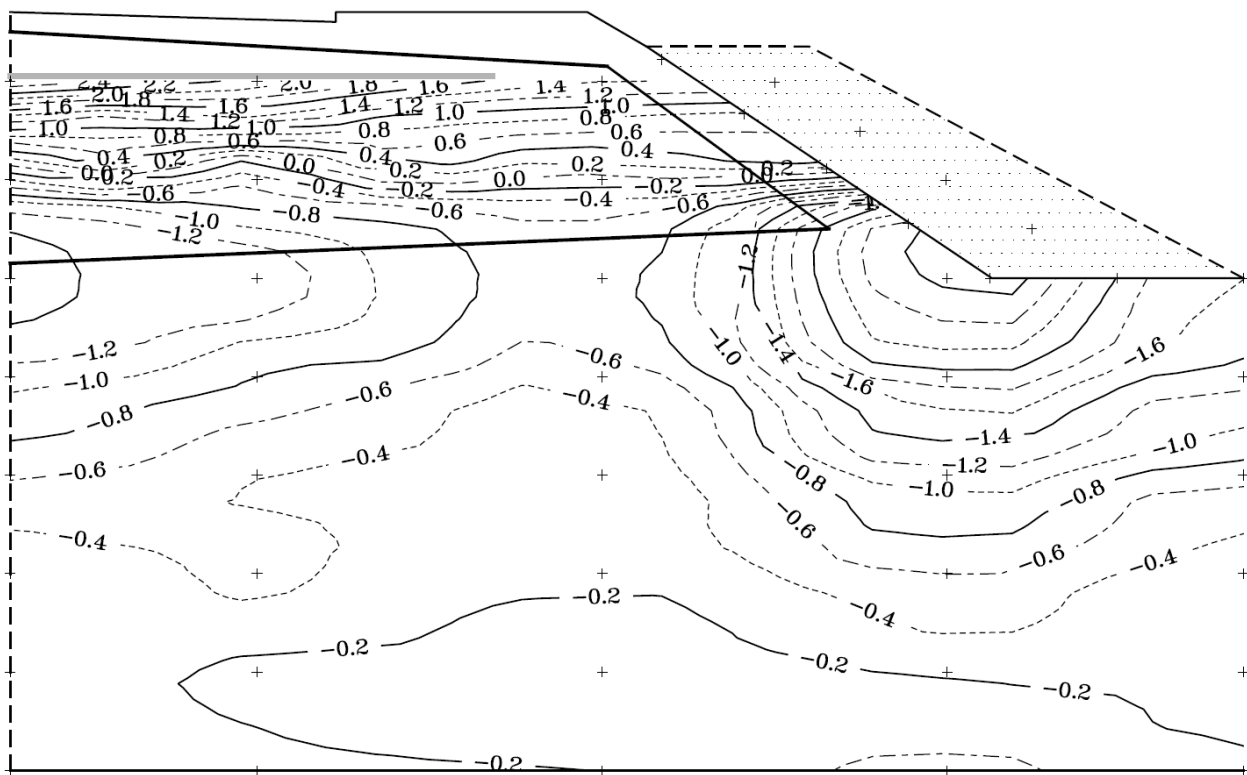
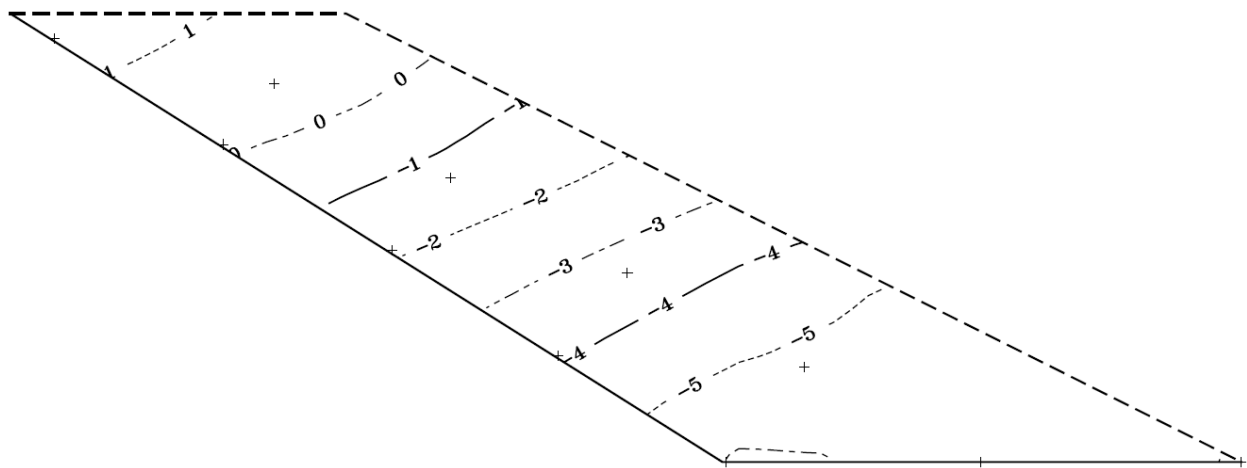
Figure A-3 Mean annual temperature contours for test section 1 in 2007, (a) ventilated shoulder, (b) embankment core and foundation soils

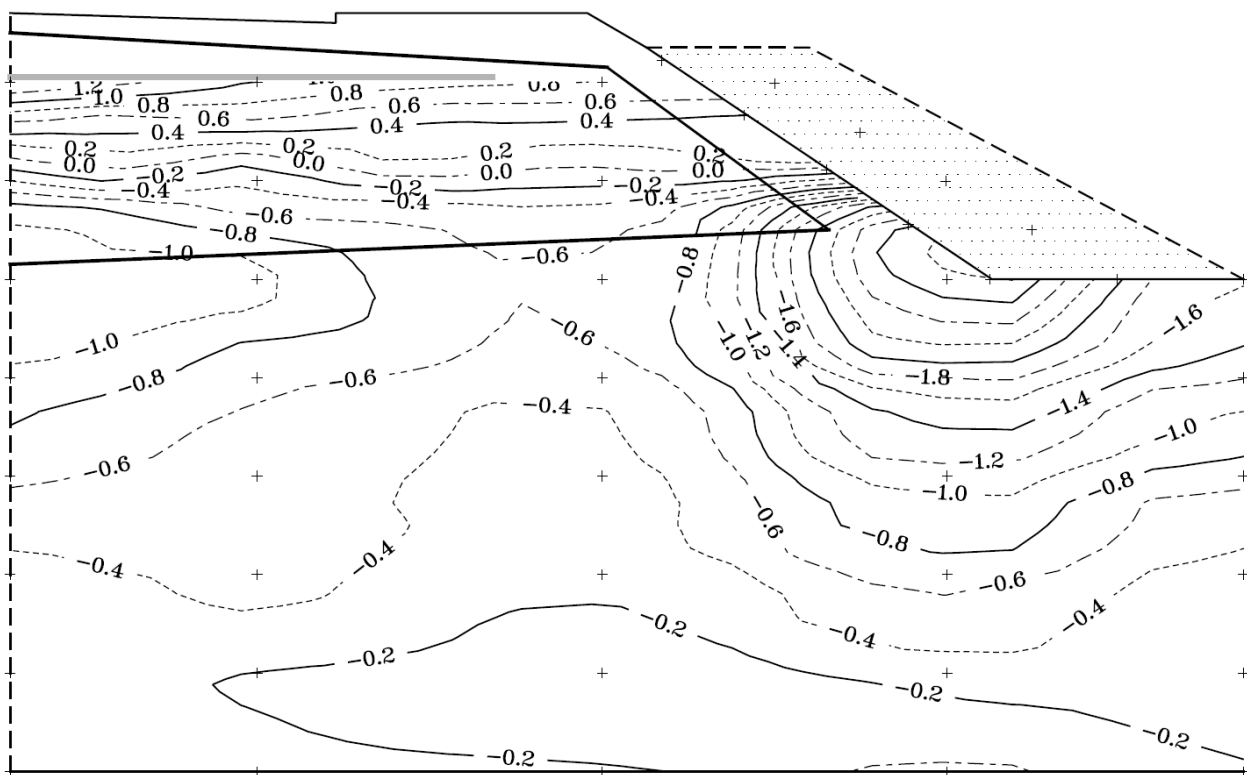
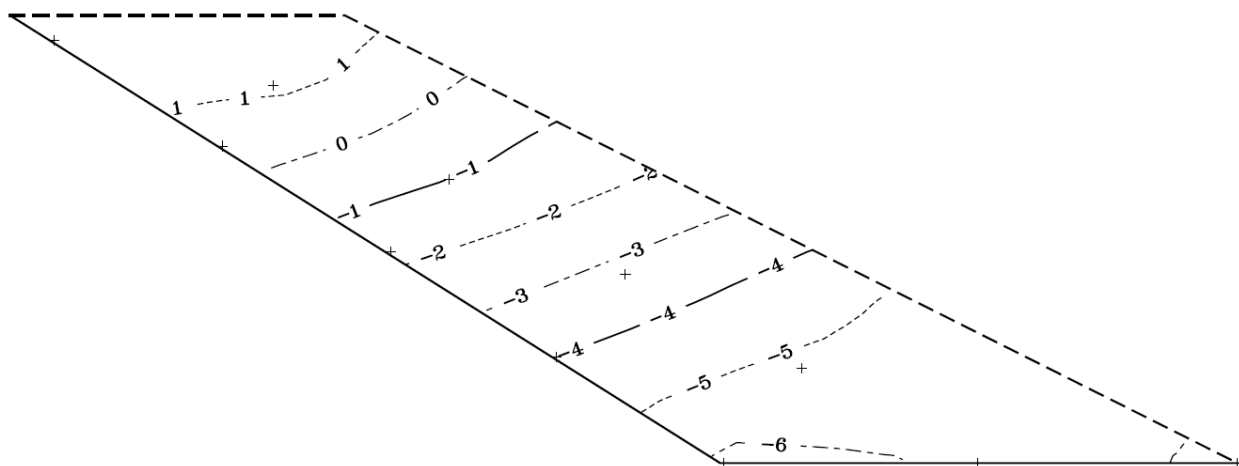
Figure A-4 Mean annual temperature contours for test section 1 in 2008, (a) ventilated shoulder, (b) embankment core and foundation soils

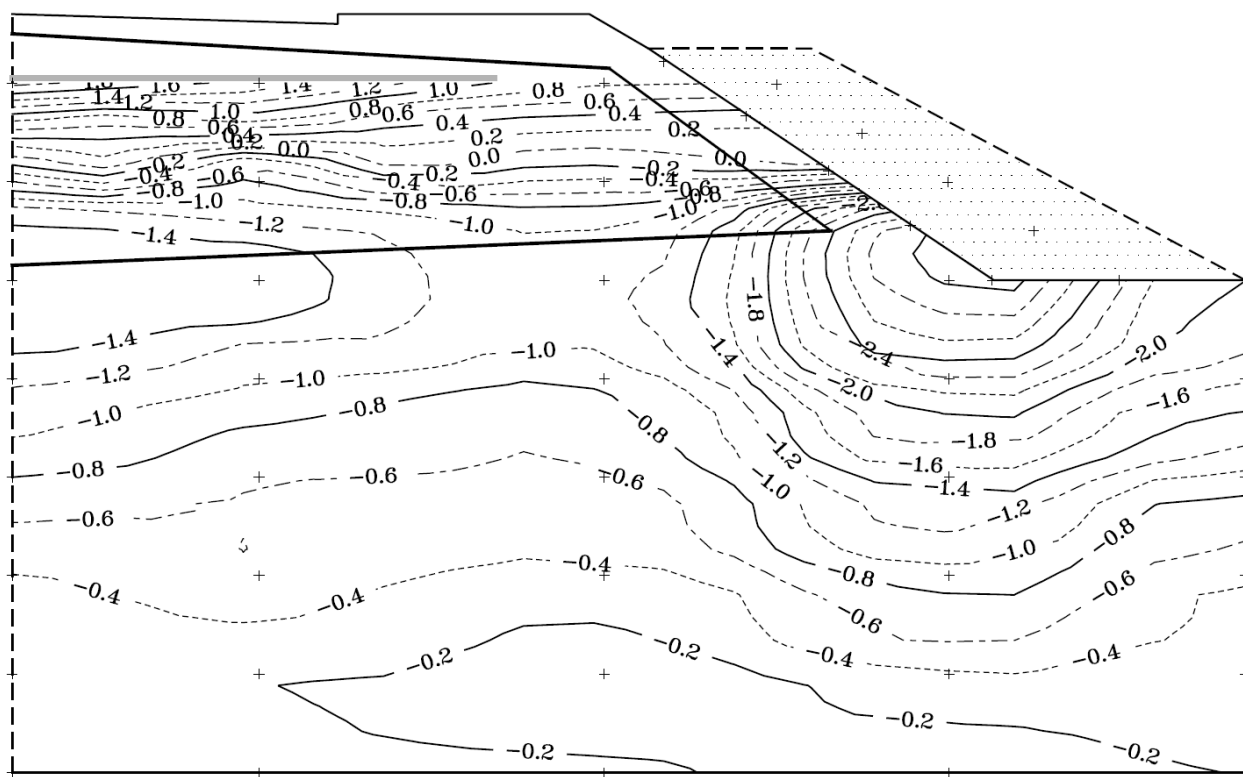
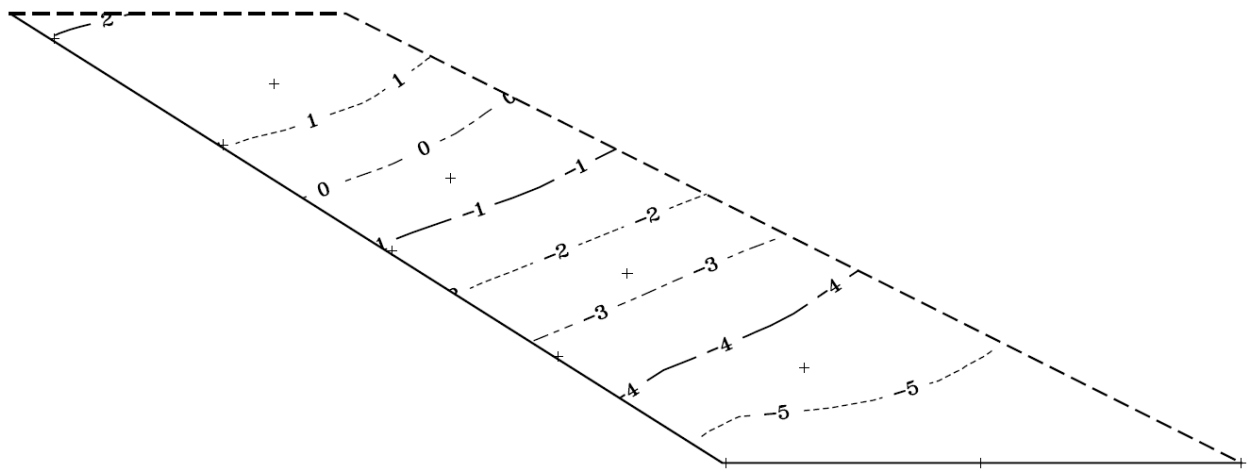
Figure A-5 Mean annual temperature contours for test section 1 in 2009, (a) ventilated shoulder, (b) embankment core and foundation soils

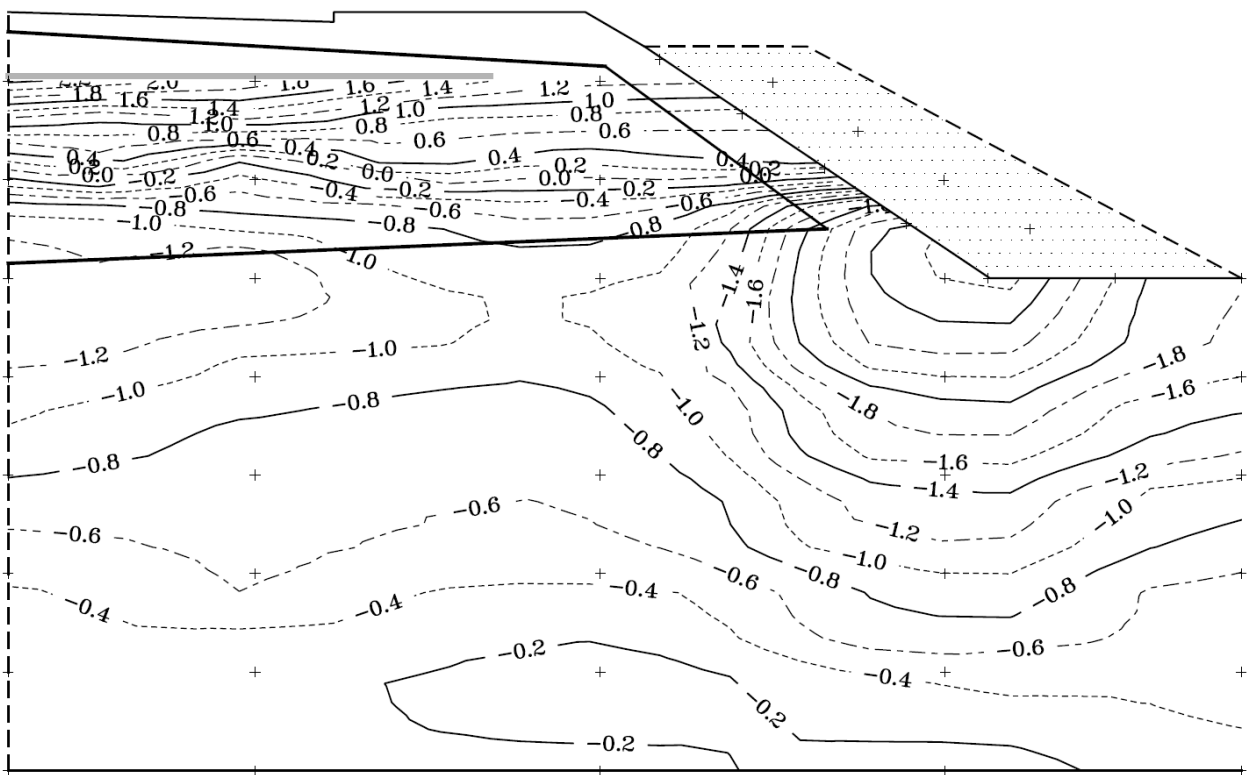
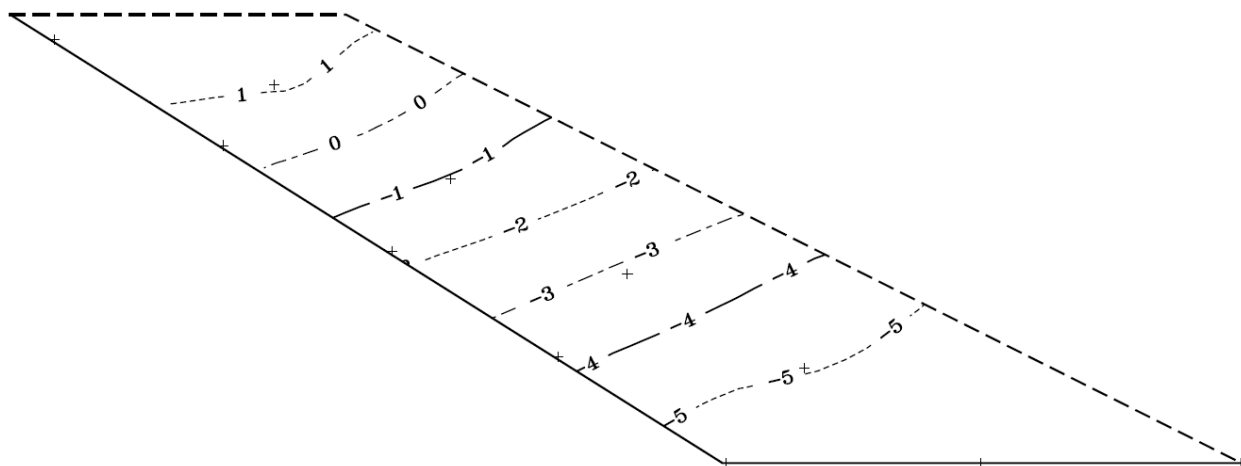
Figure A-6 Mean annual temperature contours for test section 1 in 2010, (a) ventilated shoulder, (b) embankment core and foundation soils

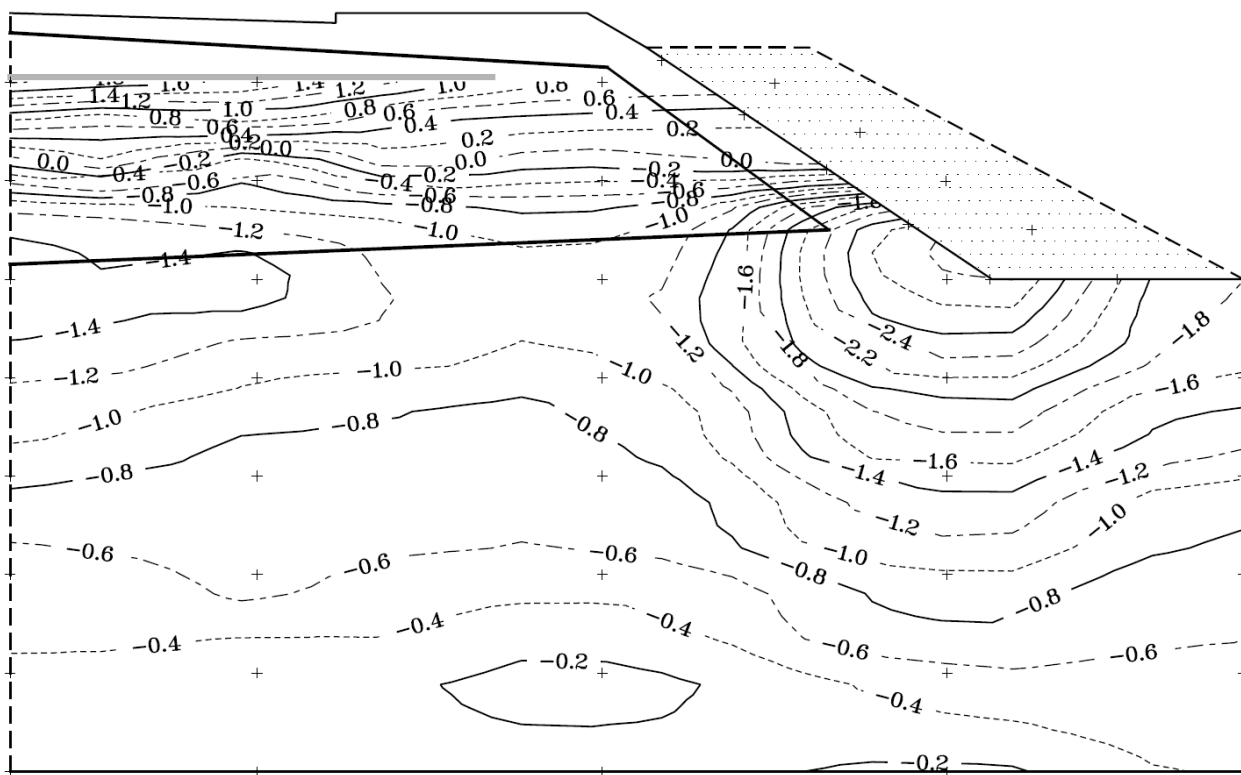
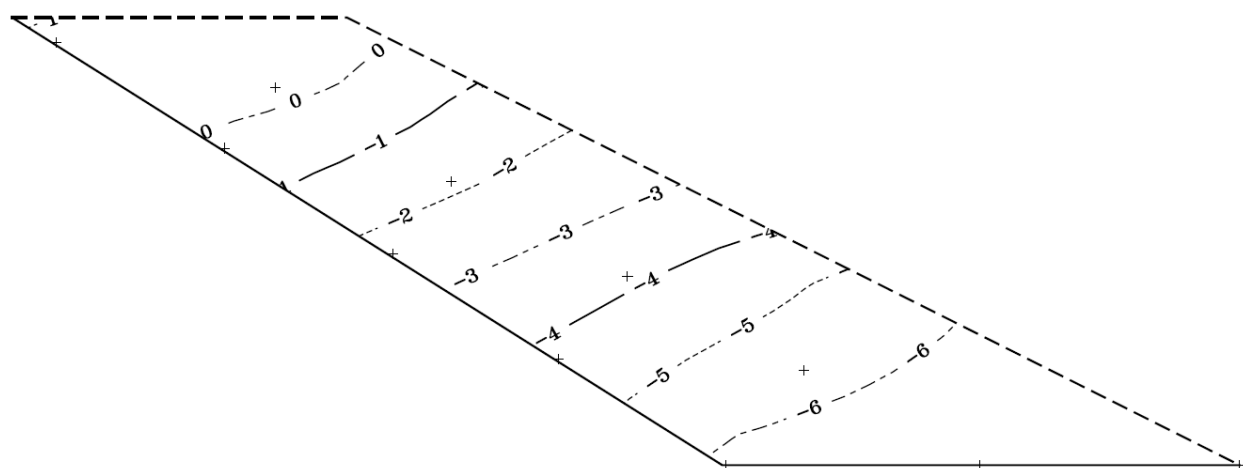
Figure A-7 Mean annual temperature contours for test section 1 in 2011, (a) ventilated shoulder, (b) embankment core and foundation soils

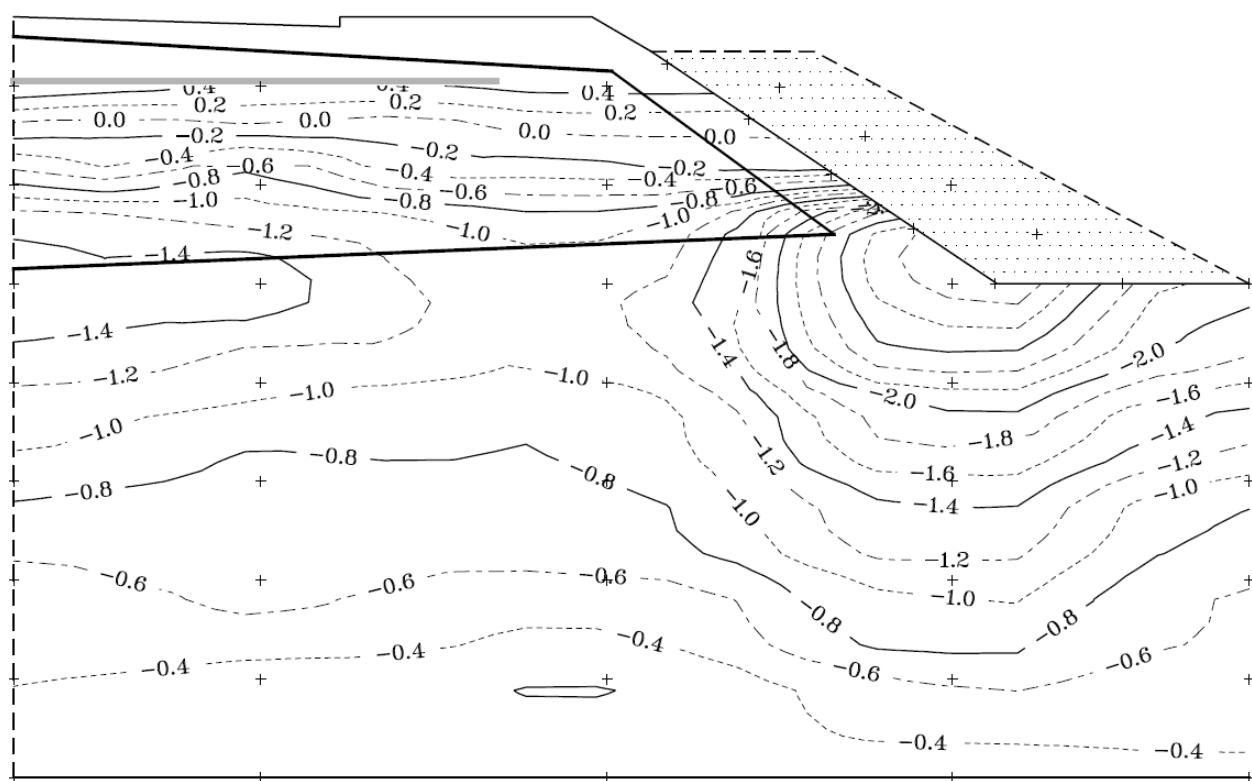
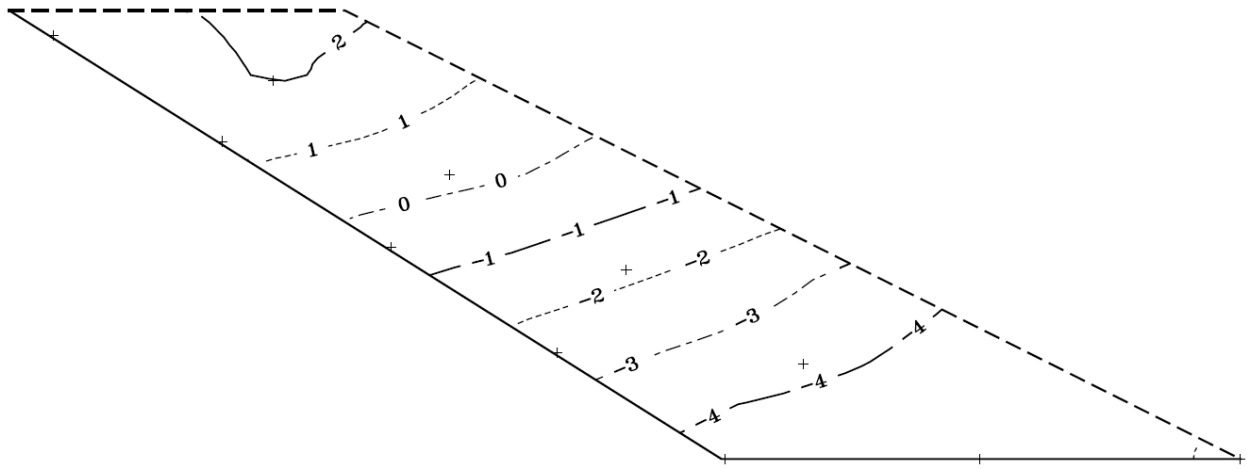
Figure A-8 Mean annual temperature contours for test section 1 in 2012, (a) ventilated shoulder, (b) embankment core and foundation soils

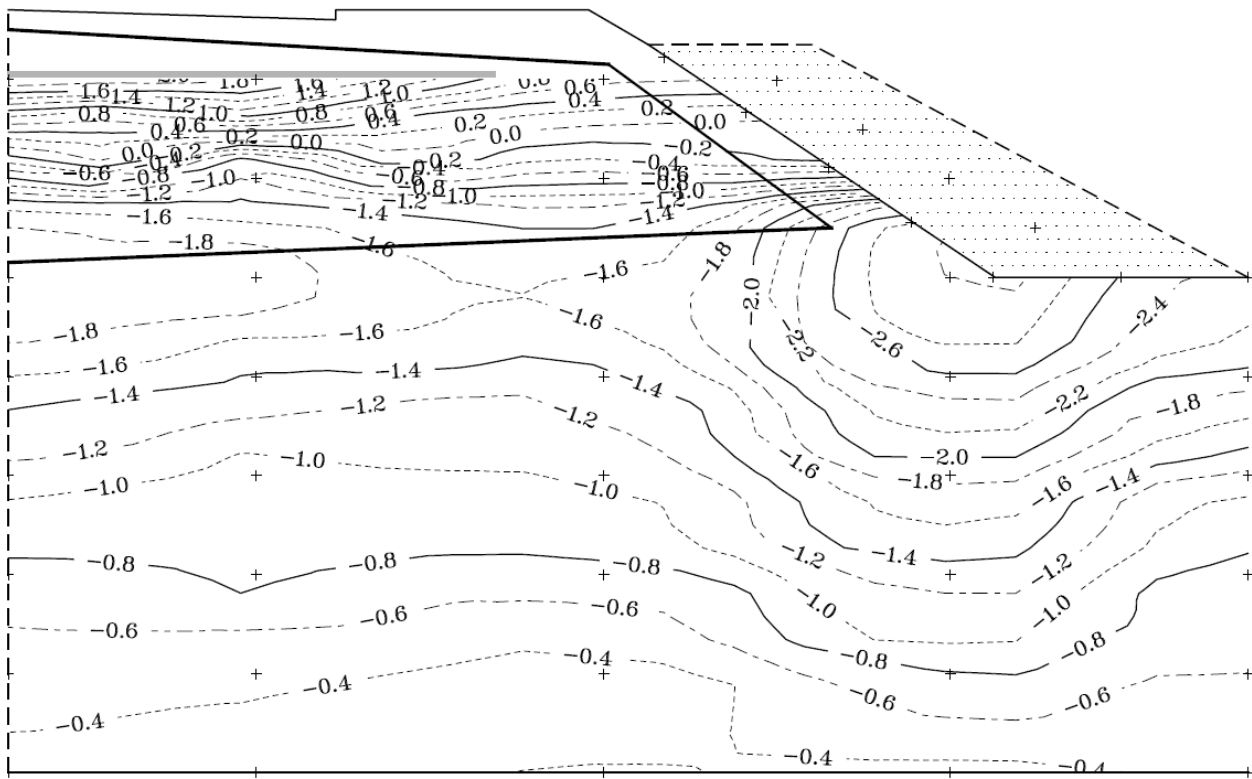
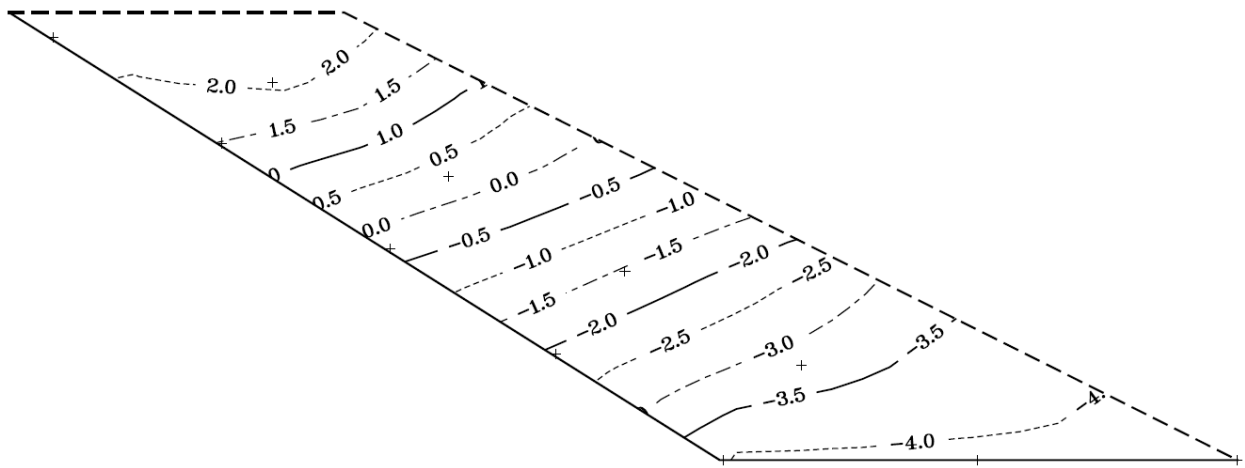
Figure A-9 Mean annual temperature contours for test section 1 in 2013, (a) ventilated shoulder, (b) embankment core and foundation soils
