# Improved Permafrost Protection Using Air Convection and Ventilated Shoulder Cooling Systems — Final Project Report

**Date:** November 2022

**Publication Number:** FHWA-AK-RD-4000(185)

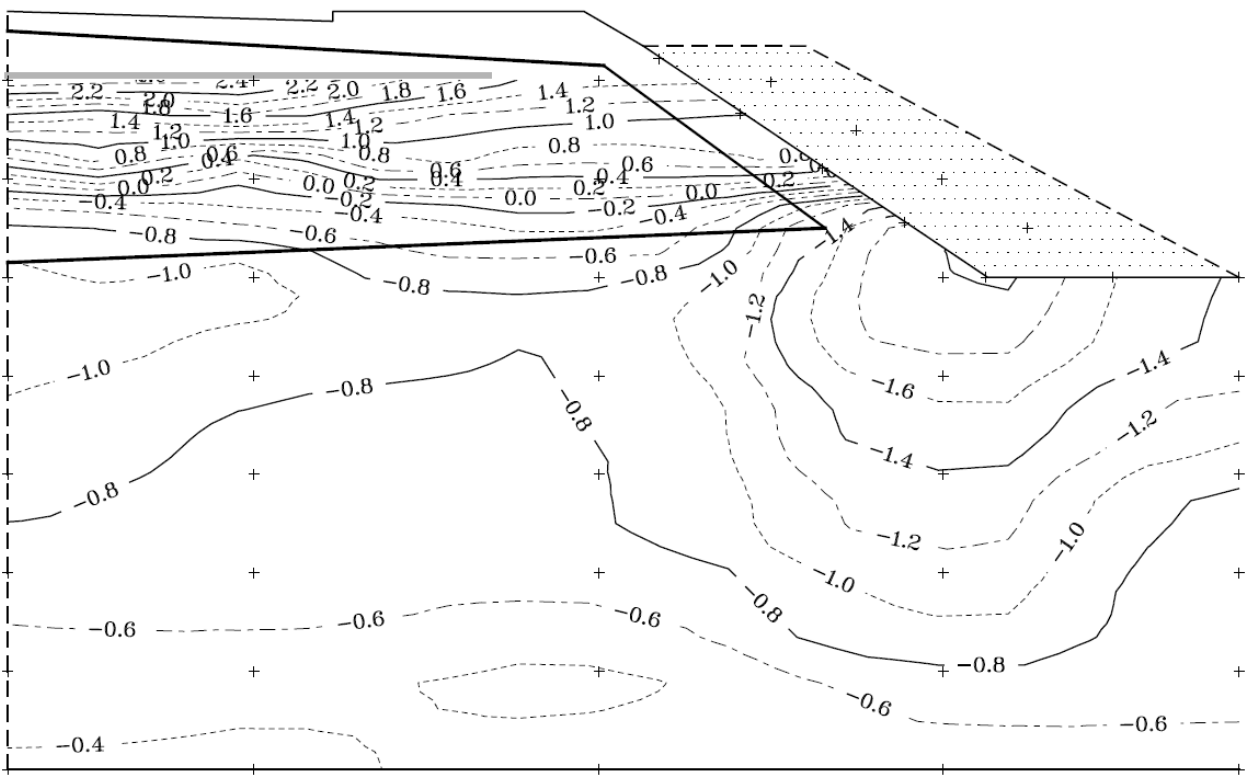
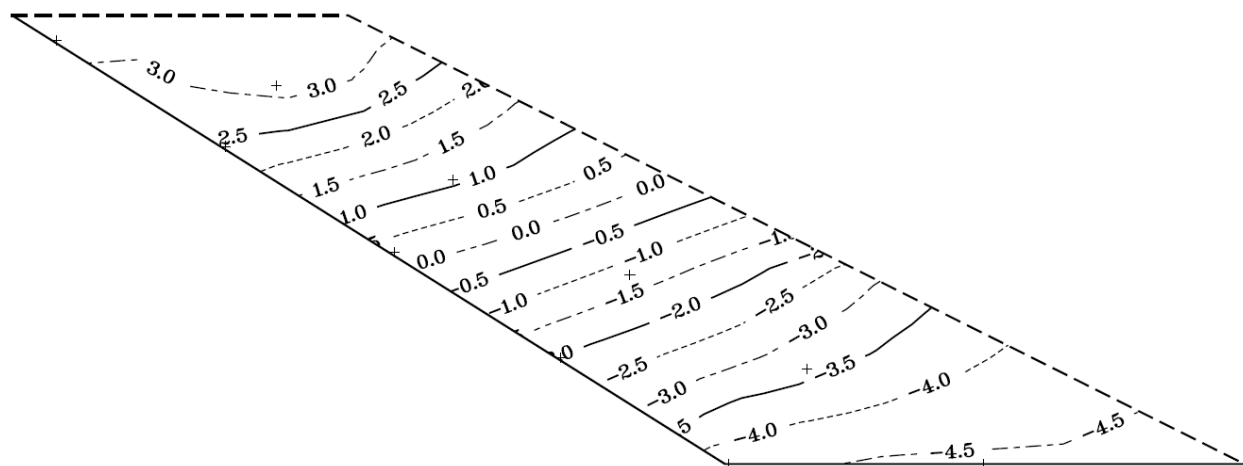
Figure A-10 Mean annual temperature contours for test section 1 in 2014, (a) ventilated shoulder, (b) embankment core and foundation soils

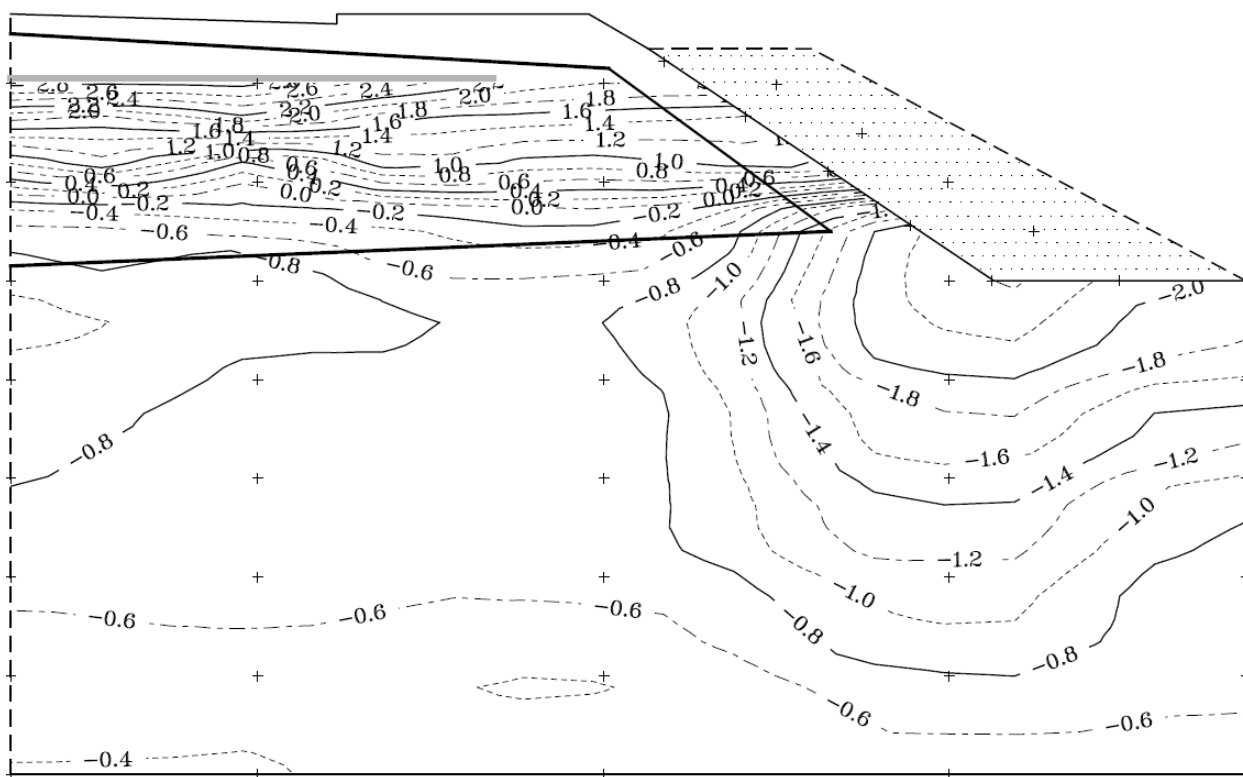
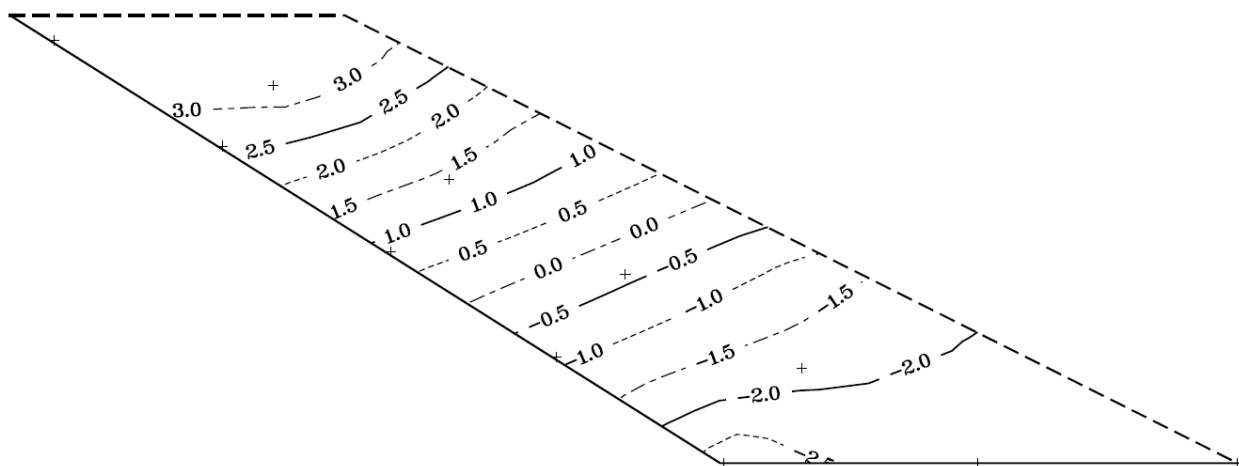
Figure A-11 Mean annual temperature contours for test section 1 in 2015, (a) ventilated shoulder, (b) embankment core and foundation soils

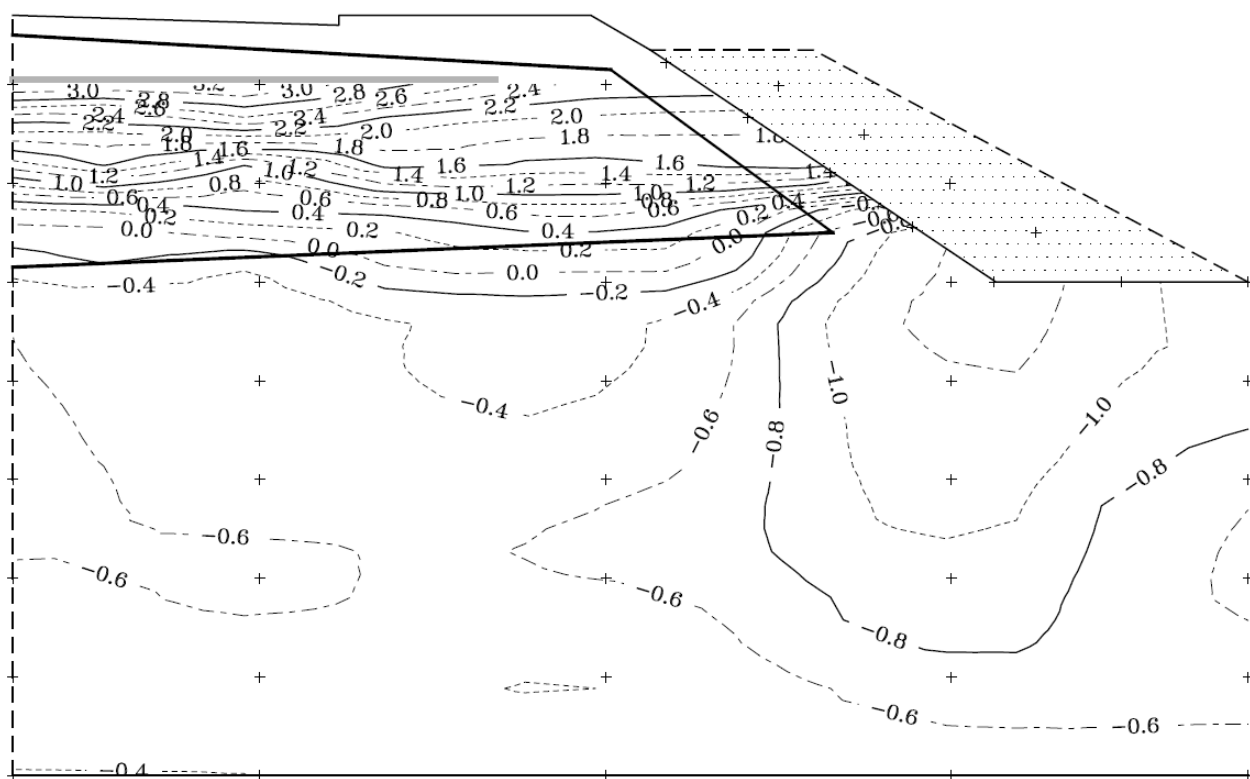
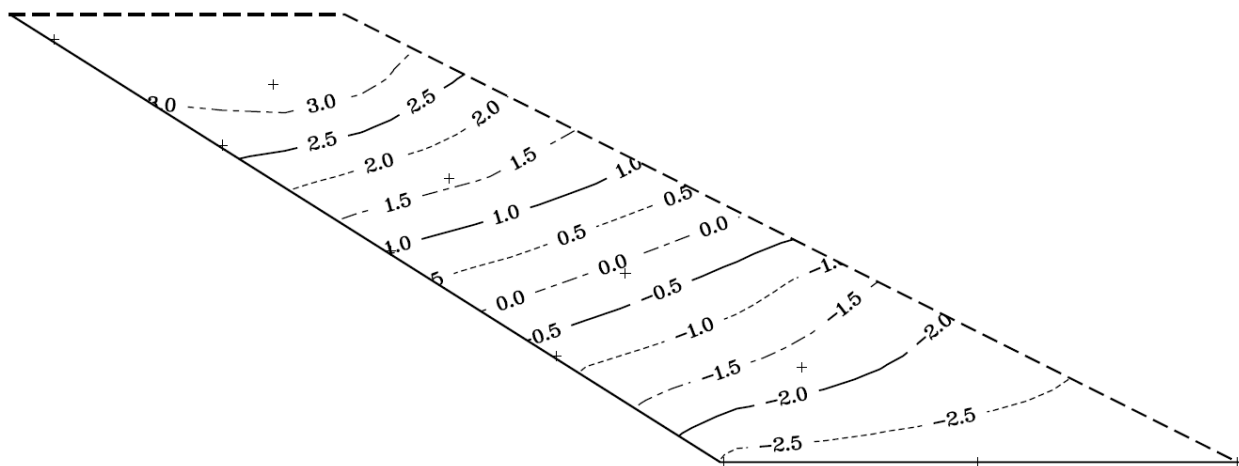
Figure A-12 Mean annual temperature contours for test section 1 in 2016, (a) ventilated shoulder, (b) embankment core and foundation soils

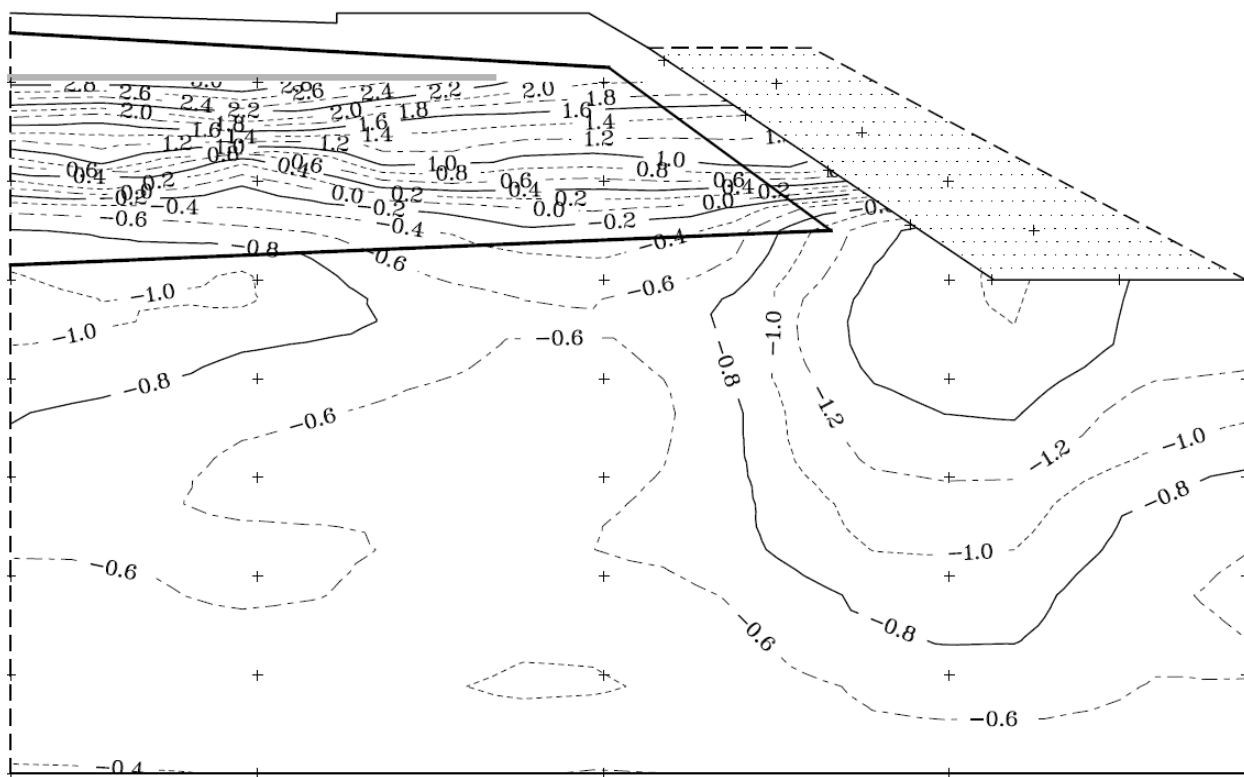
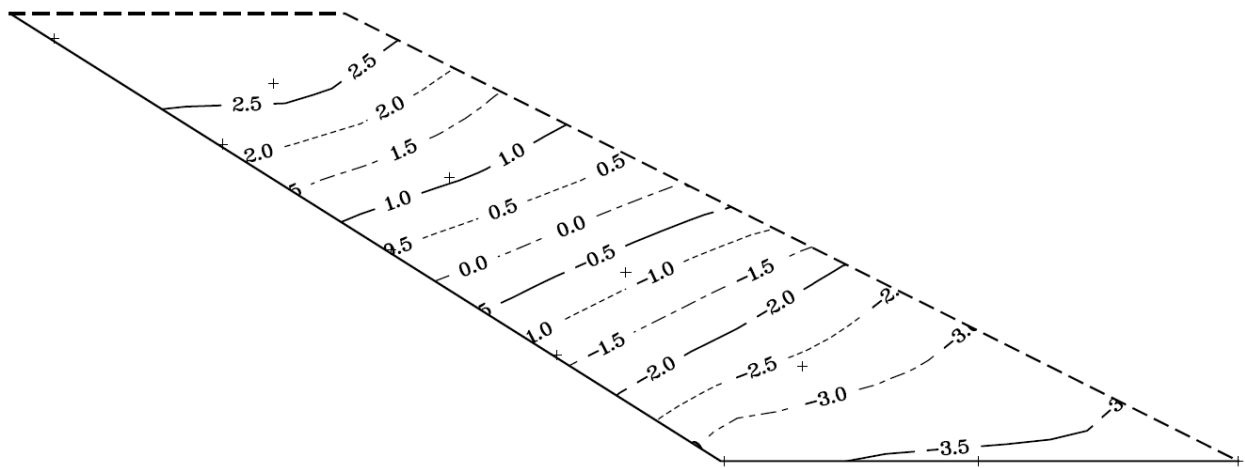
Figure A-13 Mean annual temperature contours for test section 1 in 2017, (a) ventilated shoulder, (b) embankment core and foundation soils

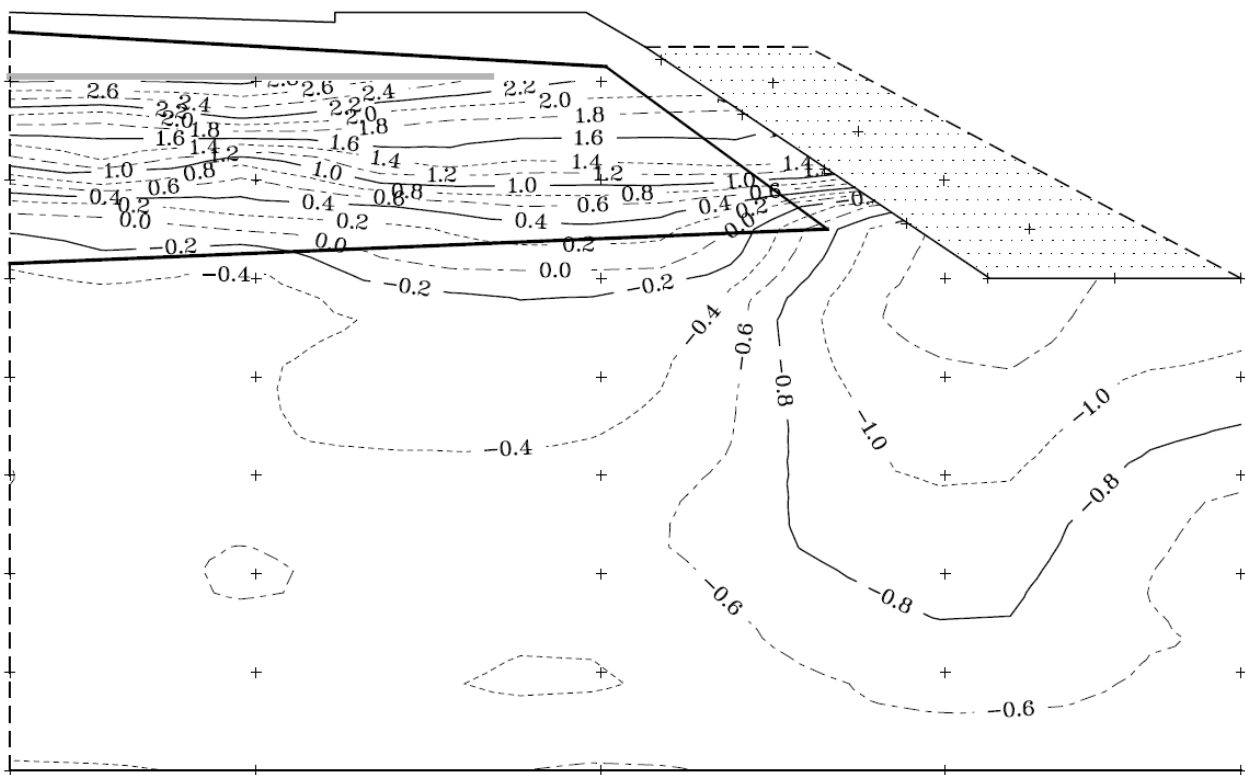
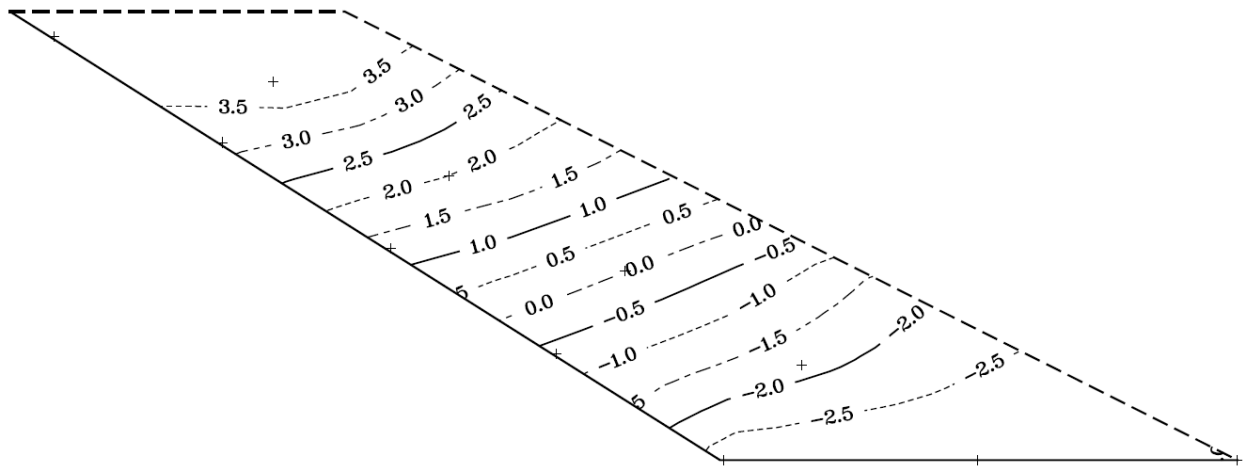
Figure A-14 Mean annual temperature contours for test section 1 in 2018, (a) ventilated shoulder, (b) embankment core and foundation soils

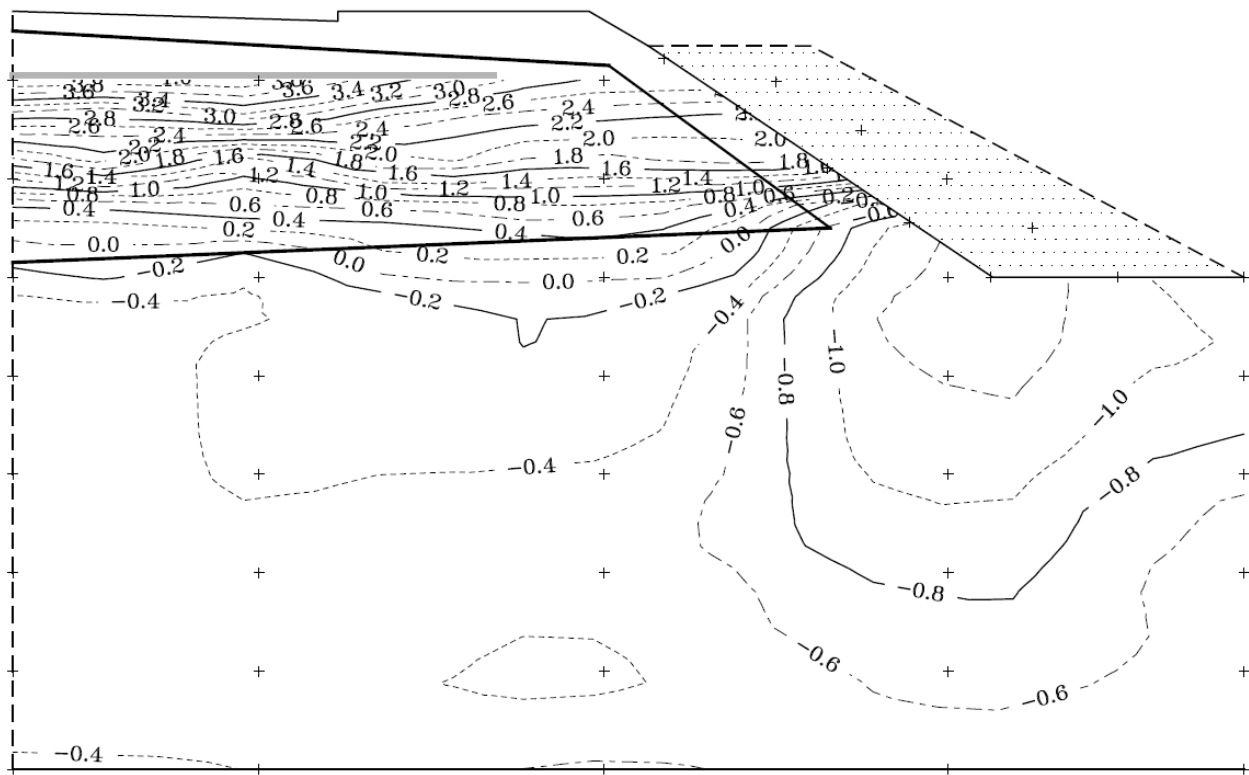
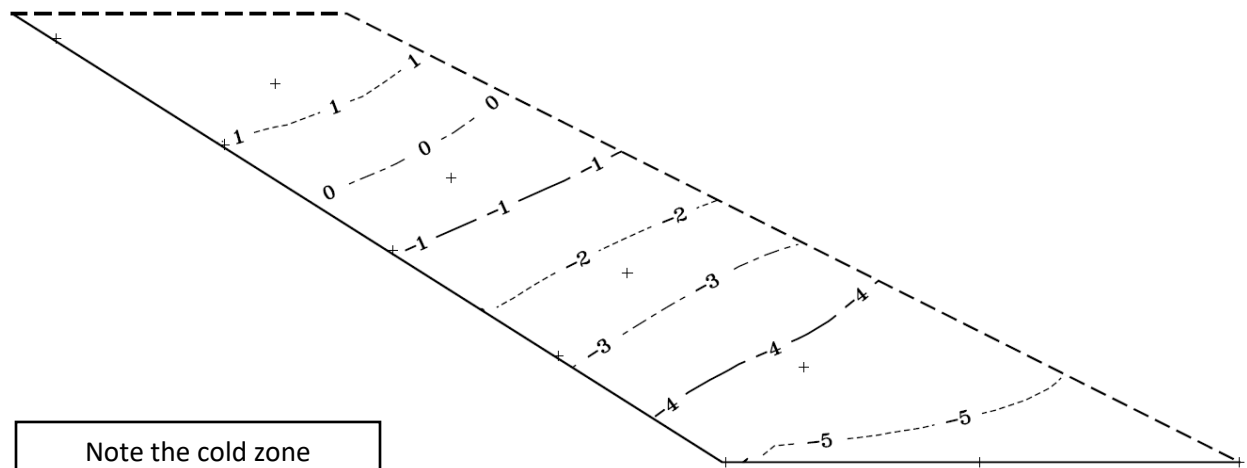
Figure A-15 Mean annual temperature contours for test section 1 in 2019, (a) ventilated shoulder, (b) embankment core and foundation soils

Note the cold zone generated by the thermosyphon evaporator.

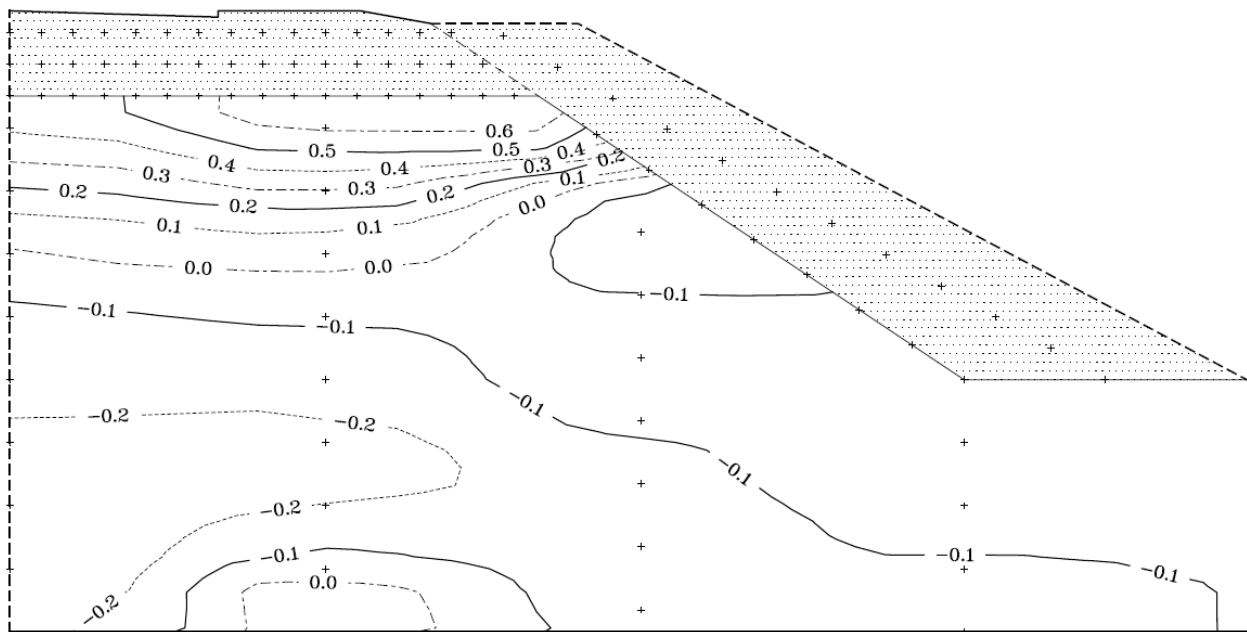
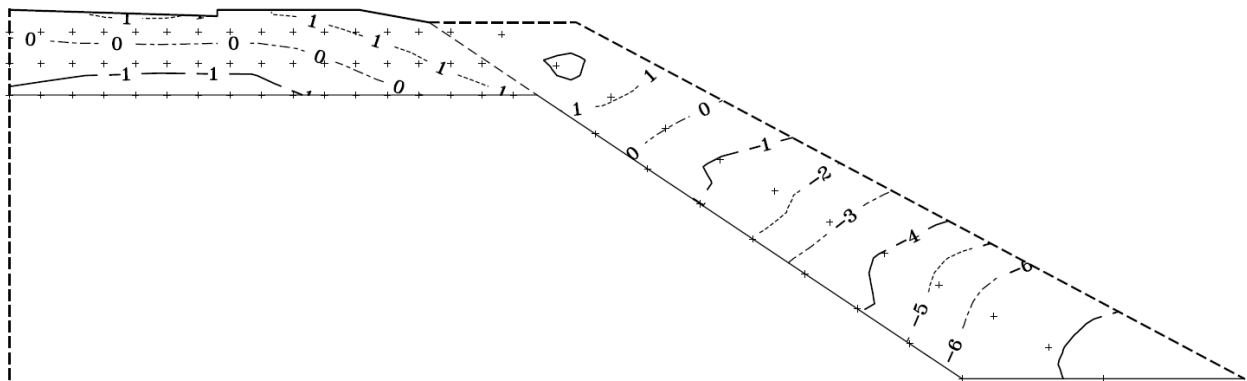
Figure B-1 Mean annual temperature contours for test section 2 in 2005, (a) ACE and ventilated shoulder layers, (b) embankment core and foundation soils

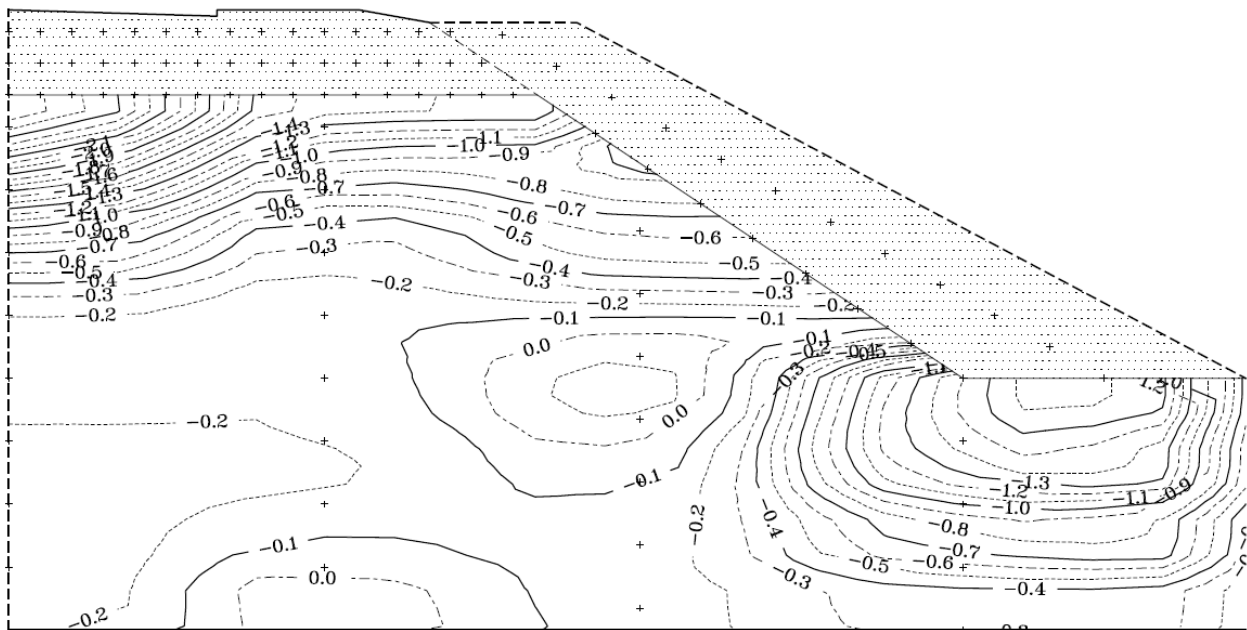
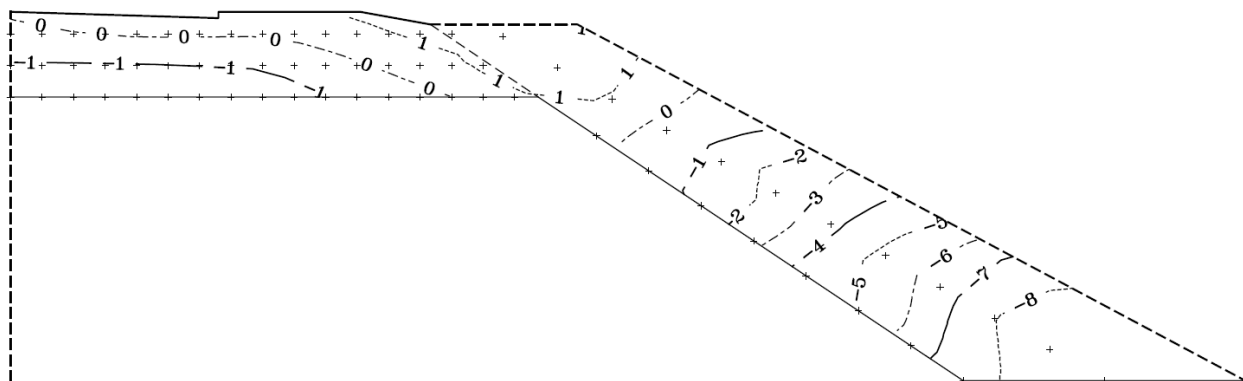
Figure B-3 Mean annual temperature contours for test section 2 in 2007, (a) ACE and ventilated shoulder layers, (b) embankment core and foundation soils

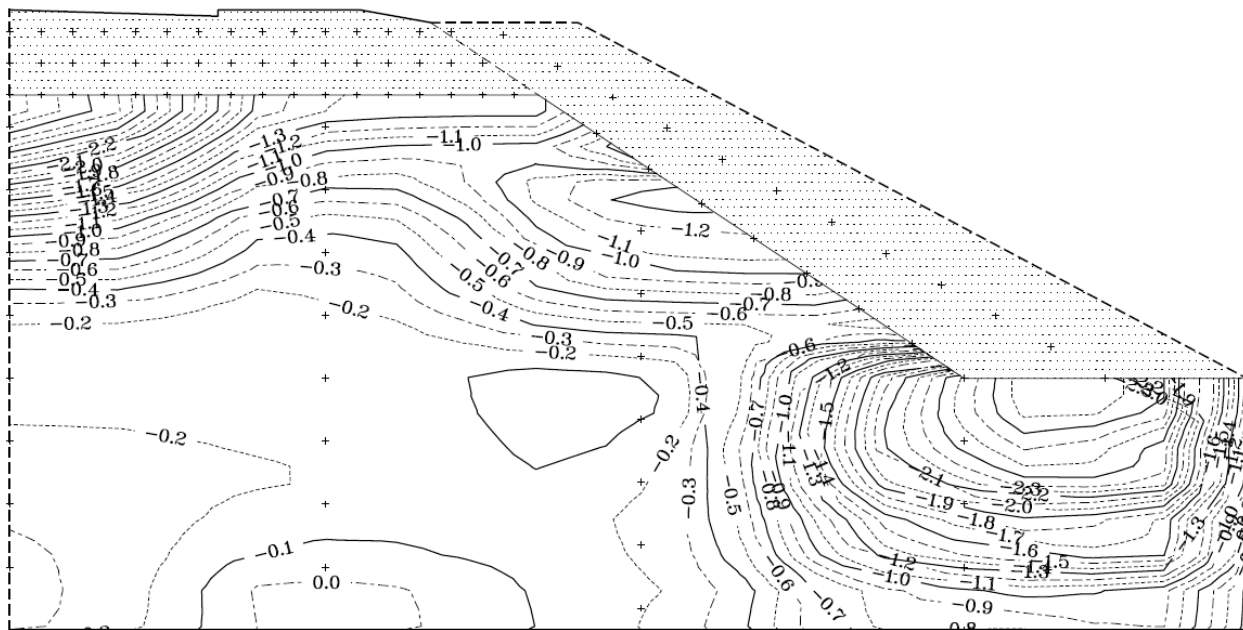
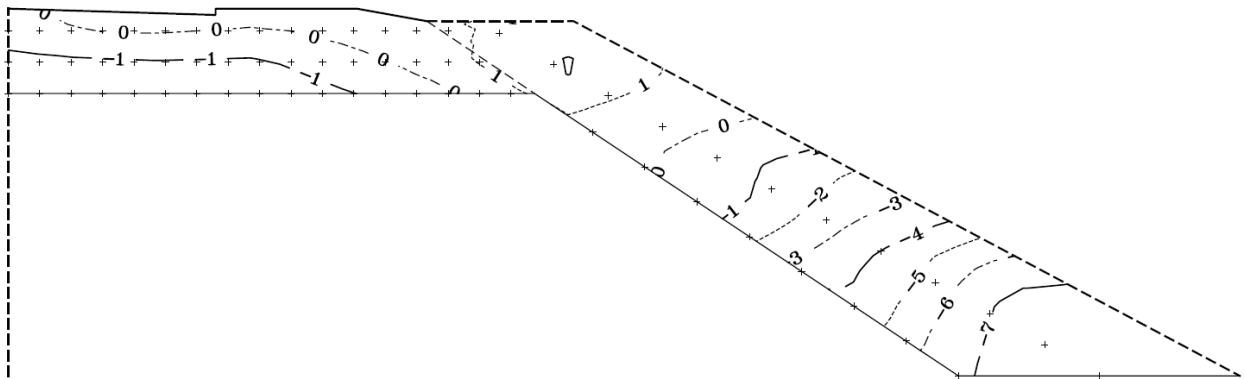
Figure B-5 Mean annual temperature contours for test section 2 in 2009, (a) ACE and ventilated shoulder layers, (b) embankment core and foundation soils
