# ACCIDENT REDUCTION FACTORS RELATING TO MOOSE-VEHICLE COLLISION CRASH TYPES

**Osama A. Abaza, C.Eng., Ph.D. and Colleen C. Moran, P.E.**  
**University of Alaska Anchorage**

May 2018

Alaska Department of Transportation & Public Facilities  
Statewide Research Office  
3132 Channel Drive  
Juneau, AK 99801-7898

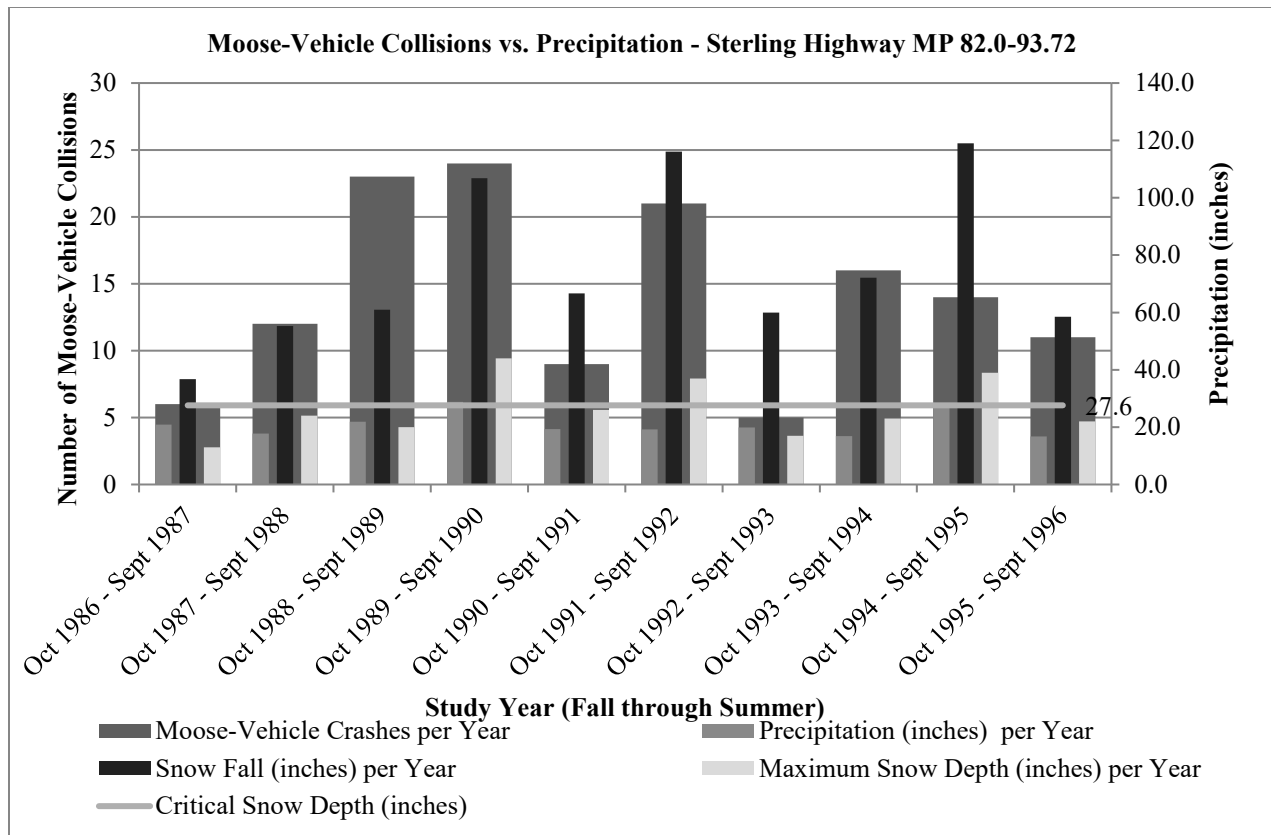
**Figure 7 – Moose-Vehicle Collisions vs. Precipitation**

Figure 9. Precipitation and snow depth are in harmony, since years of high precipitation yield high snowfall and snow depth, and therefore have a similar relationship with MVCs. Figure 6 and Figure 8 are graphs of the same data in ascending order, from lowest number to highest number of MVCs. Although the overall rising trend is similar between snow depth and MVCs and between snowfall and MVCs, these graphs indicate no direct connection between the two. The highest collision years were not the highest snowfall or maximum snow depth years, so other factors are contributing to MVCs. The lowest dip in MVCs occurred the second year of post-project completion.
