LOW TEMPERATURE TRANSVERSE CRACKS IN
ASPHALT PAVEMENTS IN INTERIOR ALASKA

Final Report

Geophysical Institute
Univeristy of Alaska
Fairbanks, Alaska 99701

April, 1986

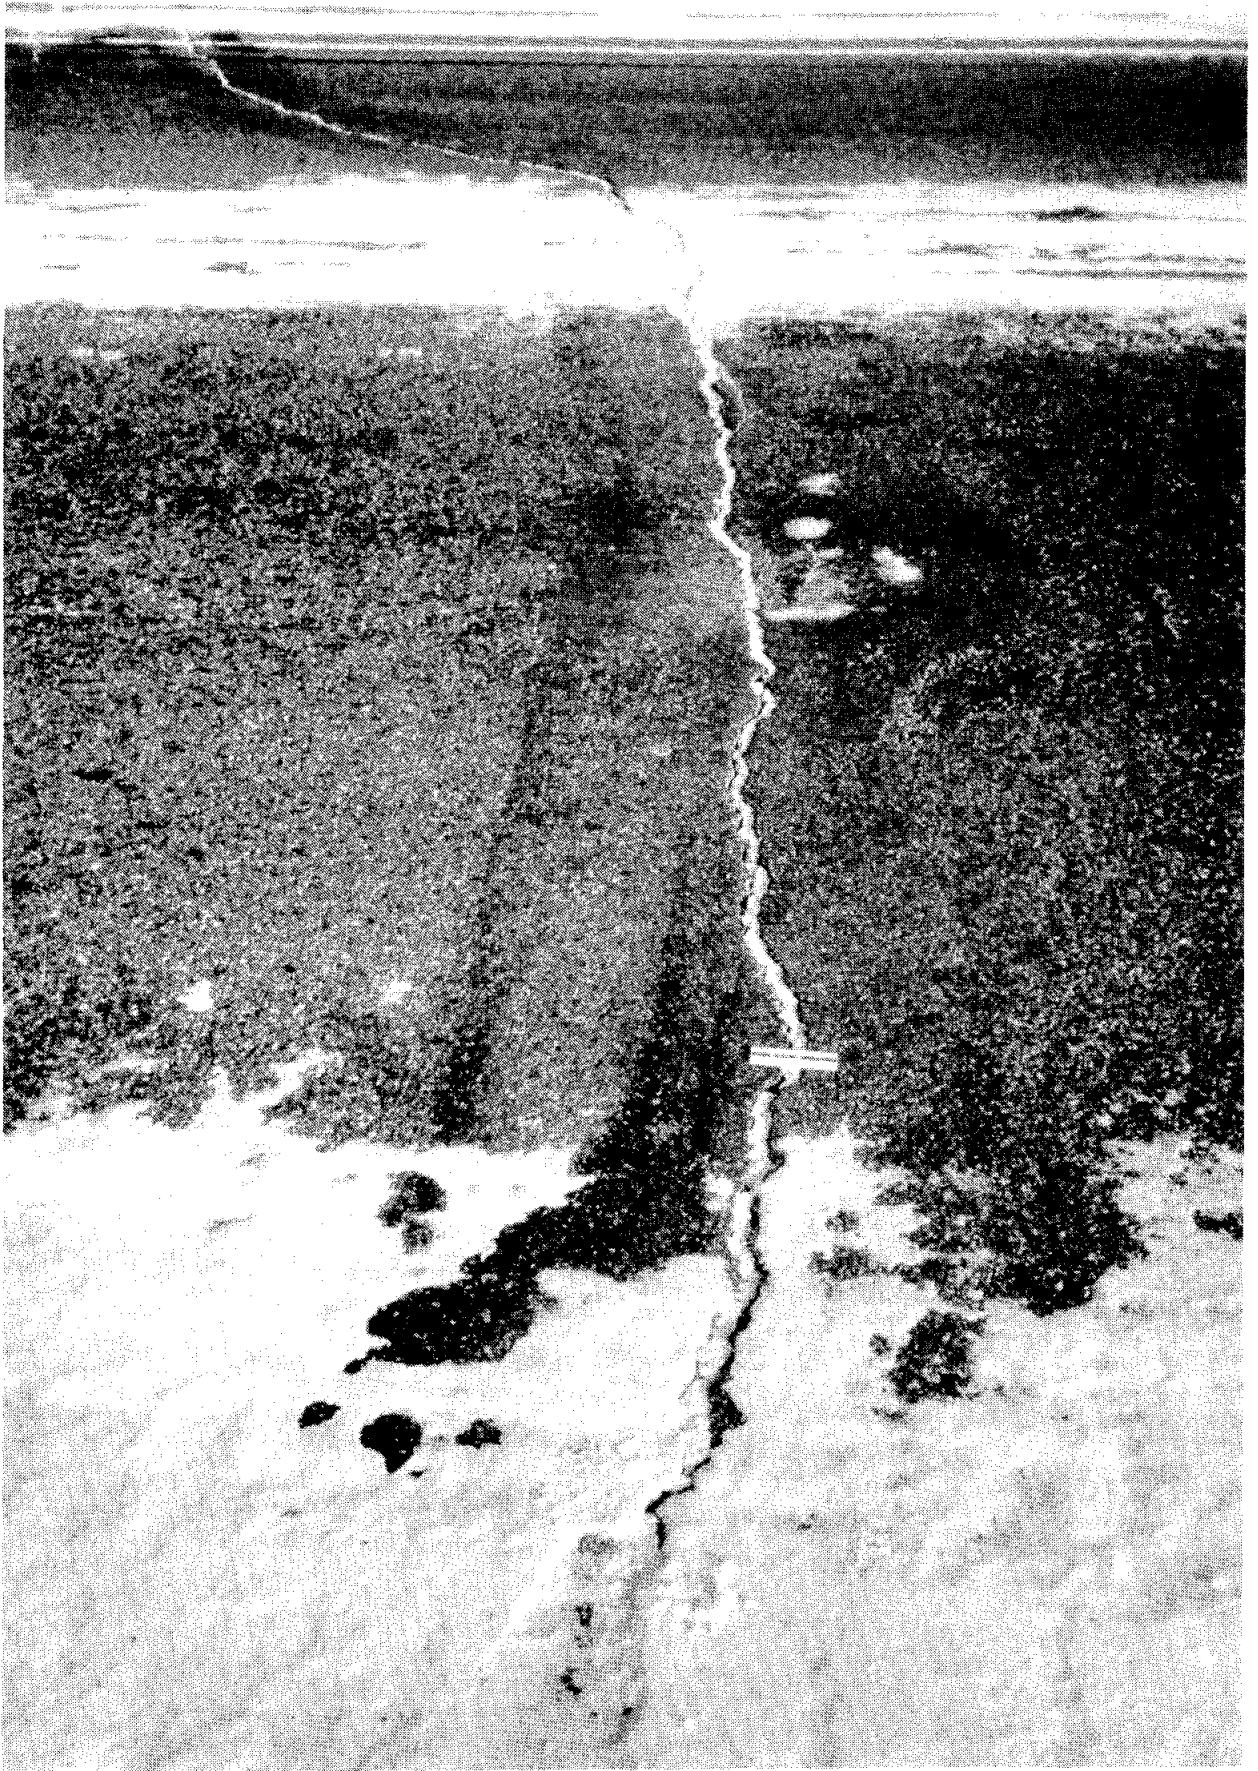
Figure 1: Transverse pavement crack on the Parks Highway (crack number 12, Table 1) during winter. The scale left of center is ≈ 17 cm in length.

Low temperature transverse cracks are the most common form of asphalt pavement damage observed on Alaskan highways and airport runways, taxiways, etc. These cracks, which constitute a pavement failure, cause the annoying cyclic bumps so familiar to the Alaskan driver. Transverse cracks are defined, for the purposes of this report, as those cracks roughly perpendicular to the pavement direction which extend from one side of the pavement to the other. These cracks often extend to the shoulder of the road and sometimes continue across ditches, bike paths, frontage roads and all lanes of divided roadways. The cracks may transect concrete curbing, sometimes damaging it. Figures 1 and 2 illustrate transverse pavement cracks on the Parks Highway.

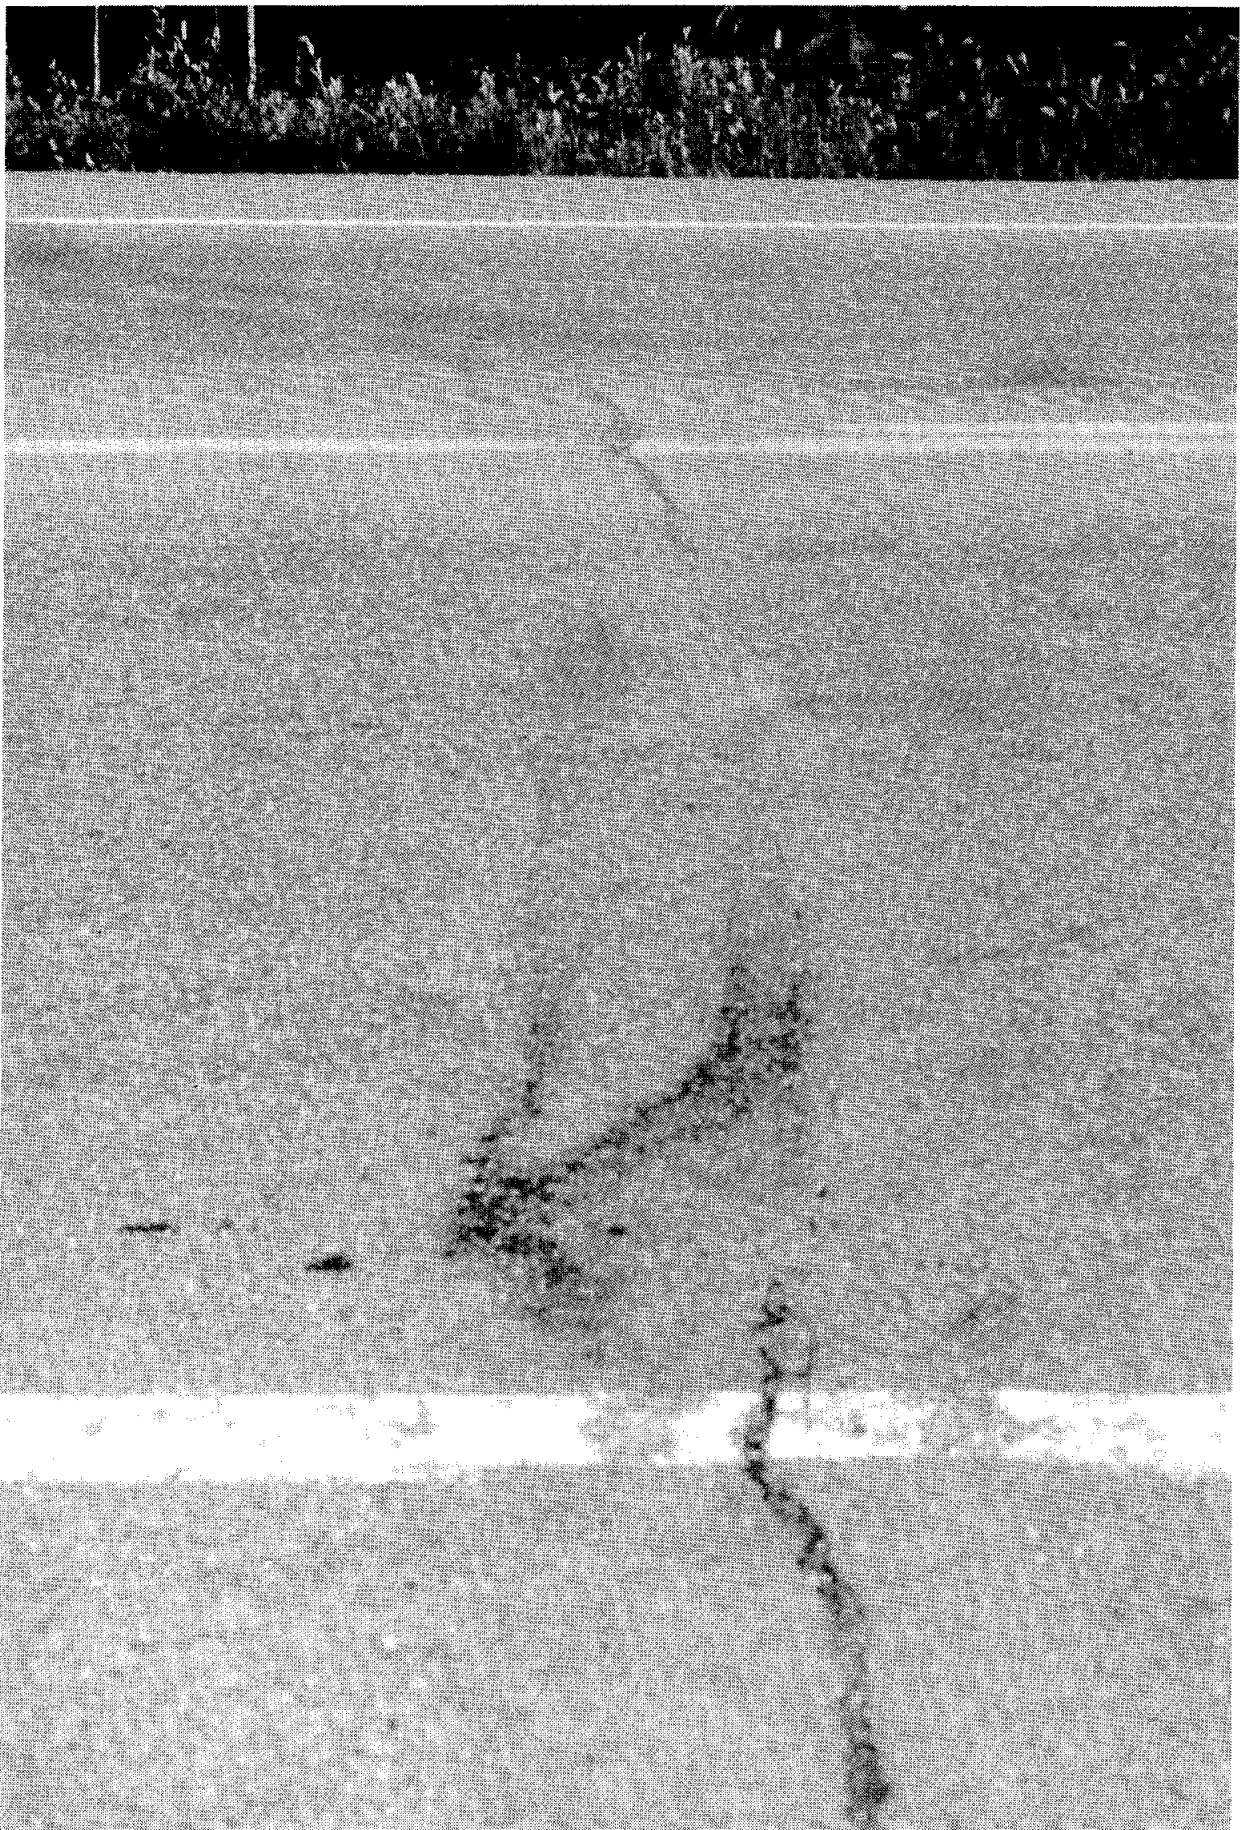
Figure 2: Transverse pavement crack on the Parks Highway during summer.

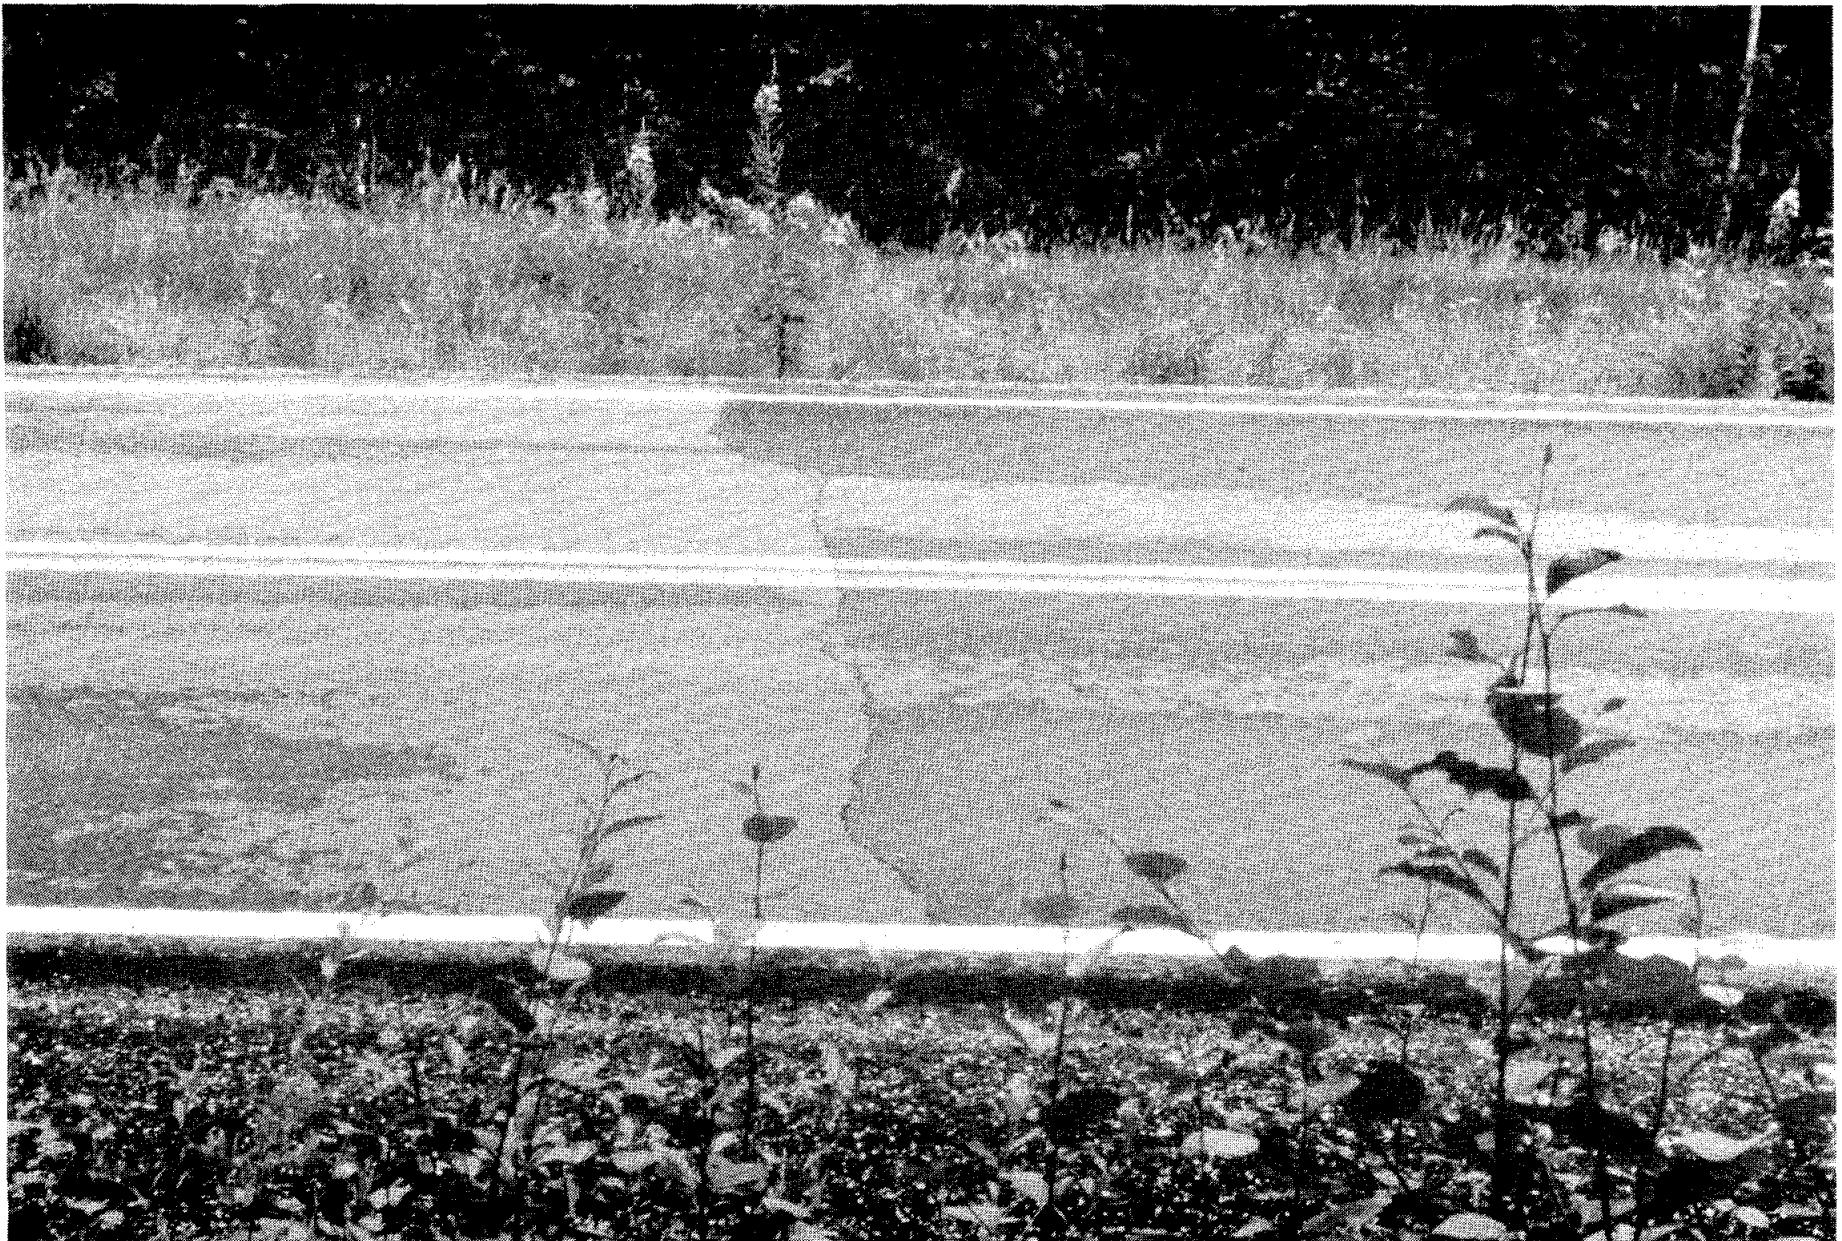
Figure 3: Transverse pavement crack after a shower showing the wet pavement on the uphill (right side) of the crack and the dry pavement on the downhill side.

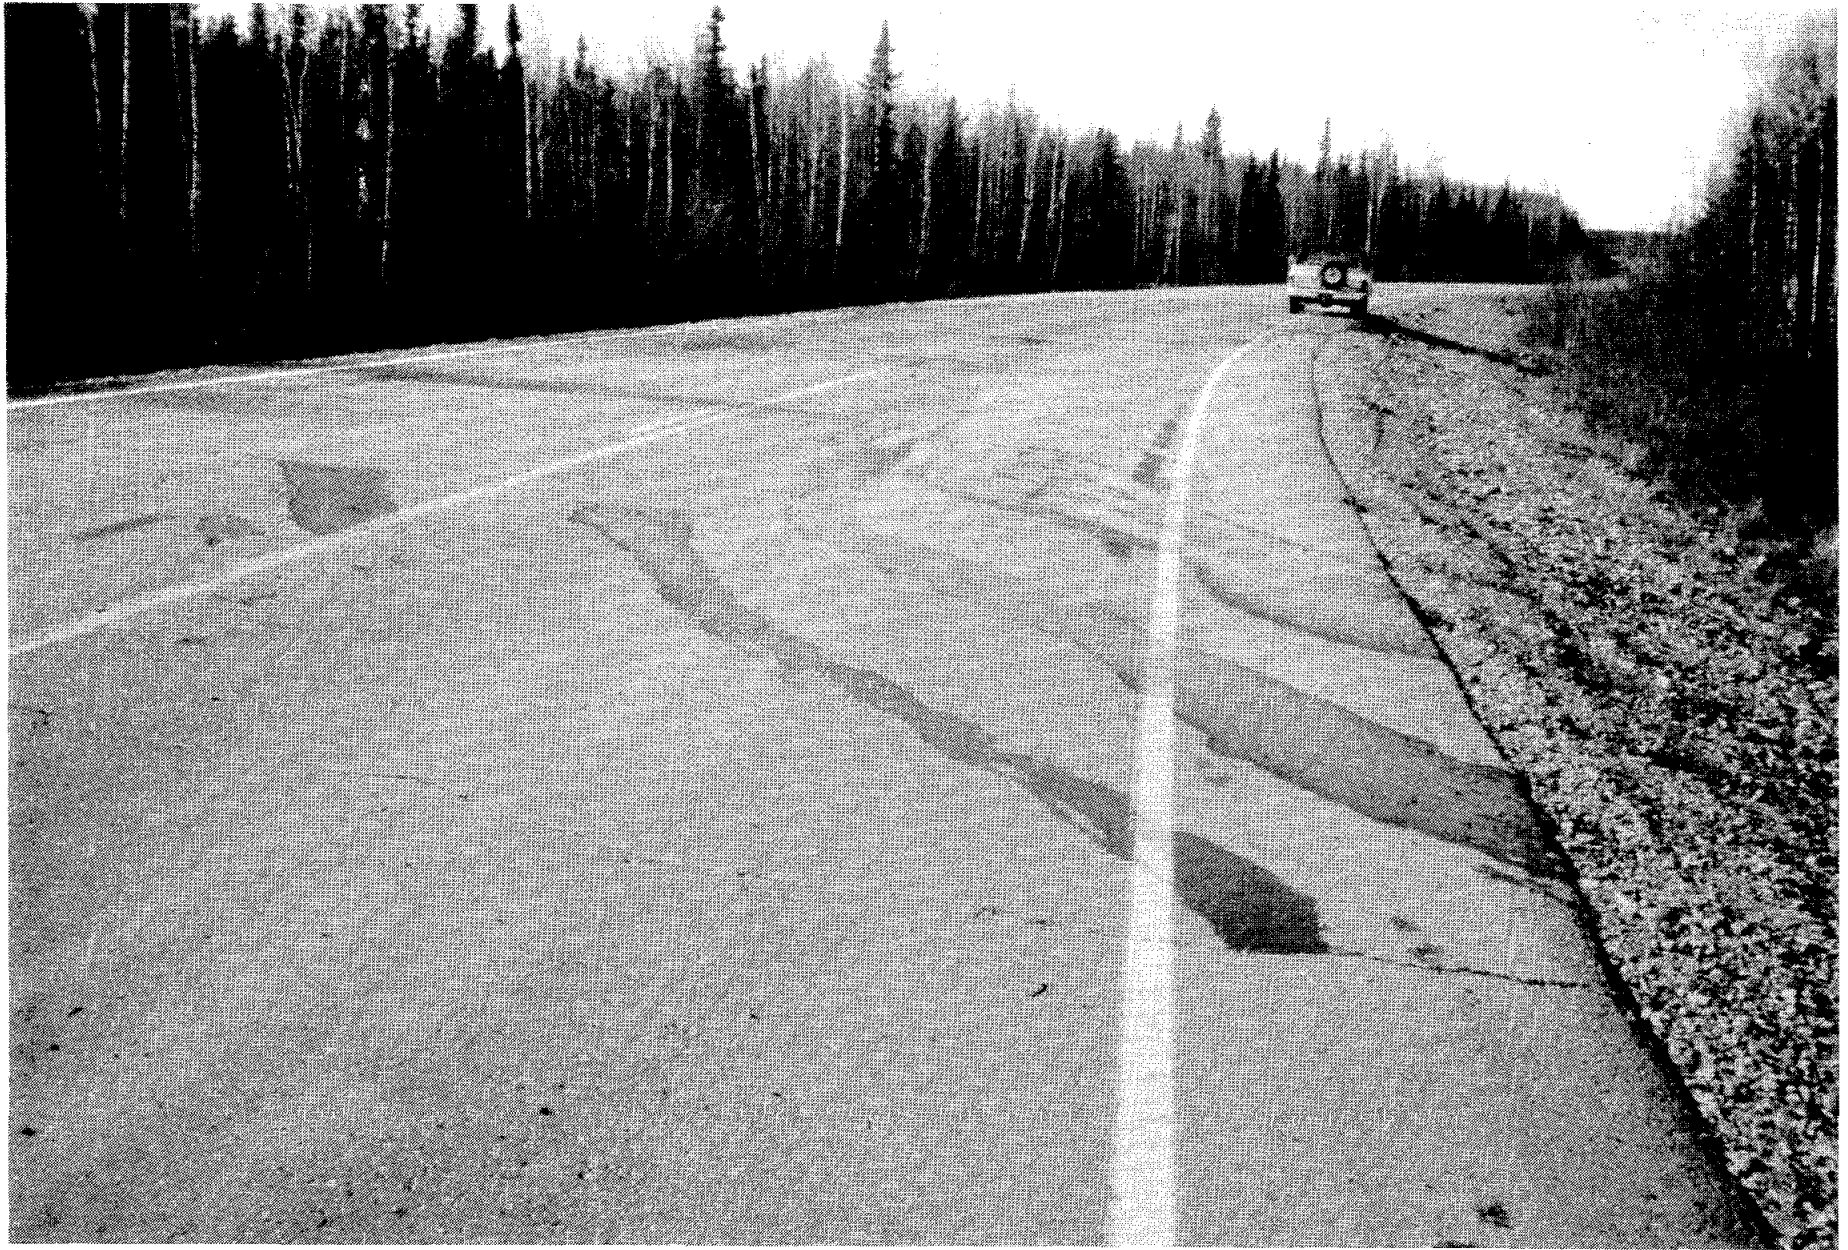
Figure 4: View looking uphill on the Elliott Highway showing water coming out of a transverse crack and the running into another crack.

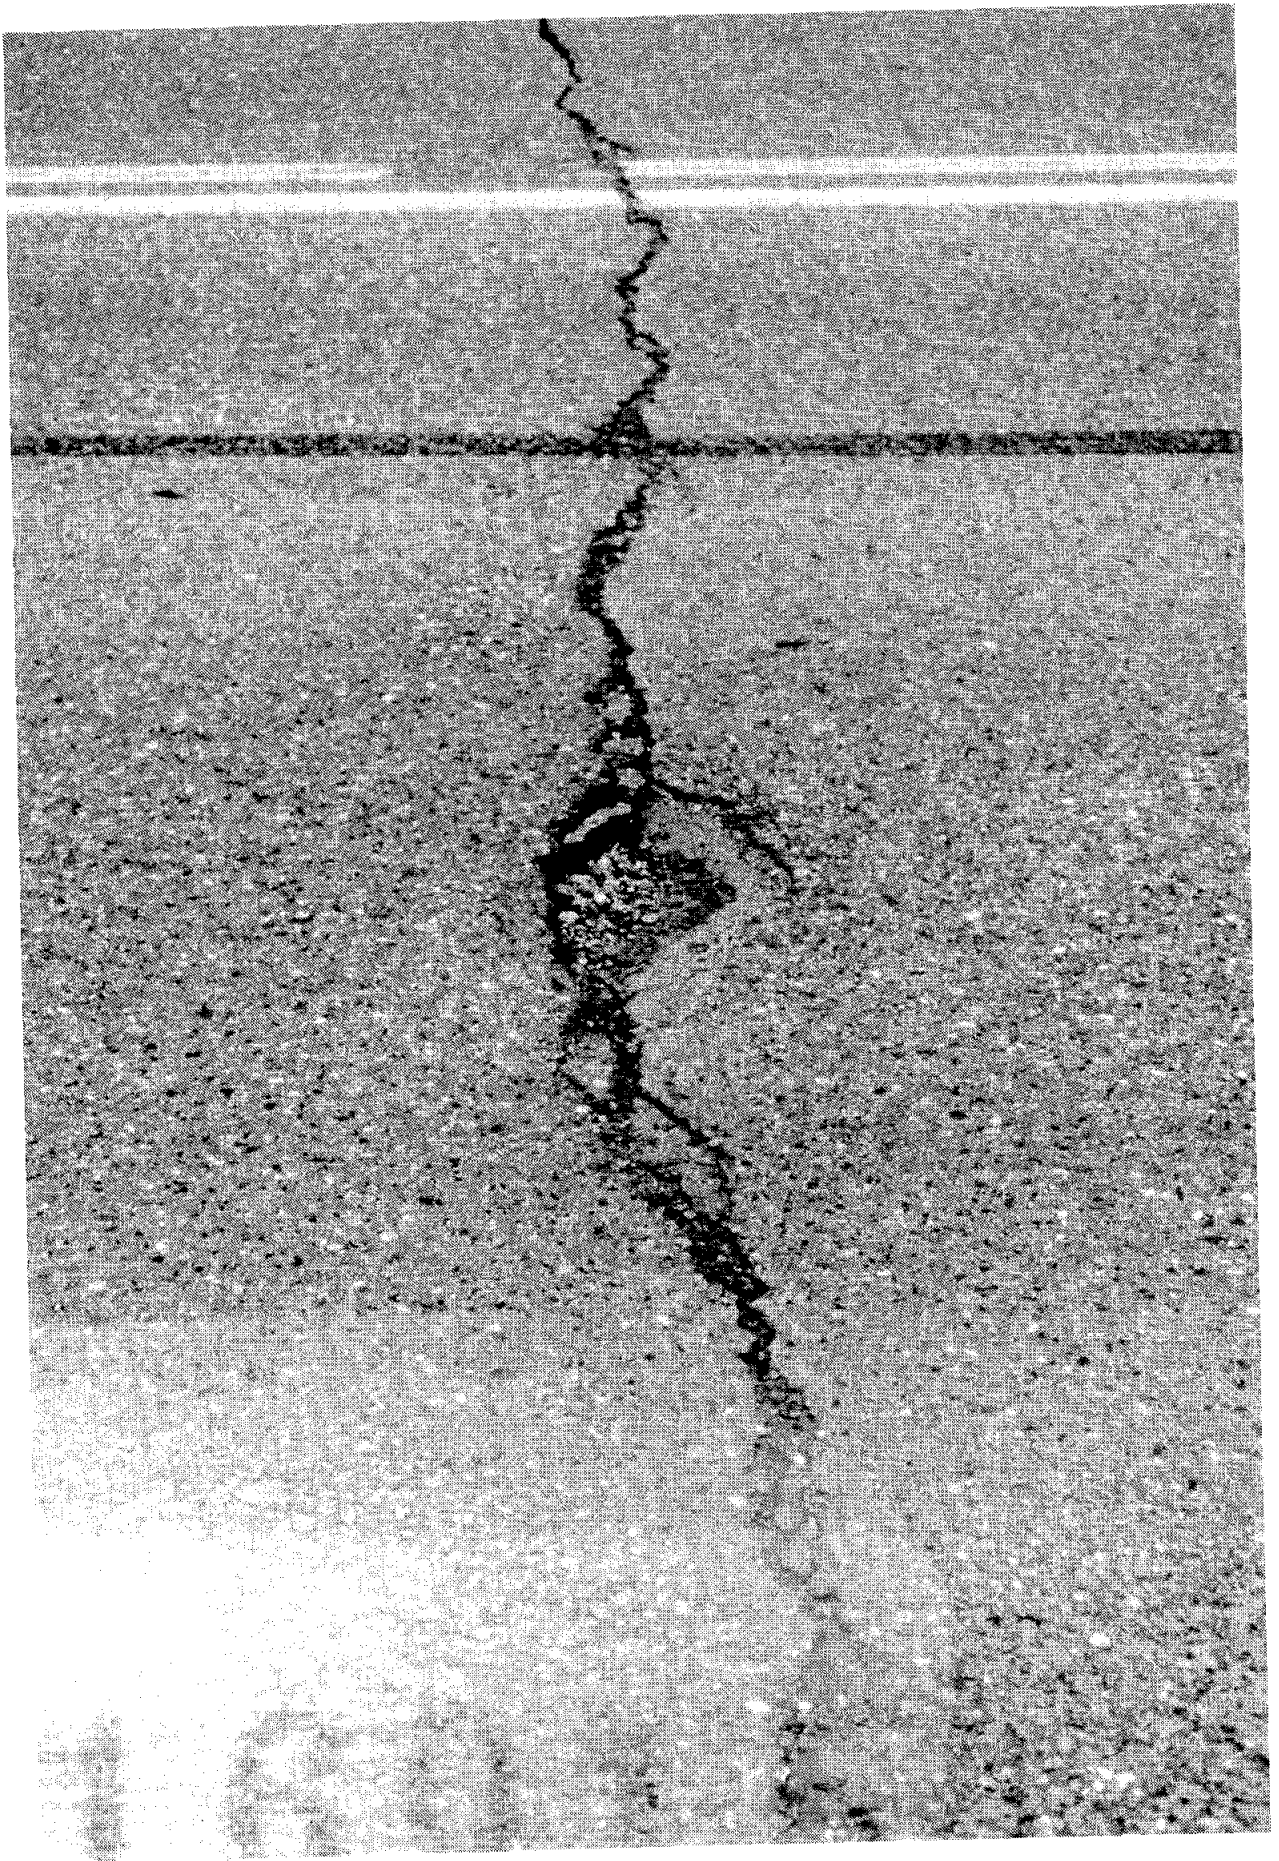
Figure 6: Pothole beginning to form in a crack.

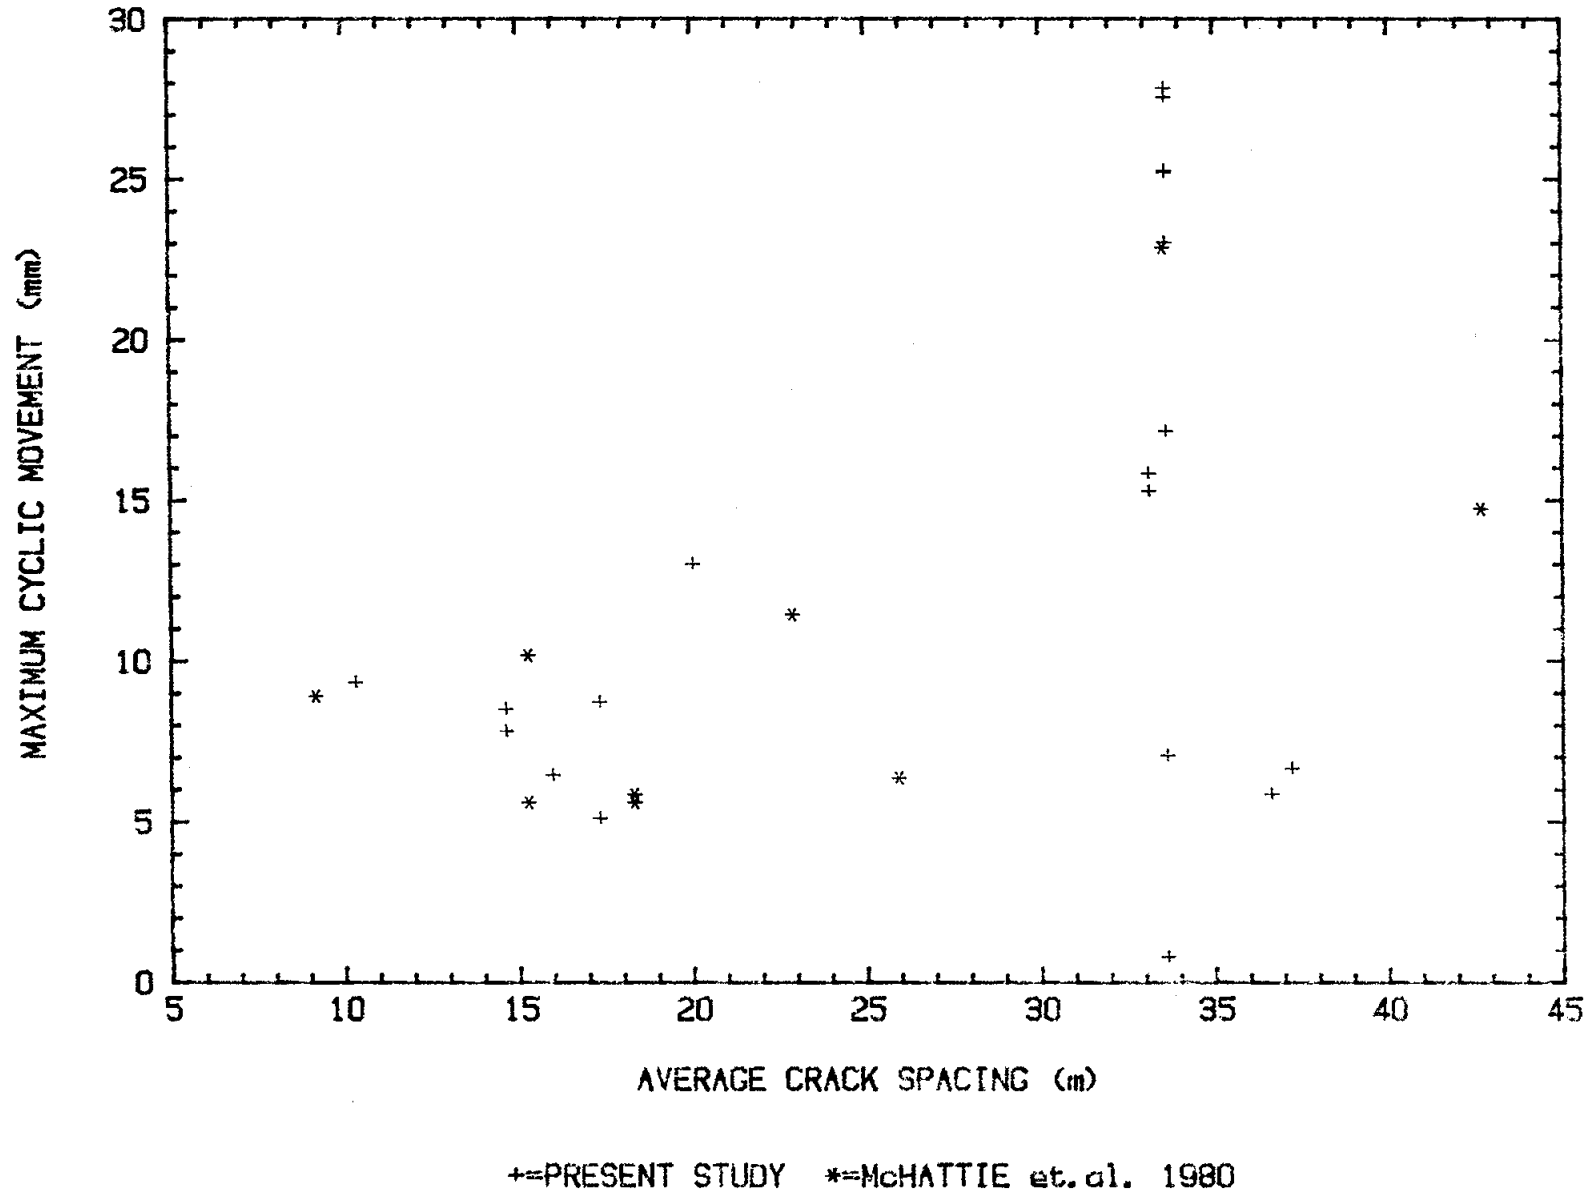
Figure 9: Maximum cyclic movement of the cracks vs. the average crack spacing for the present study and that of McHattie et al. (1980).

where α is the linear thermal expansion coefficient, ΔT is the change in temperature of the road and L is the spacing between cracks. Figure 9 is a graph of ΔL vs. the average crack spacing (on either side of the measured crack). Figure 9 suggests increased movement with an increase in average crack spacing. This result will be discussed further in Section V.

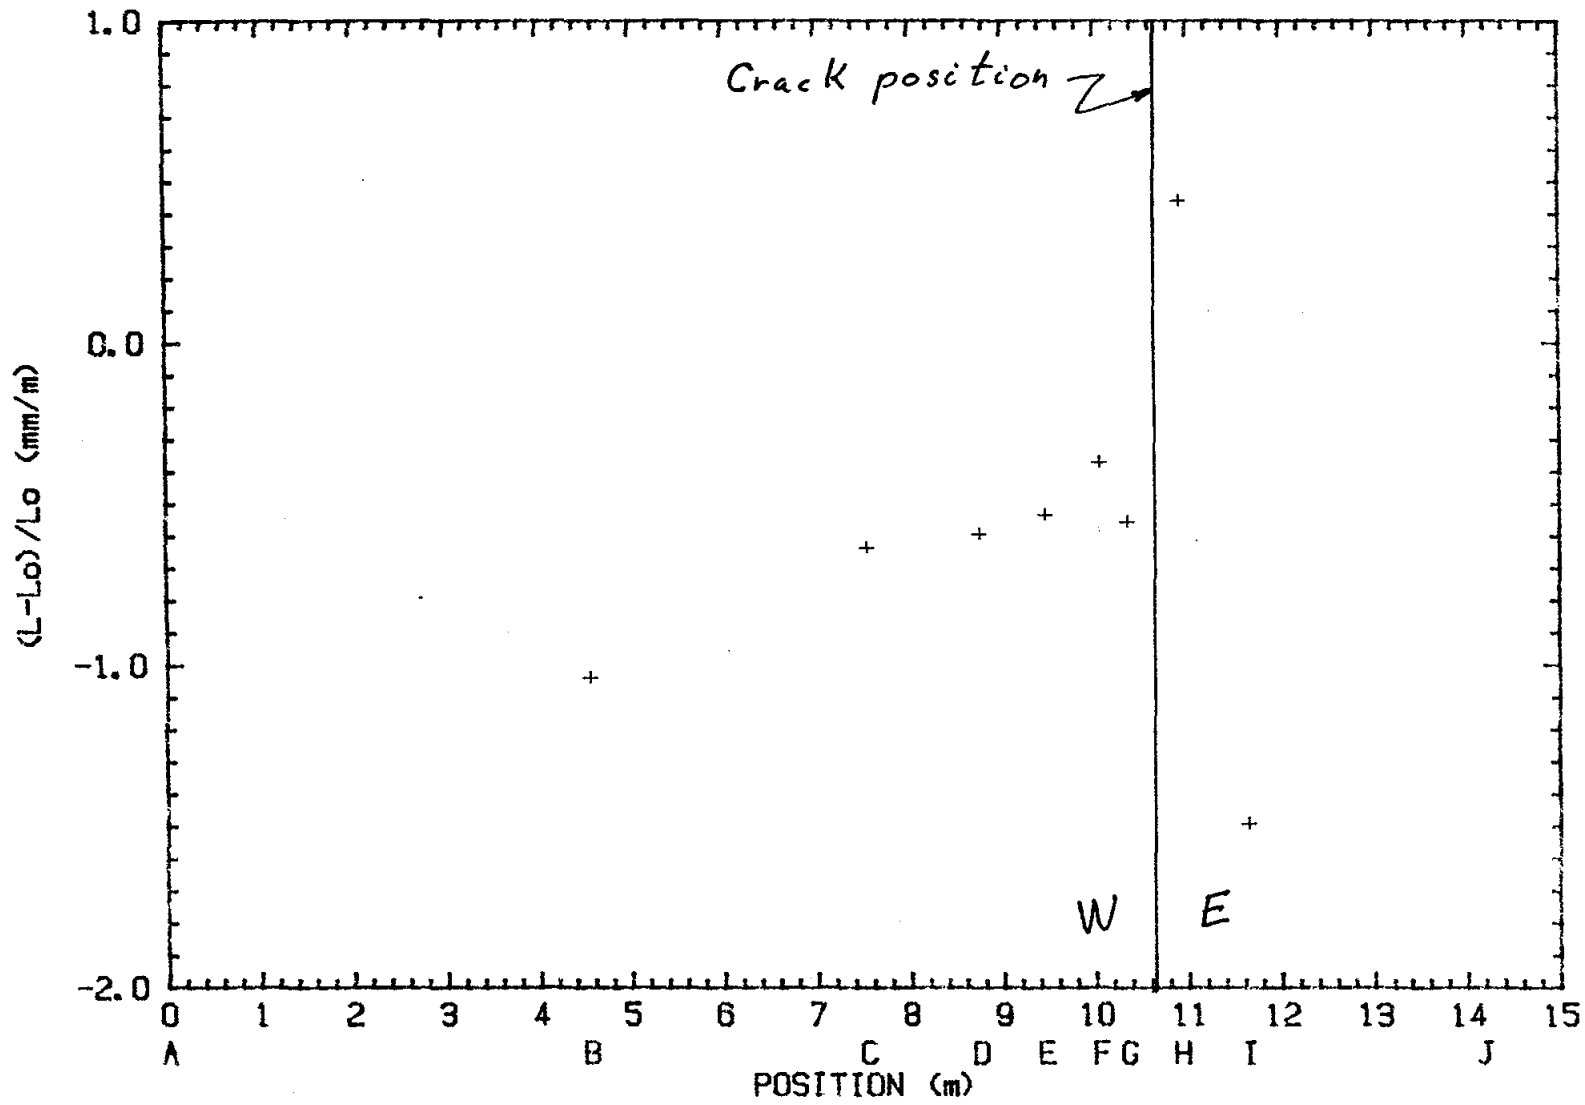
Figure 11: Strain, $\Delta L/L_0$, as a function of position for the period from December, 1982 to April, 1983 for the Parks Highway crack

suggests, with simplifying assumptions, that the strain, $\Delta L / L_0$, should be constant for a given value of ΔT . Figure 11 is a graph of strain vs. position in the uncracked pavement near site 12-2. The strain is nearly constant on the west side and within 3 m of the crack but not at

other points. However, it now appears that there were a few hairline cracks in the pavement between the A and G positions. If these hairline cracks were present and opened during the measurements then a more detailed analysis of this point is not warranted.

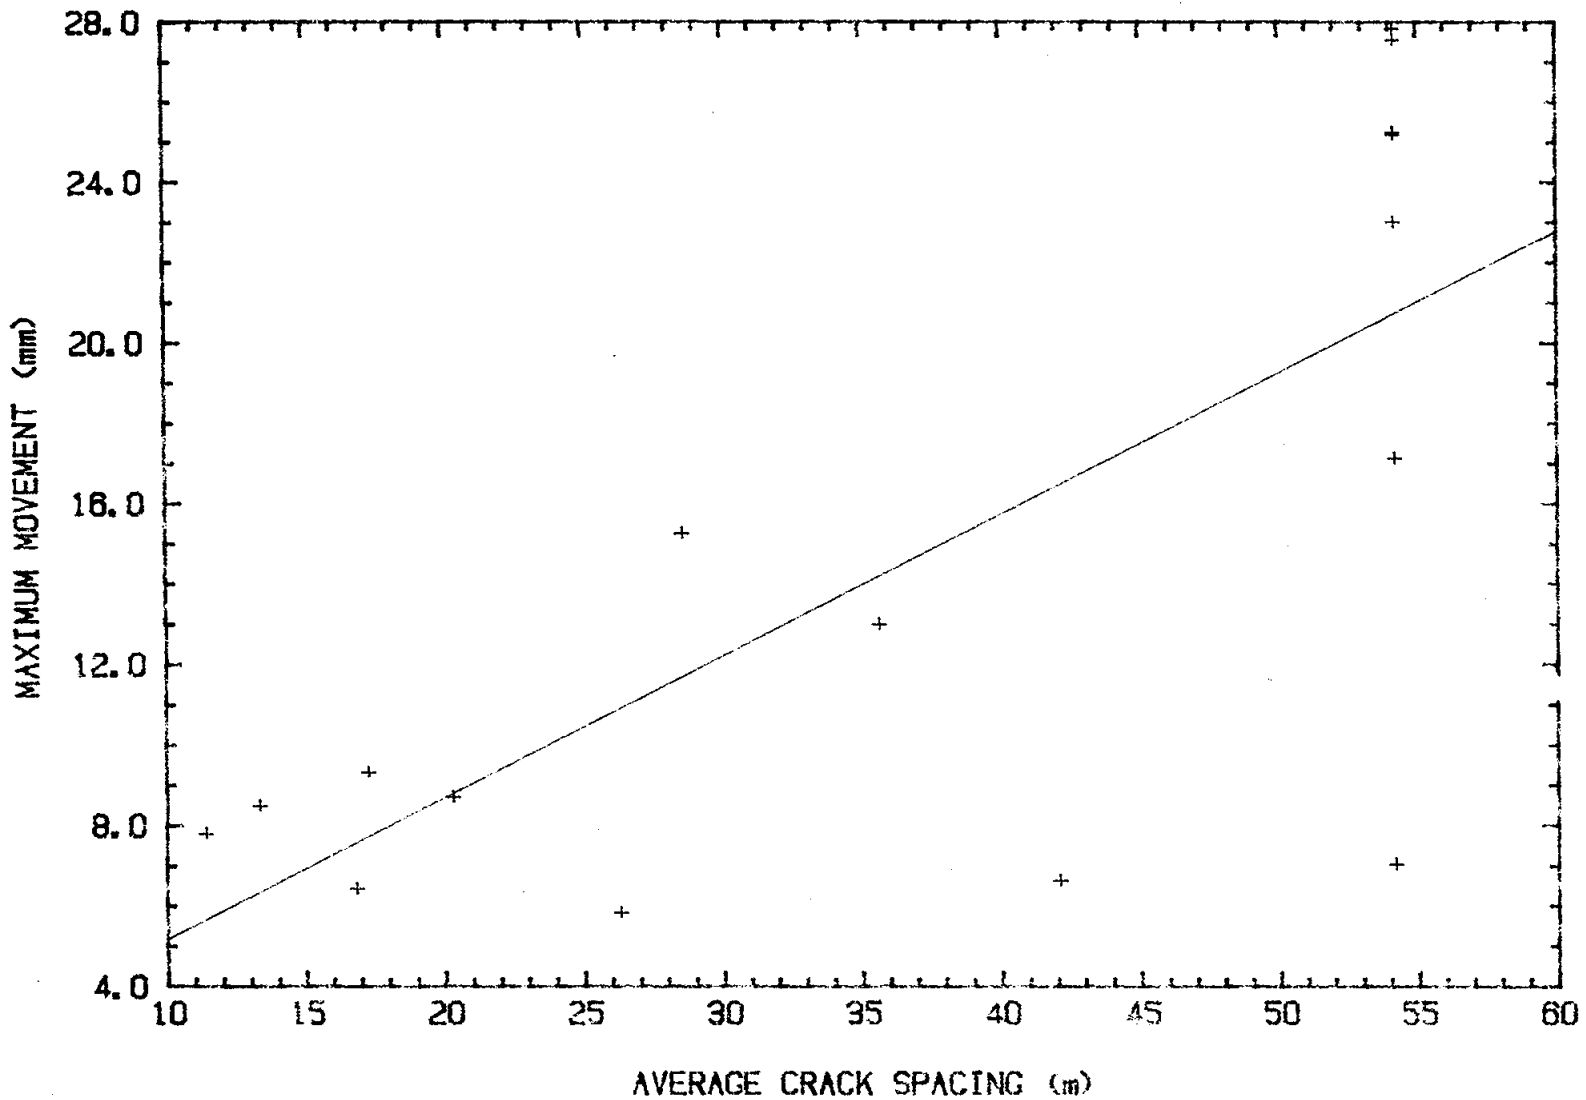
Figure 12: Maximum crack movement vs. the average spacing of the two cracks immediately adjacent to the measured crack. The solid line is a least squares fit to the data.

Figure 12 is a graph of the maximum crack movement with respect to the average crack spacing for the two cracks on either side of the measured crack. Equation 2.2 can be modified under simplifying assumptions to show that

where $(L_1 + L_2)/2$ is the average crack spacing for the two cracks on either side of the measured crack. Equation 5.1 shows that there should be a correlation between ΔL and $(L_1 + L_2)/2$ which is illustrated in Figure 12. However, these data are not directly comparable since some of the cracks were measured over different time spans. In addition, the mechanisms controlling crack movement are still uncertain. Therefore, no physical meaning can be attached to the least squares line through the data.

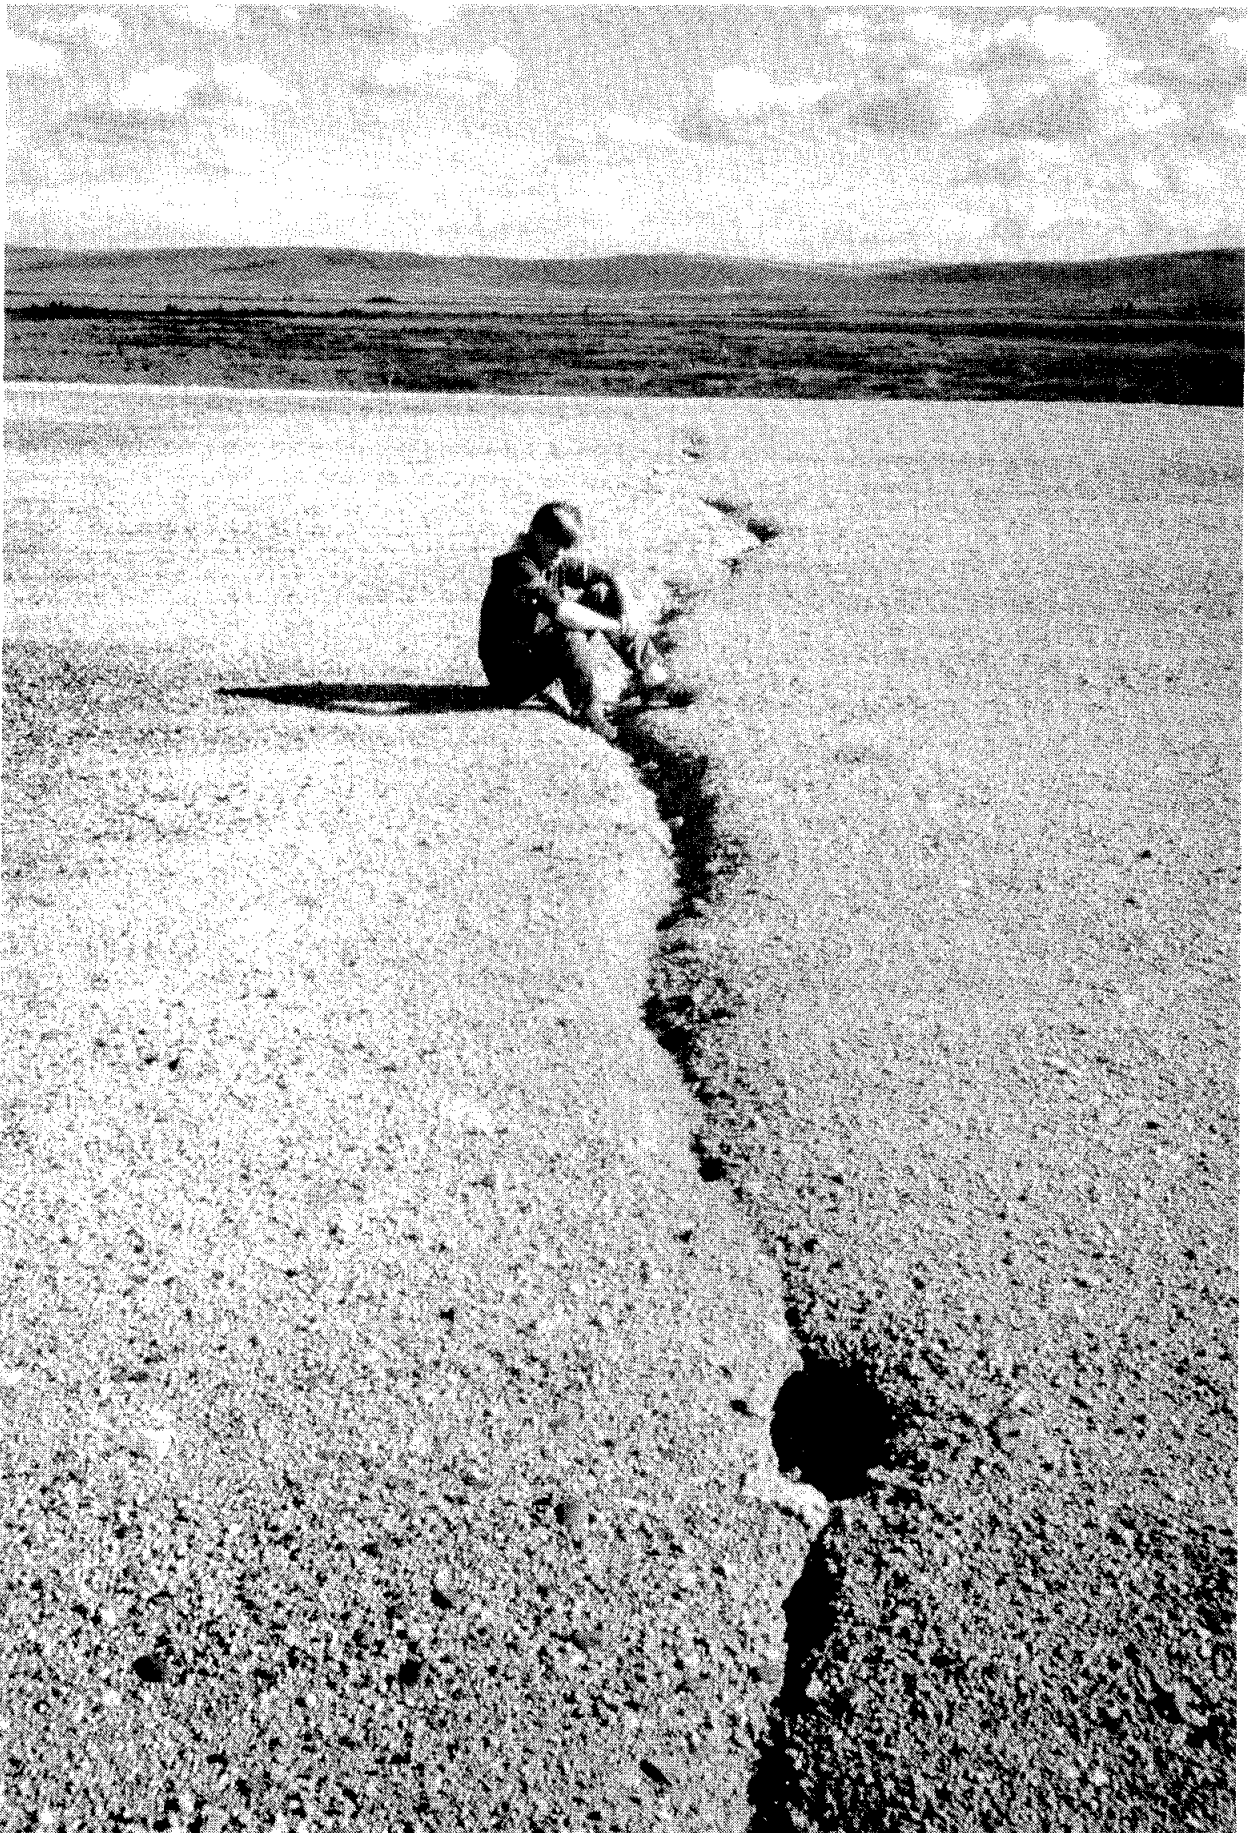
Figure 16: A major transverse crack in the gravel runway of Old Man Airport.

The Old Man Airport runway is located near the Old Man pipeline camp just south of the Arctic Circle. It is an unpaved, gravel, runway about 1600 m in length and about 70 m in width. The gravel fill appears to be 2-3 m in thickness. Major transverse cracks were observed in this runway during July, 1985 (Figure 16) at an estimated spacing of 30-60 m. There

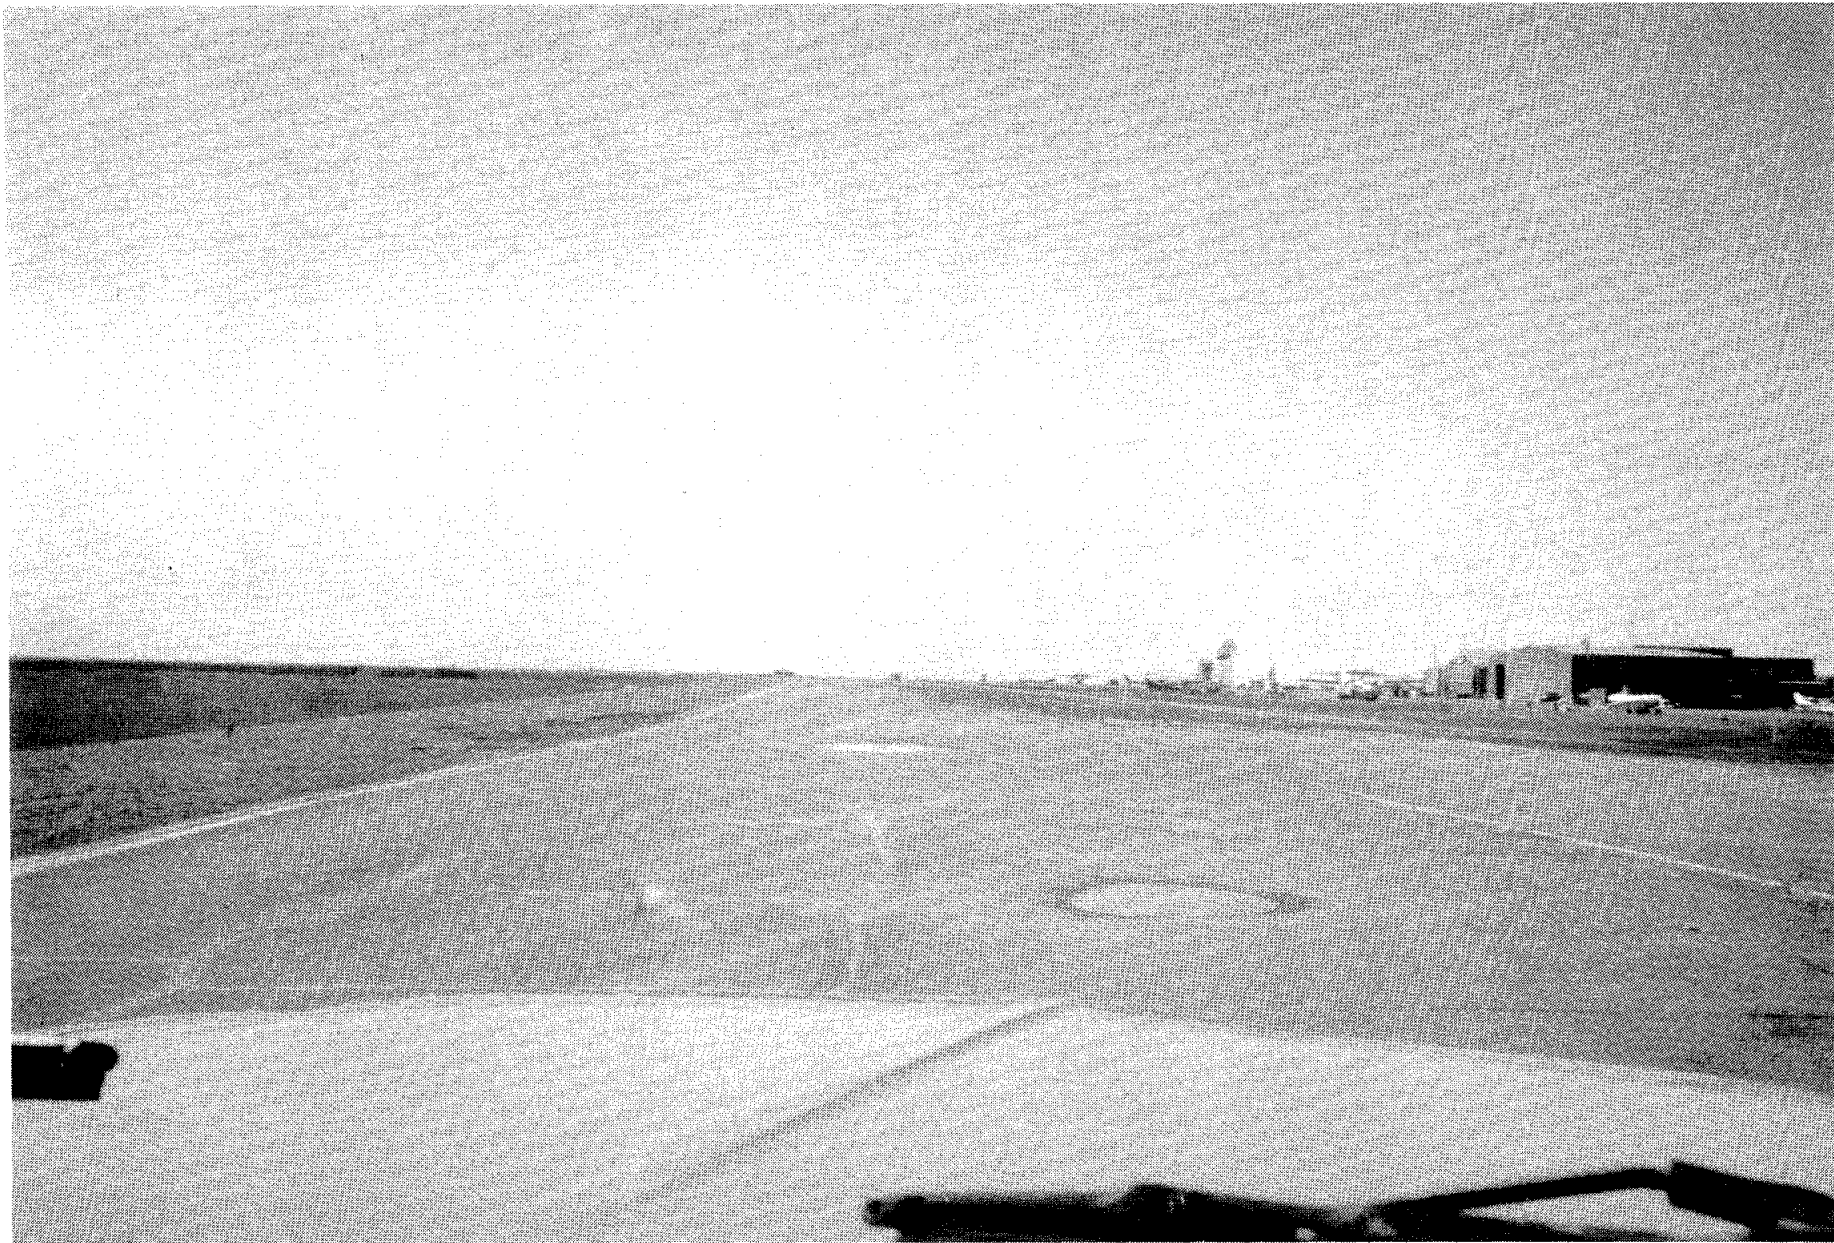
Figure 17: Pooled water on a ramp of the Deadhorse Airport which shows the areas subjected to settling due to the thawing of the underlying ice-rich permafrost.

are several areas of the runway that appear to be settling by thaw consolidation of the underlying ice-rich permafrost and by thawing of ice wedges. Water is pooled at a number of places on the uphill (north) side of the runway. Some of these cracks appear to be associated with the polygonal ground (ice wedges).
