LOW TEMPERATURE TRANSVERSE CRACKS IN
ASPHALT PAVEMENTS IN INTERIOR ALASKA

Final Report

Geophysical Institute
Univeristy of Alaska
Fairbanks, Alaska 99701

April, 1986

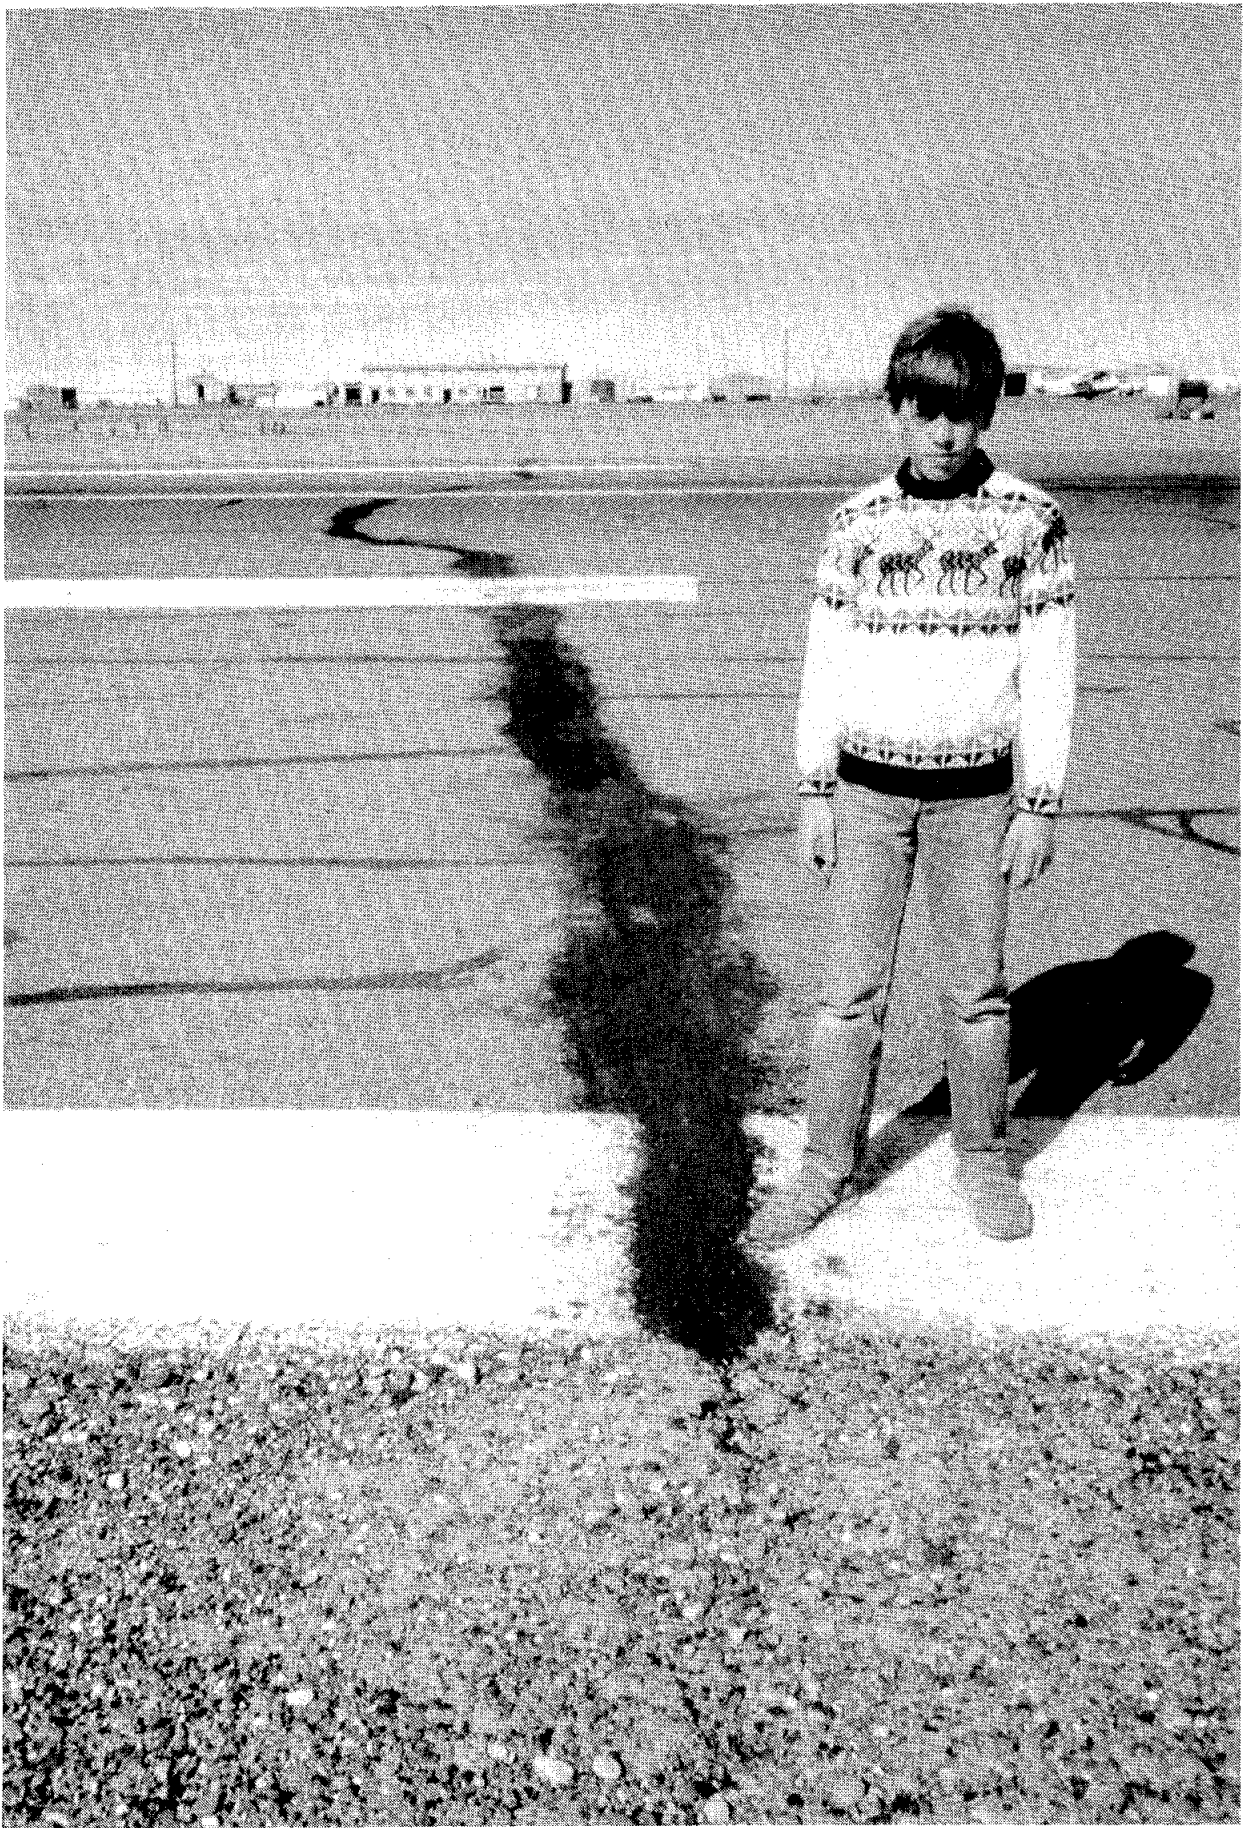
Figure 20: Major transverse crack in the pavement on the northeast end of the Deadhorse Airport Runway which has been patched recently. The cracks in this end of the runway were much more prominent than in the southwest end (Figures 18 and 19).

extended through the gravel apron and had a 5-10 cm deep trough at the gravel surface. There did not appear to be any correlation between the position of ice wedge polygons off the edge of the runway and the cracks.
