## COMPUTER VISION TOOLS FOR BRIDGE INSPECTIONS AND REPORTING – CONCRETE DECKS AND STEEL GIRDERS

**Report # FHWA-AK-4000(219)**

January 2026

Alaska Department of Transportation & Public Facilities Statewide Research Office

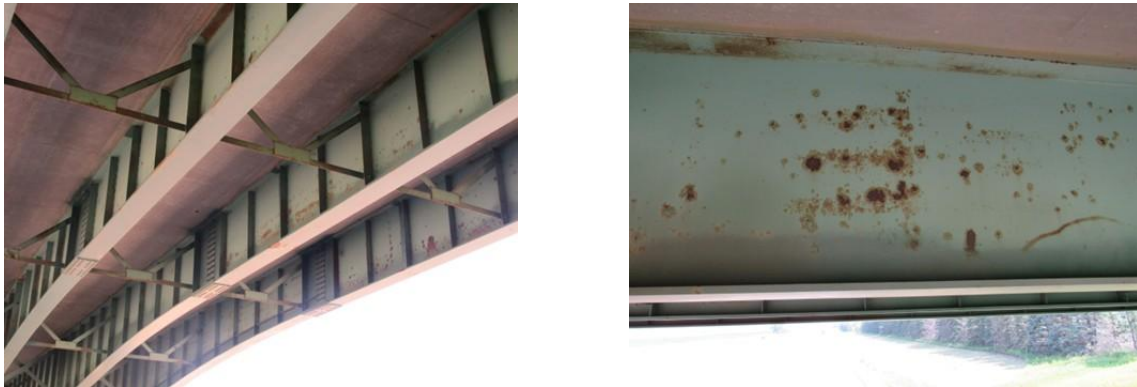
For steel girders, images were collected using handheld cameras and drones (e.g., **Fig. ES.3**). More than 6,700 images of steel girders, including corrosion and paint loss, were collected.

**Figure ES.3 – Sample RGB Images for Steel Girders**

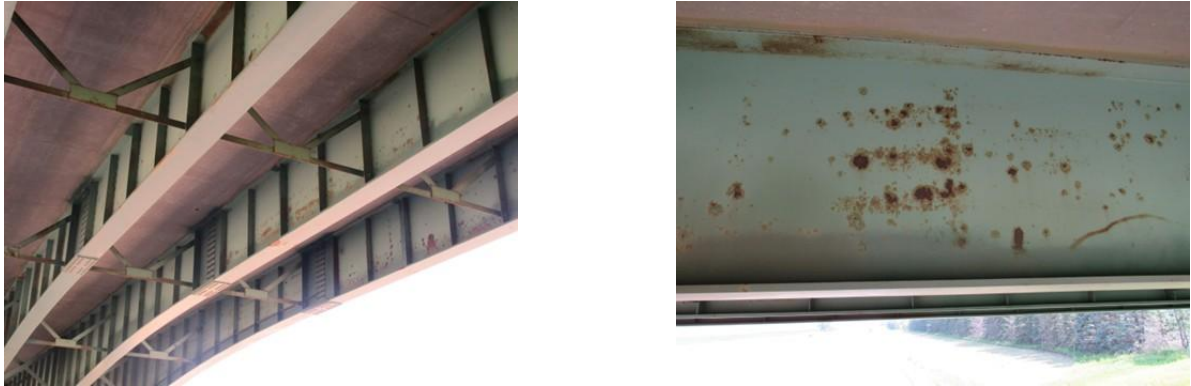
For steel girders, images were collected using handheld cameras and drones (e.g., **Fig. 4.3**). More than 6,700 images of steel girders were collected. Note that most of the observed defects in steel girders were the loss of protective paints.

**Figure 4.3 – Sample RGB Images for Steel Girders**

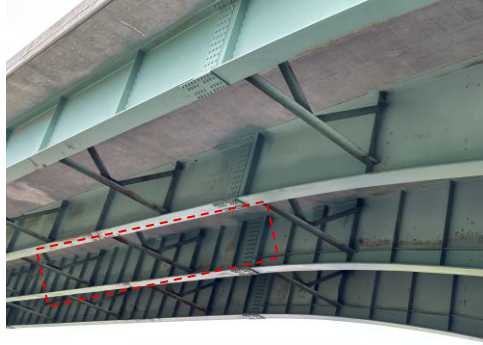
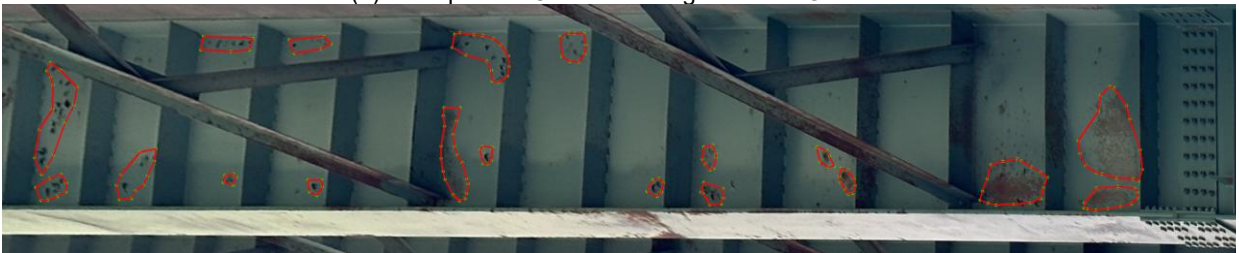
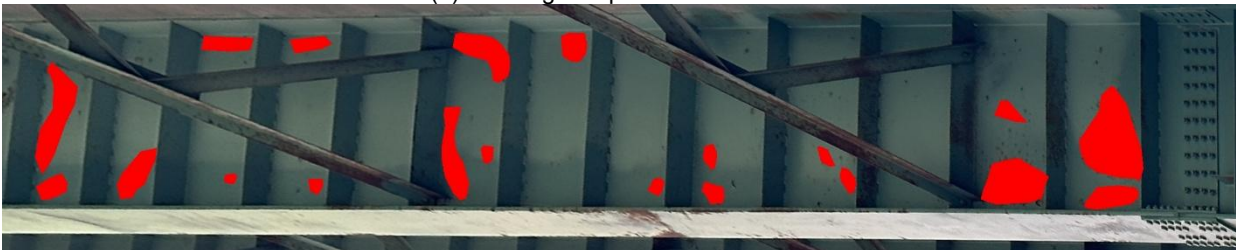
(a) Collected RGB Image

(b) Perspective Corrected Image of Third Girder

(c) Annotation of Damaged Regions

(d) Damage Map for Steel Girder

(e) Damaged Map Overlaid on Steel Girder (Damaged Regions Shown in Red)

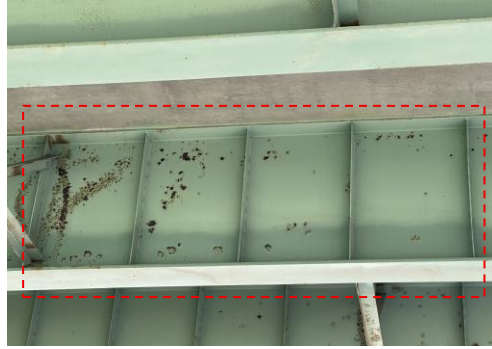
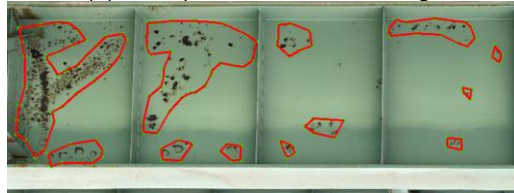
(a) Collected RGB Image

(c) Annotation of Damaged Regions

(d) Damage Map for Steel Girder

(e) Damaged Map Overlaid on Steel Girder (Damaged Regions Shown in Red)

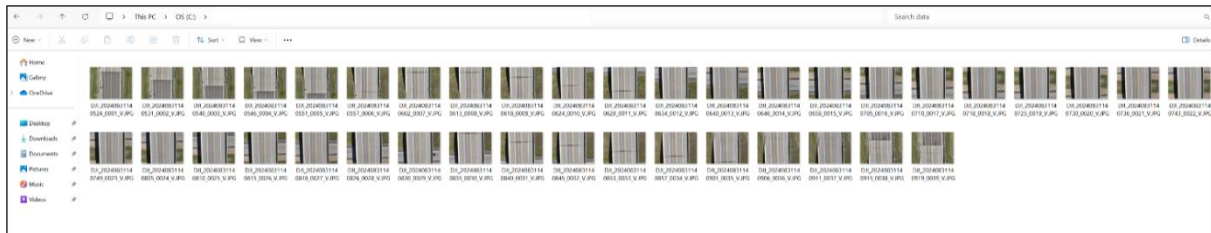
**Figure 8.7 – Overlapping RGB Images of Bridge Deck with Delamination Marks**

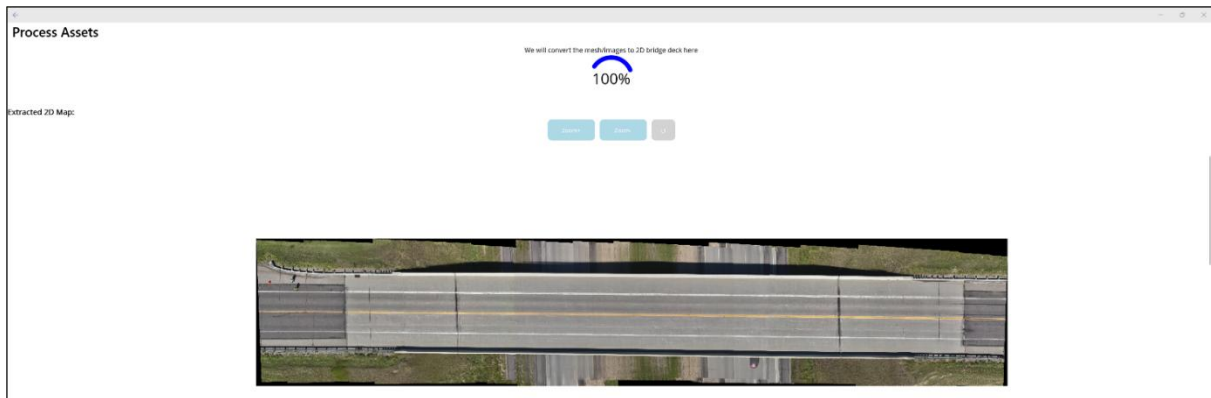
**Figure 8.9 – Stitched 2D RGB Map of a Bridge Deck**
