Selection of Pavement Marking Materials

Publication Number:
FHWA-AK-RD-00-01

Selection of Pavement Marking Materials Interim Report

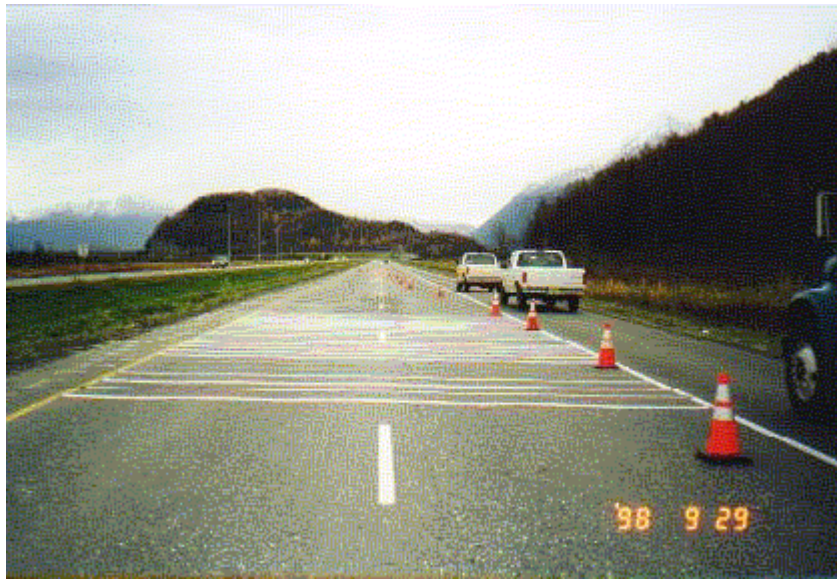
The Anchorage test deck (Glenn Highway) is a bituminous asphalt site with an Average Annual Daily Traffic (AADT) of 9,800 for the northbound lanes. A permanent classification counter station is nearby. The surface is five years old, with no resurfacing or surface repair, and has good drainage. It is a divided four-lane highway, located near a high bluff, approximately 28 miles north of Anchorage. Because the high bluff is to the south of the site, much of the direct sunlight on the test deck is blocked during the “low-sun” period (November through March). The test deck is in the two northbound lanes. Test deck installation began on Tuesday, September 29, 1998 and was completed the next day.

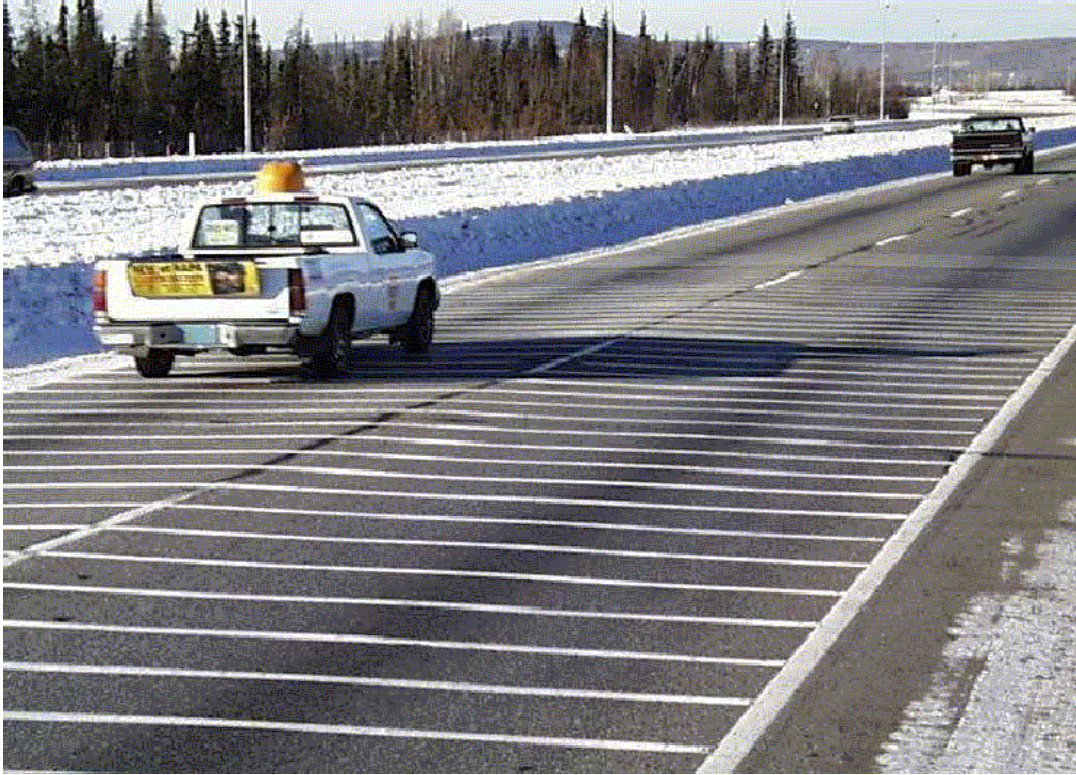
The Fairbanks test deck (Mitchell Expressway) is a bituminous asphalt site with an Average Annual Daily Traffic (AADT) of 6,050 for both lanes through December 1999. A permanent counter station is nearby. The surface is 11 years old, with no resurfacing or surface repair, and has good drainage. It is a divided four-lane highway, located in the Tanana Flats, approximately 2 miles south of downtown Fairbanks. This site has full exposure to the sun throughout the daylight hours. The test deck is in the two westbound lanes. We began the installation of the test deck on Saturday, August 14th and completed the work on Monday, August 30, 1999.
