**Nighttime Visibility of In-Service
Pavement Markings, Pavement
Markers, and Guardrail Delineation in
Alaska (with and without Continuous
Lighting)**

Prepared by: Paul Carlson, Ph.D., P.E.
Operations and Roadway Safety Division Head
Texas Transportation Institute

March 2011

FHWA-AK-RD-11-04

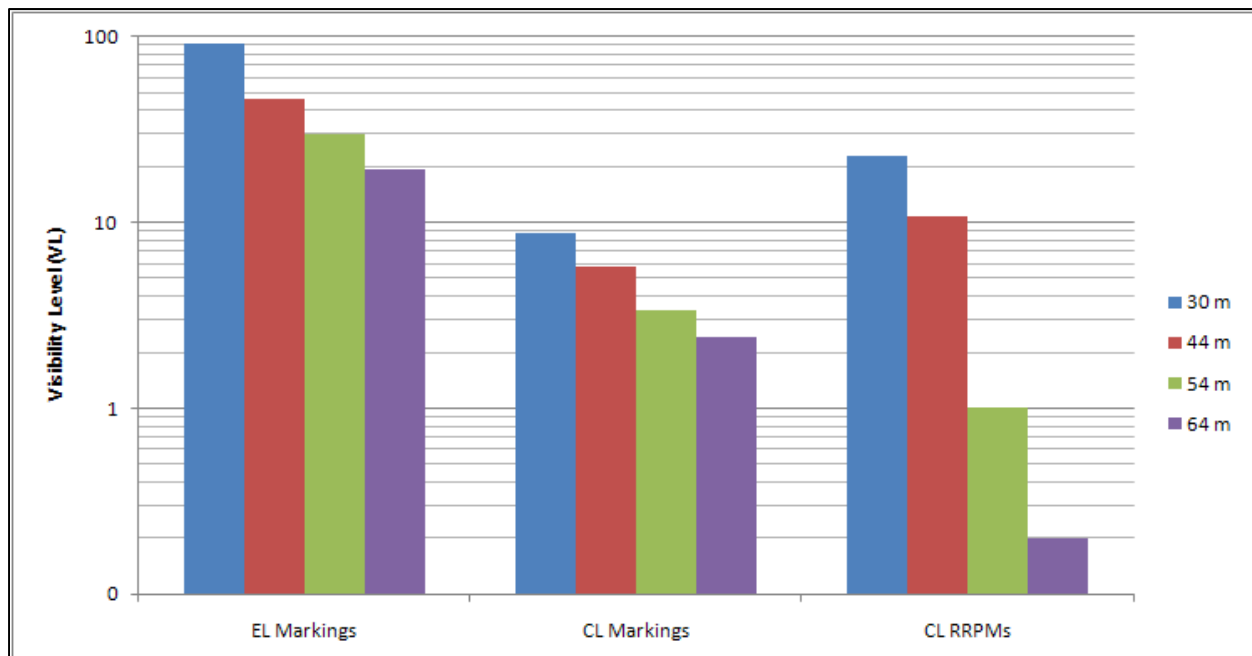
Figure 7. Visibility Levels of Delineation Treatments at MP9 on Rezanof Drive.

Figure 7 shows some interesting results regarding the visibility of the markings and center line RRPMs. First, the overall VL for the markings is relatively high given the measured retroreflectivity (110 mcd on the edge line and 80 mcd on the center line). This section of roadway was paved in 2005 and the asphalt has become polished, which typically leads to low measurements of returned pavement surface luminance. This can lead to a higher contrast and therefore higher VL levels (versus the same retroreflective markings on a road surface returning higher luminance levels). Second, the center line markings provide the same VL trend as the edge line markings except that they are at a noticeably reduced level. These lower VL are a function of two factors working in tandem—the yellow center line markings have lower retroreflectivity levels than the white edge line markings (80 versus 110), and the reduced headlamp illumination reaching center line markings compared to edge line markings.

When the site was repaved in 2005, the original markings were installed using methylmethacrylate (MMA). They were refurbished with low VOC paint and AASHTO Type I beads approximately one week before they were measured for this paper. The center line RRPMs were installed in 2005 when the road was resurfaced (see Figure 8). They were nonplowable retroreflective raised pavement markers and they were installed in a groove about 0.5 inch deep (AKDOT&PF specified depth is 0.375 inch). Subjectively speaking, the nighttime visibility of the RRPMs along this site was marginal. During night drives through this site, it was common to see two consecutive RRPMs but seeing RRPMs beyond two in view at any one time was uncommon. From visual observations made while driving this site at night, a VL of 1 or less would be almost undetectable and therefore unacceptable (the VL of the CL RRPMs at 54 and 64 m are less than or equal to 1). The photometric equipment used in this study is capable of measuring RRPMs at distances beyond what the human eye can see. The results in Figure 7

seem to coincide as the RRPM visibility measured with VL is greater than or equal to 10 for the 30 and 44 m distances but much less for the longer distances (less than or equal to one).

At this site, which is only about 7 miles from the first Kodiak site (shown in Figure 7), the center line RRPMs performed much better despite being in a horizontal curve. However, these RRPMs were only one year old versus five years old at the first Kodiak site. Again, even though a sixth RRPM is shown in the graph (with a VL < 1), it was not possible to detect this RRPM at night. For distances out to 64 m, the center line RRPMs provide about double the visibility of the center line markings.

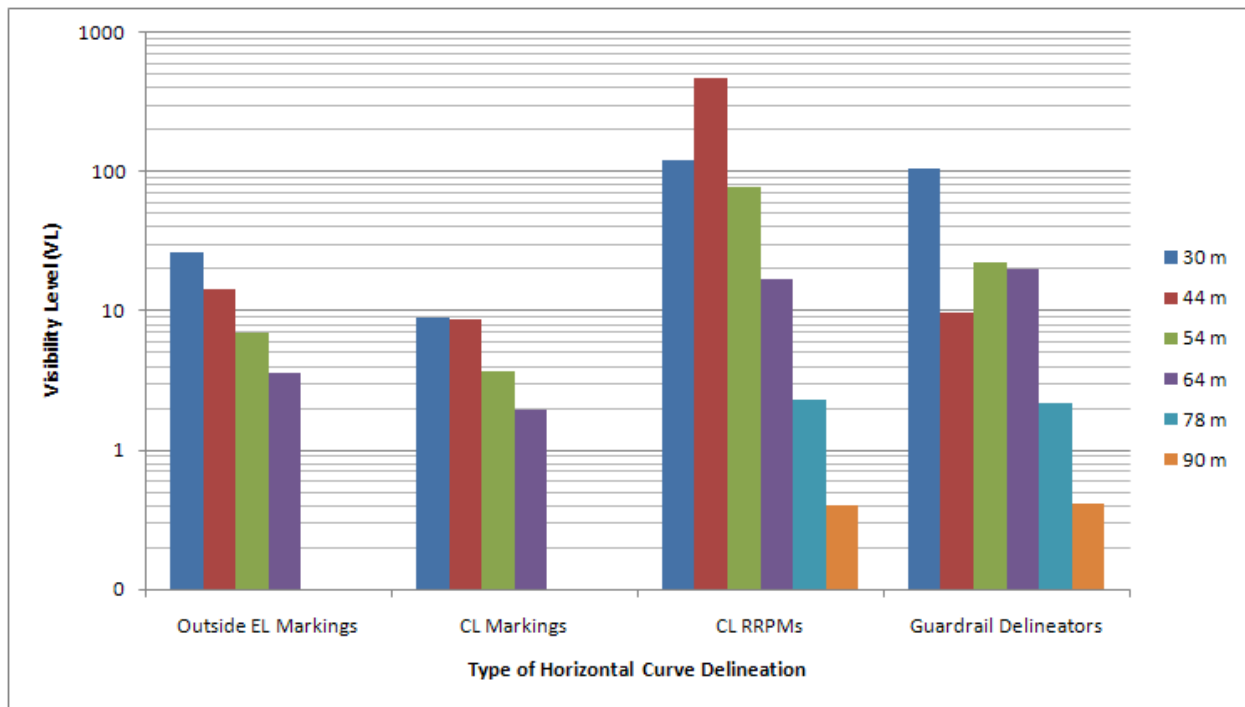
Figure 10 shows the VL values for the edge line markings, center line markings, center line RRPMs, and guardrail delineator tabs along the second site on Kodiak (MP2 on Rezanof Drive),

Figure 10. Visibility Levels of Delineation Treatments at MP2 on Rezanof.

Figure 10 shows the same trends in the pavement markings as noted previously except with a lower overall VL. The markings were just applied within the week prior to the measurements using low VOC paint and Type I AASHTO M247 beads. The RRPMs were nonplowable retroreflective raised pavement markers and they were installed in a 0.5 inch deep groove as per the contract specification. The guardrail delineator tabs were the butterfly variety and they were installed in 2004.

which happened to be a horizontal curve. The pavement markings at this site were refreshed within one week prior to our measurements. The RRPMs were installed in 2009, when the site was resurfaced. The guardrail delineation tabs were installed in 2004.

The guardrail along this curve ran concentric with the curve and was offset approximately 8 feet from the edge line. Inside the W-beam were guardrail delineator tabs installed in 2004. The second guardrail delineator was noticeably damaged and the VL for that delineator shows it. Overall though, the guardrail delineation here provides greater visibility than the edge line

markings, at least out to 64 m. The sixth guardrail delineator is shown in Figure 10 but could not be seen by the eye at night. Daytime and CCD images from this site are shown in Figure 11.

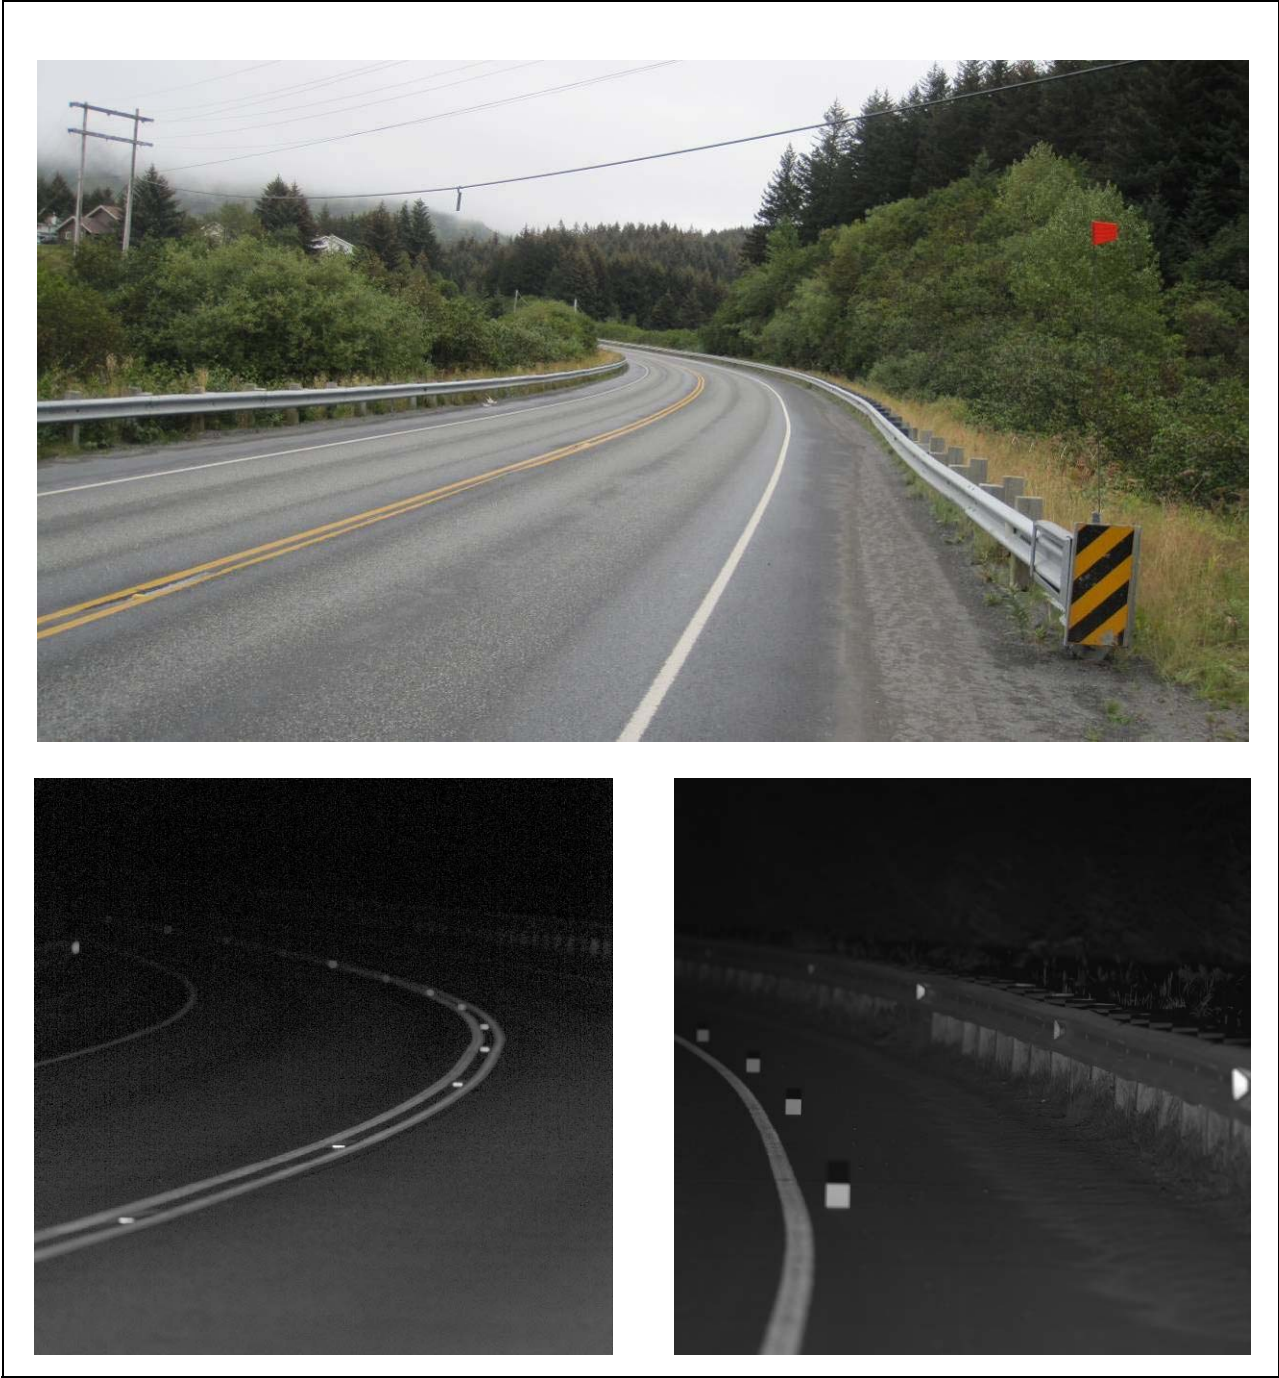
Figure 11. Images from MP2 on Rezanof Drive on Kodiak.
