UAV Based Inspections for Highway Bridge and Structural Condition Monitoring and Inspection works

Report # FHWA-AK-RD-4000(206)

January 2024

Alaska Department of Transportation & Public Facilities

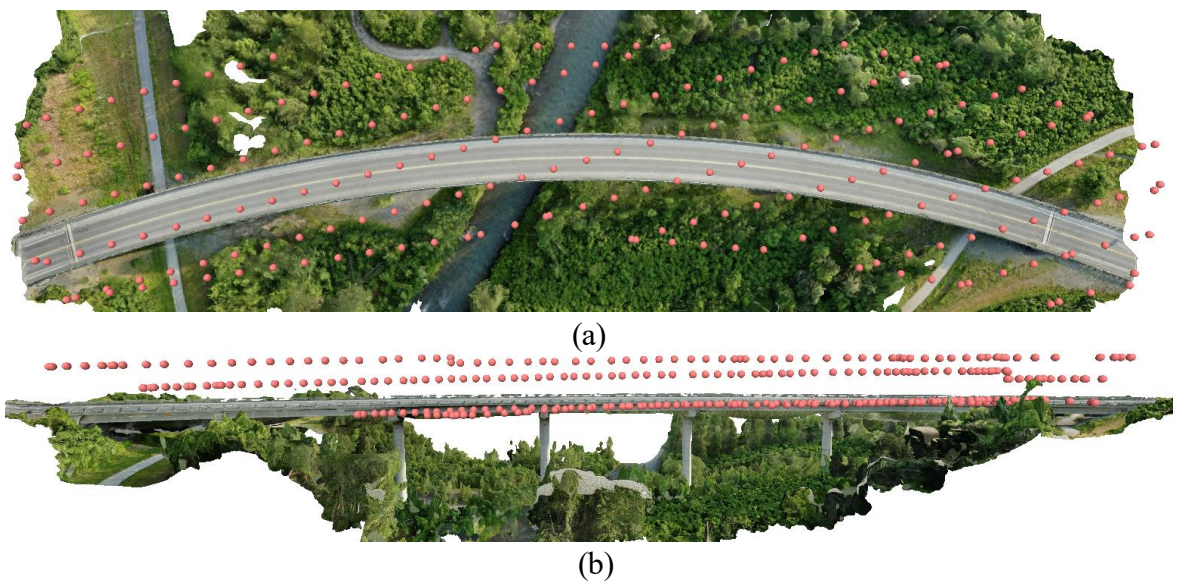
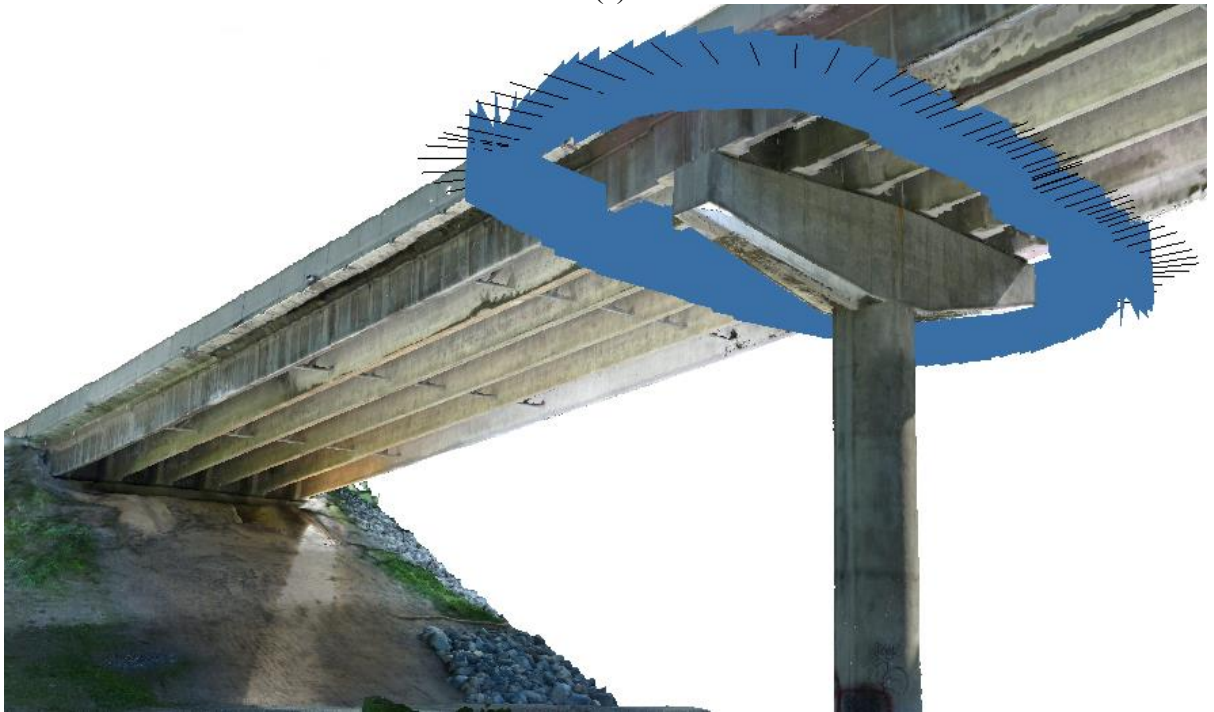
- Abutments were captured through horizontal flight legs flown parallel to the width of the bridge and distributed along the depth of the bridge (Figure 1f). Depending on the clearance depth available near the abutment slopes, the horizontal legs can be distributed horizontally at different lateral distances from the abutment. A debrief of the field inspections was conducted at the end of each inspection.

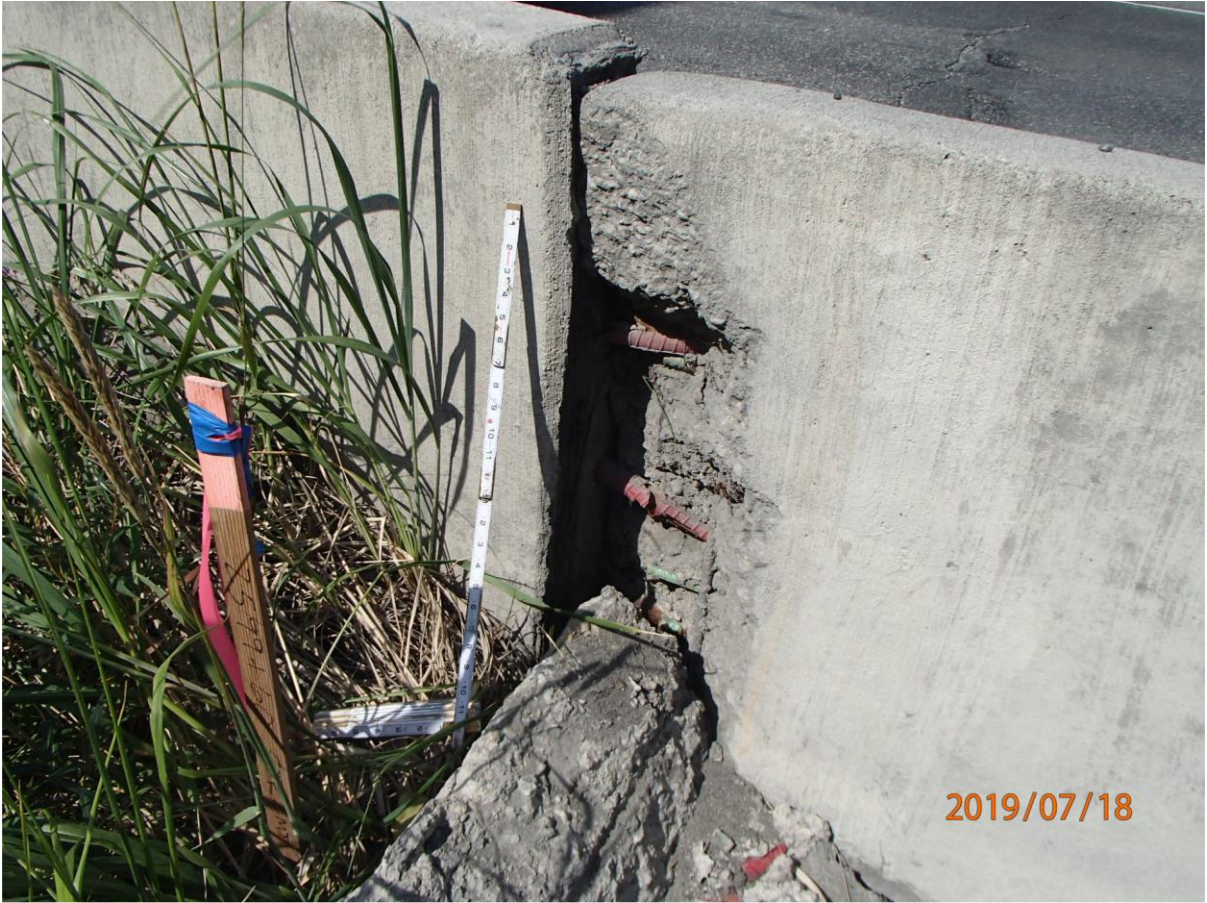
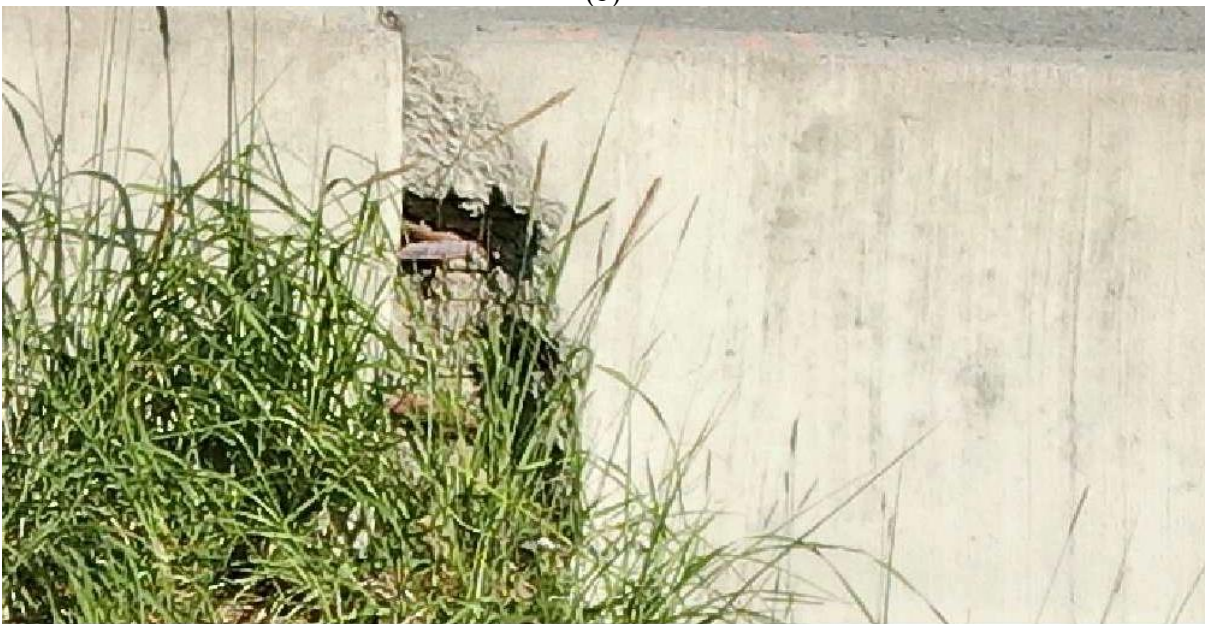
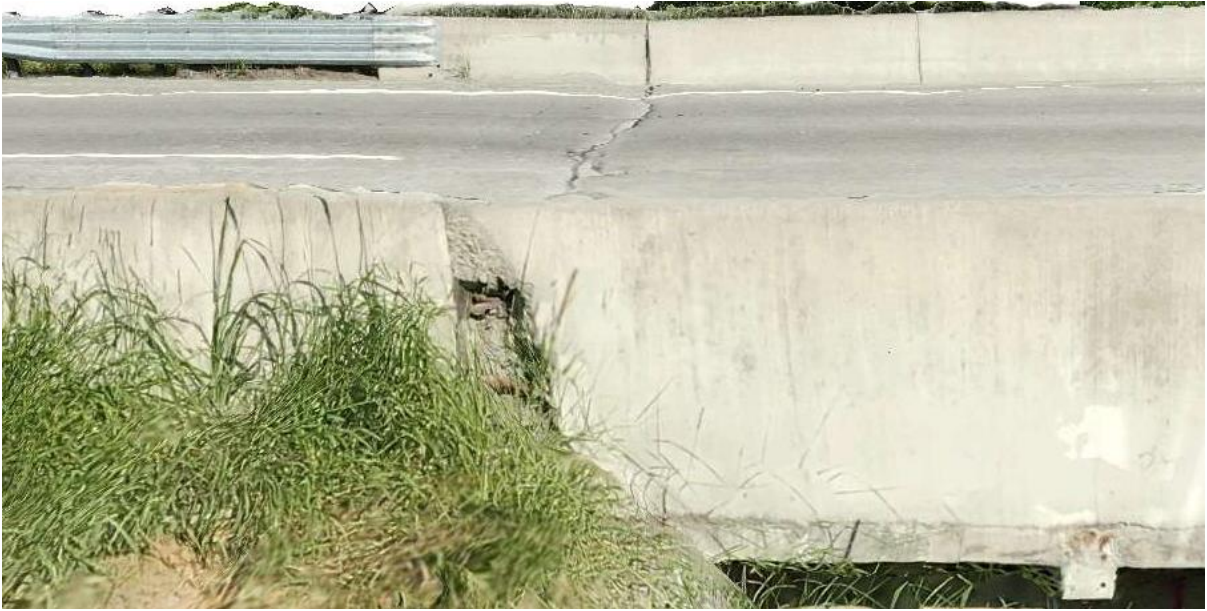
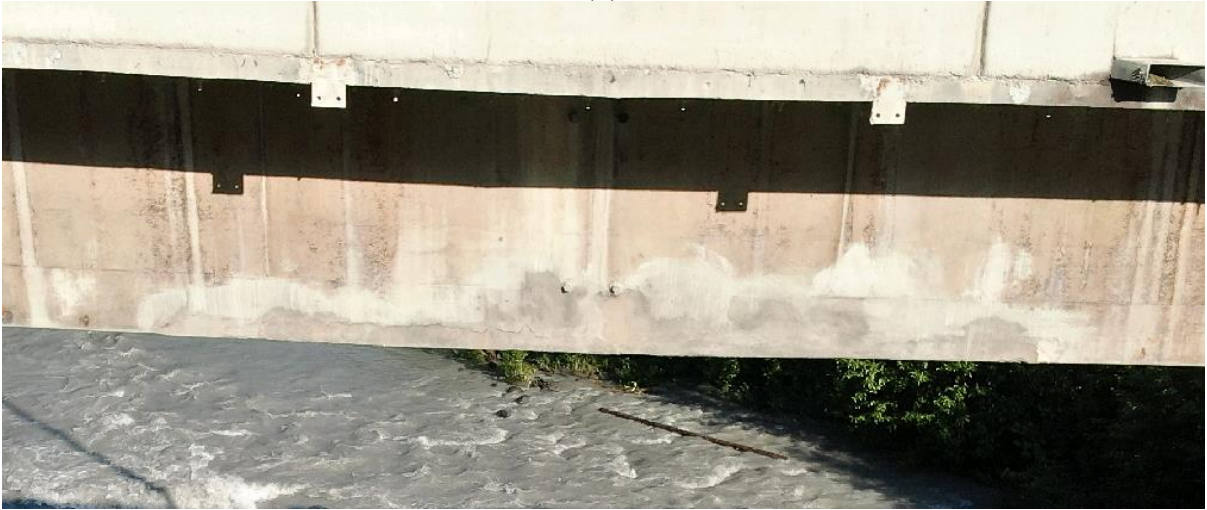
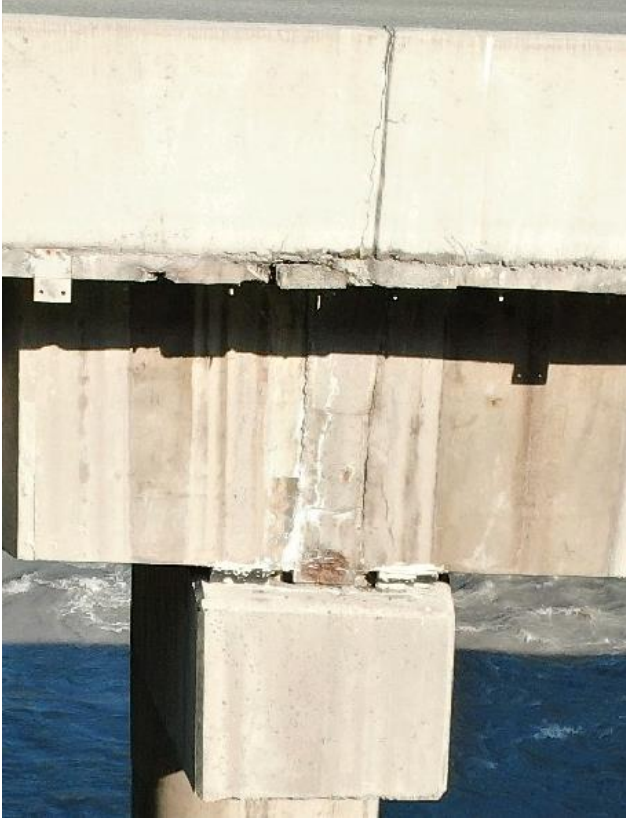
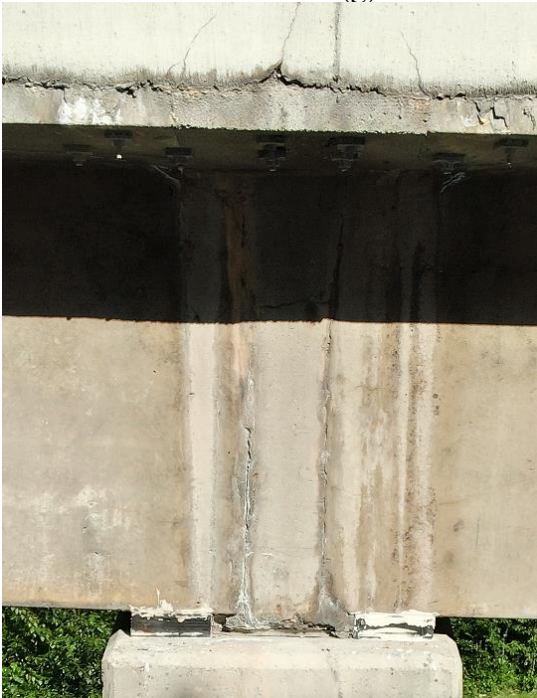
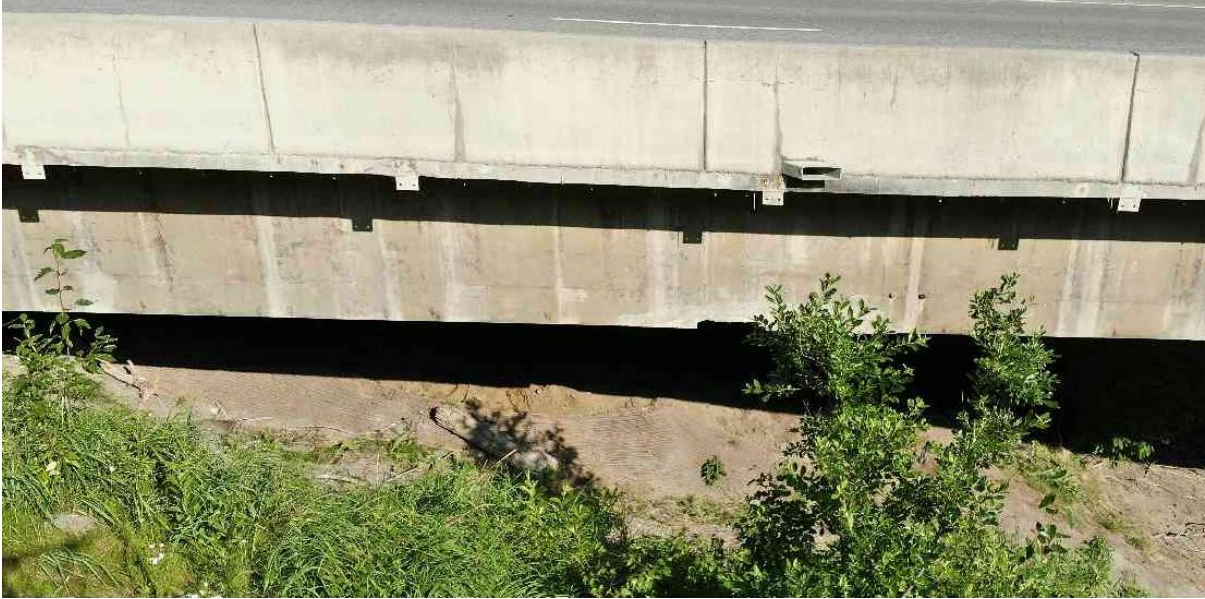
Patched areas, cracks, and efflorescence were identified on both faces, especially on the

south face. Some of the cracks caused by formwork can also be identified in the infrared images shown in Figure 4. The routine bridge inspection report prepared for this bridge by Alaska DOT&PF in 2019 was accessed to make a comparison with the aerial imagery and 3D models. Some of the assessments identified in both inspections are asphalt cracking, spalling, efflorescence, rust stains, and erosion.

The importance of the thermal loading and its angle of incidence for the identification of cracks, formed due to formwork, can be observed from the inability to distinguish cracks in infrared images, even though they are visible in optical images shown in Figures 4g-j. Concrete falloff near the patched area on the south face girder can be observed in Figure 4k. It can be observed that the optical illusion created by the shadows behind the distress and the vegetation in front of it almost obscures the presence of the distress. However, multiple images collected following the photogrammetric principles helped in identifying the distress and confirming its presence by leveraging multiple views of the bridge in the 3D model.

Figure 4. Eagle River Bridge condition assessments (a) 3D model viewed from the south direction (b) Railing end spall identified during the routine inspections in 2019 (c) Rail end spall in the aerial RGB image (d) Railing end spall and asphalt crack in the 3D model viewed from the southeast (e) Optical image of patchwork crack (f) Infrared image of patchwork crack (g) Angle of incidence: optical image of formwork cracks (h) Angle of incidence: infrared image of formwork cracks (i) Thermal loading: optical image of formwork cracks (j) Thermal loading: infrared image of formwork cracks (k) Concrete fall off on south side face of the bridge.

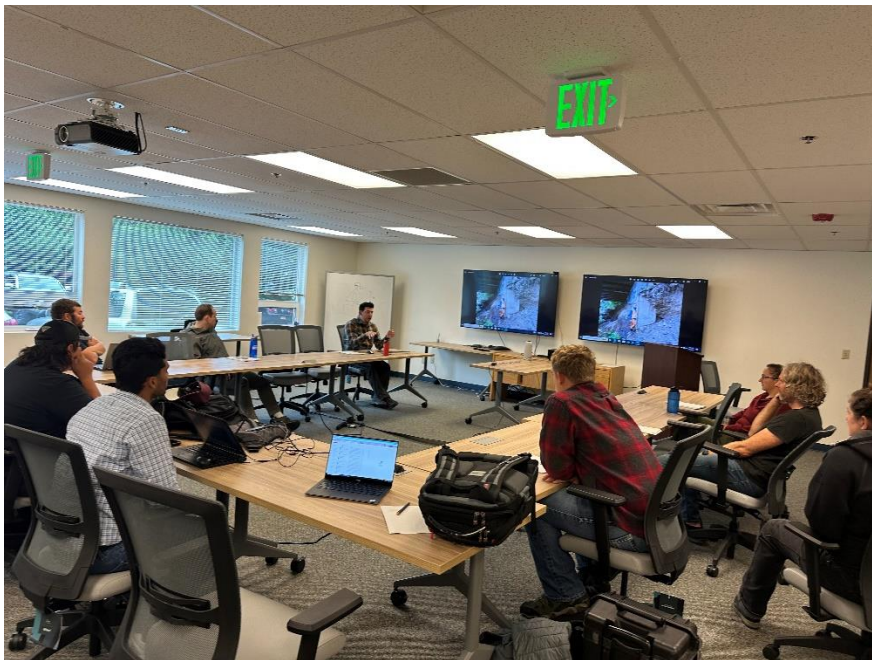
Figures 5a and 5b show Jesse Escamilla, Design Squad 1 Lead, Bridge Design Division, Alaska DOT & PF, leading the planning of flight missions and UAV-based field inspections, respectively, during the hands-on workshop. Some of the bridge personnel, who were FAA-certified drone pilots, were divided into groups and assigned a visual observer to carry on the inspection of specific bridge elements, as shown in Figure 5. The bank erosion that occurred due to the flooding and the highest water level due to the flooding can be observed by the moisture marks highlighted on the bridge shown in Figures 5d and 5e. Figure 5e shows the 360° bridge inspection conducted using a drone and the view from the camera inspecting the bridge elements. These inspections post-disaster events not only help in ensuring the optimal performance of the bridge condition but also help create baseline data for future reference. Overall, the workshop was successful in disseminating the details of the workflow and providing a hands-on experience to the bridge personnel for conducting 360° bridge inspections using UAVs.

Figure 5. Mendenhall River Bridge Inspection post flooding due to glacier melt (a) Mission planning (b) Stage I: Deck inspection (c) Stage III: Underspan inspection (d) Stage III: Bank erosion (e) Stage III: Close range inspection of the bridge pier cap (f) Stage III: Abutment inspection

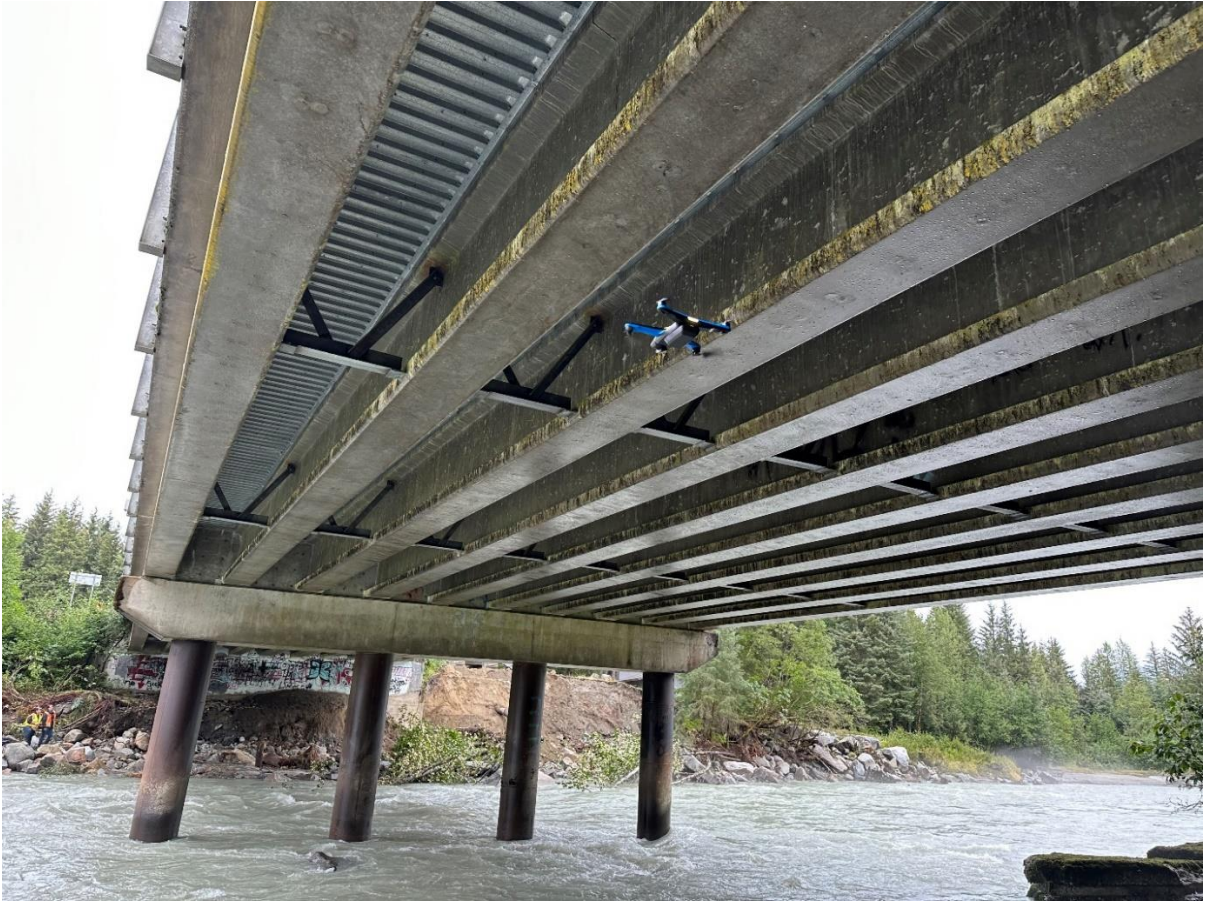
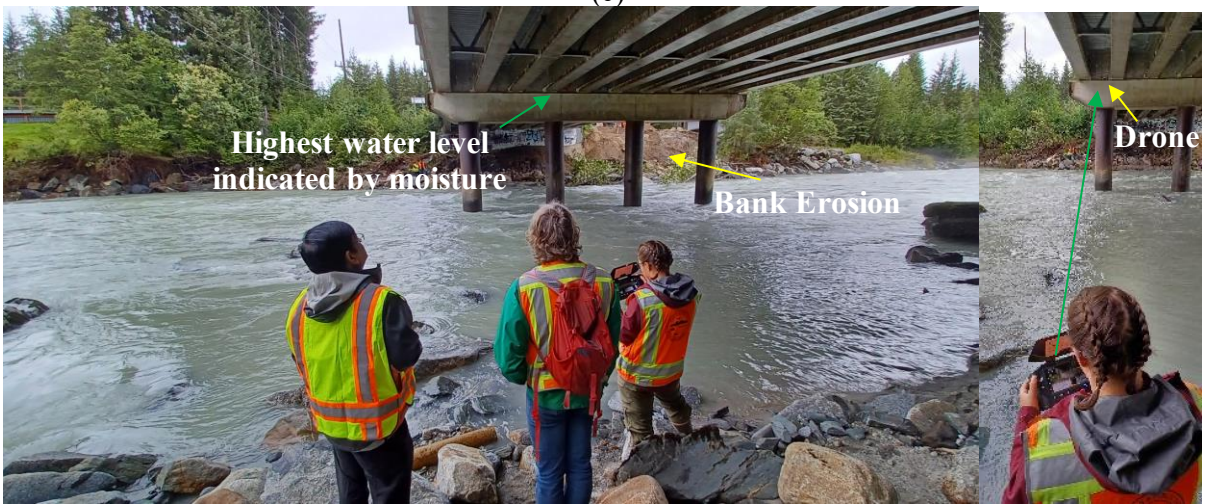
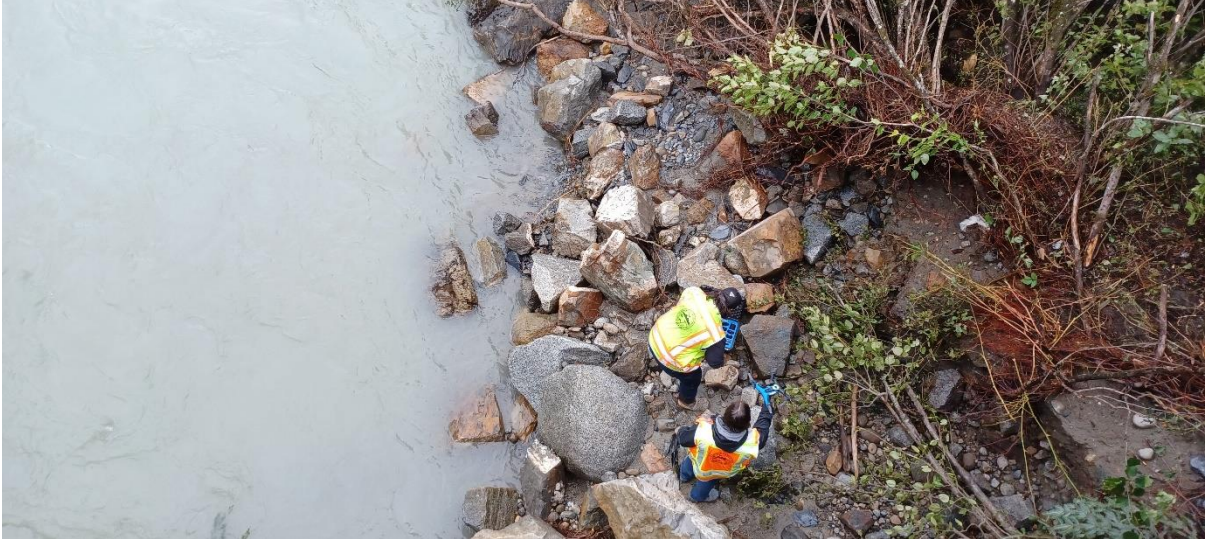
Highest water level
indicated by moisture

Bank Erosion
