## *SEISMIC BEHAVIOR OF HIGH-STRENGTH REINFORCING STEEL AT LOW TEMPERATURES*

*December 2025*

Alaska Department of Transportation & Public Facilities

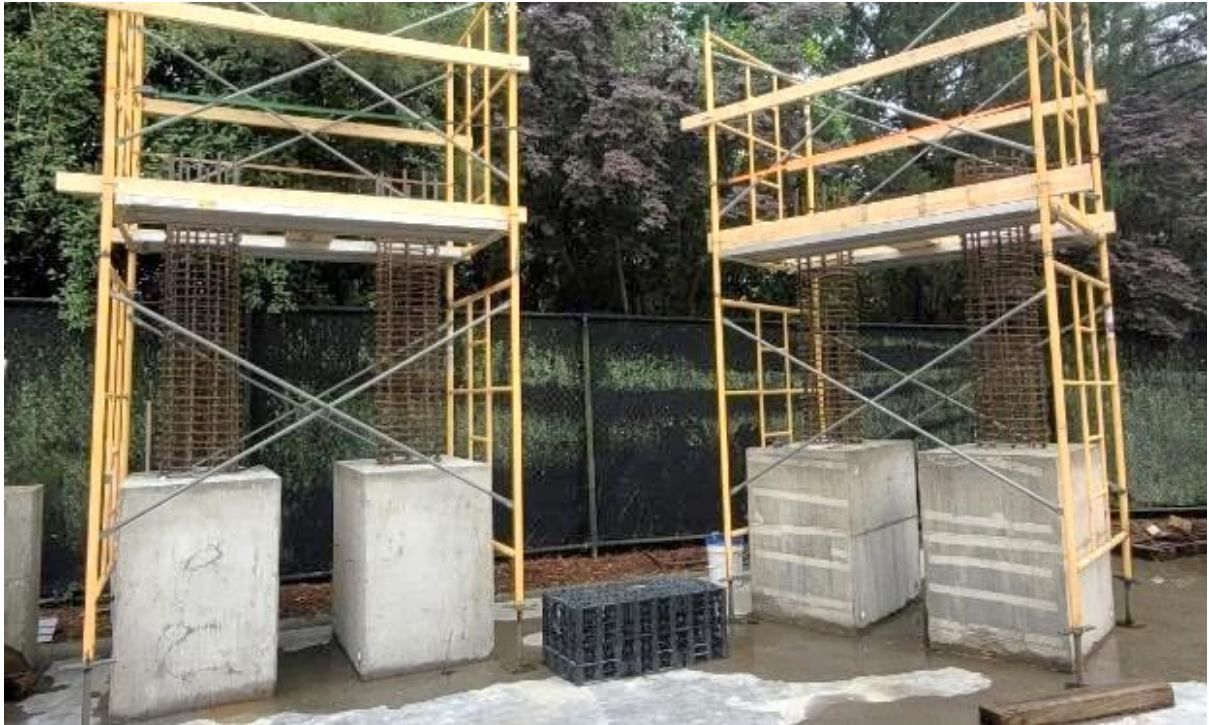
Figure 5-6 Placement of the specimens and scaffolding for column and cap beam construction

After the footings were built, the columns and cap beams were constructed. Scaffolding was erected around the column cages to support the cap beam casting and provide access to the top of the specimen, facilitating concrete pouring and vibration. Two specimens were positioned within each scaffolding setup. Figure 5-6 shows the specimen arranged within the scaffolding in preparation for the column and cap beam construction.

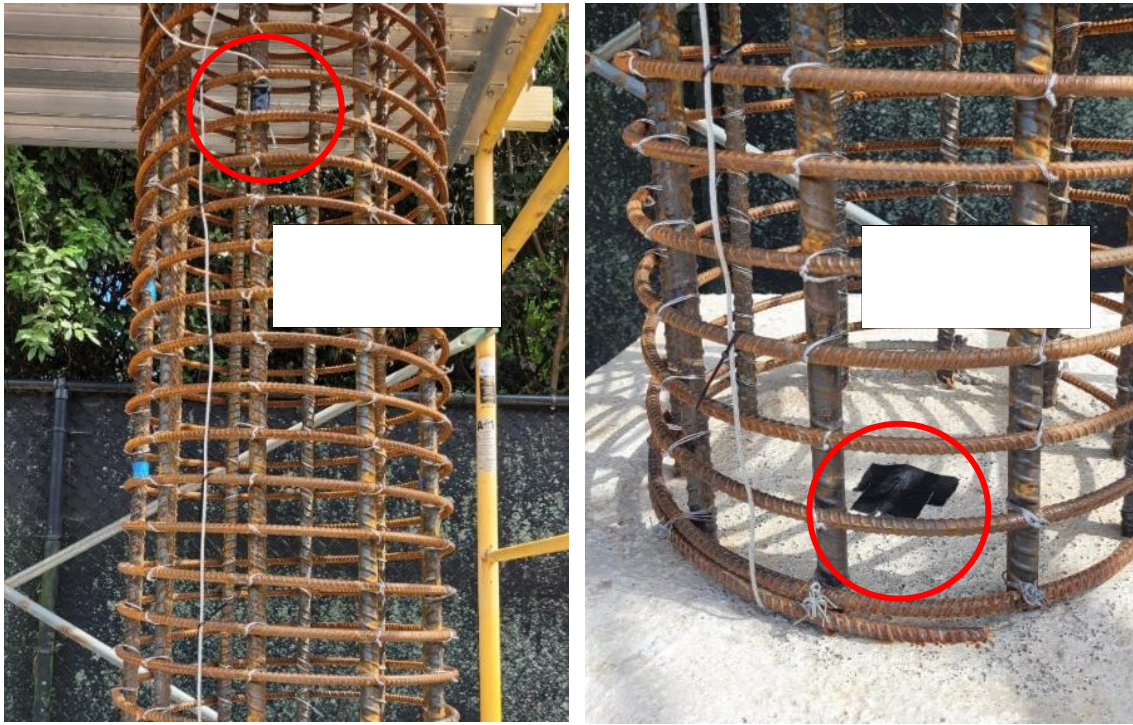
Figure 5-7 Thermocouples installation

Two type T thermocouples were installed in each specimen: one to measure the temperature at the core of the column and the other at a longitudinal bar. Additionally, 1-inch-thick foam blocks were placed around the perimeter of the reinforcing steel along the expected plastic hinge length to expose the steel in that area (without cover) after casting. Exposing the steel in the plastic hinge region facilitates the installation of the column's instrumentation and enables tracking of the damage progression on the reinforcing steel during the test.

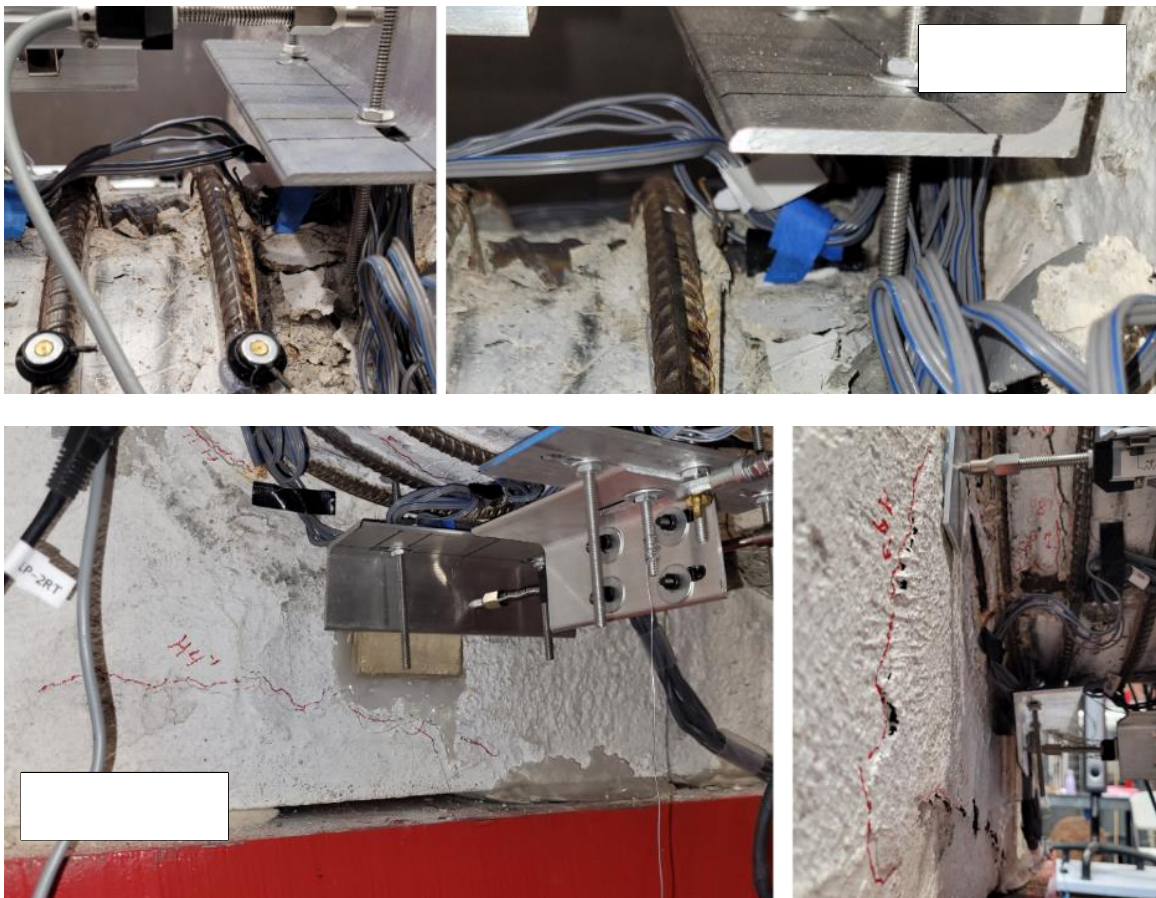
Figure 5-29 First cycle of  $\mu_4$  (pulling): Concrete crushing around bar T2, and cracking and uplifting of concrete at the footing.

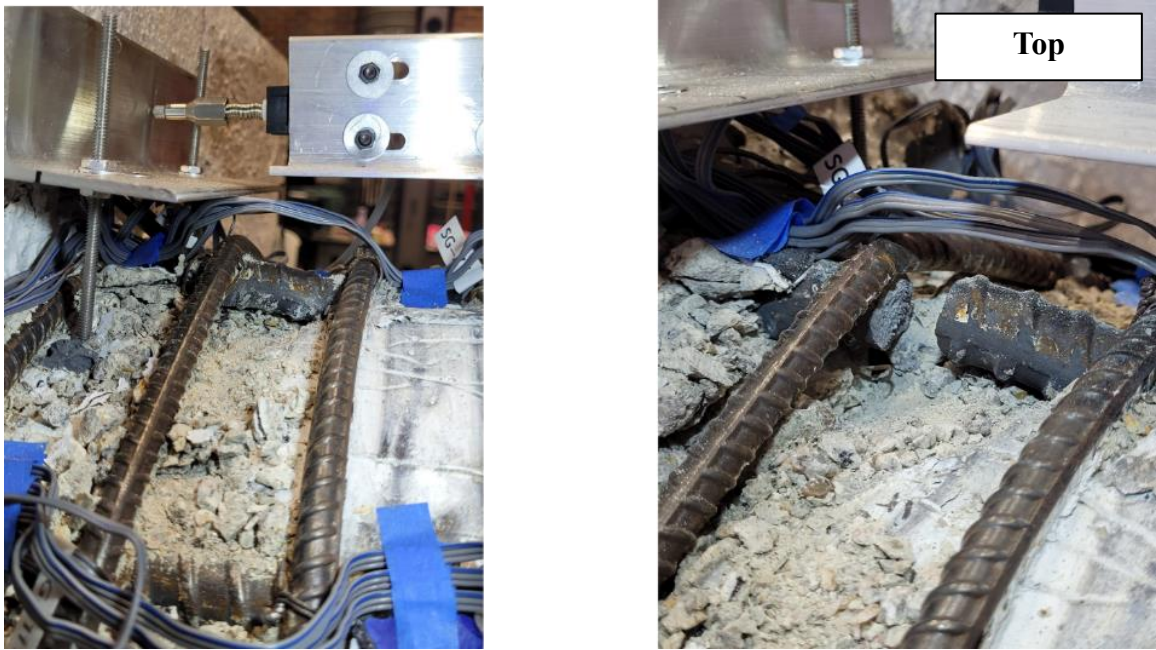
Figure 5-31 Third cycle  $\mu_5$ : Visible bar buckling in pulling cycle and fractured in pushing cycle of the top extreme bar 2T

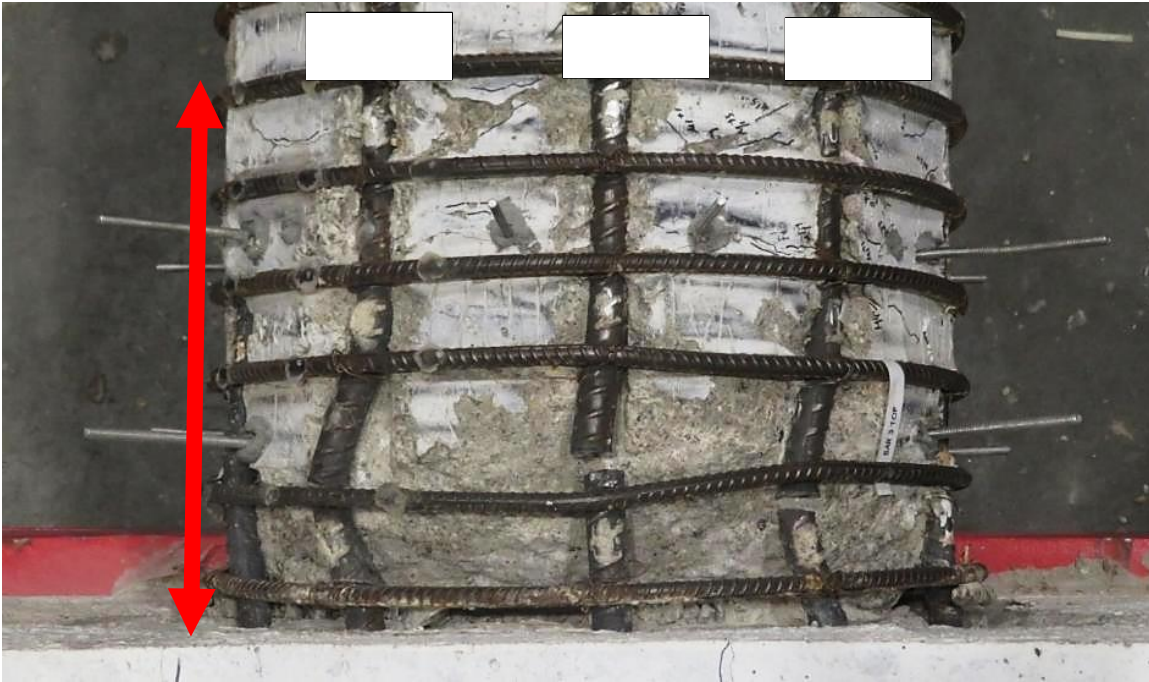
Figure 5-34 Final state of the specimen: Fracture of bars 1T, 2T, and 3T, and concrete core crushing.

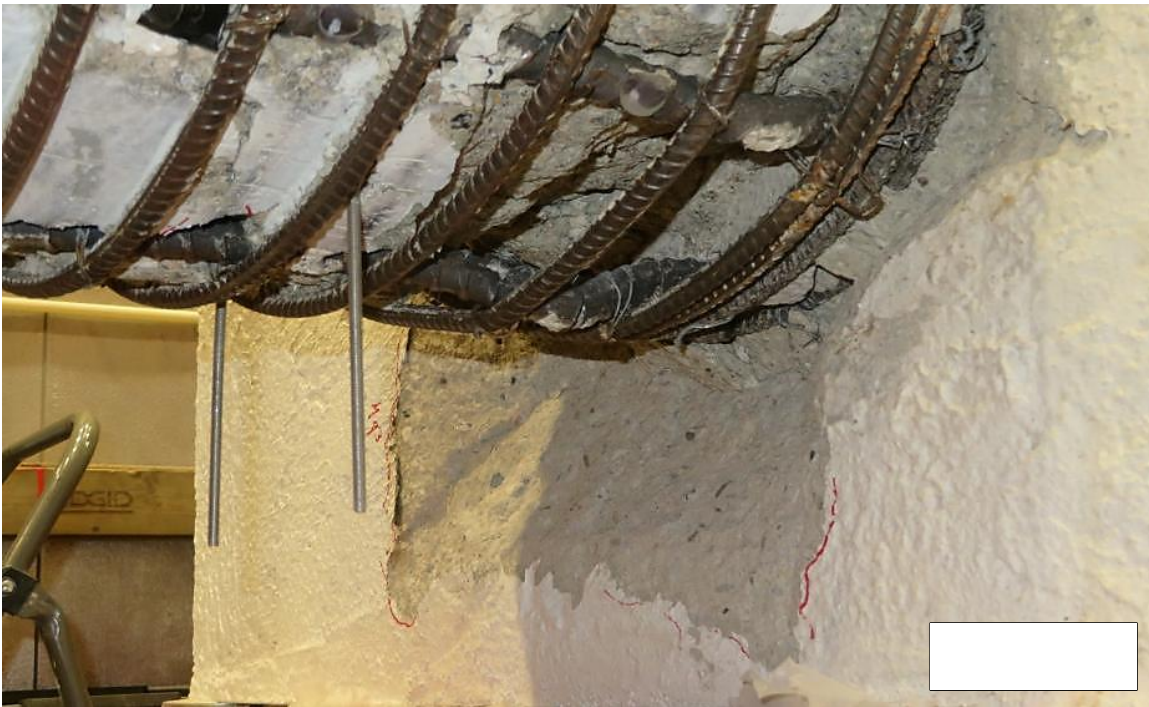
Figure 5-35 Damage at the bottom of the column: Fracture of bar 2B, concrete core crushing, and footing concrete breakout due to stress concentrations on footing support.

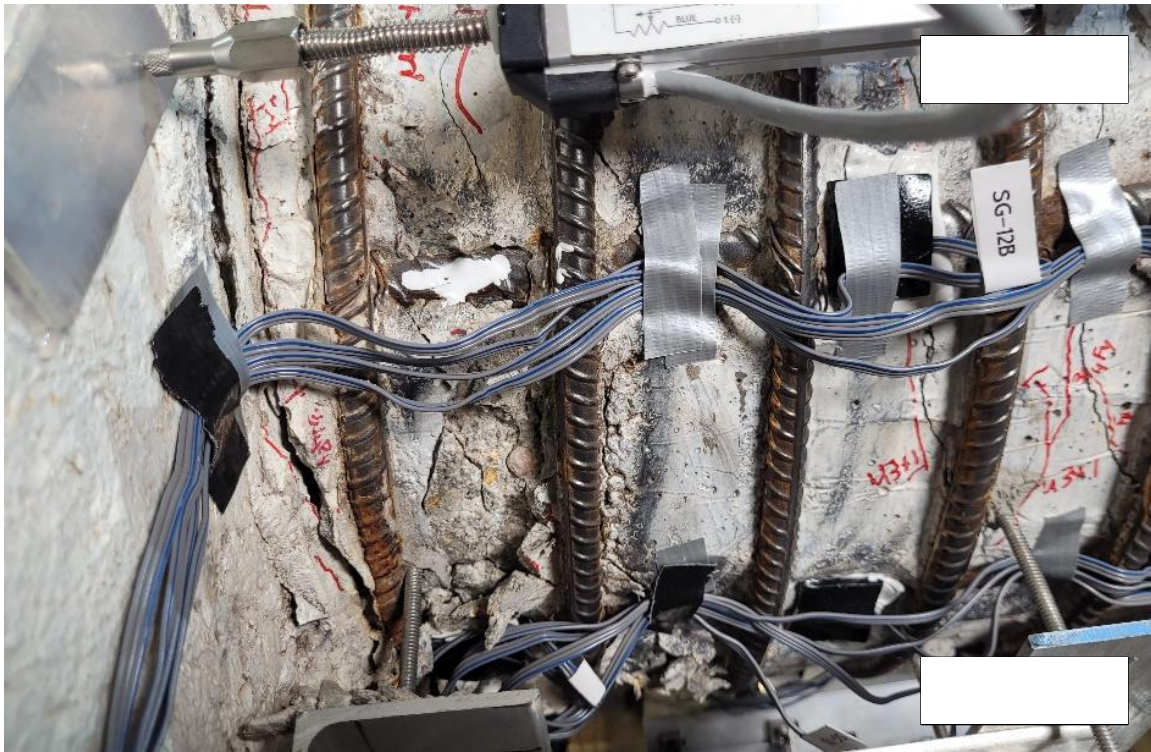
Figure 5-47 Third cycle of  $\mu_4$  (pulling): Cracks are widening at the base of the footing.

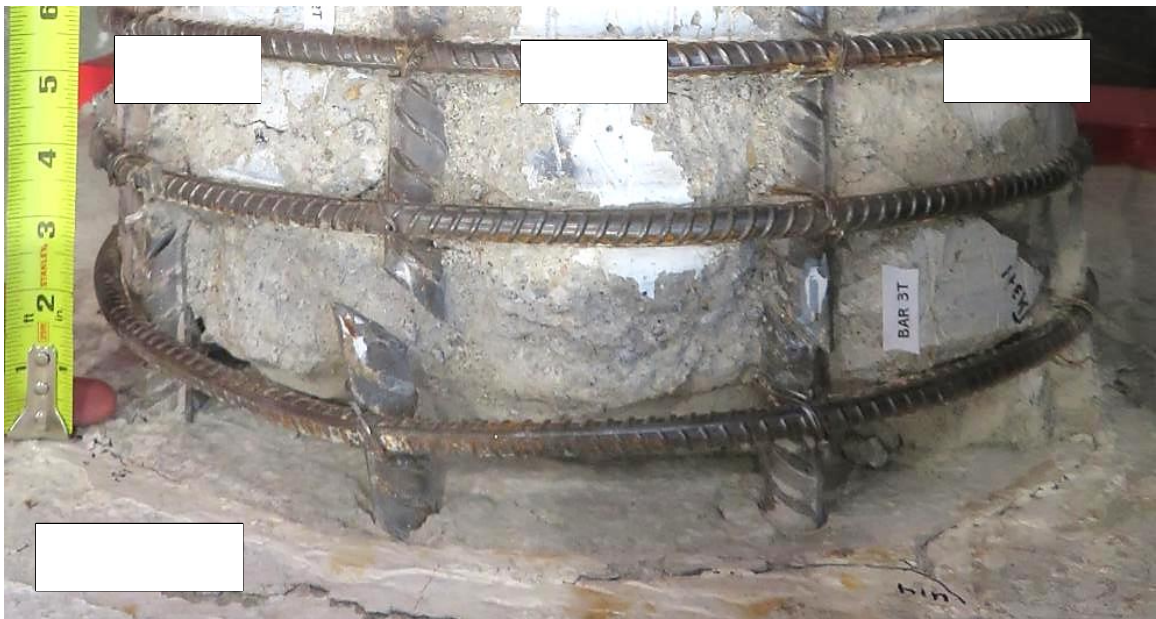
Figure 5-51 Damage at the top of the column along the plastic hinge: Fracture of bars 1T, 2T, and 3T, and concrete core crushing.

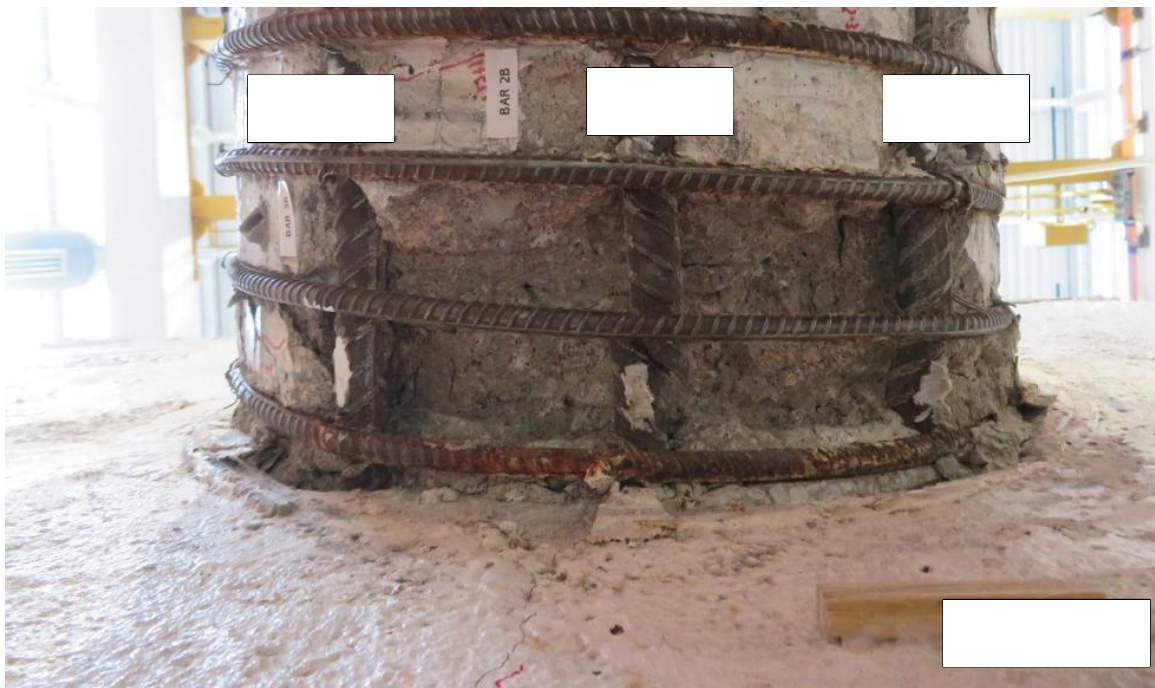
Figure 5-52 Damage at the bottom of the column: Fracture of bar 2B, concrete core crushing.

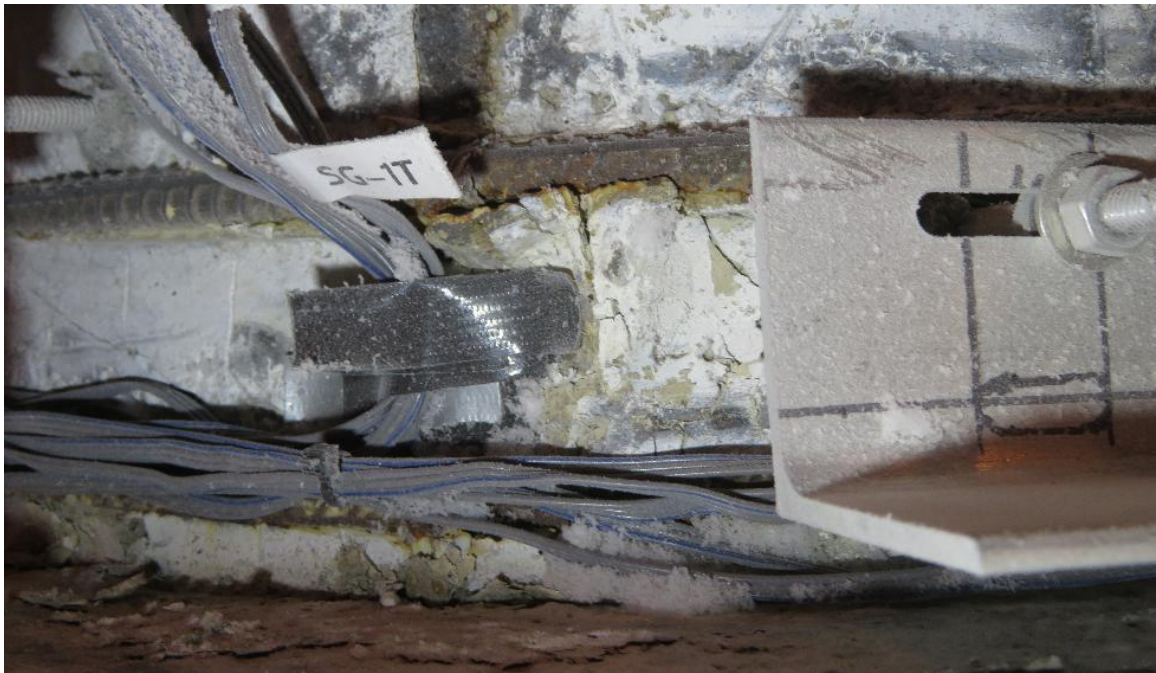
Figure 5-63 First cycle of  $\mu_4$  (pulling). Initiation of concrete crushing

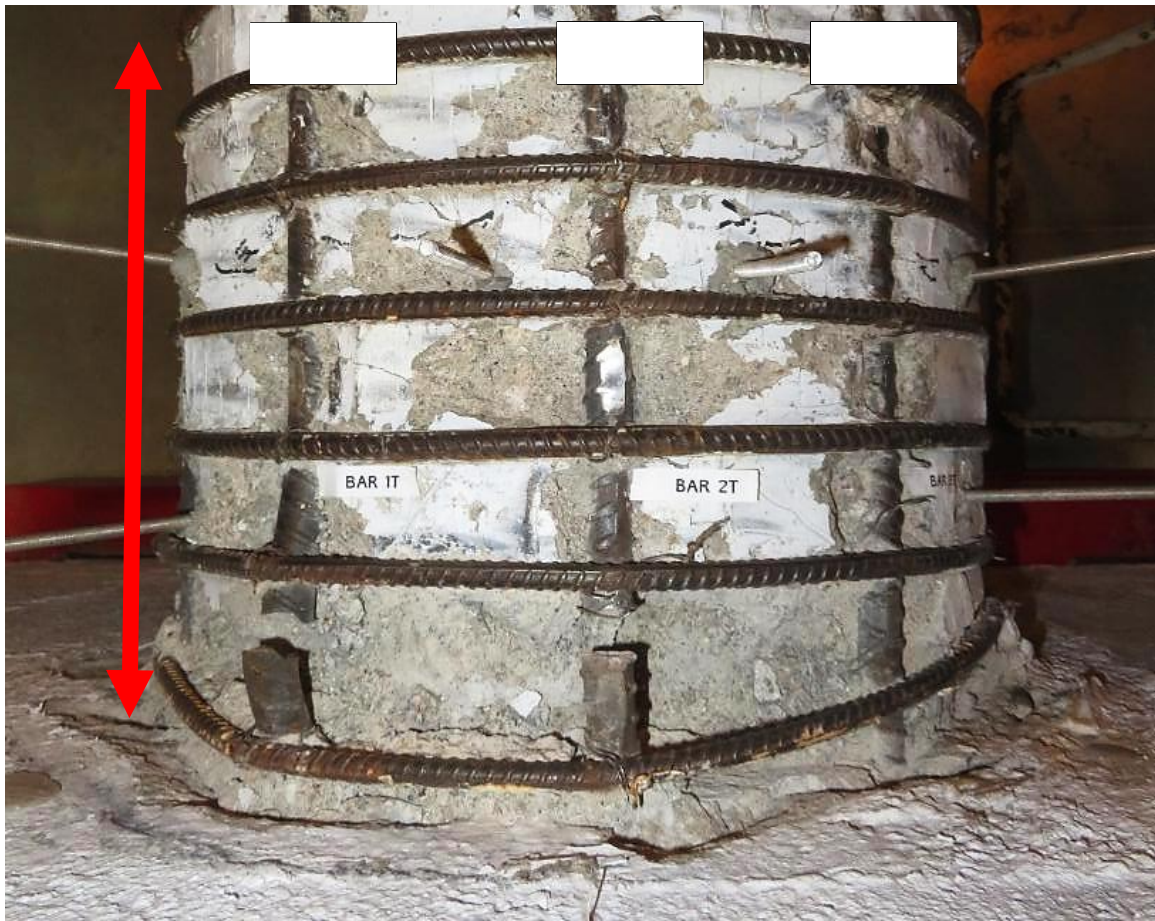
Figure 5-68 Damage at the top of the column along the plastic hinge: Fracture of bars 1T and 2T, and concrete core crushing.

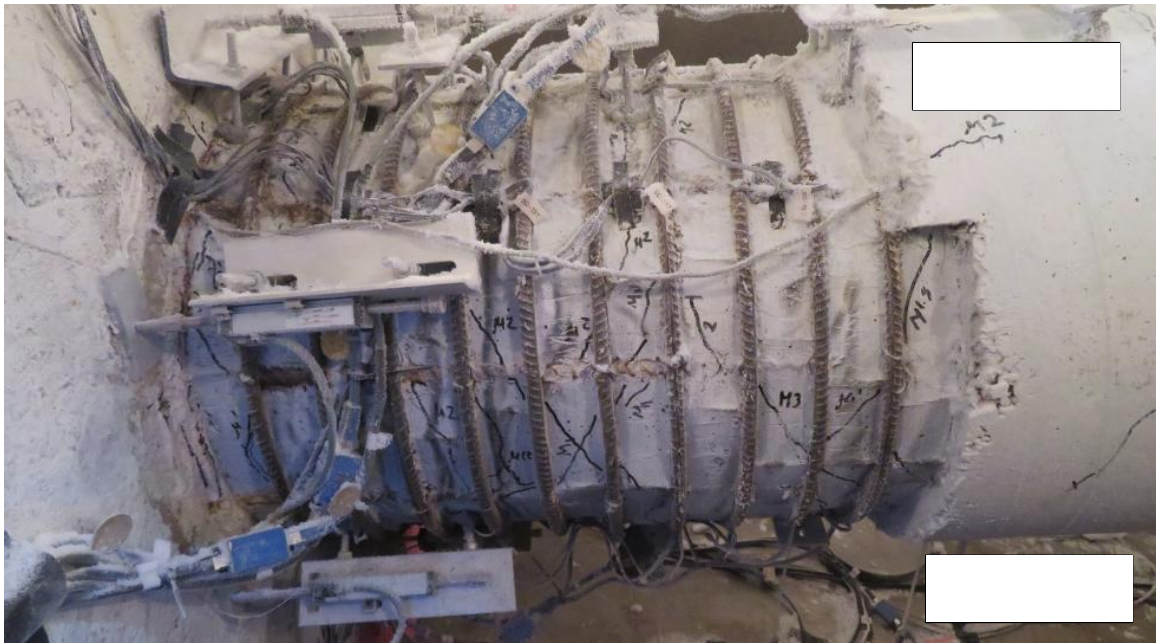
Figure 5-79 First cycle of  $\mu_3$  (pushing) visible shear cracks and extension of existing cracks

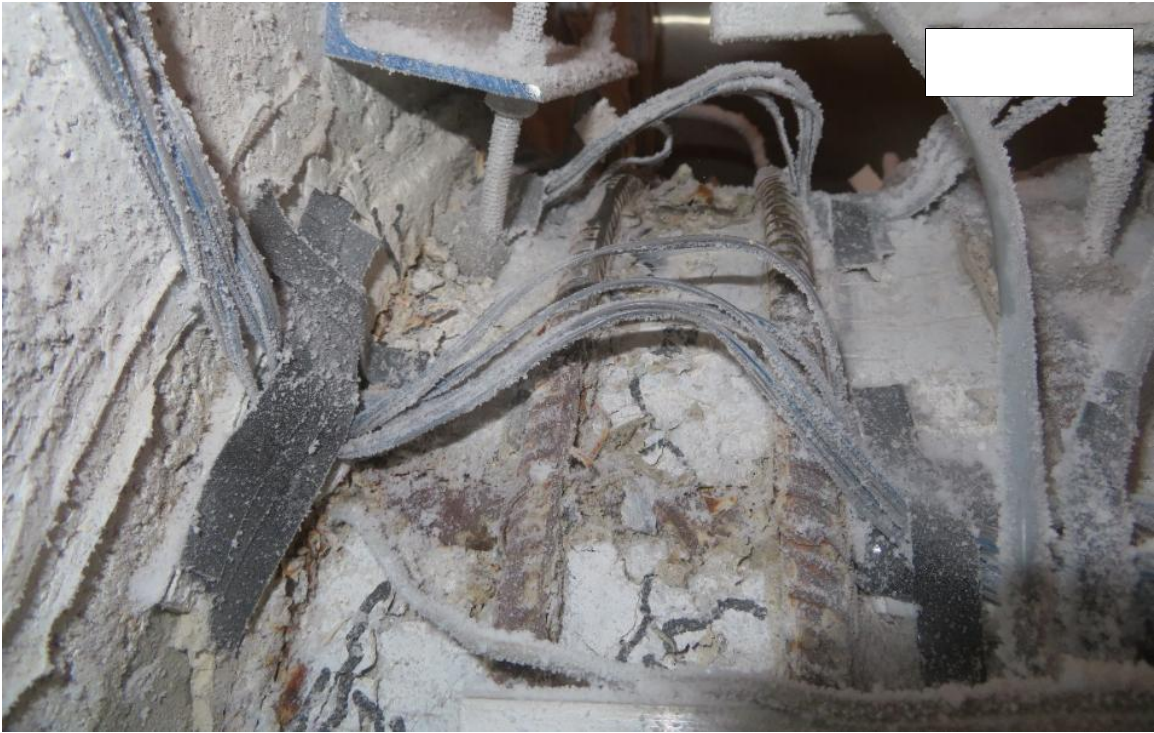
Figure 5-81 First cycle of  $\mu_4$  (pulling): Concrete crushing

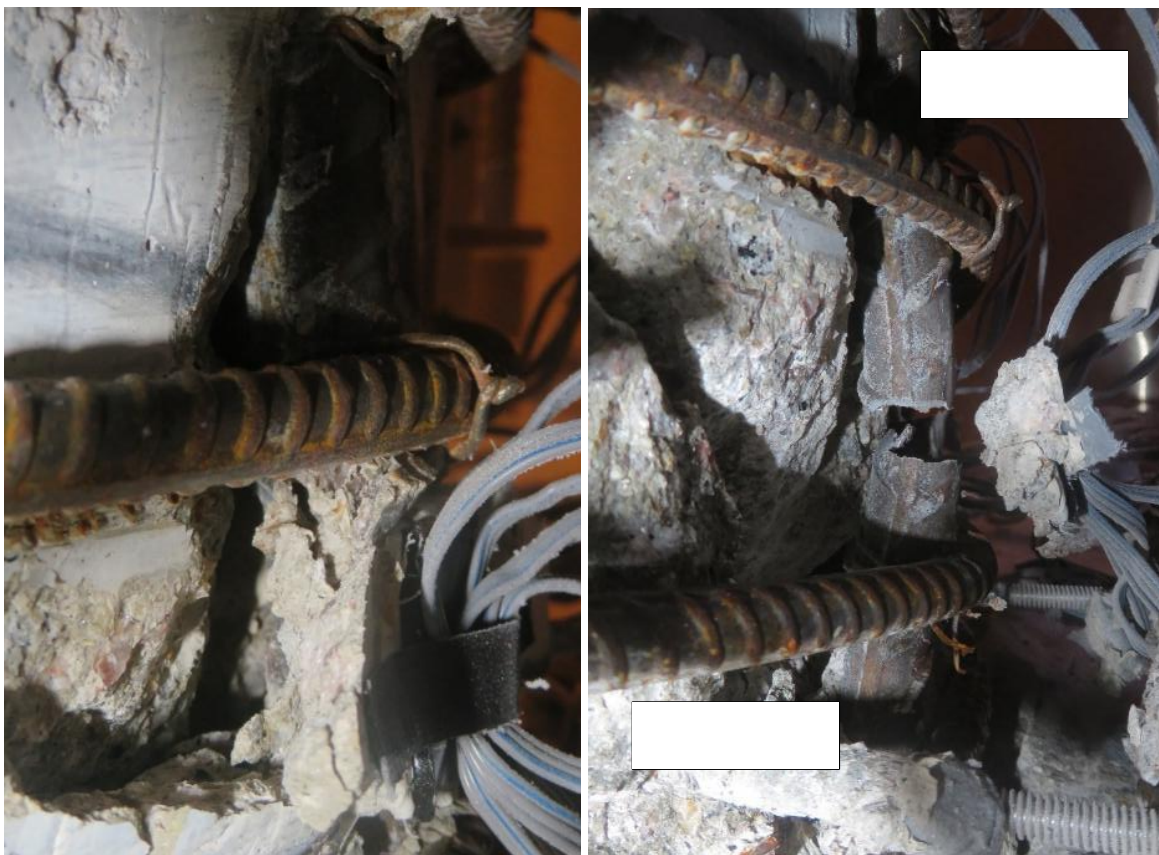
Figure 5-84 Bar buckling of the extreme bottom bar 2B at the first pushing cycle of  $\mu 5$  and fracture of the bar 2B at the third pulling cycle  $\mu 5$

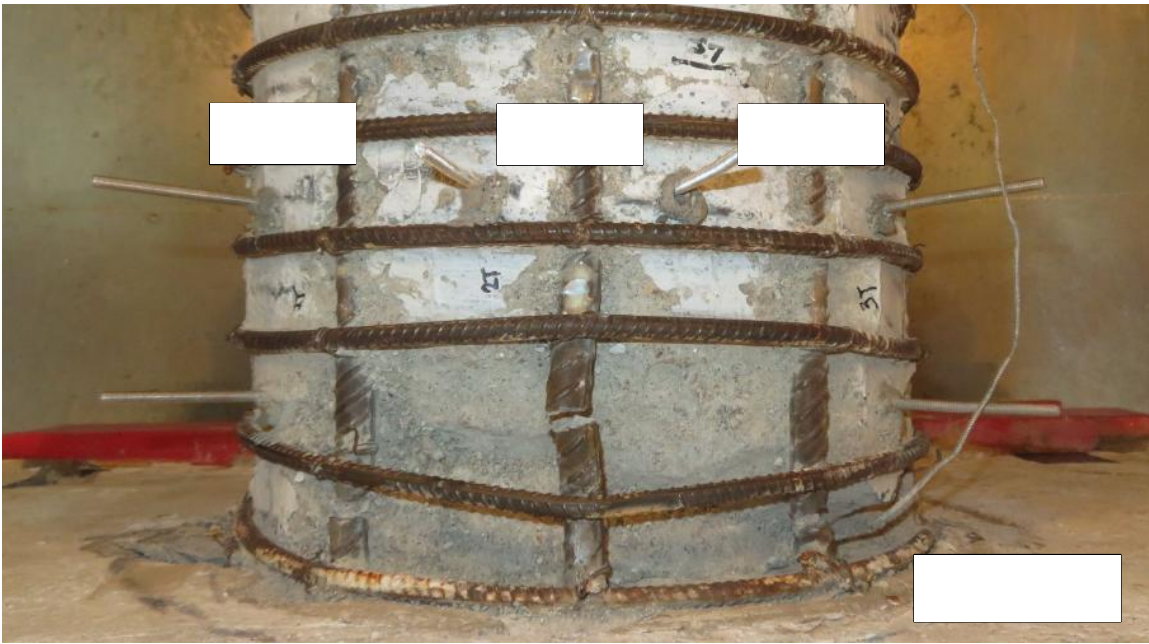
Figure 5-85 Damage at the top of the column along the plastic hinge: Fracture of bars 1T, 2T, and 3T, and concrete core crushing

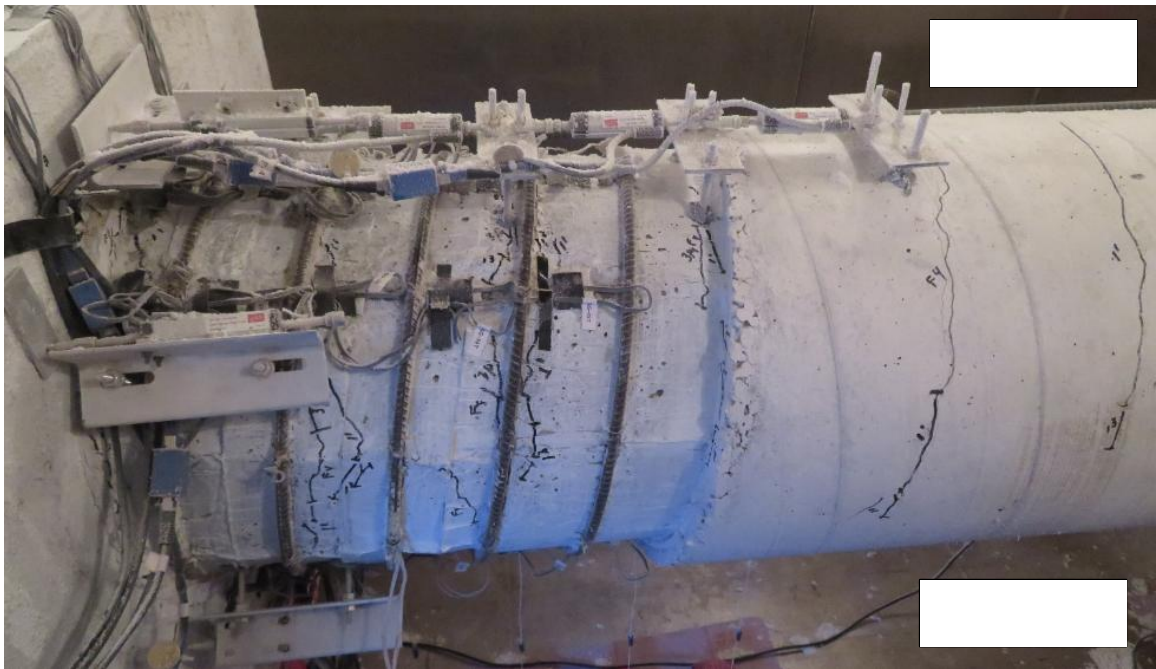
Figure 5-94 First cycle of  $\mu_1$  (pushing): Extension of cracks

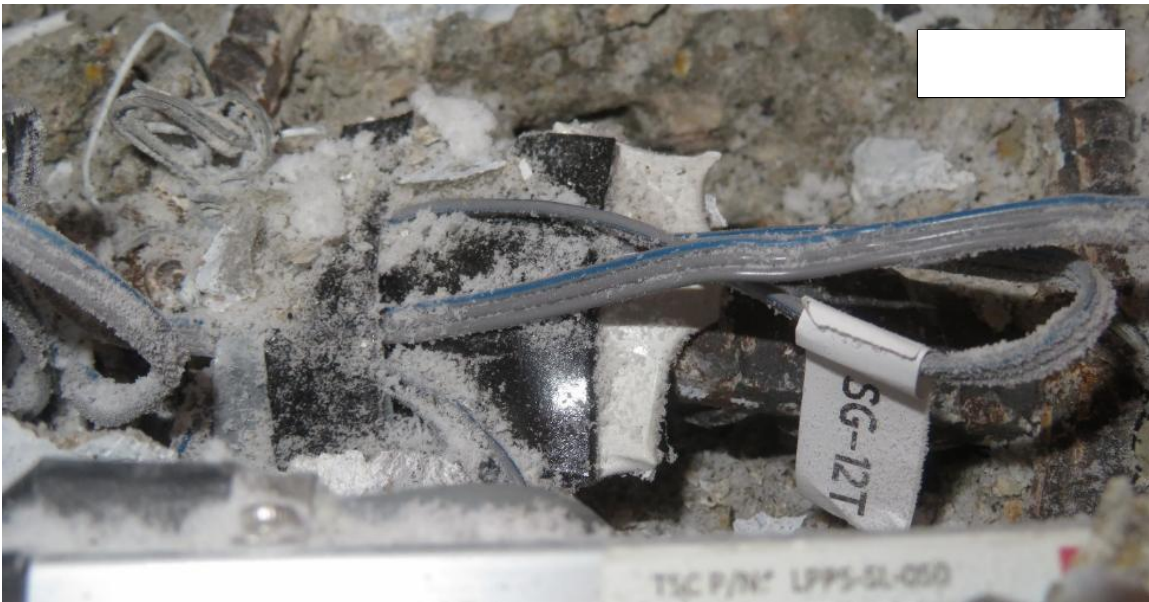
Figure 5-100 Third pulling cycle of  $\mu 5$ : Visible buckling of adjacent bar to top bar, 3T

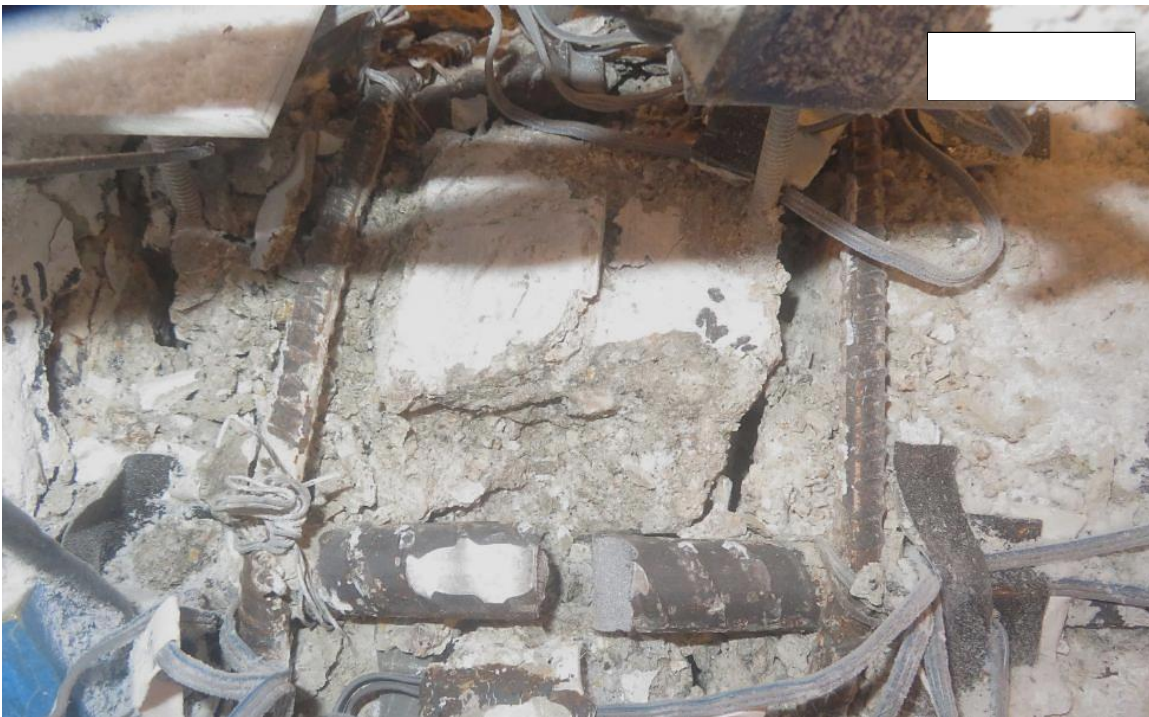
Figure 5-101 Third pushing cycle of  $\mu 5$ : Bar fracture of bottom bar, 3B

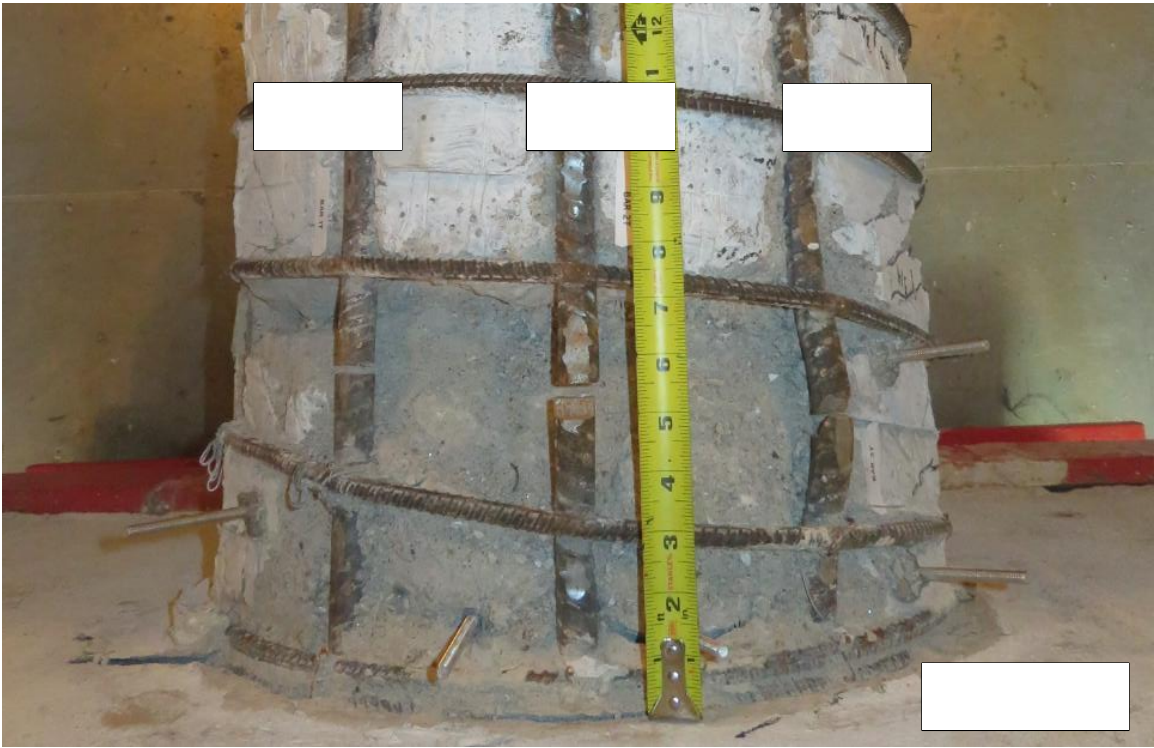
Figure 5-102 Damage at the top of the column along the plastic hinge: Fracture of bars 1T, 2T, and 3T, and concrete core crushing

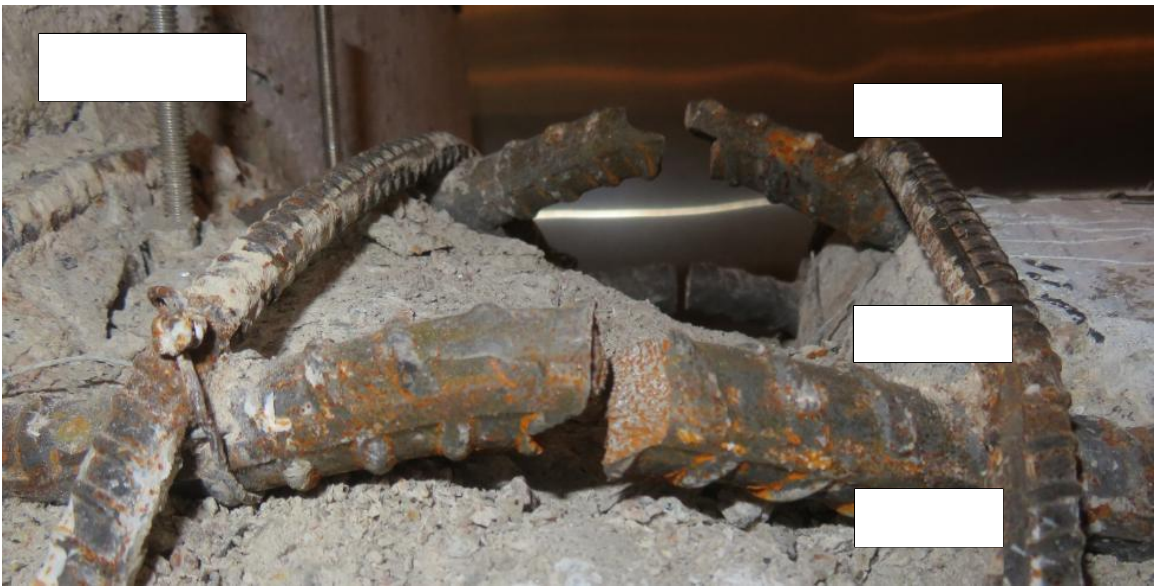
Figure 5-103 Brittle fracture surface of top bars (1T, 2T, and 3T)

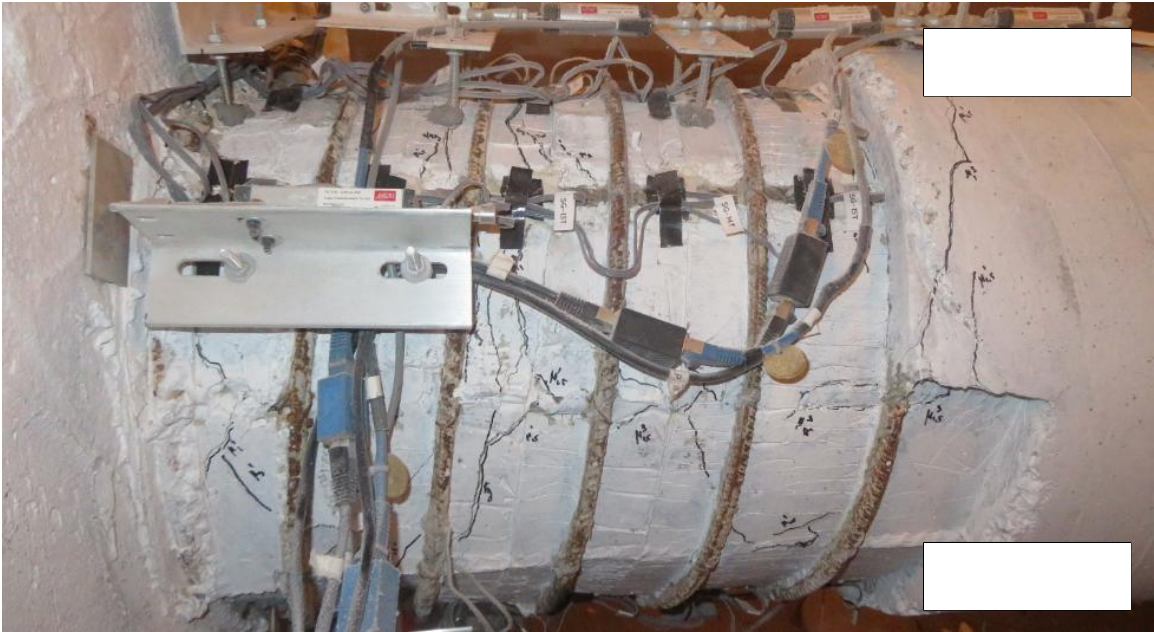
Figure 5-114 Third pushing cycle of  $\mu 1.5$ : Extension of cracks and formation of some shear cracks

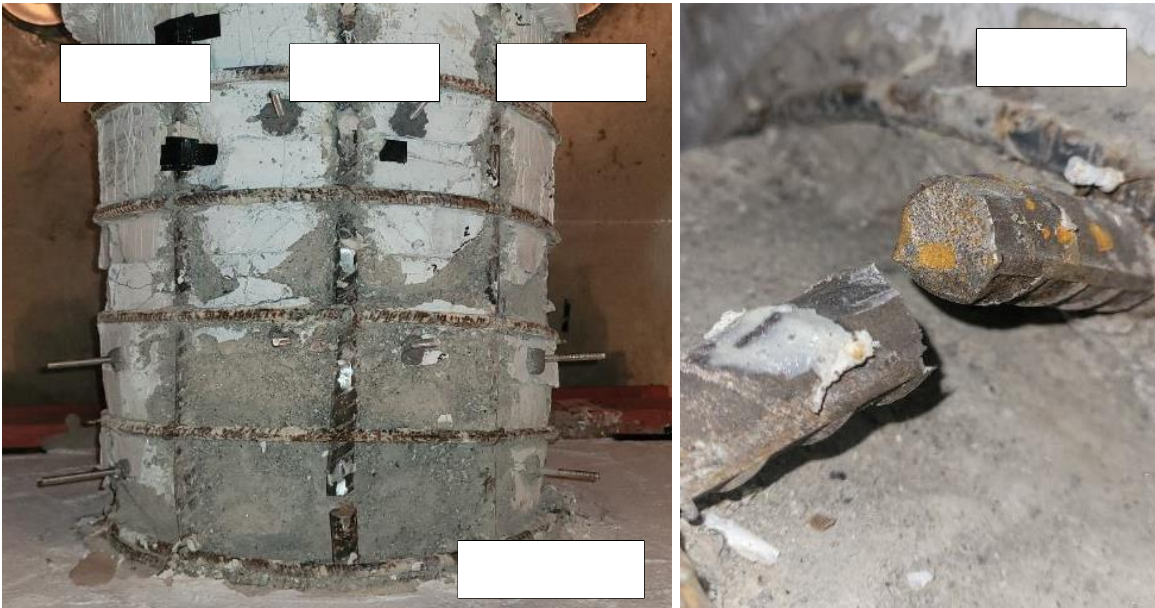
Figure 5-121 Damage at the top of the column along the plastic hinge: Fracture of bar 2T and concrete core crushing
