HOONAH AIRPORT

2004 Alaska Airport Pavement Condition Report

HOONAH AIRPORT - 2004

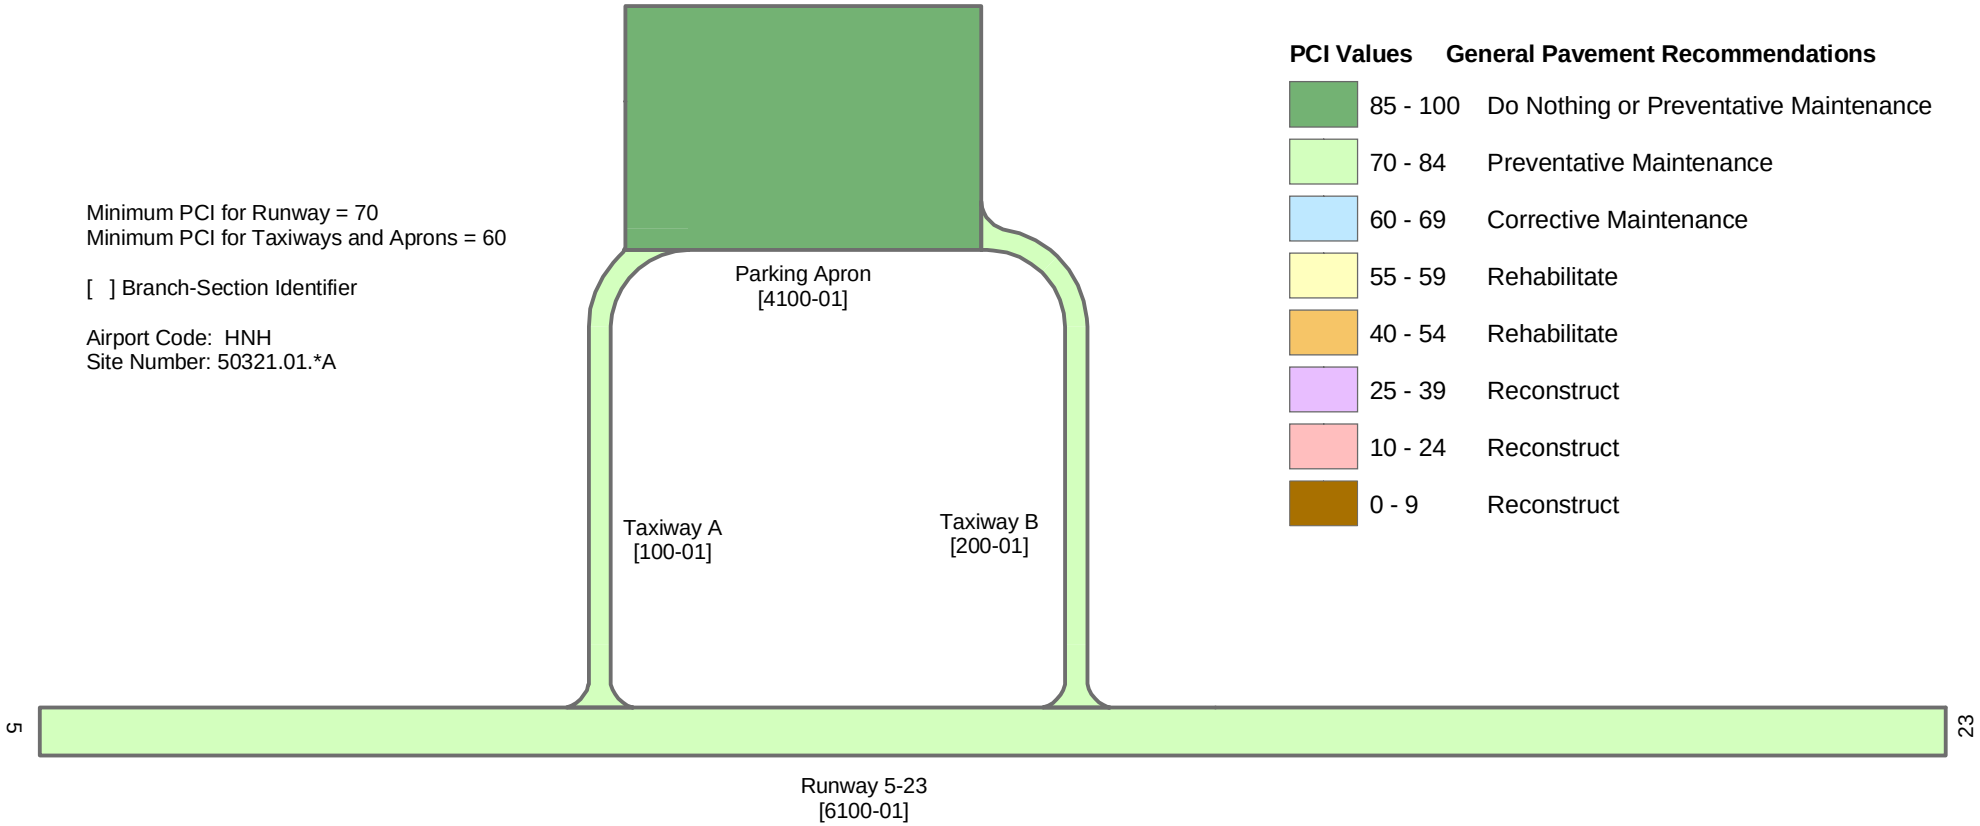
Pavement Condition Index (PCI)
Measured Values for the Year 2003

Minimum PCI for Runway = 70
Minimum PCI for Taxiways and Aprons = 60

- **Recommendations:** Maintain pavement by crack sealing cracks wider than ¼" and patching as needed.
