YUKON RIVER BRIDGE USE
RISK ANALYSIS CRITERIA DEVELOPMENT

Peratrovich & Nottingham, Inc.
Anchorage, Alaska

1981

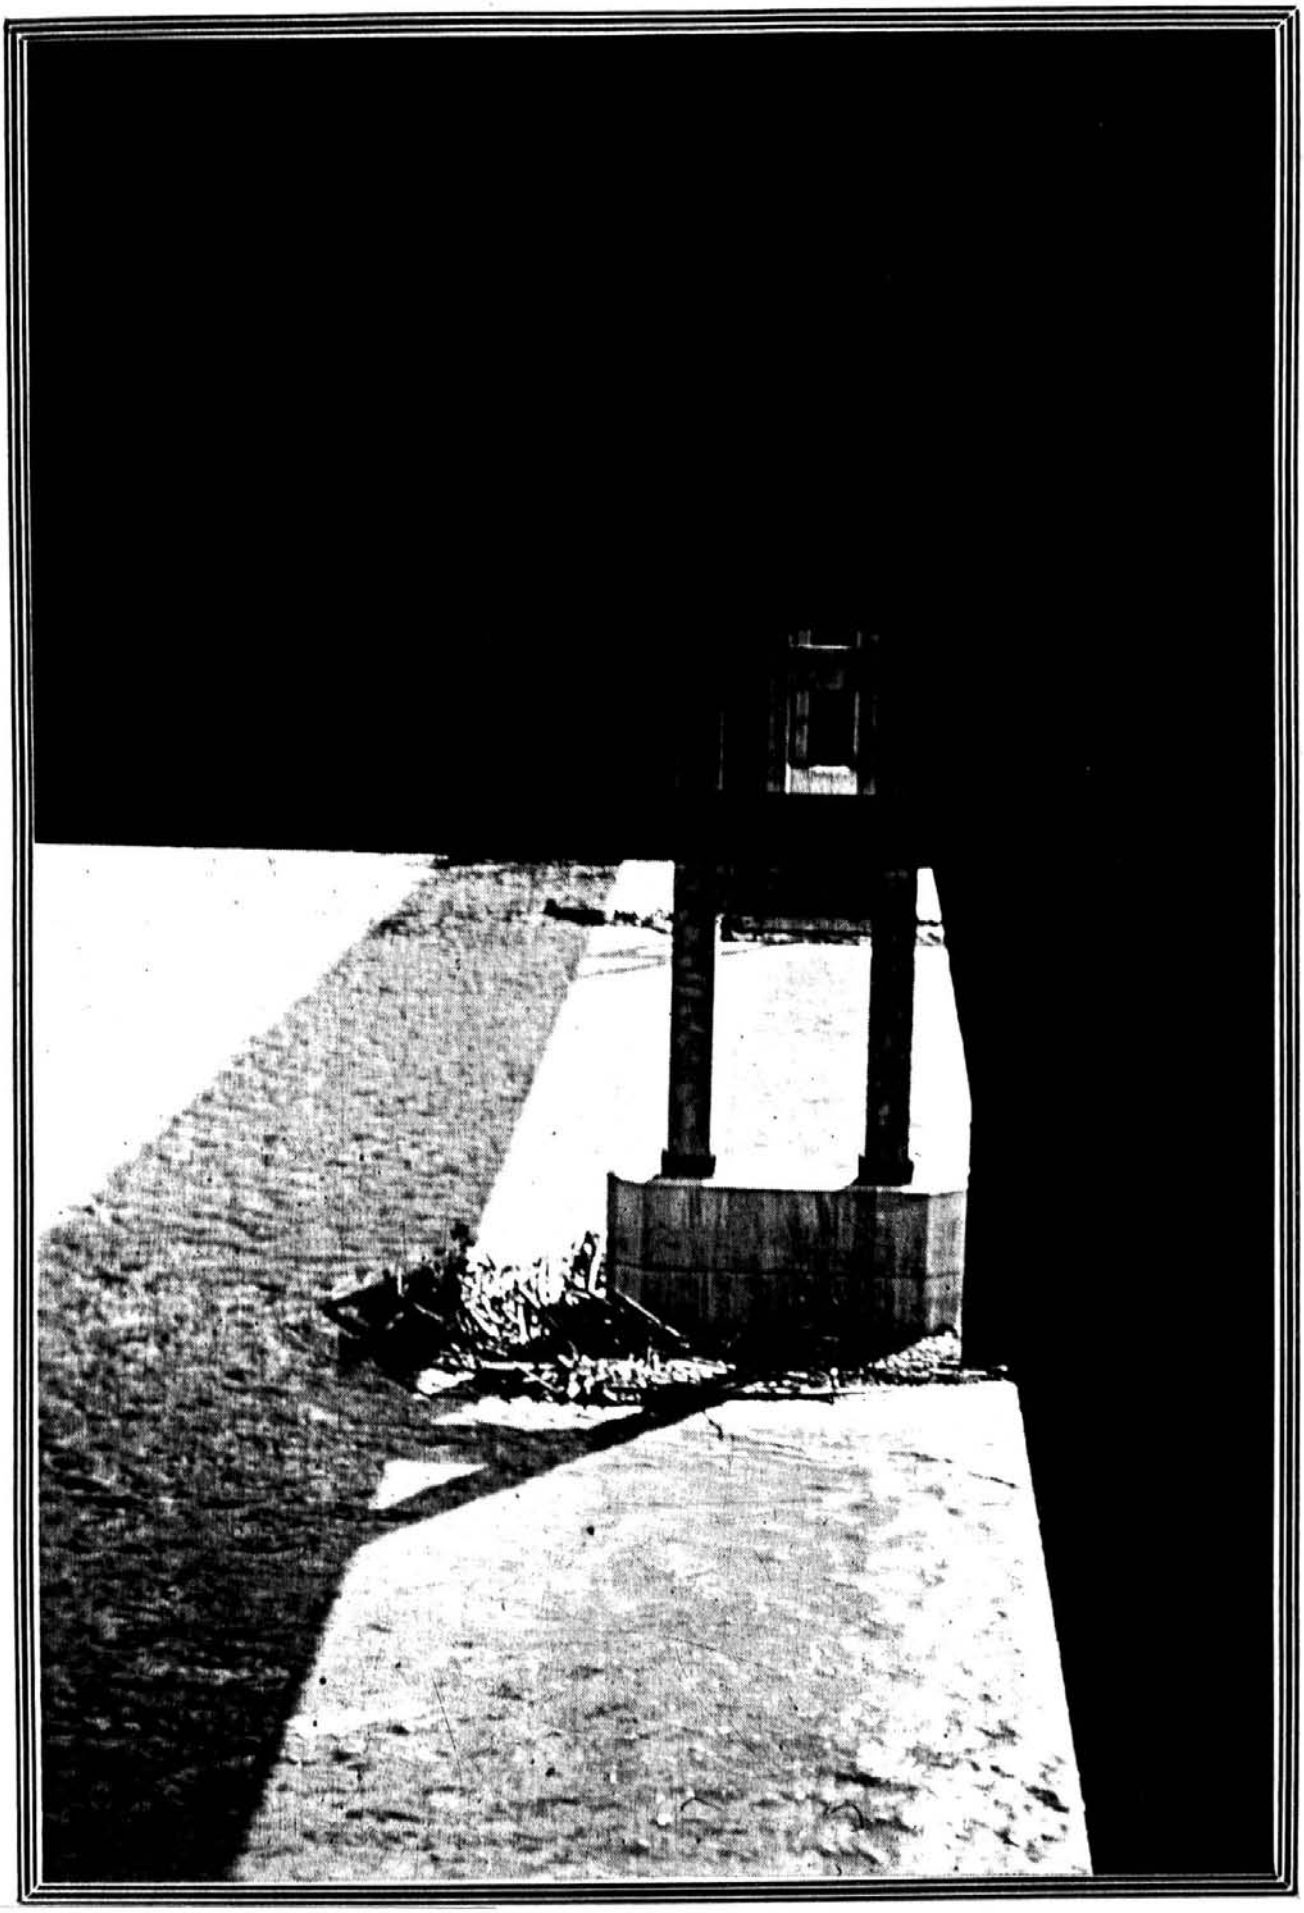
ILLUSTRATION No. 3

This photo shows drift accumulation ± 80 feet wide at a river pier, and the bridge underside with catwalks and other details.

Drift accumulation of this nature can increase foundation scour potential. Assessment of foundation performance using geophysical methods during winter ice cover would help address this potential and confirm performance to date.

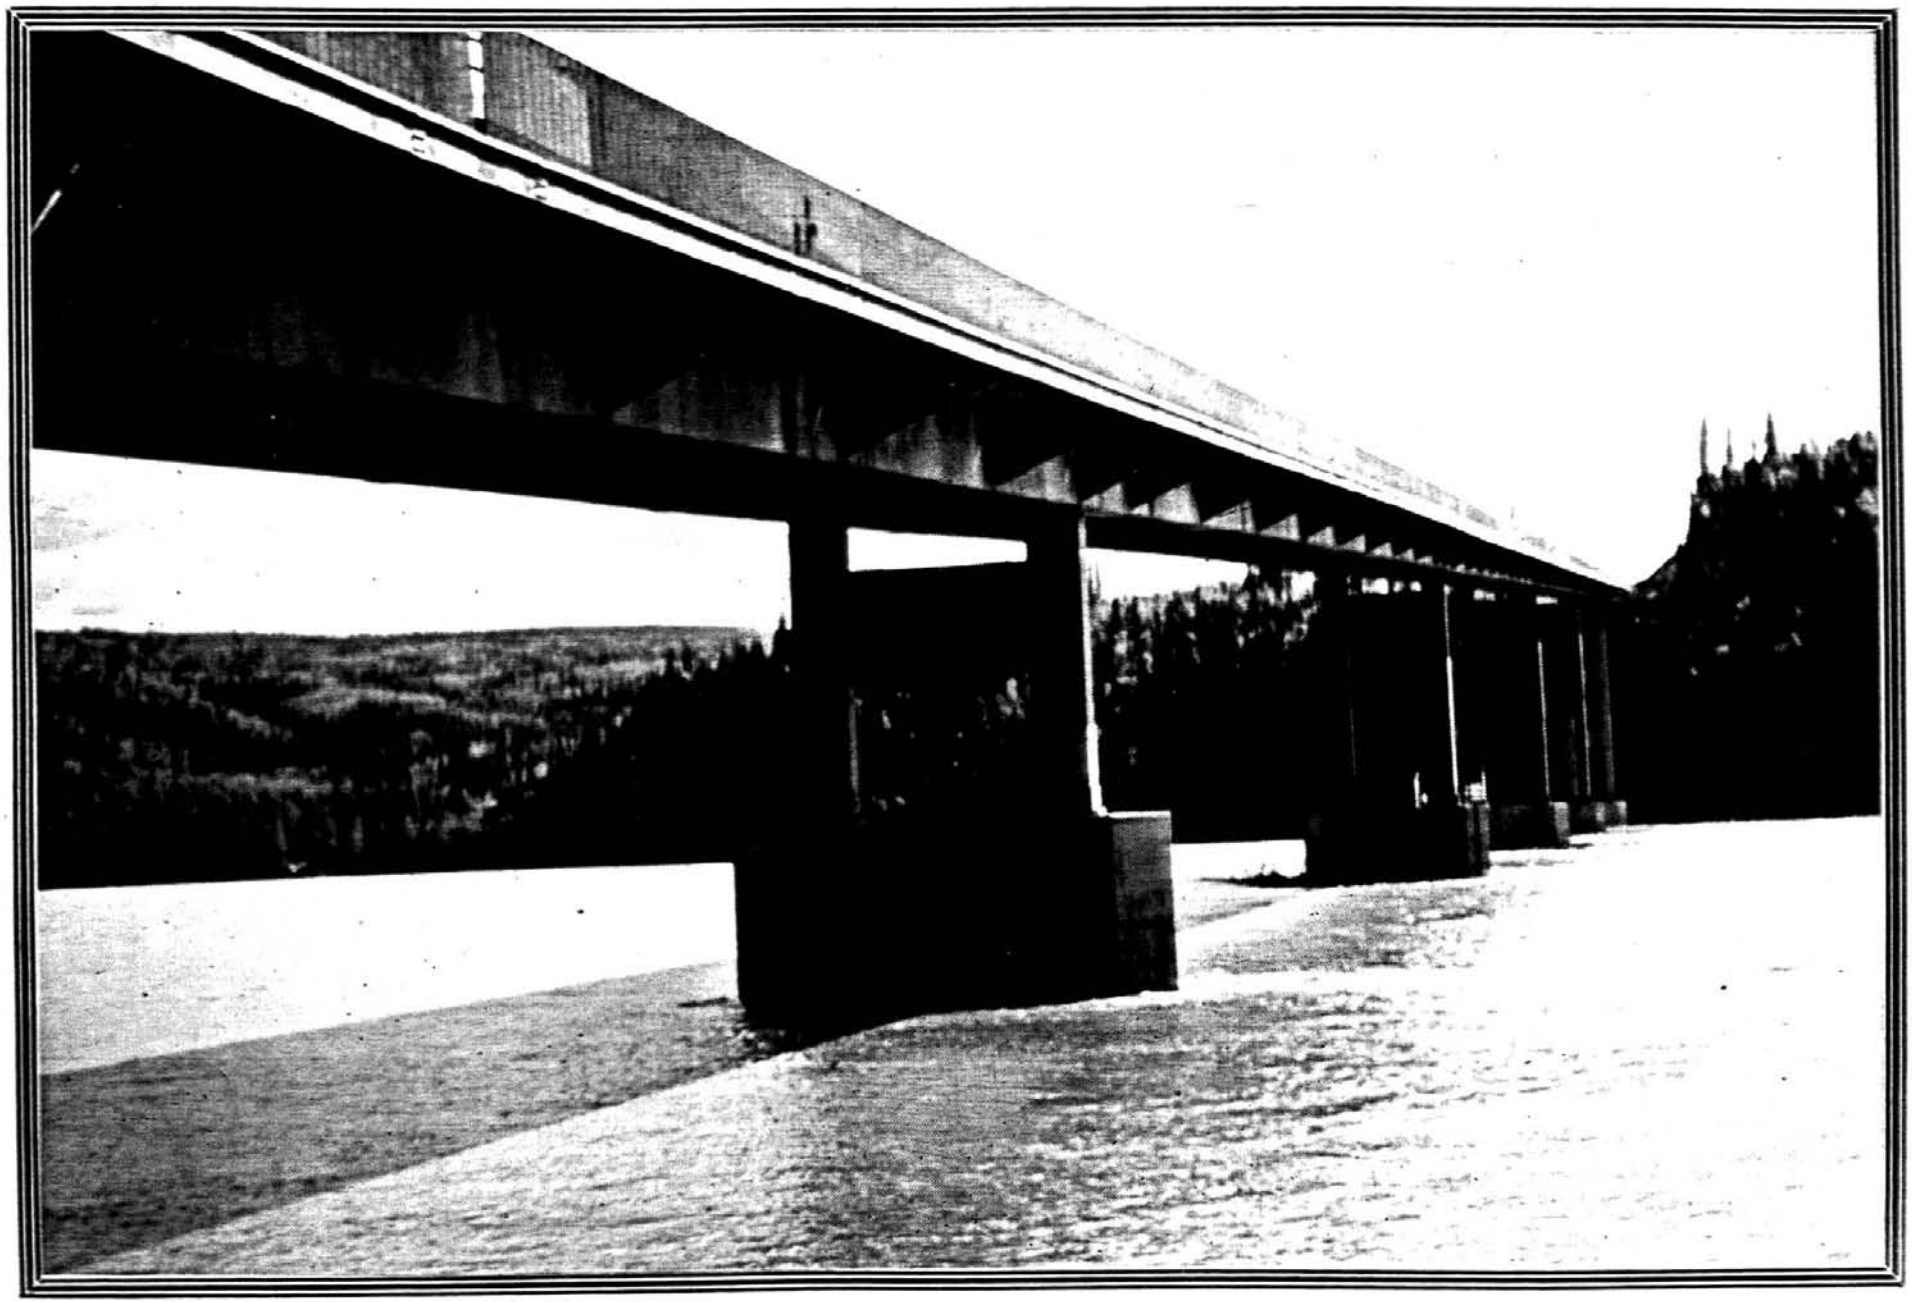
ILLUSTRATION No. 4

This photo of the completed bridge looks south. Readily apparent on the horizon is a ± 40-foot cut in frozen silt. Some deterioration of this cut has been noted during bridge inspection, which demonstrates the critical nature of future design and construction on or around this land form.

Risk of slope failure with increased excavation is an important factor in all future design and assessment.

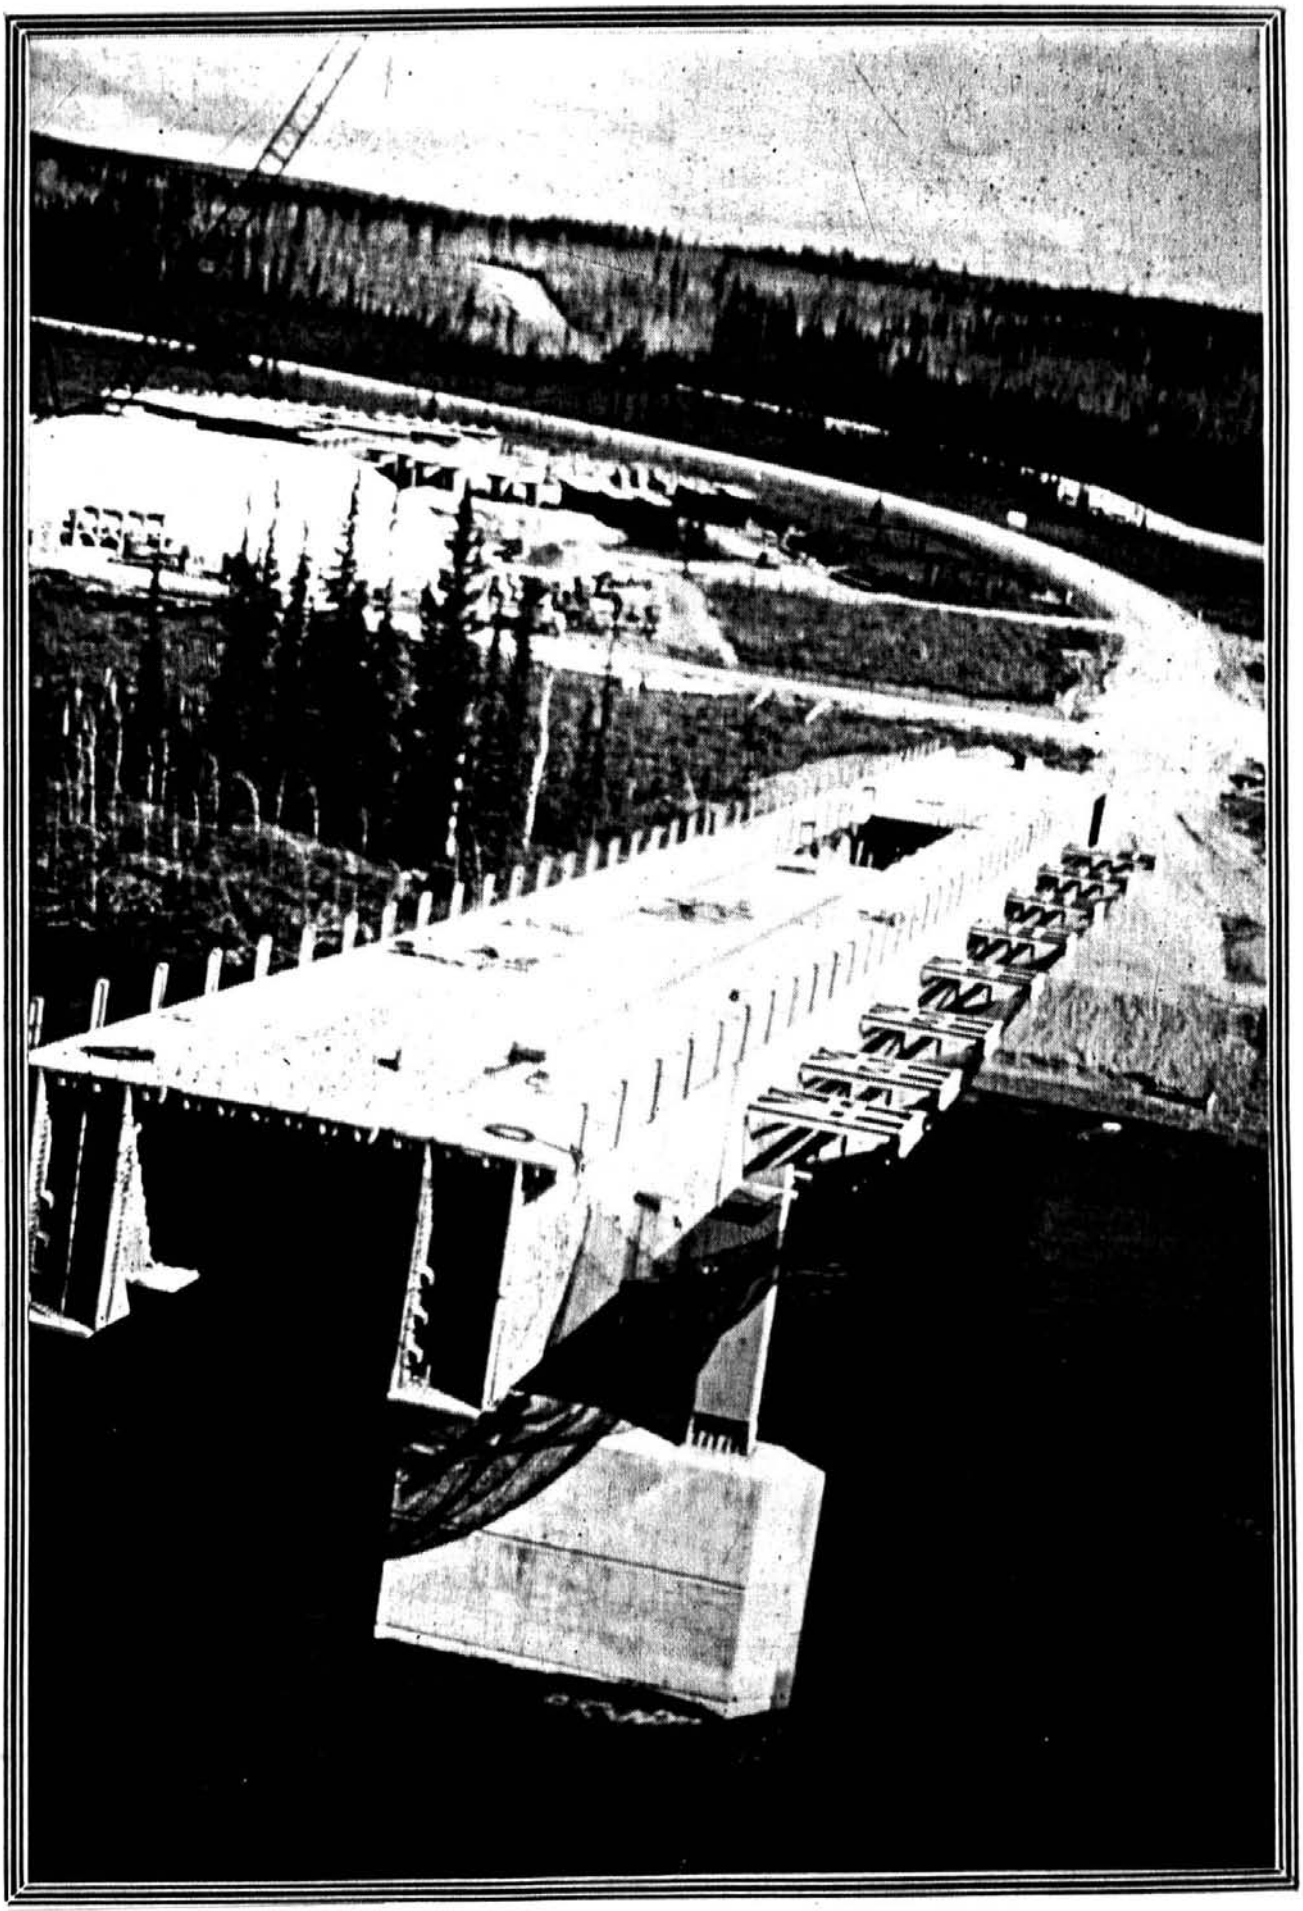
ILLUSTRATION No. 6

This photo further illustrates box girder construction and shows various details. The view also shows the north floodplain, composed of frozen silts overlying frozen gravel.

Project design flood levels are calculated to submerge box girder soffits by two feet at the north abutment.

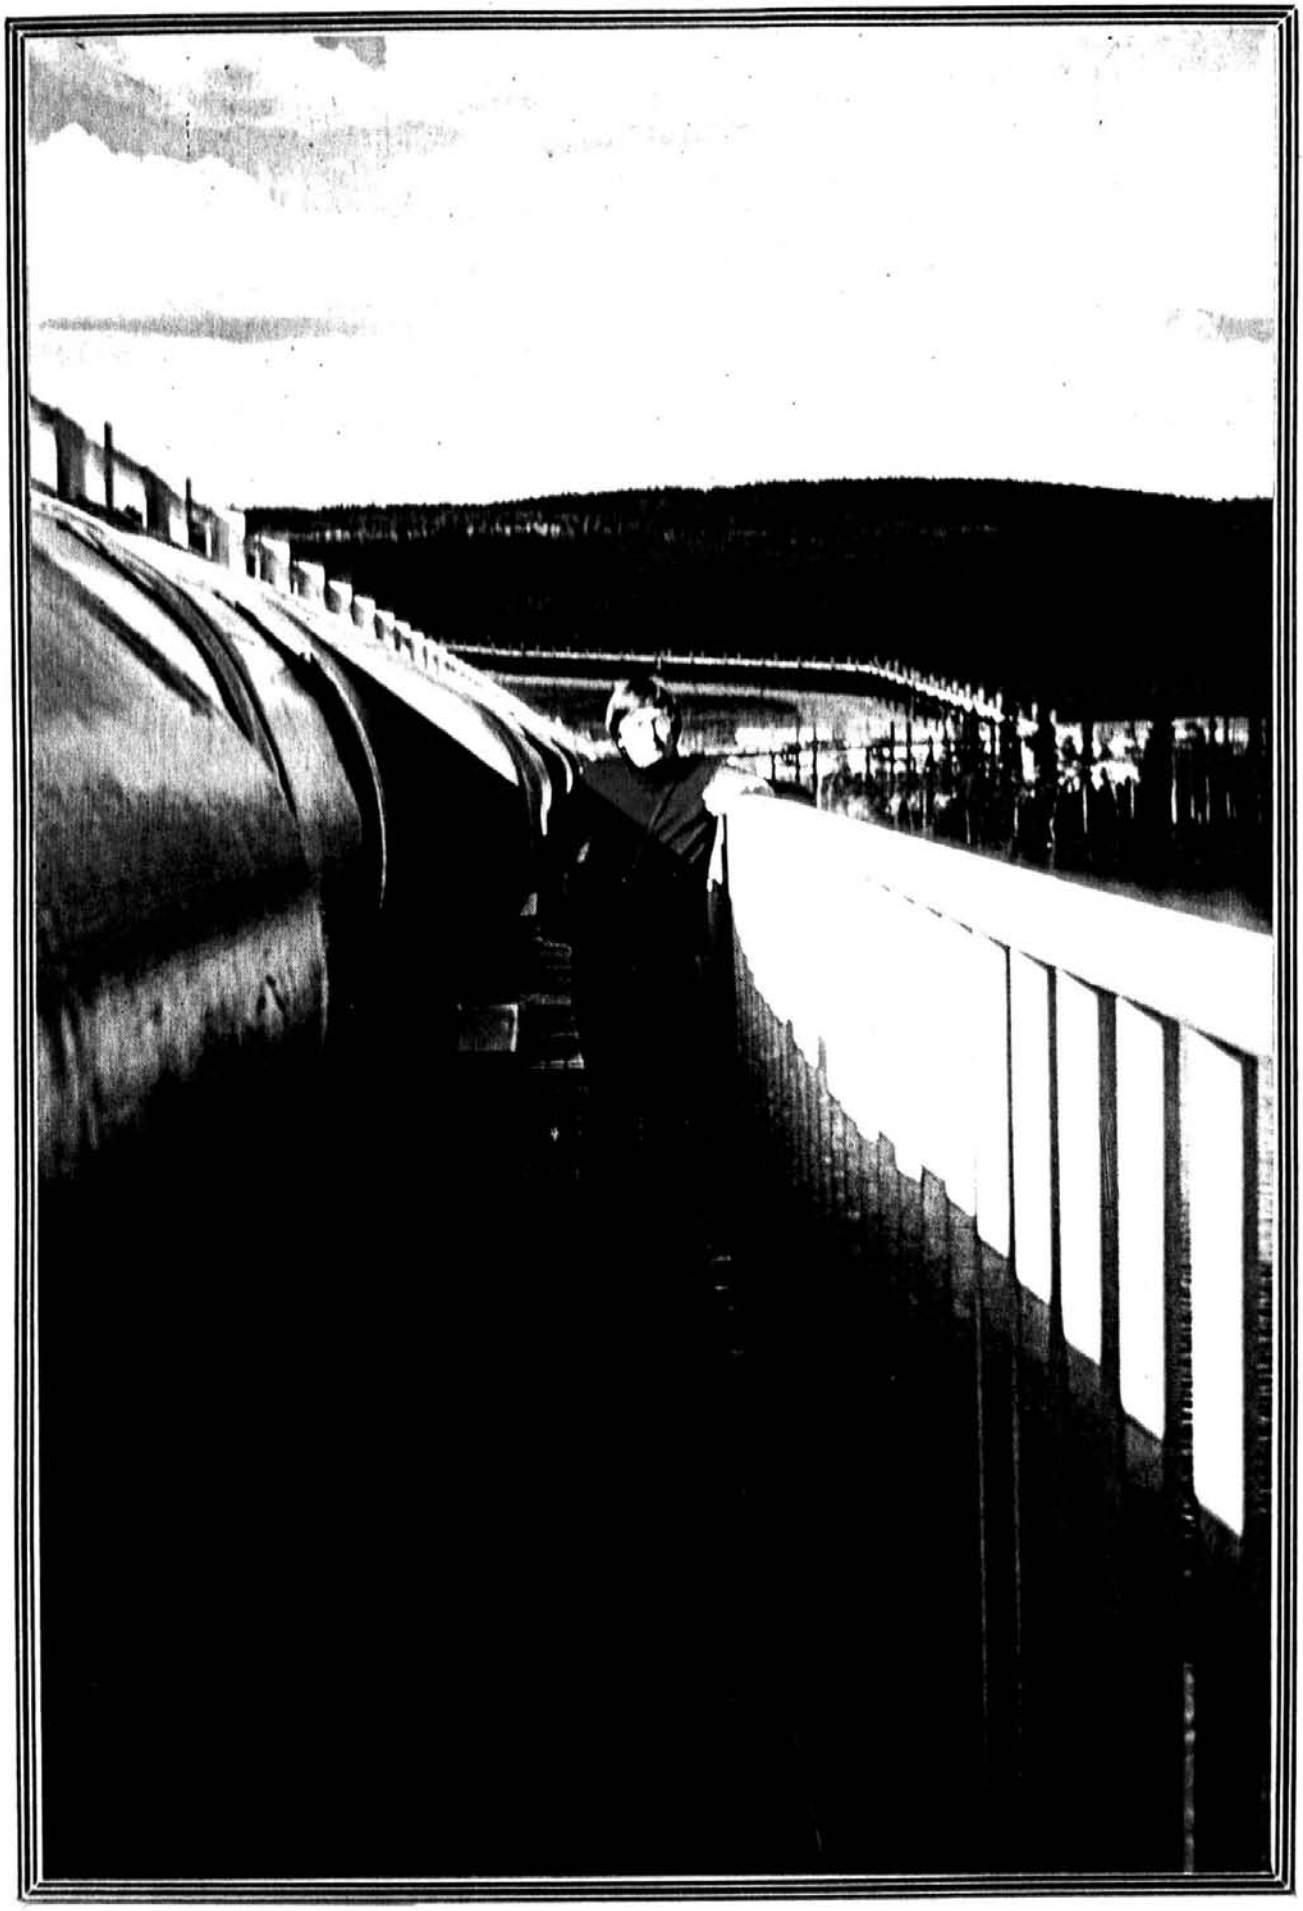
ILLUSTRATION No. 7

This photo shows the relative scale of oil pipeline supports and the oil line as constructed. A 4-foot roadway barrier rail can be seen at the top, while a 5-foot screen rail partially obscures the pipeline from a frontal view.

Since this photo was taken, various security devices and covers have been added, with some increase in dead load.

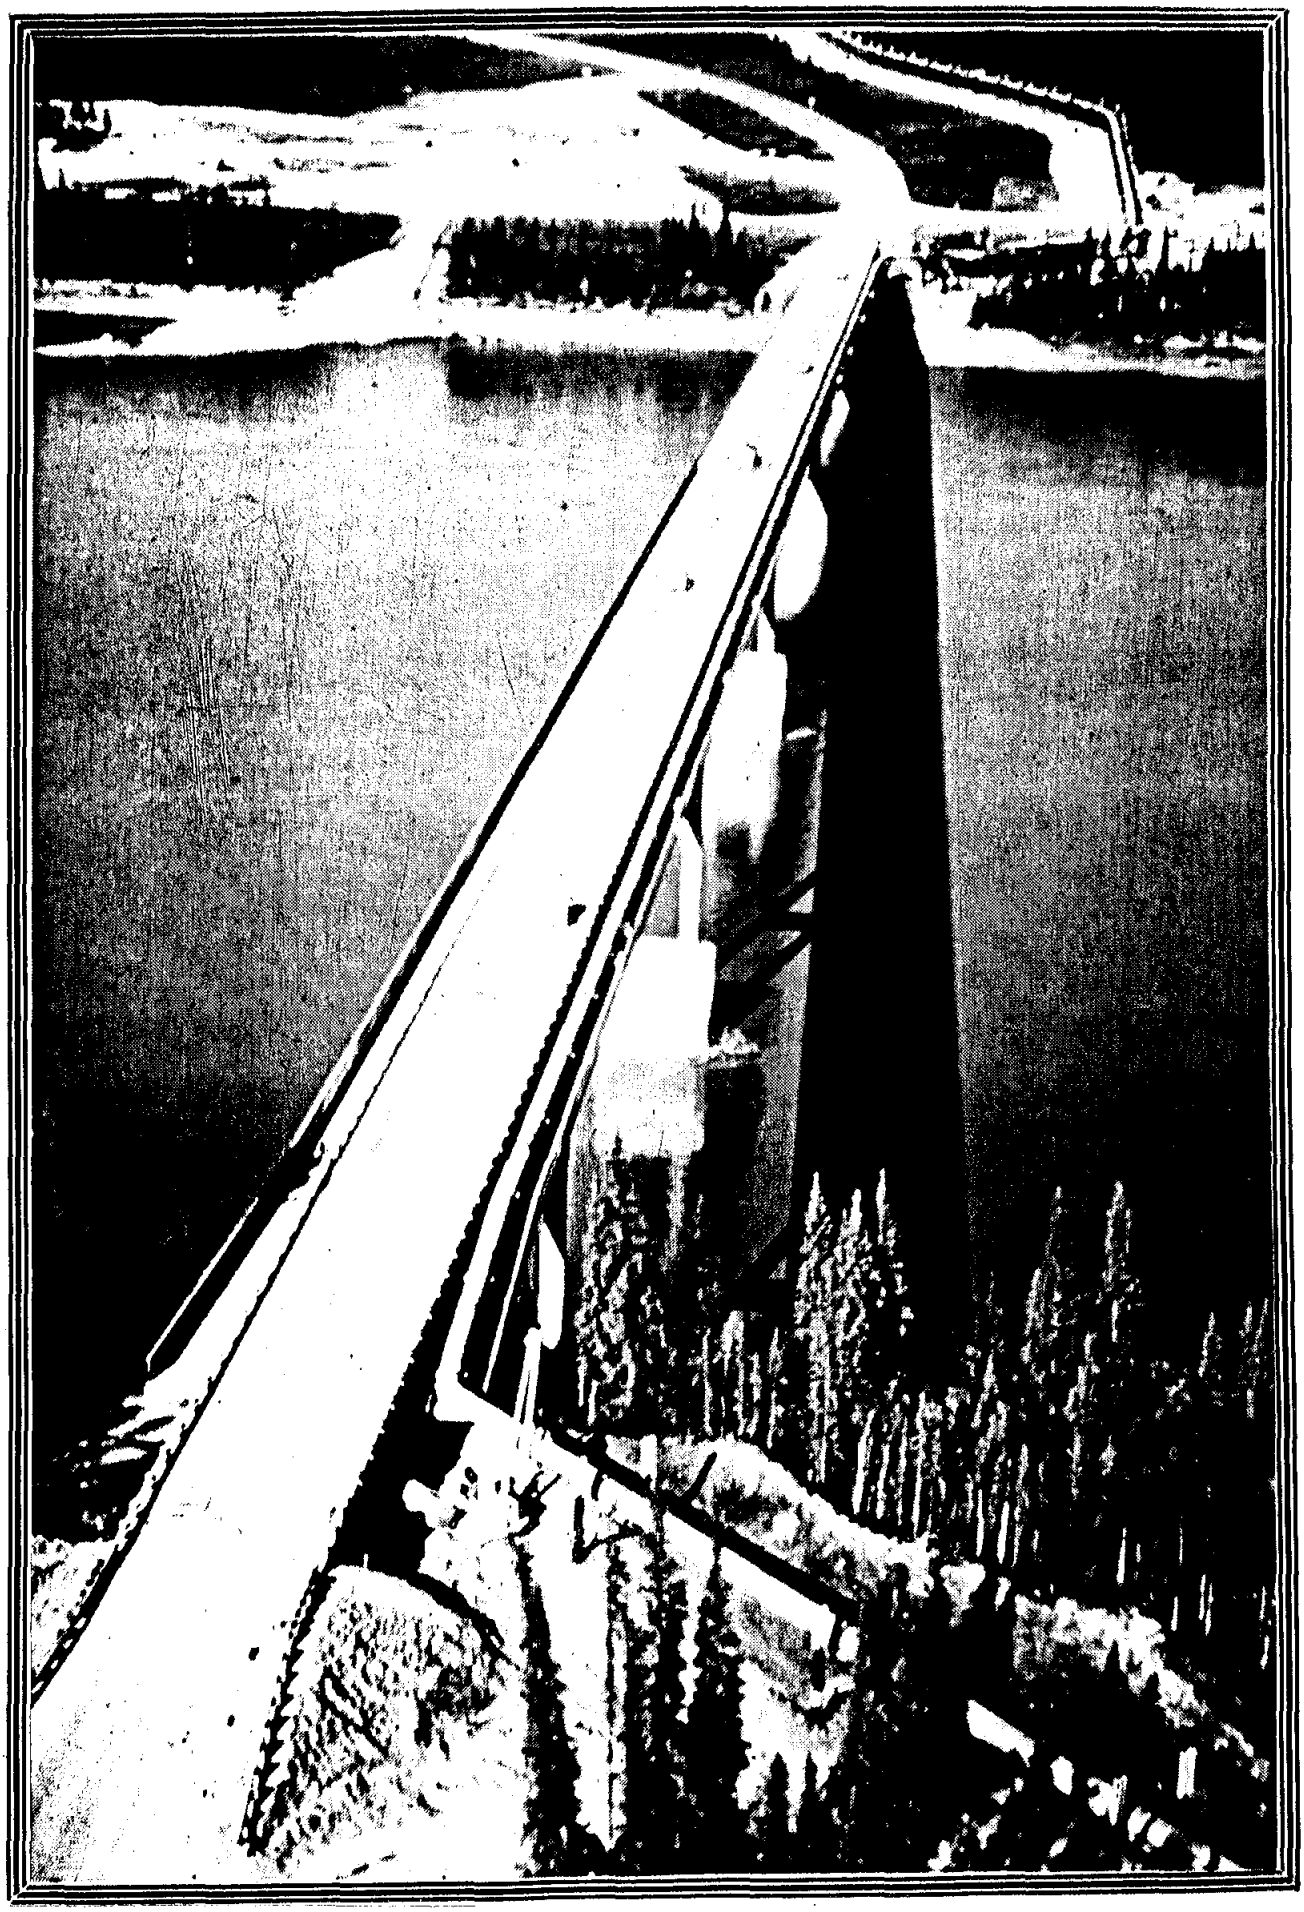
ILLUSTRATION No. 8

The bridge shortly after pipeline completion is shown here. Most geometrical features can be seen. Future oil line supports are visible on the left.

Presently a temporary timber wearing surface covers the orthotropic steel deck surface. Eventually, after most construction is finished, a suitable permanent surface (such as epoxy asphalt) is planned.

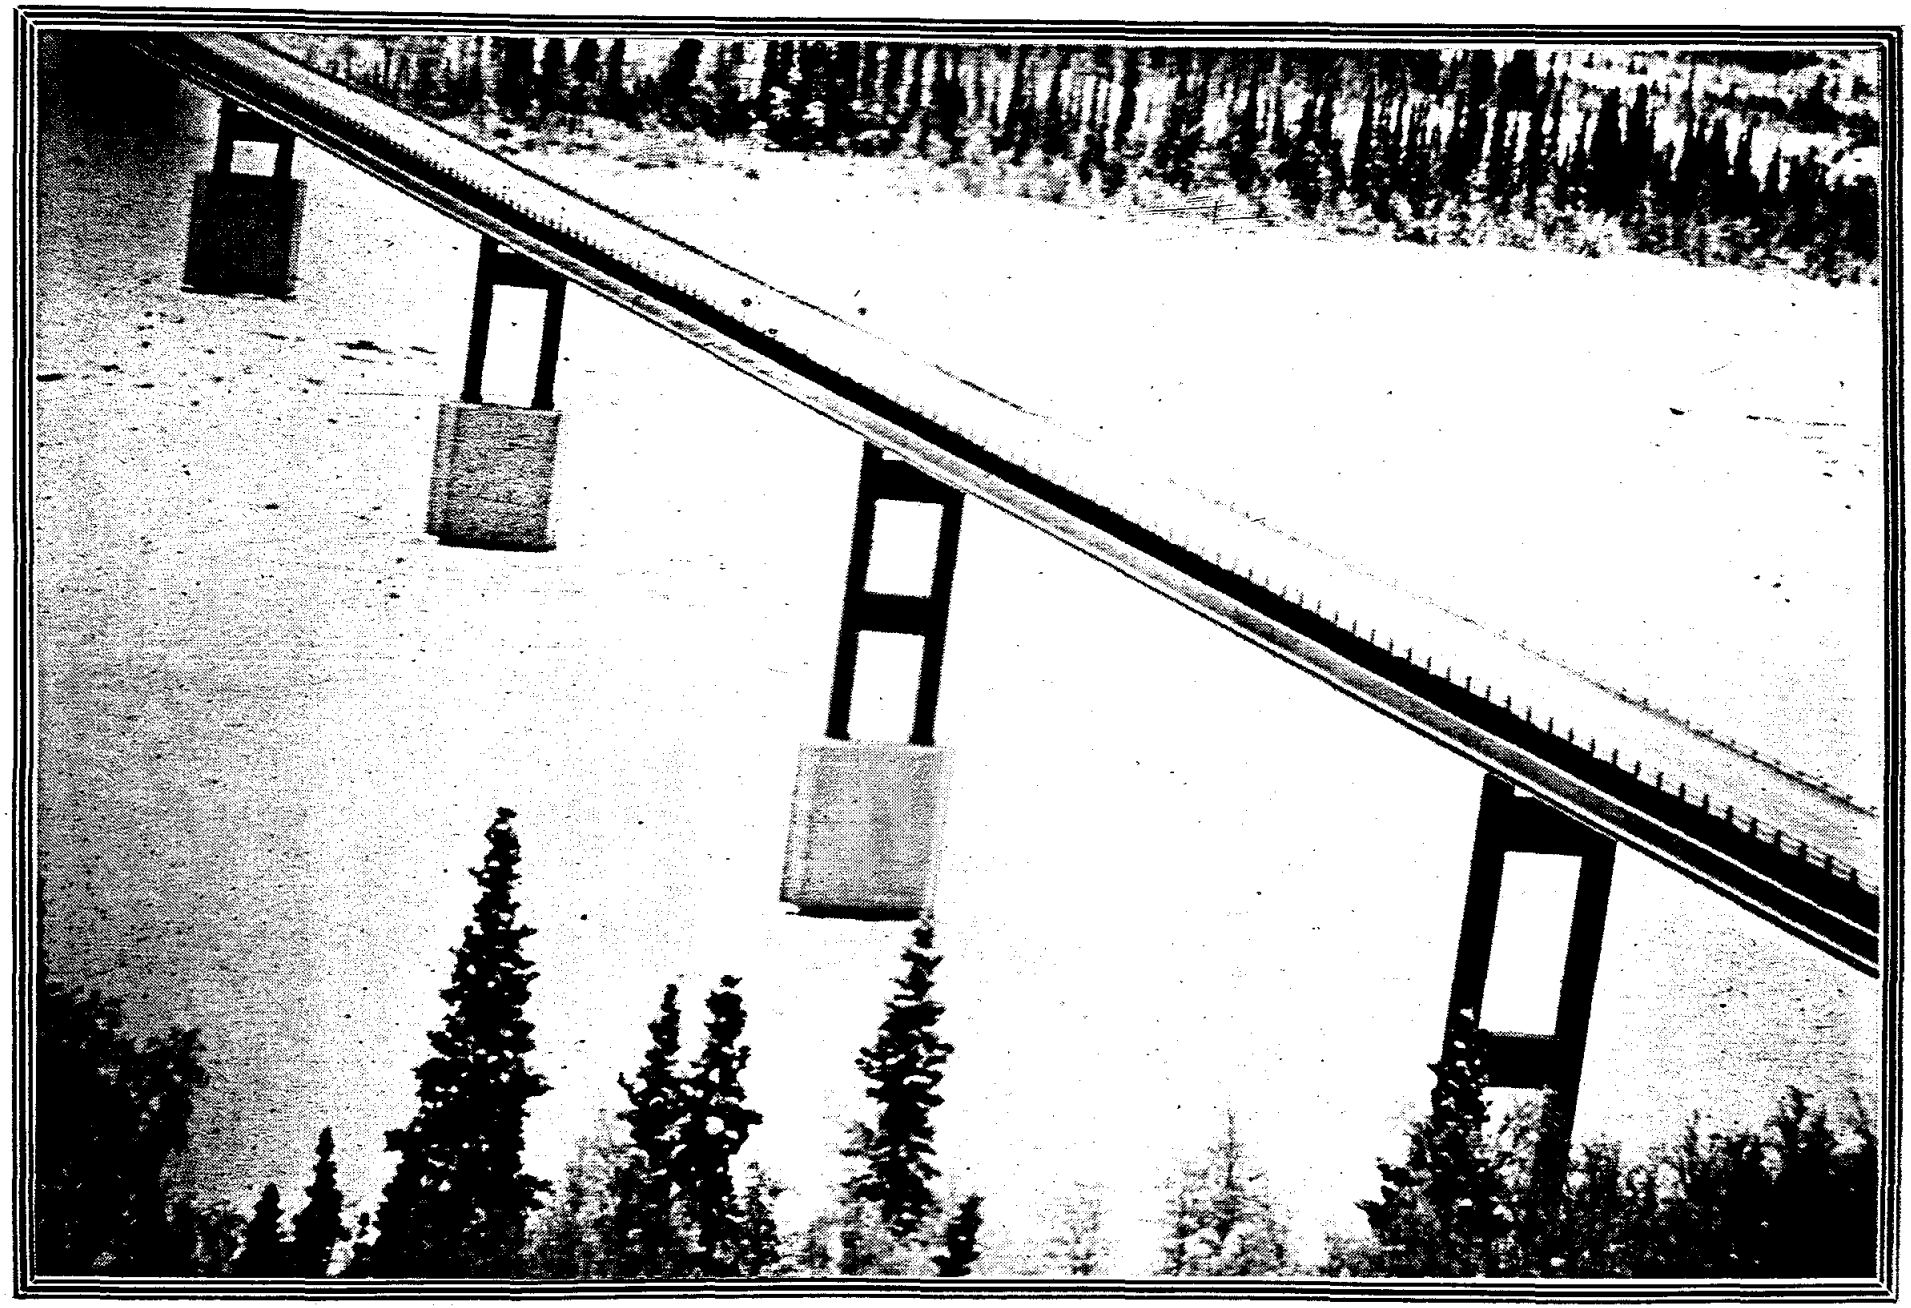
ILLUSTRATION No. 9

This winter view illustrates the significant drop in river water level and shows relatively easy access over the ice.

Some experimental ice force measurements have been taken, and more are currently being planned, using river piers.
