NCHRP REPORT 350 TEST 4-10 OF THE ALASKA MULTI-STATE BRIDGE RAIL

Research Project 404311-1
Contract No. T97232

December 1998

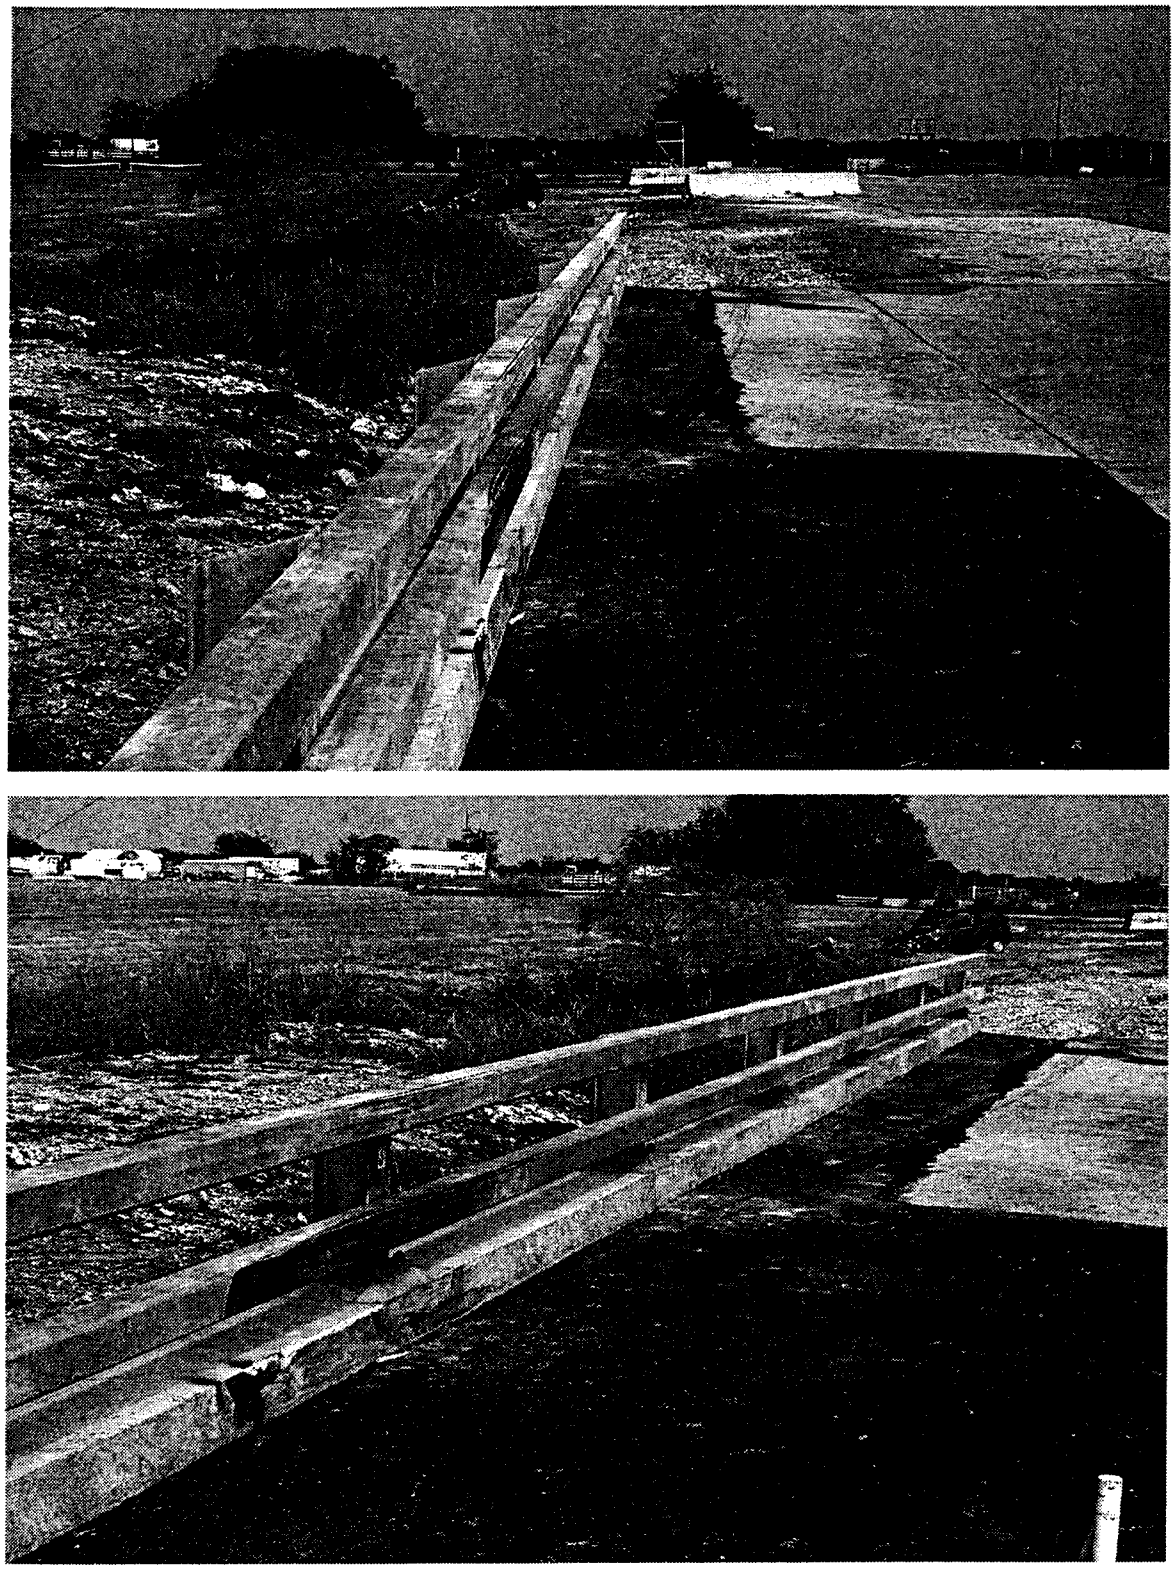
Figure 7. After impact trajectory for 404311-1.

The vehicle did not intrude into adjacent traffic lanes as it came to rest behind the installation.

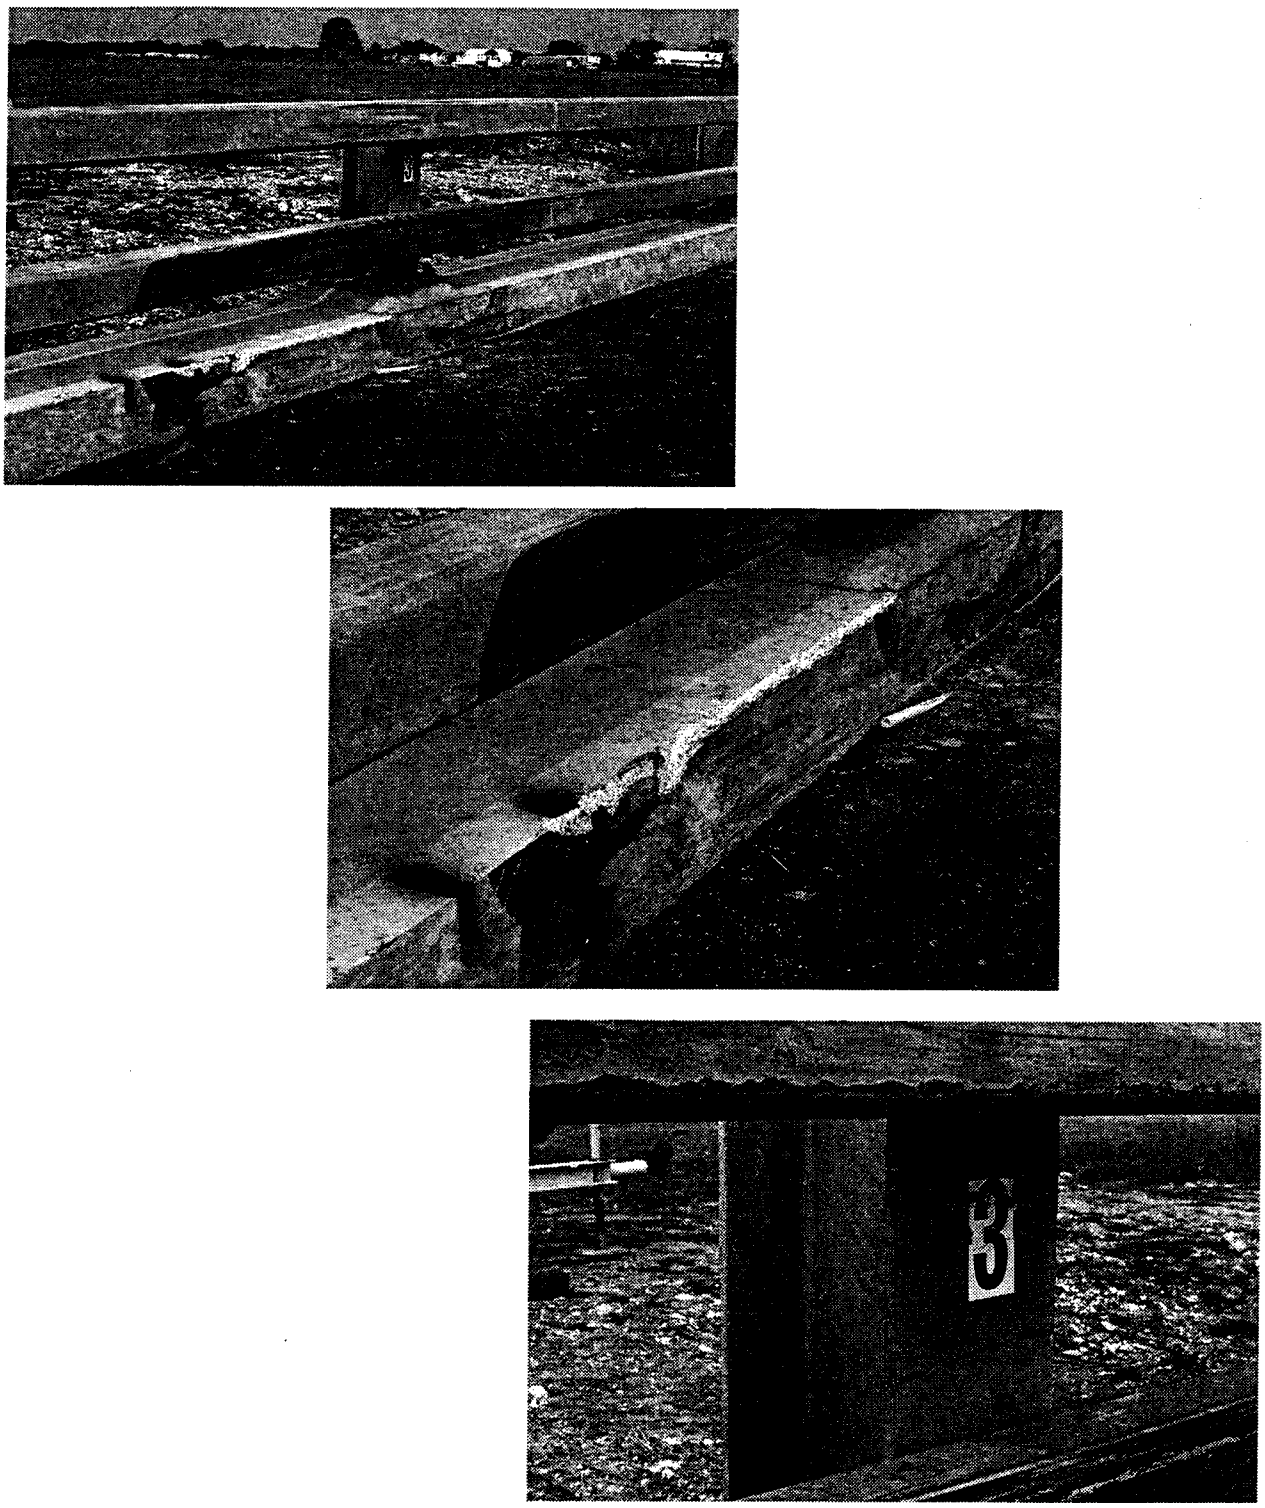
Figure 8. Installation after test 404311-1.

Damage to the Alaska Multi-State Bridge Railing mounted on the curb is shown in figures 7 and 8. At impact the edge of the curb was scraped, and tire marks were along the face of the curb. The front face of post 3 was marred with red paint from the vehicle and the curb was chipped. Cosmetic damage with no measurable deformation occurred to the rail elements. The top rail was contacted, but did not move. Total length of contact of the vehicle with the bridge railing was 4.5 m.

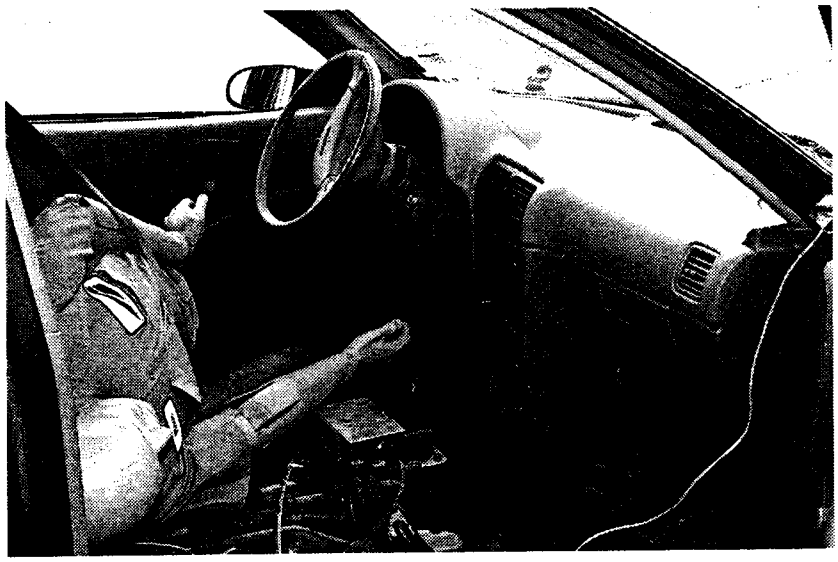
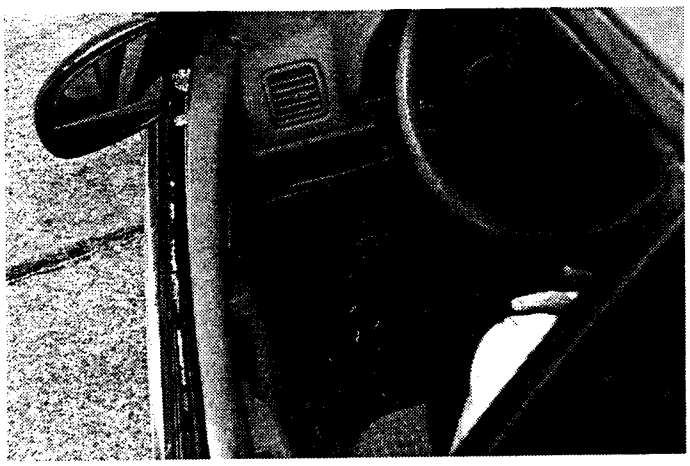
Figure 10. Interior of vehicle for test 404311-1.

The vehicle sustained structural damage on the front left and left side. The left strut, CV joint, A-pillar and A-arm were severely damaged. The front left portion of the bumper, hood, grill, fan, radiator, left front tire and wheel were deformed as shown in figure 9. The windshield was shattered on the driver's side and the left front and rear quarter panels were deformed. The roof was buckled between the A and B pillars and deformed downward 20 mm. The maximum exterior crush to the left side of the bumper 700 mm above the ground was 200 mm. Maximum deformation of the occupant compartment was 47 mm (4 percent reduction in space) in the driver's side door, 36 mm (5 percent reduction in space) in the left firewall area and 30 mm (10 percent reduction in space) in the left floor pan area. The interior of the vehicle is shown in figure 10. Exterior vehicle crush and occupant compartment measurements are shown in appendix C, tables 3 and 4.
