TEXAS TRANSPORTATION INSTITUTE

NCHRP REPORT 350 TEST 4-11 OF THE ALASKA MULTI-STATE BRIDGE RAIL

Research Project 404311-2
Contract No. T97232

December 1998

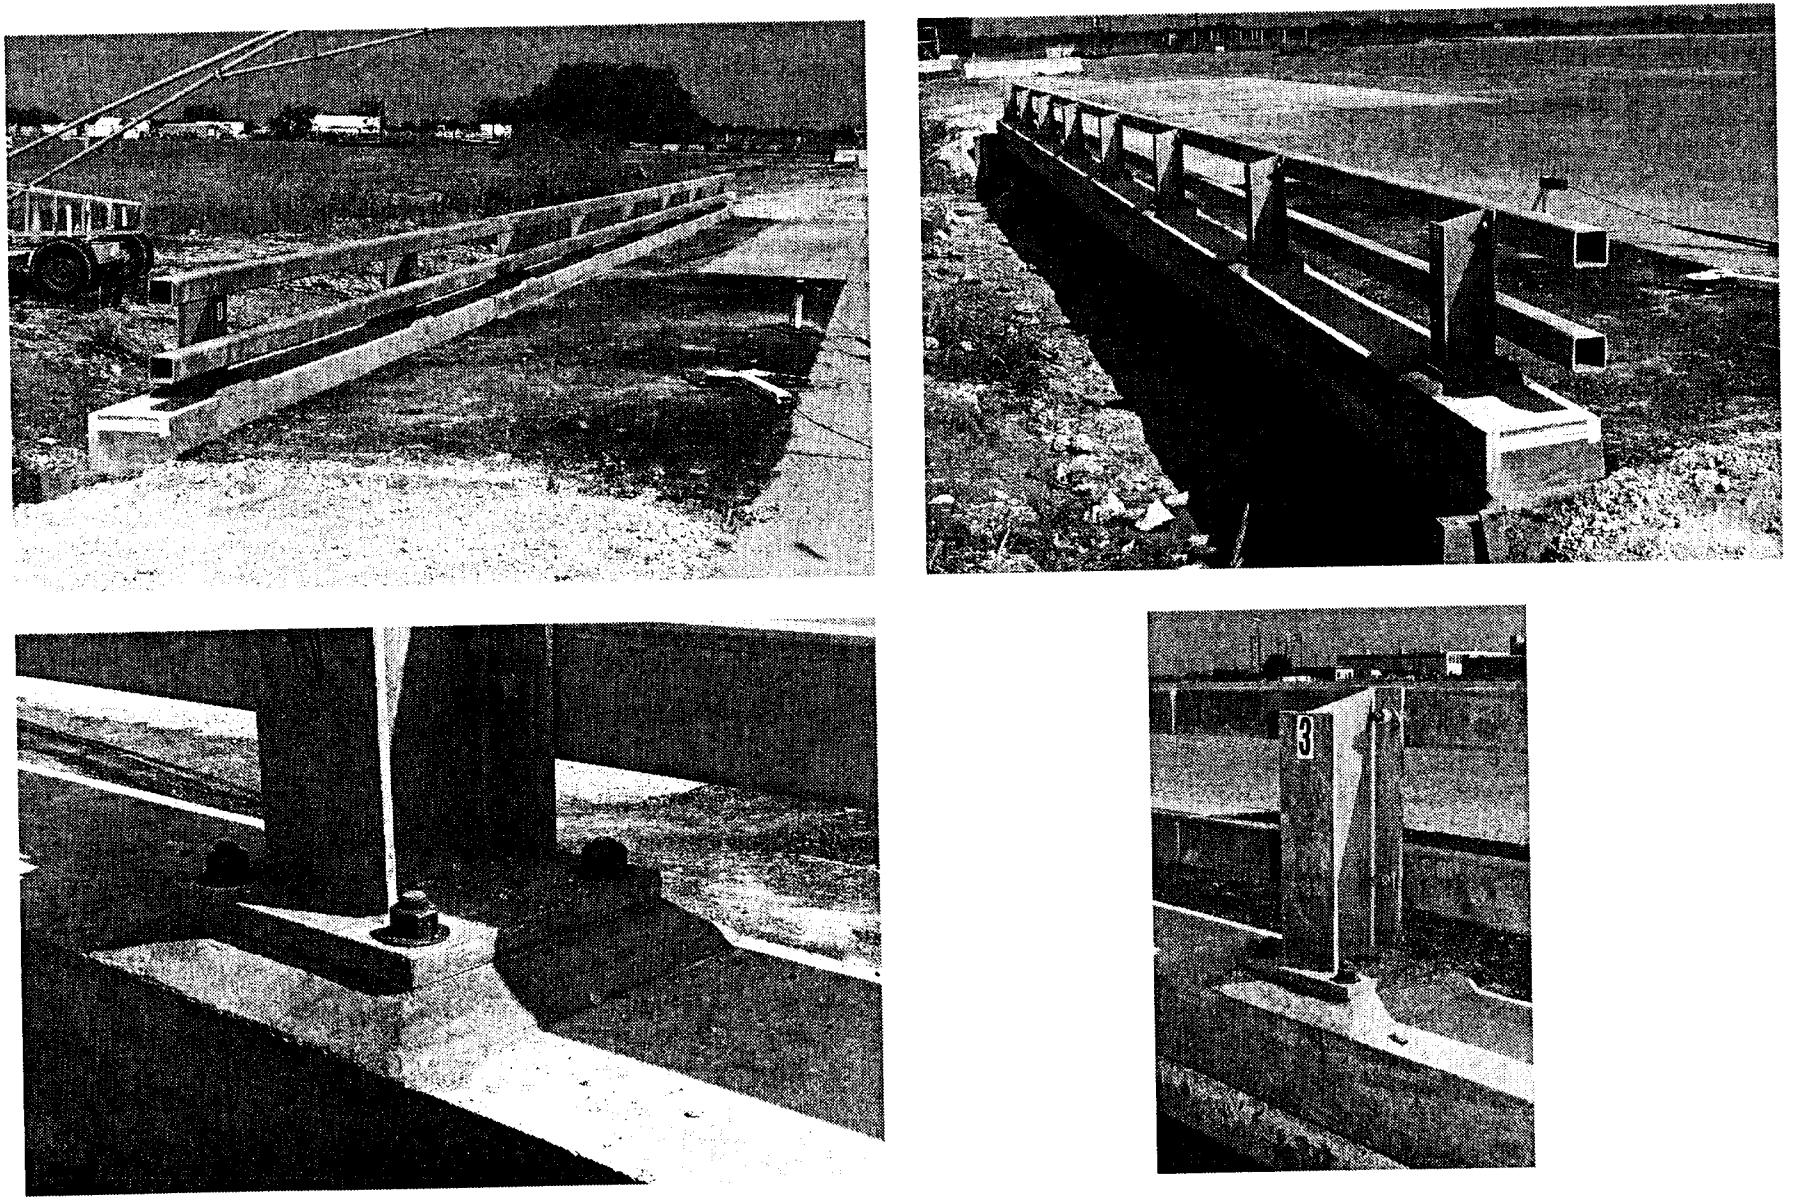
Figure 3. Alaska Multi-State Bridge Railing mounted on the curb before test 404311-2.

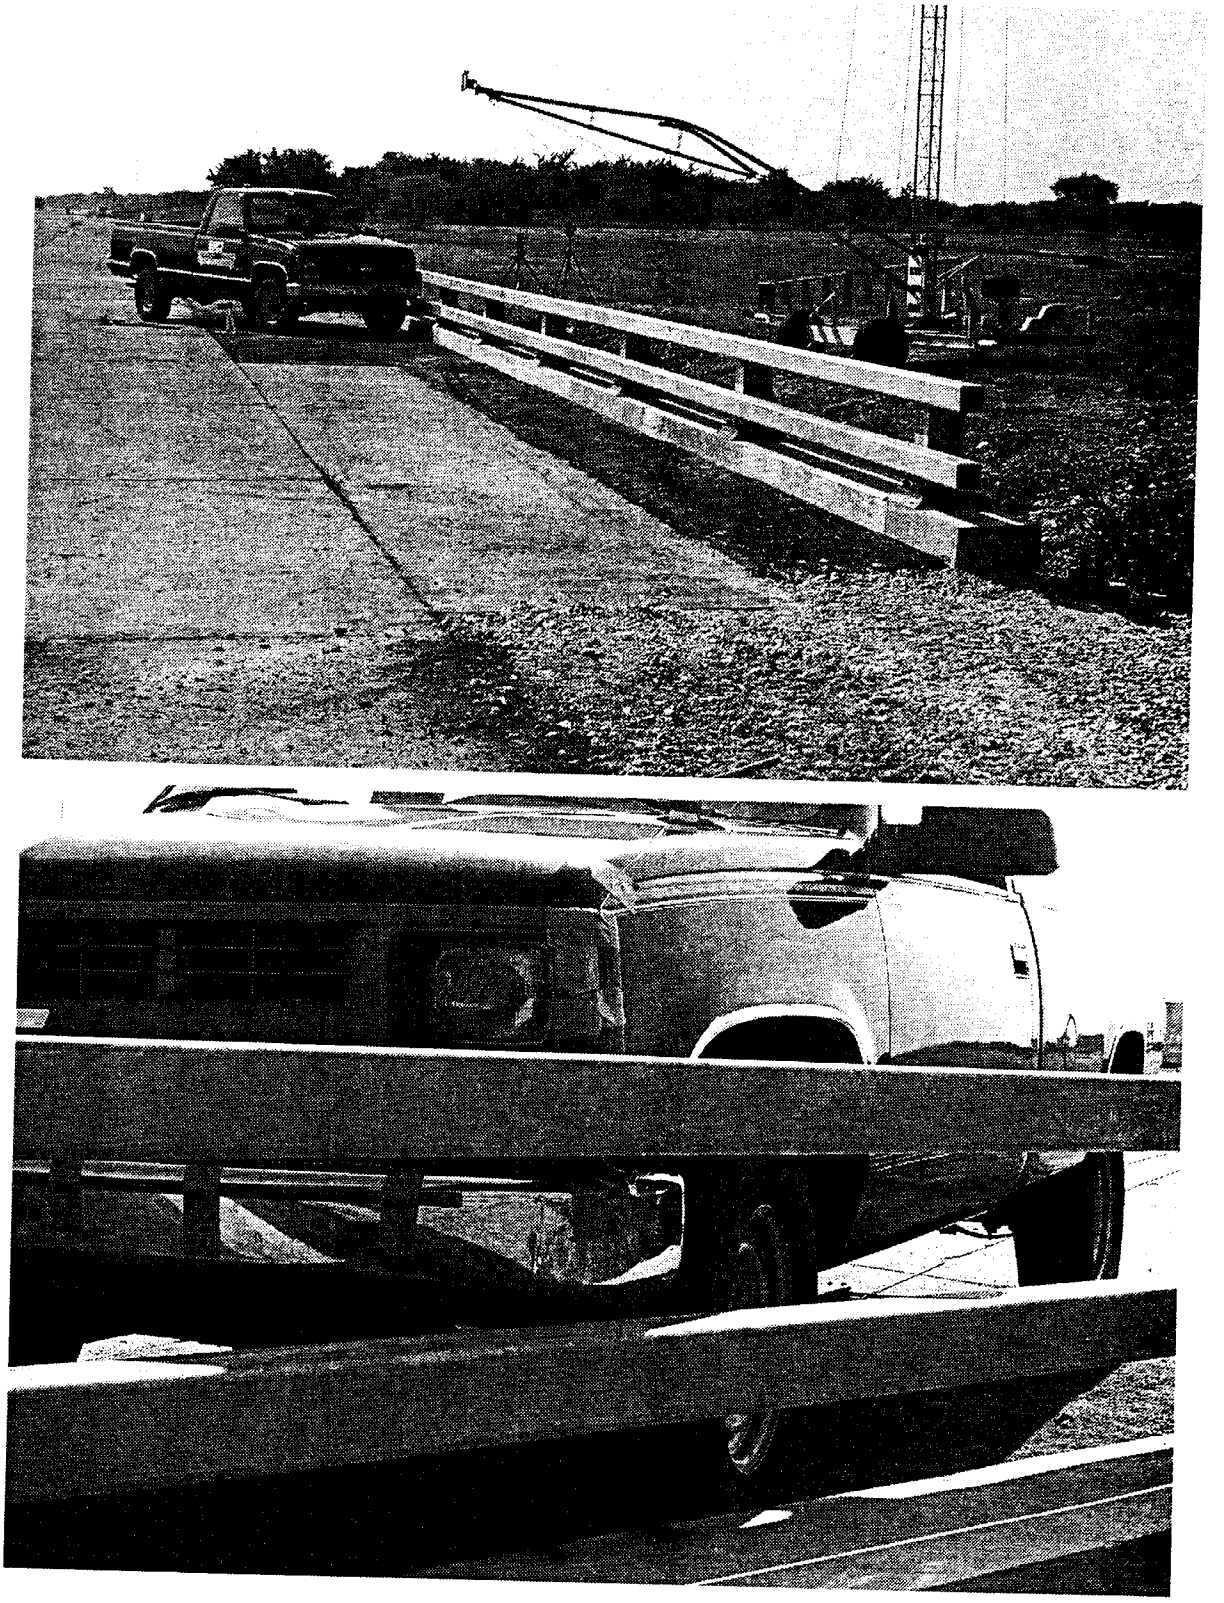
Figure 4. Vehicle/installation geometrics for test 404311-2.

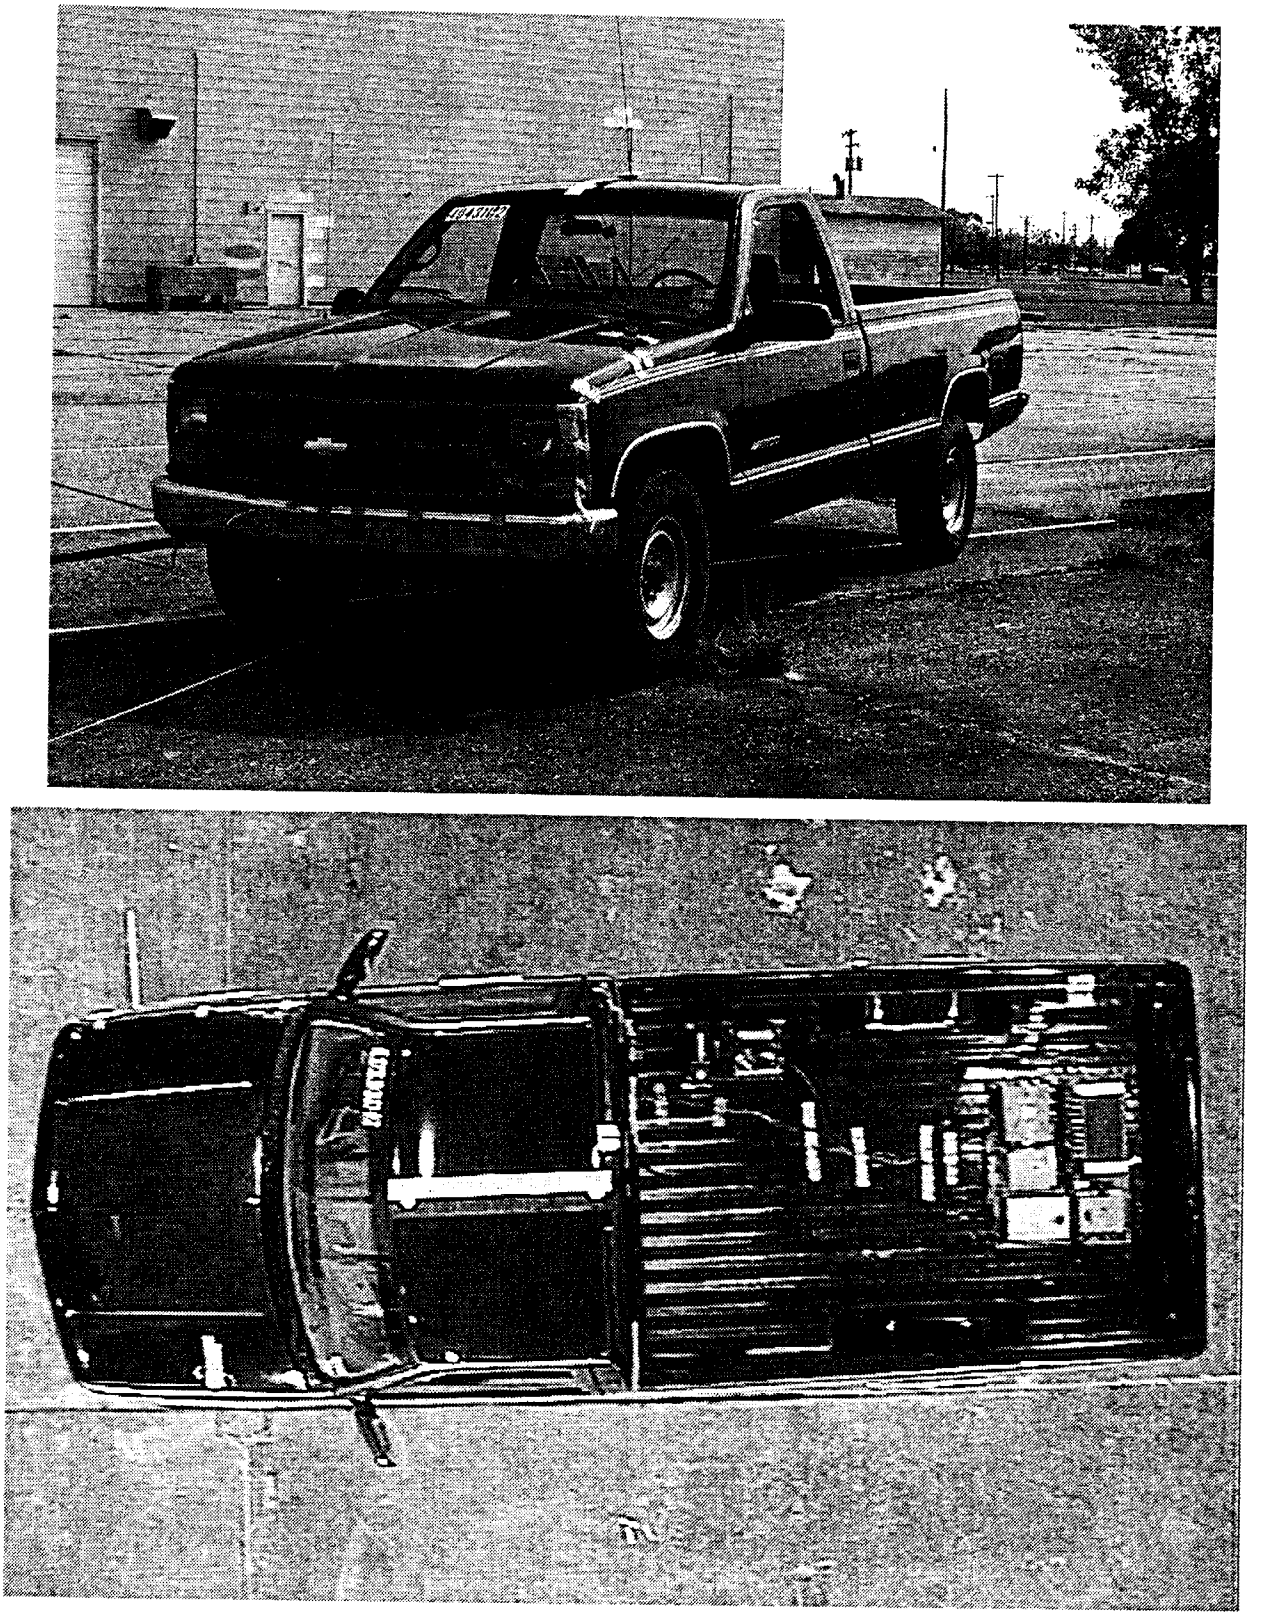
Figure 5. Vehicle before test 404311-2.

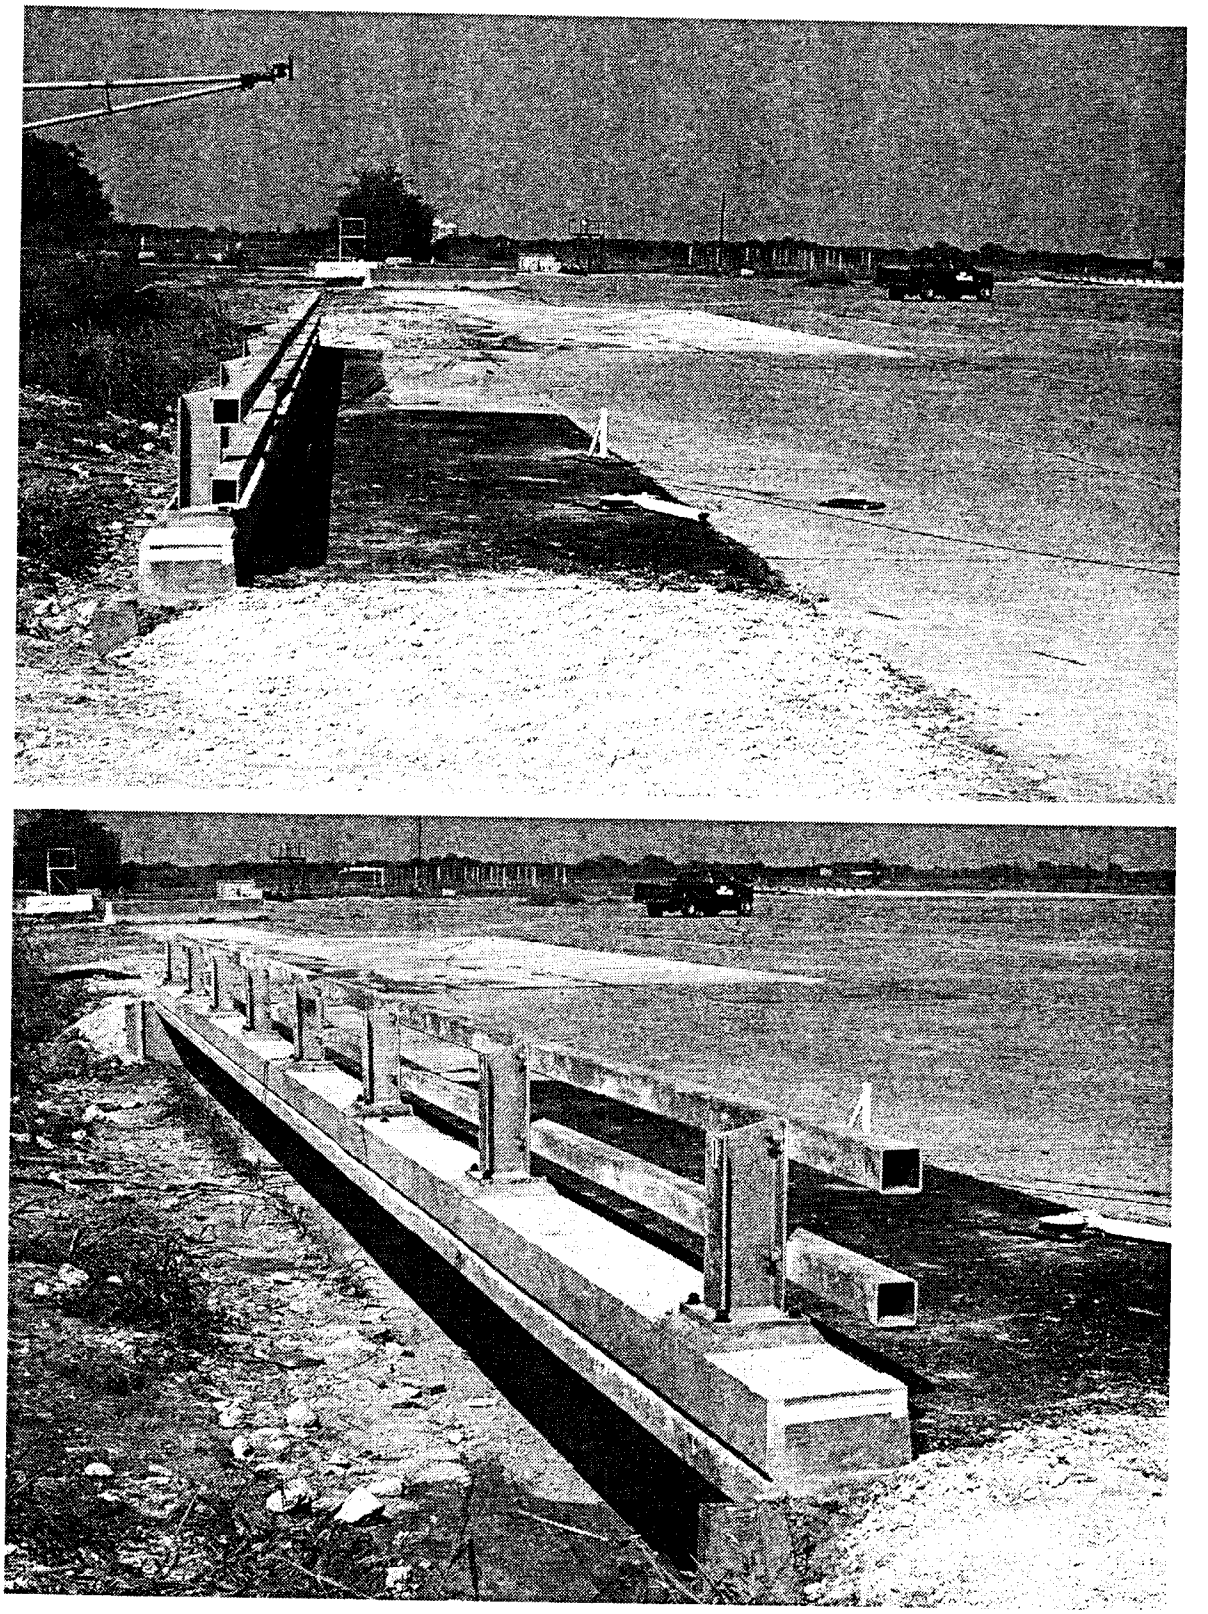
Figure 6. After impact trajectory for 404311-2.

The vehicle came to rest 24.4 m toward traffic lanes and intruded into adjacent traffic lanes.

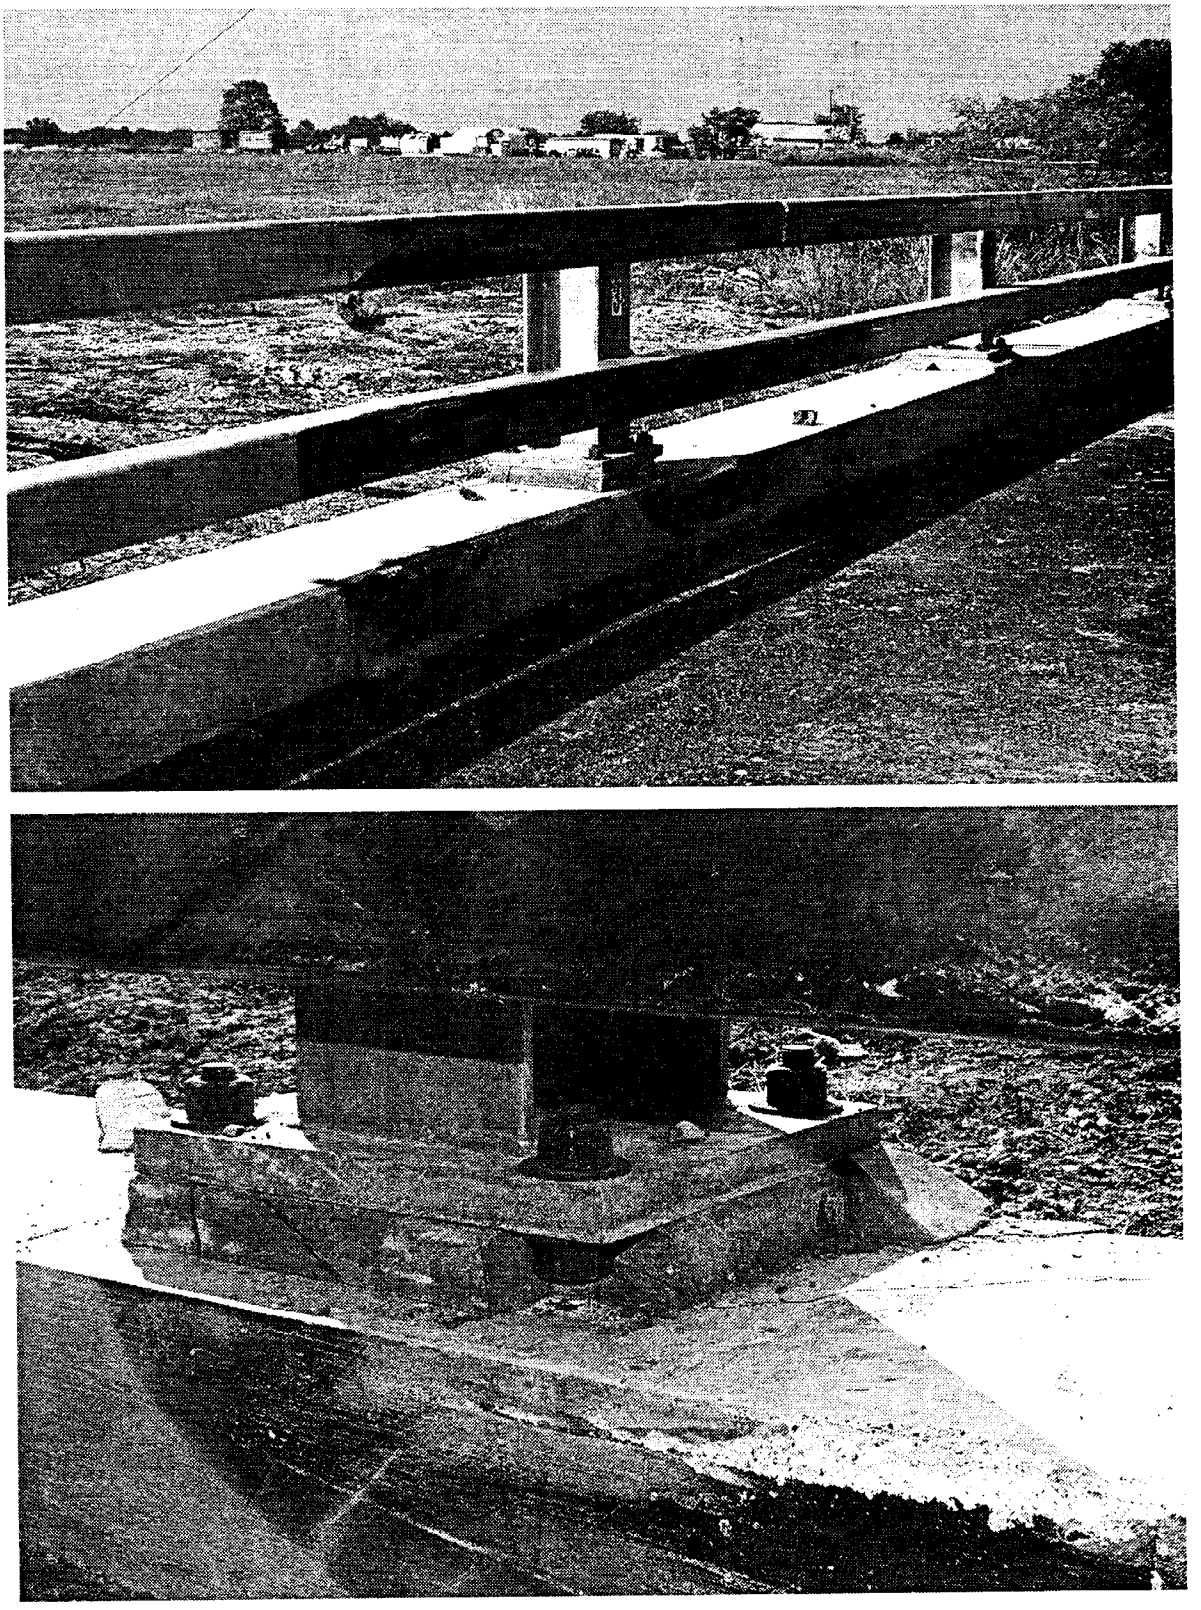
Figure 7. Damage to rail at post 3 after test 404311-2.

Damage to the Alaska Multi-State Bridge Railing mounted on the curb is shown in figures 6 thru 8. At impact the edge of the curb was scraped, and tire marks were along the face of the curb. Deflection at post 3 during the test was 0.40 m. Cracks in the bridge deck radiated out from the front and rear bolts and at post 3 the grout was missing at the front and sides of the base plate. The front face of post 3 was marred with blue paint from the vehicle and the curb was chipped. Total length of contact of the vehicle with the bridge railing was 4.8 m.

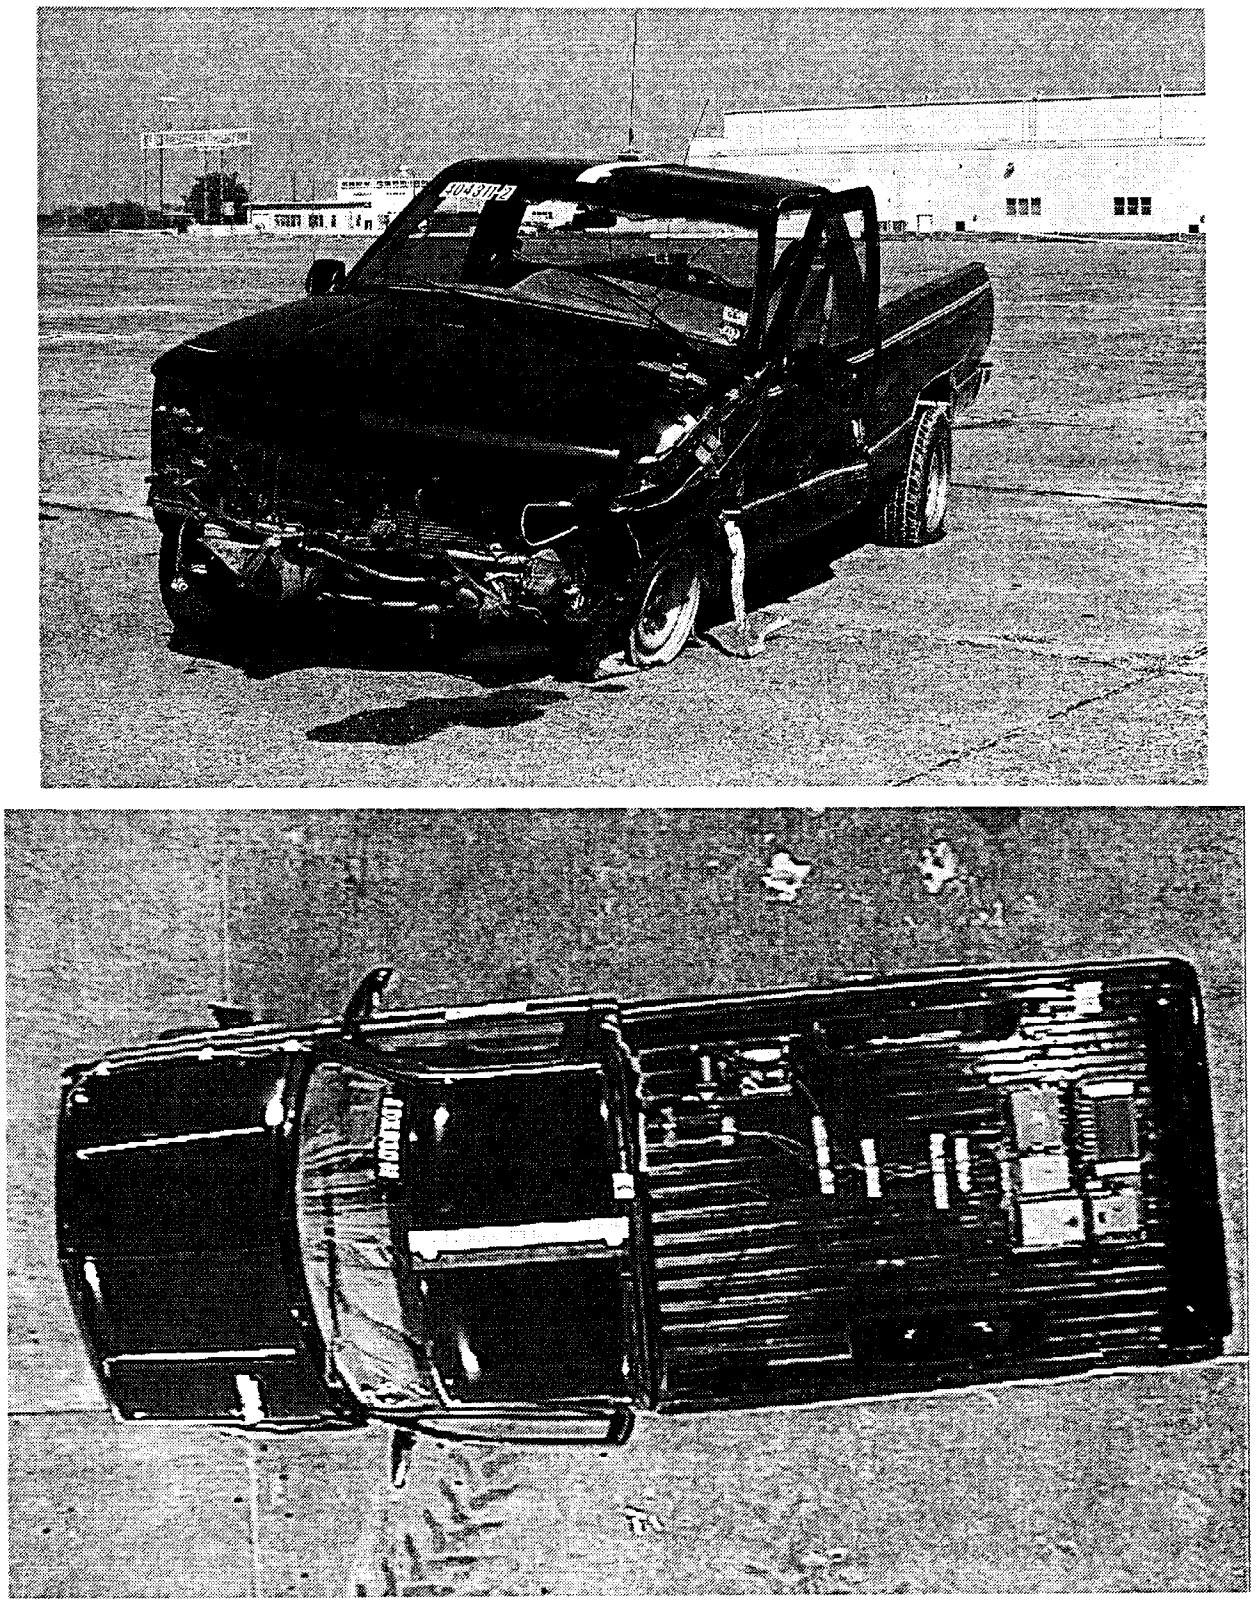
Figure 9. Vehicle after test 404311-2.

The vehicle sustained structural damage to the sway bar, left outer tie rod, left frame rail and left A-arm. The front left portion of the bumper, hood, grill, fan and radiator were deformed as shown in figure 9. Both left side tires and rims were damaged. The windshield was shattered and the left door had a gap that measured 170 mm. The left front and rear quarter panels were dented. The cab of the vehicle was pushed against the bed of the vehicle and the driver's side dash was bent up and pushed forward. The maximum exterior crush to the radiator support was 540 mm and at 900 mm above the ground to the left side of the bumper measured 405 mm. Maximum deformation of the occupant compartment was 115 mm (7 percent reduction in space) in the lateral direction near the occupant's feet, 60 mm (4 percent reduction in space) in the firewall area and 37 mm (3 percent reduction in space) in the floor pan area. The interior of the vehicle is shown in figure 10. Exterior vehicle crush and occupant compartment measurements are shown in appendix C, tables 2 and 3.

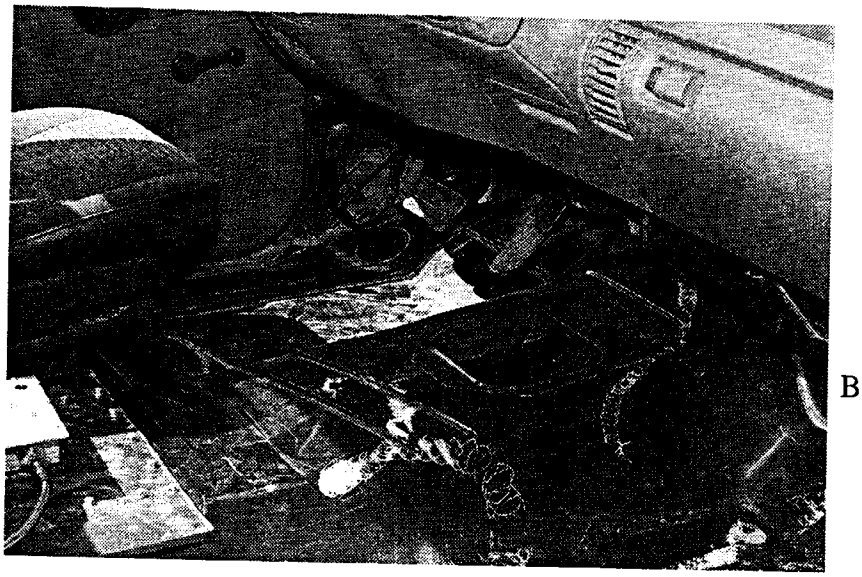
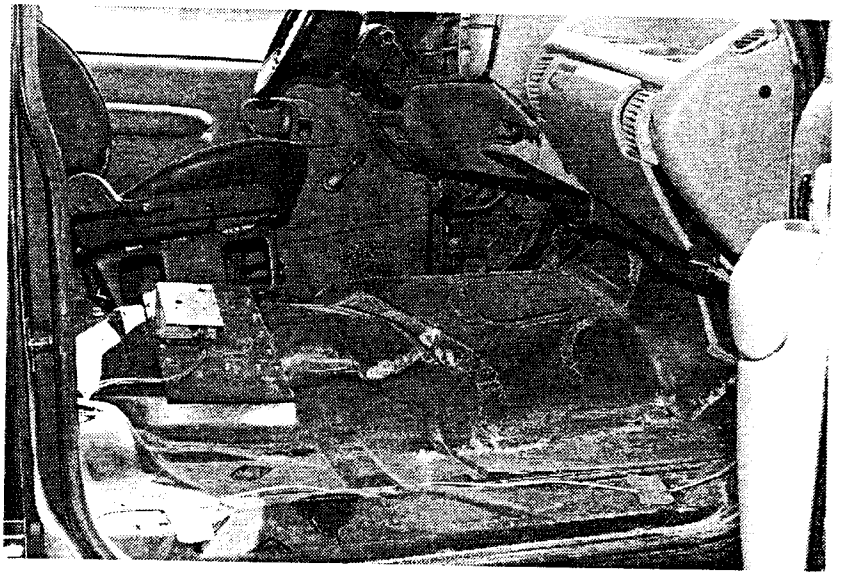
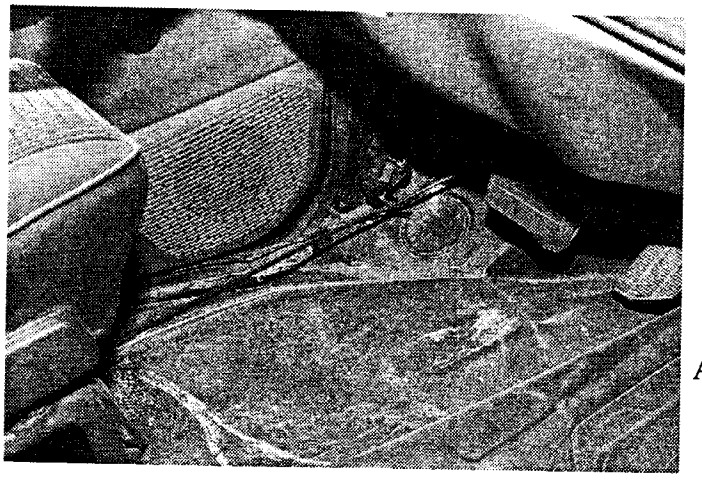
Figure 10. Interior of vehicle for test 404311-2.

No detached elements, fragments or other debris were present to penetrate nor to show potential for penetrating the occupant compartment, nor to present undue hazard to others in the area. Maximum deformation of the occupant compartment was 115 mm (7% reduction in space) in the lateral deformation near the occupant's feet.

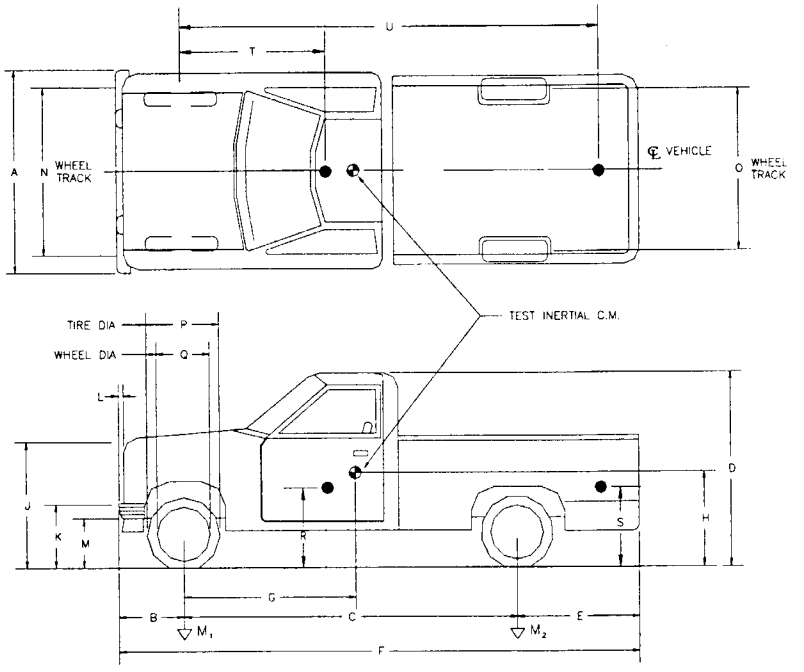
DESCRIBE ANY DAMAGE TO VEHICLE PRIOR TO TEST:

CRACK IN WINDSHIELD MARKED

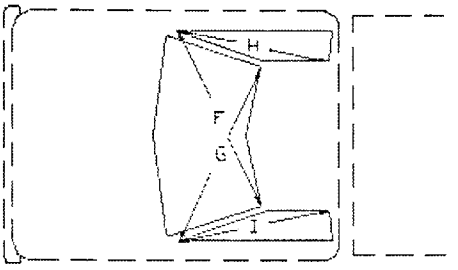
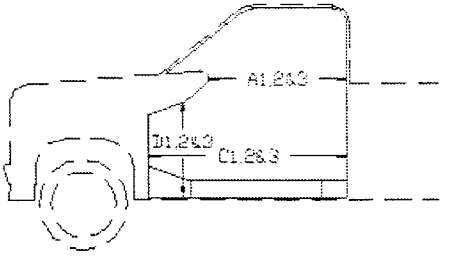
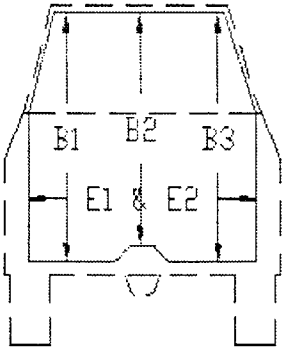
Occupant Compartment Deformation

BEFORE	AFTER
A1	870	858
A2	897	885
A3	910	910
B1	1075	1020
B2	1072	1035
B3	1075	1075
C1	1380	1320
C2	1261	1242
C3	1375	1370
D1	316	260
D2	158	158
D3	312	322
E1	1582	1566
E2	1590	1605
F	1465	1465
G	1465	1455
H	900	900
I	900	885
Lateral deformation near occupant's feet	1520	1405
