TEXAS TRANSPORTATION INSTITUTE

NCHRP REPORT 350 TEST 4-12 OF THE ALASKA MULTI-STATE BRIDGE RAIL

Research Project 404311-3
Contract No. T97232

February 1999

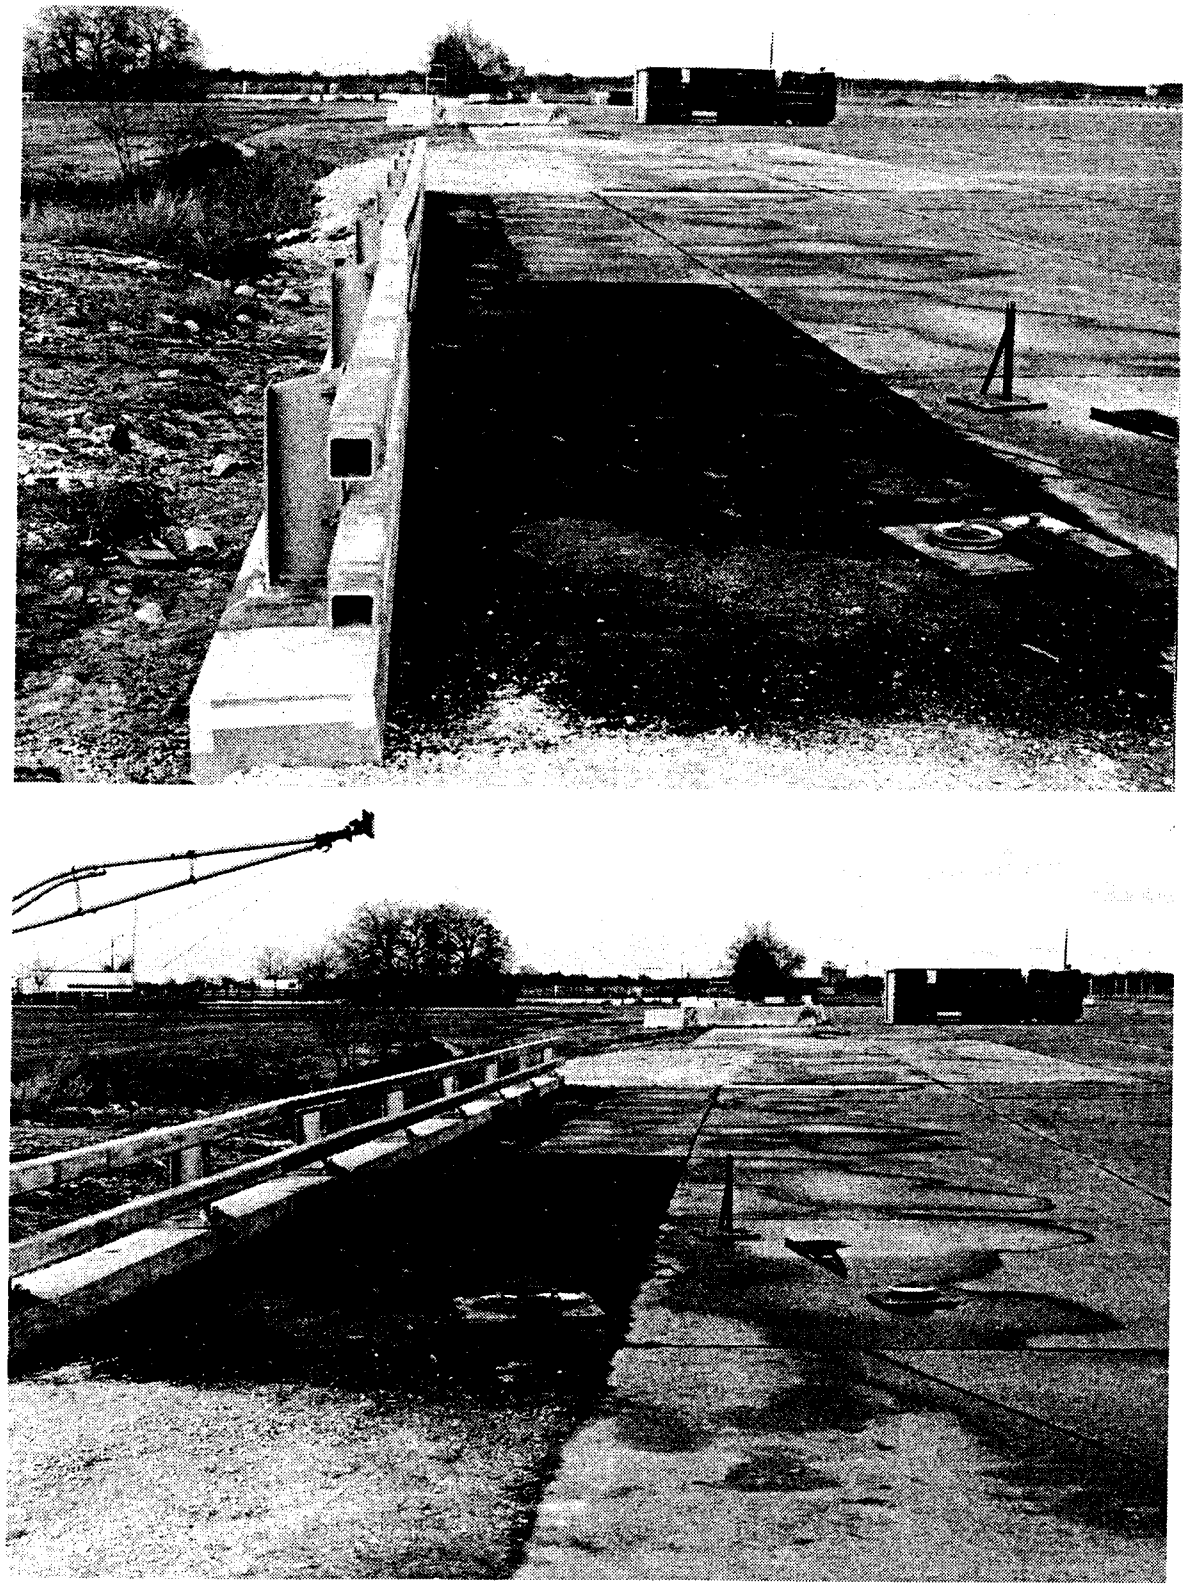
Figure 6. Vehicle trajectory path after test 404311-3.

left side after exiting the installation at 2.609 s. The vehicle came to rest on its left side 64.7 m downstream and 13.7 m toward traffic. Sequential photographs of the test period are shown in appendix D, figures 12 and 13.

Intrusion into adjacent traffic lanes occurred as the vehicle came to rest 13.7 m toward traffic.

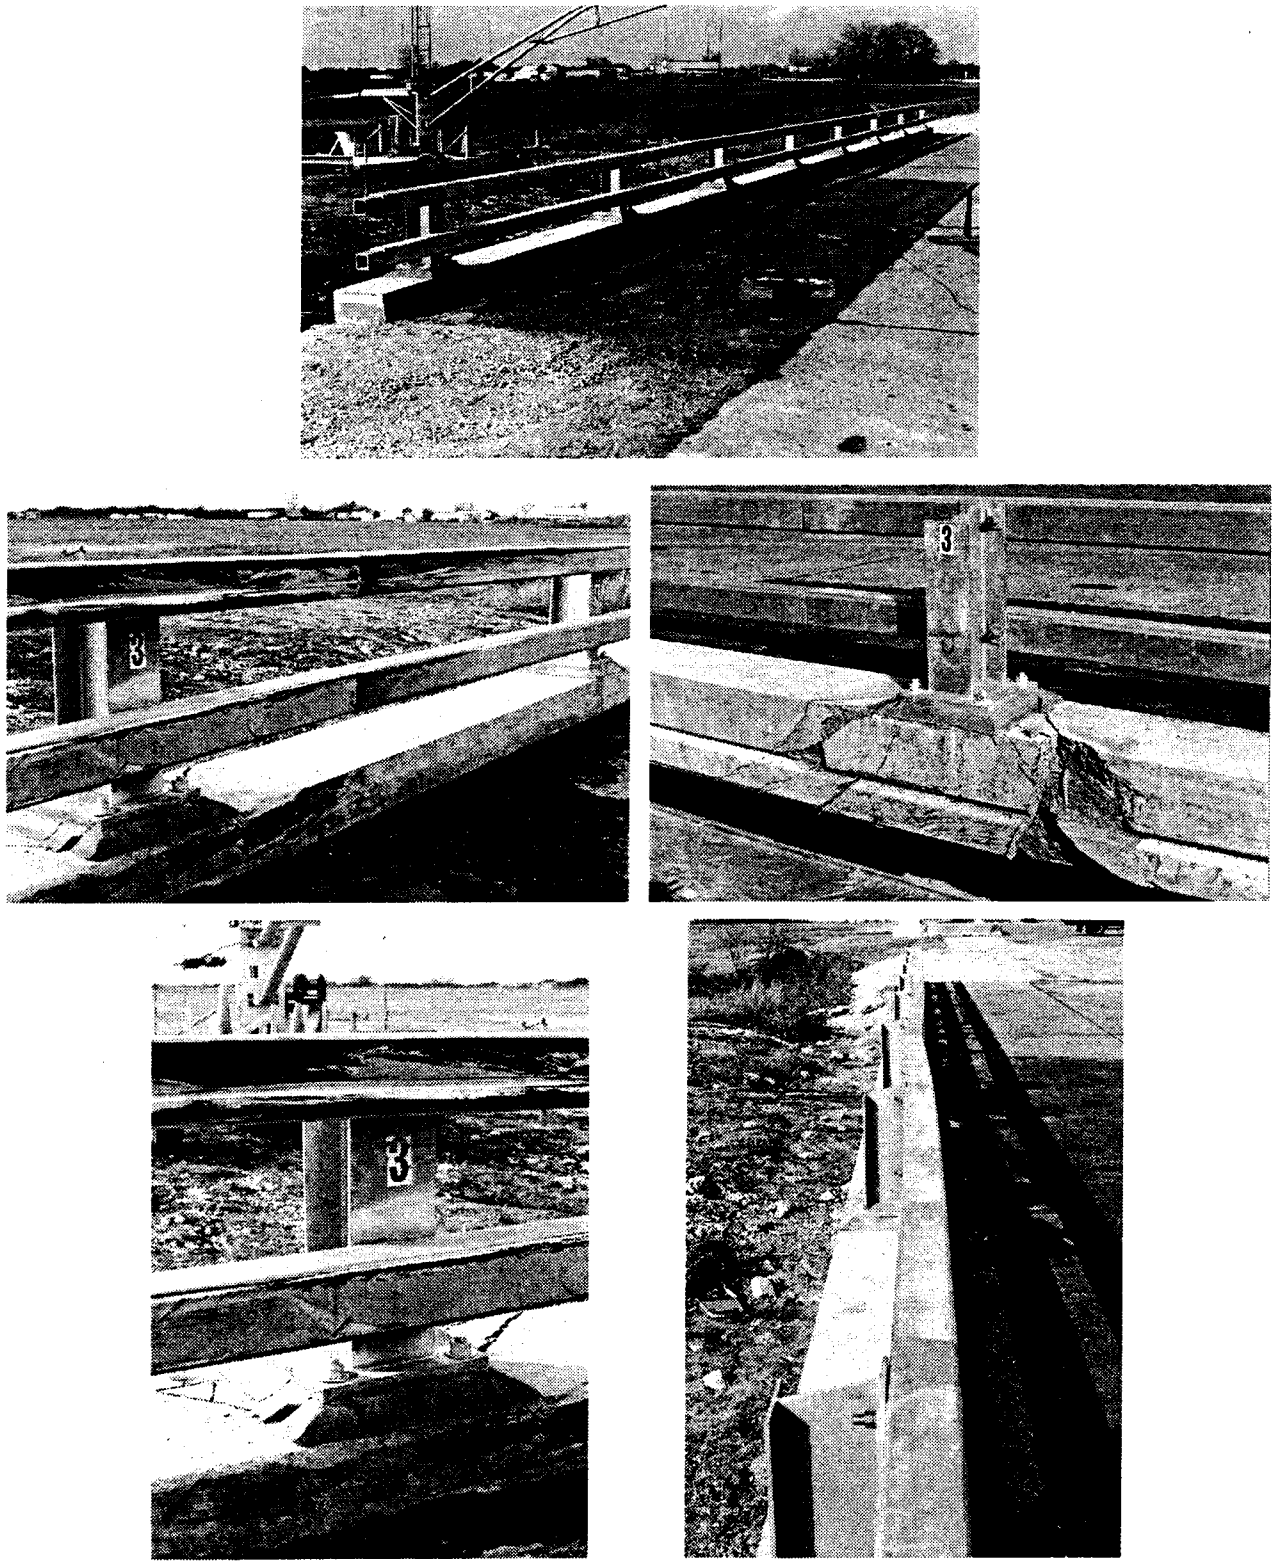
Figure 7. Installation after test 404311-3.

Damage to the Alaska Multi-State Bridge Railing mounted on the curb is shown in figures 6 and 7. At impact the edge of the curb was scraped, and tire marks were along the face of the curb. The front face at post 3 was marred by contact with the vehicle and the curb was structurally damaged. Cracks in the bridge deck at post 3 radiated out from the front and rear bolts and the grout was missing at the front and sides of the base plate. The top rail element was deformed. Total length of contact of the vehicle with the bridge railing was 7.3 m. Maximum dynamic deflection of the rail element was not attainable due to the vehicle blocking view of the camera. Maximum permanent deformation was 5 mm.

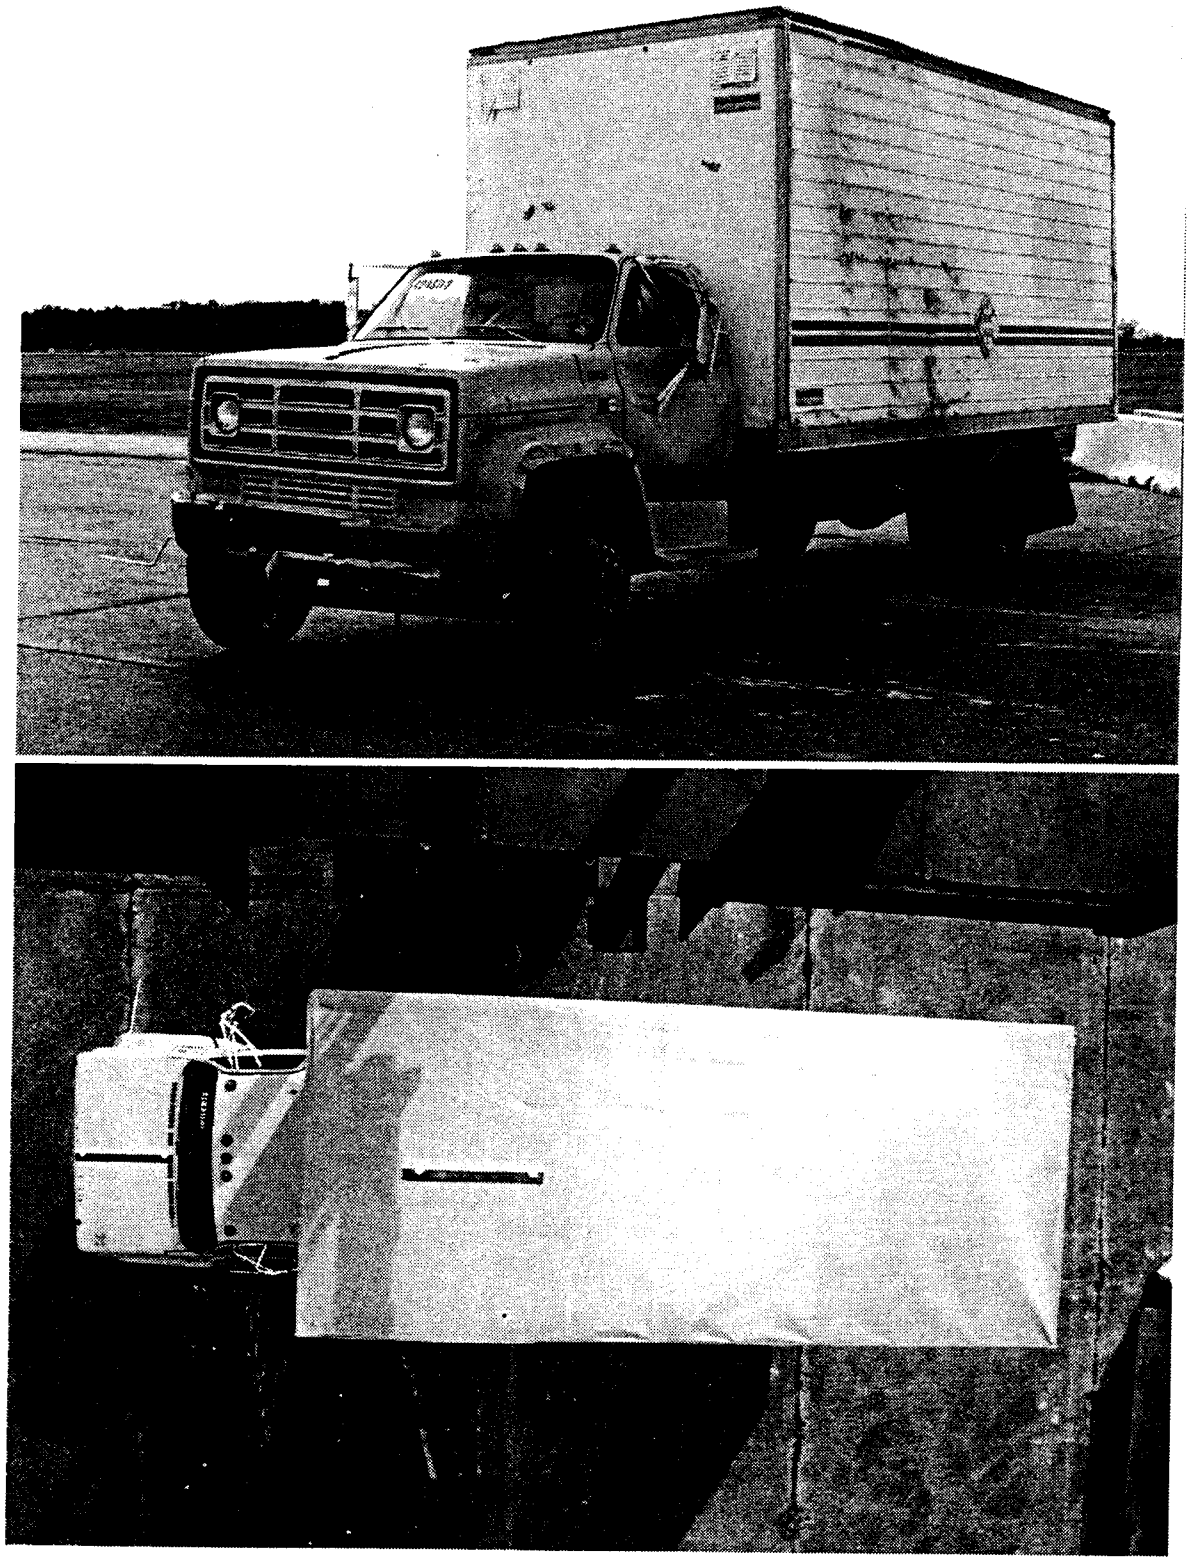
Figure 8. Vehicle after test 404311-3.

The vehicle sustained minor damages on the front left corner and left side as shown in figure 8. Structural damage was received by the left front springs and the left front axle was pushed back. Damage was also received by the bumper, left front fender and left front wheel. The left door, mirror, and step were deformed. The left side box of the vehicle was scraped. Maximum exterior crush to the vehicle was 150 mm and no deformation or intrusion into the occupant compartment occurred. The interior of the vehicle is shown in figure 9.
