NCHRP REPORT 350 TEST 4-21 OF THE ALASKA MULTI-STATE BRIDGE RAIL THRIE-BEAM TRANSITION

Contract No. T97232
Research Project 404311-5

July 1999

TEXAS TRANSPORTATION INSTITUTE
THE TEXAS A & M UNIVERSITY SYSTEM
COLLEGE STATION, TEXAS

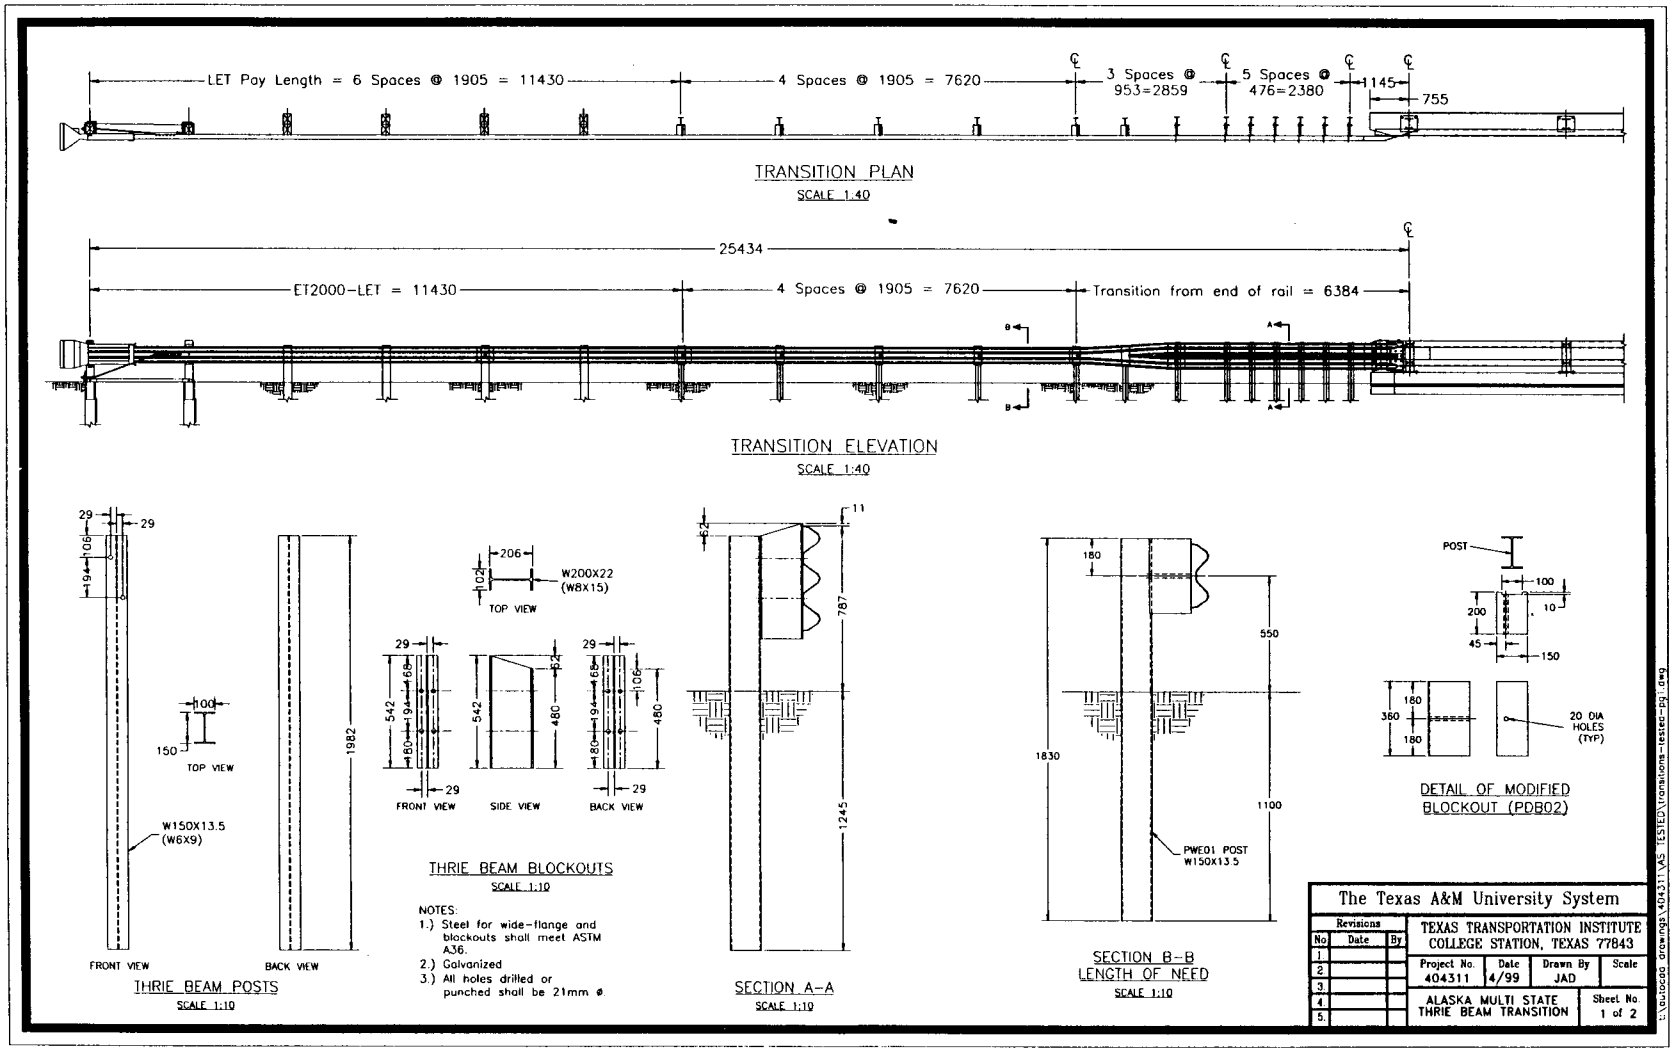
Figure 1. Details of the Alaska Multi-State Bridge Rail Thrie-Beam Transition.

TTI modified the curb at the end of the bridge deck by cutting the curb back 114 mm over a horizontal distance of 457 mm. This modification was also made to prevent excessive wheel snagging from occurring at his location. Details of the installation are shown in figures 1 and 2, and photographs of the completed installation are shown in figure 3.

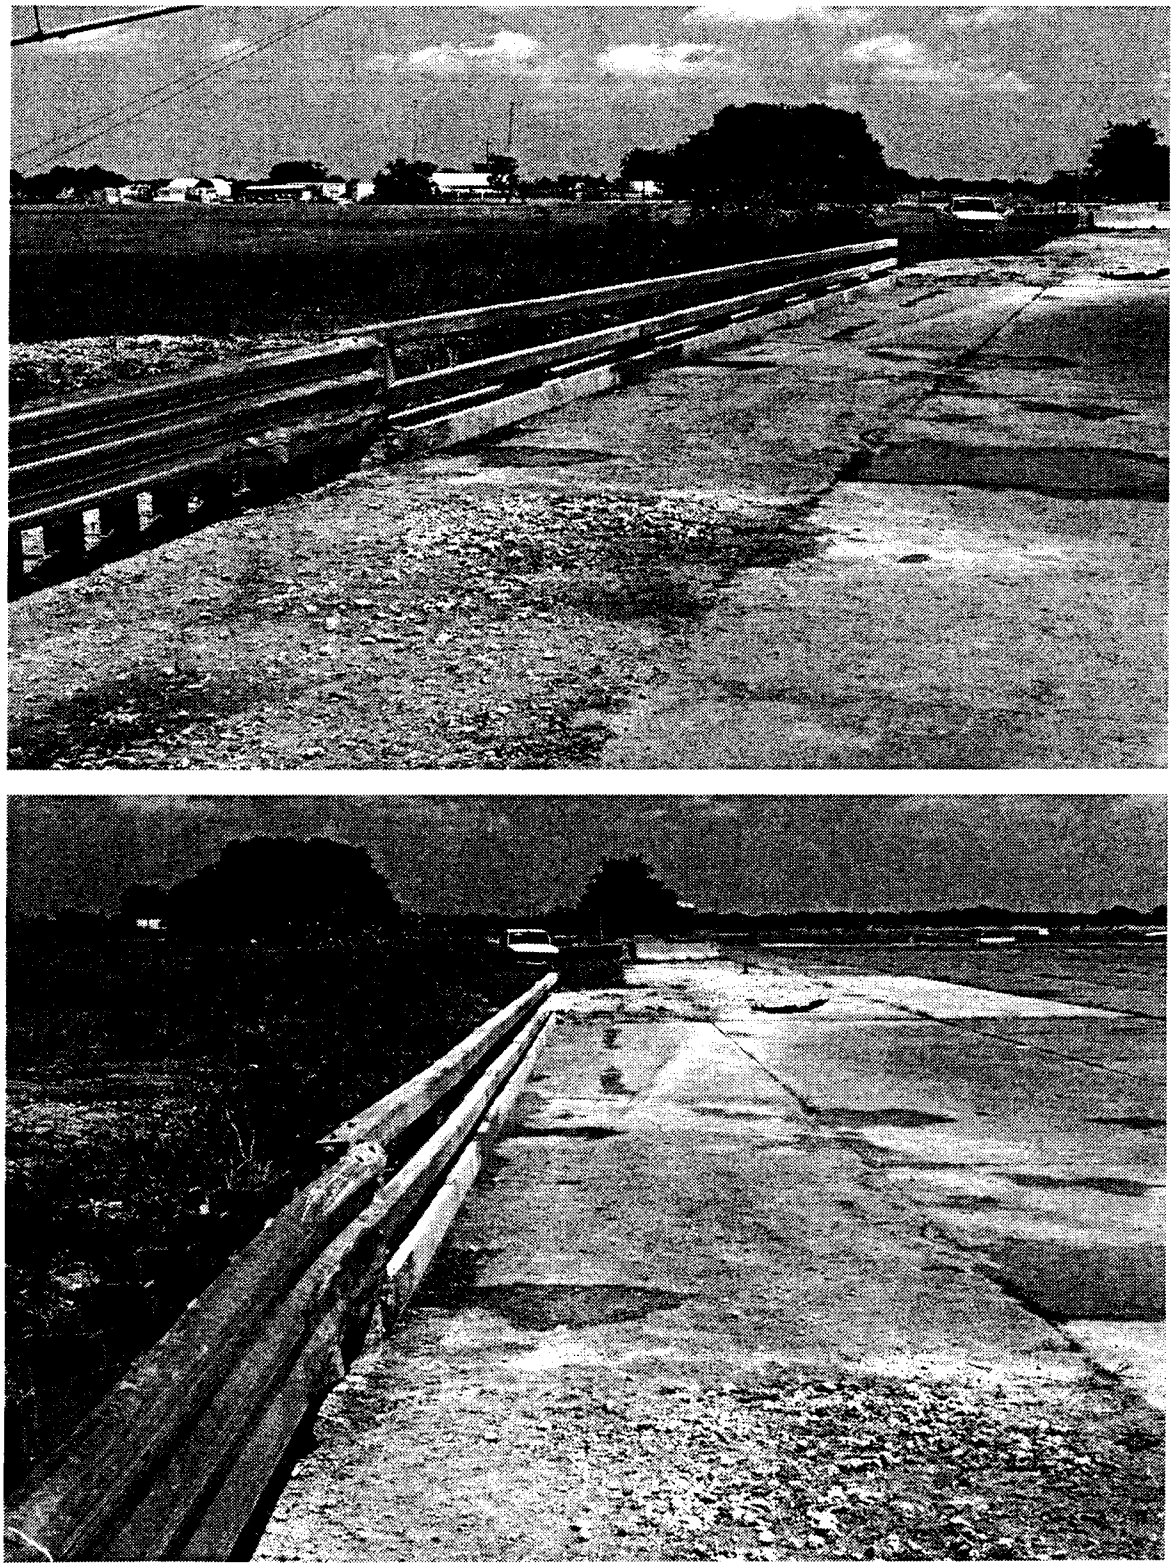
Figure 6. Vehicle trajectory path after test 404311-5.

The Alaska Multi-State Bridge Rail Transition received moderate damage as shown in figure 6 through 8. Tire marks were on the face of the curb at post 20 for a total of 1.1 m. The front connection bolt on the end shoe to the lower tube was pulled out. Cracks in the deck radiated outward from the bolts of the base plate at post 20 (the first bridge rail post). Total length of contact by the vehicle with the transition and bridge rail was 3.9 m. Maximum dynamic deflection of the top of the rail element was 131 mm and maximum permanent deformation was 50 mm at post 19.

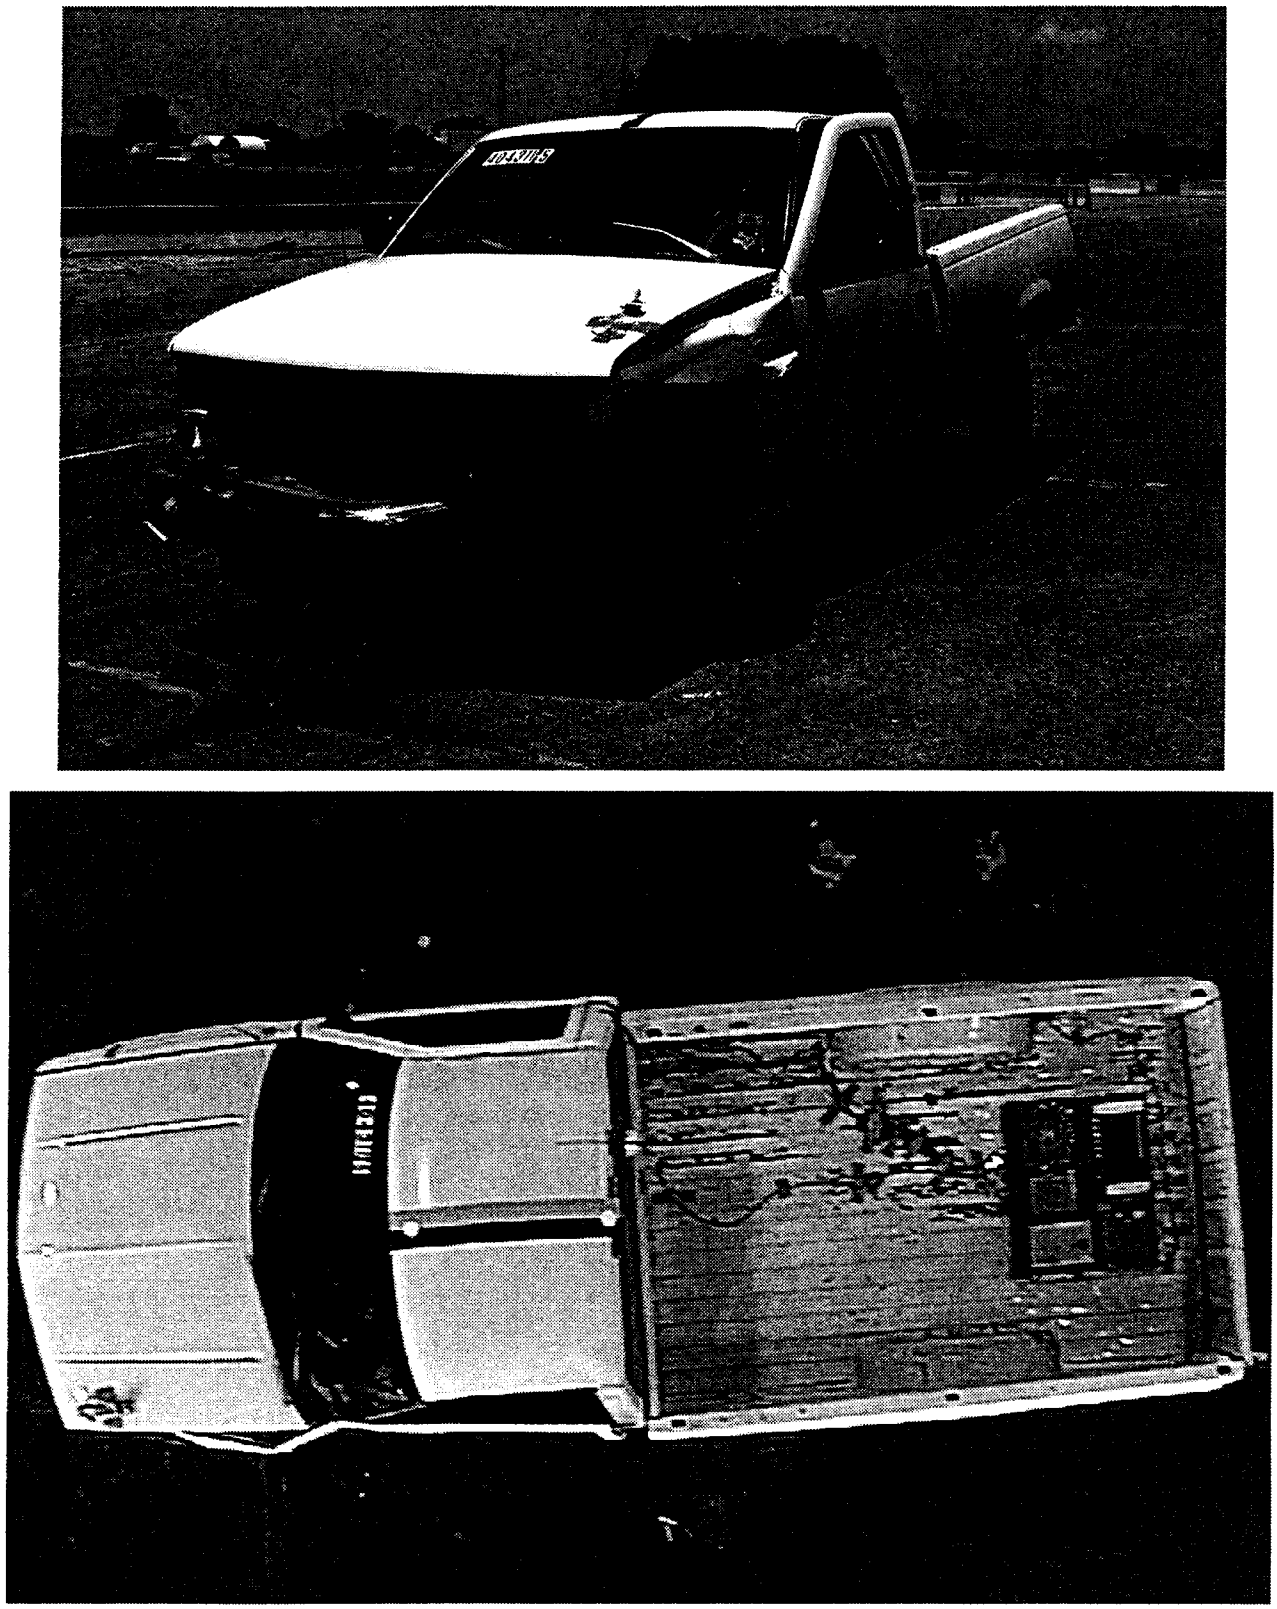
Figure 9. Vehicle after test 404311-5.

The vehicle sustained damage as shown in figure 9. Structural damage included upper A-arm, sway bar, left upper ball joint, left outer tie rod, floor pan and frame. The left front tire, wheel and quarter panel were crushed. The front bumper, hood, grill, radiator, and fan were deformed. The left rear quarter panel, tire rim and left rear bumper were also deformed. The windshield was shattered and the instrument panel was deformed. The driver's side door was pulled open 110 mm and the cab of the vehicle shifted outward 90 mm on the driver's side. Maximum exterior crush to the vehicle was 570 mm at the front bumper and 340 mm the left side of the bumper. Maximum deformation of the occupant compartment was 130 mm (12 percent reduction in space) to the floor pan behind the driver's seat to the right at the inside seat belt bolt and 104 mm to the lower portion of the kick panel area. The interior of the vehicle is shown in figure 10. Exterior vehicle crush and occupant compartment measurements are shown in appendix B, tables 2 and 3.

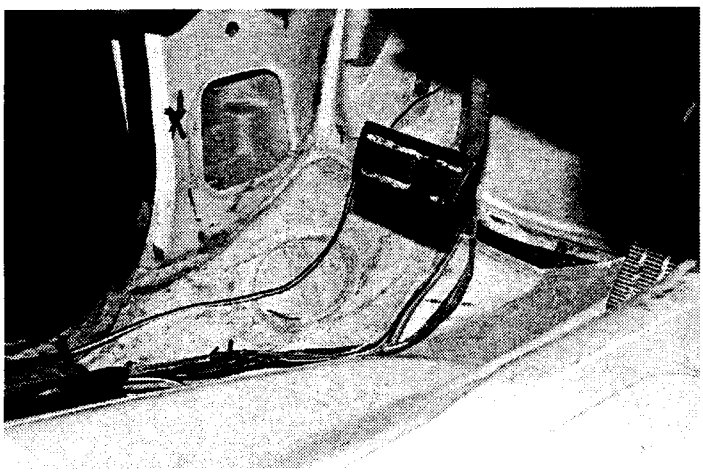
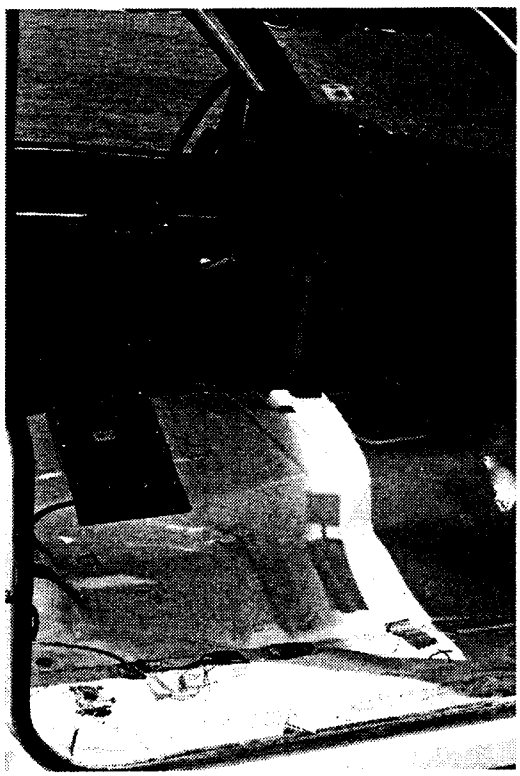
Figure 10. Interior of vehicle for test 404311-5.

No detached elements, fragments or other debris were present to penetrate or to show potential for penetrating the occupant compartment nor to present undue hazard to others in the area. Maximum deformation of the occupant compartment was 130 mm (12 percent reduction in space) to the floor pan behind the driver's seat to the right at the inside seat belt bolt and 104 mm to the lower portion of the kick panel area.

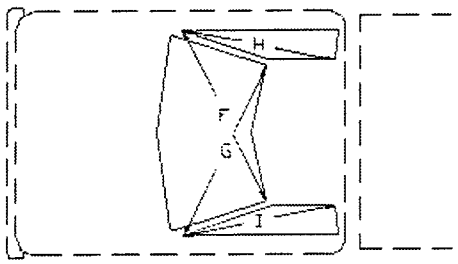
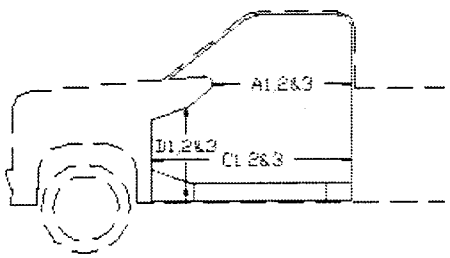
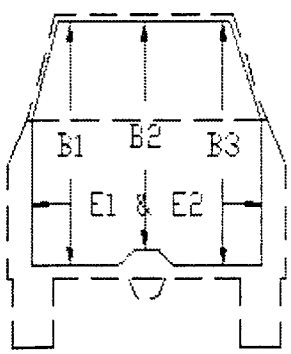
Occupant Compartment Deformation

BEFORE	AFTER
A1	1040	1036
A2	1084	1091
A3	1045	1051
B1	1075	1060
B2	1065	935
B3	1082	1073
C1	1385	1341
C2	1262	1245
C3	1372	1372
D1	309	370
D2	97	80
D3	310	316
E1	1597	1605
E2	1592	1620
F	1470	1455
G	1470	1460
H	900	900
I	900	880
J	1524	1420
