TEXAS TRANSPORTATION INSTITUTE

NCHRP REPORT 350 TEST 4-22 OF THE ALASKA MULTI-STATE BRIDGE RAIL THRIE-BEAM TRANSITION

July 1999

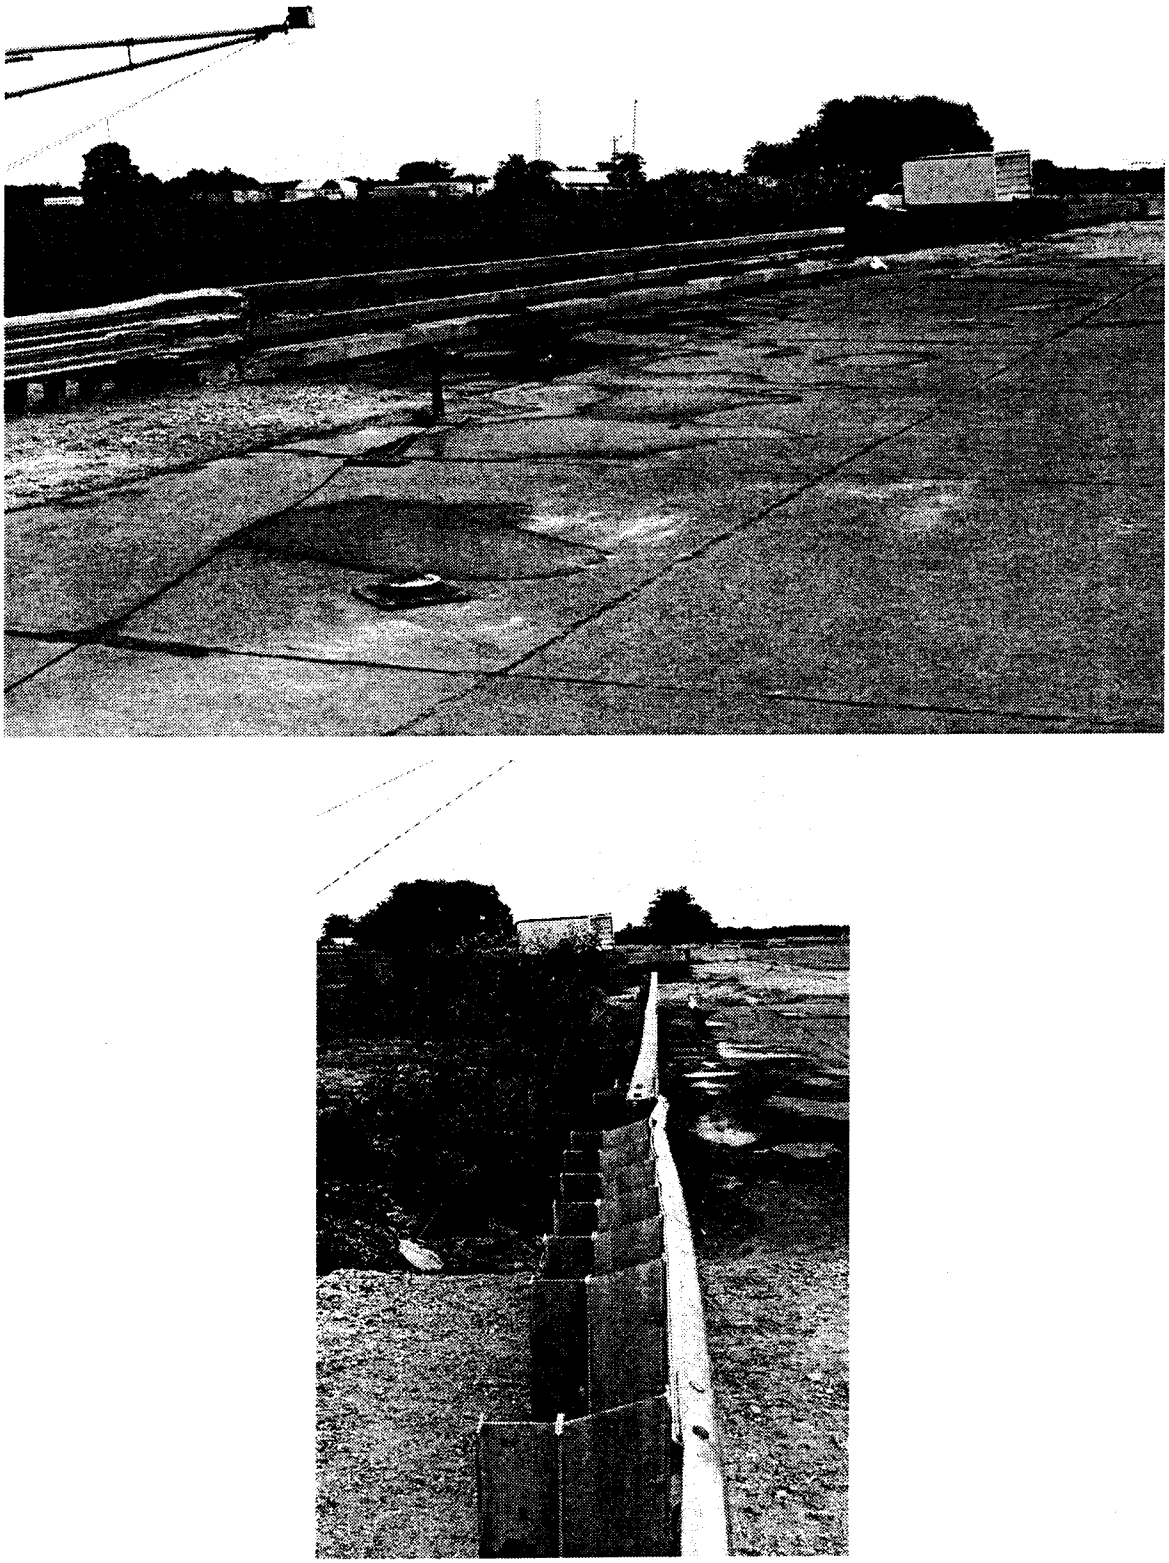
Figure 8. Installation after test 404311-6.

Minimal damage was sustained by the transition as shown in figures 7 and 8. However, structural damage was imparted to the bridge deck around post 20 (the first bridge rail post). Post 1 through post 14 were disturbed, post 15 moved back 5 mm and post 16 moved back 9 mm. Post 17 was pushed back 22 mm, post 18 was pushed back 44 mm and post 19 was pushed back 42 mm. The end of the curb at the edge of the bridge deck was cracked and pushed back 2 mm. The vehicle was in contact with the transition and bridge rail for a total of 5.0 m. Maximum dynamic deflection of the rail during the test was 77 mm and maximum permanent deformation of the rail was 49 mm.

The Alaska Multi-State Bridge Rail Transition contained and redirected the 8000S vehicle. The vehicle did not penetrate, underride, or override the installation, however, structural damage did occur to the bridge deck. Maximum dynamic deflection of the rail was 77 mm.

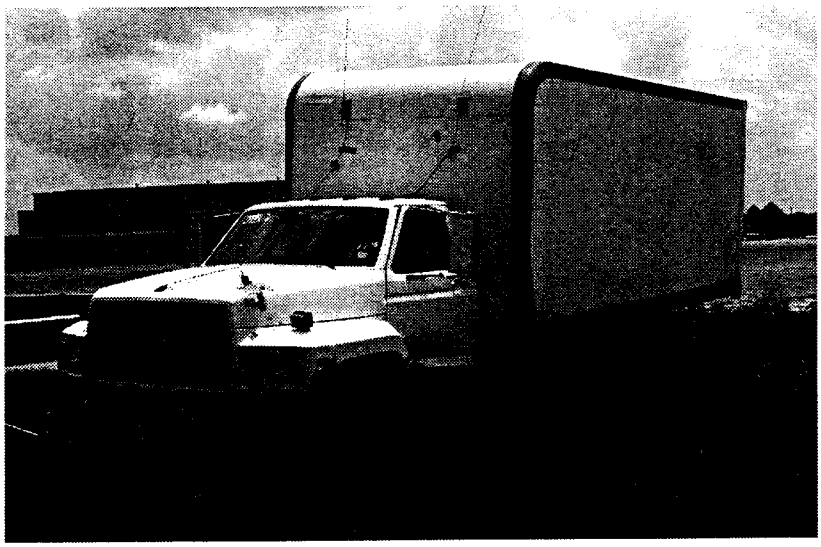
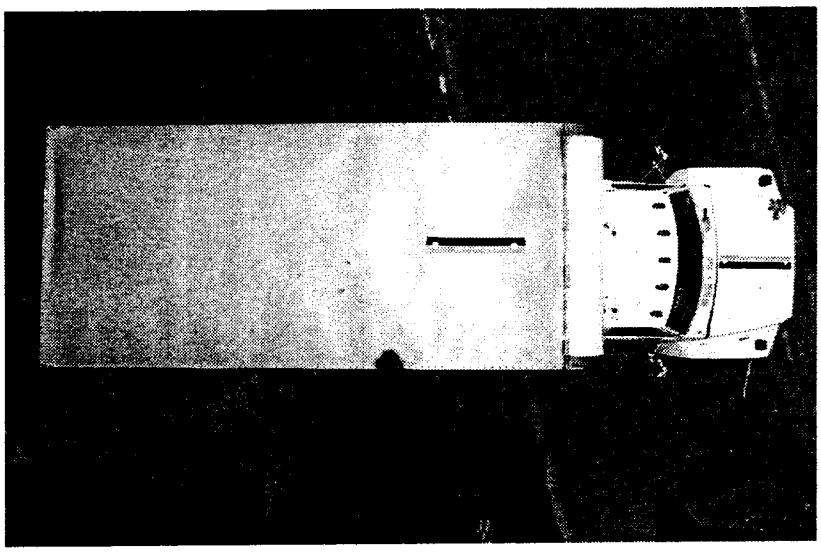
Figure 9. Vehicle after test 404311-6.

Damage to the vehicle is shown in figure 9. The left side of the front axle was separated from the vehicle and the left side spring, U-bolts, shock, rod ends and steering arm were damaged. The front bumper, grill, left front quarter panel, and left side door were deformed. The left front tire and wheel rim and the left rear outside tire and wheel rim were damaged. The lower edge of the box van was damaged and the floor pan on the left side was deformed slightly. Photographs of the interior of the vehicle are shown in figure 10.
