Conditions and Needs Assessment

Dillingham Airport Master Plan Update

Project No. CFAPT00353/ AIP 3-02-0078-017-2018

December 2021

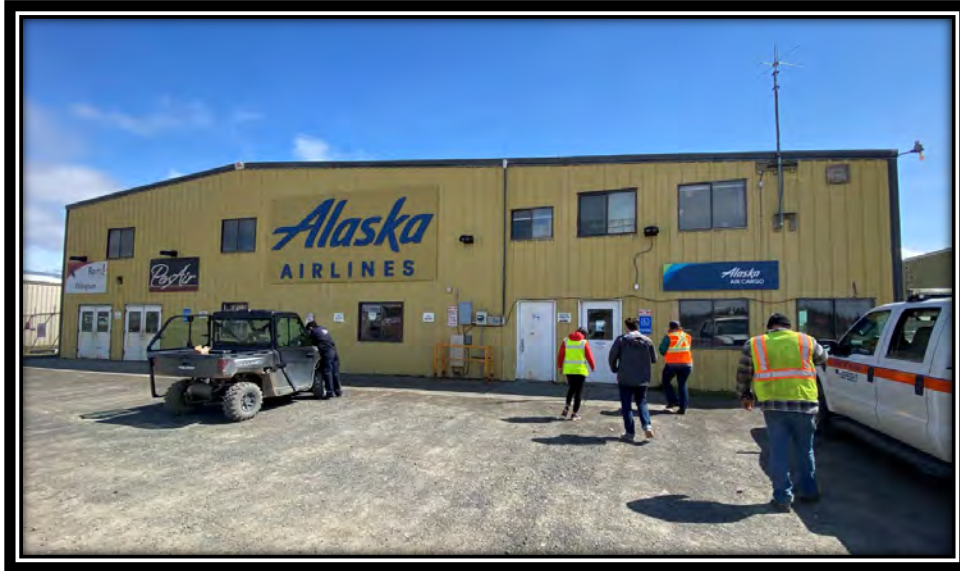
Figure 6: Alaska Airlines/Ravn Air Terminal Building Exterior

There is a single gate and baggage claim area at the Alaska Airlines/Ravn Alaska terminal building. The ticketing area has five kiosks. The waiting area is not physically separated from the gate for security purposes, although TSA personnel are present. There are no restaurants, concession areas, or vending machines at the airport. Restroom facilities are unreliable and inadequately sized to meet needs during the busier summer months.

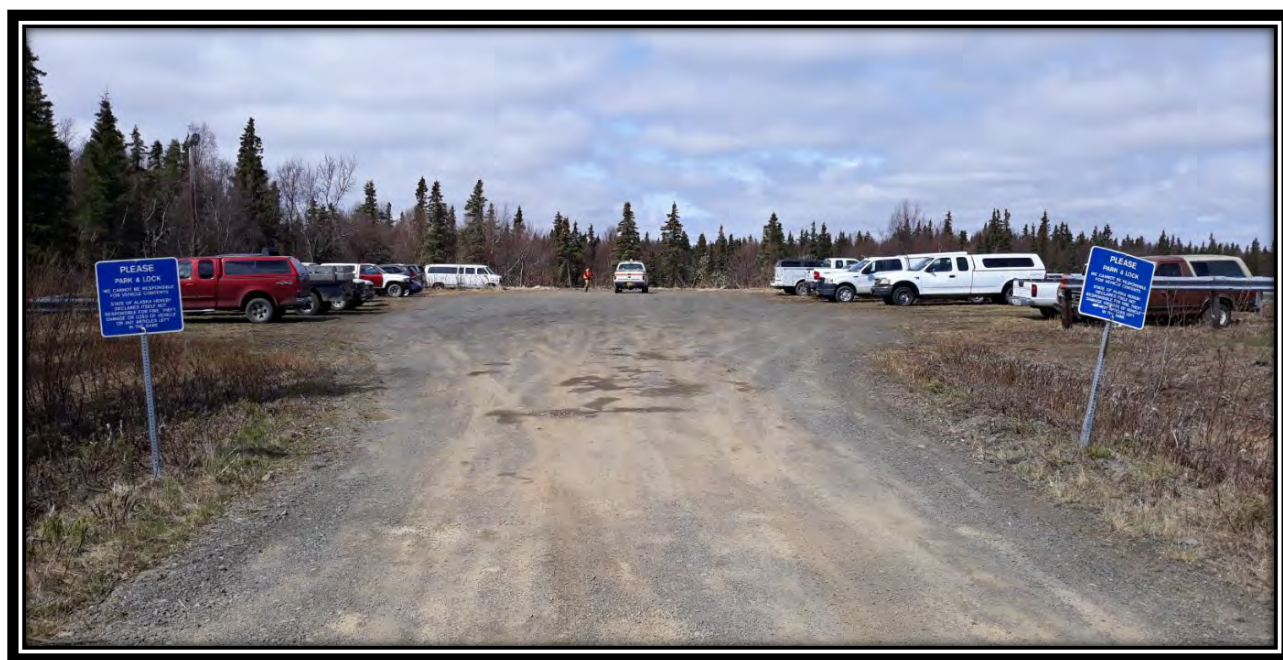
Figure 13: Long Term Parking Lot at DLG

Separate vehicle parking for general aviation is not available. Pilots park personal vehicles in the airplane’s tie-down spot while flying. The long-term parking area is approximately 0.3 miles southwest from the Alaska Airlines/Ravn Air terminal building. Two overhead lights have been added since the previous Airport Master Plan update, but the area is otherwise unsecured. Several junk vehicles have been abandoned in the long-term parking lot. While DOT&PF requires vehicle owners to move their vehicles from the long-term parking after 30 days, enforcement remains a challenge. Removing the abandoned vehicles would improve the security and operability of the parking lot.

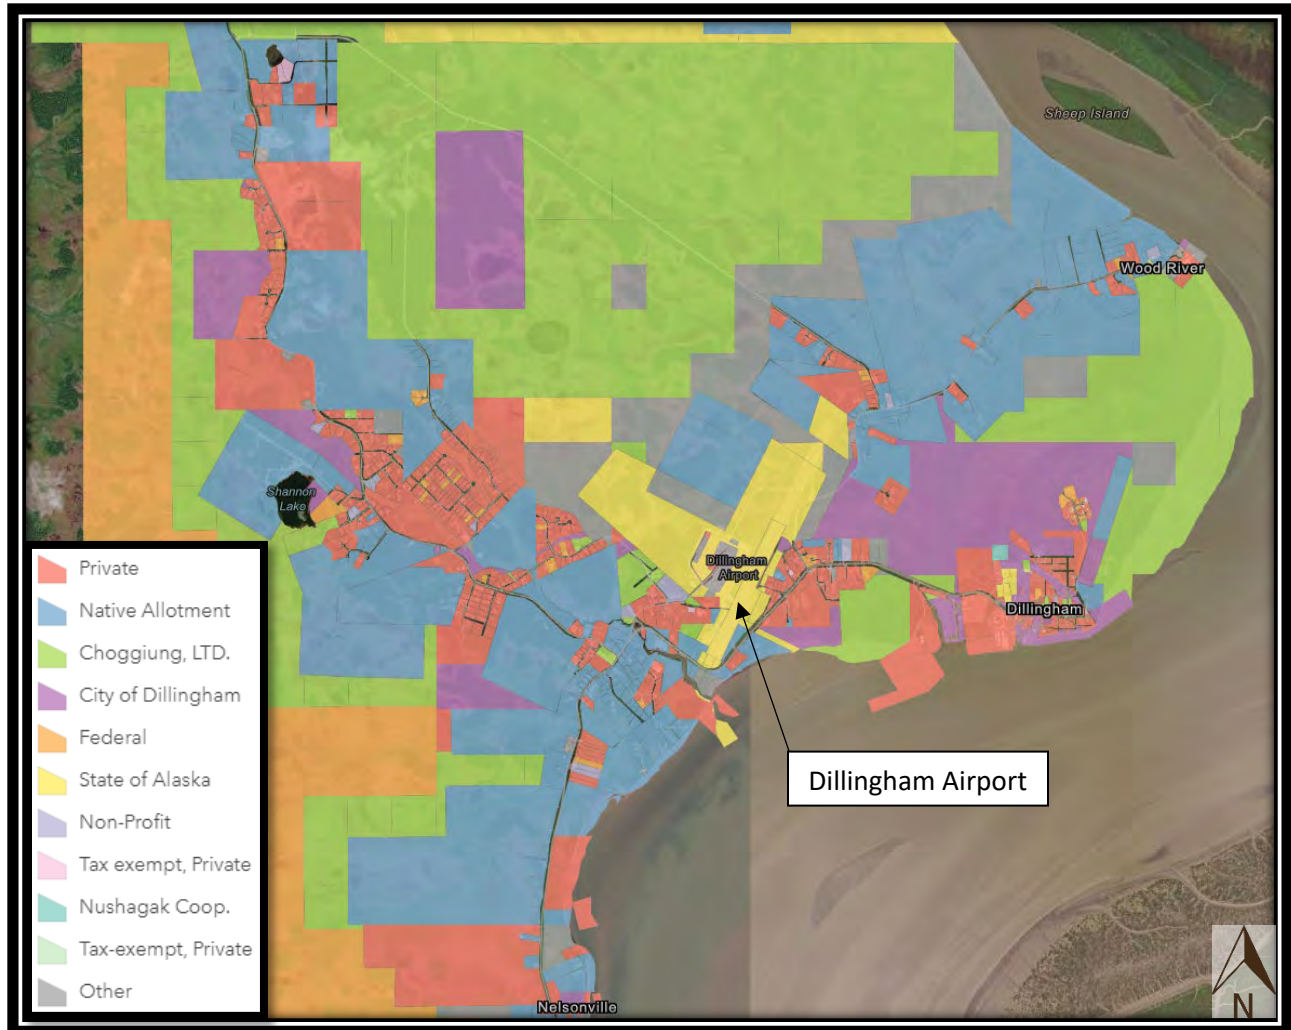
Figure 20: City of Dillingham Land Ownership Map. Source: City of Dillingham Parcels (2021 GIS)

The locations of existing residential properties and the Evergreen Cemetery present possible land use conflicts with airport property. Two residents are located adjacent to the northwest airport property boundary. Access to the residential property is from Airport Road connecting to West Airport Road and North Airport Road, around the general aviation (GA) apron. This may result in difficult public access control along these roads and on airport property. Additionally, a residence encroaches onto airport property east of the runway, north of Kananak Road.

The Evergreen Cemetery is located east of the runway on a knoll above the runway elevation, fully within airport property boundaries. The cemetery is still in use. It encroaches on the east side of the RSA which, according to FAA standards, should be cleared around the airfield. Both the adjacent residential uses and the culturally sensitive Evergreen Cemetery may affect the safe operation of the airport or limit its expansion.
