**HOOPER BAY AIRPORT
IMPROVEMENTS**

PROJECT No. 57419

RECONNAISSANCE STUDY, 2005

RECONNAISSANCE Study Report

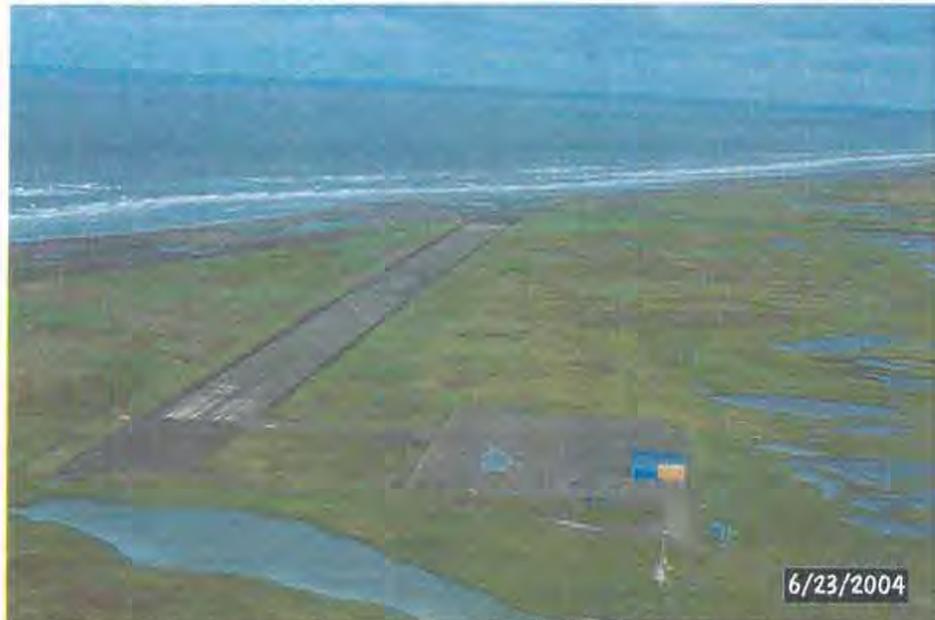
A 75' by 3300' runway currently exists with a 100' by 3900' safety area. A private hangar currently exists on the 180' by 500' apron, which is connected to the runway by a 35' by 150' taxiway. The

picture, shown right, depicts the existing facilities. Medium intensity runway lighting exists along with a lighted wind cone, rotational beacon, AWOS, VASI & segmented circle (currently damaged). Runway 31 also has an Omni Directional Approach Lighting System (ODALS). A 1.5-mile access road connects the

village to the apron and a double bay snow removal equipment (SRE) building currently exists off the airport access road. The beach access road spurs off of the airport access road along the south end of the runway. Additional aerial photography has been attached as Appendix II.

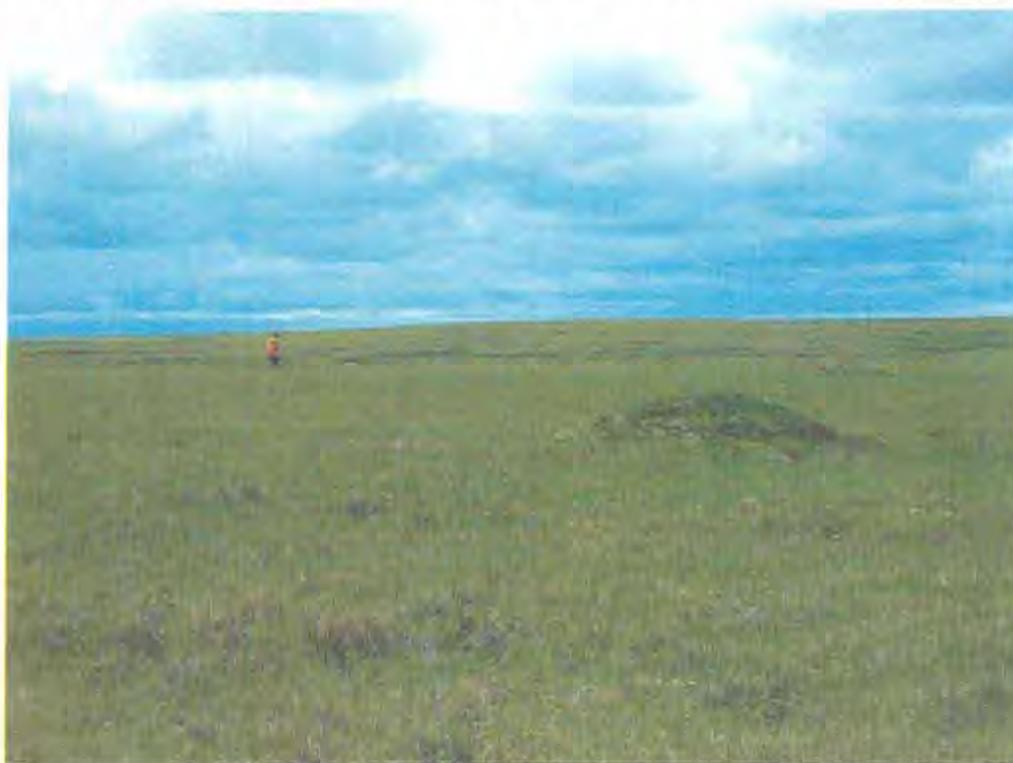
Typical Pingo

- Pingos (as shown below) are conical features up to several feet high and six to ten feet in diameter, appearing either isolated or in dispersed clusters over the terrain. Pingos are generally formed of segregated ice just below the surface. Disruption of the thermal regime of a pingo can result in a thawing sinkhole several feet deep.

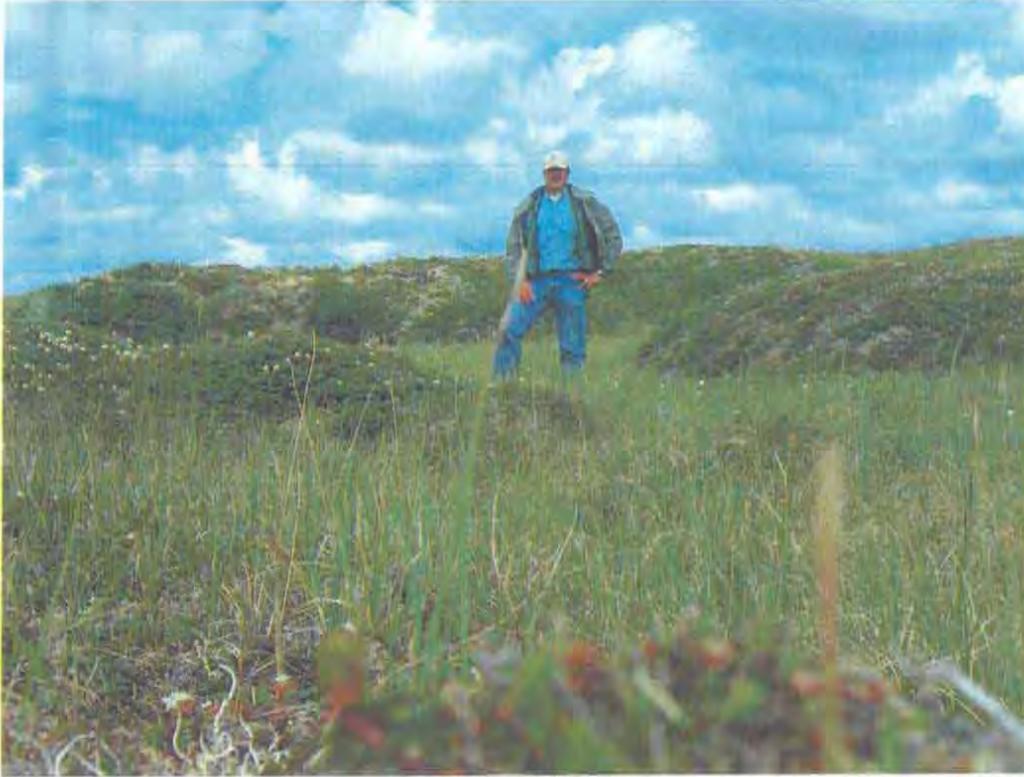
Typical Palsas

- Peat palsas (as shown in the following picture) are ice-rich peat and/or silt features, which stand above surrounding terrain by up to four feet with abrupt margins. The vegetated surfaces of palsas tend to be dryer than the immediately surrounding lowlands. Palsas can cover areas from tens of square feet to much more extensive

clusters, in the range of hundreds to thousands of square feet. They were often seen clustered along shallow slopes and across low, poorly drained basins. Disruption of the thermal regimes of palsas would result in extensive areas of soft, saturated peat and organic silt muck.

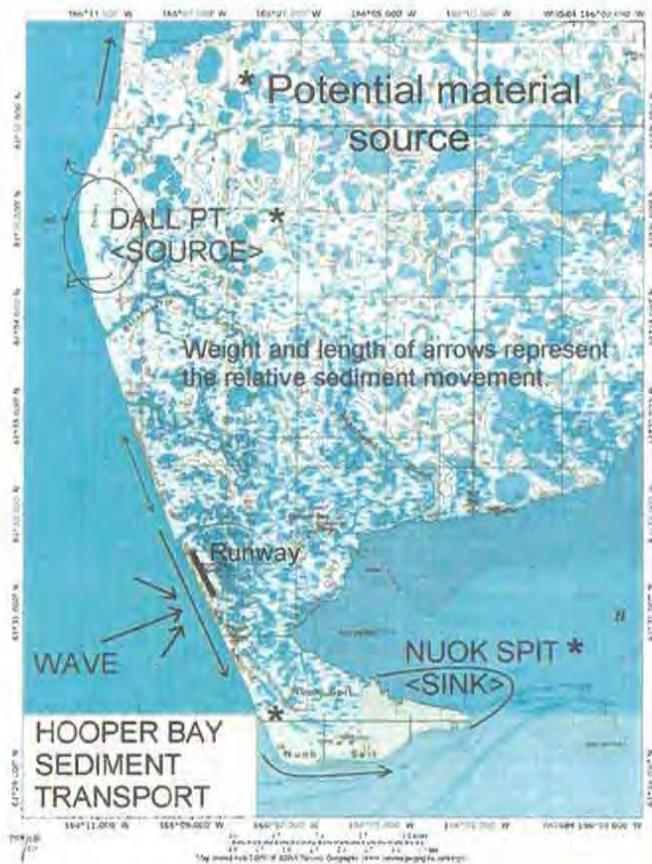
Dall Pt. (as shown right) exhibits characteristics of bi-directional transport of sediment and acts as both a sediment source and sink. Sediment moves both north and south from Dall Pt. This has potential as a material source in the event that the airport is relocated to sites 1 or 2.

Beach material parallel to the existing runway is moving south toward the spit; removal of it will have less effect on the existing runway the further south it is taken. In the event that the airport is reconstructed, it is recommended that material be mined from the beach and dunes $\frac{3}{4}$ - to 1 mile south of the existing beach access road. It is also recommended to avoid areas where there are thaw lakes near the edge of any vegetated bluff.

In the near term, it is recommended that the horizontal and vertical erosion along the face of the sheet pile wall be monitored. If more of the toe is exposed sand bags may be added to minimize erosion progression. If 75% of the length of the sheet pile wall in either direction is exposed, it is recommended that wall be extended. The ArmorFlex sections should also be monitored to prevent further erosional damage to the existing facilities.
