***NOATAK RIVER BANK EROSION STUDY
AT NOATAK, ALASKA***

ANTHC Project No. AN01-Q55

February, 2003

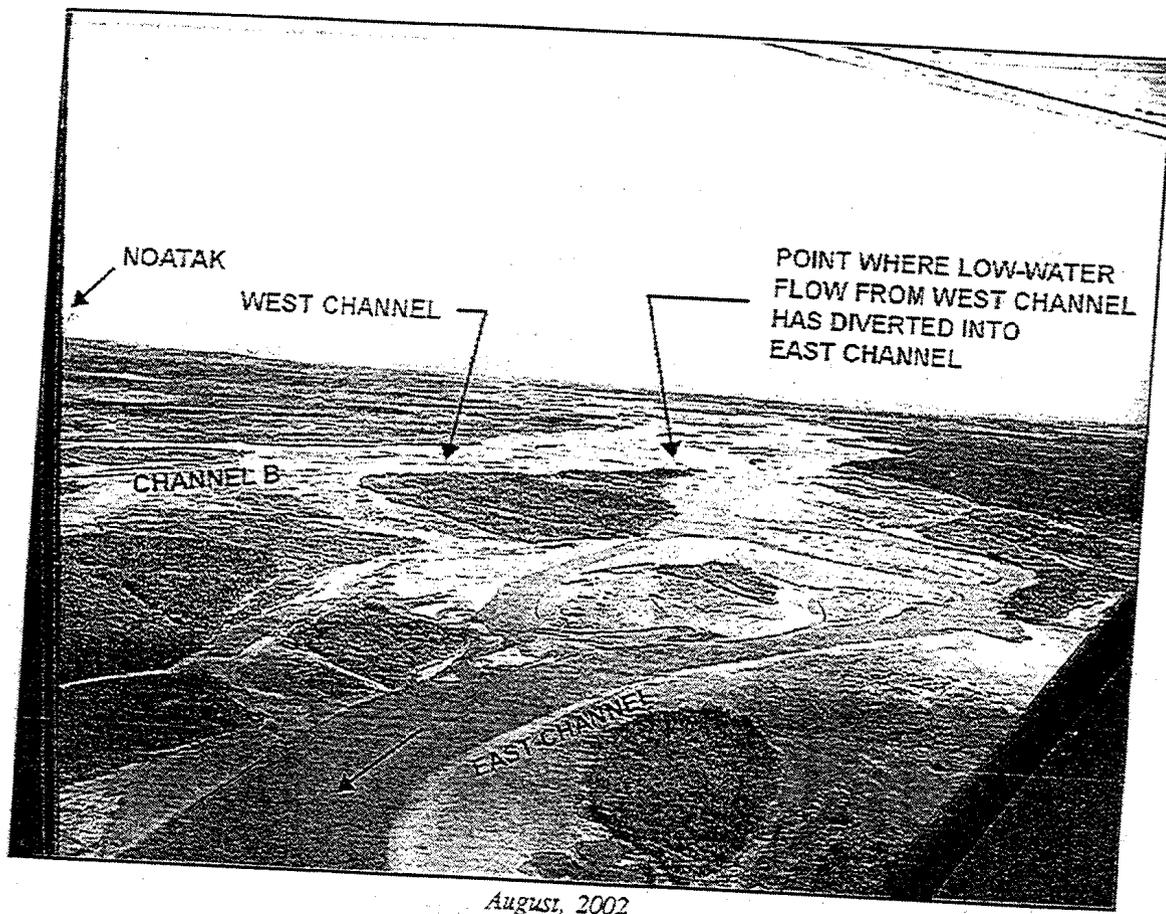
FIGURE 3

PHOTO OF RIVER FLOODPLAIN

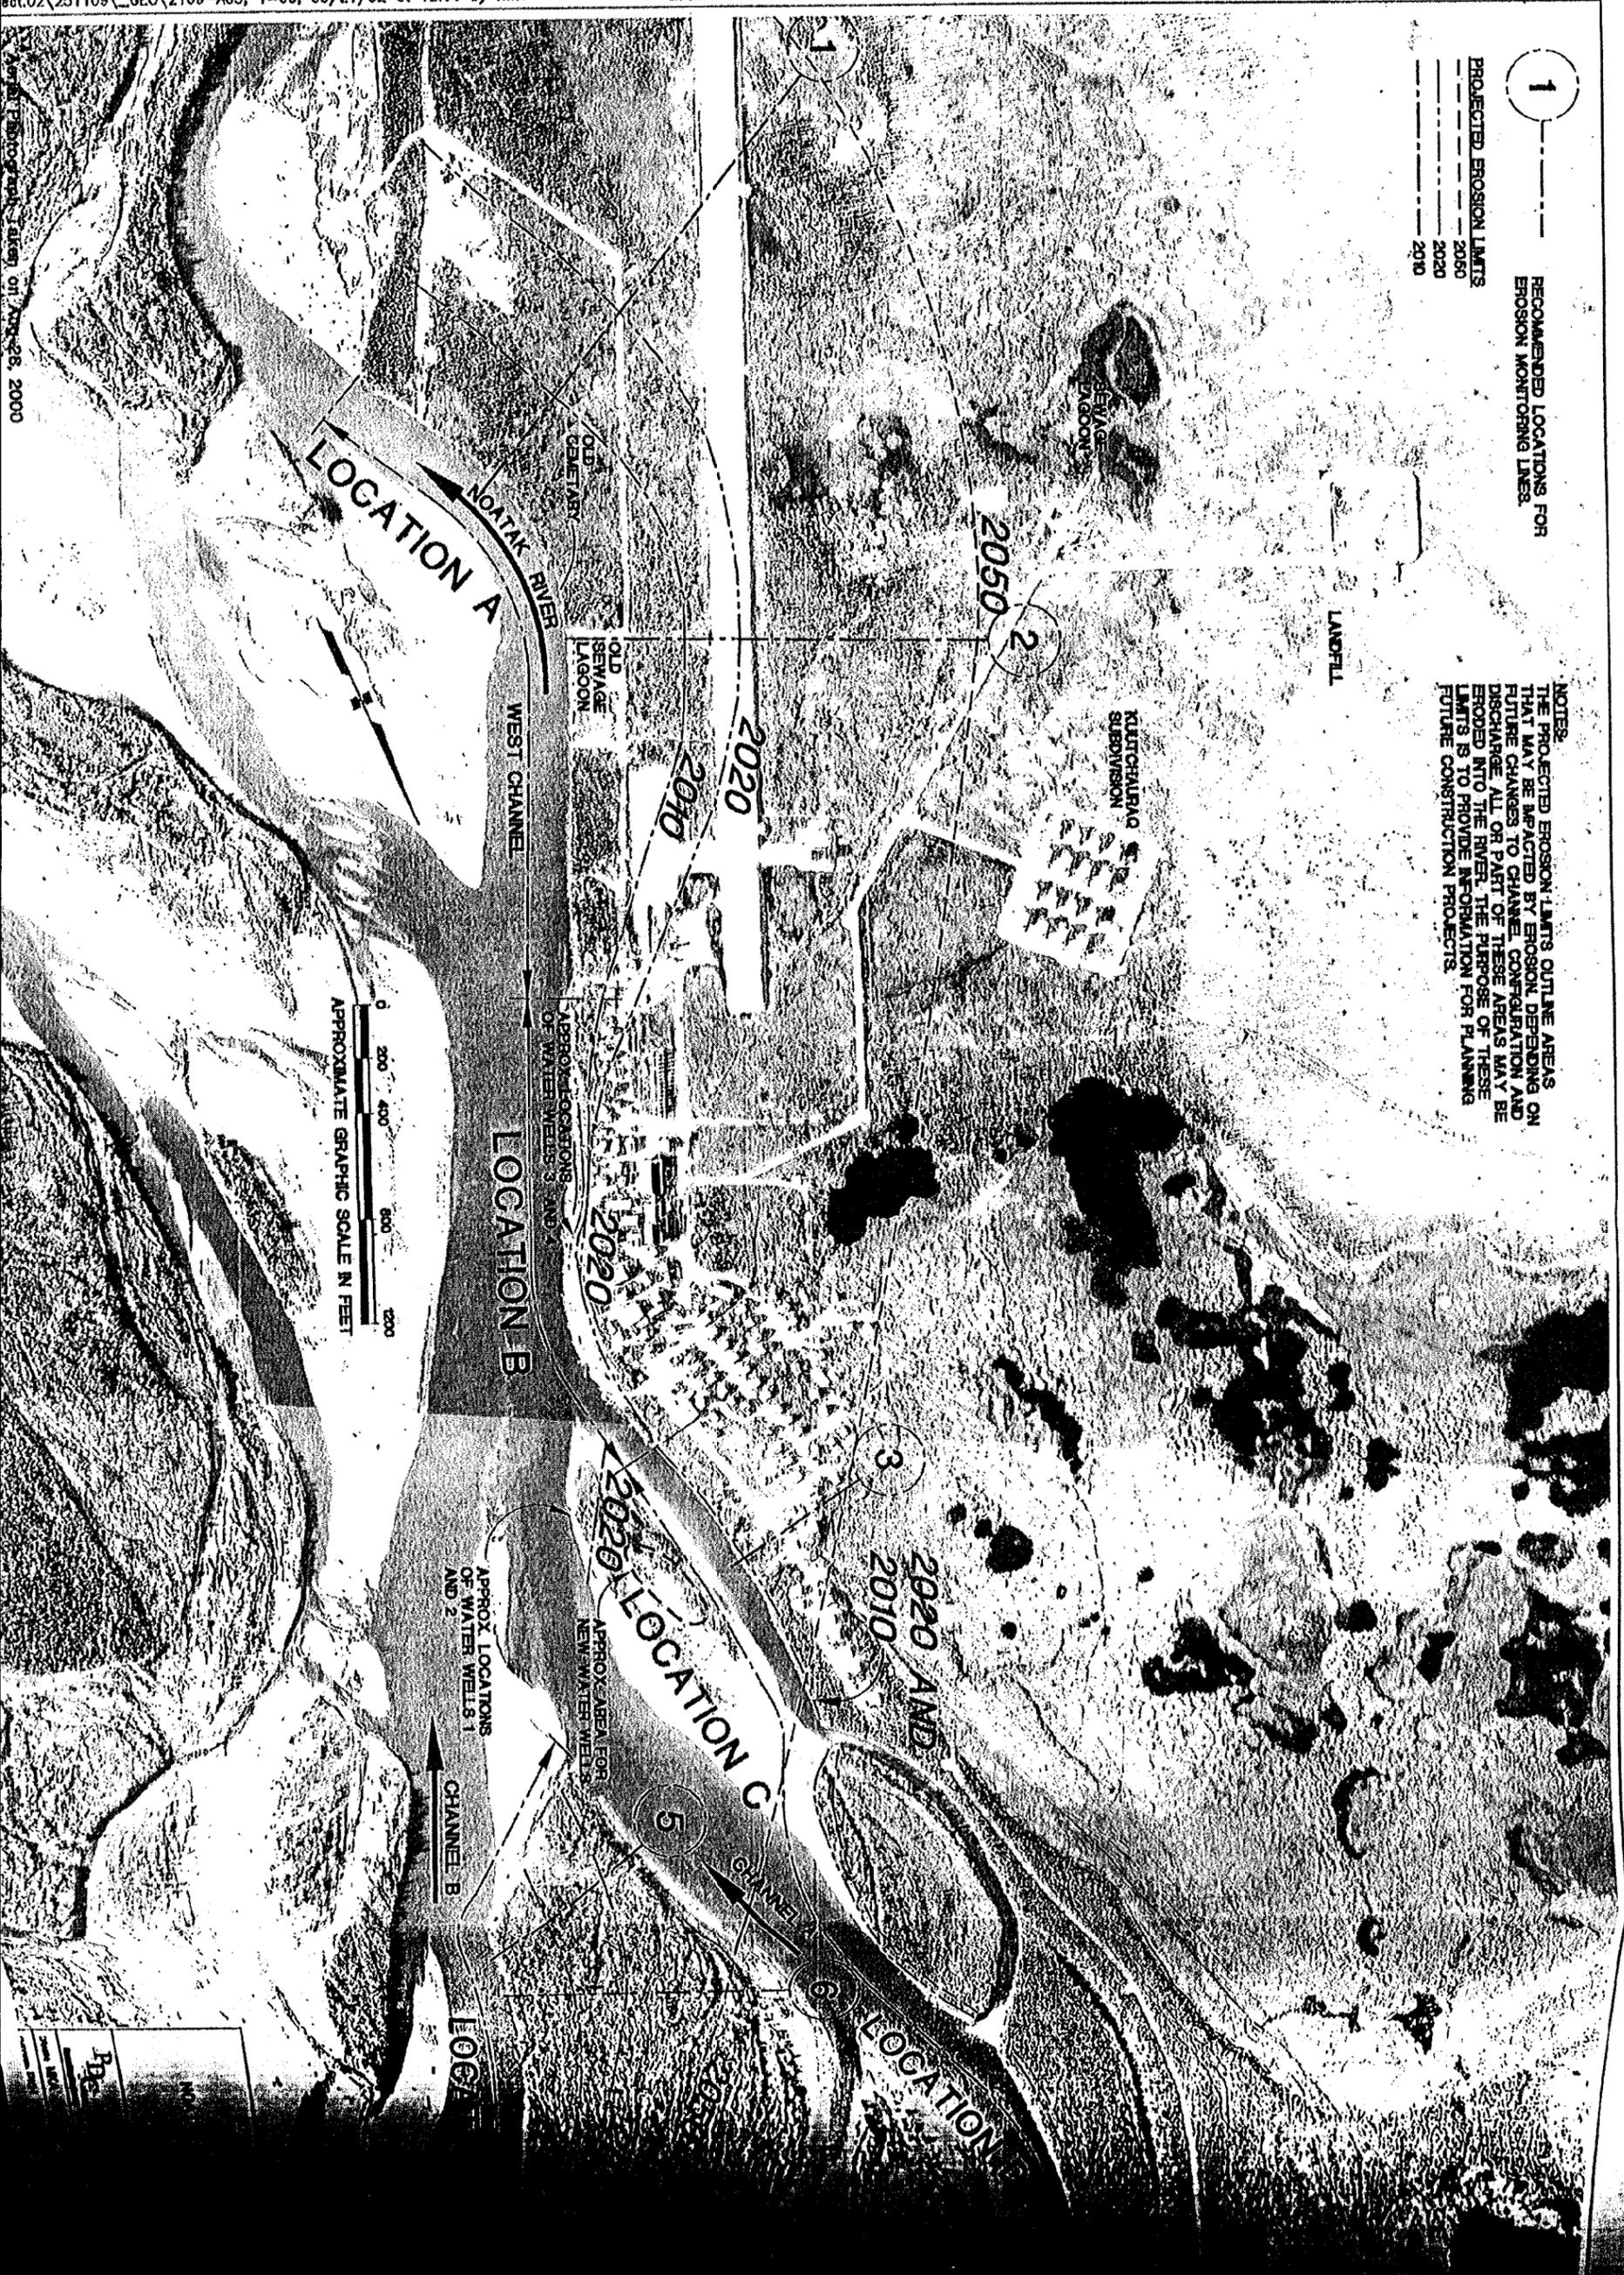
1
 RECOMMENDED LOCATIONS FOR
 EROSION MONITORING LINES.
 PROJECTED EROSION LIMITS
 2050
 2020
 2010
