## Cantwell to Healy – Parks Highway Milepost 203-259 Planning & Environmental Linkages Study

Project No. NFHWY00492

## **Needs and Opportunities Assessment Report**

> > > > October 2020

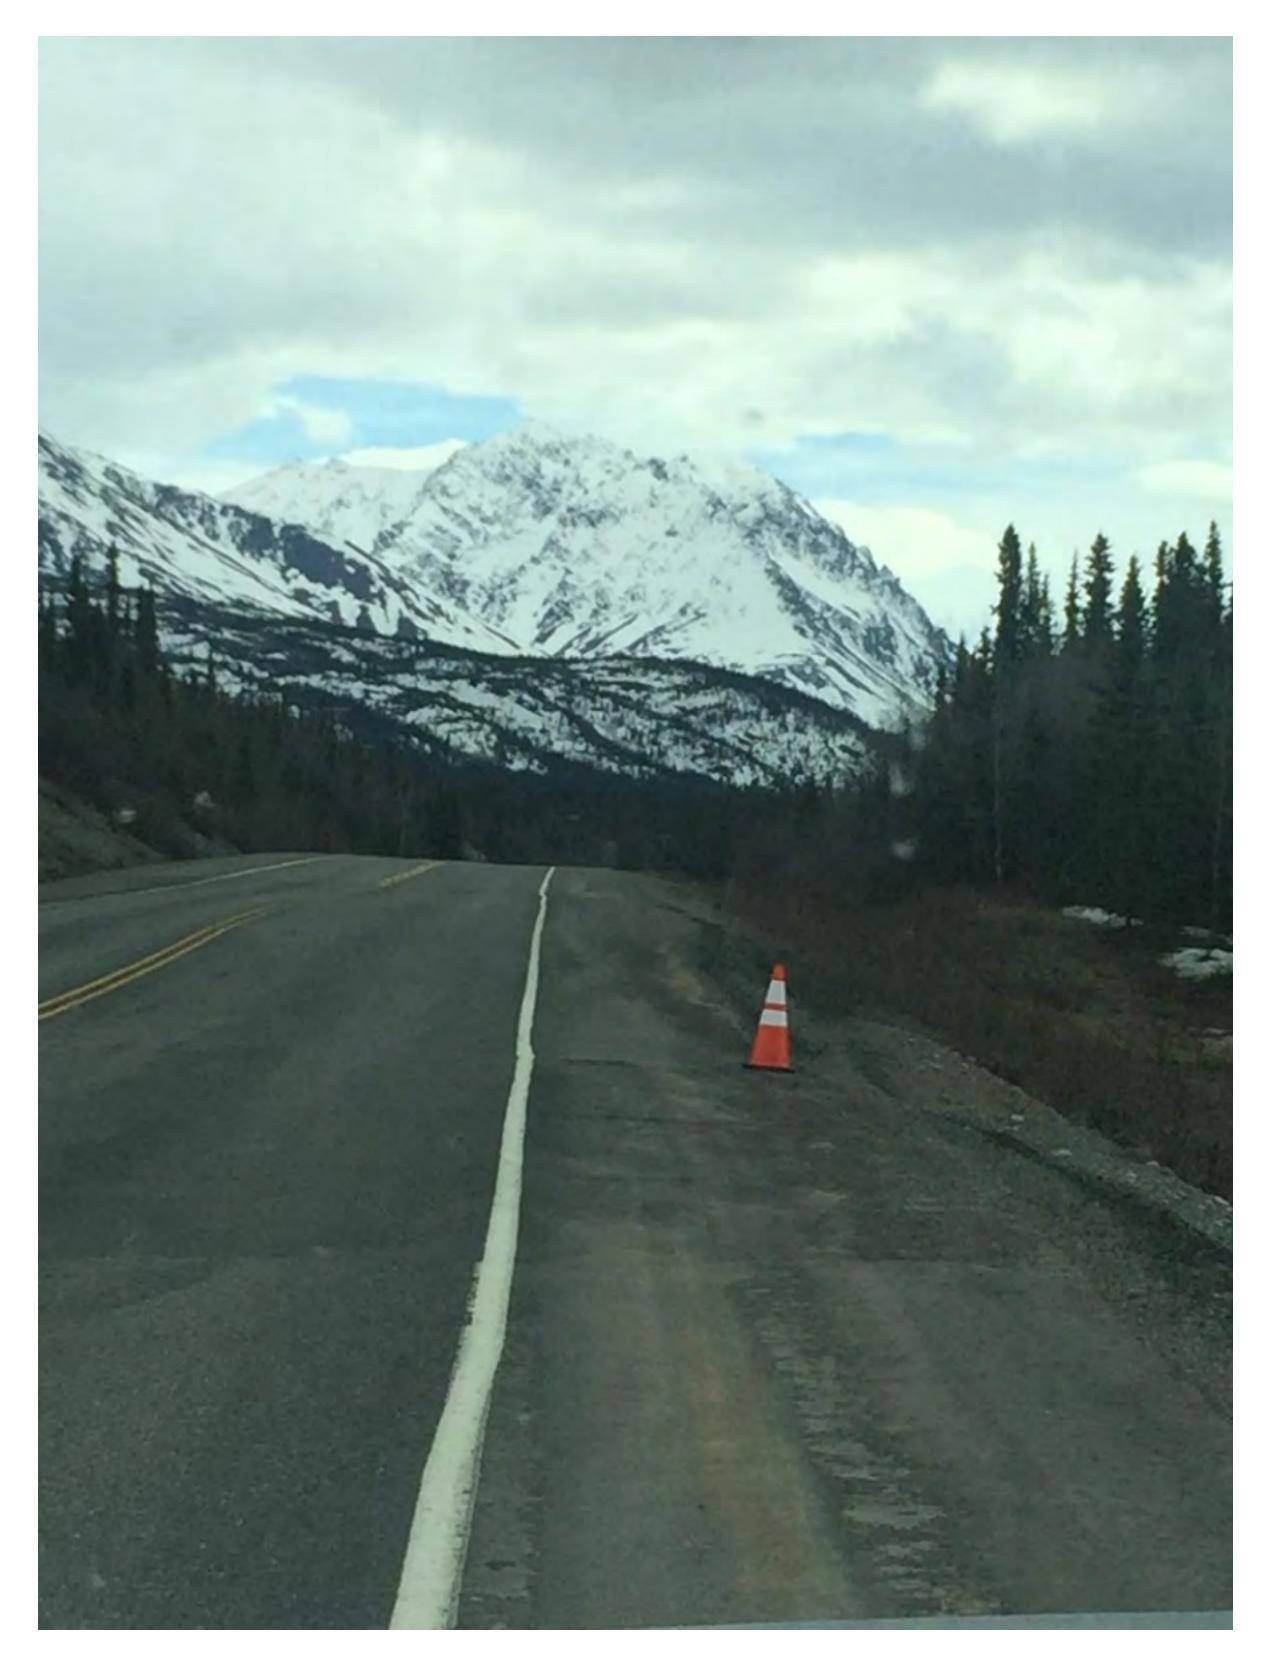
Figure 5 – Section near MP 228.5, where the road is settling

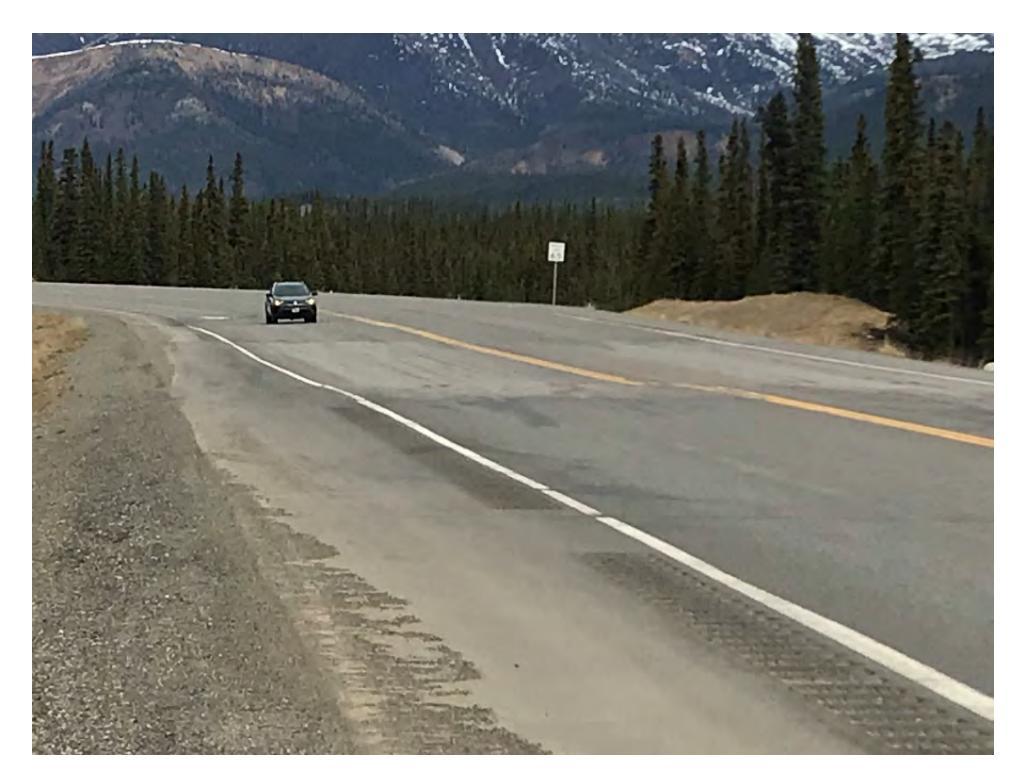
MP 232.7	Healy M&O Station	Pavement / Roadway Integrity	Figure 8	7	This location requires annual maintenance to be complete in order to address issues with uneven settling and heaving.
MP 235	Healy M&O Station	Railroad Crossing	Figure 9, Figure 10, and Figure 11	8	One concern with this crossing is that it is always causing damage to the snow removal equipment used by M&O to clear the highway. This railroad crossing also requires a large amount of maintenance annually, with crews repairing the crossing at least once a year if not more frequently. There are reoccurring maintenance issues with the pavement and the roadway integrity at this railroad crossing as well.
MP 235 - 236	Healy M&O Station	Drainage Issues / Road Shoulders	Figure 12, Figure 13, and Figure 14	9	Drainage issues along this stretch cover a pretty significant area, spanning over ¾ of a mile in both directions from MP 235.5. The condition of the pavement in this area is reported to be way below an acceptable level, likely as a partial result of these drainage issues. This stretch of roadway requires annual maintenance work to be completed. There are also concerns regarding the road shoulder, which is said to be next to non-existent in some places.

Figure 8 - Annual maintenance for pavement and roadway integrity issues near MP 232.7

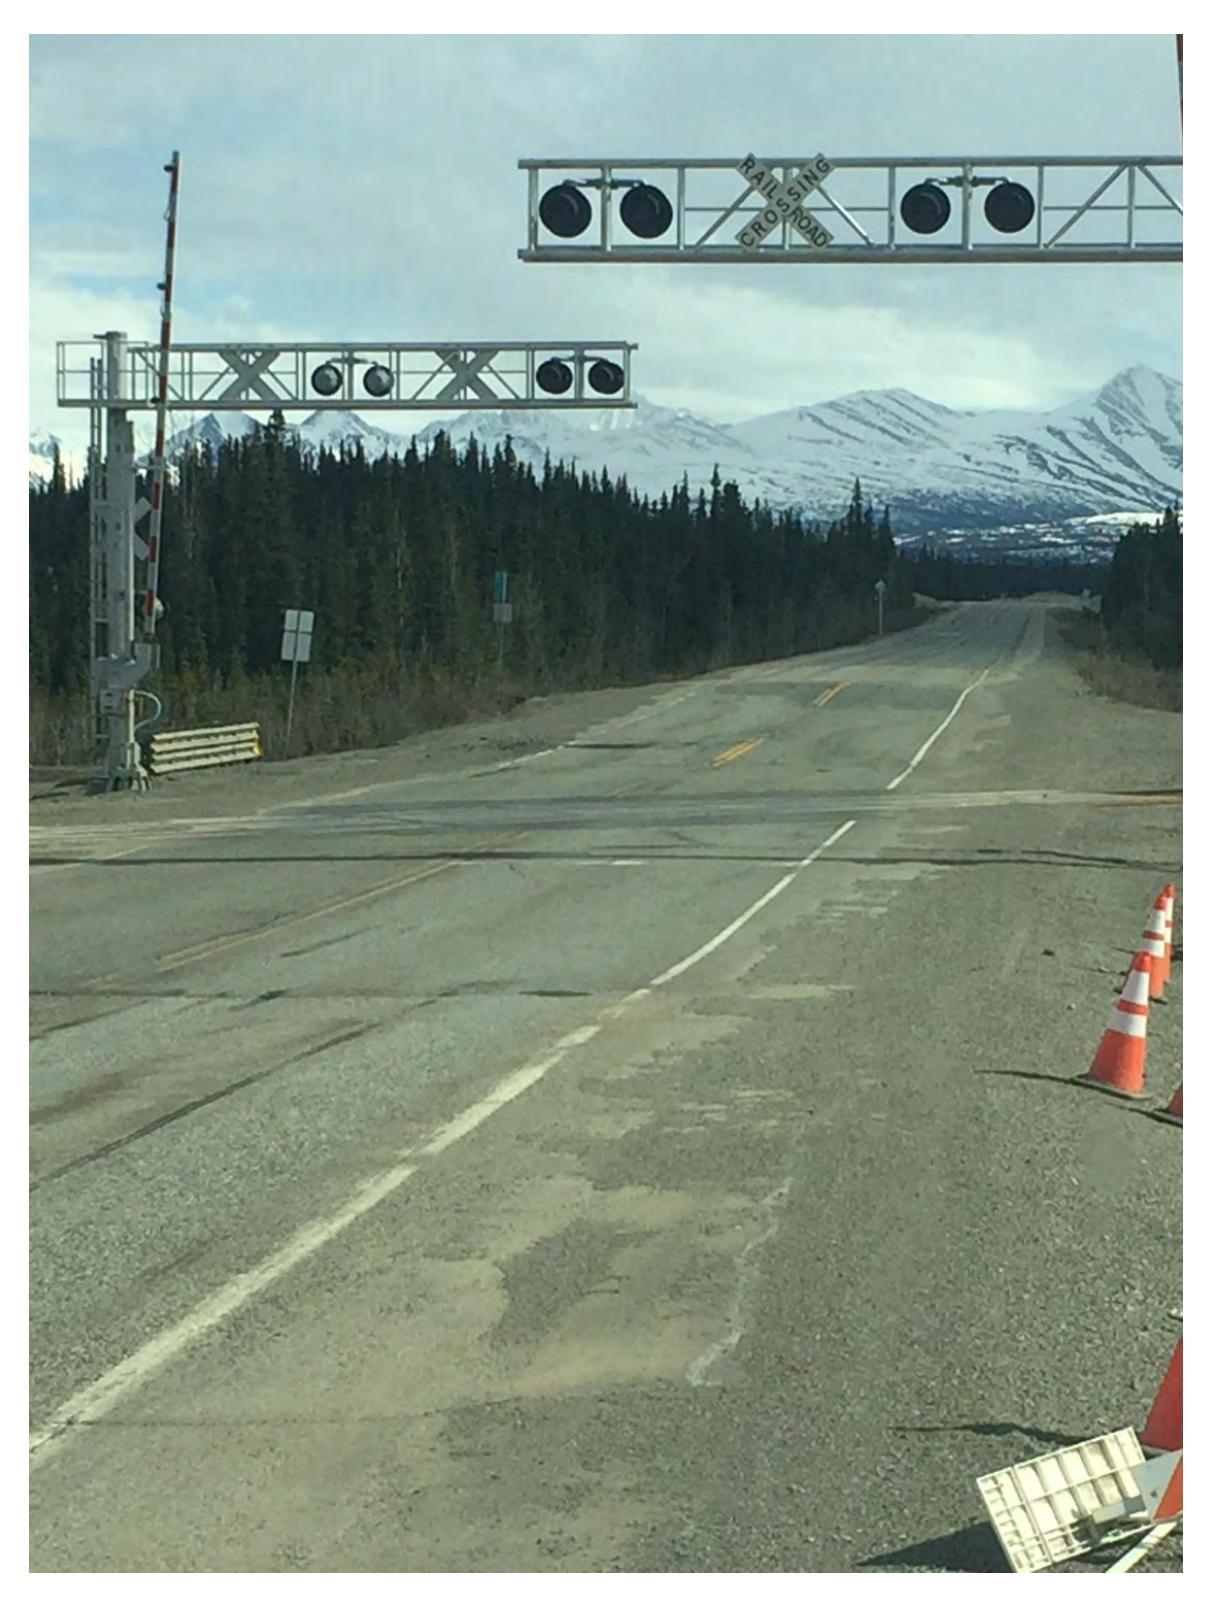
Figure 9 – Problematic Railroad Crossing at MP 235 of the Parks Highway

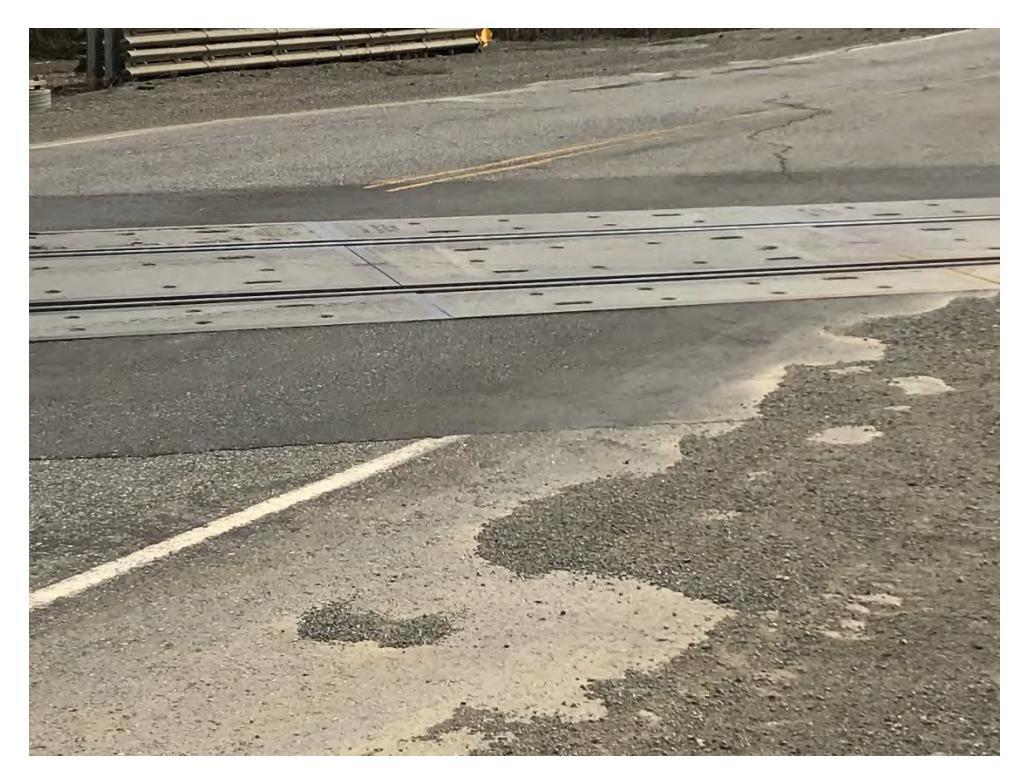
Figure 10 - Surface patches along railroad crossing

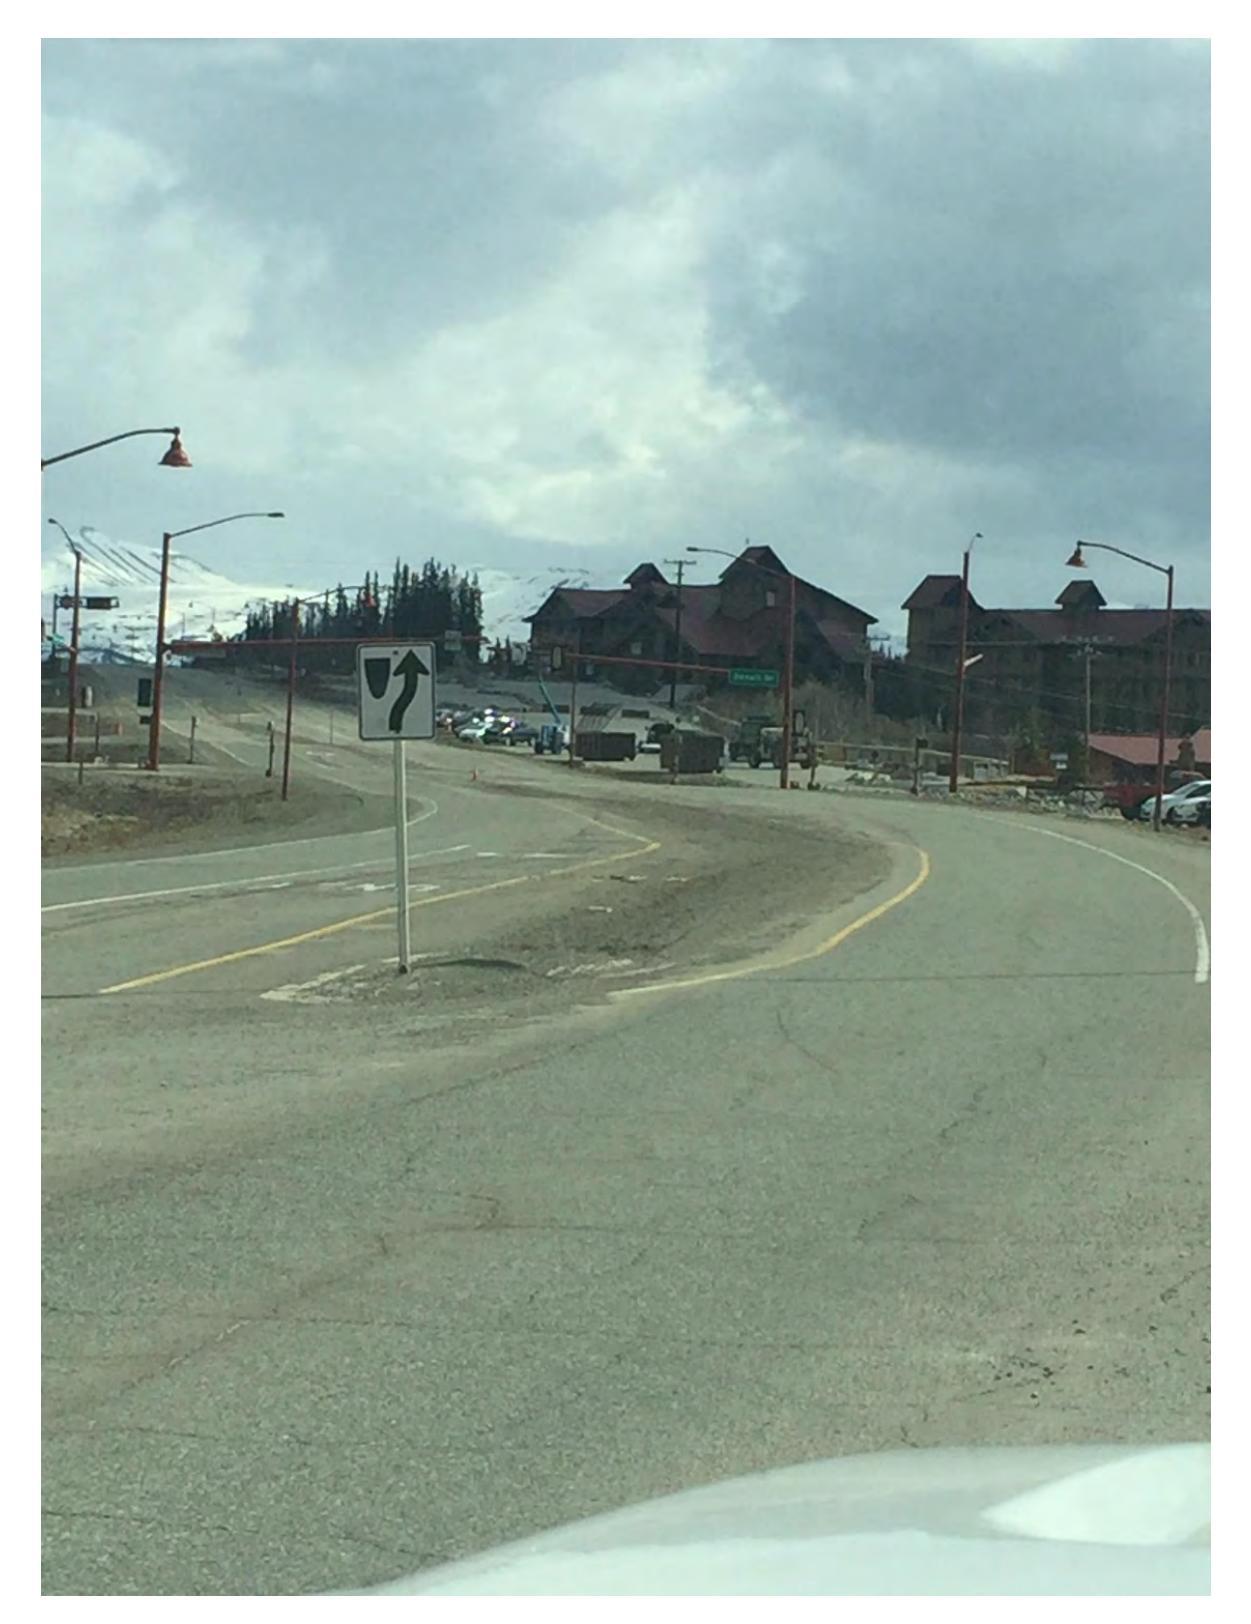
Parks Highway	Maintenance	Type of	Figure	Location	Notes
MP	Station	Concern	Number(s)	Number	
MP 239	Healy M&O Station	Inadequate Summer Parking	Figure 15	11	The Nenana Canyon Businesses corridor is another location that M&O crews have identified as a problematic area. During the summer months when tourism is around its peak, parking in this area can often fill up and overflow into the Parks Highway shoulders.
MP 239 - 240	Healy M&O Station	Active Rock Slides / Drainage	Figure 16, Figure 17, and Figure 18	12	This area is prone to active rock slides, which are a concern for M&O crews as well as the general public. When these slides occur, larger rocks can be moving with enough force to make it past protective barriers and onto the active roadway. Scott Randby, the M&O superintendent for the Denali district, said that crews will begin working in this area in the early morning hours while rocks are still frozen in place. This is to minimize the risk of getting hit by a slide directly or smashing maintenance equipment. Drainage issues are a continual problem behind jersey barriers, with annual debris slides that will often block the culverts. These jersey barriers that were installed after the last project through Nenana Canyon cause additional maintenance problems. With the current setup, M&O crews do not have adequate access around the barriers to use their normal equipment to clean all the debris from the ditches. Instead, they have to rent an excavator to do it, which results in additional maintenance costs.

Figure 15 – Northern side of Nenana Canyon Businesses, summer parking concerns

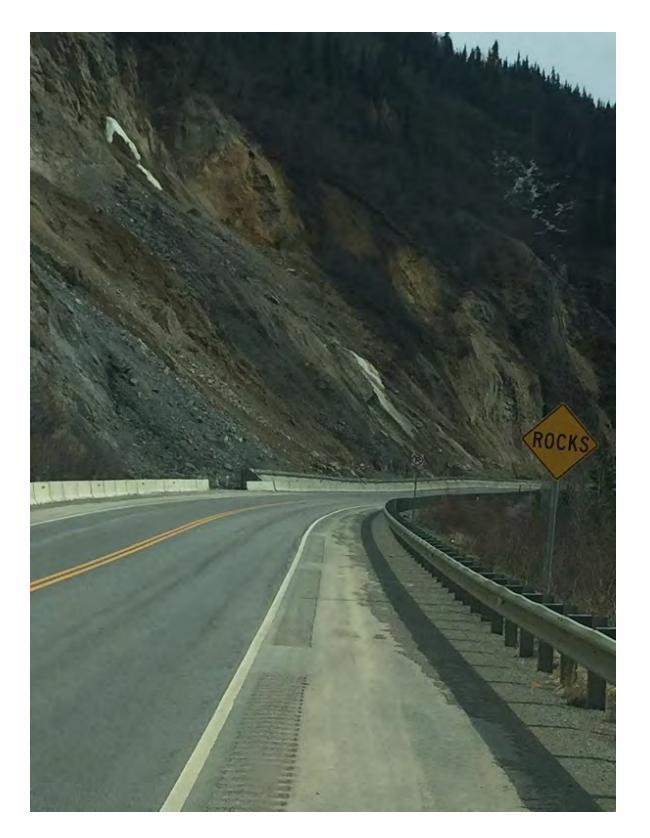
Figure 16 – Entering Nenana Canyon from the North

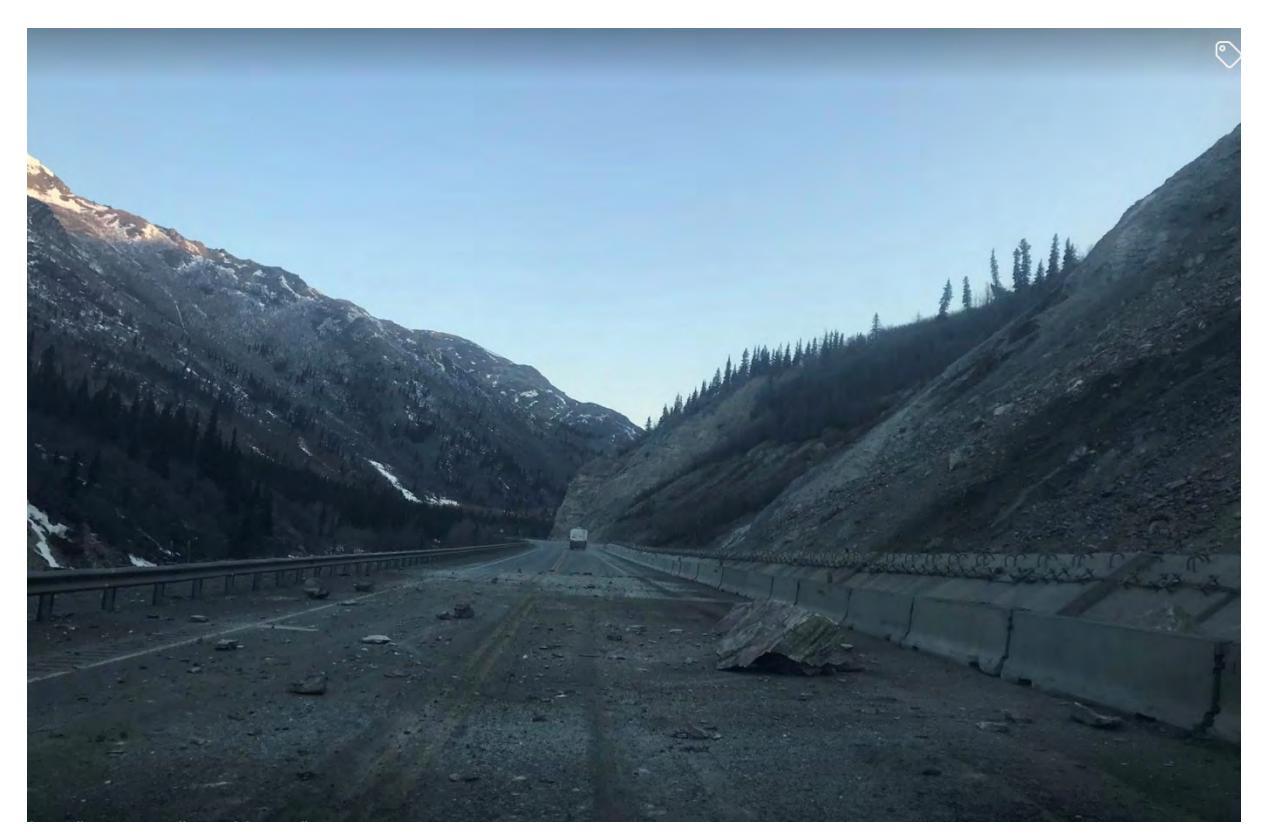
Figure 17 – Larger rockslide that has traveled onto the Parks Highway in Nenana Canyon

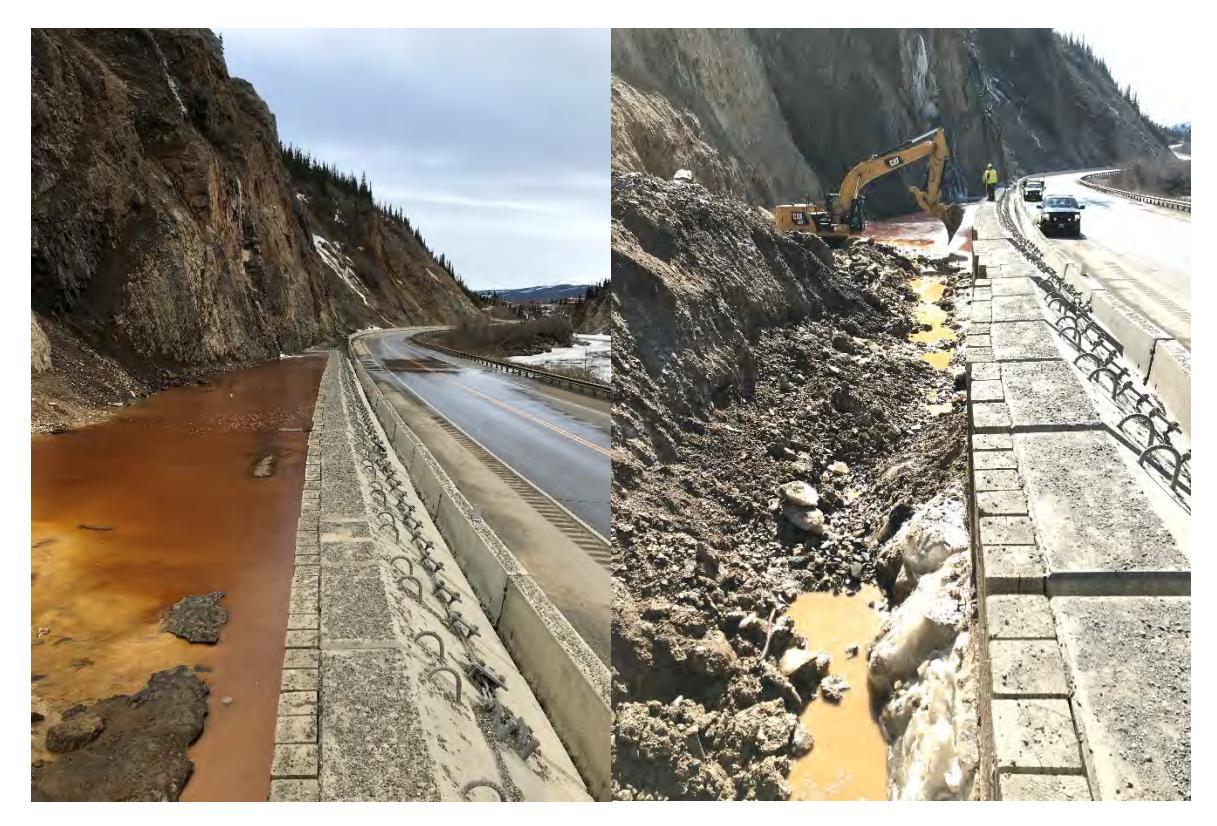
Figure 18 – Drainage issues from slide debris behind the jersey barriers

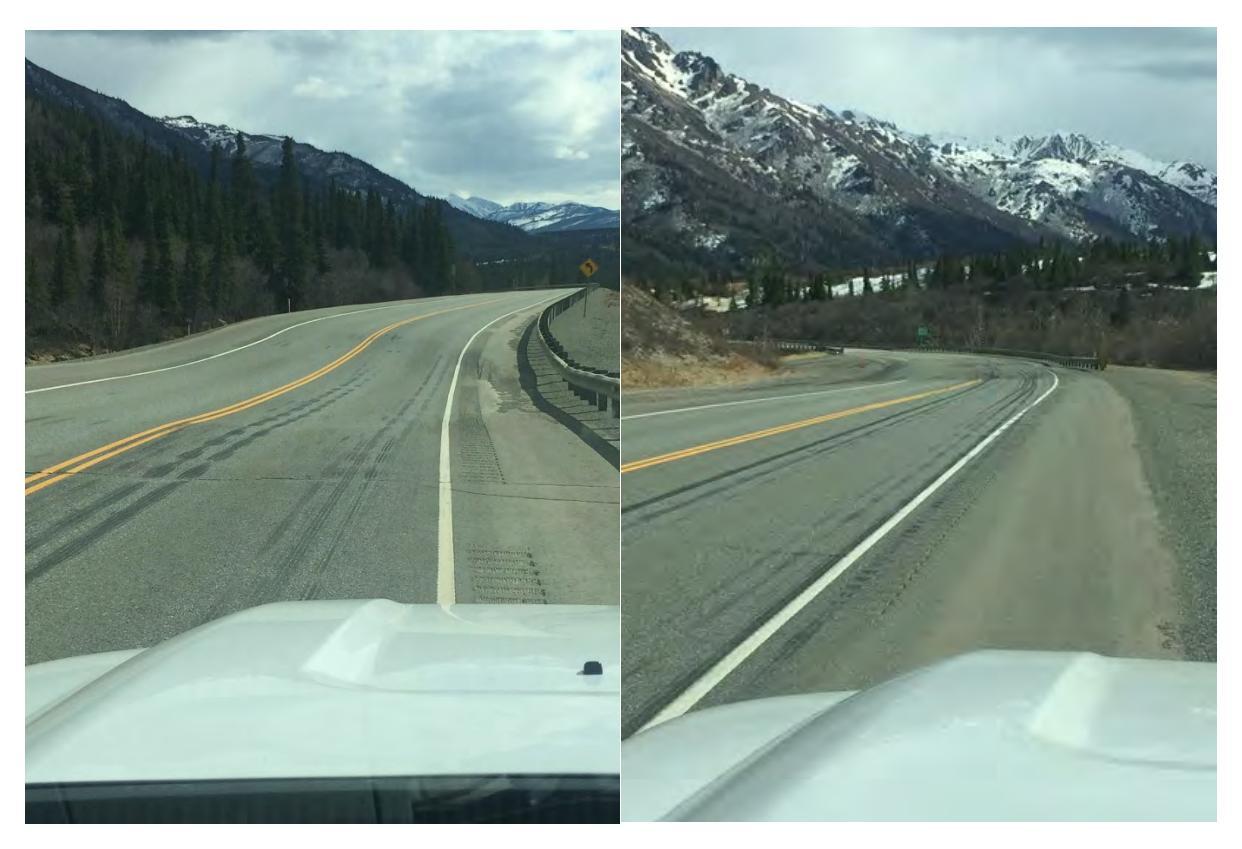
MP 242	Healy M&O Station	Roadway Sinking	Figure 19 (left)	13	This location has been identified to have issues with the roadway settling annually. This causes the highway to develop an uneven surface and sections of heaving, resulting in annual maintenance concerns.
MP 243.5	Healy M&O Station	Roadway Sinking	Figure 19 (right)	14	This location has been identified to have issues with the roadway settling annually. This causes the highway to develop an uneven surface and sections of heaving, resulting in annual maintenance concerns.
MP 248	Healy M&O Station	Pedestrian Safety / Connectivity	n/a	15	Pedestrian concerns in the community of Healy.
MP 251	Healy M&O Station	Turning Lanes	n/a	16	Requests have been received for turning lanes at intersection of Parks Highway with Stampede Road and Lignite Road.
MP 253	Healy M&O Station	Drainage Issues	Figure 20	17	Slightly to the north of MP 253, drainage issues are causing damage to the base of the road. The effect of these drainage issues on the road base are causing part of the road to begin collapsing, creating a bit of a sink hole or severe dip in the road surface.

Figure 19 – Sinking roadway around MP 242 (left) and MP 243.5 (right) of the Parks Highway

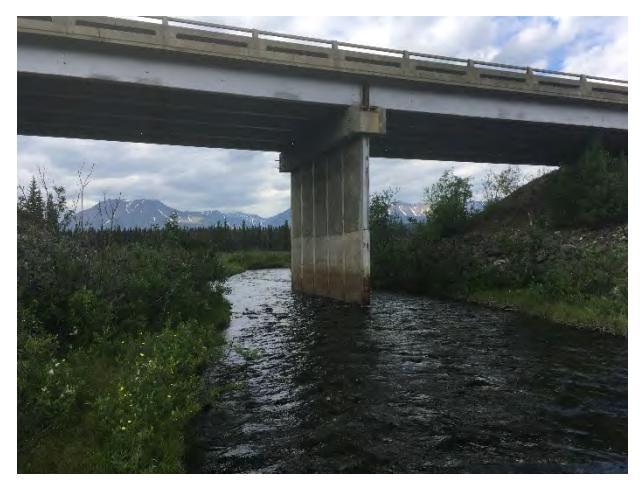
Figure 2. Pass Creek Bridge (BR 0293) Upstream Looking Downstream

Near MP 208, Pass Creek crosses under the Parks Highway roadway corridor within a single-span bridge structure (BR 0293).

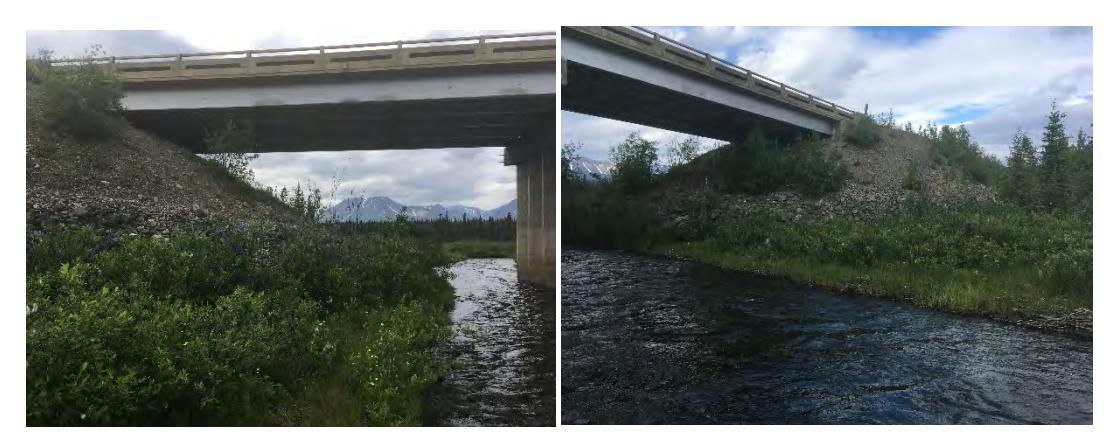
Figure 3. Looking Upstream, Left and Right Abutments

The bridge abutments are armored with moderately sized riprap and the stream does not show signs for potential migration outside its existing banks.

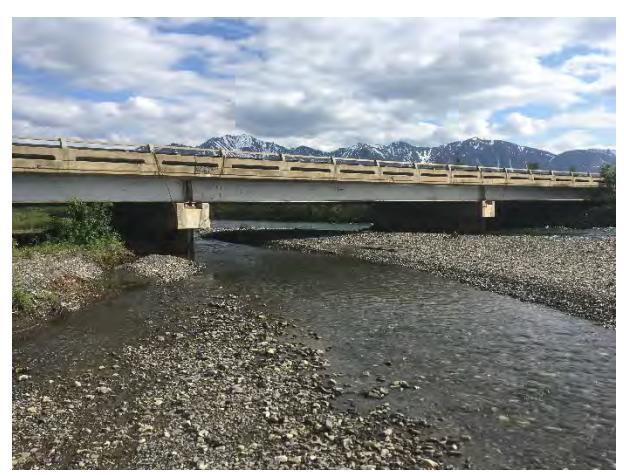
Figure 4. Jack River Bridge (BR 0293) Downstream Looking Upstream

Near MP 209.5, the Jack River crosses the Parks Highway from the east, under an existing single-span bridge structure (BR 0302). The Jack River then combines with Cantwell Creek and flows north, parallel and adjacent to the Parks Highway.

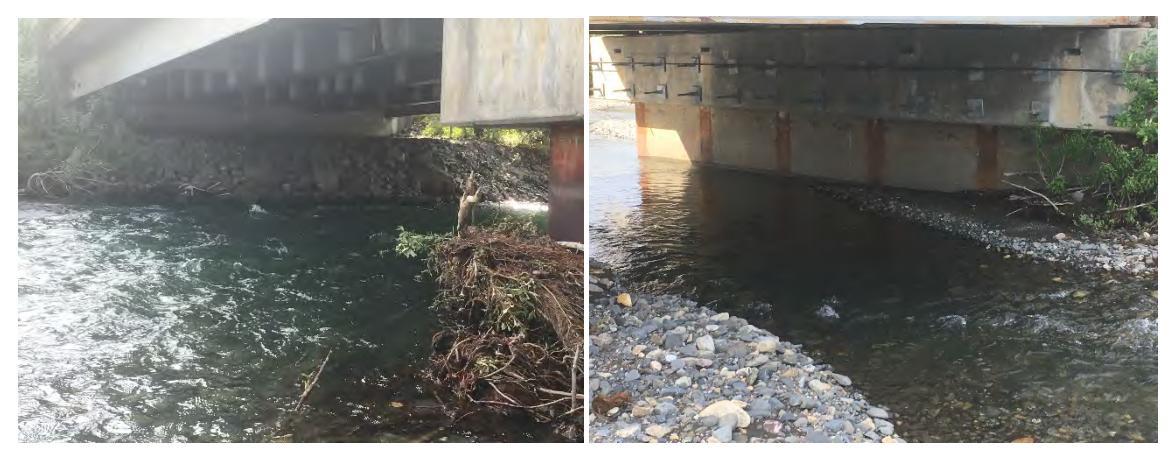
Figure 5. Looking Downstream, Left Abutment: Looking Upstream, Right Pier

The bridge abutments are armored with moderately sized riprap and the stream is braided during low flows which presents the opportunity that the main channel could possibly migrate within its own river banks. Possible stream bed degradation is occurring on the upstream side of the piers with aggregation on the downstream side.

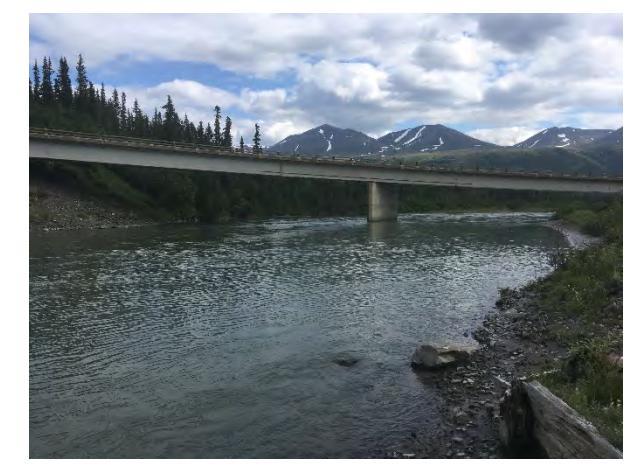
Figure 6. Nenana River Bridge (BR 1243) Downstream Looking Upstream

Near MP 215.6, the Nenana River crosses the Parks Highway from the east, under an existing dual-span bridge structure (BR 1243). The Nenana River then combines with the Jack River and continues to flow north, parallel and adjacent to the Parks Highway. For the next 10 miles, the Parks Highway and the Nenana River continue north and are situated at the bottom of a narrow canyon.

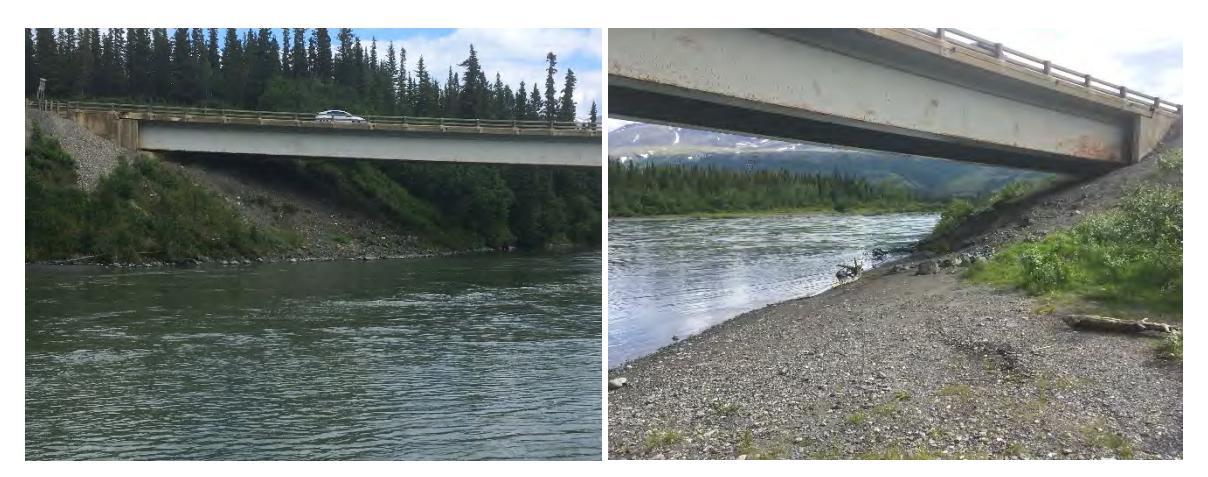
Figure 7. Looking Upstream, Left and Right Abutment

The bridge abutments are armored with moderately sized riprap and the river does not show signs of potential migration outside its existing banks.

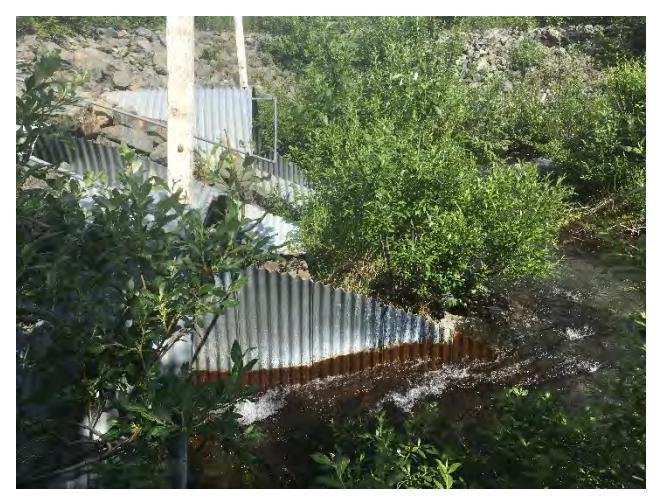
Figure 8. Slime Creek Cross Culverts, Upstream Side Looking North

As Slime Creek approaches the upstream side of the highway, it meanders abruptly toward the left prior to entering the cross culverts. The outer bank of this meander is heavily armored with riprap and vegetation and does not show any signs of degradation. (**Figure 8**) Moderate rusting along the bottom of this culvert was observed. The downstream side of the crossing appears stable with heavily vegetated banks.

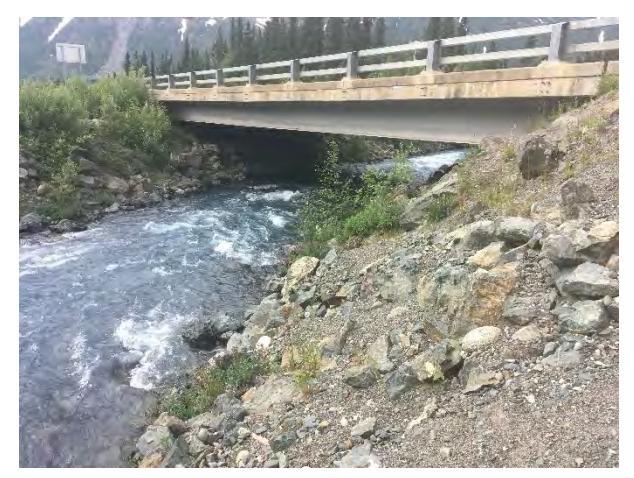
Near MP 224, Carlo Creek crosses the Parks Highway from the east within a single-span bridge structure (BR 0693).

The bridge abutments are armored with moderately sized riprap and the creek does not show signs of potential migration outside its existing banks.

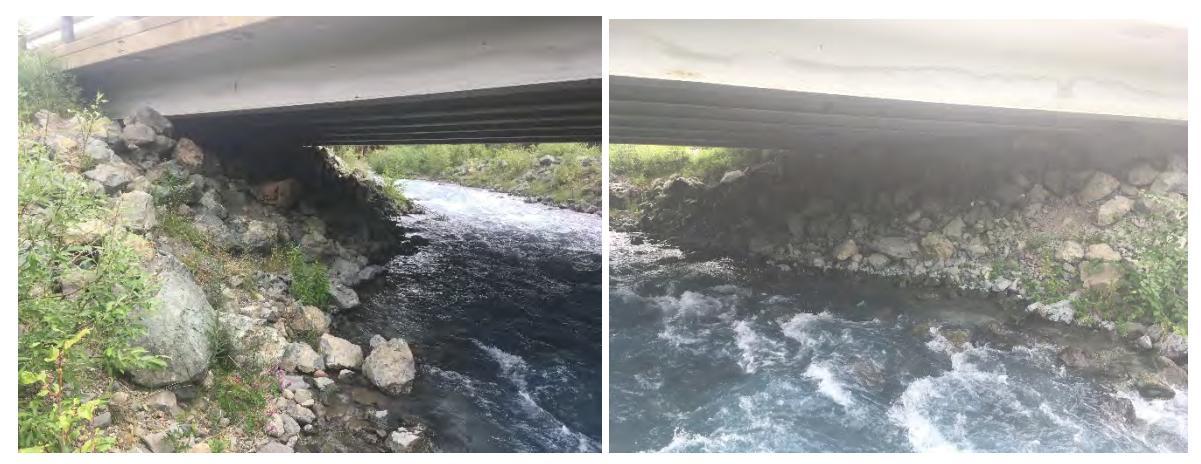
Figure 11. Looking Upstream, Left and Right Abutment

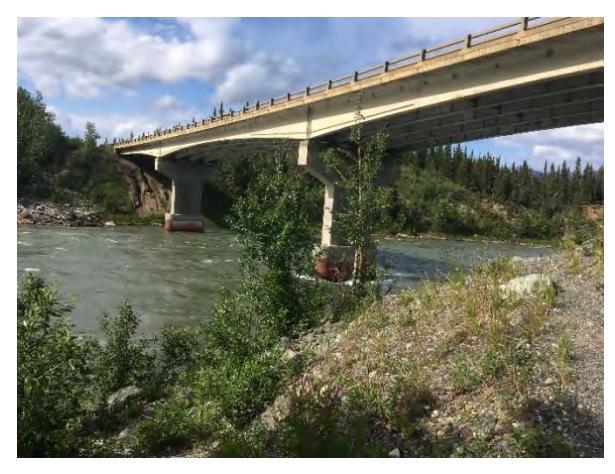
Figure 12. Nenana River Bridge (BR 0694), Downstream Looking Upstream

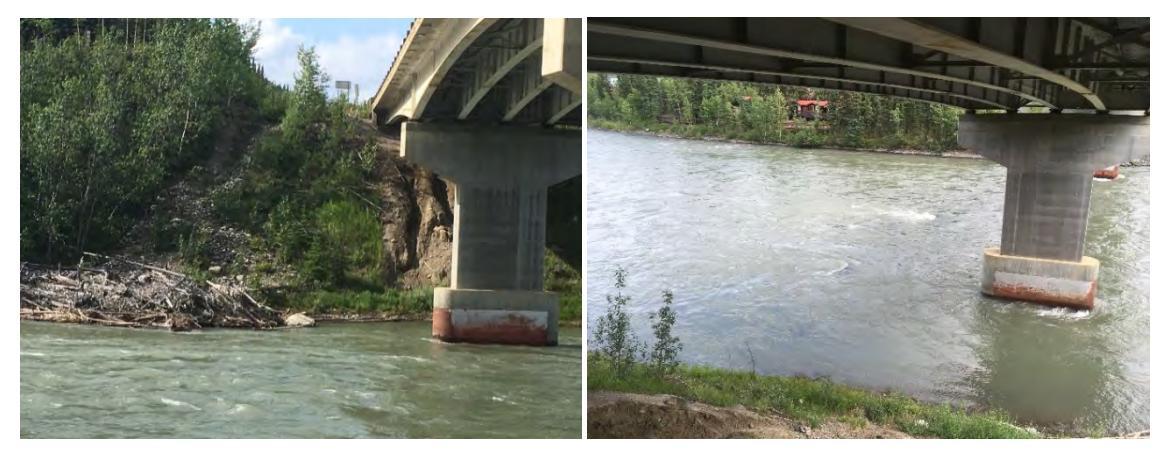
The bridge abutments are armored with mildly sized riprap only on the upstream and downstream sides. Moderate erosion in the form of rilling exists immediately under the bridge deck on each abutment. The cause of such erosion does not seem obvious although it appears roadway runoff is being captured by the bridge seam and being conveyed under the deck along the top of the abutment. The river does not show signs of potential migration outside its existing banks. Some minor aggradation was observed on the right bank just downstream of the bridge crossing.

Figure 13. Looking Upstream, At Left Abutment, Looking Upstream from Left Abutment

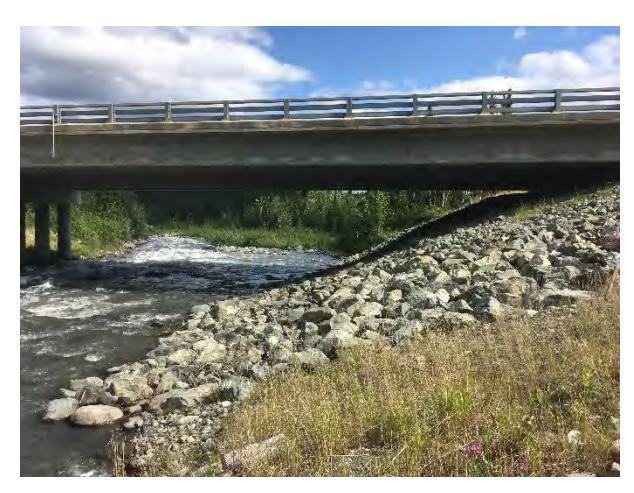
Figure 14. Riley Creek Bridge (BR 0695), Upstream Looking Downstream at Right Abutment

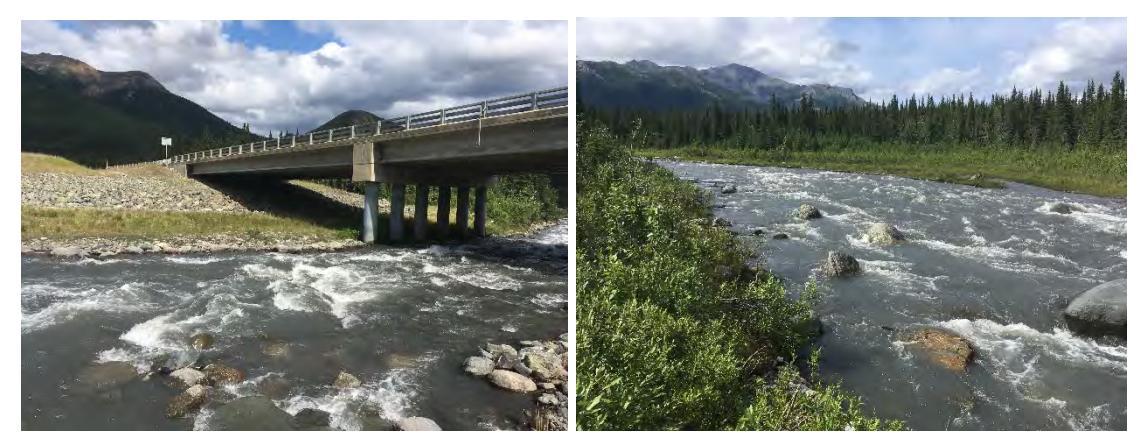
The bridge abutments are armored with moderately sized riprap and the creek does not show signs of potential migration outside its existing banks. Overflows appear to be directed under the left side of the bridge.

Figure 15. Riley Creek Looking Downstream, At Left Abutment, Looking Upstream from Left Abutment

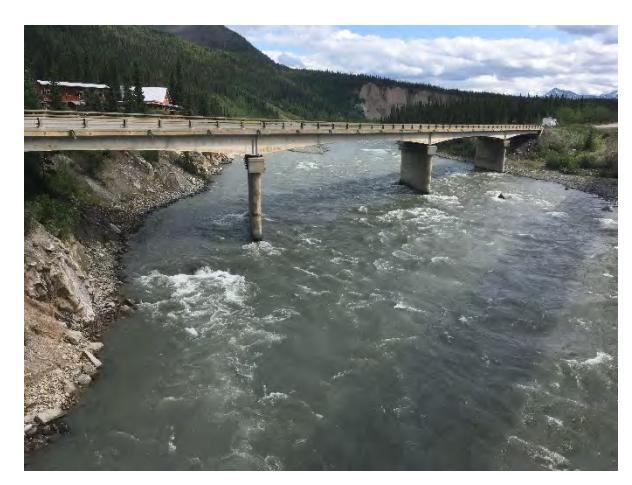
Figure 16. Nenana River Bridge (BR 1147), Downstream Looking Upstream

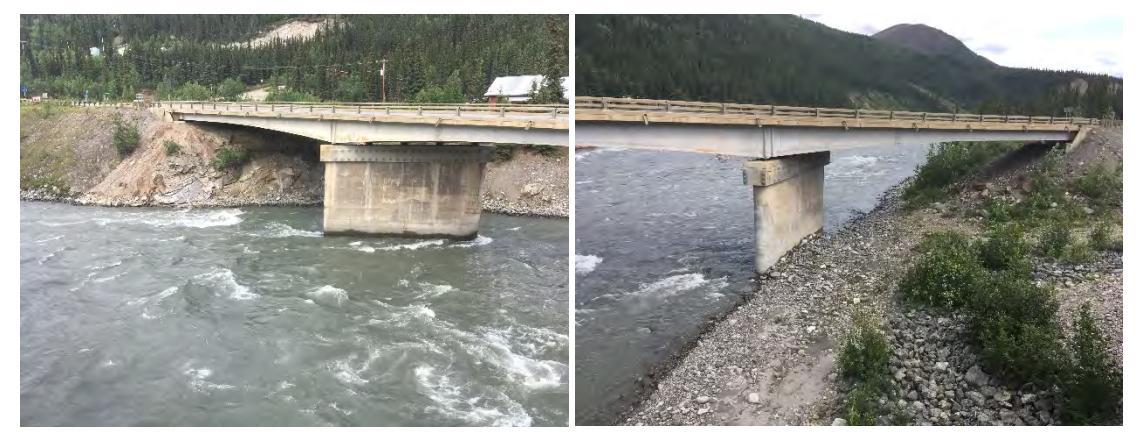
The bridge abutments are armored with mildly sized riprap. Looking upstream, the left abutment appears to be constructed on possible bedrock. The right abutment is mildly armored with riprap. The river does not show signs of potential migration outside its existing banks as these banks are very steep. Aggradation has been observed near the center of the channel just upstream of the crossing that is creating a mild braid and appears to be eroding the river bank on the left near the developed parcels. This can be noted in **Figure 17** just upstream of the left abutment. Immediately downstream of this bridge crossing, a pedestrian bridge (BR 2060) exists that does not show potential for river bank degradation.

Figure 17. Looking Upstream, At Left Abutment and Right Abutment

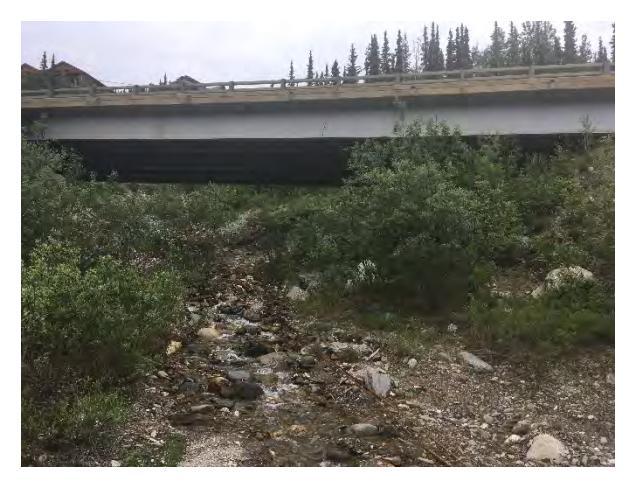
Figure 18. Kingfisher Creek Bridge (BR 0697), Downstream Looking Upstream

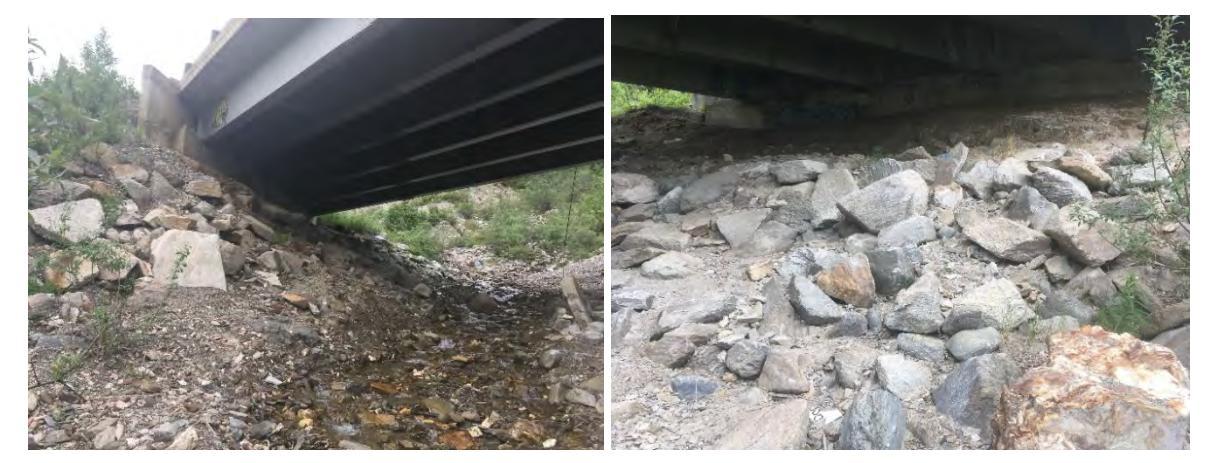
The bridge abutments are armored with moderately sized riprap and the creek does not show signs of potential migration outside its existing banks. The Creek is very steep, and the bed is made up of large cobbles and rock that don't appear to be aggregating. Minor flows from roadside ditches appear to be maintained on the upstream side of the crossing and no signs of bank erosion were observed.

Figure 19. Looking Upstream, At Left Abutment and Right Abutment

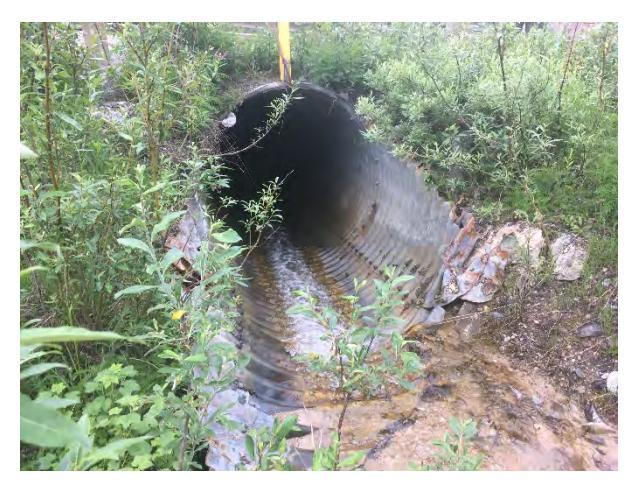
Figure 20. Junco Creek Cross Culvert, Upstream Looking Downstream

The upstream culvert end treatment has been mitered to the roadway slope and looks moderately damaged. The culvert shows minor rust but is generally in good condition. The creek does not show signs of potential migration outside its existing banks as these banks are heavily vegetated.

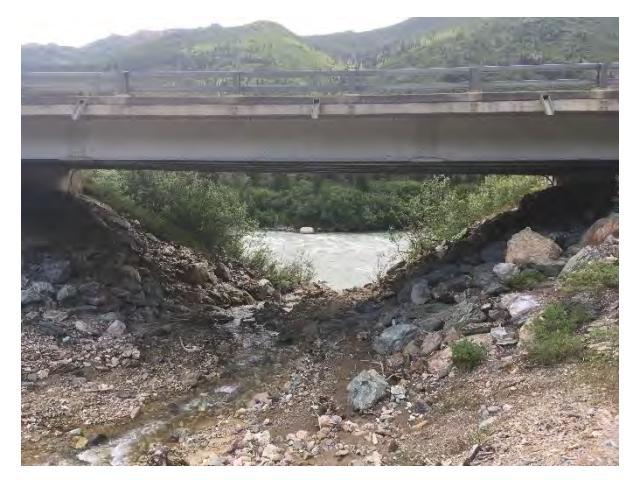
Figure 21. Iceworm Gulch Bridge (BR 1146), Upstream Looking Downstream

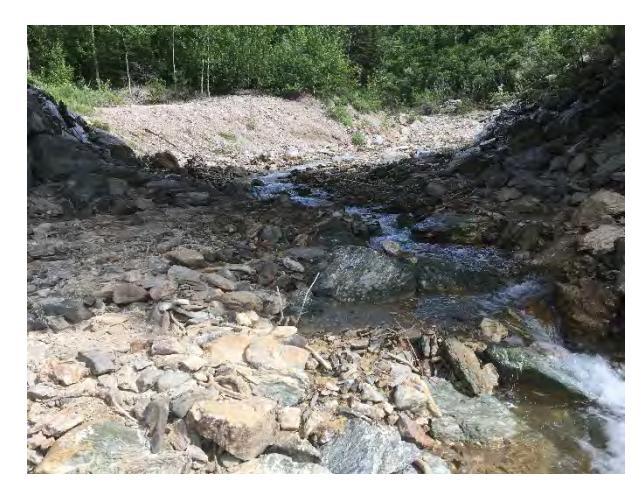
The bridge abutments are armored with moderately sized riprap and the creek does not show signs of potential migration outside its existing banks as the banks are relatively steep. The channel bed consists of cobles and rock and the channel is relatively steep. The channel banks are made up of a smaller material that does pose the potential for erosion though none were observed.

Figure 22. Looking Upstream

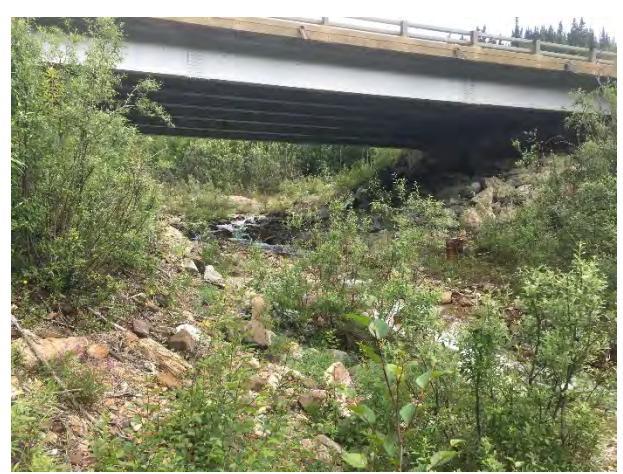
Figure 23. Hornet Creek Bridge (BR 1145), Downstream Looking Upstream
