## Cantwell to Healy – Parks Highway Milepost 203-259 Planning & Environmental Linkages Study

Project No. NFHWY00492

## **Needs and Opportunities Assessment Report**

> > > > October 2020

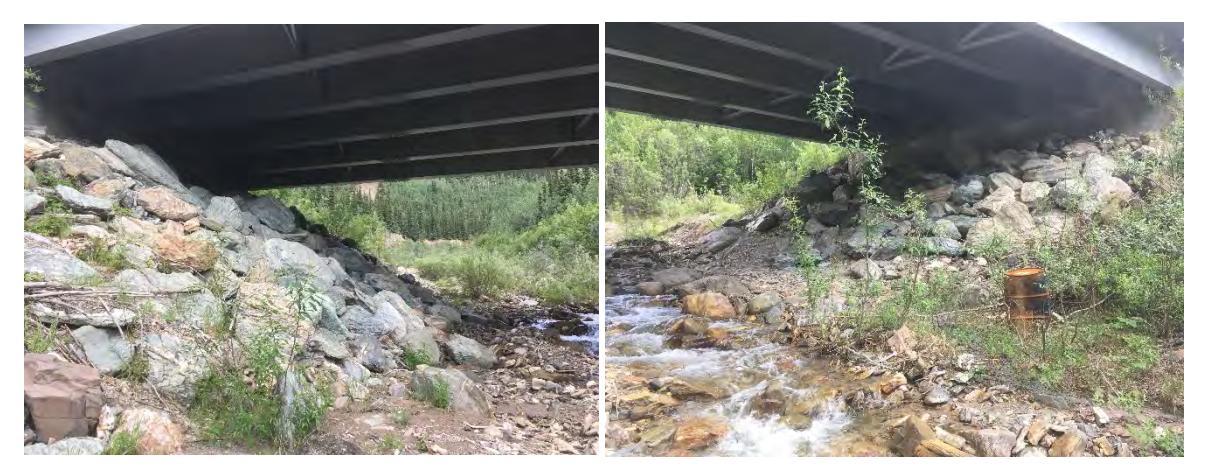
The bridge abutments are armored with moderately sized riprap and the creek does not show signs of potential migration outside its existing banks as the banks are relatively steep. The channel bed consists of cobles and rock and the channel is relatively steep.

Figure 24. Looking Upstream, Left Abutment and Right Abutment

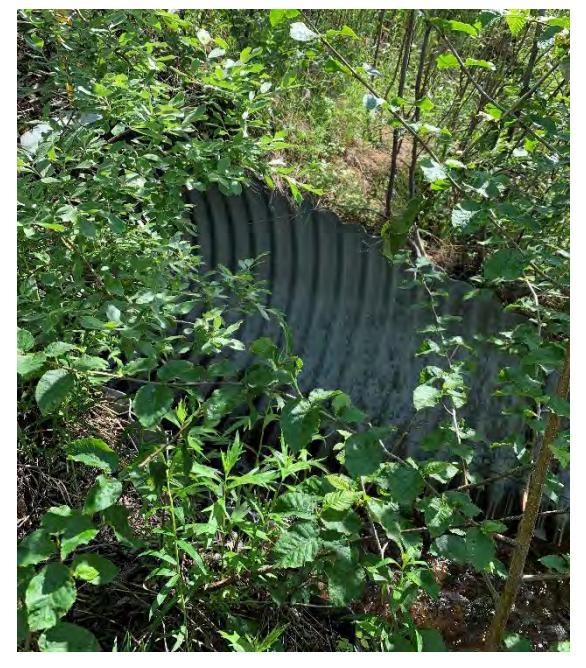
Figure 25. Grizzly Creek Cross Culvert, Upstream Side Looking North

The upstream and downstream culvert end treatments have been mitered to the roadway slope and appears relatively intact. The culvert shows moderate rust but is generally in fair condition. The creek does not show signs of potential migration outside its existing banks as these banks are heavily vegetated.

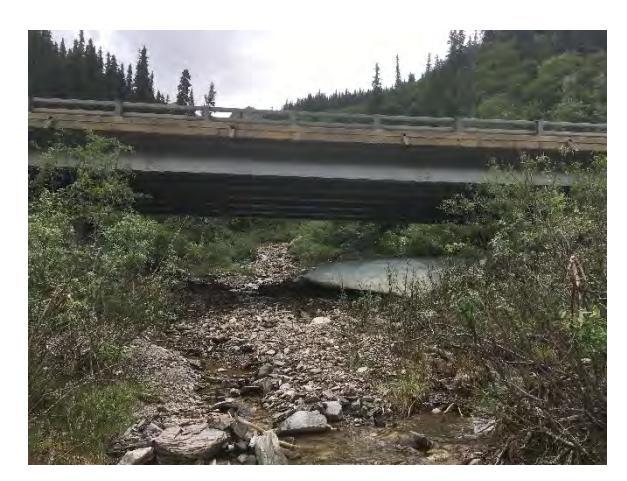
Figure 26. Fox Creek Bridge (BR 1144), Upstream Looking Downstream

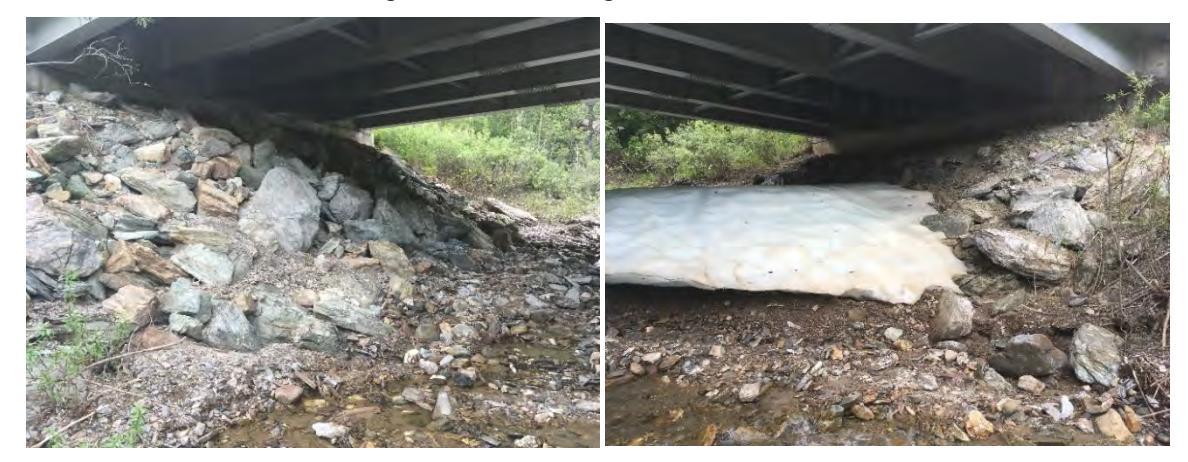
The bridge abutments are armored with moderately sized riprap and the creek does not show signs of potential migration outside its existing banks as the banks are relatively steep and somewhat vegetated. The channel bed consists of cobles and rock and the channel is relatively steep. As indicated in the field photos, overflows tend to freeze and glaciate over the right abutment.

Figure 27. Looking Upstream, Left and Right Abutment

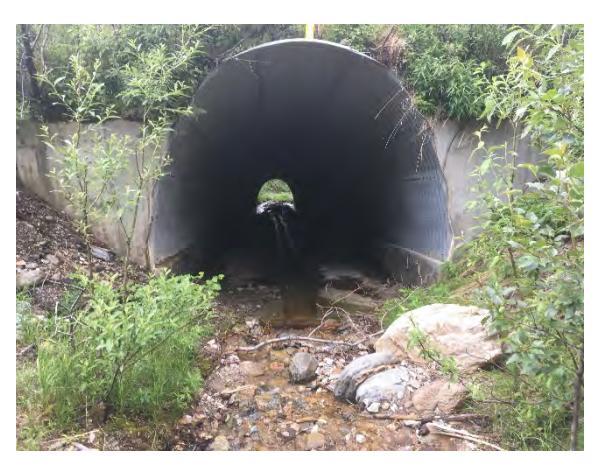
Figure 28. Eagle Creek Cross Culvert (7111/1076), Upstream Looking Downstream

The condition of the existing cross culvert appears to be deteriorating. There is separation between the concrete bottom and the concrete spread footing on the bottom edges of the arch structure.

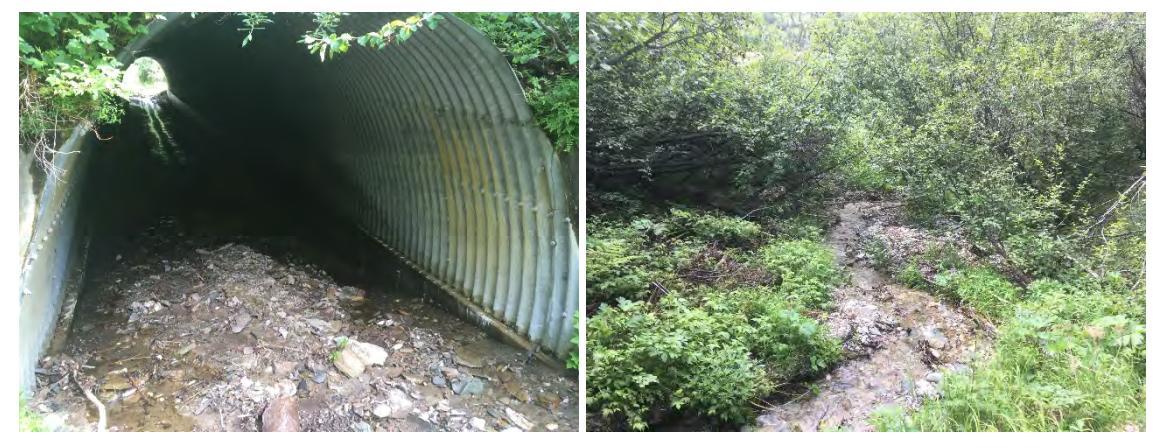
The upstream and downstream culvert end treatments include headwalls that appear to be in good condition. The creek is aggregating near the downstream portion of the crossing indicating the steep nature of the culvert relative to the slope of the creek. The does not show signs of potential migration outside its existing banks as the banks are relatively steep and vegetated. The channel bed consists of cobbles and rock.

Figure 29. From Downstream Side Looking Upstream and Downstream

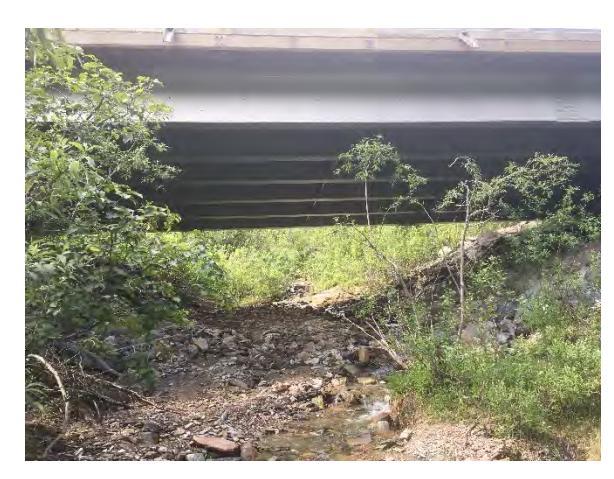
Figure 30. Dragonfly Creek Bridge (BR 1075), Downstream Looking Upstream

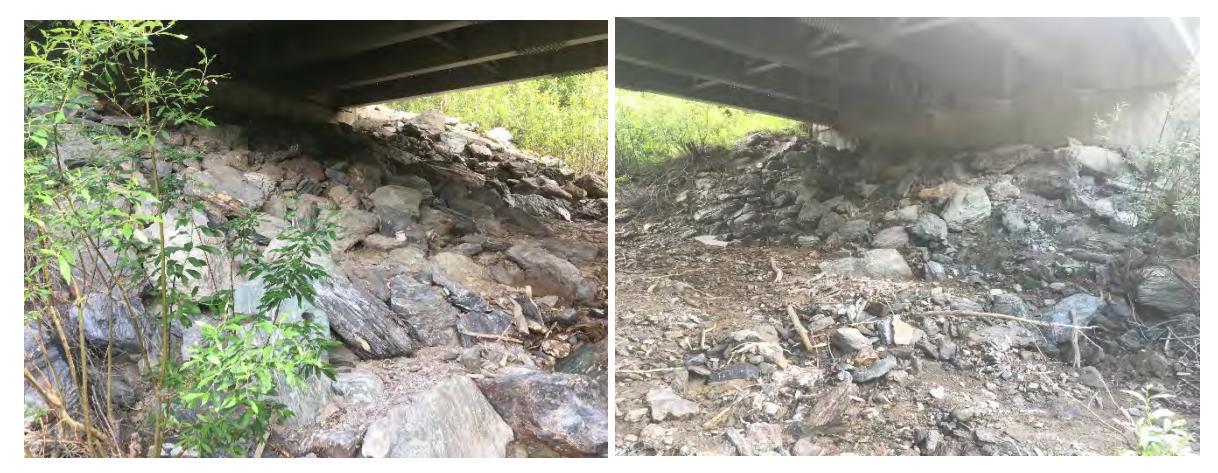
The bridge abutments are armored with moderately sized riprap and the creek does not show signs of potential migration outside its existing banks as the banks are relatively steep. The channel bed consists of cobles and rock and the channel is relatively steep.

Figure 31. Looking Upstream, Left and Right Abutment

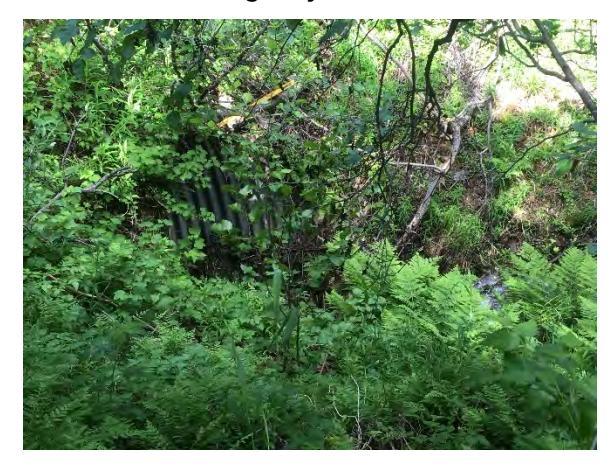
Figure 32. Coyote Creek Cross Culvert, Upstream Side Looking North

There did not appear to be end treatments on this culvert. The culvert shows moderate rust but is generally in good condition. The creek does not show signs of potential migration outside its existing banks as these banks are heavily vegetated.

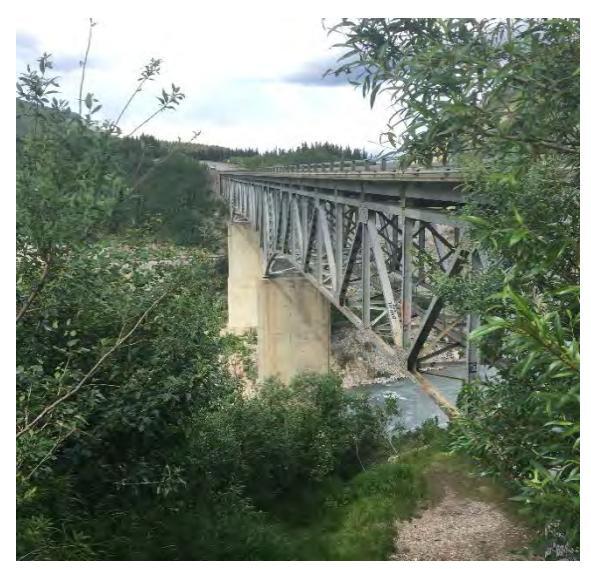
Figure 33. Nenana River Bridge (BR 1143), Downstream Looking Upstream and North

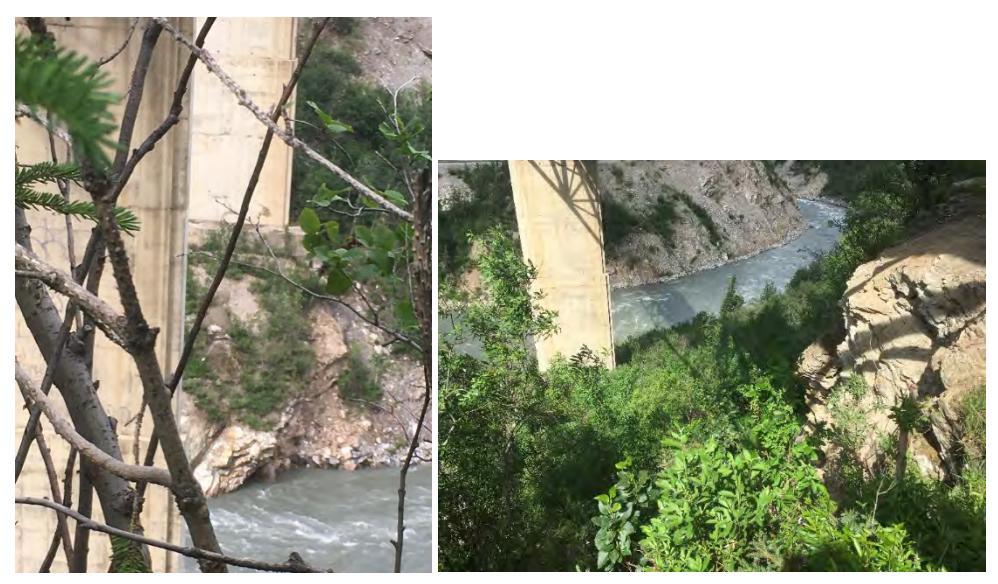
The bridge abutments are armored with mildly sized riprap. Looking downstream, the left and right abutments appear to be constructed on possible bedrock. The river does not show signs of potential migration outside its existing banks as these banks are very steep and the river exists within a deep gorge. Erosion is observed to exist on the left bank where the river is abutting to the railroad embankment.

Figure 34. Looking Downstream, Left Pier and Right Abutment

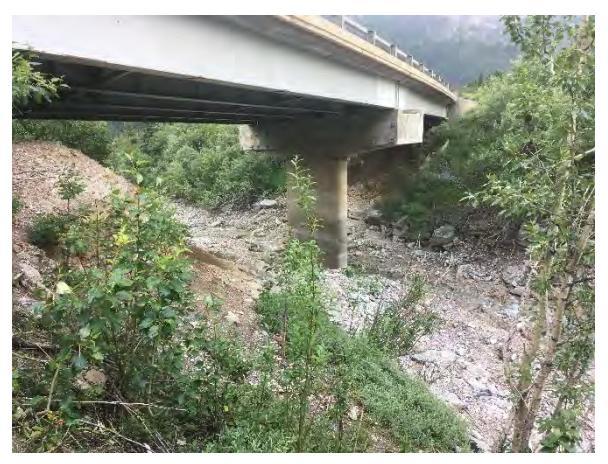
Figure 35. Bison Gulch Bridge (BR 1142), Downstream Looking Upstream and East

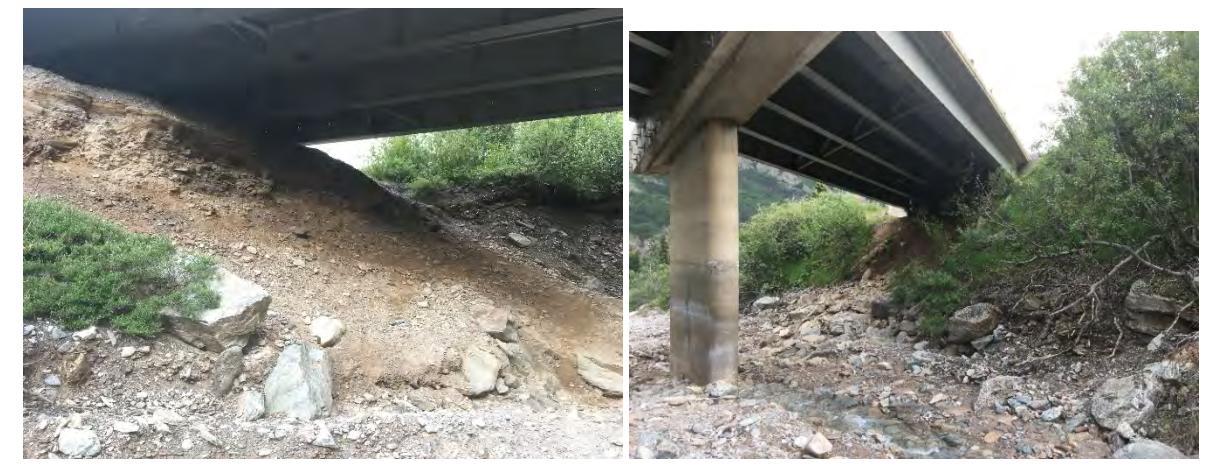
The bridge abutments do not appear to be armored yet the creek does not show signs of potential migration outside its existing banks as the banks are relatively steep. There is a potential for the creek to erode the abutment walls. The channel bed consists of cobles, rock and large boulders and the channel is relatively steep. There appears to be aggradation around the upstream side of the pier and degradation around the downstream side of the pier.

Figure 36. Looking Downstream, Left and Right Abutment

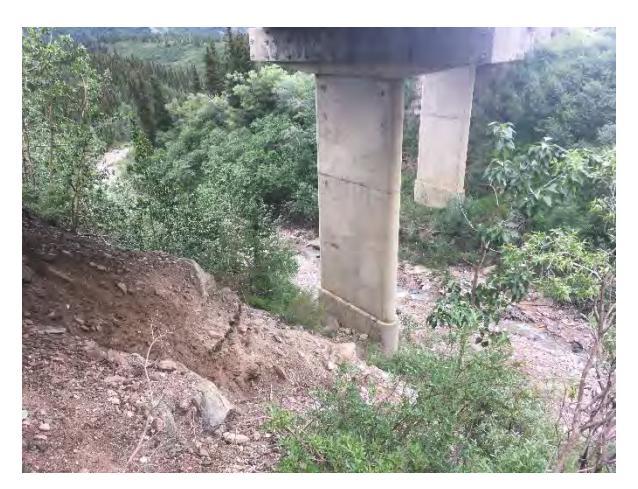
Figure 37. Antler Creek Bridge (BR 1141), Downstream Looking Upstream and East

The bridge abutments do not appear to be armored. Moderate erosion in the form of rilling exists immediately under the bridge deck on each abutment. The cause of such erosion does not seem obvious. The river does not show signs of potential migration outside its existing banks. The creek bed is made up of smaller cobbles and gravel and is relatively steep. There is potential for this river to create significant erosion of the abutments and its own banks during larger runoff events.

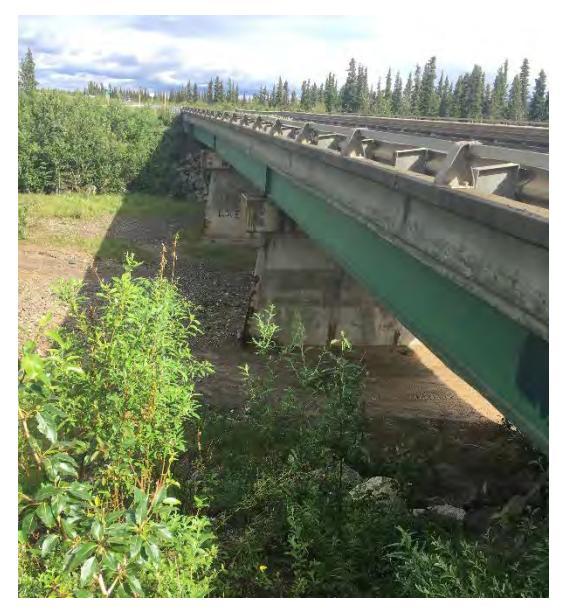
Figure 38. Dry Creek Overflow Bridge (BR 0852), Downstream Looking Upstream and Northwest

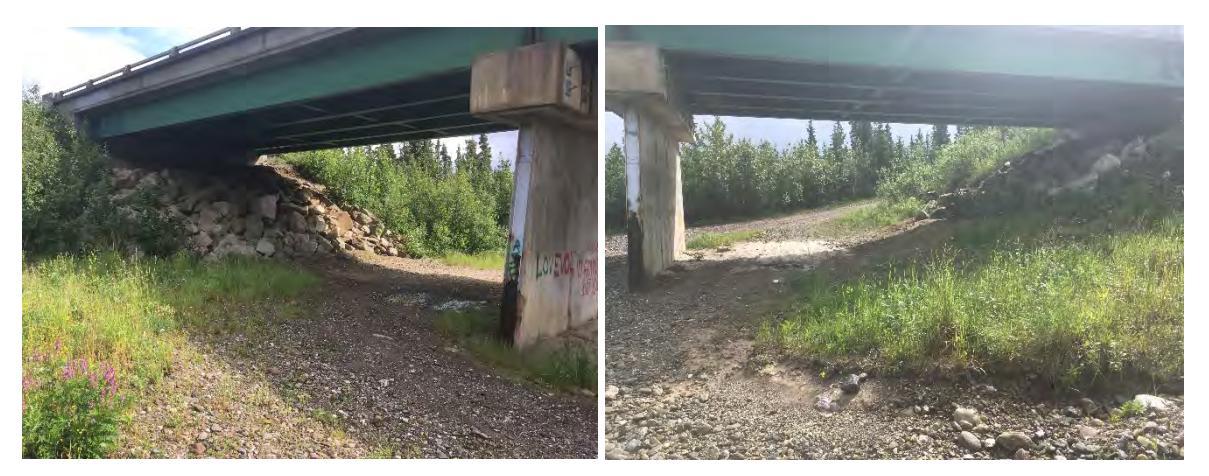
The bridge abutments are armored with moderately sized riprap that appears to be intact. The creek does not show signs of potential migration outside its existing banks as these banks are very steep. This overflow also appears to contain very few runoff events. The channel bed is made up of small cobbles and gravel.

Figure 39. Looking Downstream, Left and Right Abutment

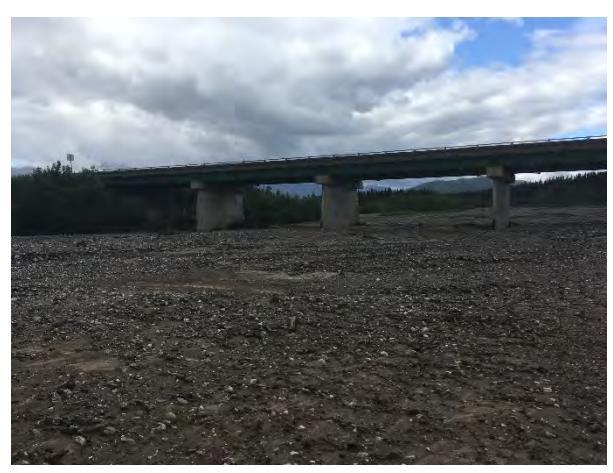
Figure 40. Dry Creek Bridge (BR 0851), Downstream Looking Upstream and South

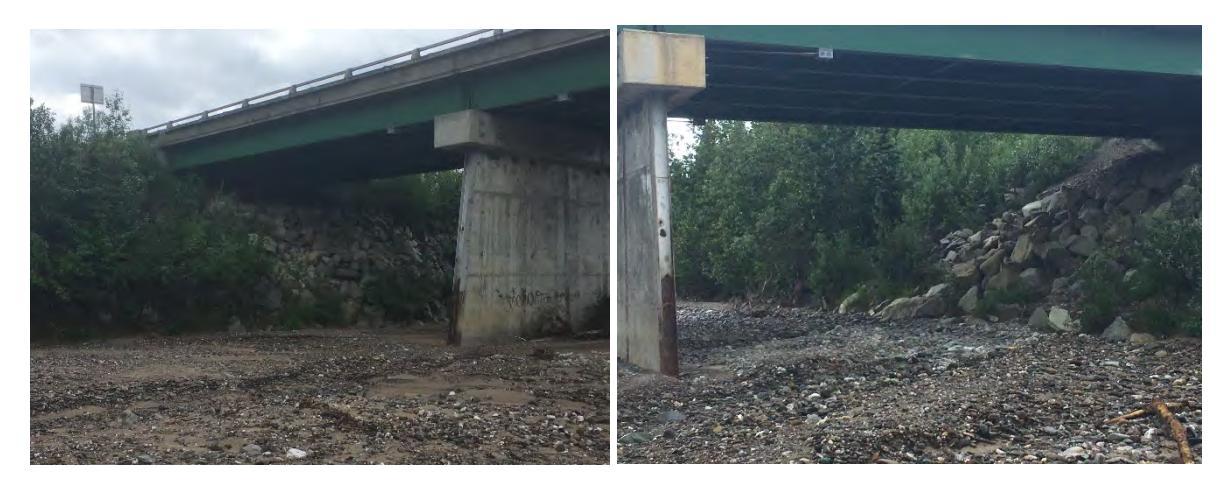
The bridge abutments are armored with moderately sized riprap that appears to be intact. The creek does not show signs of potential migration outside its existing banks as these banks are very steep. The channel bed is made up of small cobbles and large gravel.

Figure 41. Looking Upstream, Left and Right Abutment

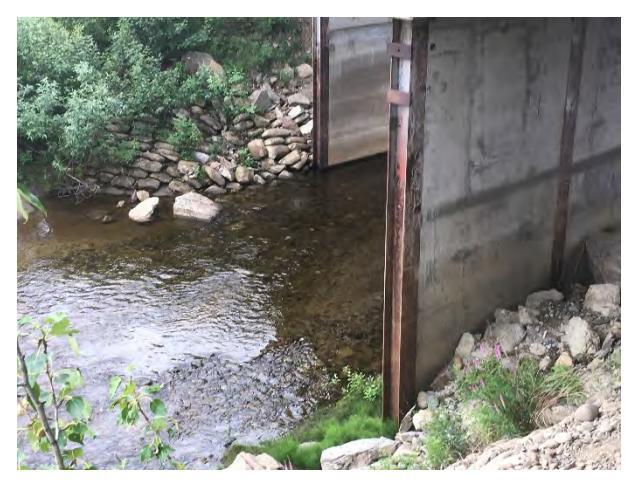
Figure 42. Panguingue Bridge (BR 0313), Downstream Looking Upstream and South

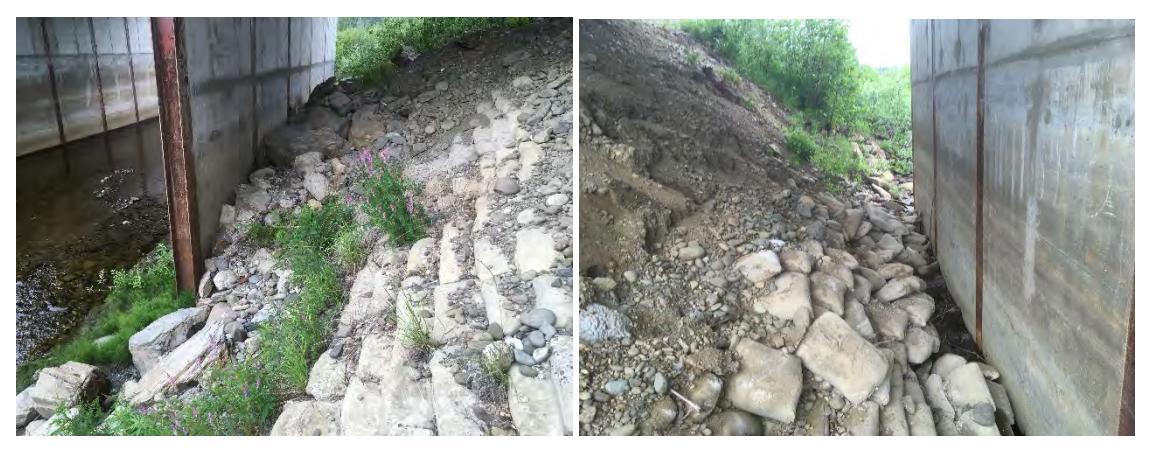
The bridge abutments are armored with moderately sized riprap as well as solidified concrete sacks that are somewhat intact although mildly crumbling. The creek does not show signs of potential migration outside its existing banks as these banks are very steep. The creek is braided through the bridge structure during low flows giving it the potential to create a main channel in various locations along the channel bed throughout the seasons. The channel bed is made up of cobbles and rocks. The banks are vegetated, and some erosion was observed on the downstream right side of the channel bank where vegetation is starting to fall into the creek.

Figure 43. Looking Upstream, Left Abutment: Looking Downstream, Right Abutment

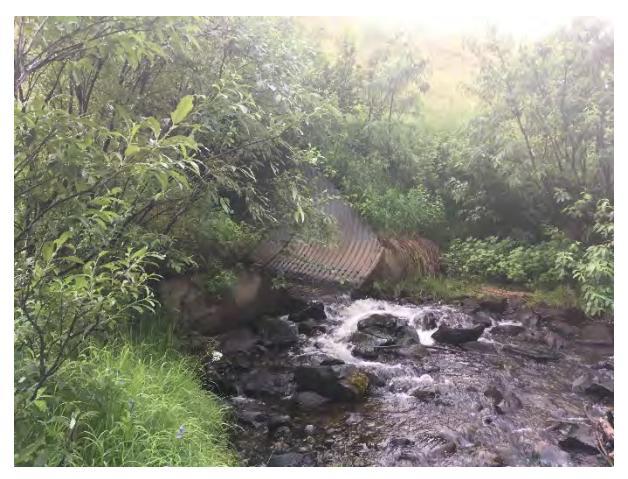
Figure 44. Little Panguingue Creek Cross Culvert, Downstream Looking Upstream

The upstream and downstream culvert end treatments have been mitered to the roadway slope and appears relatively intact. The culvert shows moderate rust but is generally in good condition. The creek does not show signs of potential migration outside its existing banks as these banks are heavily vegetated. The creek appears to be degrading on the outlet side of the culvert as it is elevated above the channel bottom. The channel bed is made up of large boulders and cobbles.

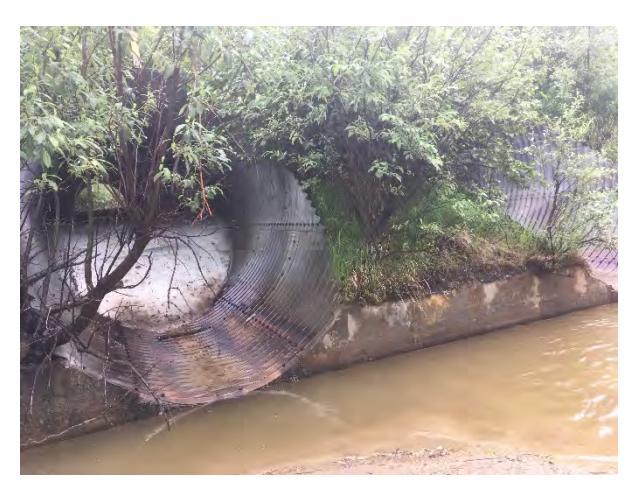
Figure 45. Slate Creek Cross Culverts, Downstream Side Looking Upstream

The upstream and downstream culvert end treatments have been mitered to the roadway slope with cutoff walls. Each end treatment appears relatively intact. The culverts show moderate rust but are generally in good condition. The creek does show a slight potential to migrate outside its existing banks as the channel is braided as it approaches the roadway crossing. The channel banks are heavily vegetated. The creek appears to be degrading on the outlet side of the culvert as it is elevated above the channel bottom. The channel bed is made up of cobbles and smaller gravel. The southernmost culvert shows signs of glaciation.

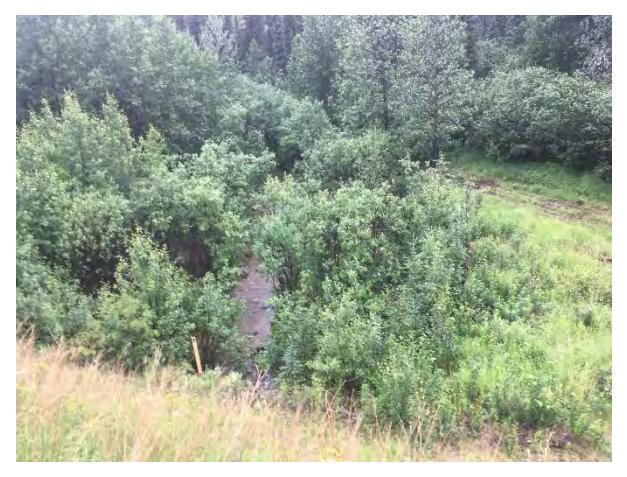
Figure 46. Looking Upstream from Roadway

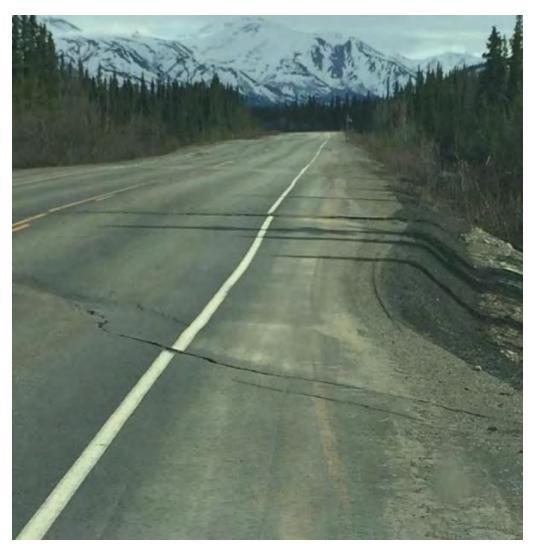
**Figure 47. MP 235.5** Source: DOT&PF 2020

An area of concern that the DOT&PF maintenance and operation crews has identified is the section of roadway near MP 235 through MP 236. Drainage issues along this stretch cover a significant area, spanning over 0.75 miles in both directions from the location pictured in **Figure 47**, which was taken around MP 235.5. The condition of the pavement in this area is reported to be substantially below an acceptable level, likely as a partial result of these drainage issues. (DOT&PF 2020)

A field visit to this area has verified the deteriorating condition of the roadway pavement. Between MP 232 and MP 236, numerous regional offsite low points exist adjacent to the roadway corridor which has accumulated ponded water. In general, the regional topography is sloped toward the Nenana River on the west side of the corridor. The deteriorating roadway pavement and embankment has generally been observed where ponded water has abutted to the roadway embankment. The source of the ponded water is a combination of thawing subsurface ice, onsite roadway runoff and offsite surface runoff. Few cross culverts exist here, and roadside ditch low points do not match the locations where these culverts have been installed.

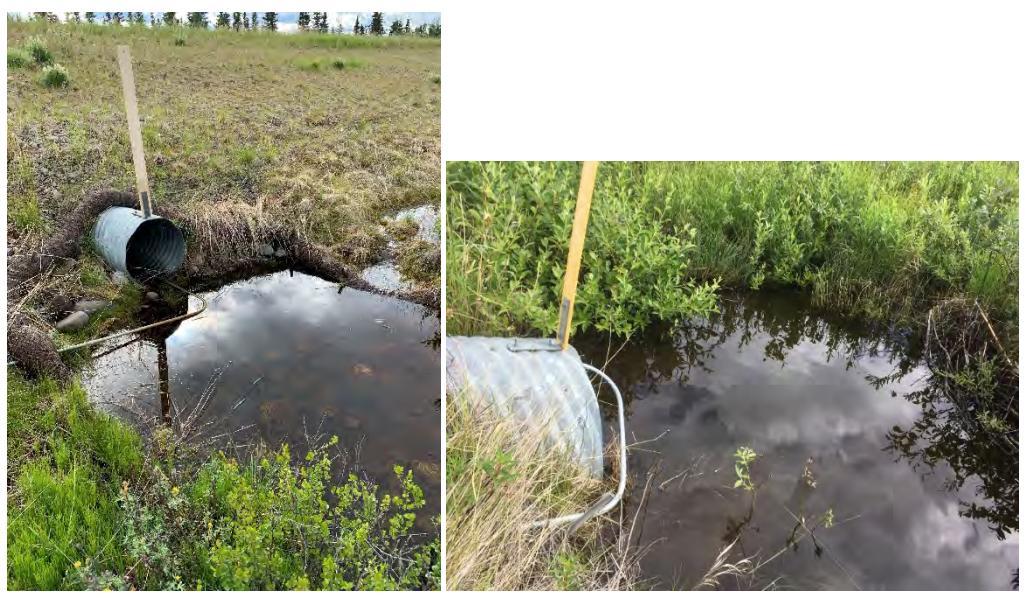
Slightly to the north of MP 253, drainage issues are causing damage to the base of the road. The effect of these drainage issues on the road base are causing part of the road to begin collapsing. A sink hole or a severe dip is being created in the road surface.

A field visit has verified roadway damage at this location. Regional topography shows the adjacent surface generally slopes from the west toward the Nenana River in the east. The roadside ditch on the east side of the roadway corridor has developed local low points that accumulates surface runoff into ponding that is currently abutting up to the roadway embankment. This ponding is assumed to be the source of weakening embankment identified, as part of the Baseline Geologic and Geotechnical Assessment Memorandum, between MP 253 and MP 254.

Culverts that have been installed in this area are in good condition. The roadside ditches do not appear to convey the complete captured surface runoff to each culvert on the upstream side (western side of the

corridor). Local low points created on the downstream side (eastern side of the corridor) appear to exacerbate the issue.

Figure 50. Upstream End of Culvert (West Looking East): Downstream End of Culvert

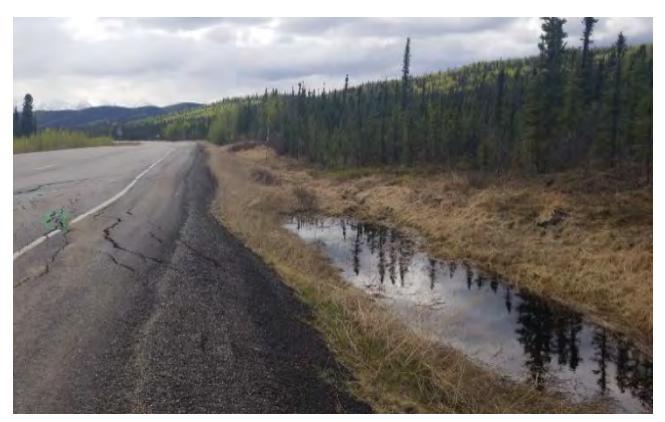
Maintenance crews have identified a section of roadway around MP 256.5 where the road shoulder is failing because of damage caused by issues with drainage. There are many cracks forming along the road shoulder as well as along the active roadway, causing the road shoulder to begin to fall off. DOT&PF maintenance and operations crews have reported that drainage issues are also a concern in the area near MP 258.5 of the Parks Highway. These drainage issues are a problem that is affecting the base of the roadway. (DOT&PF 2020)

A field visit has verified roadway damage at this location. Regional topography shows the adjacent surface generally slopes from the west toward the Nenana River in the east. The roadside ditch on the east side of the roadway corridor has developed local low points that accumulates surface runoff into ponding that is currently abutting up to the roadway embankment. This ponding is assumed to be the source of weakening embankment identified, as part of the *Baseline Geologic and Geotechnical Assessment Memorandum*, between MP 256 and MP 259.

Culverts that have been installed in this area are in good condition. The roadside ditches do not appear to convey the complete captured surface runoff to each culvert on the upstream side (western side of the corridor). There appears to be an adequate number of cross culverts and that conveyance to these culverts is being impeded.

Figure 51. Ponding Observed on the Upstream Side (West Side) Near MP 256.5 Source: S&W 2020

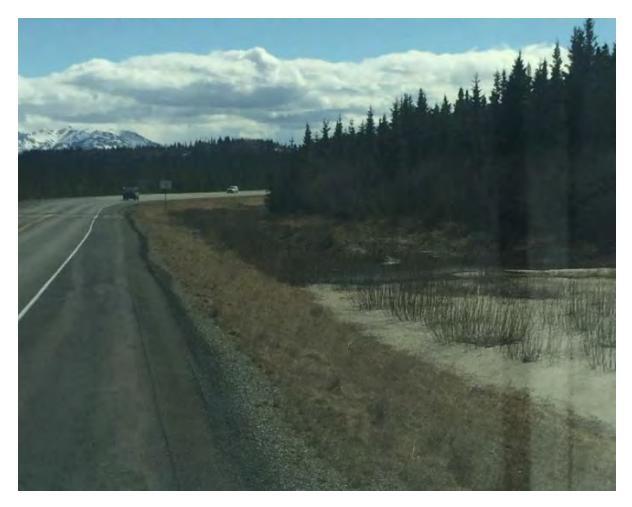
Figure 52. Ponding Observed on the Upstream Side (West Side) Near MP 258.5 Source: DOT&PF 2020

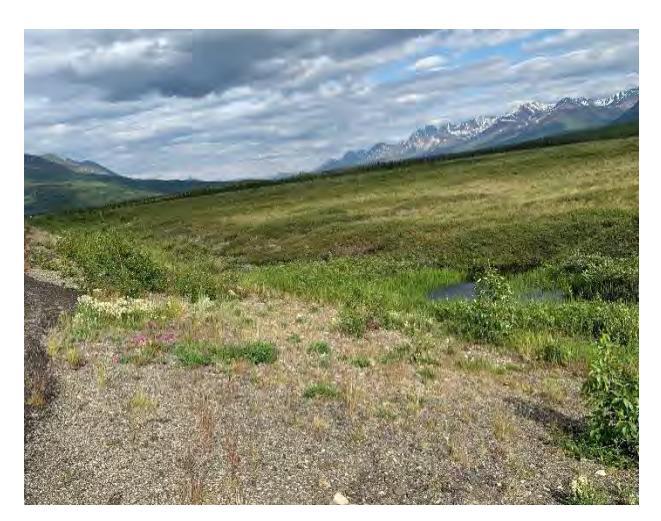
Between the southern limit of the study corridor and MP 215, the surrounding topography is observed to be very flat adjacent to the roadway corridor. There are many regional low points that have accumulated surface runoff in the form of ponding throughout this section of the study corridor. Locations that have been identified as part of the *Baseline Geologic and Geotechnical Assessment Memorandum* as areas with unstable embankment tend to coincide with regional ponding that is abutted against the roadway embankment. The source of the ponded water is a combination of thawing subsurface ice, onsite roadway runoff and offsite surface runoff. The highest concentration of these local ponds exists between MP 208 and MP 215.

Figure 53. Ponding Observed on the East Side Near MP 208

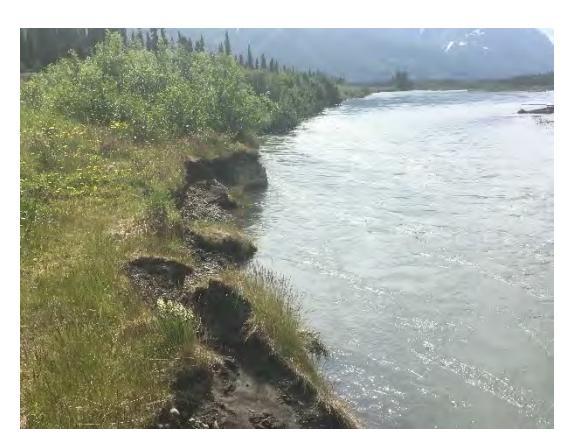
The Nenana River flows north, adjacent to the west side of the roadway corridor between MP 218 and MP 223.5. The roadway embankment includes moderate riprap protection along this stretch. A small portion of the roadway is eroding due to the Nenana River undercutting of the roadway embankment between MP 221.8 and MP 222 as identified within the Baseline Geologic and Geotechnical Assessment Memorandum. This situation appears to be happening just north of MP 223 as well.

Figure 54. Erosion Just North of MP 223 Looking South (Upstream of the Nenana River)

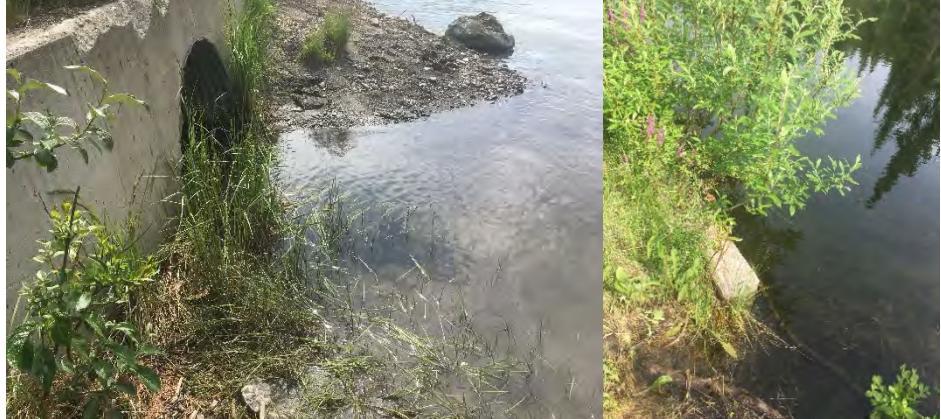
Just north of MP 222, a permanent pond exists adjacent to the east side of the roadway corridor and abuts against the roadway embankment. This pond includes a 48-inch culvert pipe with headwall end

treatments that directly discharges into the Nenana River. The Nenana River creates a tailwater condition that keeps this pond full. See Figure 55.

Figure 55. Culvert Just North of MP 222, Downstream Looking South, Upstream Looking North

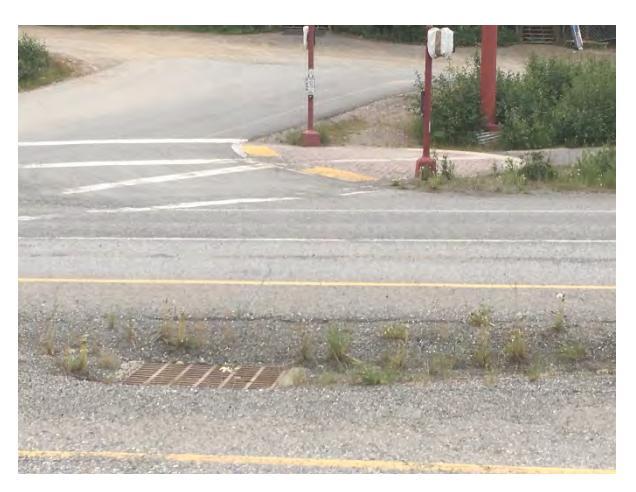
Between MP 238 and MP 239, the roadway typical section includes a vegetated median with pedestrian pathways on both sides of the roadway. This section of roadway includes roadside ditches between the mainline roadway and the pedestrian pathways on each side of the corridor. There appears to be an inadequate number of culverts that convey collected onsite and offsite surface runoff along the roadway profile to the nearest discharge location (Junco Creek toward the north). Localized ponding occurs prior to multiple access driveways along the roadway corridor. The vegetated median cross section includes a ditch which collects onsite roadway runoff and conveys this runoff along the roadway profile toward Junco Creek. At intersections, this vegetated median ditch terminates at storm drain inlets in multiple location along this area. Existing storm drain systems then outlet these flows into the roadside ditches located on the west side of the roadway corridor.

Figure 56. Storm Drain Median Inlet Near MP 238.6

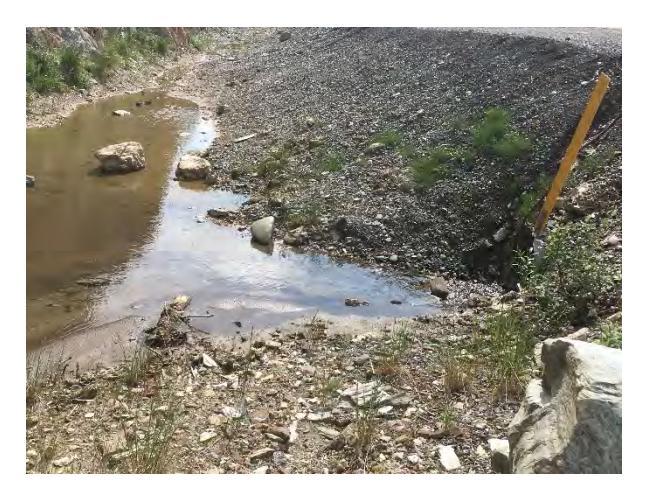
Near MP 241, just north of the Grizzly Creek crossing, a small 24-inch cross culvert has been installed that conveys offsite and onsite surface runoff from the east toward the Nenana River on the west side of the corridor. It appears that the roadside ditch may be too flat, or the culvert is undersized which has created a backwater condition at the upstream side.

Figure 57. Upstream Side of Culvert Looking South Near MP 241

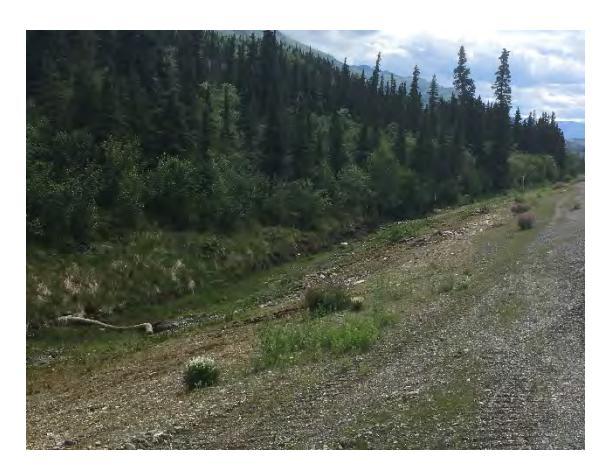
Near MP 242.1, the roadside ditch on the east side of the roadway corridor appears to have a low point created because of slope inundation. No cross culvert has been installed at this location. The regional topology indicates surface sloping from the east toward the Nenana River on the west side of the study corridor.

Figure 58. Roadside Ditch Low Point on the West Side Near MP 242.1

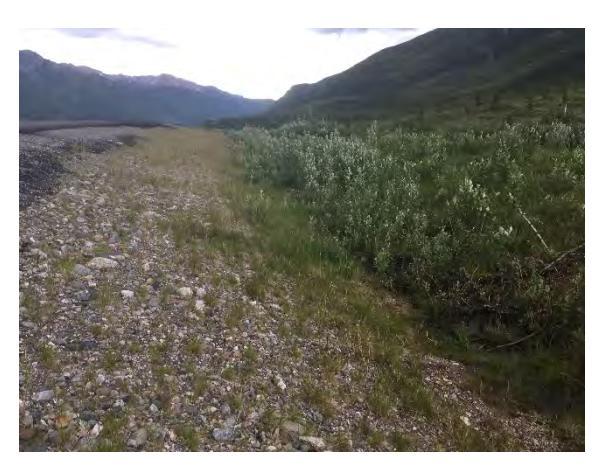
A small section near MP 244 appears to include low points within the roadside ditches on both sides of the roadway corridor. The regional topology indicates surface sloping from the west toward the Nenana River on the east side of the study corridor. There is a regional low point identified as a pond that exists on the west side of the roadway corridor that appears to have no outlet.

Figure 59. Roadside Ditch Low Point on the West Side Near MP 244

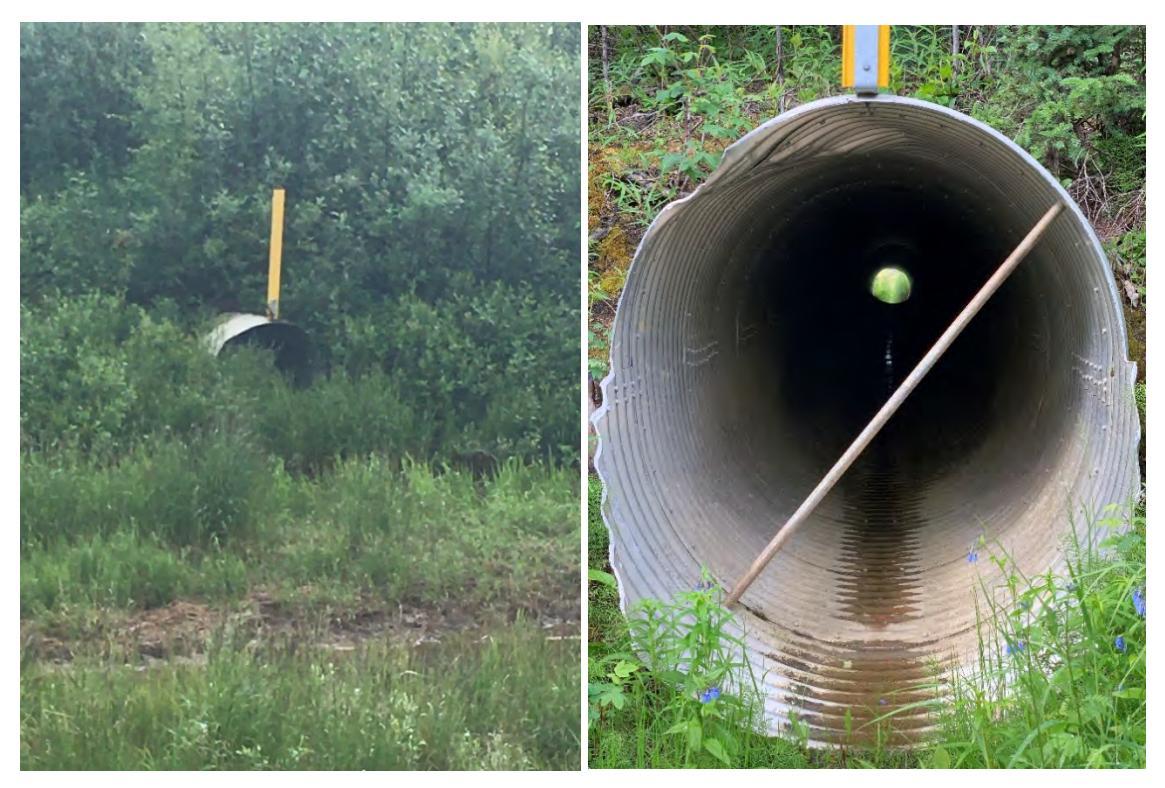
Near MP 248.4, the regional topology indicates surface sloping from the west toward the Nenana River on the east side of the study corridor. This location has a 48-inch cross culvert installed conveying surface runoff flows from the west toward the Nenana River on the east side of the roadway corridor. This culvert appears to be in poor condition with a broken back near the center (directly under the roadway). This has created a situation where upstream headwater is unable to drain and ponding occurs.

Figure 60. Culvert at MP 248.4: From Upstream Looking Downstream: From Downstream Looking Upstream

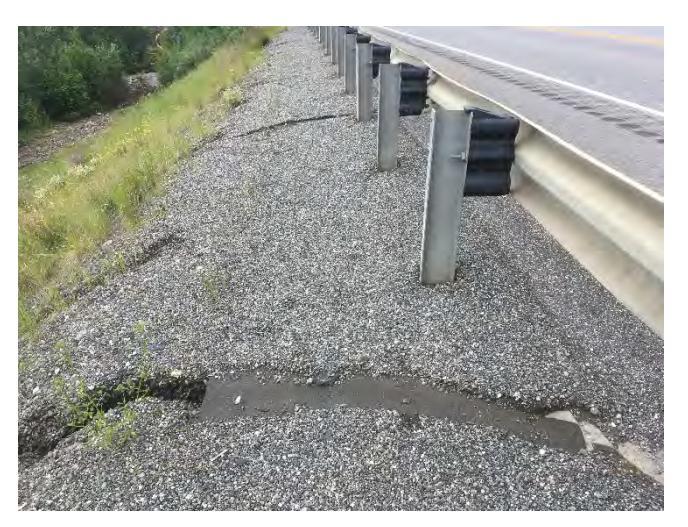
In several locations along the study corridor, simple roadway embankment erosion was observed where roadway runoff was unintentionally concentrated on the shoulder prior to being able to flow down the roadway embankment. This occurred more frequently where guardrail was present.

Figure 61. Shoulder Erosion Near MP 252.5 Looking South Towards the Panguingue Creek Crossing

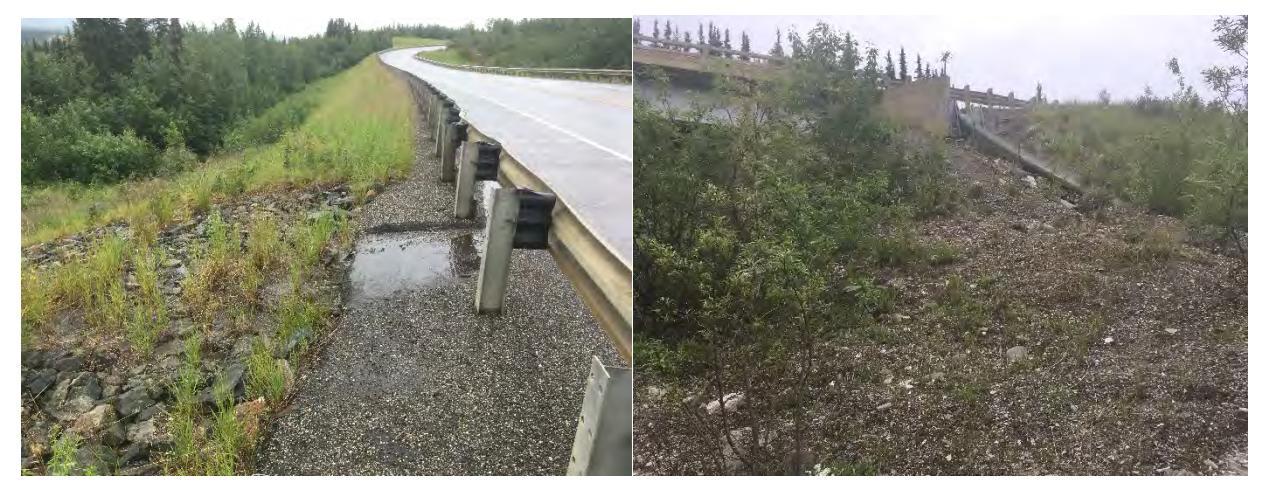
Several locations along the corridor include batter board where guardrail is present. There would then typically include a flume (metal or riprap) to convey concentrated flows from openings in the batter board to the bottom of the roadway embankment. These are typically placed near bridges where concentrated flow is unavoidable but were also observed where steep embankments warranted guardrail.

Figure 62. Typical Riprap Flume Looking Toward Slate Creek: Typical Metal Flume on Southbound Side of the Kingfisher Creek Crossing

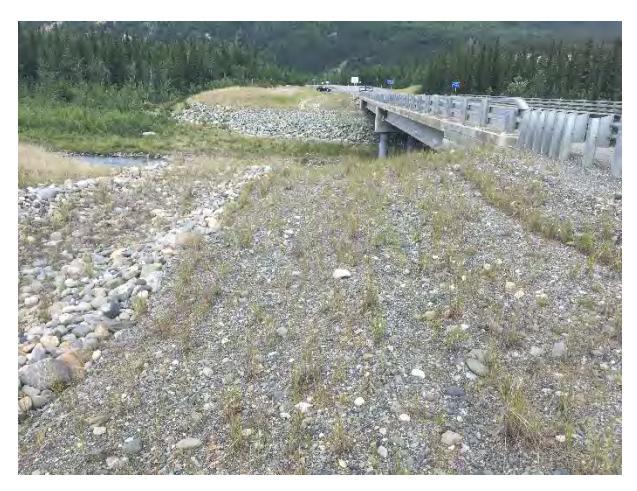
Erosion within roadside ditches appeared to be minimal as riprap was effectively used where slopes became steep.

Figure 63. Typical Riprap Roadside Ditch Looking Toward Riley Creek

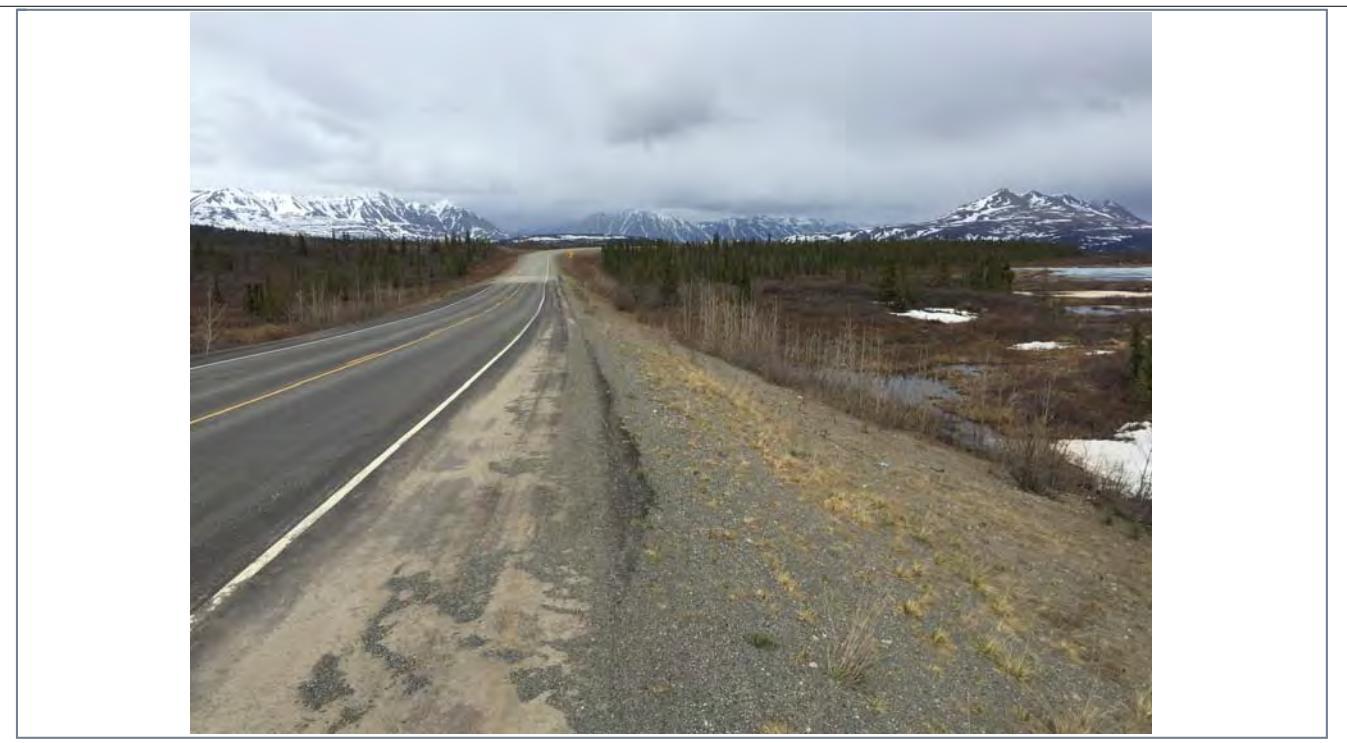
#### Photo 1: MP 206.2 to 206.3

Road bumps where embankment crosses a low spot between ridges. Settlement likely caused by compressible organics and thawing permafrost.

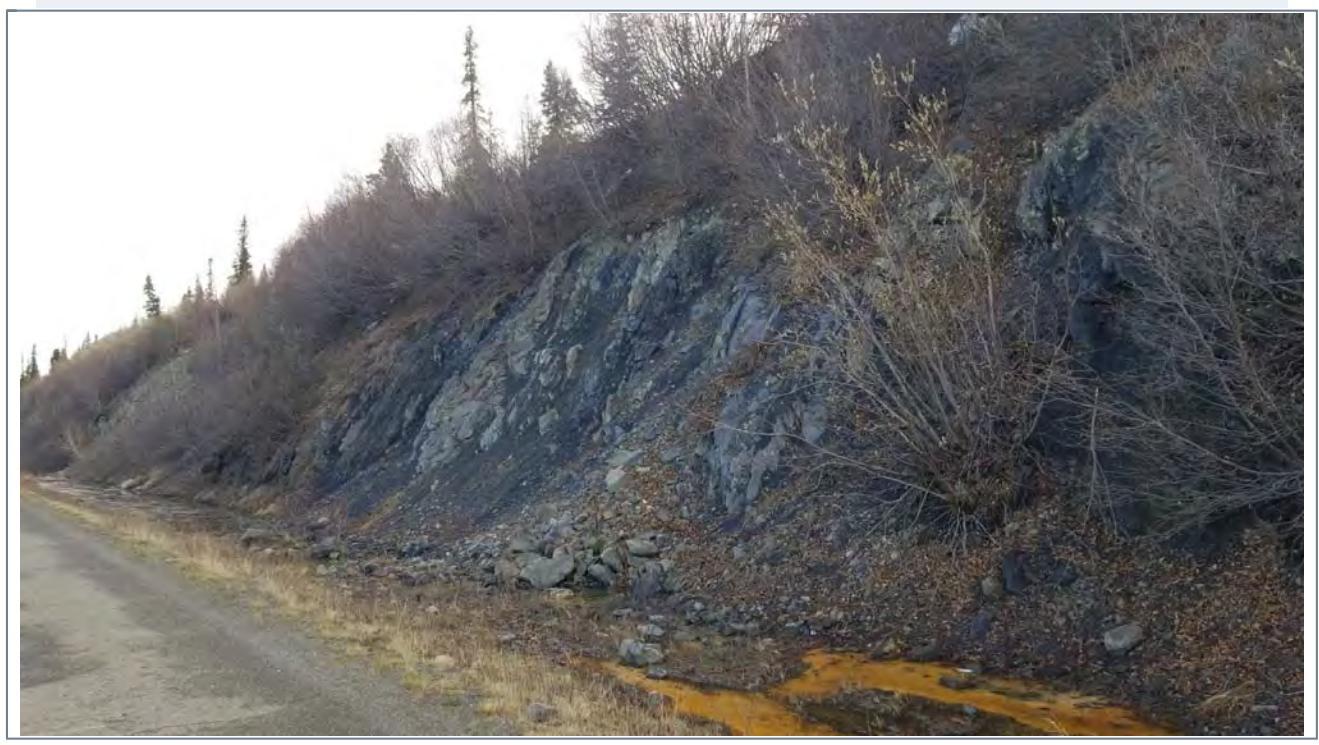
#### Photo 6: MP 212

Unstable soil and rock slope. Vern Carlson (Maintenance Foreman) stated that the site was a slow-moving slide that caused the ditch to be cleaned out every three to five years depending on rainfall.
