## Cantwell to Healy – Parks Highway Milepost 203-259 Planning & Environmental Linkages Study

Project No. NFHWY00492

## **Needs and Opportunities Assessment Report**

> > > > October 2020

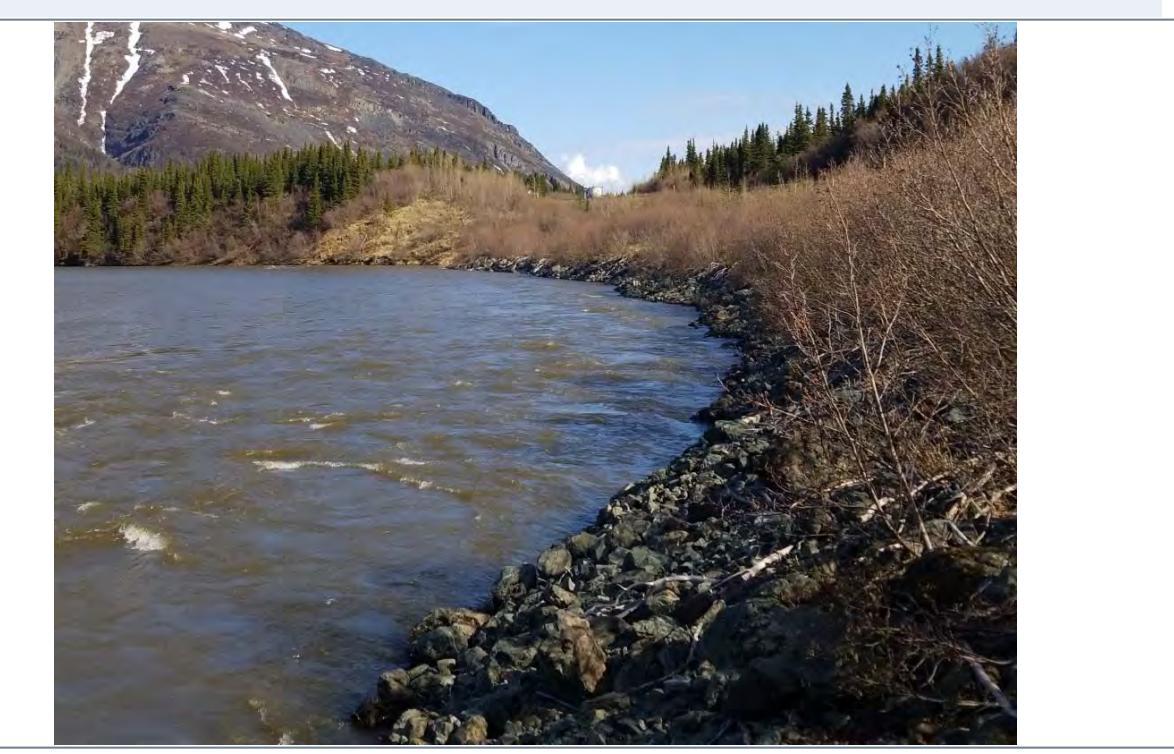
#### Photo 8: MP 219

Existing erosion protection along the Nenana River.

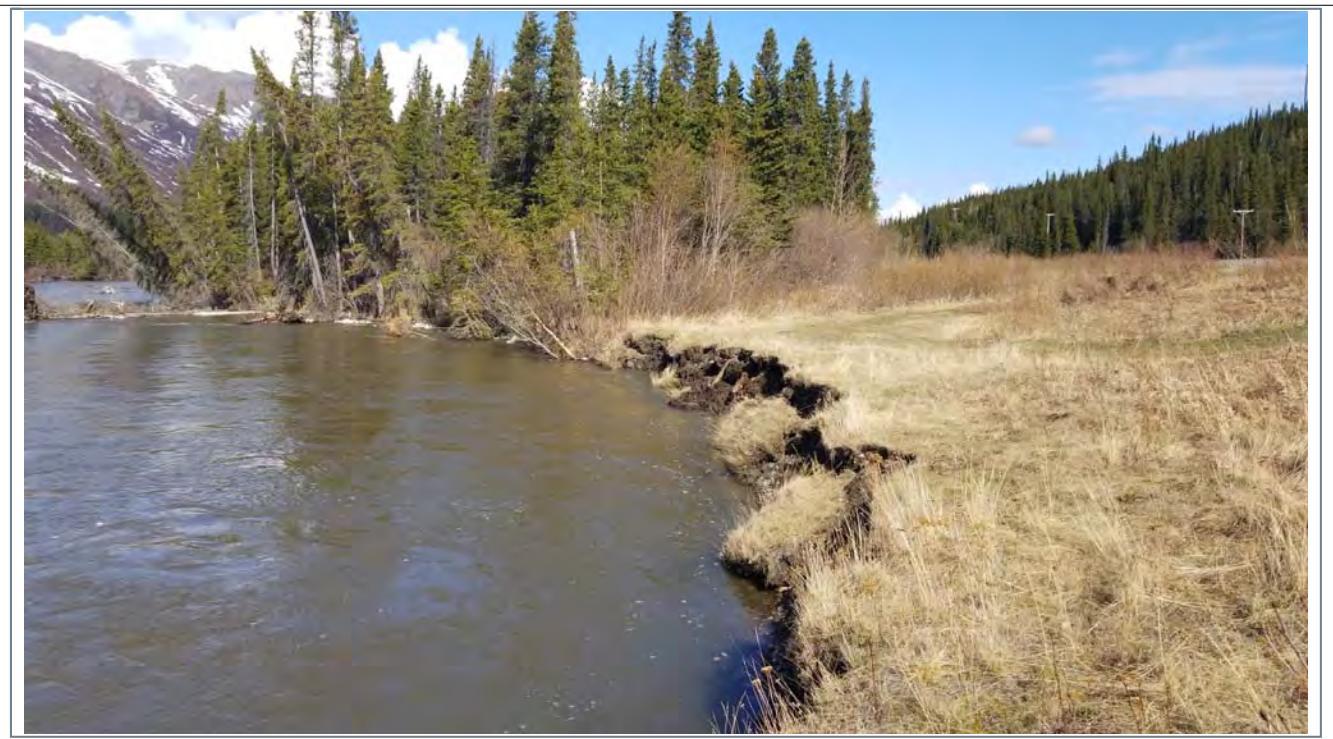
Photo 9: MP 221.8 to 222 Minor erosion due to river undercutting in unprotected banks at north end of section. (SW2020)

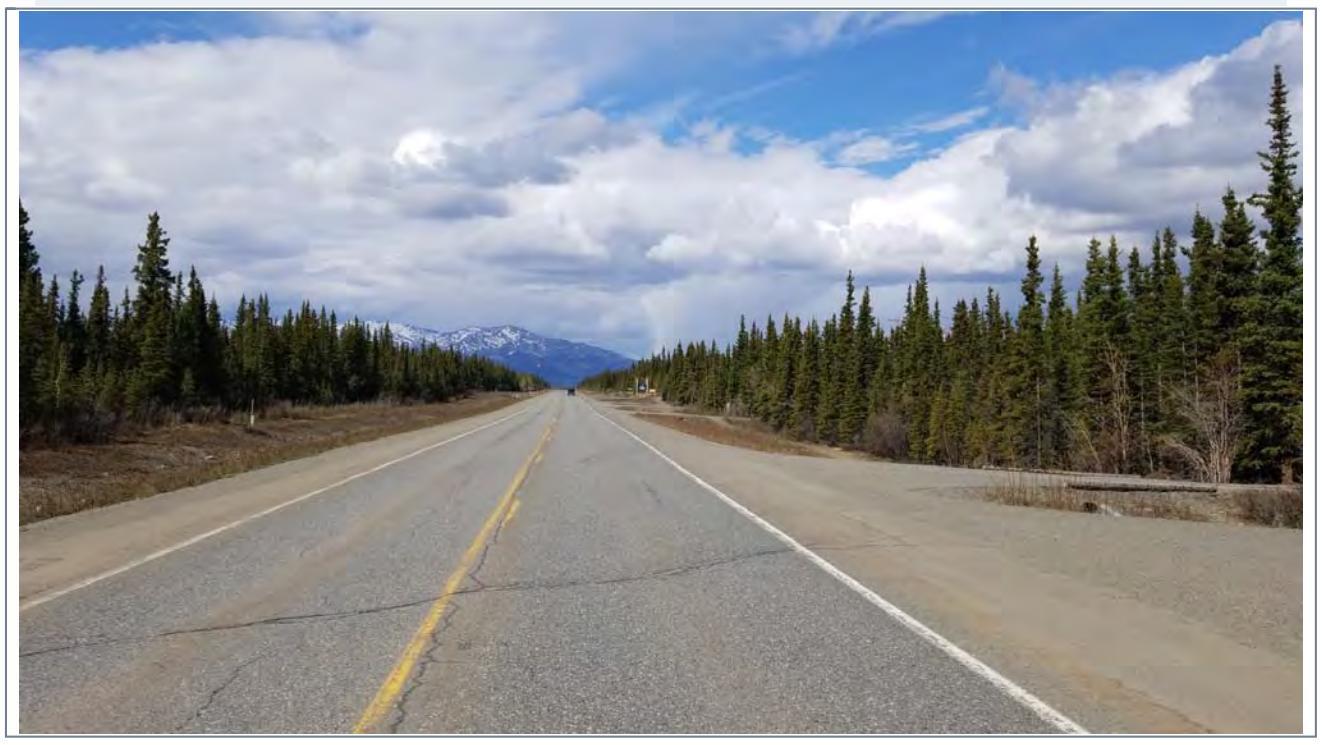
Photo 10: MP 228.9 Frequent driveways along this section of highway.

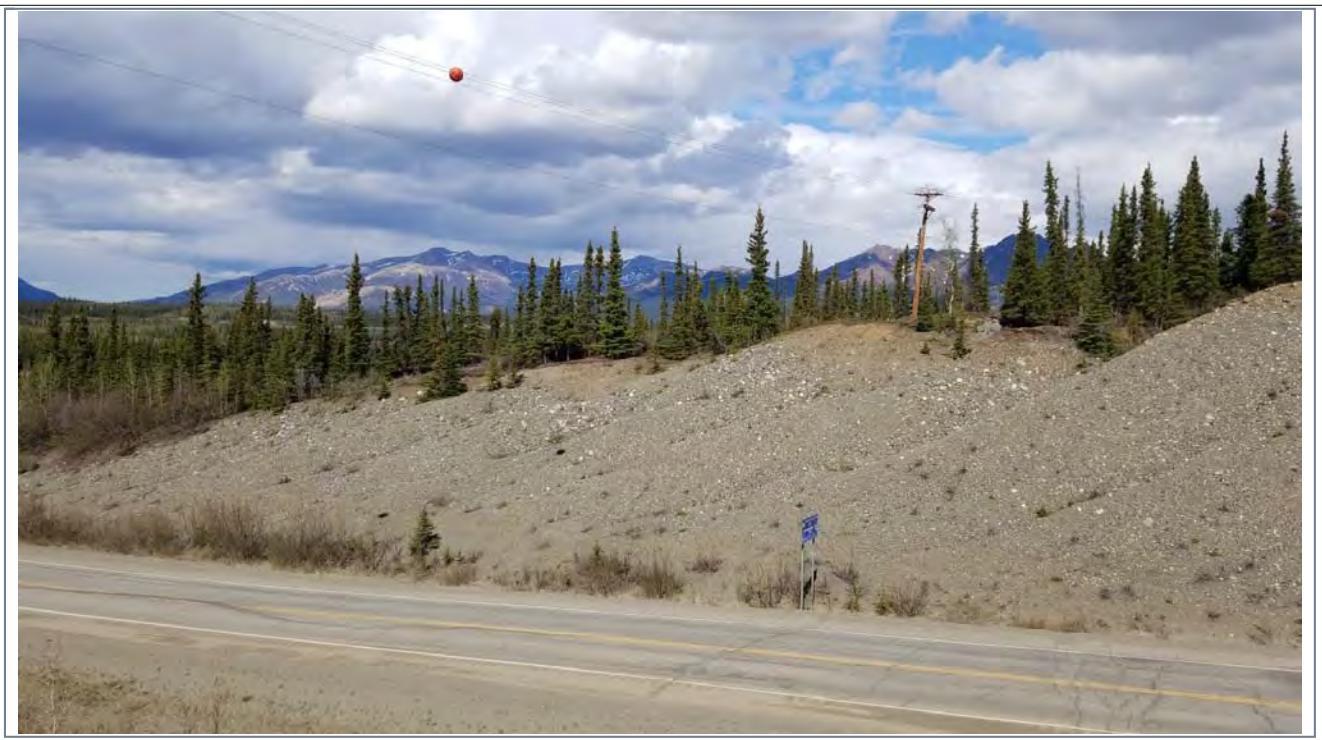
Photo 11: MP 230.8 Possible scarp lines in road cut. Relative movement of slide is obliquely away from highway.

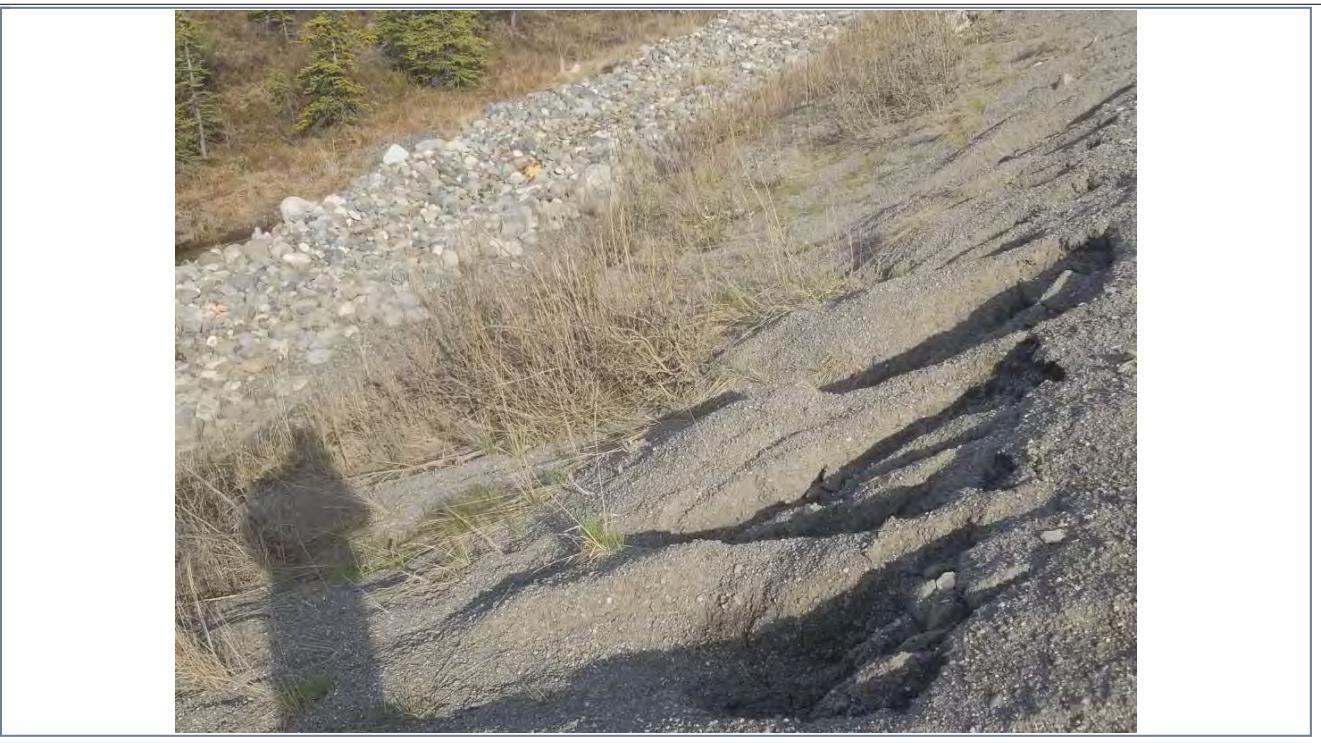
#### Photo 13: MP 235

Example of embankment erosion due to surface runoff in area where pavement settlement has occurred.

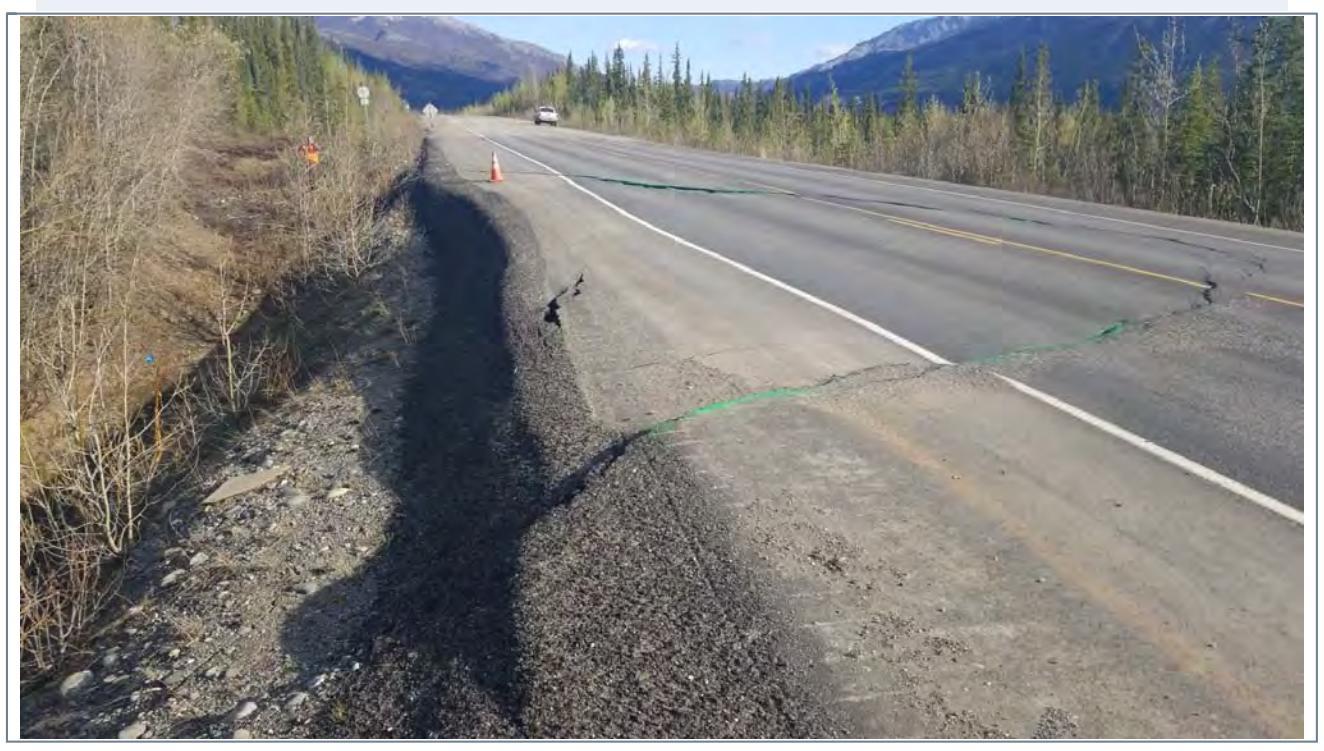
Photo 14: MP 235.5

Bumpy road due to extreme thaw settlement. 5 to 6-foot deep thaw hole at left toe with large circular failure expression in roadway and in backslope. (SW2020)

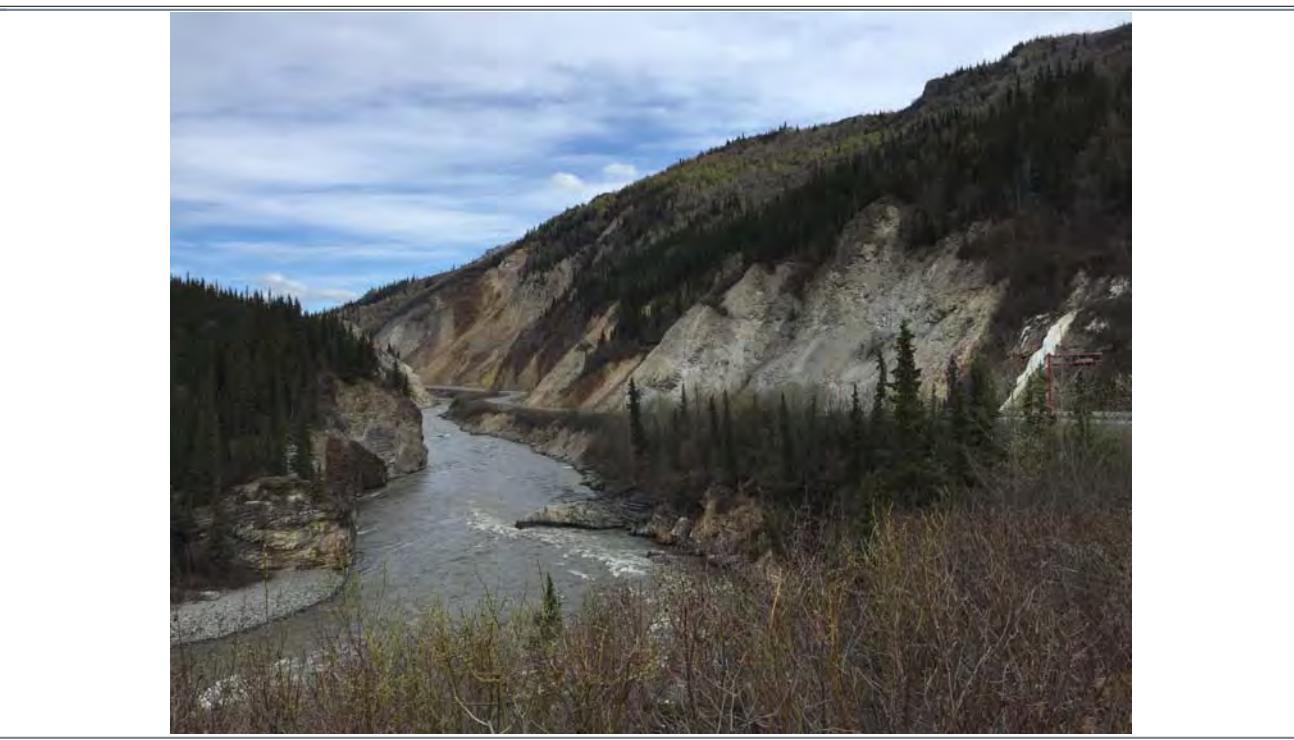
#### Photo 17: MP 239 to 240 The Nenana River flowing through Nenana Canyon.

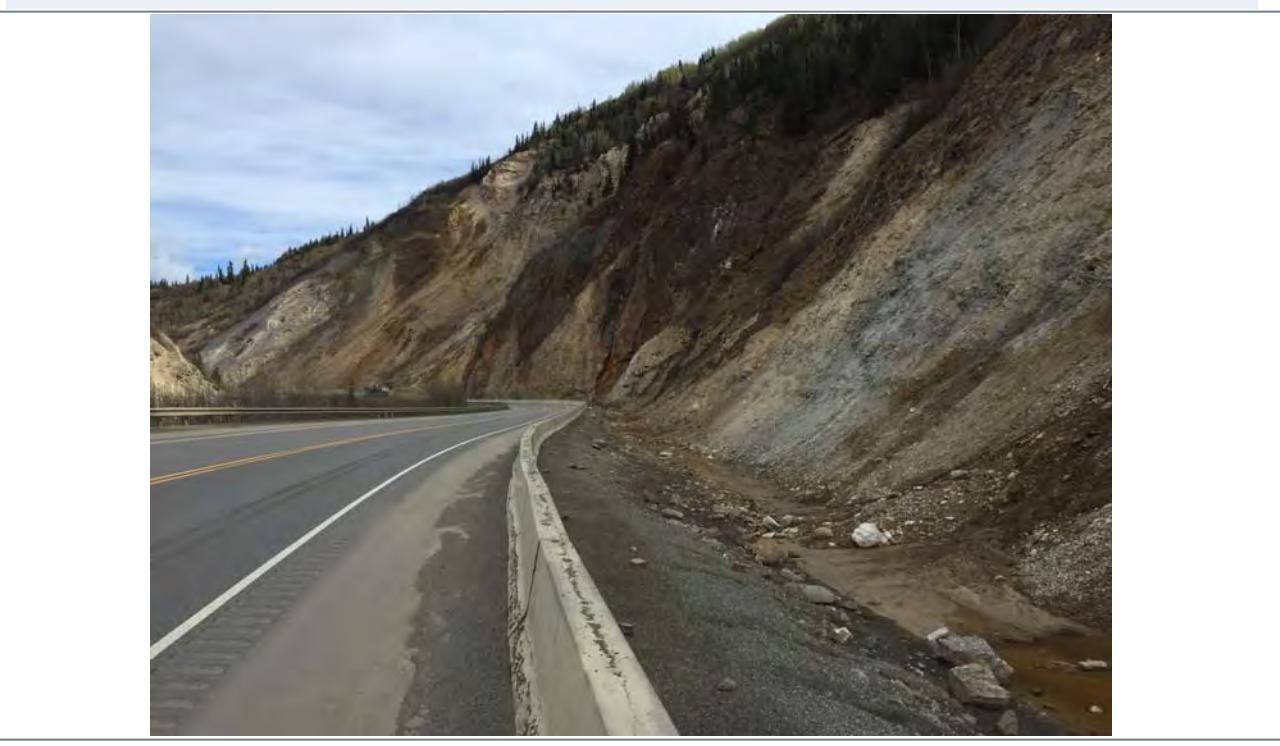
#### Photo 18: MP 239.2 Widened ditch with concrete traffic barrier. Some rockfall debris in ditch.

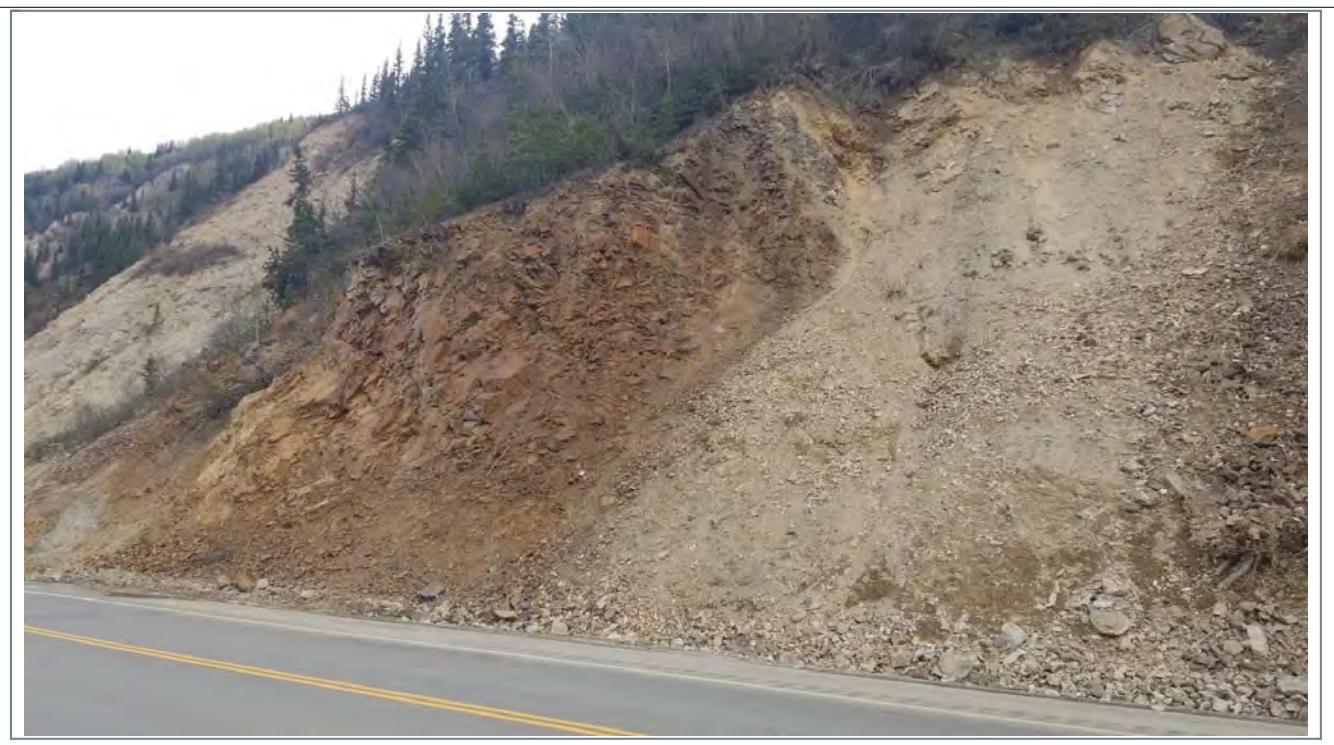
#### Photo 19: MP 239.3 Rock outcropped identified by Landslide Technology as an actively moving block.

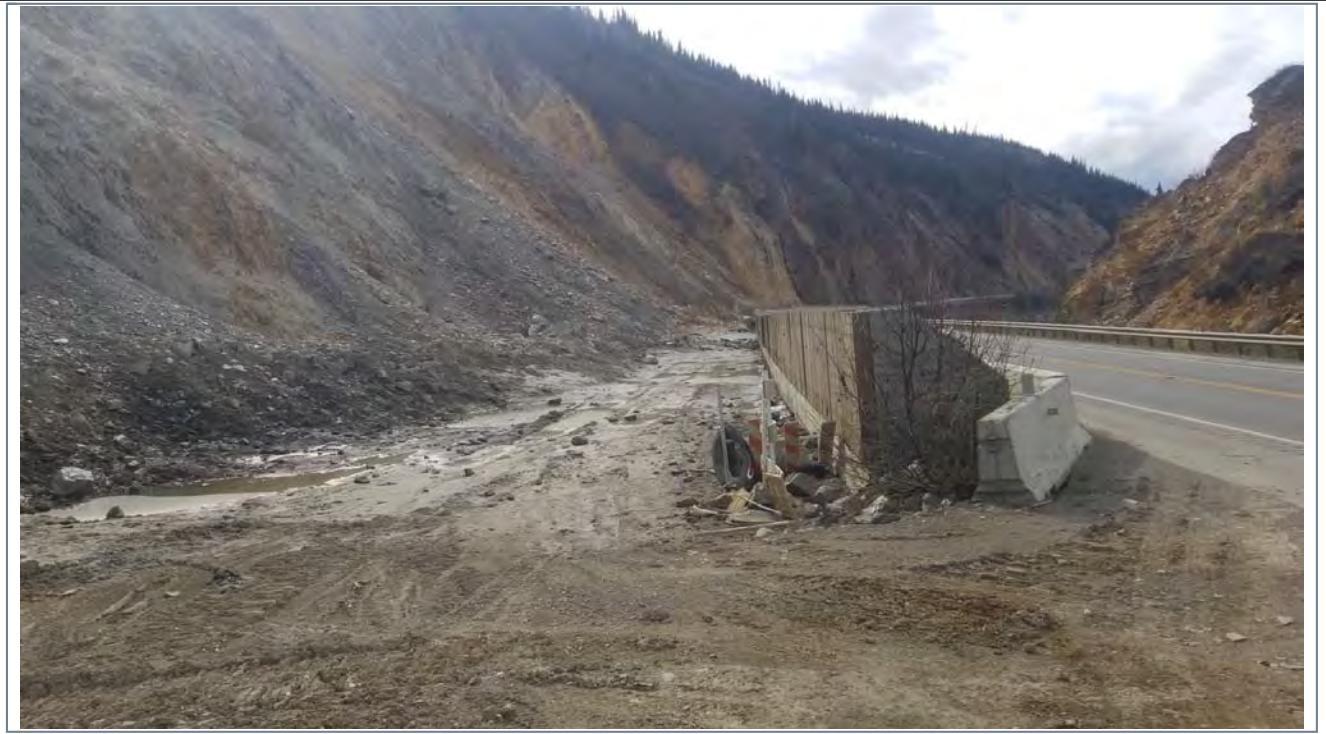
#### Photo 20: MP 239.6

Nenana Canyon rockslide and rockfall area with robust concrete barrier protection.

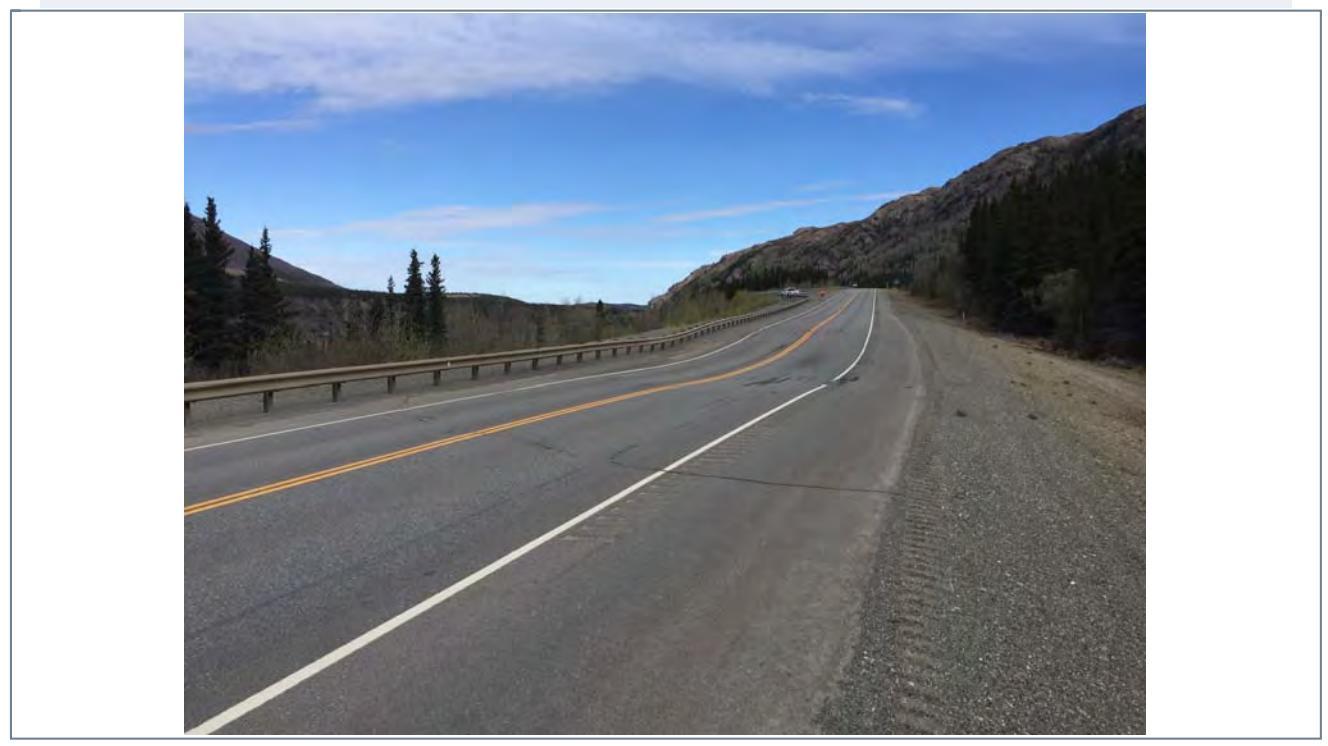
Photo 21: MP 239.7 End of rockfall barrier with ditch section that requires frequent clearing by M&O.

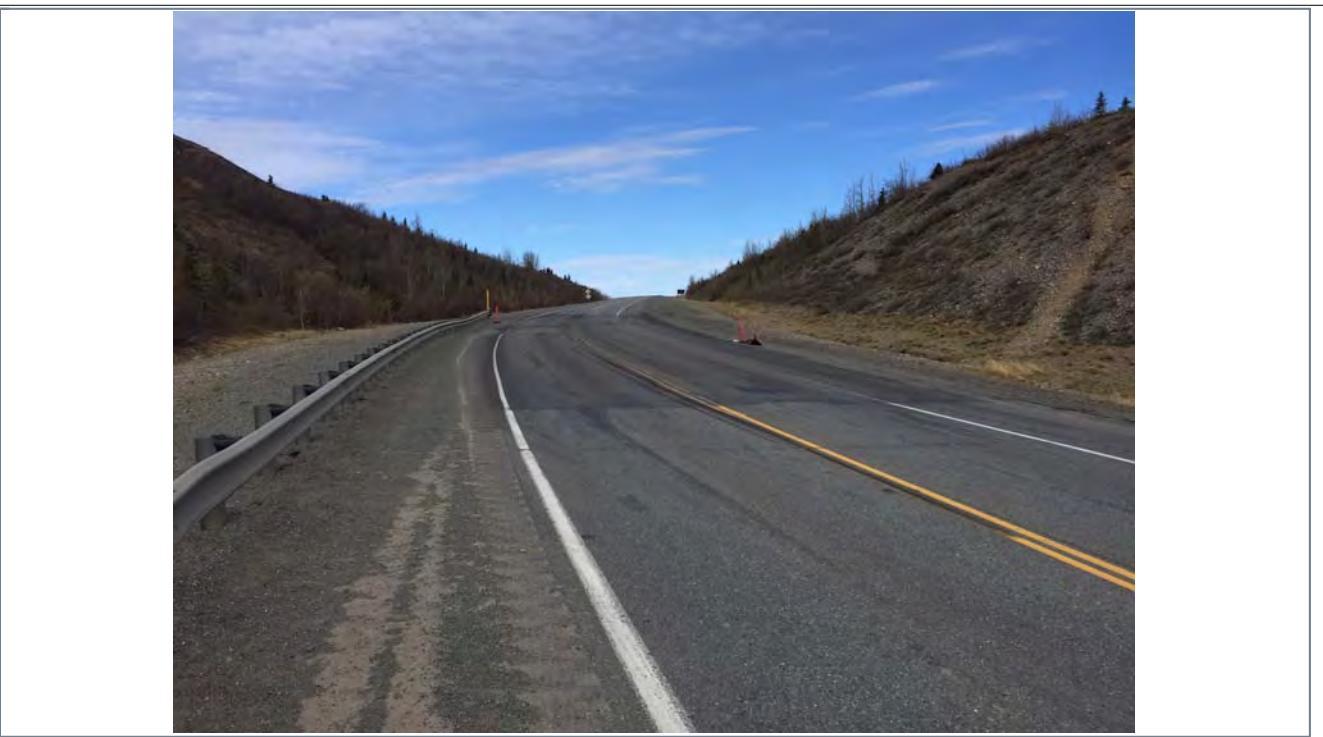
Photo 22: MP 242.1 Highway develops repeated dips. (M&O) Large heave/depression. Possible thawing ice wedge. (SW2020)

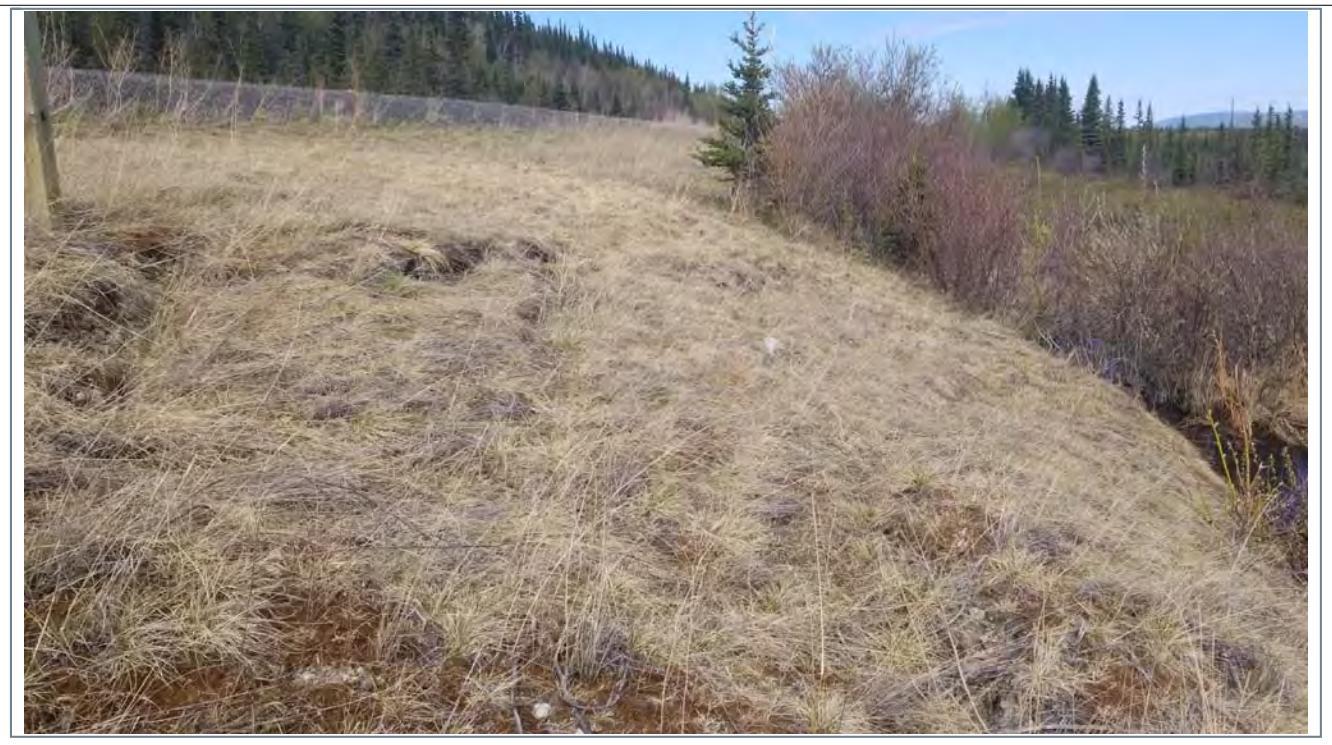
Photo 23: MP 243.5 Highway develops repeated dips. (M&O) Abrupt depression in roadcut. (SW2020)

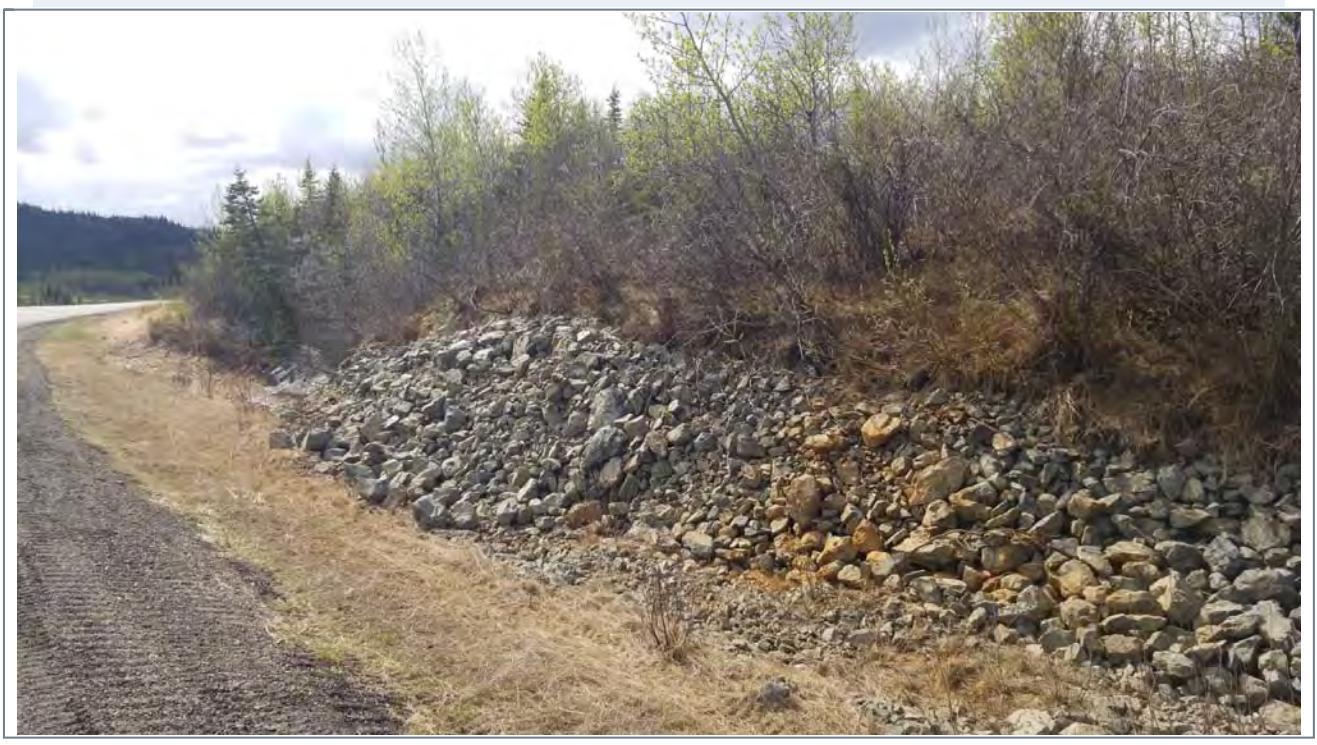
#### Photo 28: MP 258.3

Bumpy road with numerous patches and drainage issues. Large scale creeping failure of slopes above the road (MP258.3-258.6) and impacting the ROW. Small riprap "buttress" on backslope is "failing". (SW2020) Drainage issues affecting road base. (M&O)
# Important Information
