# HAINES HIGHWAY

MILEPOST 3.5-25.3

ENVIRONMENTAL SITE ASSESSMENT

DOT&PF PROJECT NO. 68606  
HAINES, ALASKA

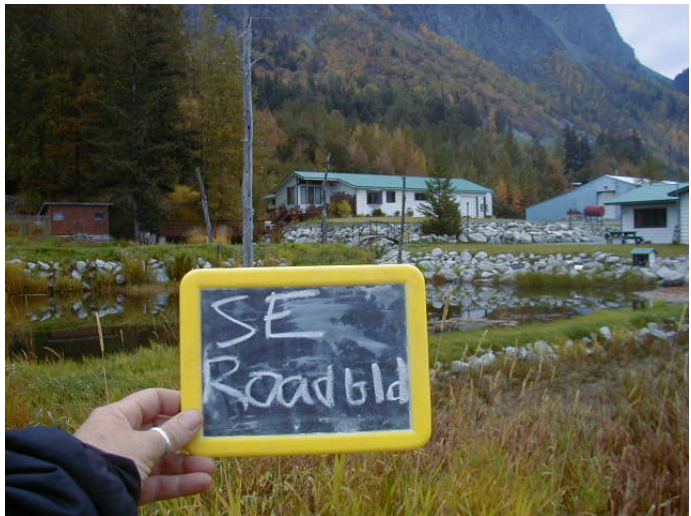
<p><b>Photograph No. 6</b></p> <p>Location: N/A</p> <p>Direction: Facing east</p> <p>Comments: Photo of pond on property</p>

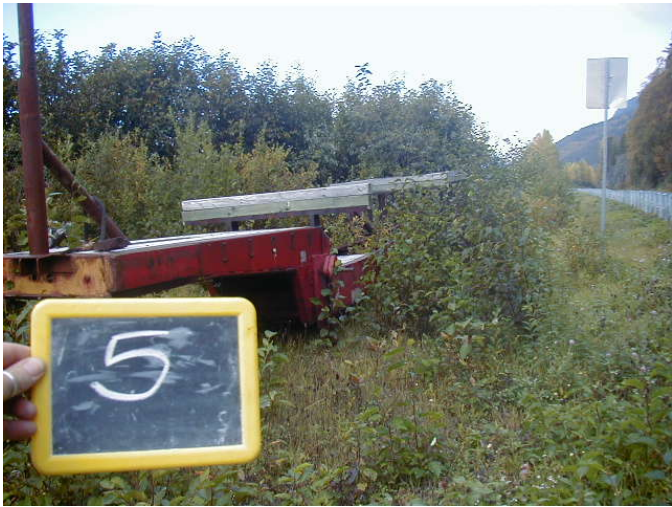
<p><b>Photograph No. 20</b></p> <p>Location: Site 7</p> <p>Direction: Facing northwest</p> <p>Comments:</p>

- Site 6: On the shoulder, between the highway and the river is a recently used firepit and old trailer.
- Site 7: A large area, which contains a dilapidated old home site, was found between the road and the mountains. Associated debris included one drum, a partially collapsed house, car, and shed with one old drum. A smaller building was also observed up the hill.

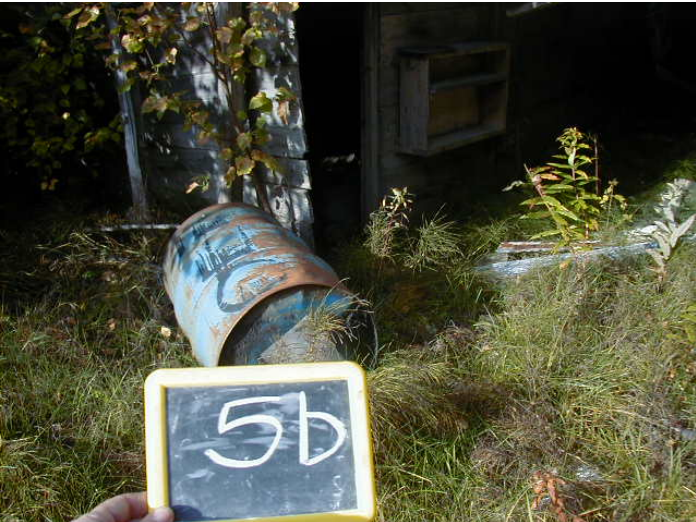
<p><b>Photograph No. 27</b> Location: Site 8 Direction: Facing east Comments:</p>

- Site 8: An illegal shooting range was observed on the mountainside of the highway.
- Site 9: Between the highway and the river is a large parking area with signs of illegal loitering, which included a burn pile approximately 15x10x5 feet large, a used trailer and associated machinery, and a pit that appears to be an old outhouse site.

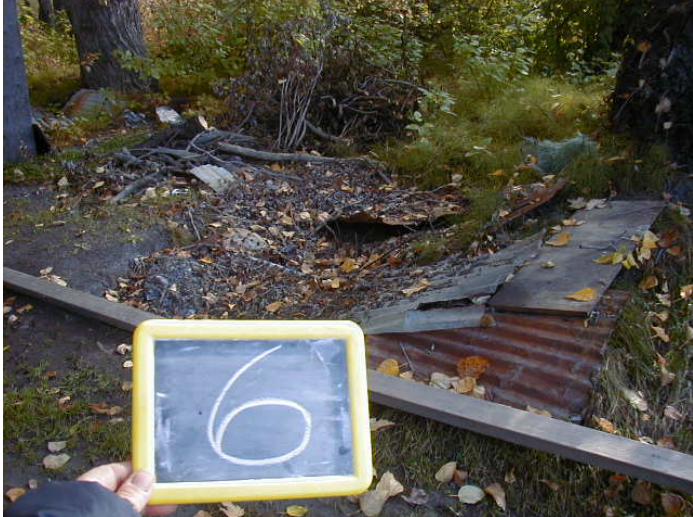
<p><b>Photograph No. 38</b> Location: Site 10 Direction: Facing east Comments:</p>

- Site 10: An abandoned car was observed in the heavily wooded area between the highway and the mountains.
- Site 11: Two porta-potties were observed on the parking area between the river and the highway.

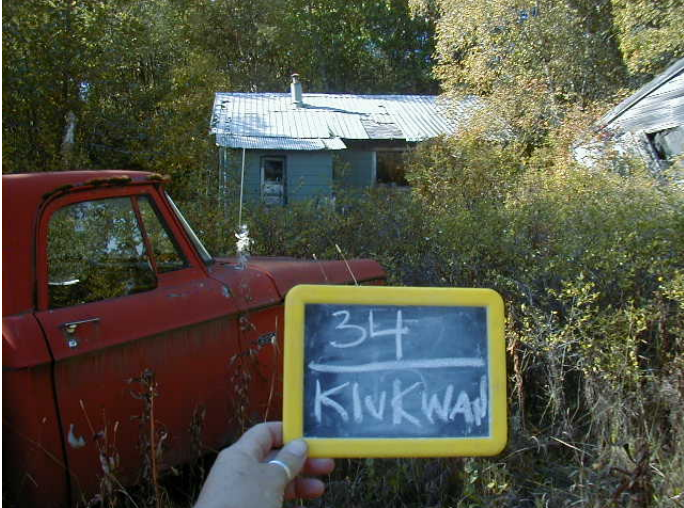
<p><b>Photograph No. 50</b></p> <p>Location: Site 13</p> <p>Direction: Facing east</p> <p>Comments:</p>

- Site 12: At the Klukwan turnoff, an area was observed that contained multiple vehicles, oil buckets, and associated debris.
- Site 13: A large area that contains a dilapidated house, shed, truck, and trailer.

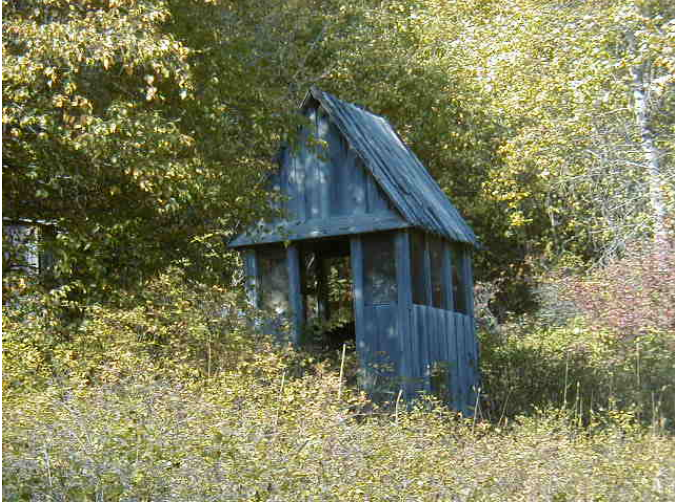
<p><b>Photograph No. 51</b></p> <p>Location: Site 14</p> <p>Direction: Facing east</p> <p>Comments:</p>

- Site 14: An old abandoned structure was observed between the highway and the mountains.
