FINAL REPORT

**LYNN CANAL HIGHWAY
PHASE I
ZONE 4 GEOTECHNICAL INVESTIGATION**

STATE PROJECT NUMBER: 71100

*Golder Associates Inc.
1750 Abbott Road, Suite 200
Anchorage, Alaska 99507*

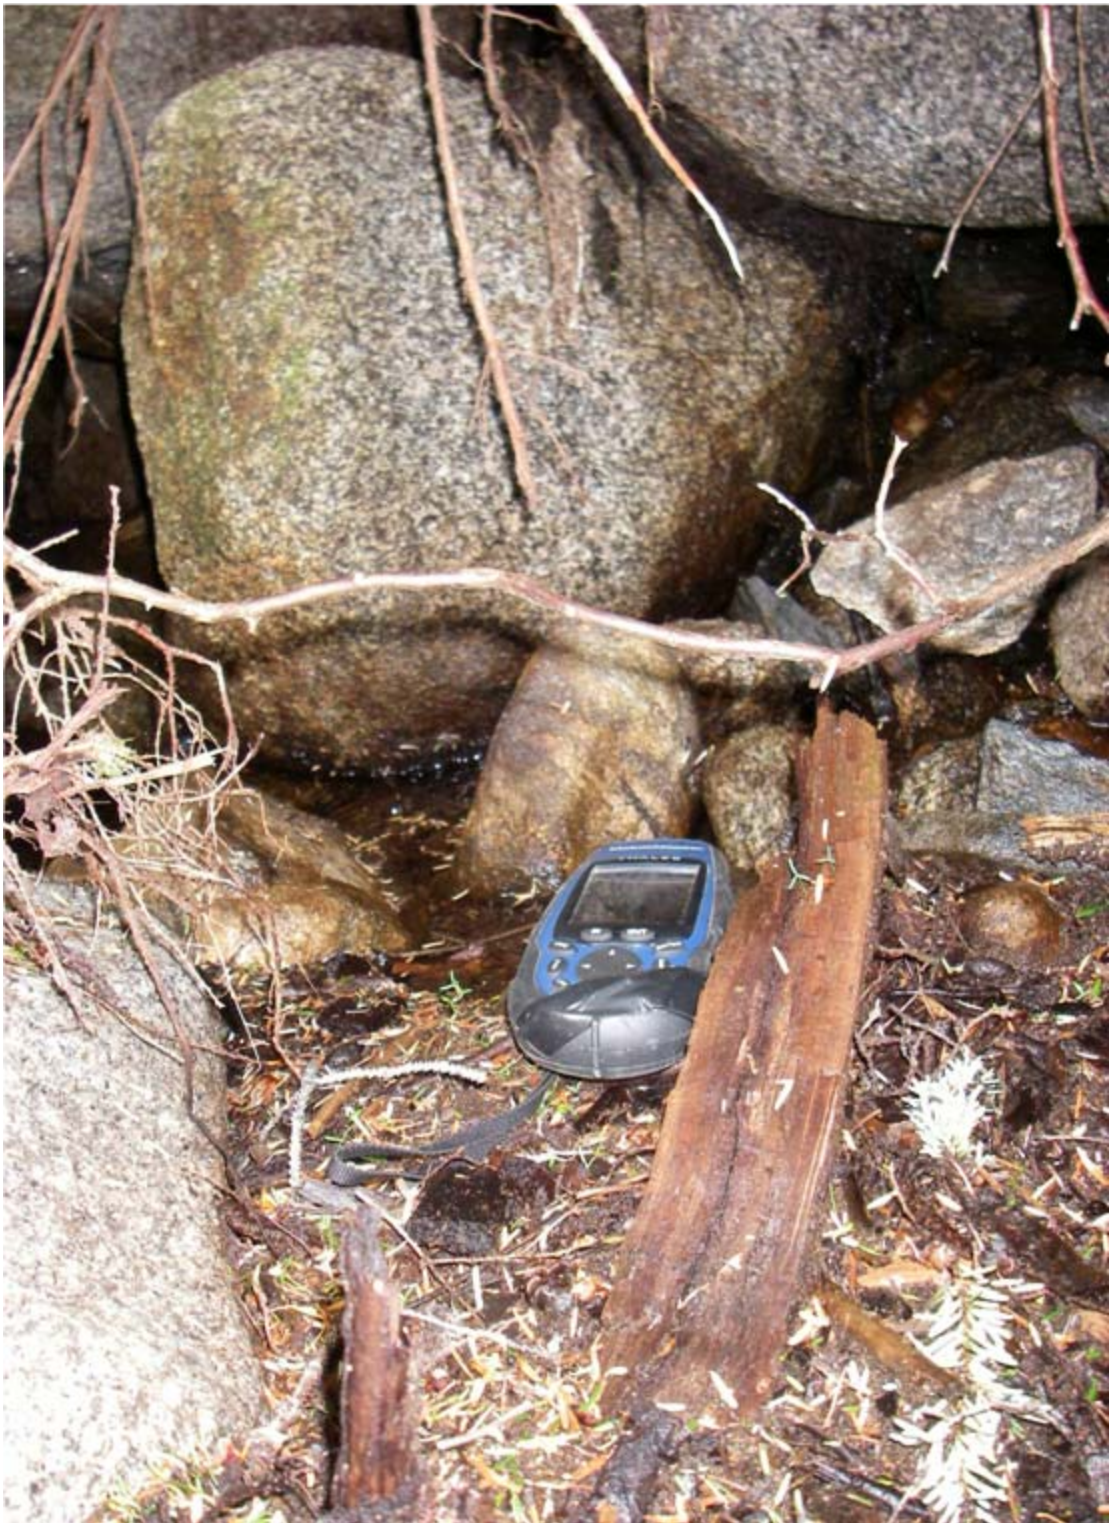
Colluvium (Qc) - View of typical colluvial material. Material is angular to subrounded and multi-lithic. Handheld MobileMapper™ is 3 inches wide for scale. Photo taken 75 ft right of IRP 2006 2008+50.

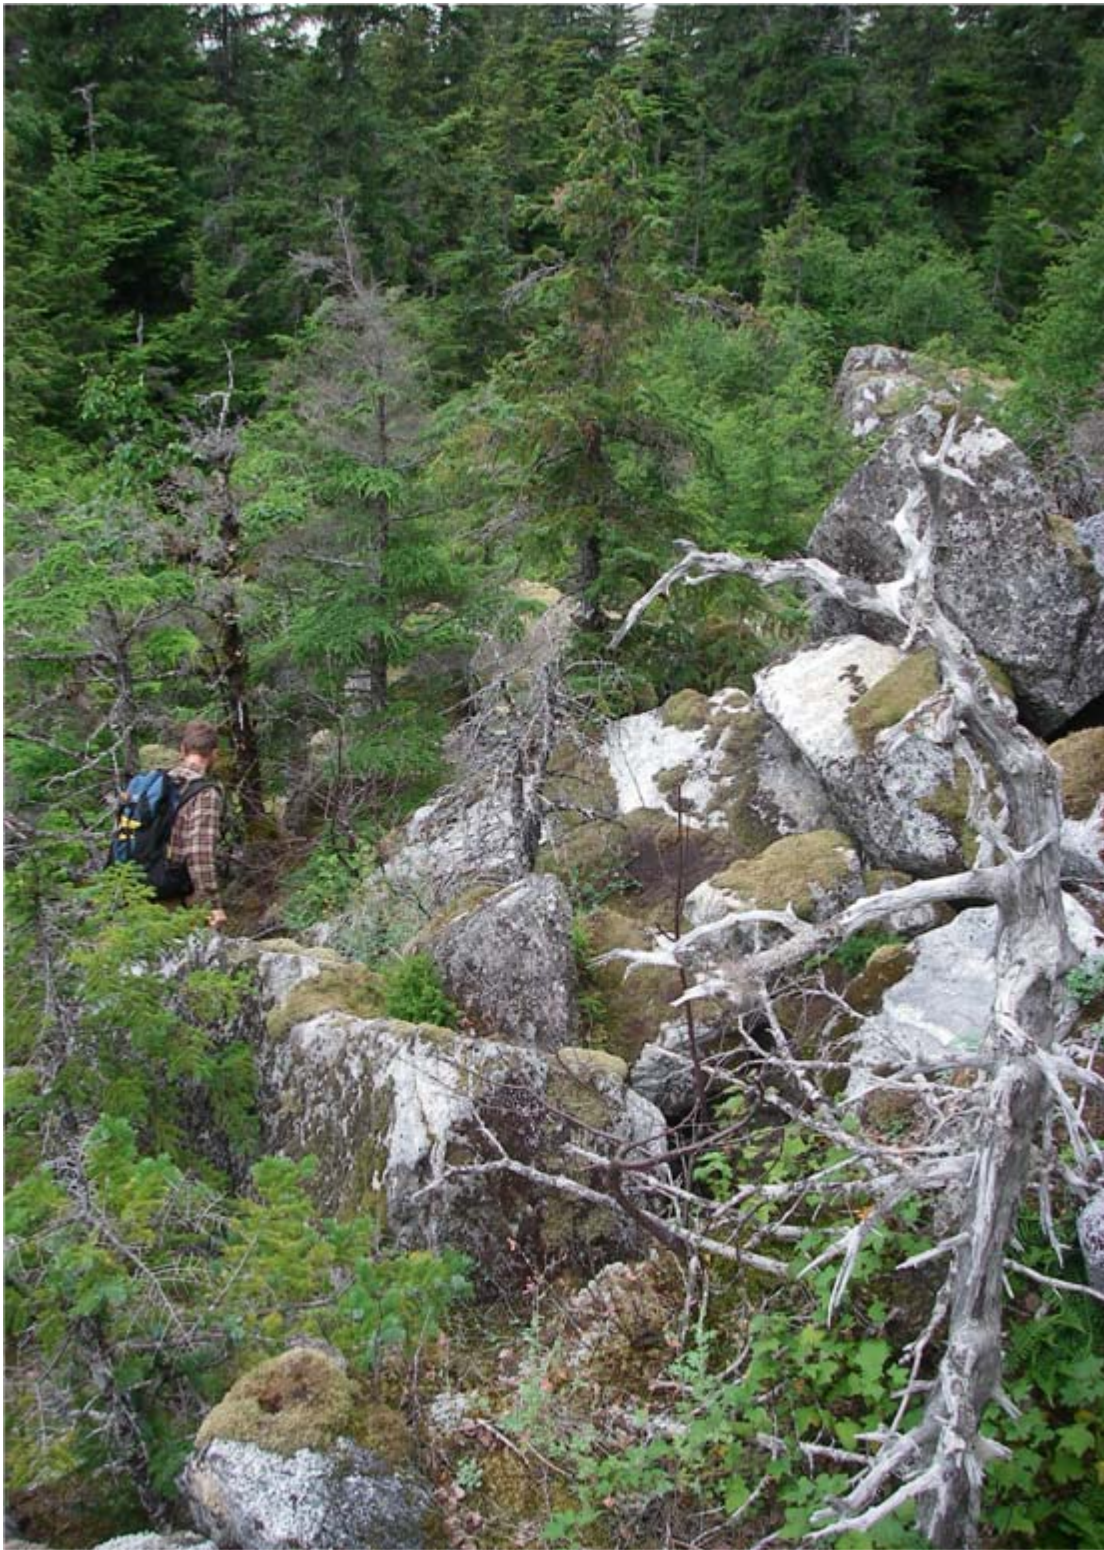
Talus deposits (Qct) - View of typical talus deposit. Person for scale to left of center. Photo taken 500 ft right of IRP 2006 2612+30.

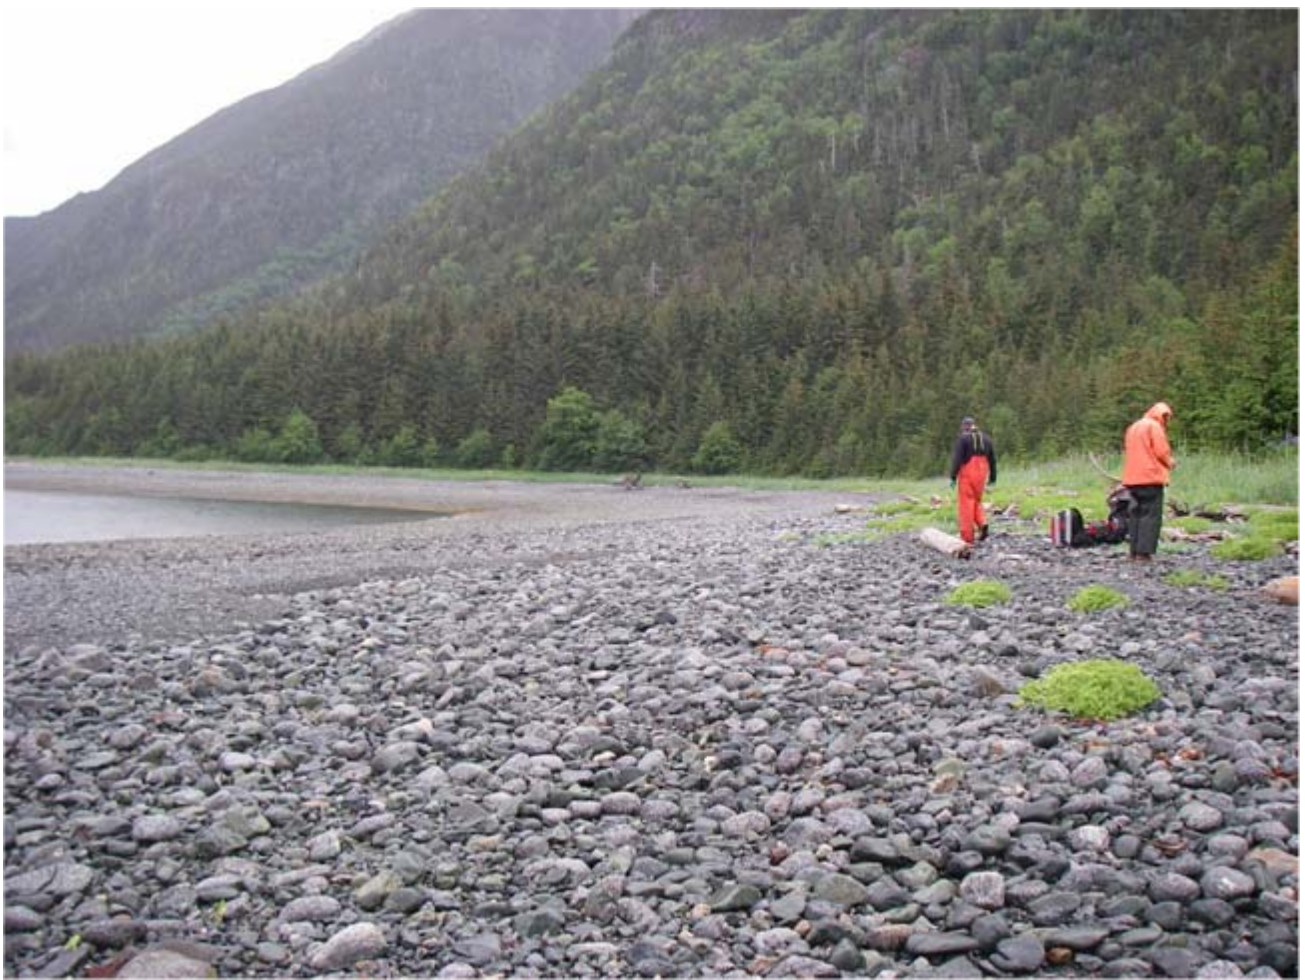
Modern beach deposits (Qb) - View north across typical modern beach deposits. Notice lack of fines and subrounded to rounded cobbles. Photo taken 100 ft left of IRP 2006 1455+00.

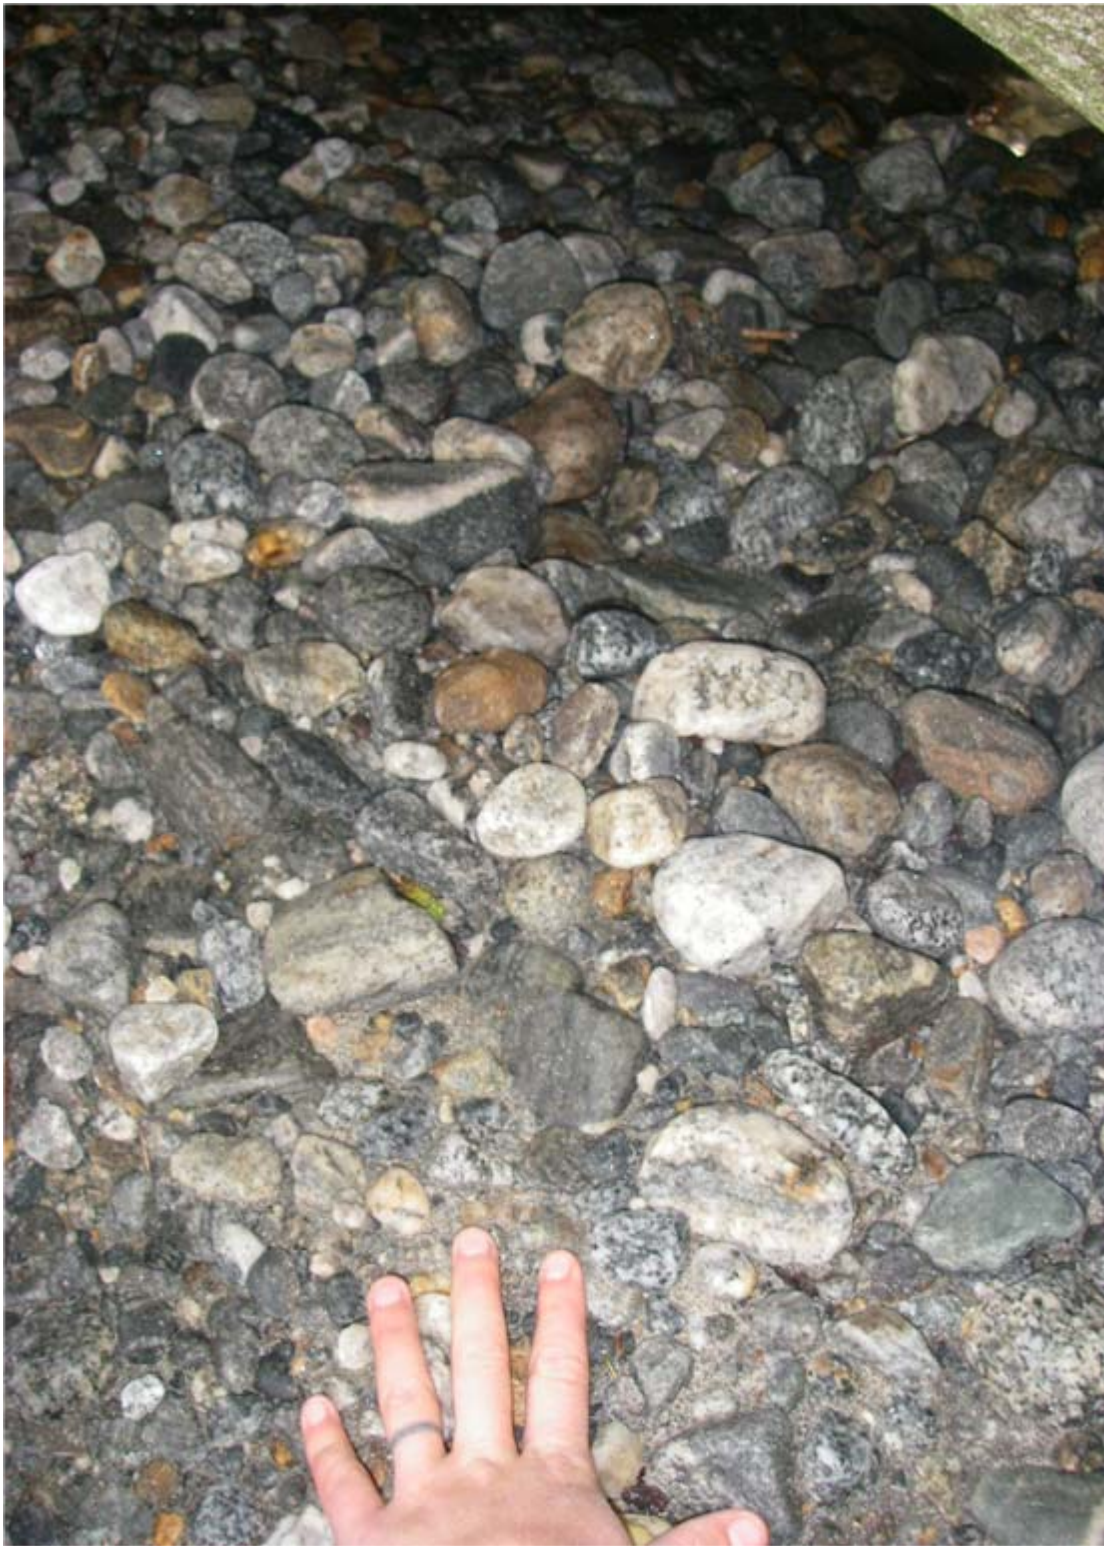
Elevated beach deposits (Qeb) - View of typical elevated beach deposit material. Photo taken 490 ft right of IRP 2006 2418+00.

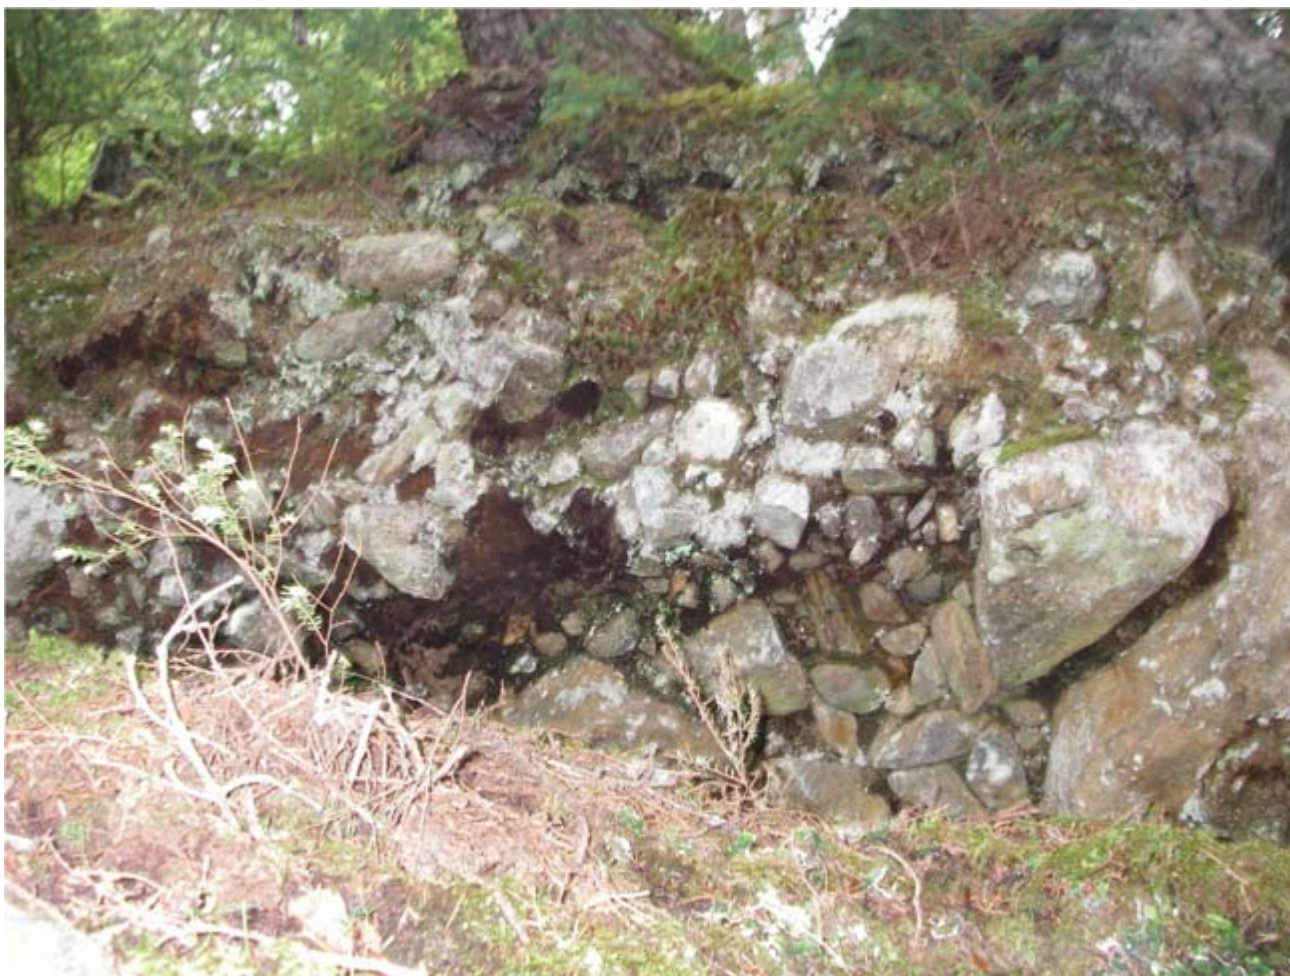
Elevated beach deposits (Qeb) - View upslope at weakly cemented elevated beach deposits. Photo taken at centerline at IRP 2006 2158+00.

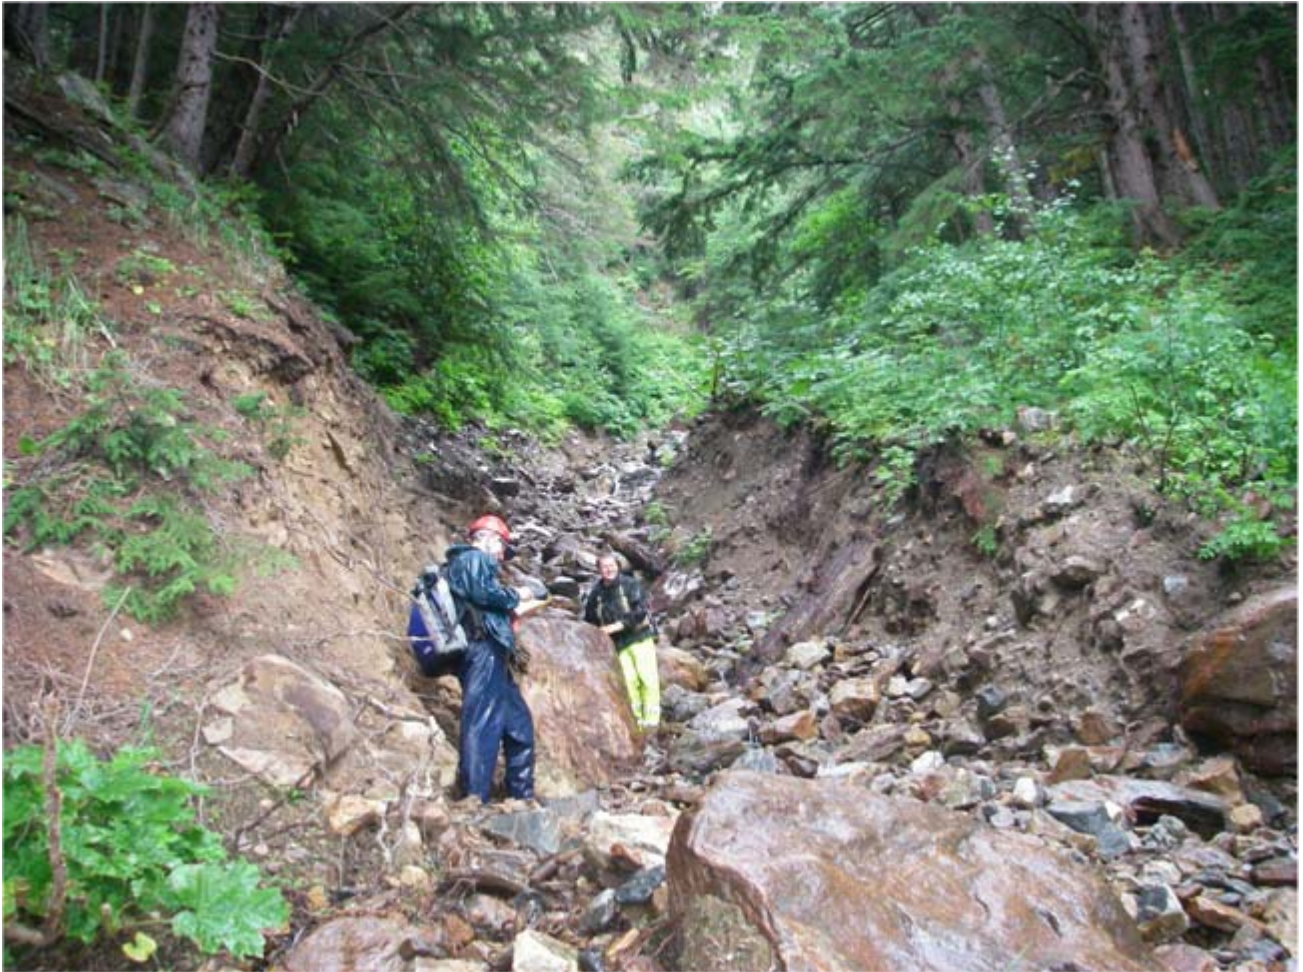
Debris flow deposits (Qdf) - View upslope at typical debris flow deposits. Photo taken at centerline at IRP 2006 1747+00.

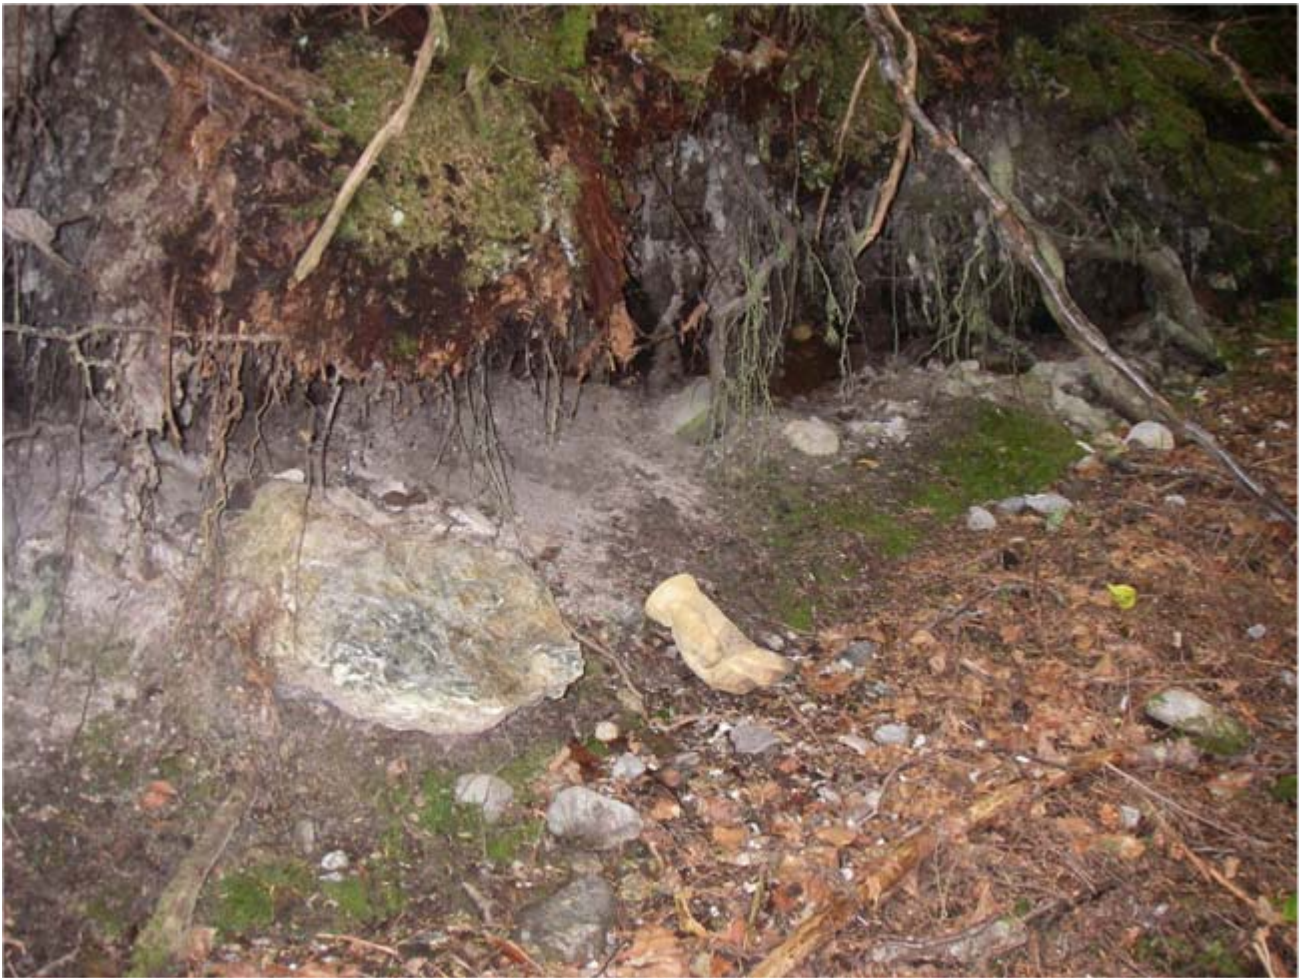
Alluvial fan deposits (Qaf) - View of typical alluvial fan material. Notice presence of sand. Photo taken 225 ft right of IRP 2006 1976+00.

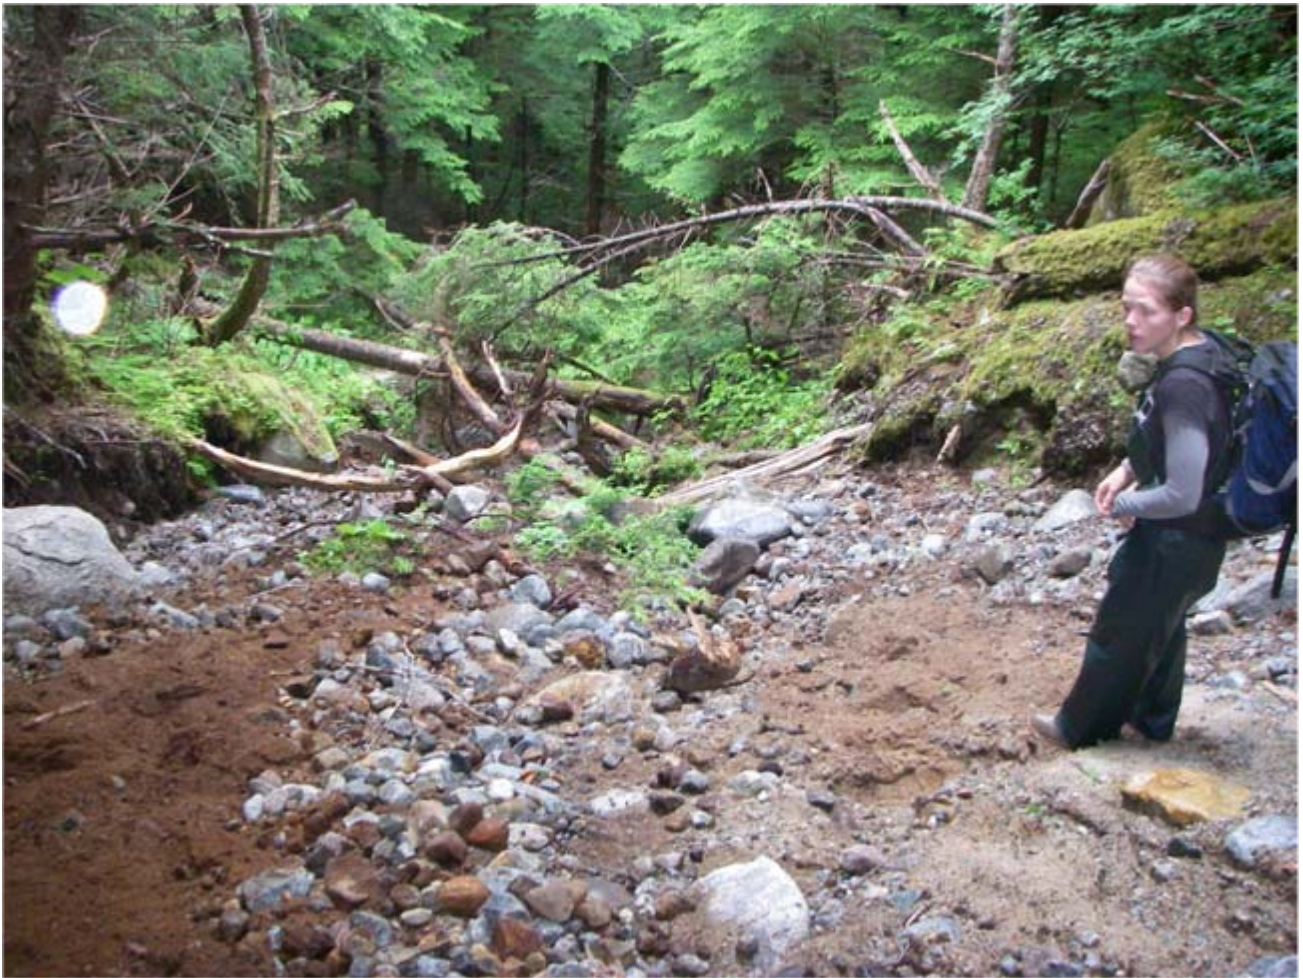
Landslide deposits (Qls) - View downslope at landslide deposits with glacial outwash as a parent material. Photo taken 100 ft right of IRP 2006 2427+00.

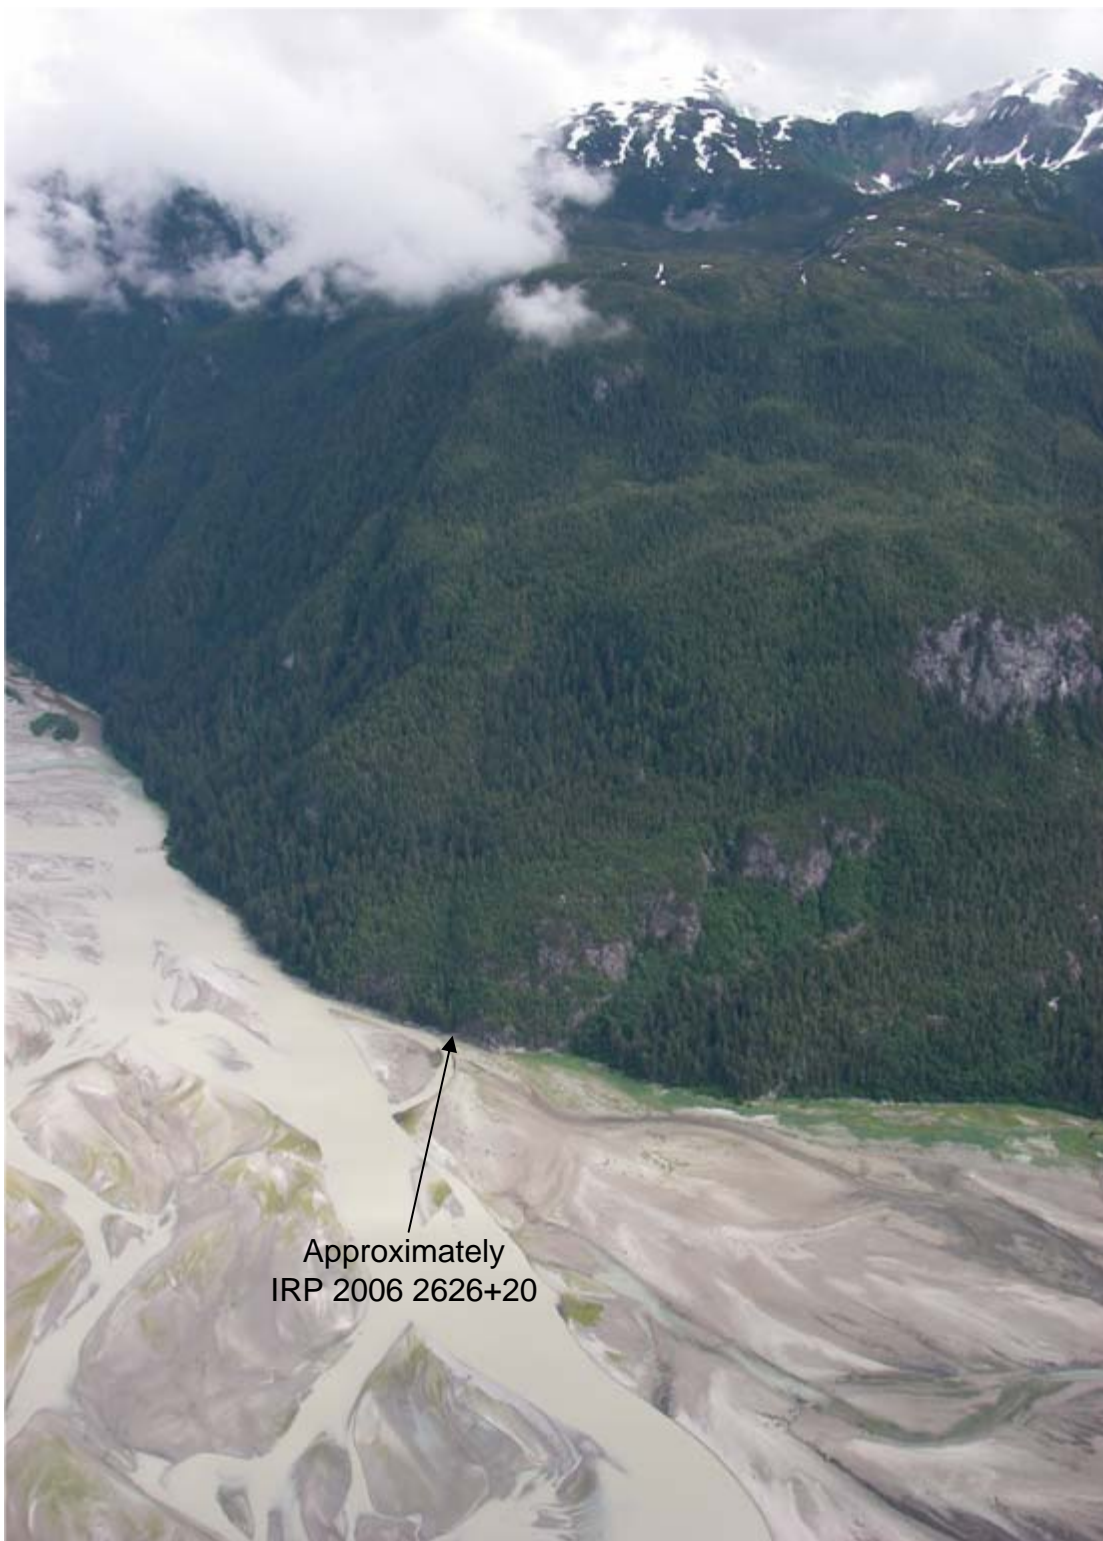
River deposits (Qr) - View east at the mouth of the Katzehin River and typical river deposits.

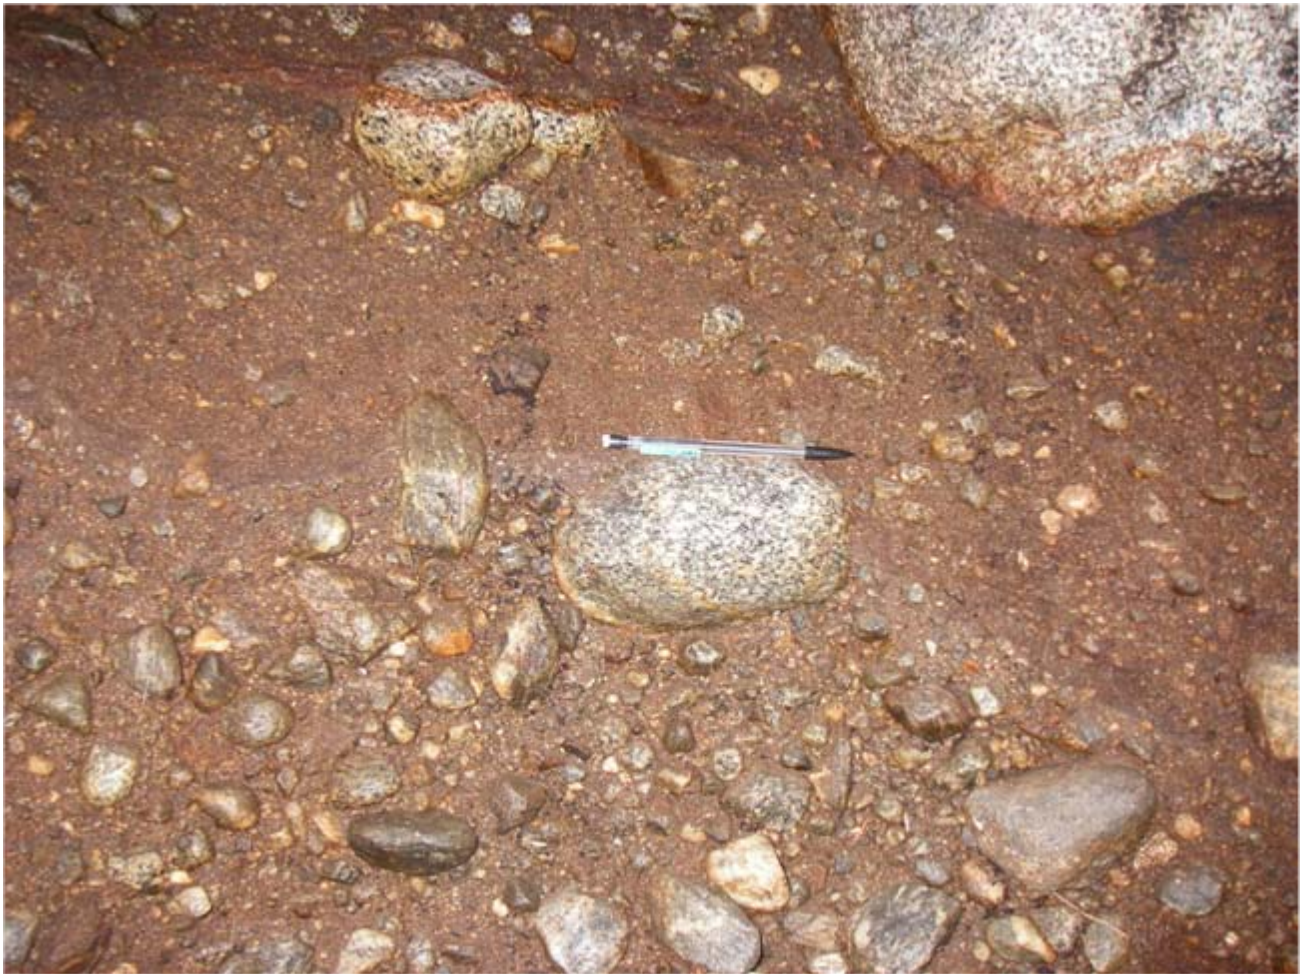
Glacial outwash deposits (Qgo) - View of typical glacial outwash deposit. Pencil approximately 6 inches long for scale. Photo taken 120 ft right of IRP 2006 2427+00.

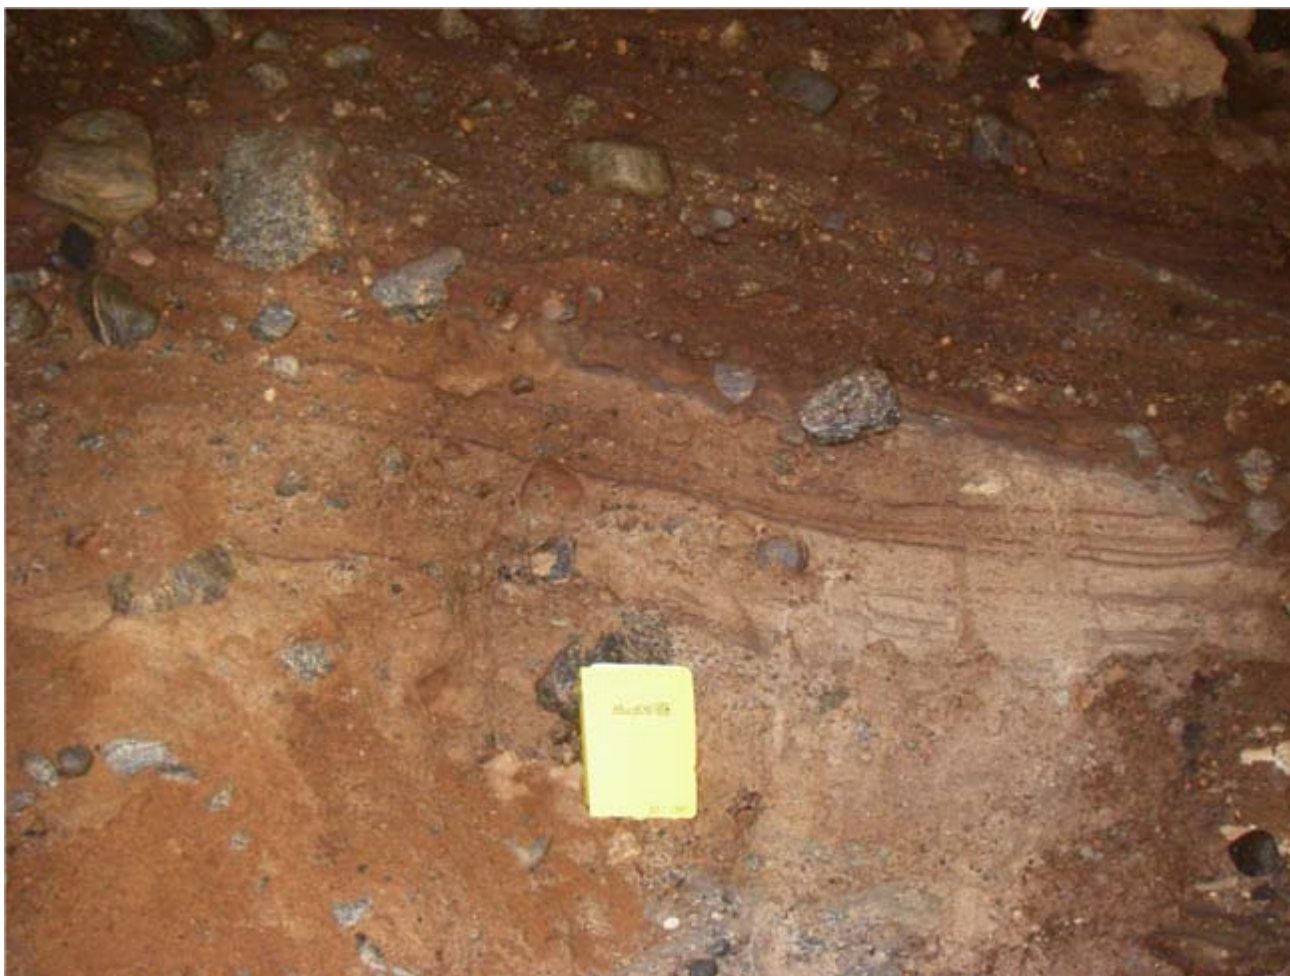
Glacial outwash deposits (Qgo) - View of typical glacial outwash deposit. Note stratification of sands. Field book approximately 5.5 inches wide for scale. Photo taken 120 ft right of IRP 2006 2427+00.

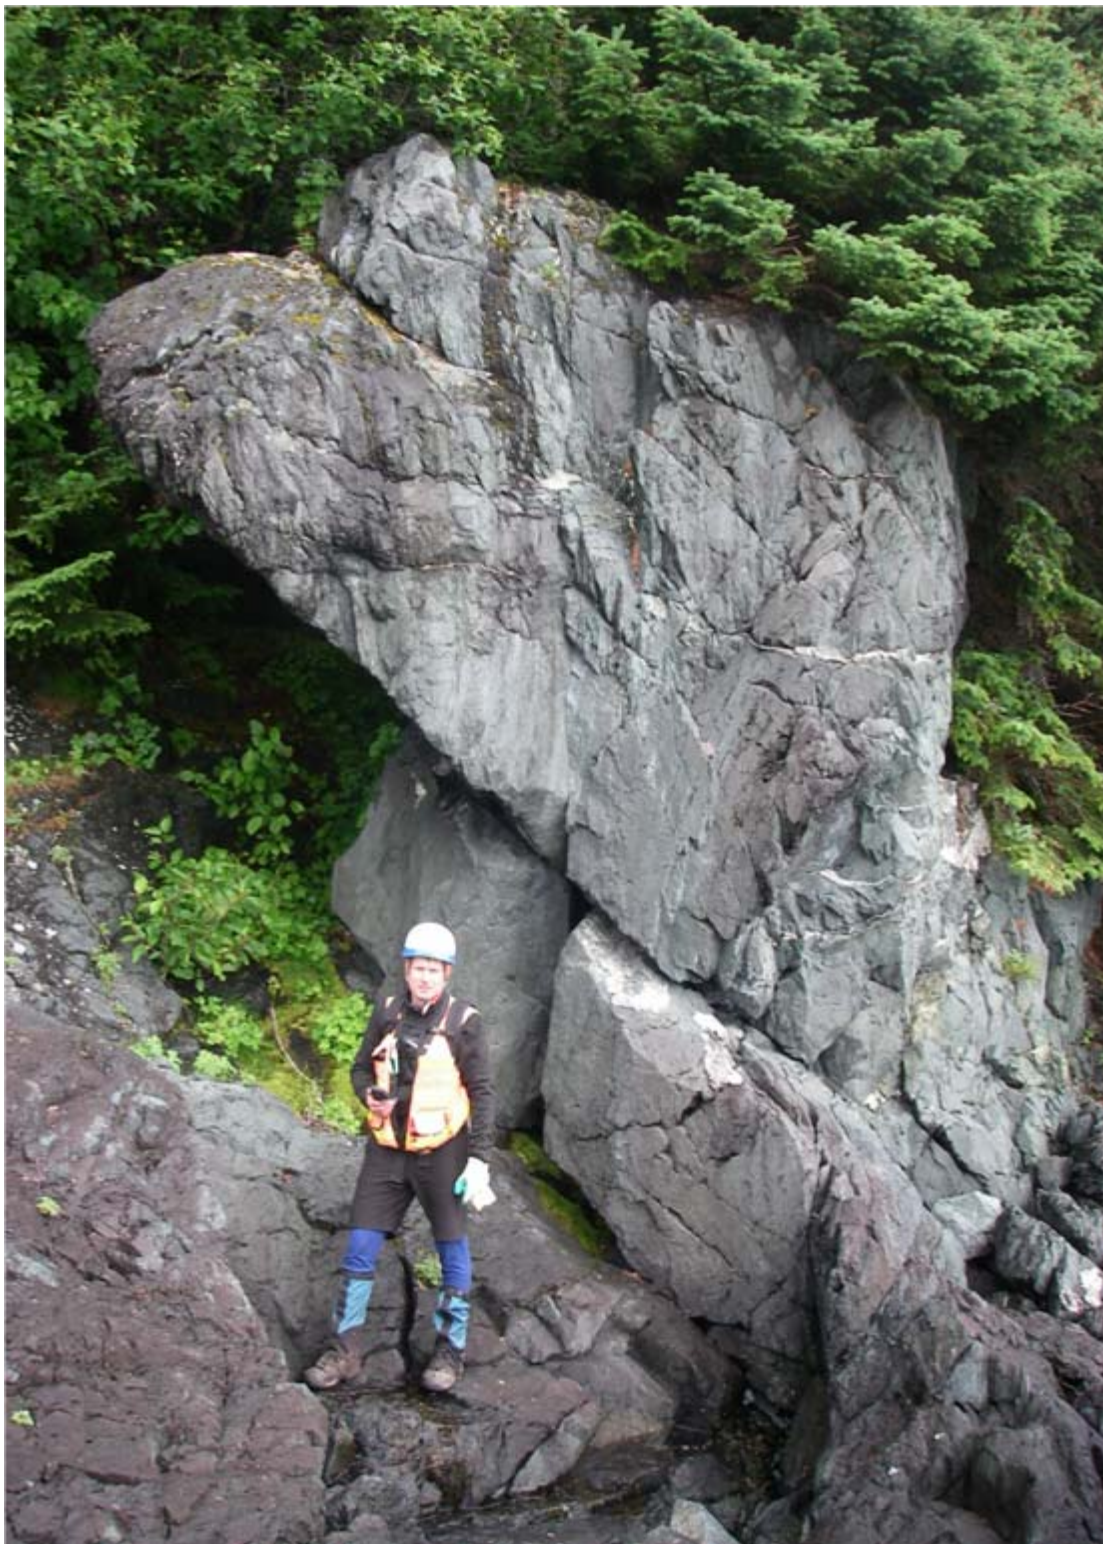
Basalt bedrock (Bxv) - view of typical basalt bedrock outcrop. Note massive appearance and multiple joint sets. Photo taken 15 ft left of IRP 2006 1716+00.

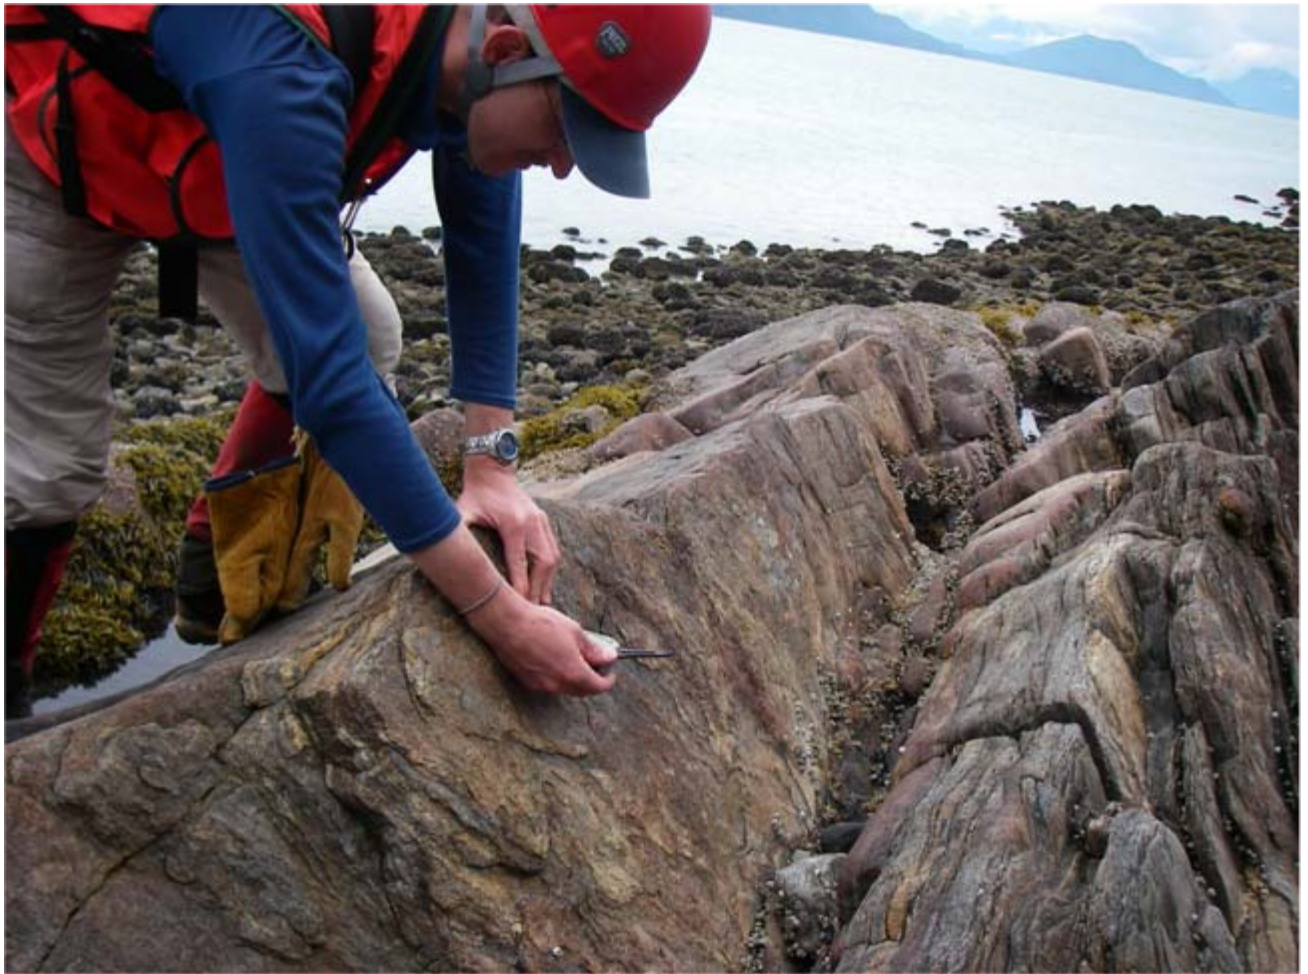
Metasedimentary bedrock (Bxms) - View of typical metasedimentary bedrock outcrop. Notice strong foliation. Photo taken 40ft left of IRP 2051+00.

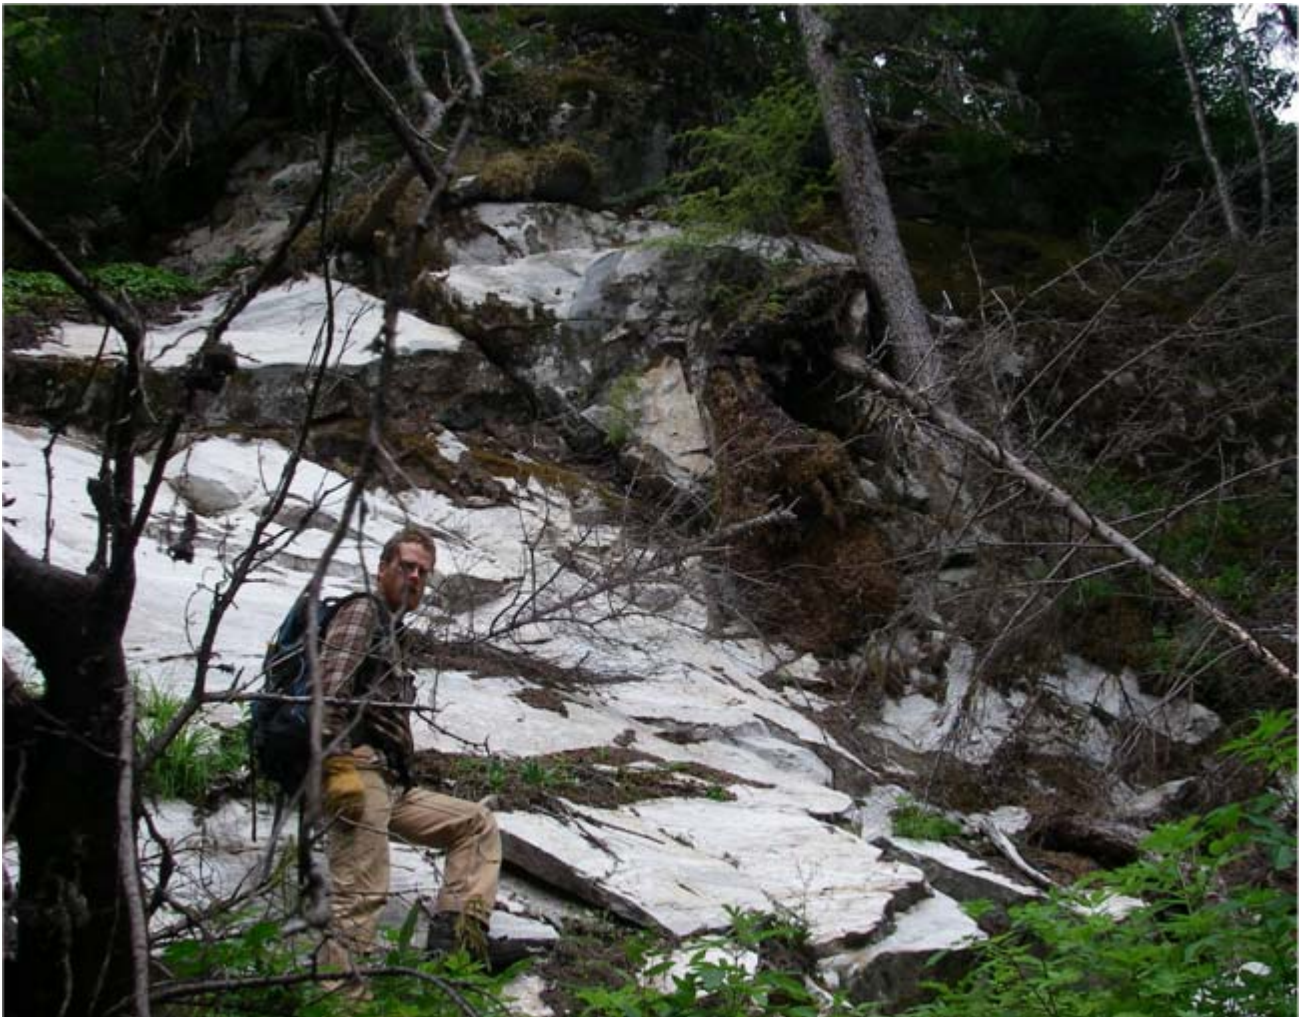
Gneiss bedrock (Bxmg) - View upslope of freshly exposed gneiss outcrop. Photo taken 140 ft right of IRP 2006 2605+00.

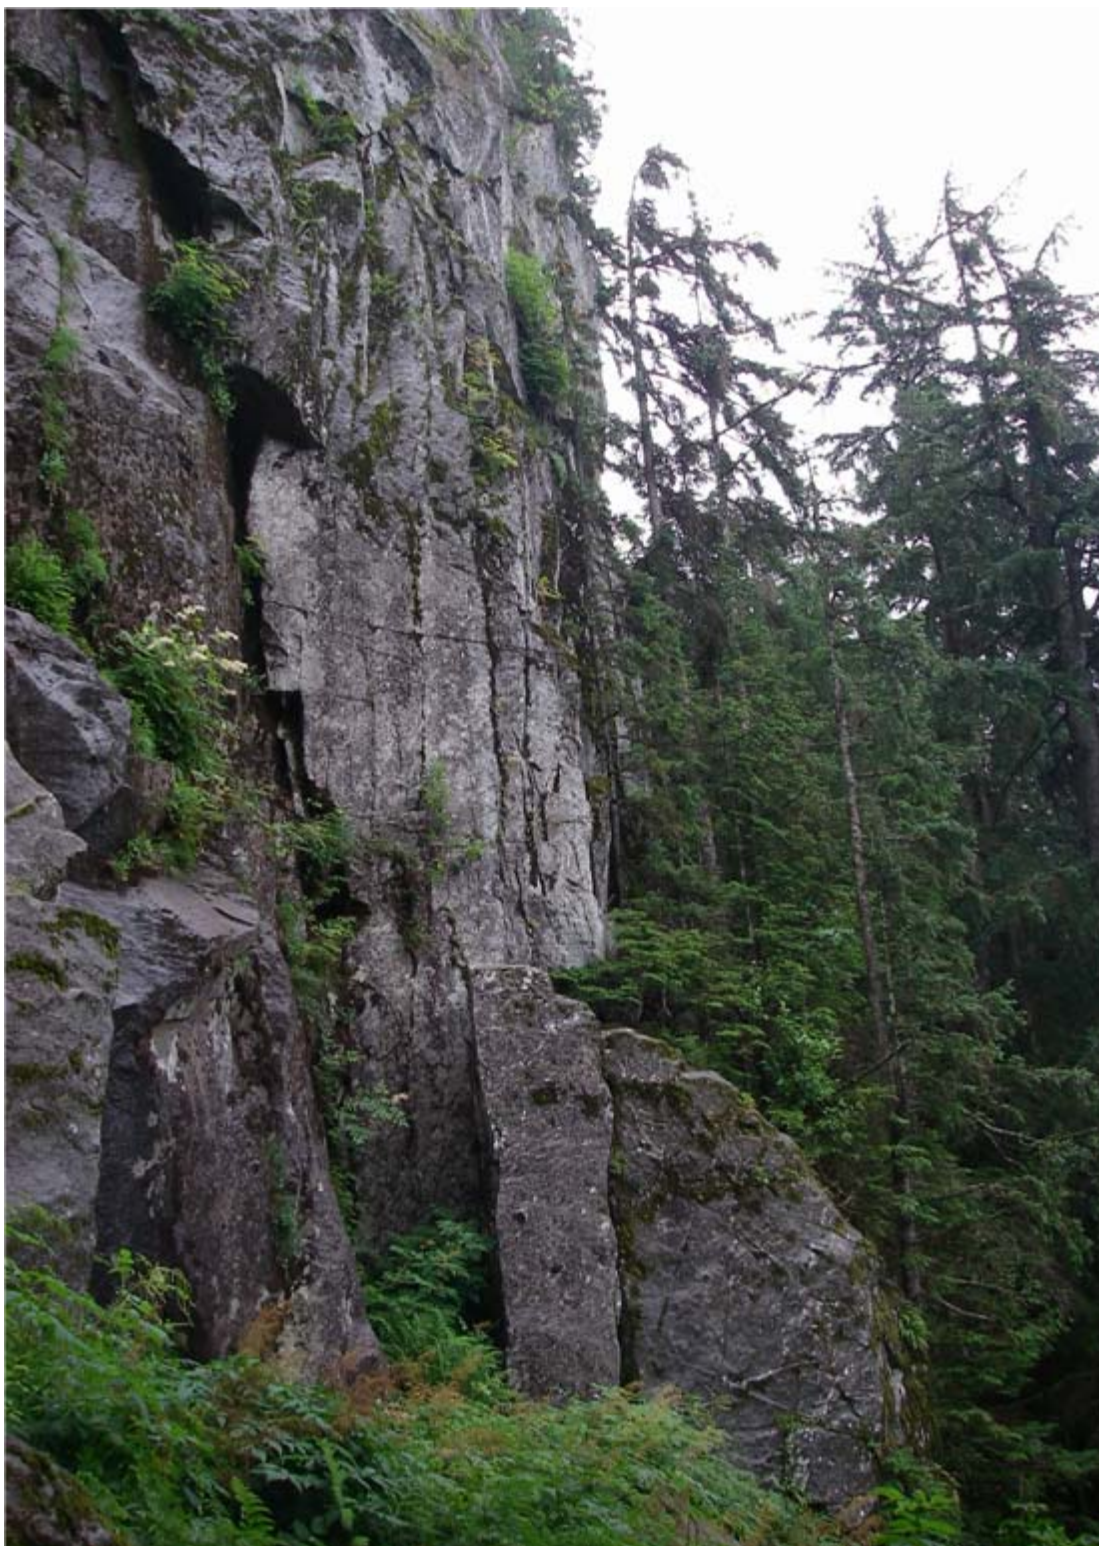
Gneiss bedrock (Bxmg) - View of typical gneiss cliff. Note prominent joint set. Visible cliff is approximately 150 ft tall. Photo taken 100 ft right of IRP 2006 2365+00.
