FINAL REPORT

**LYNN CANAL HIGHWAY
PHASE I
ZONE 4 GEOTECHNICAL INVESTIGATION**

STATE PROJECT NUMBER: 71100

*Golder Associates Inc.
1750 Abbott Road, Suite 200
Anchorage, Alaska 99507*

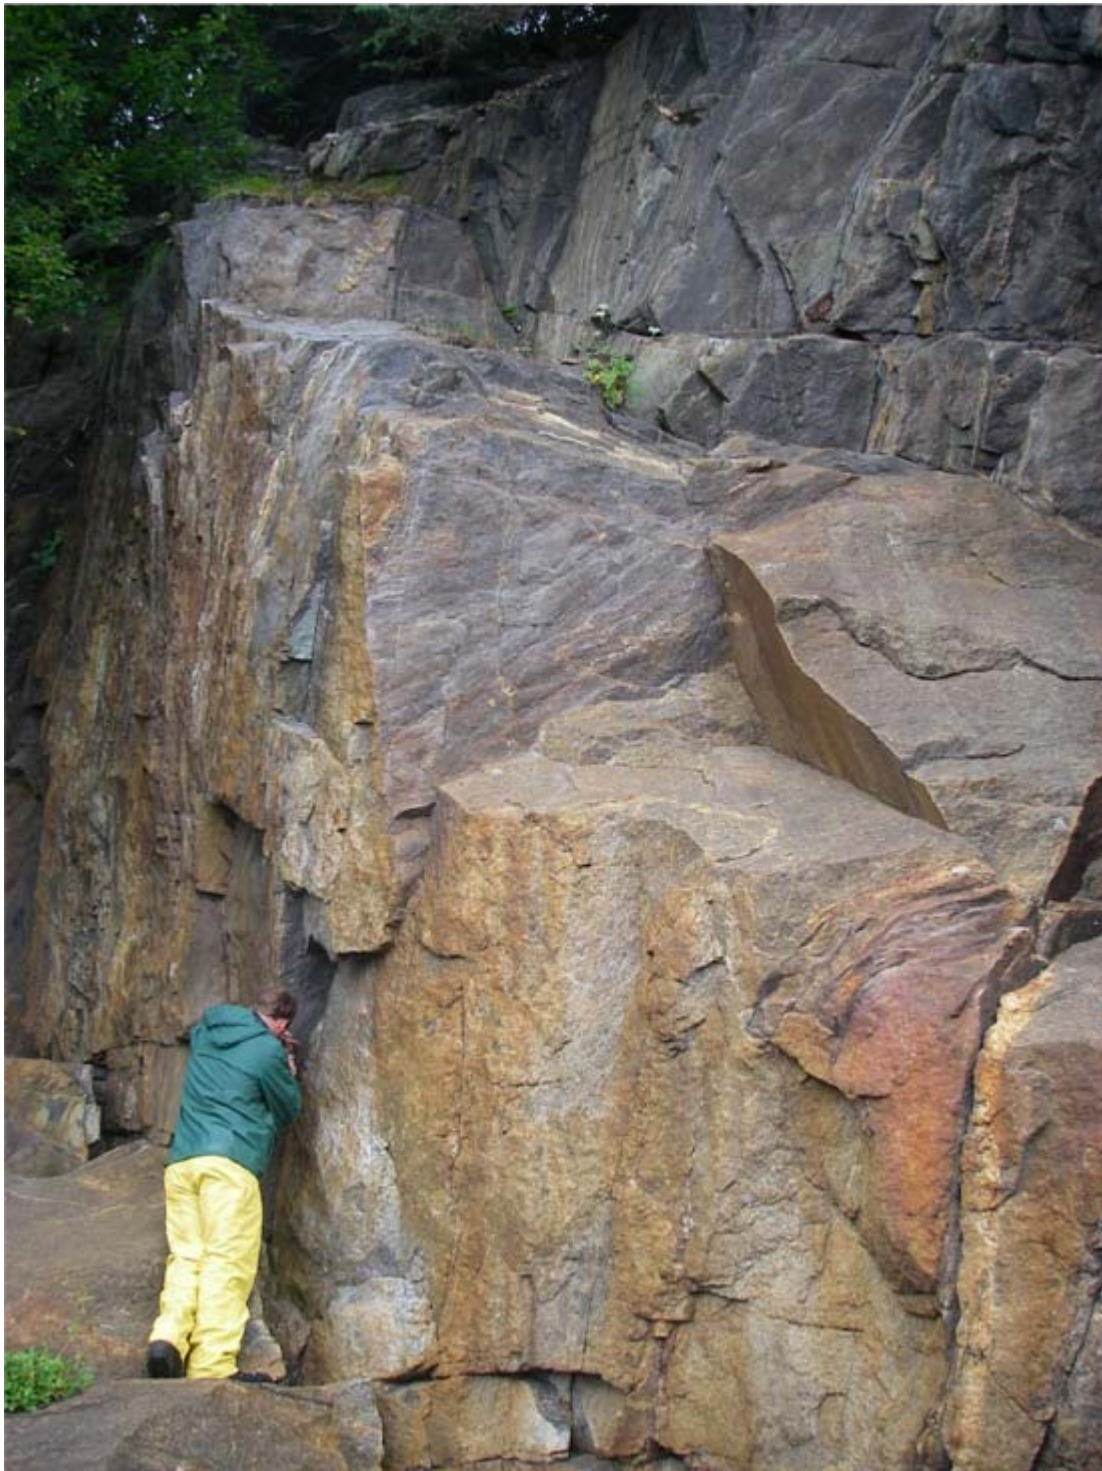
Undifferentiated metamorphic bedrock (Bxm) – View east at a shoreline cliffs greater than 40 ft high, with banded gneiss and metasedimentary bedrock (quartzite and metamorphosed carbonate observed.) Photo taken on centerline at IRP 2006 2106+75.

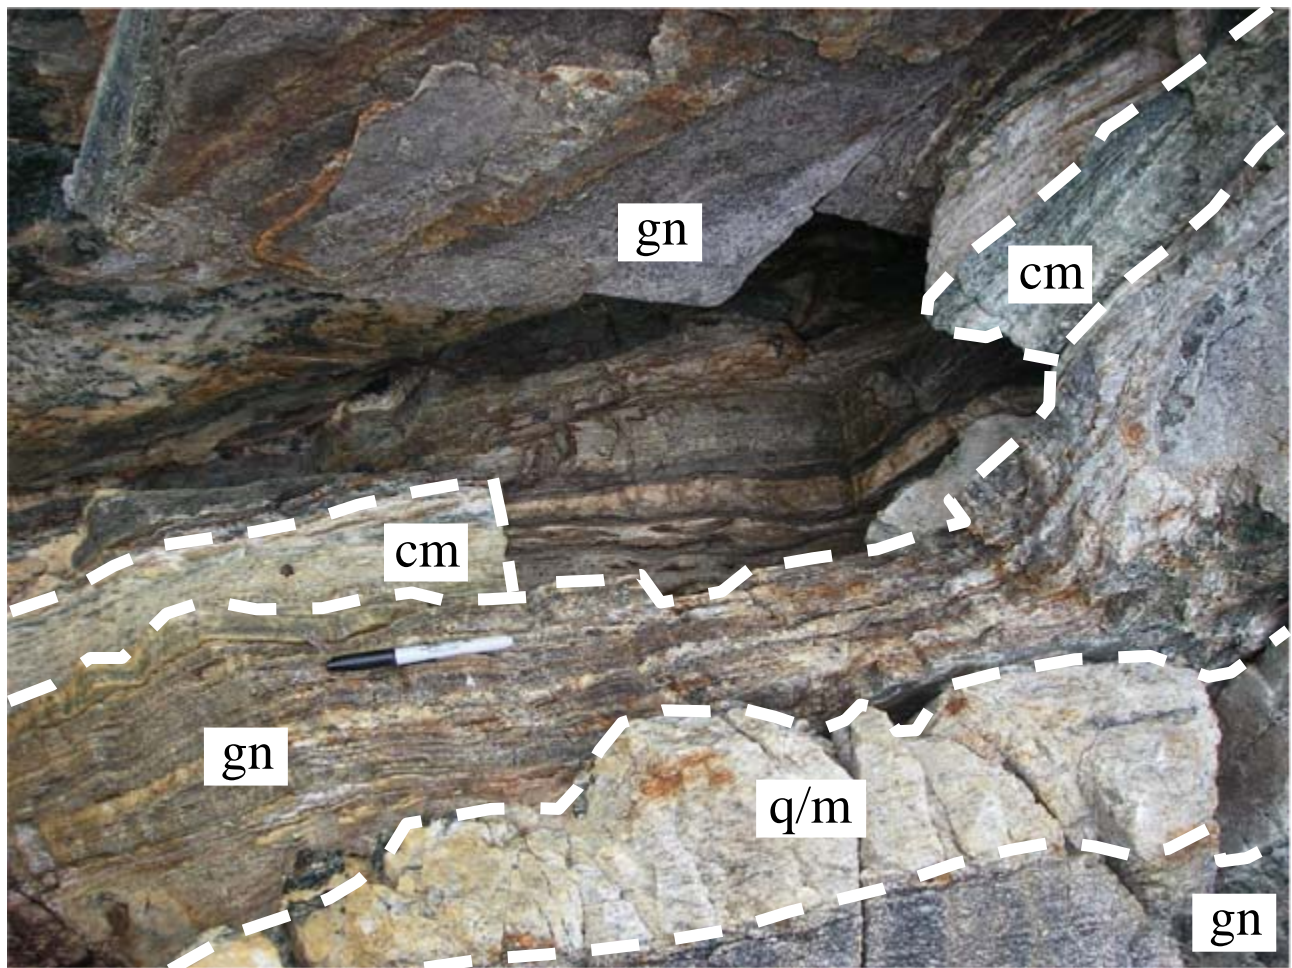
Undifferentiated metamorphic bedrock (Bxm) – Closeup view of banded metamorphic bedrock with (gn) gneiss, (cm) carbonate marble, and (q/m) quartzite vein/migmatite. Pen is approximately 5.5 inches long for scale. Photo taken on centerline at IRP 2006 2106+65.

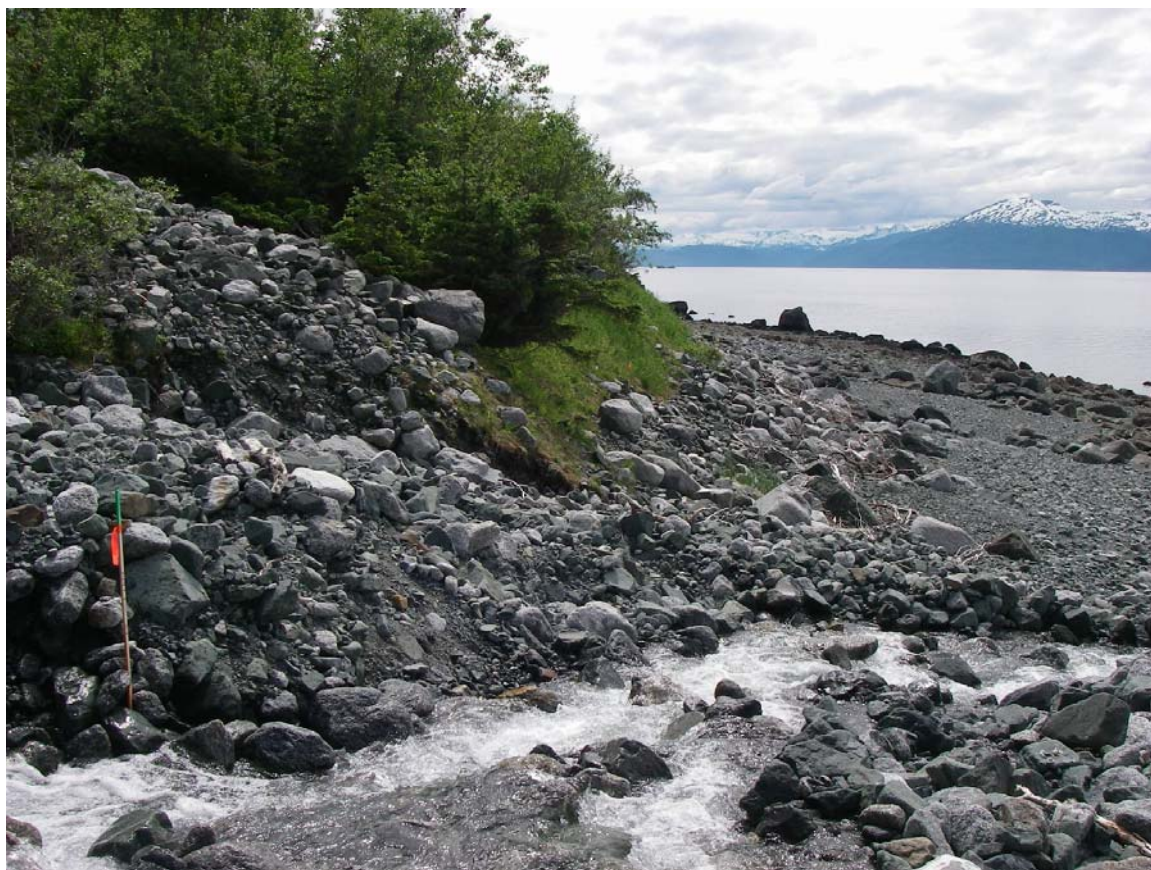
Hazard ID #:	DF01
Hazard Type:	debris_flow
HIN:	225
Rating:	A
IRP 2006 Location:	1493
Frequency (yrs):	1-5
Predictability:	moderate
Material Volume (CY):	100-1000
Clast Size (ft):	1-2
Source Elev. (ft):	>1000
Centerline Slope:	fan
Alignment Location:	deposition_zone
Impact Alignment:	yes
Alignment Exposure (ft):	500+
Vegetation:	denuded
Deciduous Trees:	yes
IRP 2006 South Margin:	1492+90
IRP 2006 North Margin:	1498+90
Photo #:	4098, 4099, 5146

DF01. View south/down alignment at debris flow deposition zone at beach. Stake represents IRP 2006 1494+00.

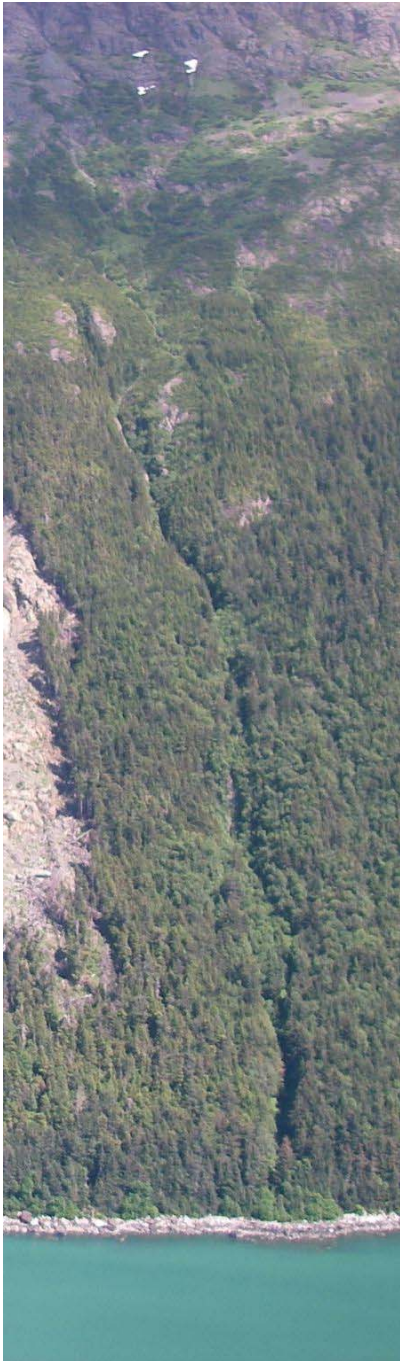
DF02. View east/upslope
at debris flow channel and
avalanche path ELC003.

Hazard ID #:	DF02
Hazard Type:	debris_flow
HIN:	129
Rating:	A
IRP 2006 Location:	1515
Frequency (yrs):	1-5
Predictability:	moderate
Material Volume (CY):	<10
Clast Size (ft):	0-1
Source Elev. (ft):	2000-3000
Centerline Slope:	fan
Alignment Location:	deposition_zone
Impact Alignment:	yes
Alignment Exposure (ft):	50-200
Vegetation:	disturbed
Deciduous Trees:	yes
IRP 2006 South Margin:	1514+50
IRP 2006 North Margin:	1515+50
Photo #:	1515, 2036, 5865

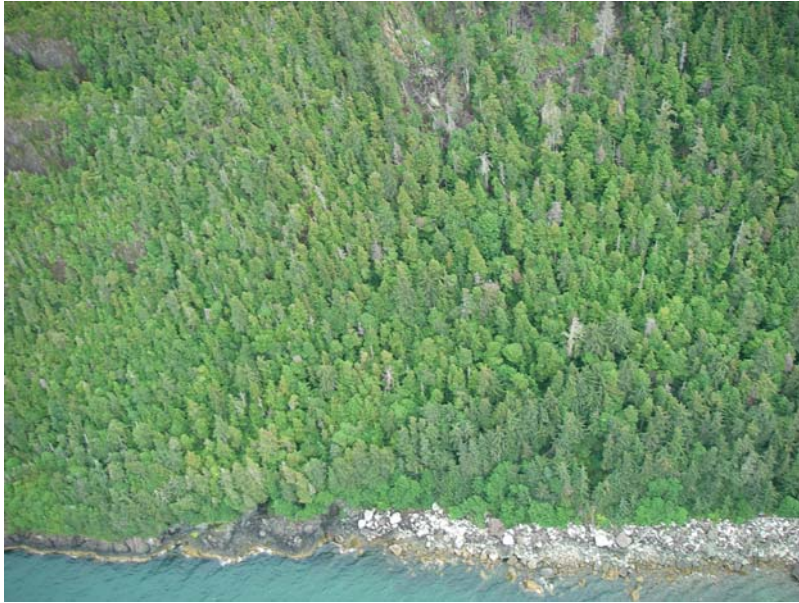
Hazard ID #:	RS01
Hazard Type:	rock_slide
HIN:	219
Rating:	A
IRP 2006 Location:	1522
Frequency (yrs):	unknown(>25?)
Predictability:	unpredictable
Material Volume (CY):	100-1000
Clast Size (ft):	4+
Source Elev. (ft):	>1000
Centerline Slope:	open_bedrock_slope
Alignment Location:	deposition_zone
Impact Alignment:	no
Alignment Exposure (ft):	200-500
Vegetation:	denuded
Deciduous Trees:	no
IRP 2006 South Margin:	1521+80
IRP 2006 North Margin:	1525+50
Photo #:	4123, 4124, 4126, 5148, 5865

RS01. View east/upslope of area directly under rockslide. Some debris approaches the IRP 2006 alignment which is located just east/upslope of the beach.

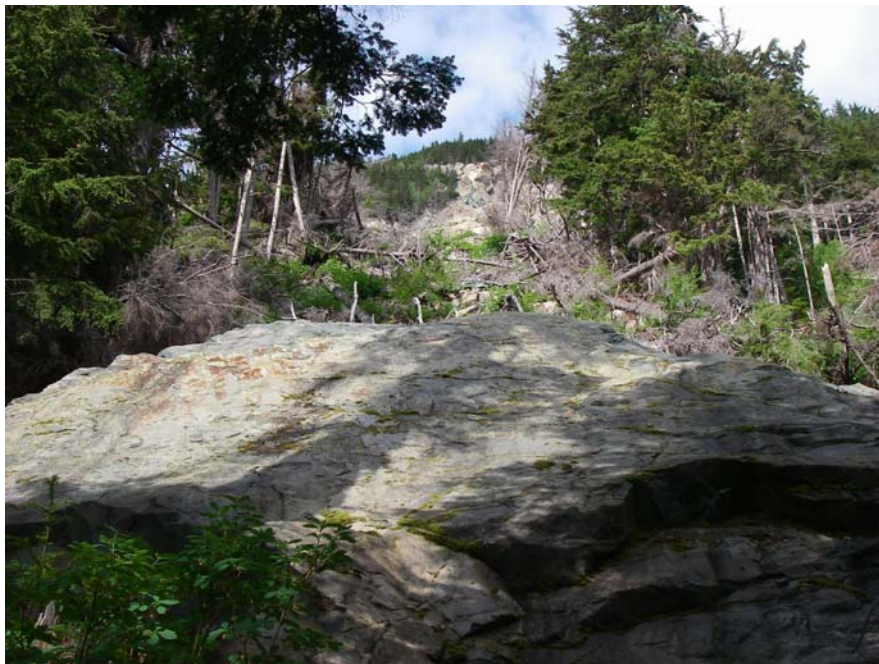
RS01. View east/upslope of 40 ft diameter boulder at bottom of rockslide and avalanche path ELC003-1. Photo taken 360 ft right of IRP 2006 1522+00.

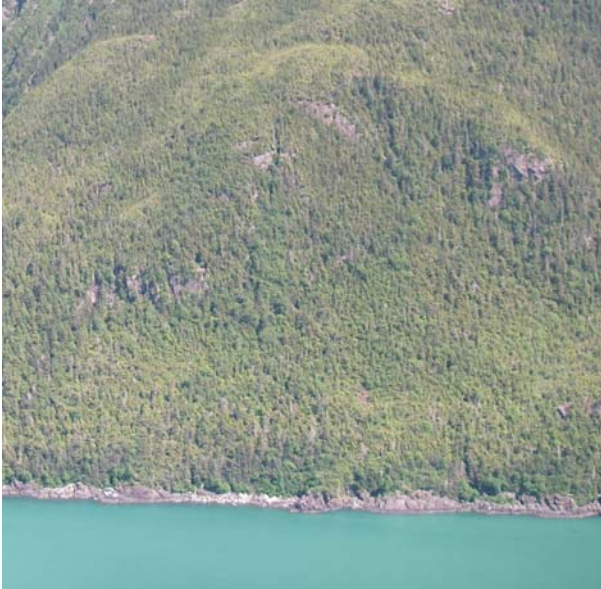
RF01. View east/upslope at rockfall hazard area.

Hazard ID #:	RF01
Hazard Type:	rockfall
HIN:	147
Rating:	C
IRP 2006 Location:	1549
Frequency (yrs):	1-5
Predictability:	unpredictable
Material Volume (CY):	<10
Clast Size (ft):	3-4
Source Elev. (ft):	100-500
Centerline Slope:	open_soil_slope
Alignment Location:	below_deposition_zone
Impact Alignment:	no
Alignment Exposure (ft):	200-500
Vegetation:	disturbed
Deciduous Trees:	yes
IRP 2006 South Margin:	1549+00
IRP 2006 North Margin:	1552+50
Photo #:	4212, 4214, 5148

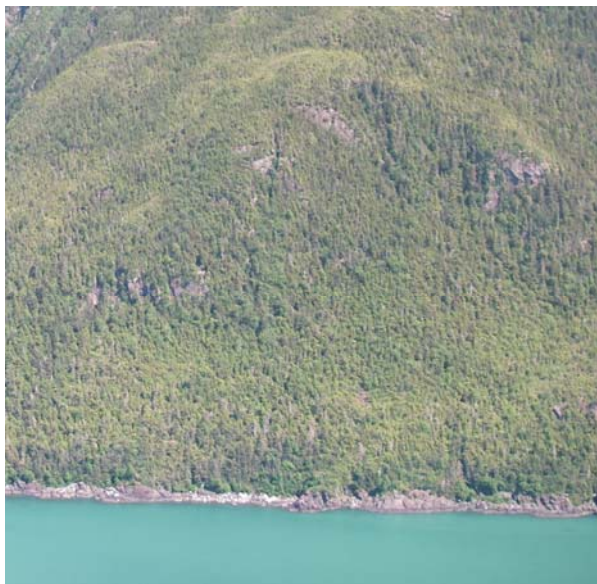
RF02. View east/upslope at rockfall hazard area.

Hazard ID #:	RF02
Hazard Type:	rockfall
HIN:	111
Rating:	C
Station Location:	1553
Frequency (yrs):	5-25
Predictability:	unpredictable
Material Volume (CY):	<10
Clast Size (ft):	0-1
Source Elev. (ft):	100-500
Centerline Slope:	open_soil_slope
Alignment Location:	below_deposition_zone
Impact Alignment:	no
Alignment Exposure (ft):	50-200
Vegetation:	disturbed
Deciduous Trees:	yes
IRP 2006 South Margin:	1553+00
IRP 2006 North Margin:	1554+00
Photo #:	3049, 5149

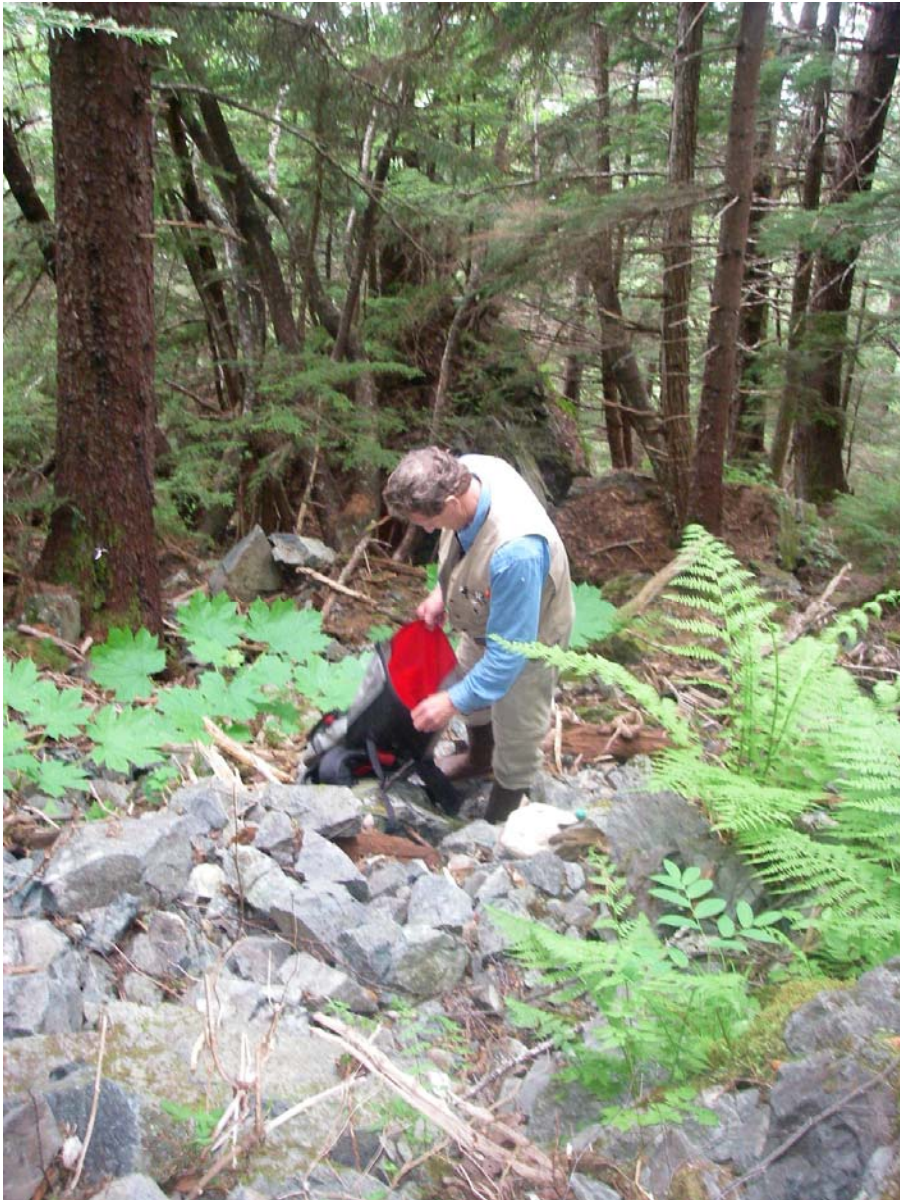
RF02. View west/downslope at rockfall deposition. Photo taken 350 ft right of IRP 2006 1552+00.

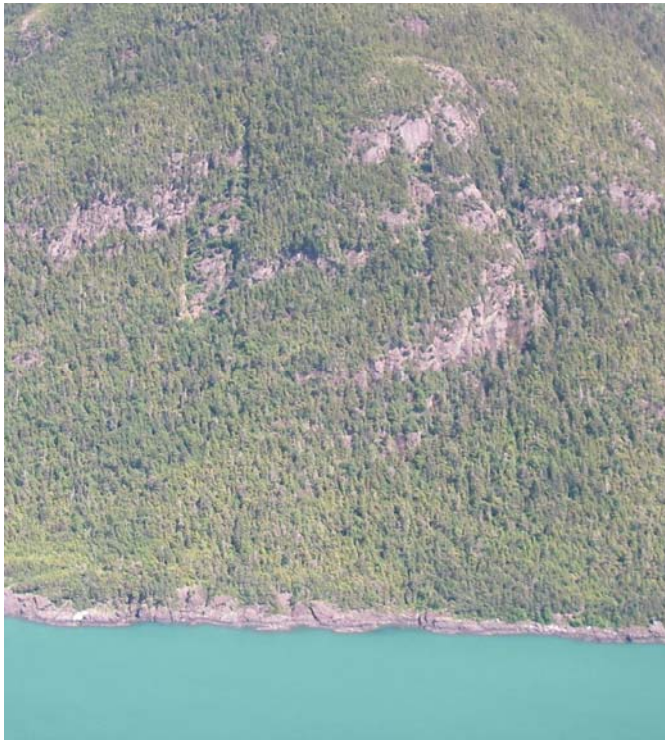
RF03. View east/upslope at rockfall area.

Hazard ID #:	RF03
Hazard Type:	rockfall
HIN:	129
Rating:	B
IRP 2006 Location:	1586
Frequency (yrs):	5-25
Predictability:	unpredictable
Material Volume (CY):	<10
Clast Size (ft):	4+
Source Elev. (ft):	100-500
Centerline Slope:	single_channel
Alignment Location:	deposition_zone
Impact Alignment:	yes
Alignment Exposure (ft):	200-500
Vegetation:	disturbed
Deciduous Trees:	yes
IRP 2006 South Margin:	1584+50
IRP 2006 North Margin:	1587+00
Photo #:	4259, 5873

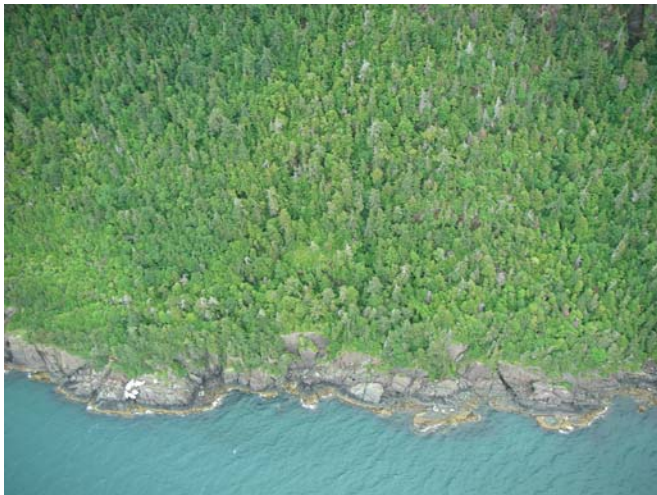
RF03. View east/upslope at rockfall area.

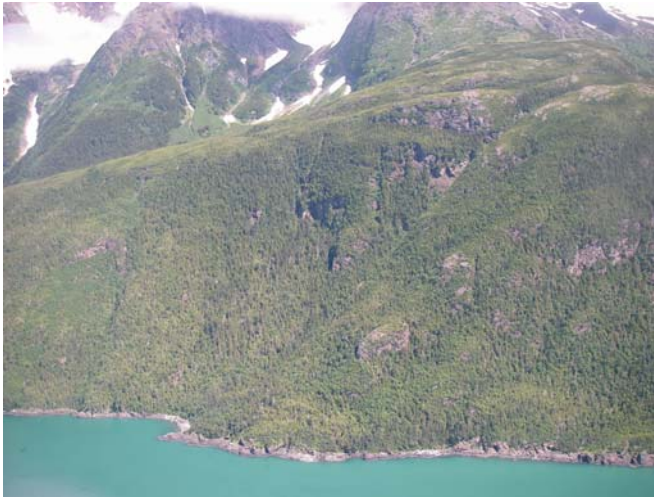
RF04. View east/upslope at rockfall area.

Hazard ID #:	RF04
Hazard Type:	rockfall
HIN:	183
Rating:	B
IRP 2006 Location:	1609
Frequency (yrs):	unknown (5-25?)
Predictability:	unpredictable
Material Volume (CY):	<10
Clast Size (ft):	4+
Source Elev. (ft):	100-500
Centerline Slope:	open_soil_slope
Alignment Location:	deposition_zone
Impact Alignment:	yes
Alignment Exposure (ft):	500+
Vegetation:	disturbed
Deciduous Trees:	yes
IRP 2006 South Margin:	1605+50
IRP 2006 North Margin:	1611+10
Photo #:	4245, 4246, 4247, 4249

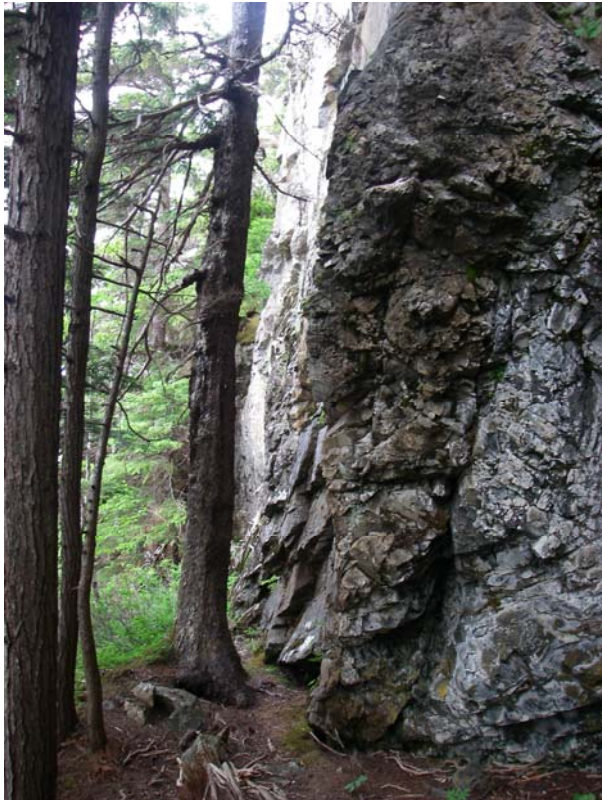
RF04. Base of vertical basalt cliff creating rockfall hazard. Photo taken 400 ft right of IRP 2006 1610+00.

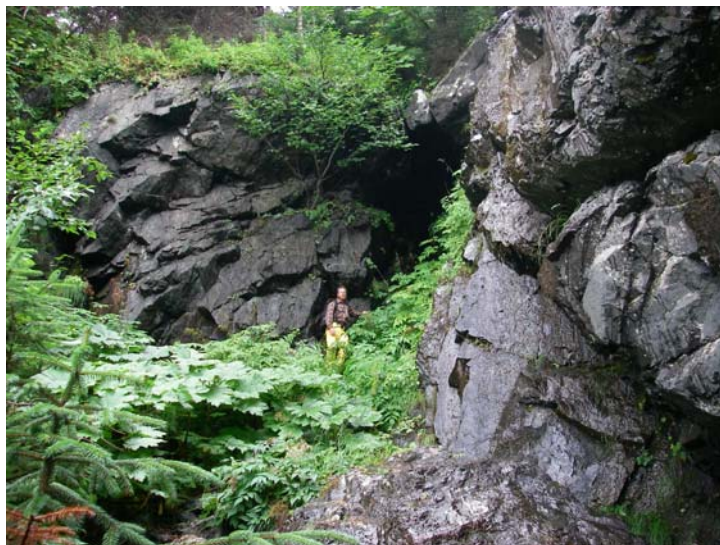
Hazard ID #:	RF05
Hazard Type:	rockfall
HIN:	105
Rating:	B
IRP 2006 Location:	1657
Frequency (yrs):	5-25
Predictability:	unpredictable
Material Volume (CY):	<10
Clast Size (ft):	4+
Source Elev. (ft):	<100
Centerline Slope:	open_bedrock_slope
Alignment Location:	deposition_zone
Impact Alignment:	yes
Alignment Exposure (ft):	50-200
Vegetation:	disturbed
Deciduous Trees:	yes
IRP 2006 South Margin:	1657+00
IRP 2006 North Margin:	1658+00
Photo #:	1086, 3904-3908, 5154, 6266

RF05. View east/upslope at basalt cliffs and rockfall. Photo taken 50 ft left of IRP 2006 1657+00.

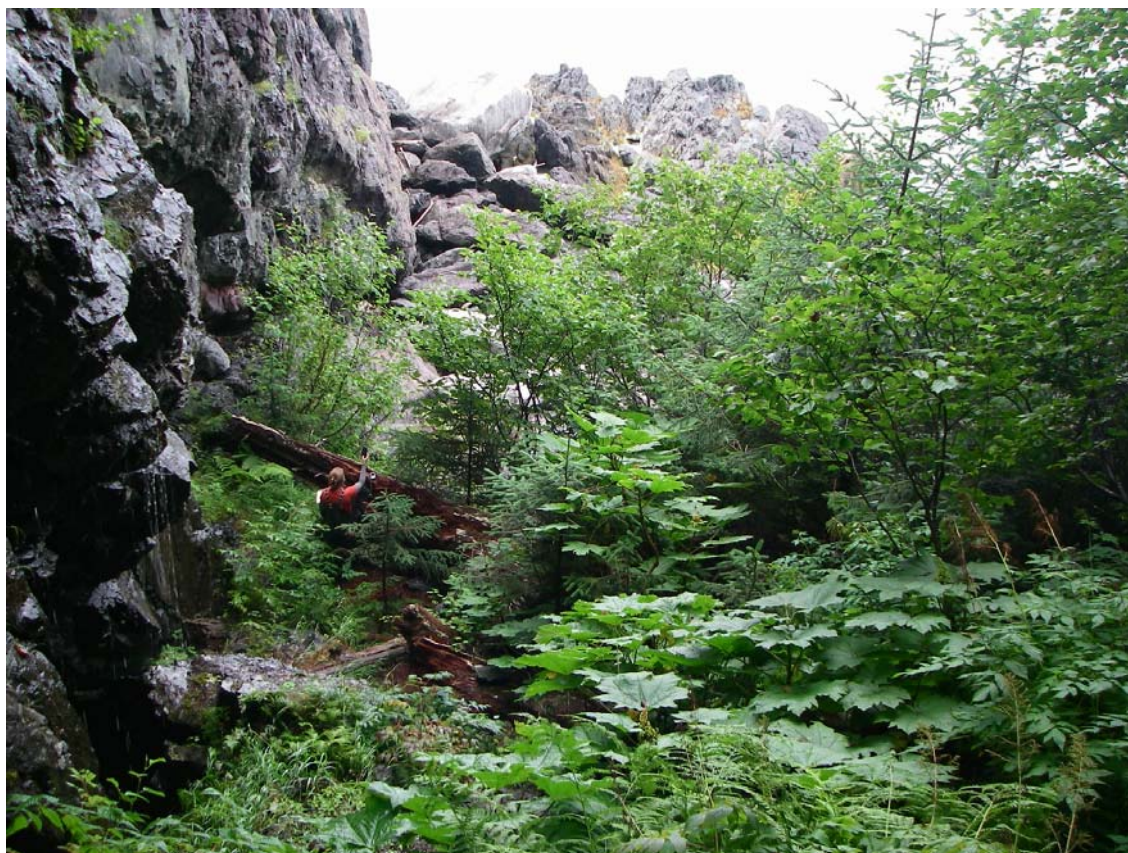
G-18

RF05. View west/downslope at rockfall from basalt cliffs. Photo taken at centerline of IRP 2006 1657+50.

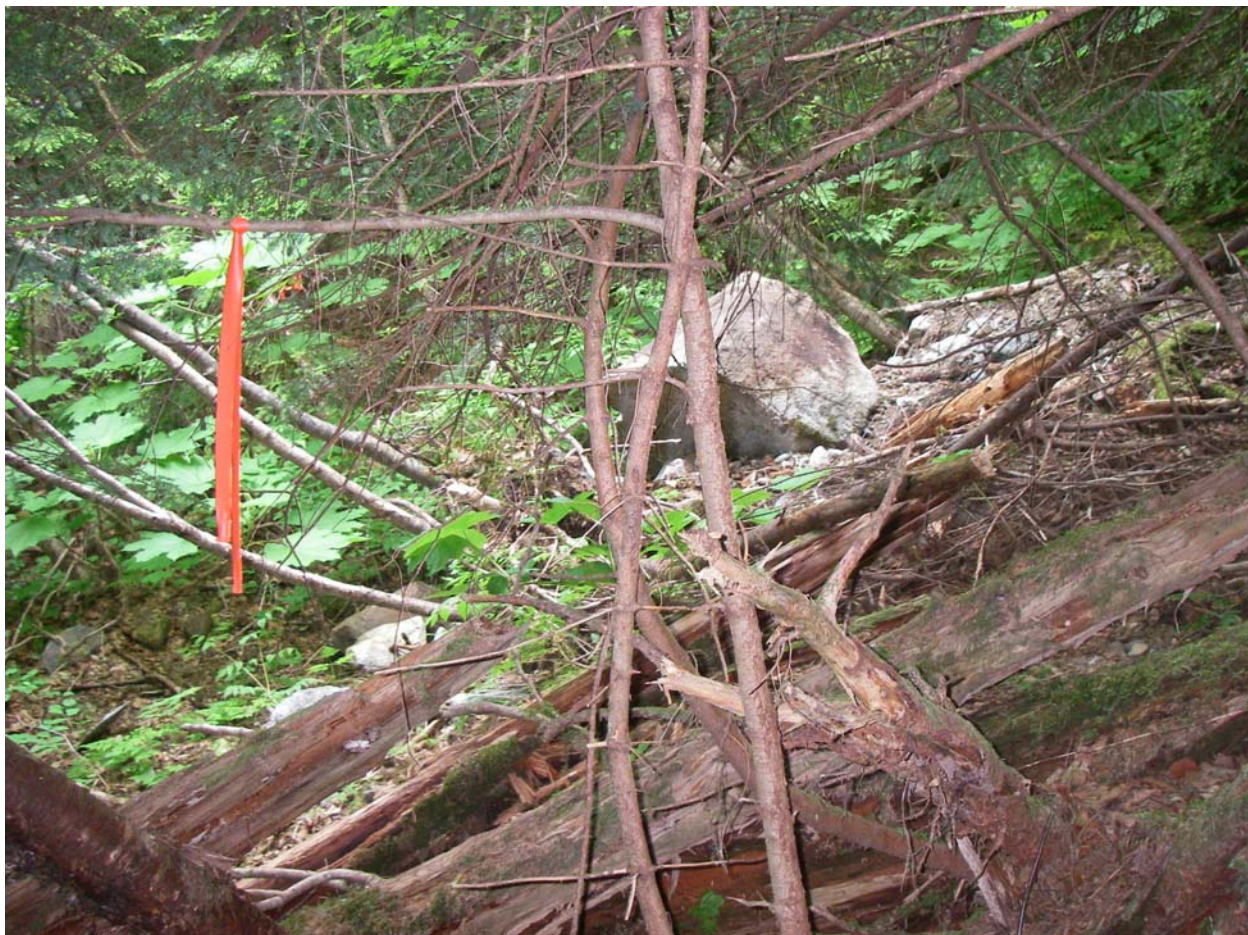
G-20

Hazard ID #:	DF04
Hazard Type:	debris_flow
HIN:	117
Rating:	B
IRP 2006 Location:	1670
Frequency (yrs):	5-25
Predictability:	moderate
Material Volume (CY):	10-100
Clast Size (ft):	0-1
Source Elev. (ft):	1000-2000
Centerline Slope:	fan
Alignment Location:	deposition_zone
Impact Alignment:	yes
Alignment Exposure (ft):	50-200
Vegetation:	disturbed
Deciduous Trees:	yes
IRP 2006 South Margin:	1668+50
IRP 2006 North Margin:	1670+50
Photo #:	3875

DF04. Debris flow deposit at IRP 2006 1670+50.

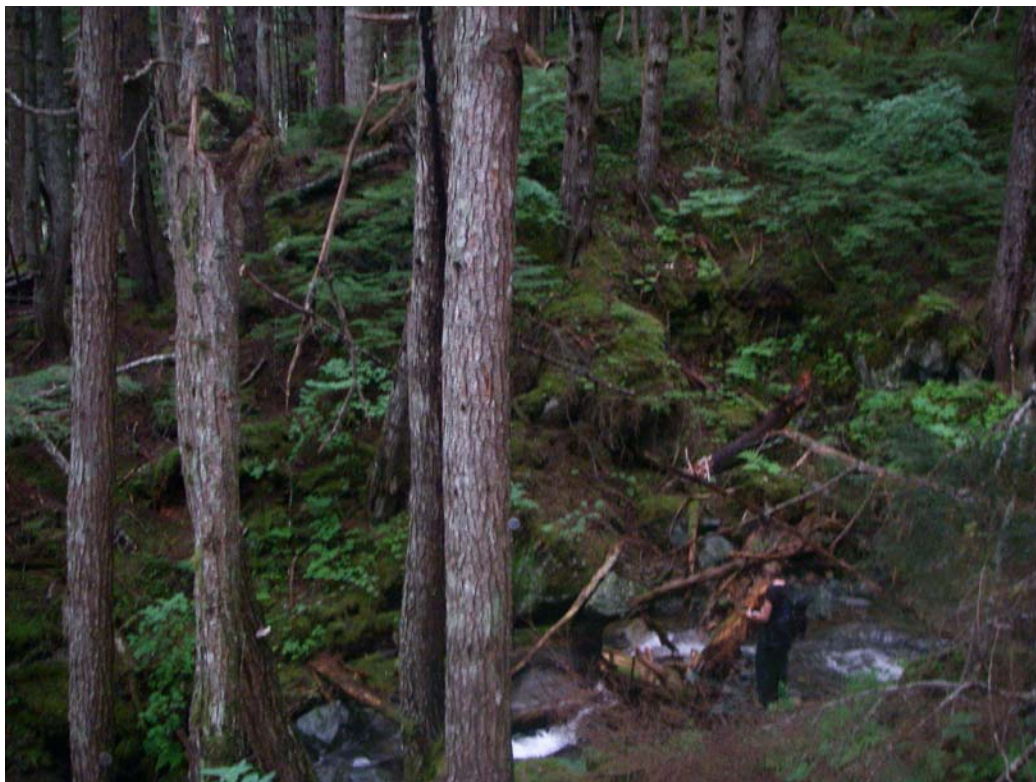
G-22

Hazard ID #:	DF05
Hazard Type:	debris_flow
HIN:	129
Rating:	A
IRP 2006 Location:	1674
Frequency (yrs):	1-5
Predictability:	high
Material Volume (CY):	10-100
Clast Size (ft):	0-1
Source Elev. (ft):	1000-2000
Centerline Slope:	single_channel
Alignment Location:	deposition_zone
Impact Alignment:	yes
Alignment Exposure (ft):	50-200
Vegetation:	denuded
Deciduous Trees:	no
IRP 2006 South Margin:	1673+80
IRP 2006 North Margin:	1675+30
Photo #:	6203, 6204

DF05. View north/up alignment along debris flow incision and levee.
Photo taken 40 ft right of IRP 2006 1674+20.

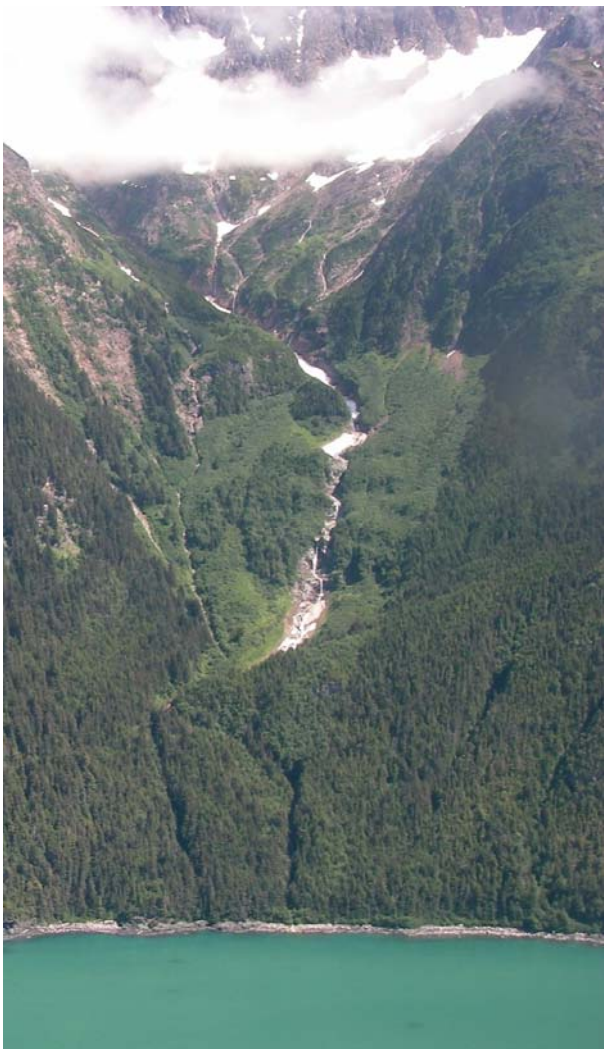
G-23

DF06. View east/upslope at debris flow channel and avalanche path ELC005.

Hazard ID #:	DF06
Hazard Type:	debris_flow
HIN:	201
Rating:	A
IRP 2006 Location:	1678
Frequency (yrs):	0-1
Predictability:	high
Material Volume (CY):	10-100
Clast Size (ft):	0-1
Source Elev. (ft):	2000-3000
Centerline Slope:	fan
Alignment Location:	deposition_zone
Impact Alignment:	yes
Alignment Exposure (ft):	200-500
Vegetation:	disturbed
Deciduous Trees:	yes
IRP 2006 South Margin:	1677+00
IRP 2006 North Margin:	1679+00
Photo #:	3876

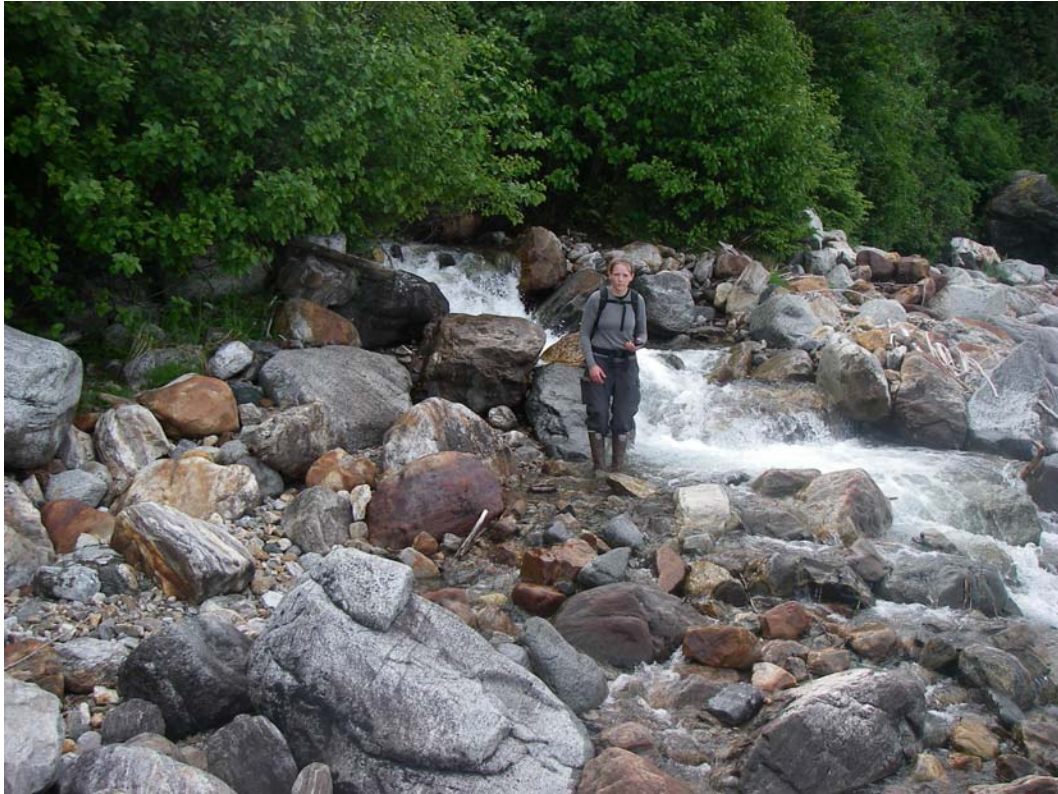
G-24

DF06. View southeast (upslope and down alignment) across debris flow deposition zone at tide line. Photo taken 20 ft left of IRP 2006 1677+50.

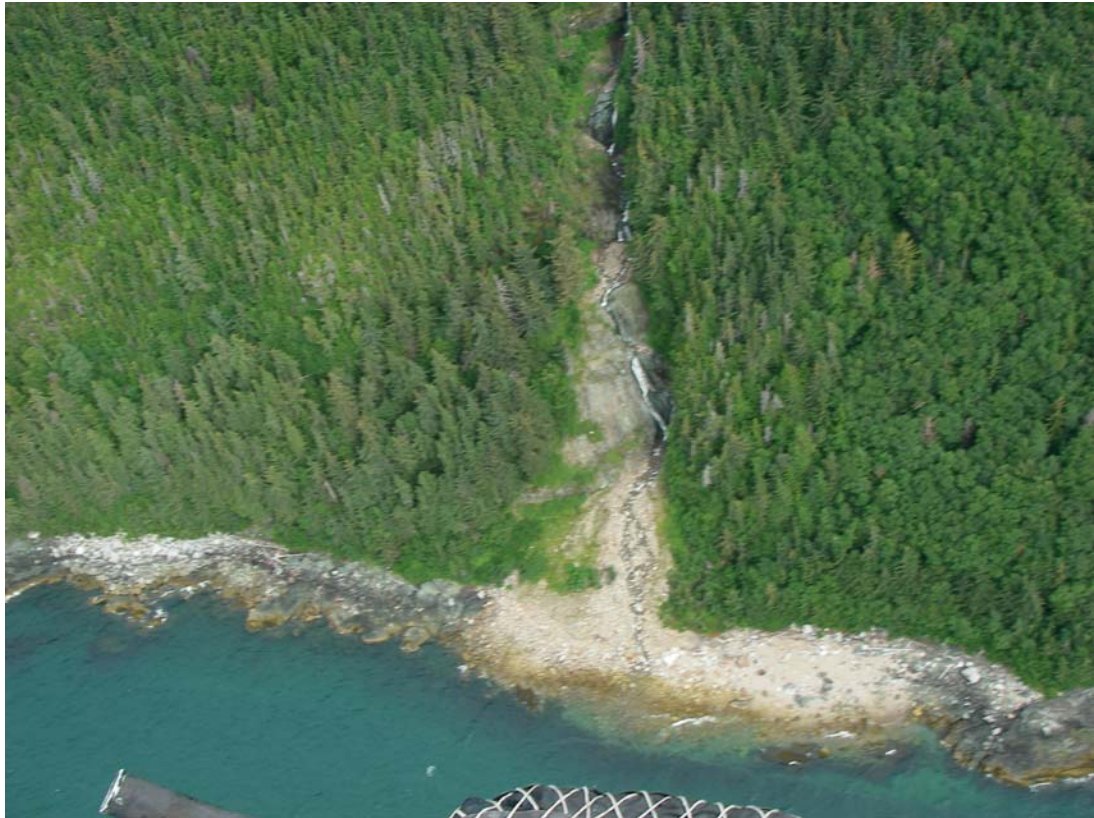
G-26

Hazard ID #:	DF07
Hazard Type:	debris_flow
HIN:	171
Rating:	A
IRP 2006 Location:	1704
Frequency (yrs):	1-5
Predictability:	moderate
Material Volume (CY):	100-1000
Clast Size (ft):	1-2
Source Elev. (ft):	>1000
Centerline Slope:	multi_channel
Alignment Location:	deposition_zone
Impact Alignment:	yes
Alignment Exposure (ft):	200-500
Vegetation:	denuded
Deciduous Trees:	yes
IRP 2006 South Margin:	1701+50
IRP 2006 North Margin:	1705+50
Photo #:	4366, 5155

DF07. Path and terminus of debris flow channel. IRP 2006 alignment located on beach.

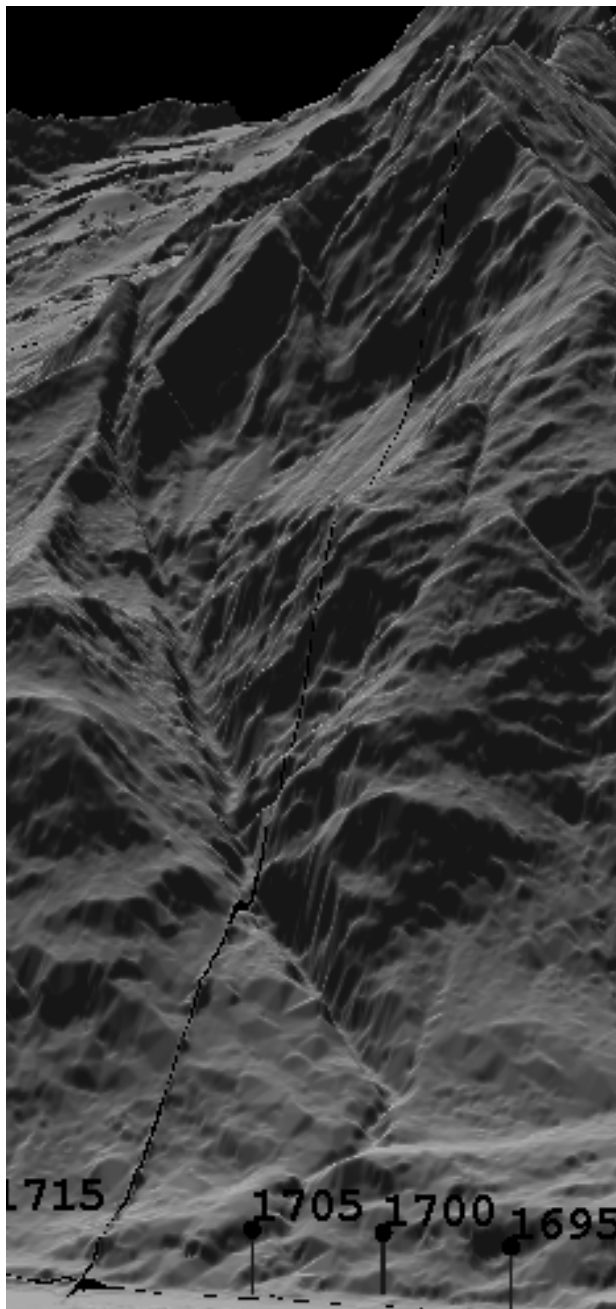
DF07. LIDAR image of debris flow channel and avalanche path ELC006.

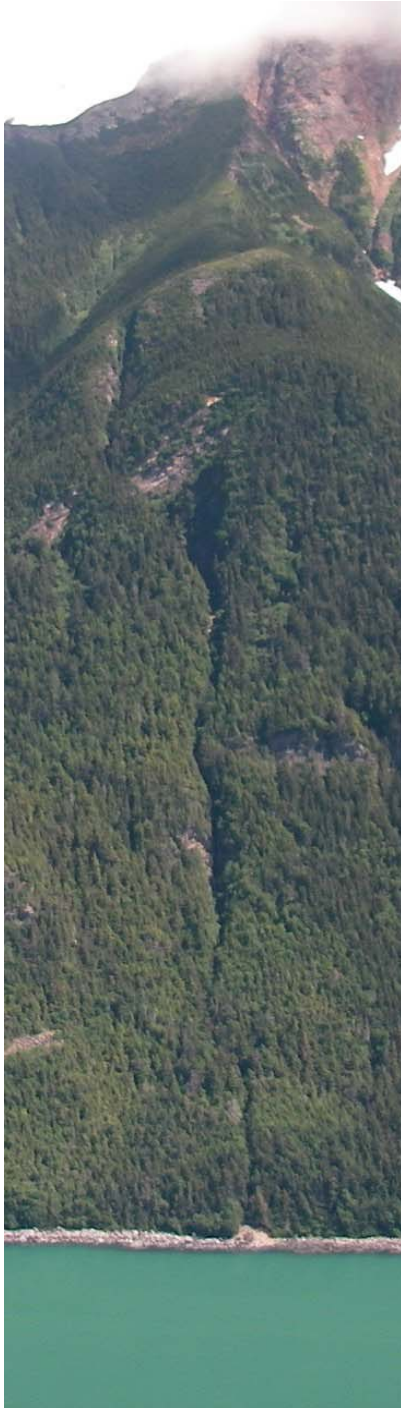
G-28

DF08. View east/upslope at debris flow channel and avalanche path ELC007.

Hazard ID #:	DF08
Hazard Type:	debris_flow
HIN:	129
Rating:	A
IRP 2006 Location:	1720
Frequency (yrs):	1-5
Predictability:	high
Material Volume (CY):	10-100
Clast Size (ft):	1-2
Source Elev. (ft):	>1000
Centerline Slope:	fan
Alignment Location:	deposition_zone
Impact Alignment:	yes
Alignment Exposure (ft):	50-200
Vegetation:	denuded
Deciduous Trees:	yes
IRP 2006 South Margin:	1719+90
IRP 2006 North Margin:	1720+80
Photo #:	1126, 5156

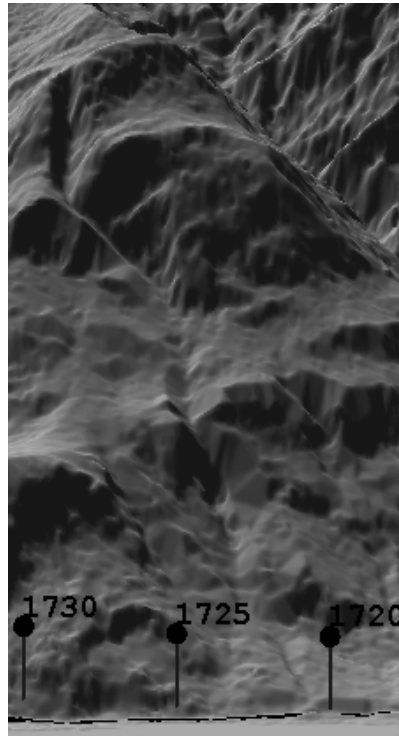
G-29

DF08. Bare earth LIDAR image of debris flow path.

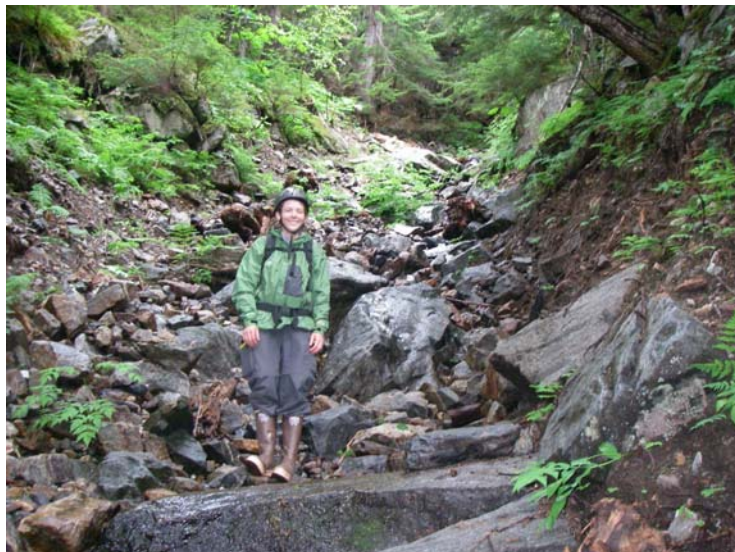
DF08. View east/upslope at debris flow chute and avalanche path ELC007, 490 ft east of IRP 2006 1720+50.

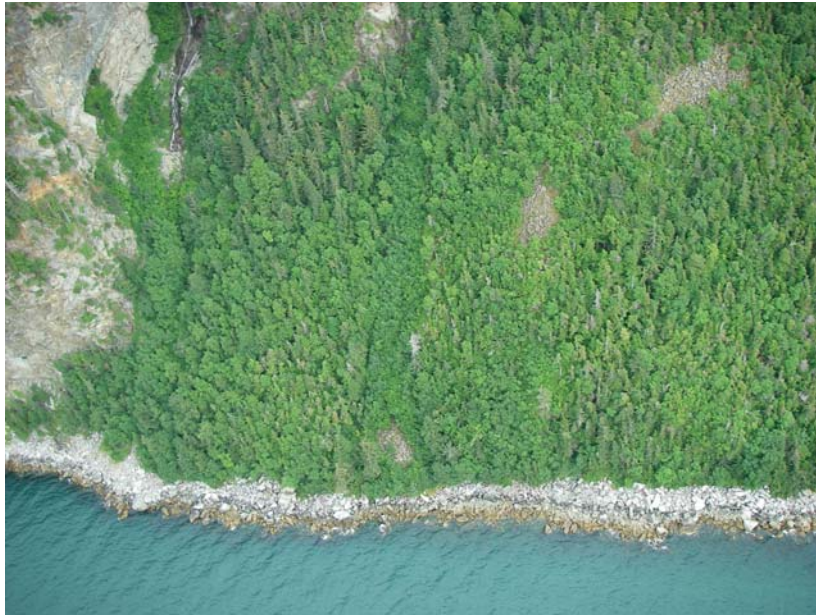
G-32

Hazard ID #:	RF06
Hazard Type:	rockfall
HIN:	183
Rating:	A
IRP 2006 Location:	1730
Frequency (yrs):	0-1
Predictability:	unpredictable
Material Volume (CY):	<10
Clast Size (ft):	3-4
Source Elev. (ft):	100-500
Centerline Slope:	open_bedrock_slope
Alignment Location:	deposition_zone
Impact Alignment:	yes
Alignment Exposure (ft):	50-200
Vegetation:	disturbed
Deciduous Trees:	yes
IRP 2006 South Margin:	1729+90
IRP 2006 North Margin:	1730+80
Photo #:	4674, 6206

RF06. View east/upslope at rockfall zone. IRP 2006 alignment located upslope of beach.

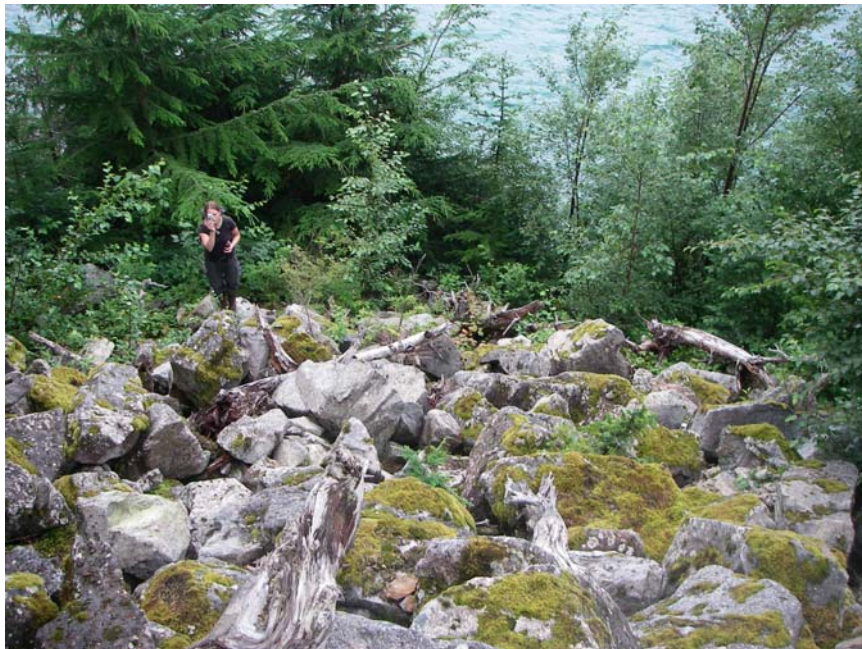
RF06. View west/downslope at rockfall. IRP 2006 1730+00 located at point where photo was taken.

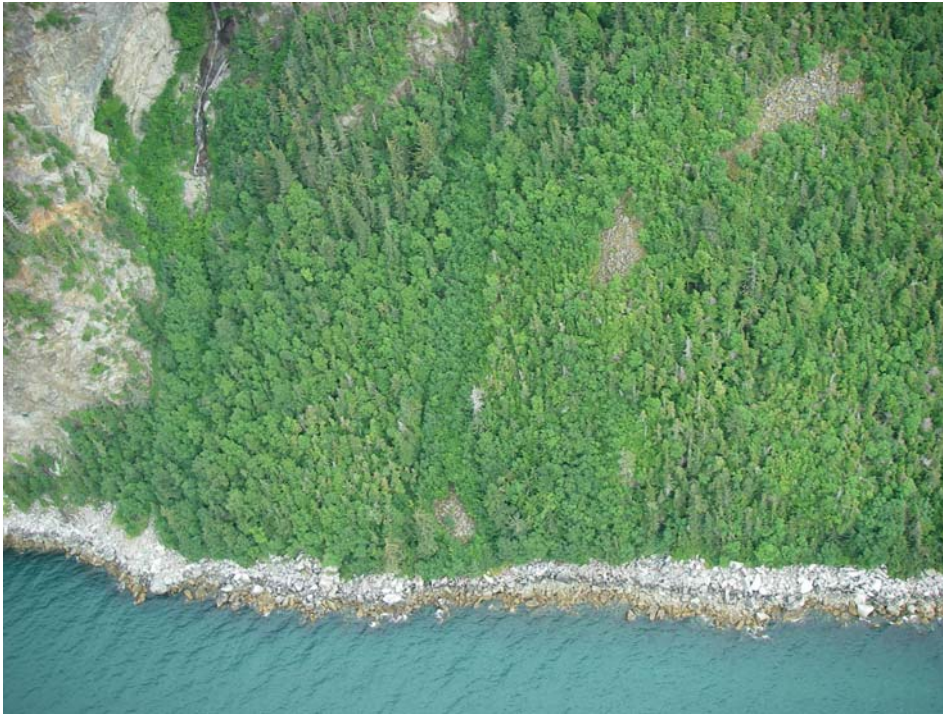
G-34

Hazard ID #:	DF09
Hazard Type:	debris_flow
HIN:	153
Rating:	A
IRP 2006 Location:	1733
Frequency (yrs):	unknown (1-5?)
Predictability:	low
Material Volume (CY):	10-100
Clast Size (ft):	1-2
Source Elev. (ft):	>1000
Centerline Slope:	single_channel
Alignment Location:	path
Impact Alignment:	yes
Alignment Exposure (ft):	50-200
Vegetation:	disturbed
Deciduous Trees:	yes
IRP 2006 South Margin:	1732+50
IRP 2006 North Margin:	1734+40
Photo #:	3307

DF09. View east/upslope at debris flow path and avalanche path ELC008 through dense deciduous trees.

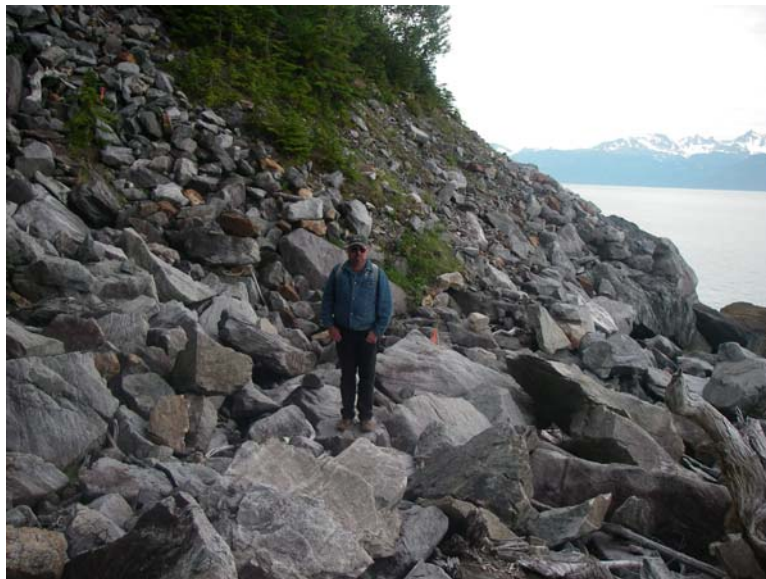
DF09. Debris flow and talus cone at base of debris flow and avalanche path ELC008 located at IRP 2006 1733+00.

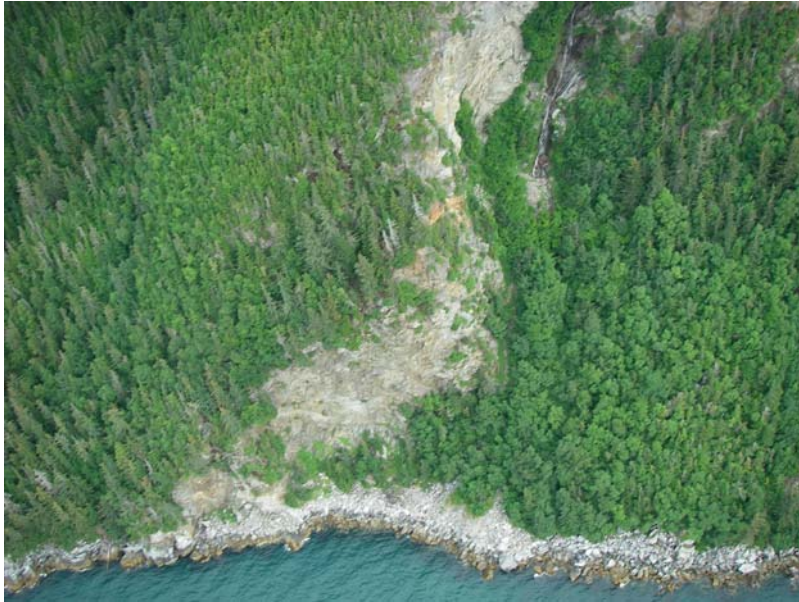
G-36

Hazard ID #:	RF07
Hazard Type:	rockfall
HIN:	279
Rating:	A
IRP 2006 Location:	1734
Frequency (yrs):	0-1
Predictability:	unpredictable
Material Volume (CY):	10-100
Clast Size (ft):	4+
Source Elev. (ft):	500-1000
Centerline Slope:	open_bedrock_slope
Alignment Location:	deposition_zone
Impact Alignment:	yes
Alignment Exposure (ft):	500+
Vegetation:	disturbed
Deciduous Trees:	yes
IRP 2006 South Margin:	1724+80
IRP 2006 North Margin:	1739+80
Photo #:	4674

RF07. View east/upslope at 500 ft high gneiss cliffs with strong jointing and rockfall.
