FINAL REPORT

**LYNN CANAL HIGHWAY
PHASE I
ZONE 4 GEOTECHNICAL INVESTIGATION**

STATE PROJECT NUMBER: 71100

*Golder Associates Inc.
1750 Abbott Road, Suite 200
Anchorage, Alaska 99507*

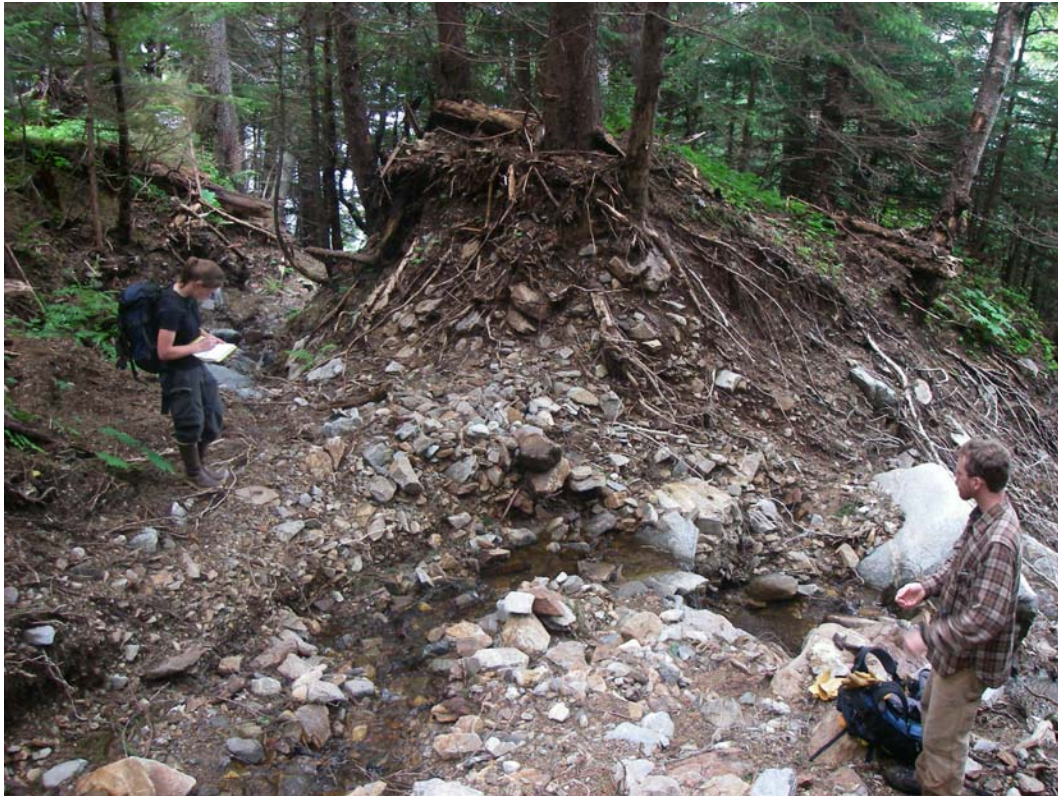
G-38

Hazard ID #:	DF10
Hazard Type:	debris_flow
HIN:	129
Rating:	A
IRP 2006 Location:	1743
Frequency (yrs):	1-5
Predictability:	high
Material Volume (CY):	10-100
Clast Size (ft):	0-1
Source Elev. (ft):	>1000
Centerline Slope:	multi_channel
Alignment Location:	path
Impact Alignment:	yes
Alignment Exposure (ft):	50-200
Vegetation:	denuded
Deciduous Trees:	no
IRP 2006 South Margin:	1742+50
IRP 2006 North Margin:	1743+40
Photo #:	4745-4748

DF10. View southwest (downslope and down alignment) at multichannel debris flow deposits at centerline at IRP 2006 1743+00.

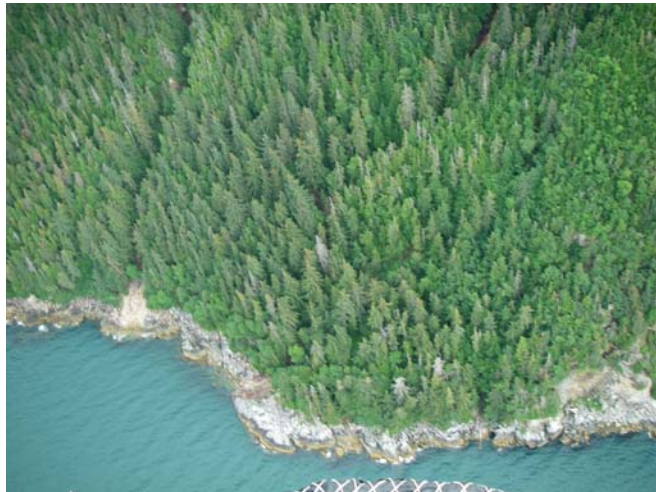
DF10. View east/upslope at debris flow terminus and deposition zone.

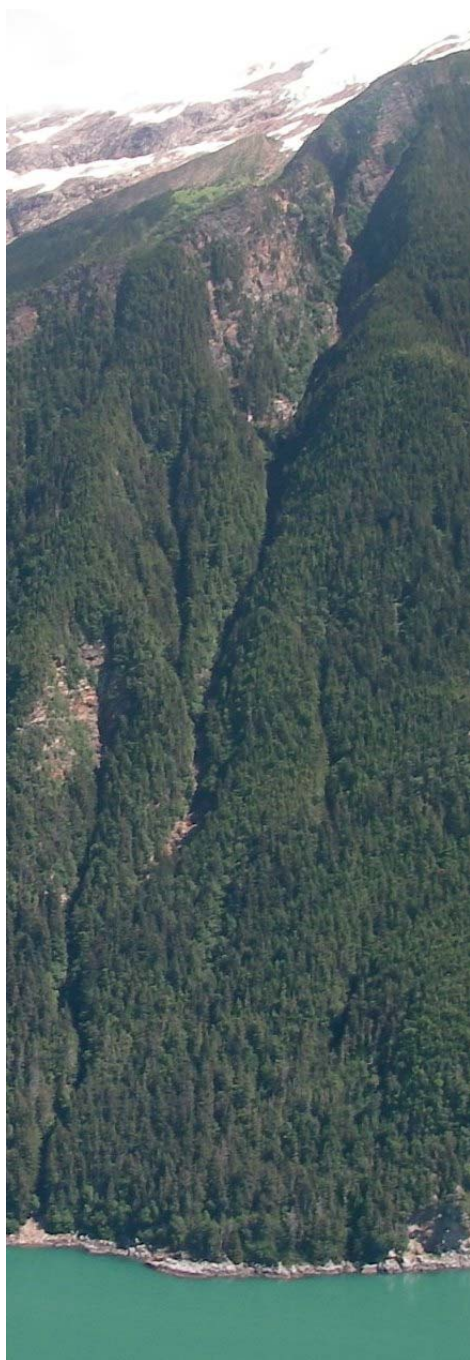
DF11. View east/upslope at debris flow channel and avalanche path ELC009.

Hazard ID #:	DF11
Hazard Type:	debris_flow
HIN:	129
Rating:	A
IRP 2006 Location:	1748
Frequency (yrs):	1-5
Predictability:	high
Material Volume (CY):	10-100
Clast Size (ft):	2-3
Source Elev. (ft):	>1000
Centerline Slope:	fan
Alignment Location:	deposition_zone
Impact Alignment:	yes
Alignment Exposure (ft):	50-200
Vegetation:	denuded
Deciduous Trees:	yes
IRP 2006 South Margin:	1746+40
IRP 2006 North Margin:	1748+20
Photo #:	4741, 4742, 5157

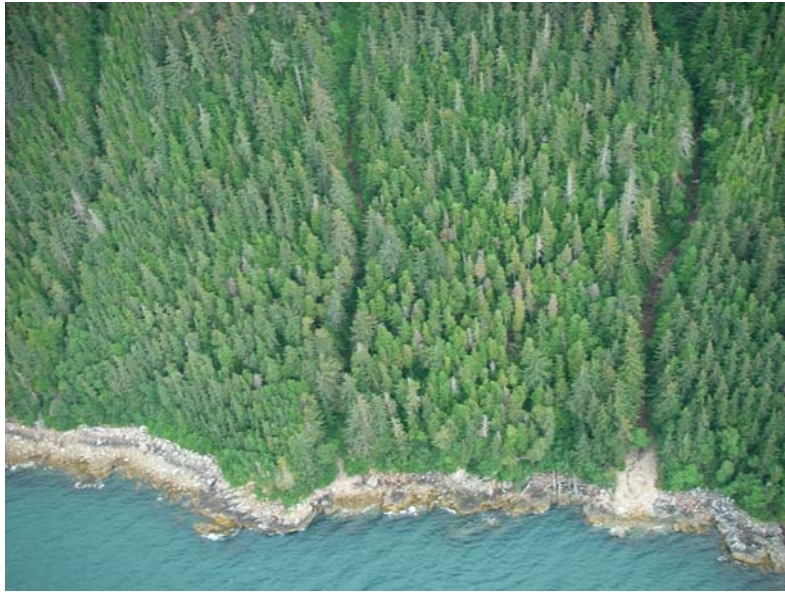
G-40

DF11. View east/upslope at debris flow deposition zone.

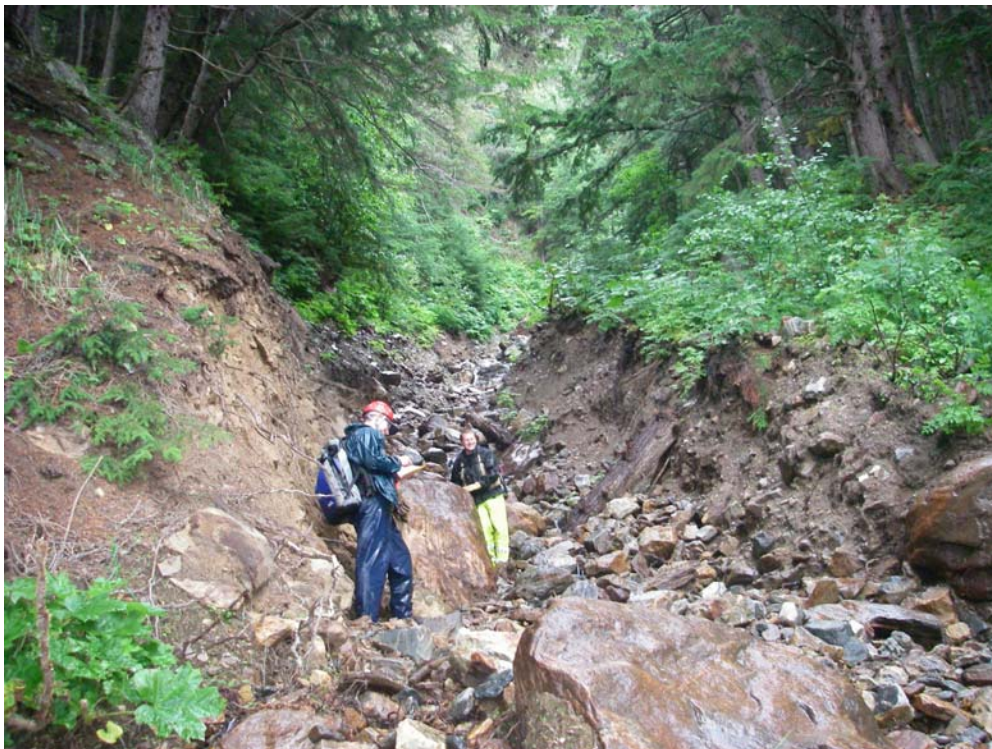
DF11. View east/upslope at debris flow channel and avalanche path ELC009. Photo taken at centerline at IRP 2006 1747+00.

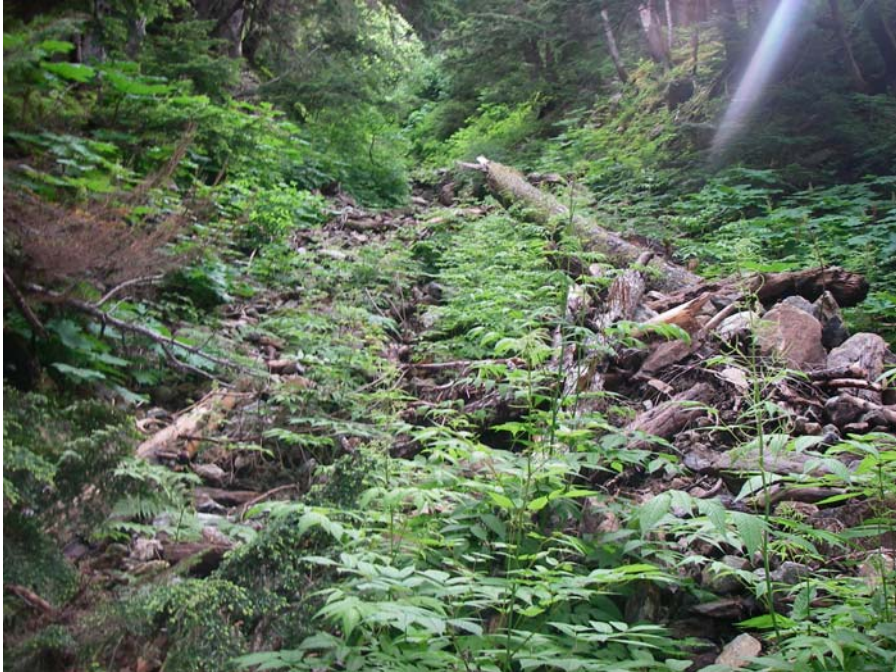
G-42

Hazard ID #:	DF12
Hazard Type:	debris_flow
HIN:	111
Rating:	A
IRP 2006 Location:	1752
Frequency (yrs):	5-25
Predictability:	high
Material Volume (CY):	10-100
Clast Size (ft):	2-3
Source Elev. (ft):	>1000
Centerline Slope:	fan
Alignment Location:	deposition_zone
Impact Alignment:	yes
Alignment Exposure (ft):	50-200
Vegetation:	disturbed
Deciduous Trees:	yes
IRP 2006 South Margin:	1751+00
IRP 2006 North Margin:	1752+00
Photo #:	4738, 4739, 5157

DF12. View east/upslope at debris flow channel and avalanche path ELC010. Photo taken 85 ft right of IRP 2006 1751+50.

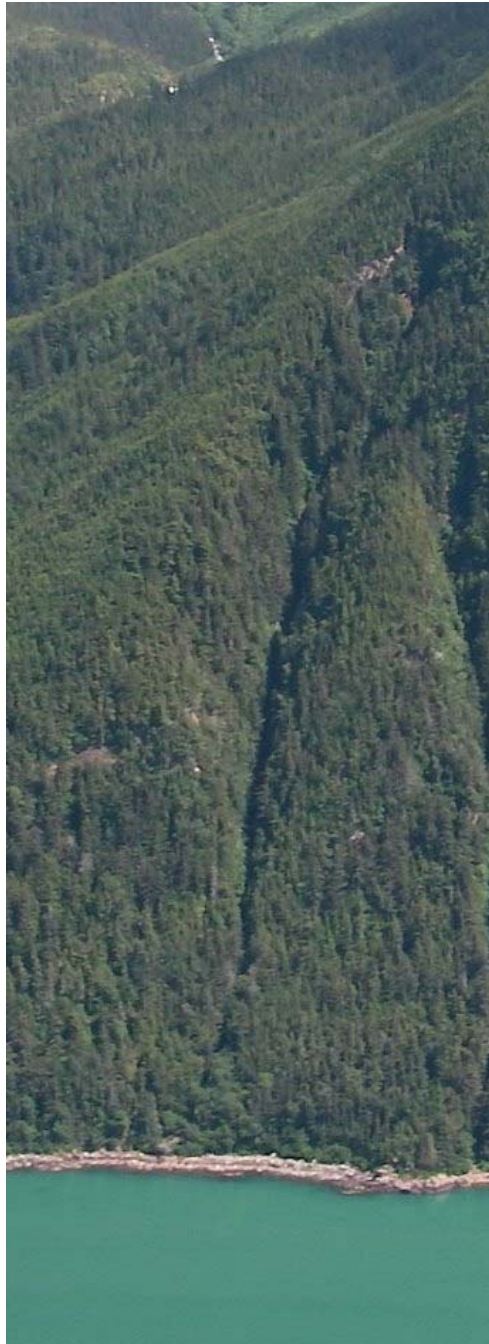
DF13. View east/upslope at debris flow channel and avalanche path ELC011.

Hazard ID #:	DF13
Hazard Type:	debris_flow
HIN:	129
Rating:	A
IRP 2006 Location:	1757
Frequency (yrs):	1-5
Predictability:	high
Material Volume (CY):	10-100
Clast Size (ft):	2-3
Source Elev. (ft):	>1000
Centerline Slope:	fan
Alignment Location:	deposition_zone
Impact Alignment:	yes
Alignment Exposure (ft):	50-200
Vegetation:	denuded
Deciduous Trees:	yes
IRP 2006 South Margin:	1756+10
IRP 2006 North Margin:	1757+50
Photo #:	4736, 4737, 5157

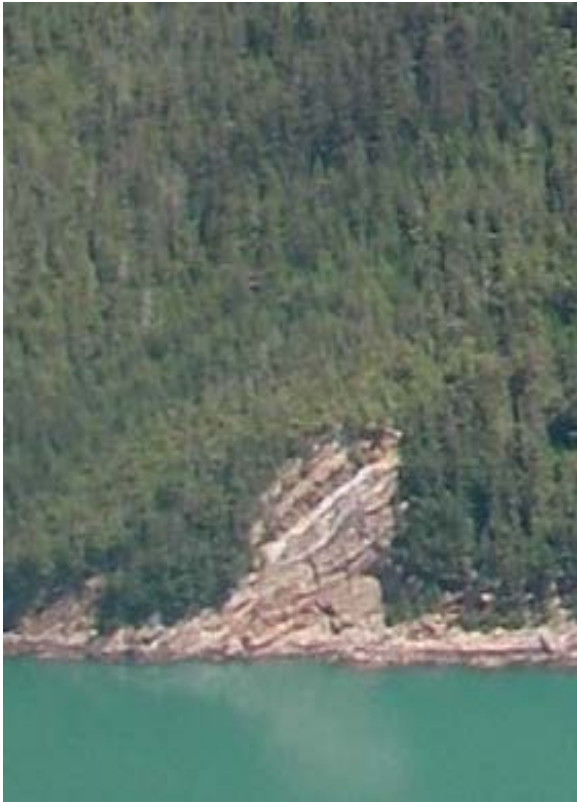
RF08. View east/upslope at rockfall hazard.

Hazard ID #:	RF08
Hazard Type:	rockfall
HIN:	183
Rating:	A
IRP 2006 Location:	1759
Frequency (yrs):	5-25
Predictability:	unpredictable
Material Volume (CY):	<10
Clast Size (ft):	4+
Source Elev. (ft):	100-500
Centerline Slope:	open_soil_slope
Alignment Location:	deposition_zone
Impact Alignment:	yes
Alignment Exposure (ft):	500+
Vegetation:	disturbed
Deciduous Trees:	no
IRP 2006 South Margin:	1759+30
IRP 2006 North Margin:	1767+00
Photo #:	5039, 5040, 5041, 5157, 6209

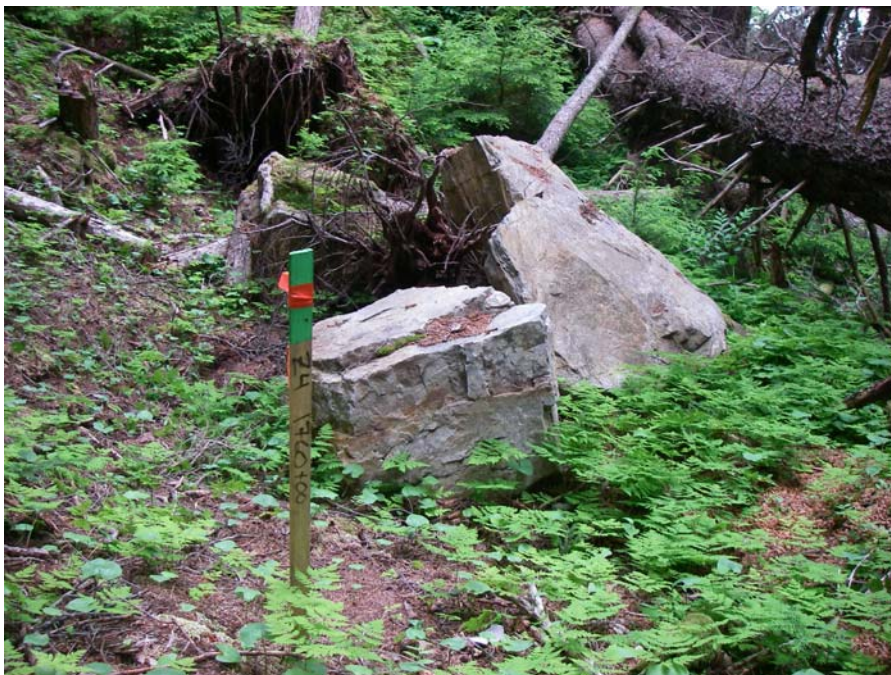
G-46

RF08. View southwest (downslope and down alignment) at rockfall debris at IRP 2006 1760+00.

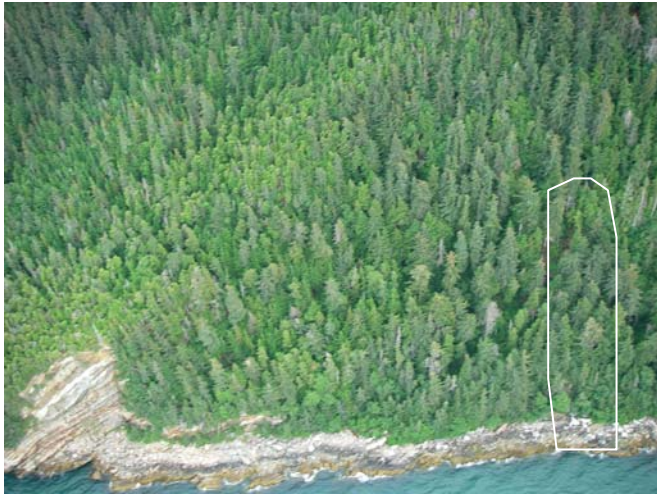
G-47

RF09. View east/upslope at area of greater frequency rockfall within rockfall area RF08.

Hazard ID #:	RF09
Hazard Type:	rockfall
HIN:	129
Rating:	A
IRP 2006 Location:	1763
Frequency (yrs):	1-5
Predictability:	unpredictable
Material Volume (CY):	<10
Clast Size (ft):	2-3
Source Elev. (ft):	100-500
Centerline Slope:	open_soil_slope
Alignment Location:	deposition_zone
Impact Alignment:	yes
Alignment Exposure (ft):	50-200
Vegetation:	disturbed
Deciduous Trees:	yes
IRP 2006 South Margin:	1763+20
IRP 2006 North Margin:	1763+80
Photo #:	3878

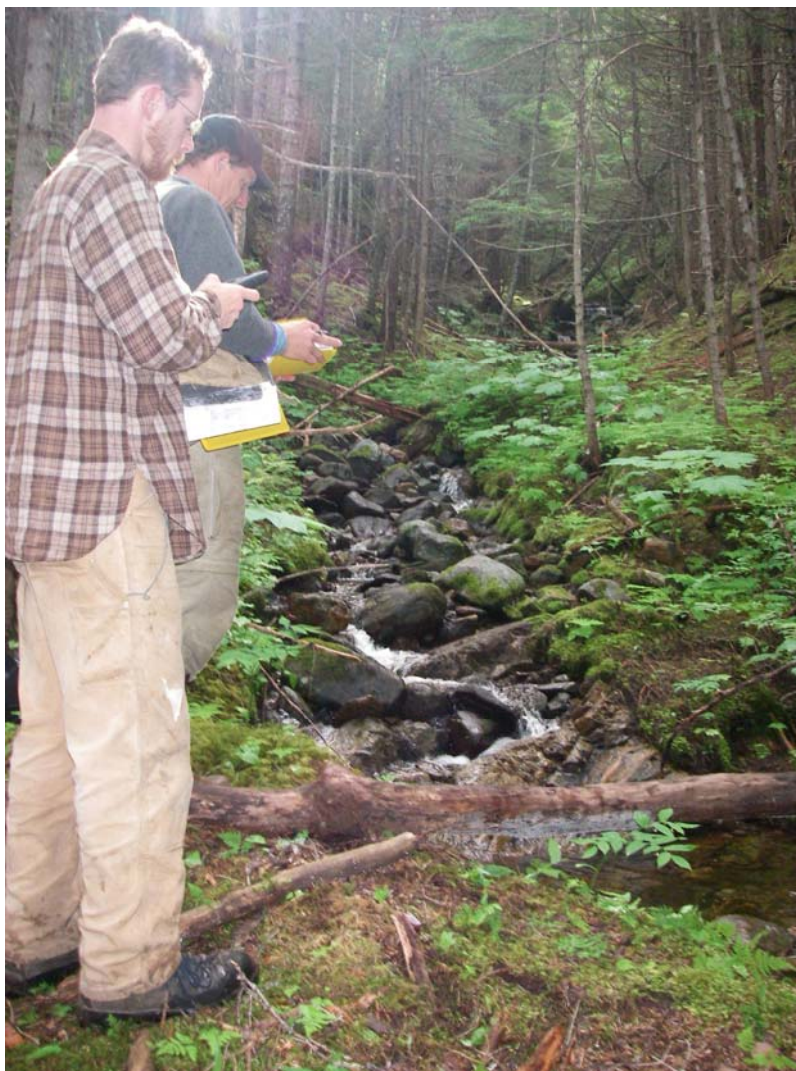
G-50

Hazard ID #:	DF14
Hazard Type:	debris_flow
HIN:	111
Rating:	A
IRP 2006 Location:	1773
Frequency (yrs):	25+
Predictability:	moderate
Material Volume (CY):	10-100
Clast Size (ft):	2-3
Source Elev. (ft):	>1000
Centerline Slope:	single_channel
Alignment Location:	path
Impact Alignment:	yes
Alignment Exposure (ft):	50-200
Vegetation:	disturbed
Deciduous Trees:	no
IRP 2006 South Margin:	1772+50
IRP 2006 North Margin:	1773+60
Photo #:	2093, 4714

DF14. View east/upslope at debris flow channel. Old levee walls visible on far left and right sides of photo. Photo taken 30 ft left of IRP 2006 1773+00.

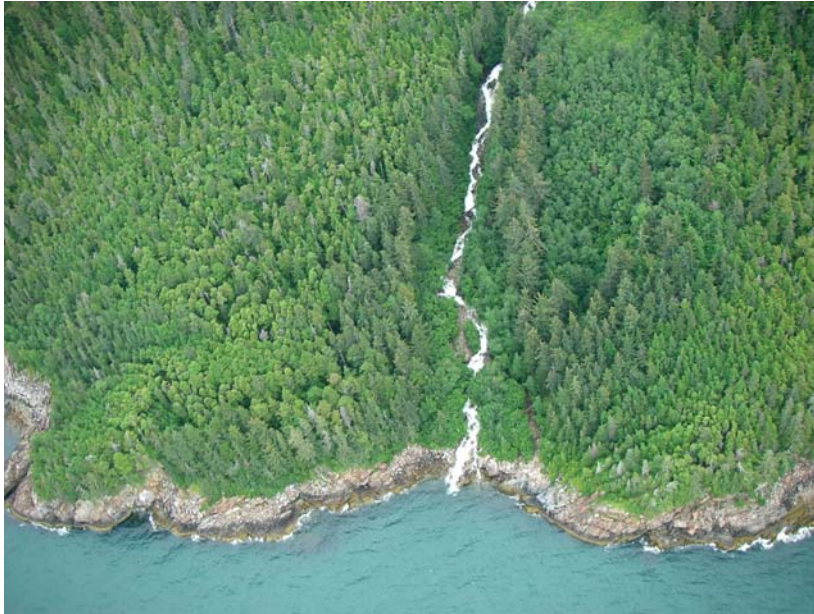
G-52

Hazard ID #:	DF15
Hazard Type:	debris_flow
HIN:	207
Rating:	B
IRP 2006 Location:	1782
Frequency (yrs):	5-25
Predictability:	moderate
Material Volume (CY):	1000+
Clast Size (ft):	2-3
Source Elev. (ft):	>1000
Centerline Slope:	multi_channel
Alignment Location:	deposition_zone
Impact Alignment:	yes
Alignment Exposure (ft):	200-500
Vegetation:	disturbed
Deciduous Trees:	yes
IRP 2006 South Margin:	1782+00
IRP 2006 North Margin:	1783+00
Photo #:	3912

DF15. View east/upslope at debris flow channel.

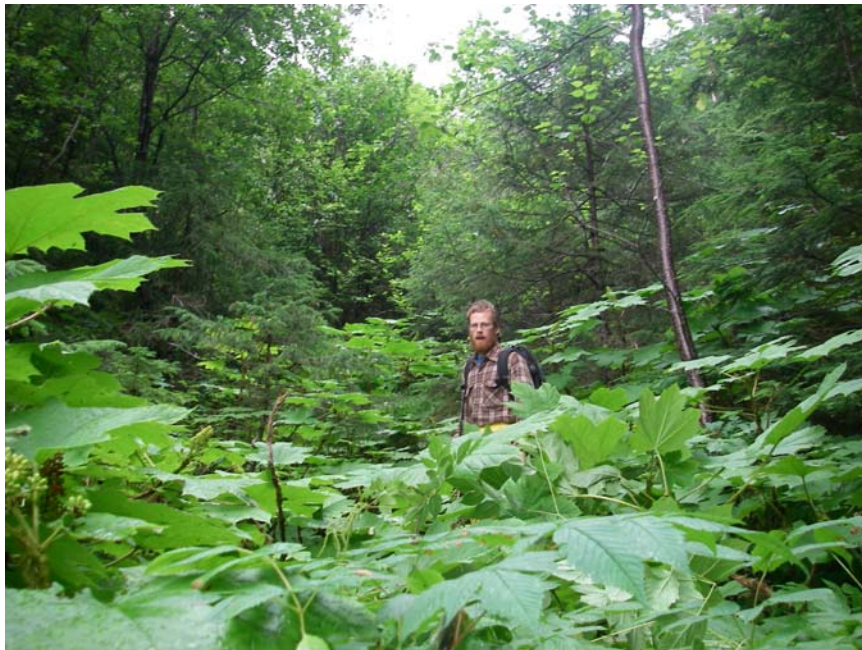
DF15. View east/upslope at abandoned/infrequently occupied debris flow path at IRP 2006 1782+00. During large events, this is believed to be an overflow channel from the adjacent, active debris flow channel at IRP 2006 1784+00.

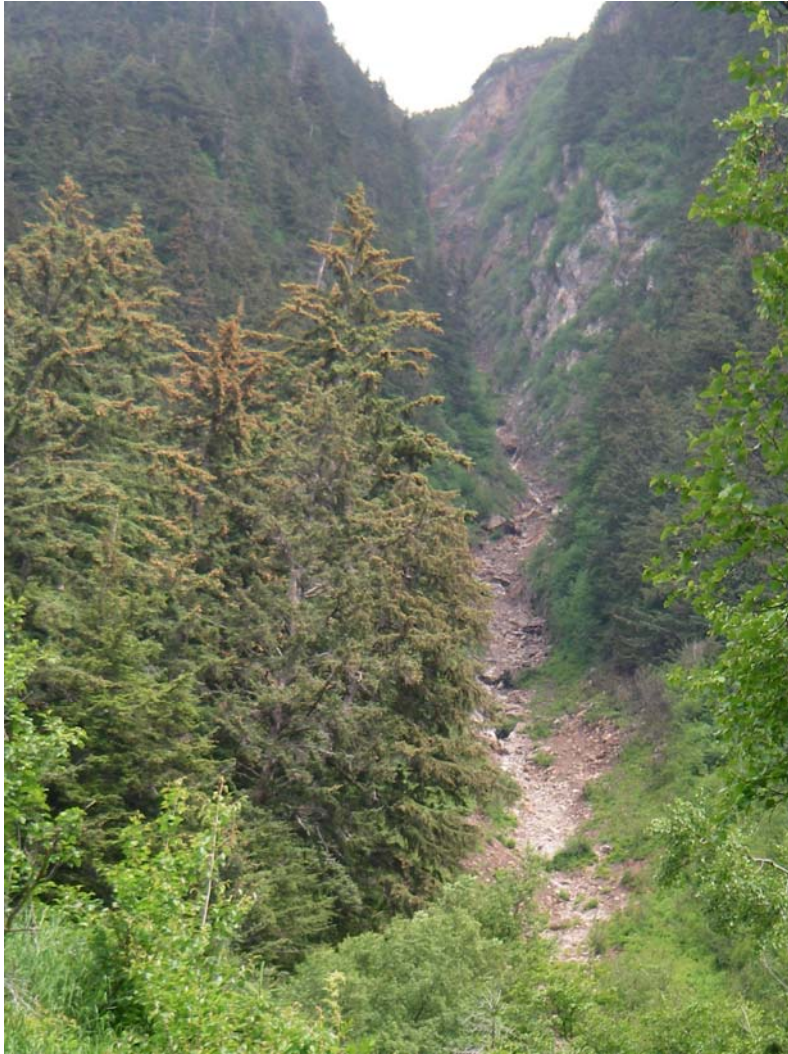
G-54

Hazard ID #:	DF16
Hazard Type:	debris_flow
HIN:	225
Rating:	A
IRP 2006 Location:	1783
Frequency (yrs):	1-5
Predictability:	moderate
Material Volume (CY):	1000+
Clast Size (ft):	2-3
Source Elev. (ft):	>1000
Centerline Slope:	multi_channel
Alignment Location:	deposition_zone
Impact Alignment:	yes
Alignment Exposure (ft):	200-500
Vegetation:	disturbed
Deciduous Trees:	yes
IRP 2006 South Margin:	1783+00
IRP 2006 North Margin:	1785+30
Photo #:	1141, 2091, 5158

DF16. View east/upslope at tributary to debris flow channel and avalanche path ELC012. Photo taken 450 ft right of IRP 2006 1784+00.

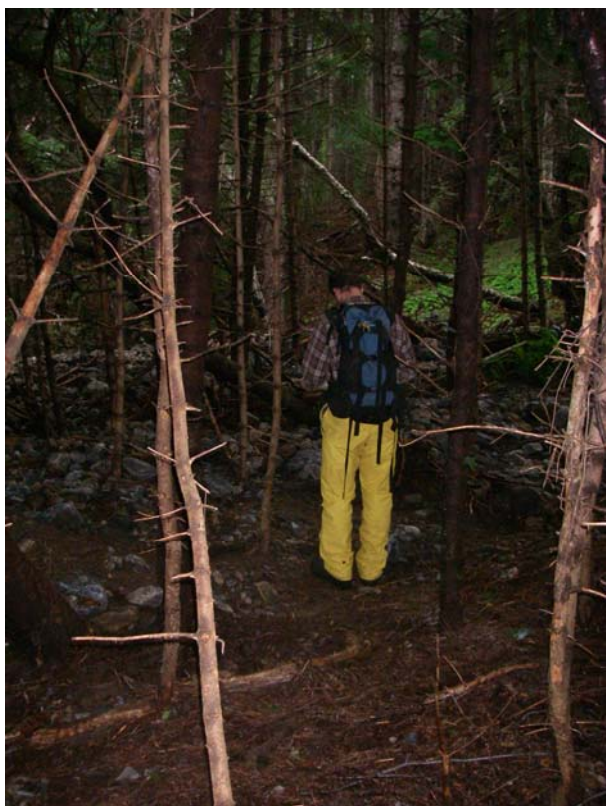
DF17. View north/up alignment at margin of old debris flow and recent debris flow. Photo taken at centerline at IRP 2006 1825+00.

Hazard ID #:	DF17
Hazard Type:	debris_flow
HIN:	147
Rating:	B
IRP 2006 Location:	1824
Frequency (yrs):	25+
Predictability:	low
Material Volume (CY):	10-100
Clast Size (ft):	1-2
Source Elev. (ft):	2000-3000
Centerline Slope:	fan
Alignment Location:	deposition_zone
Impact Alignment:	yes
Alignment Exposure (ft):	200-500
Vegetation:	disturbed
Deciduous Trees:	yes
IRP 2006 South Margin:	1824+10
IRP 2006 North Margin:	1825+50
Photo #:	1186, 4012, 4015, 5159, 6232

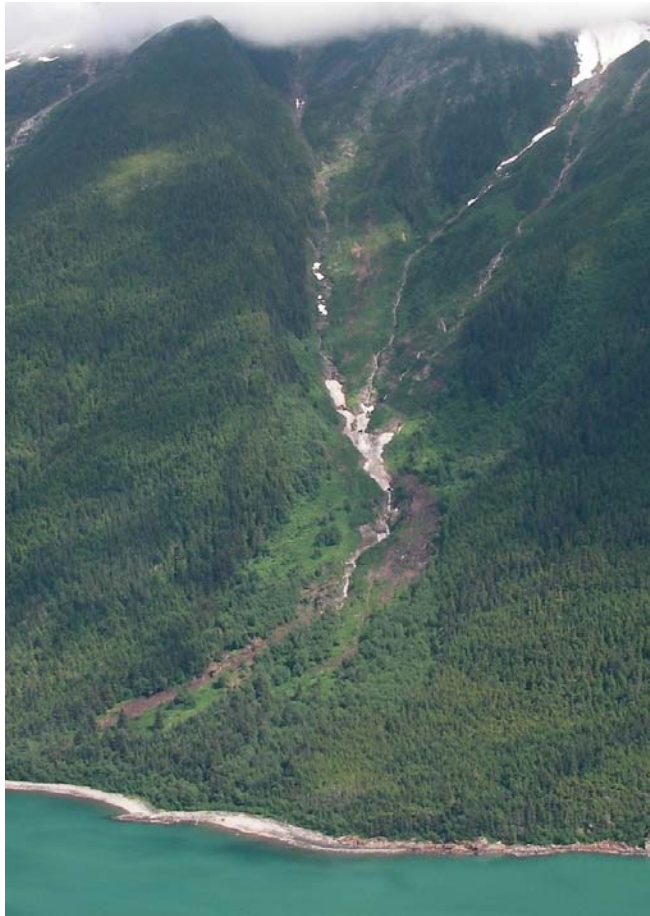
G-56

DF18. Debris flow and avalanche path
ELC013.

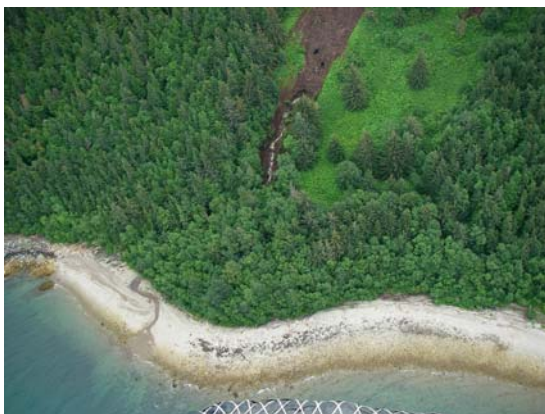
DF18. View east/upslope at debris flow.

Hazard ID #:	DF18
Hazard Type:	debris_flow
HIN:	147
Rating:	A
IRP 2006 Location:	1826
Frequency (yrs):	1-5
Predictability:	high
Material Volume (CY):	10-100
Clast Size (ft):	0-1
Source Elev. (ft):	2000-3000
Centerline Slope:	fan
Alignment Location:	deposition_zone
Impact Alignment:	yes
Alignment Exposure (ft):	200-500
Vegetation:	disturbed
Deciduous Trees:	yes
IRP 2006 South Margin:	1825+50
IRP 2006 North Margin:	1827+50
Photo #:	1186, 4012, 4015, 5159, 6232

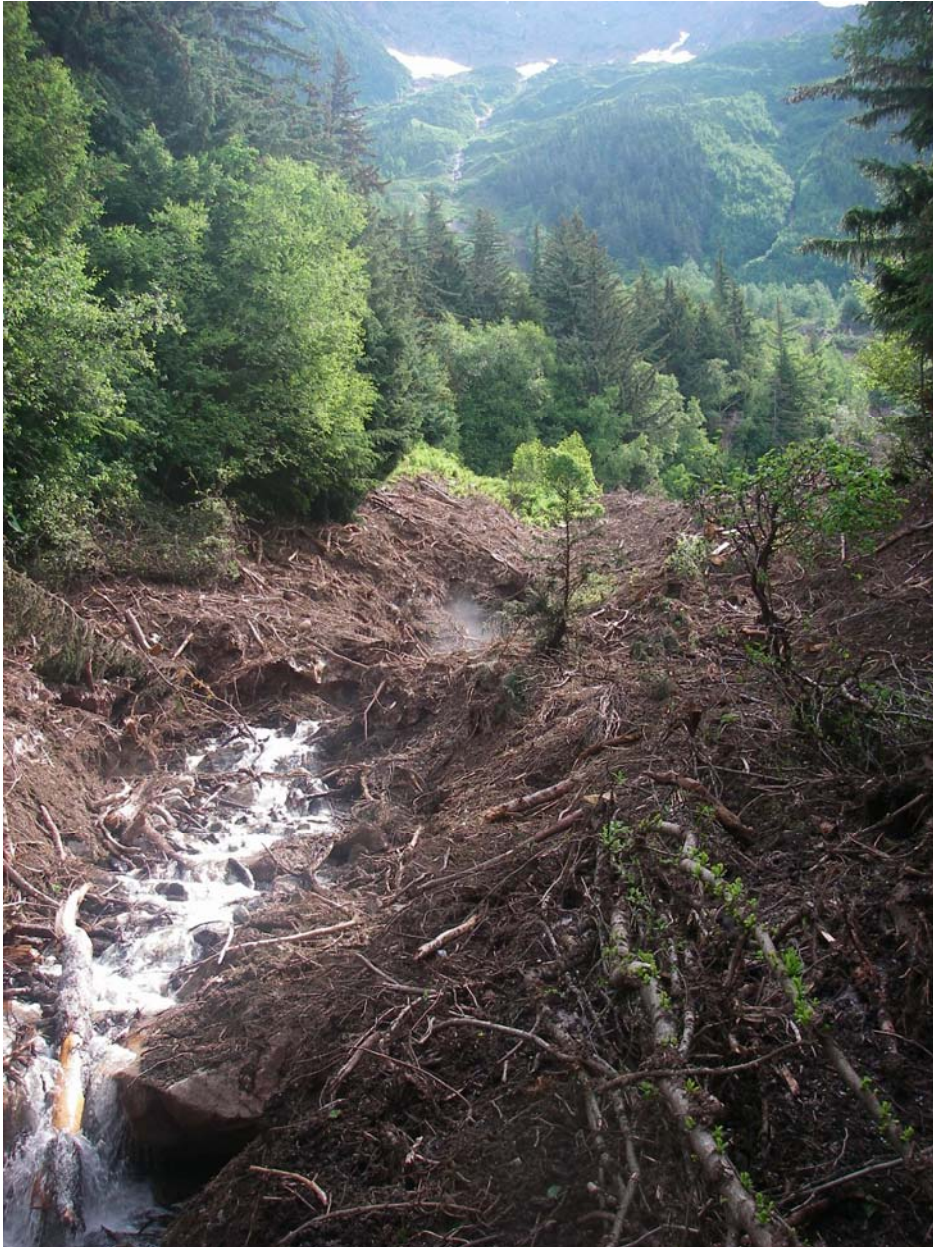
G-57

DF18. View east/upslope at debris flow and avalanche path
ELC013. Photo taken 100 ft right of IRP 2006 1826+00.

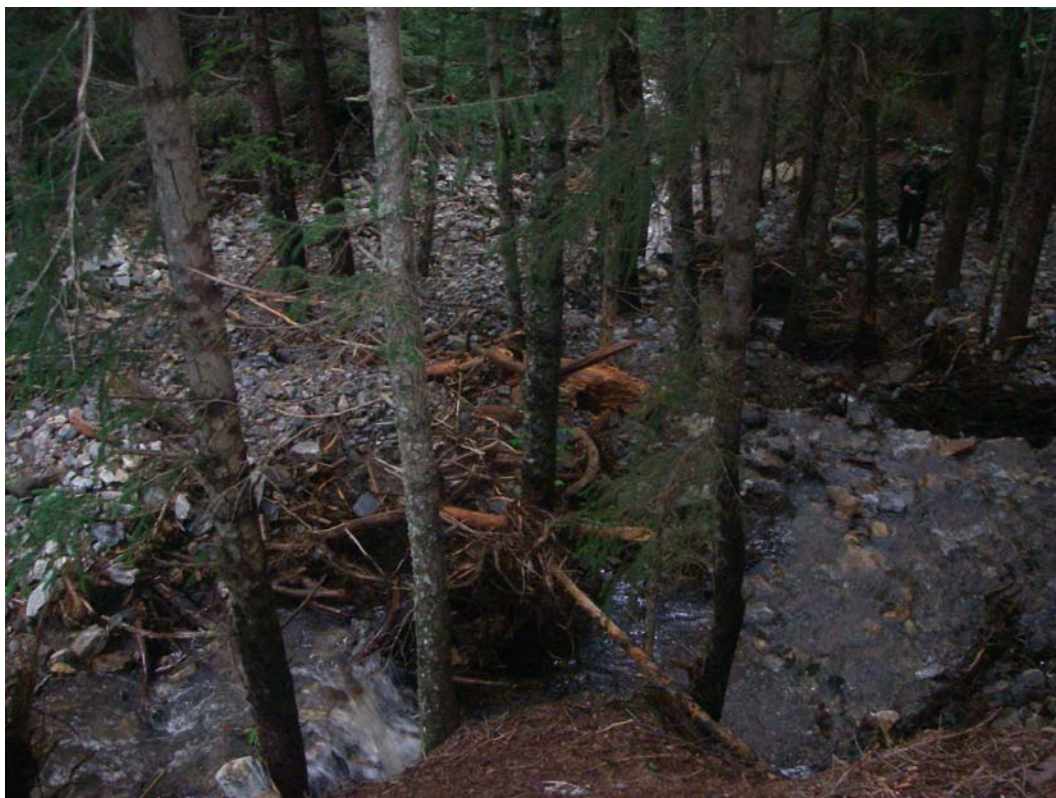
G-58

DF18. View southwest (downslope and down alignment) down a major creek, debris flow fan, and recent deposits that buried small conifer trees. Photo taken 50 ft right of IRP 2006 1826+50. Fan continues across alignment.

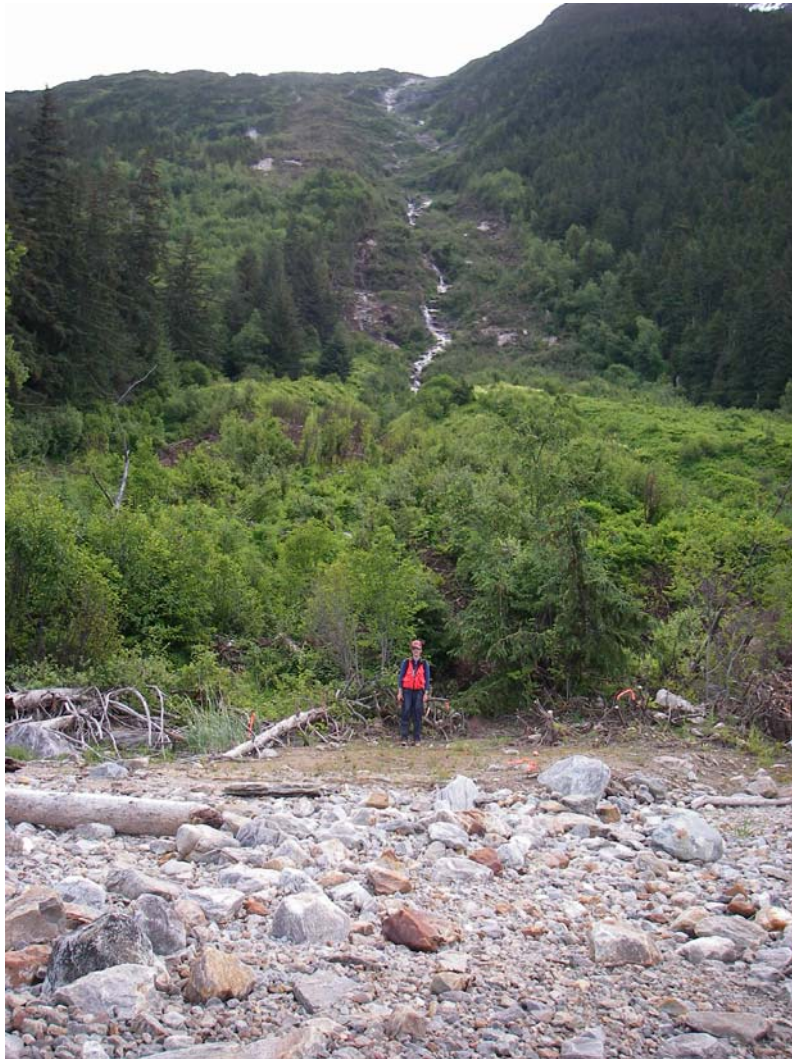
G-60

Hazard ID #:	DF19
Hazard Type:	debris_flow
HIN:	153
Rating:	A
IRP 2006 Location:	1847
Frequency (yrs):	5-25
Predictability:	low
Material Volume (CY):	10-100
Clast Size (ft):	0-1
Source Elev. (ft):	3000+
Centerline Slope:	fan
Alignment Location:	deposition_zone
Impact Alignment:	yes
Alignment Exposure (ft):	200-500
Vegetation:	denuded
Deciduous Trees:	yes
IRP 2006 South Margin:	1845+30
IRP 2006 North Margin:	1849+90
Photo #:	4809, 4812, 4830, 5160

DF19. View east/upslope from beach at debris flow and avalanche path ELC014. Photo taken 190 ft left of IRP 2006 1847+50.

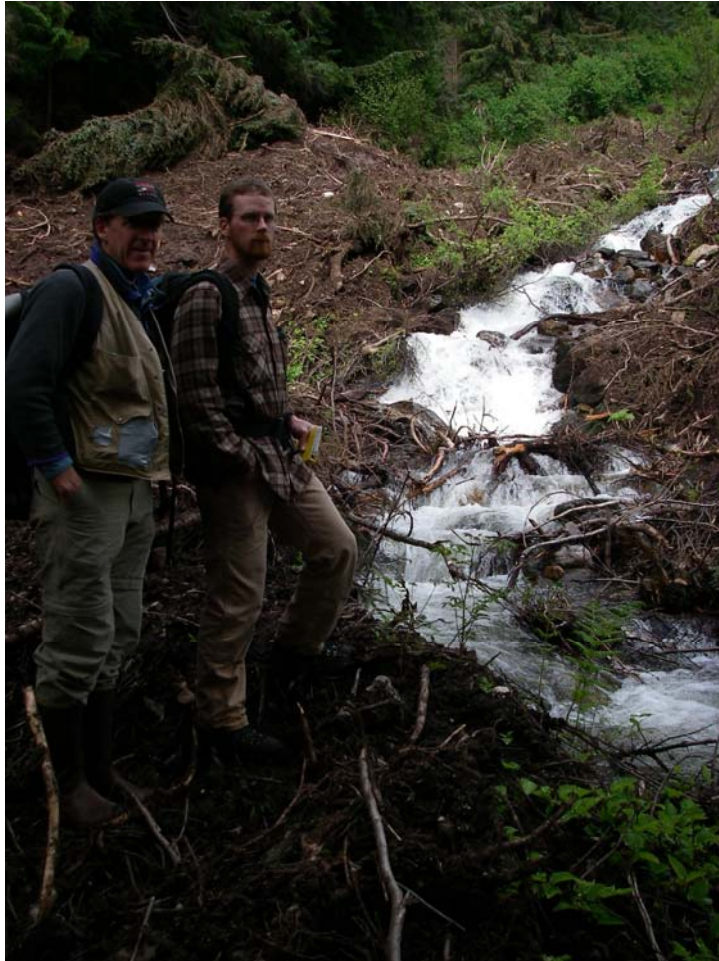
G-62

DF20. View east/upslope at debris channel. Stream is poorly channelized as a result of a high sediment/debris supply. Photo taken at centerline at IRP 2006 1852+50.

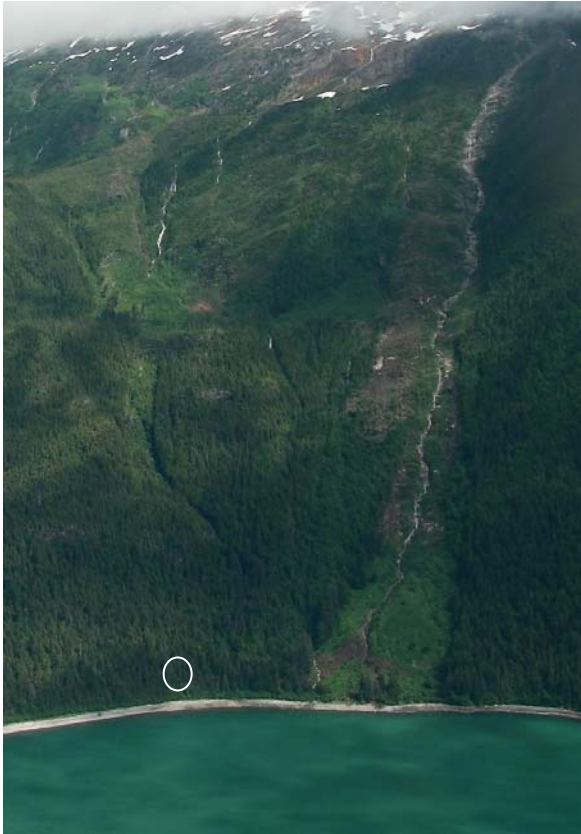
G-63

RF10. View east/upslope at rockfall.

Hazard ID #:	RF10
Hazard Type:	rockfall
HIN:	111
Rating:	C
IRP 2006 Location:	1854
Frequency (yrs):	unknown (5-25?)
Predictability:	unpredictable
Material Volume (CY):	<10
Clast Size (ft):	2-3
Source Elev. (ft):	100-500
Centerline Slope:	other
Alignment Location:	below_deposition zone
Impact Alignment:	no
Alignment Exposure (ft):	50-200
Vegetation:	disturbed
Deciduous Trees:	yes
IRP 2006 South Margin:	1853+30
IRP 2006 North Margin:	1854+30
Photo #:	4816

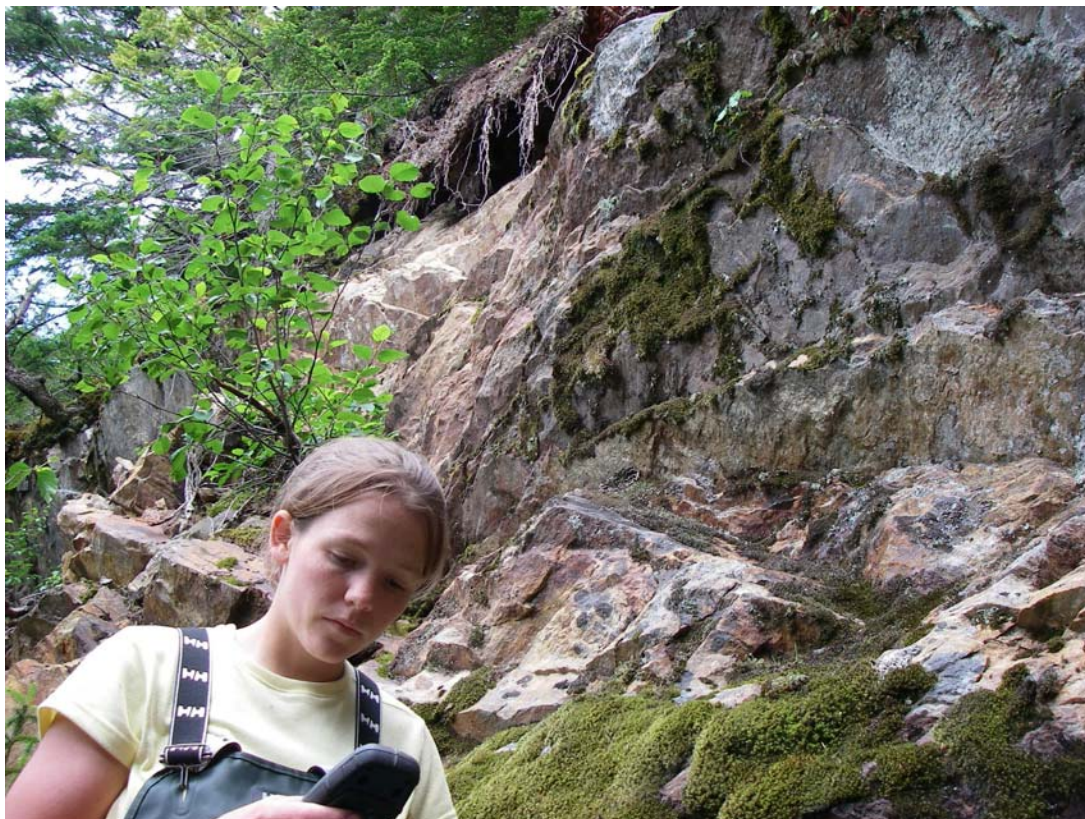
G-64

RF10. View at basalt cliffs that create the rockfall zone. Photo taken 775 ft right of IRP 2006 alignment.

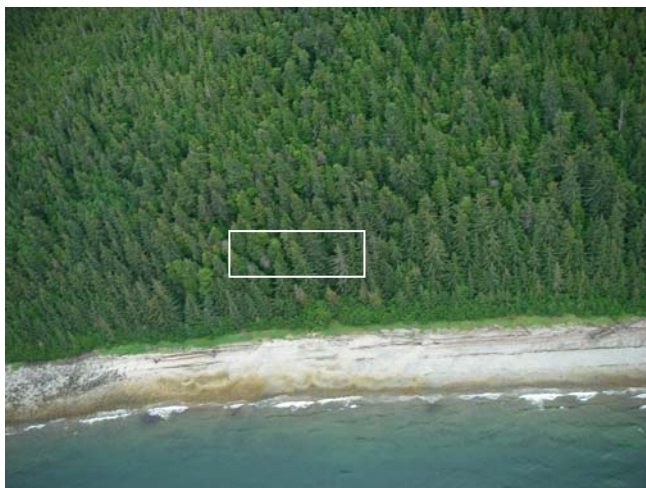
G-65

RF11. View east/upslope at rockfall area.

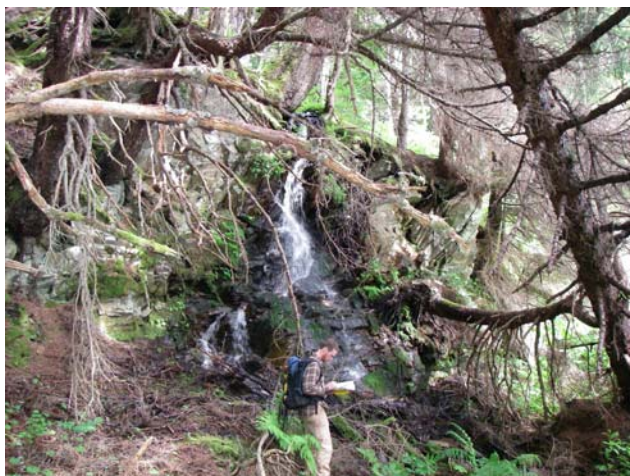
RF11. View east/upslope at minor rockfall hazard located at centerline at IRP 2006 1865+00.

Hazard ID #:	RF11
Hazard Type:	rockfall
HIN:	105
Rating:	B
IRP 2006 Location:	1865
Frequency (yrs):	5-25
Predictability:	unpredictable
Material Volume (CY):	<10
Clast Size (ft):	2-3
Source Elev. (ft):	<100
Centerline Slope:	open_soil_slope
Alignment Location:	deposition_zone
Impact Alignment:	yes
Alignment Exposure (ft):	50-200
Vegetation:	disturbed
Deciduous Trees:	yes
IRP 2006 South Margin:	1864+80
IRP 2006 North Margin:	1866+00
Photo #:	6234

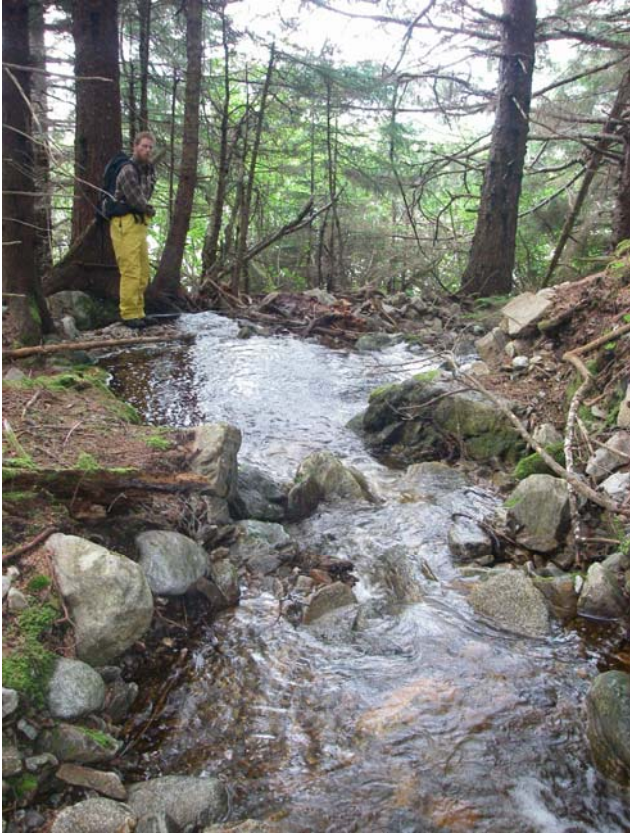
DF21. View west/downslope at debris flow deposition zone, 250 ft left of IRP 2006 1894+00.

Hazard ID #:	DF21
Hazard Type:	debris_flow
HIN:	123
Rating:	B
IRP 2006 Location:	1894
Frequency (yrs):	1-5
Predictability:	high
Material Volume (CY):	<10
Clast Size (ft):	0-1
Source Elev. (ft):	2000-3000
Centerline Slope:	single_channel
Alignment Location:	path
Impact Alignment:	yes
Alignment Exposure (ft):	50-200
Vegetation:	disturbed
Deciduous Trees:	yes
IRP 2006 South Margin:	1893+30
IRP 2006 North Margin:	1894+40
Photo #:	5161, 6238

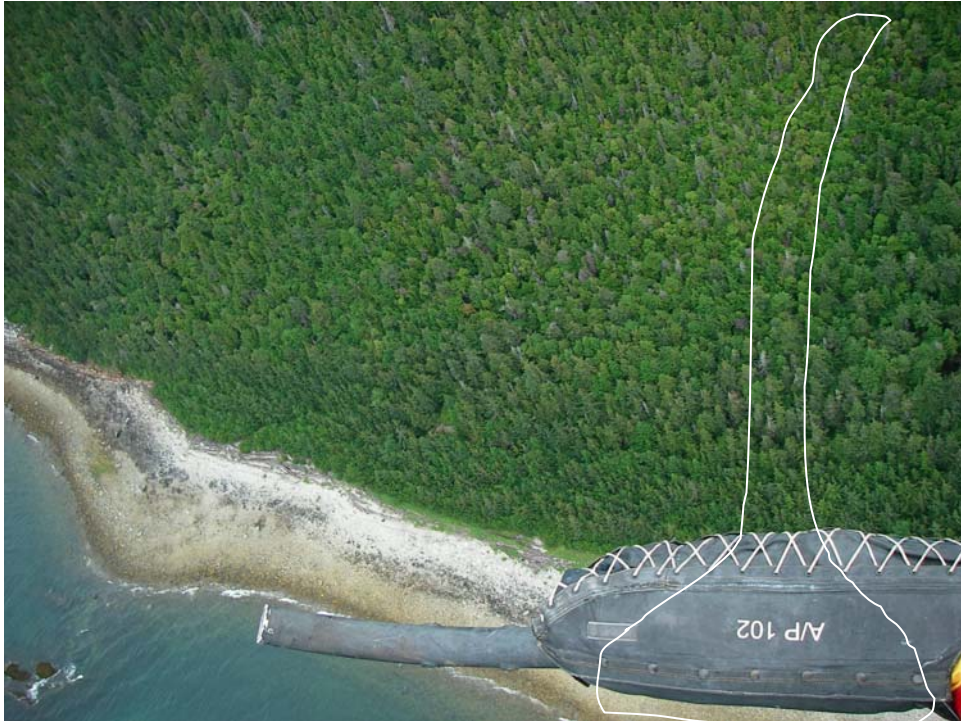
DF21. View east/upslope at moderate slope old growth covering the debris flow channel.

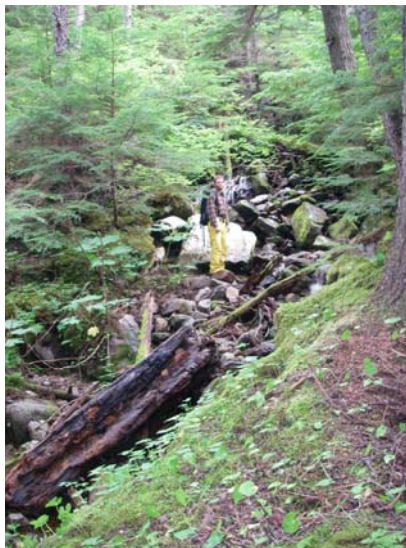
DF21. View east/upslope at debris flow channel 120 ft right of IRP 2006 1895+00.

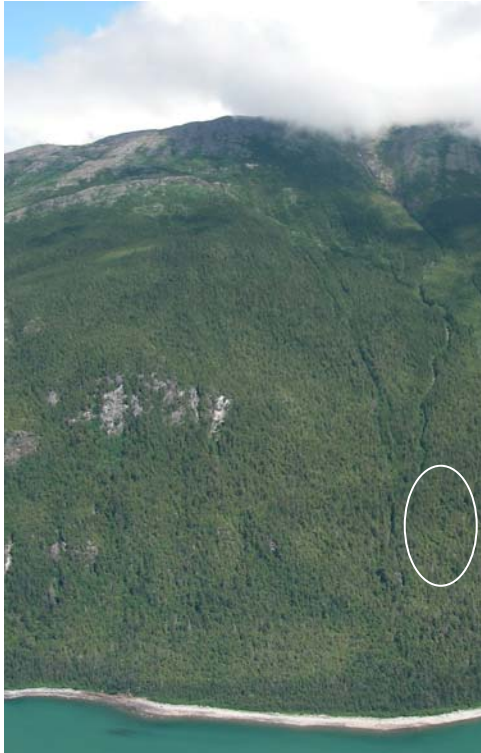
RF12. View east/upslope at rockfall area.

Hazard ID #:	RF12
Hazard Type:	rockfall
HIN:	105
Rating:	C
IRP 2006 Location:	1915
Frequency (yrs):	unknown (>25?)
Predictability:	unpredictable
Material Volume (CY):	<10
Clast Size (ft):	4+
Source Elev. (ft):	100-500
Centerline Slope:	-
Alignment Location:	below_deposition_zone
Impact Alignment:	no
Alignment Exposure (ft):	50-200
Vegetation:	disturbed
Deciduous Trees:	yes
IRP 2006 South Margin:	1915+20
IRP 2006 North Margin:	1916+50
Photo #:	5162

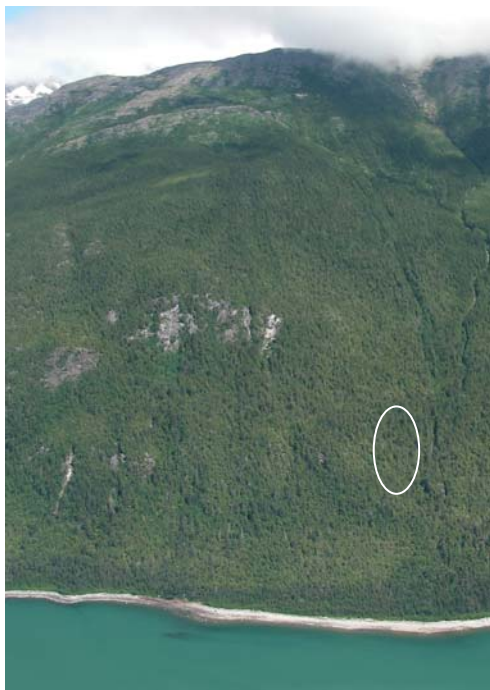
RF13. View east/upslope at rockfall area.

Hazard ID #:	RF13
Hazard Type:	rockfall
HIN:	111
Rating:	C
IRP 2006 Location:	1932
Frequency (yrs):	0-1
Predictability:	moderate
Material Volume (CY):	<10
Clast Size (ft):	1-2
Source Elev. (ft):	100-500
Centerline Slope:	-
Alignment Location:	below_deposition_zone
Impact Alignment:	no
Alignment Exposure (ft):	50-200
Vegetation:	disturbed
Deciduous Trees:	yes
IRP 2006 South Margin:	1931+80
IRP 2006 North Margin:	1933+00
Photo #:	5162

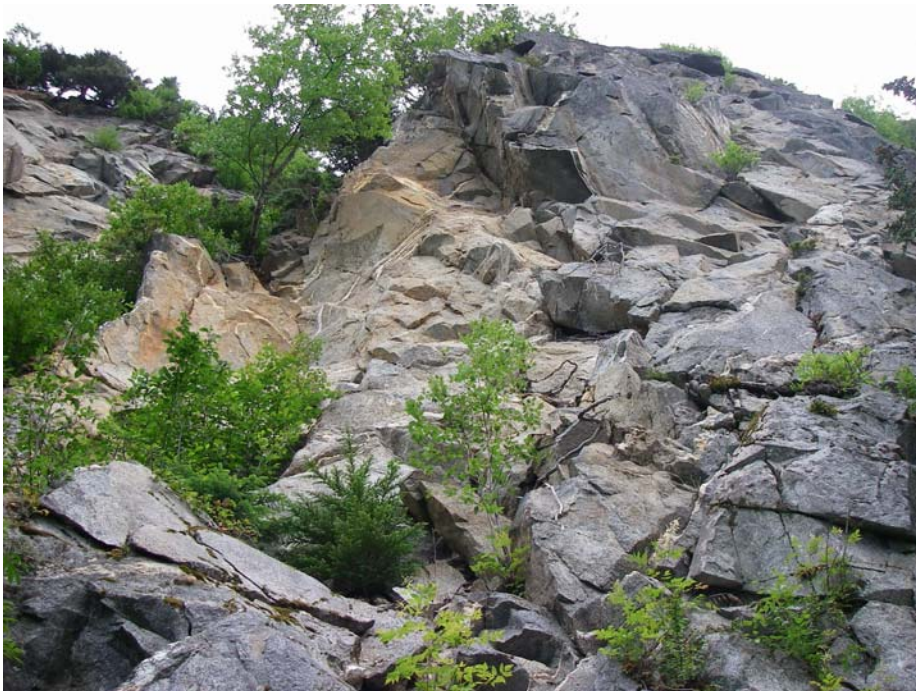
Hazard ID #:	RF15
Hazard Type:	rockfall
HIN:	129
Rating:	B
IRP 2006 Location:	1948
Frequency (yrs):	5-25
Predictability:	unpredictable
Material Volume (CY):	<10
Clast Size (ft):	4+
Source Elev. (ft):	100-500
Centerline Slope:	other
Alignment Location:	deposition_zone
Impact Alignment:	yes
Alignment Exposure (ft):	200-500
Vegetation:	disturbed
Deciduous Trees:	yes
IRP 2006 South Margin:	1946+80
IRP 2006 North Margin:	1949+00
Photo #:	5163

RF15. View east/upslope at large cliffs, fresh rockfall scars, 240 ft right of IRP 2006 1948+00.

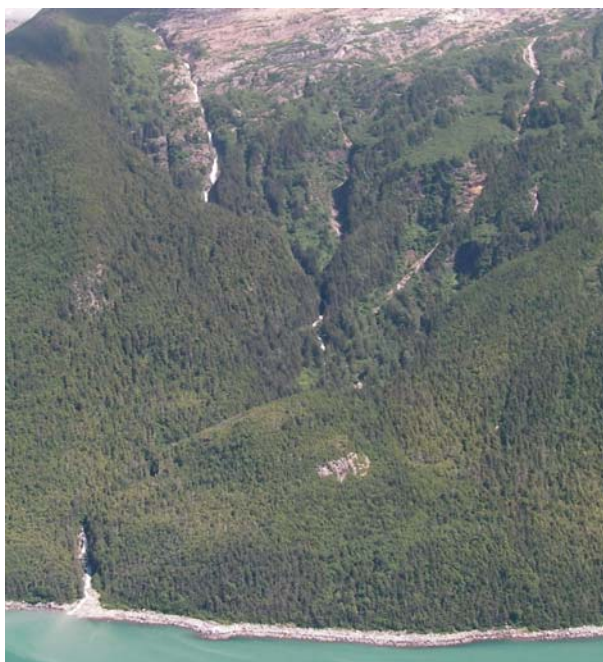
DF22. View east/upslope at debris flow channel and avalanche path ELC016.

Hazard ID #:	DF22
Hazard Type:	debris_flow
HIN:	147
Rating:	A
IRP 2006 Location:	1984
Frequency (yrs):	1-5
Predictability:	high
Material Volume (CY):	10-100
Clast Size (ft):	1-2
Source Elev. (ft):	2000-3000
Centerline Slope:	fan
Alignment Location:	deposition_zone
Impact Alignment:	yes
Alignment Exposure (ft):	200-500
Vegetation:	disturbed
Deciduous Trees:	no
IRP 2006 South Margin:	1983+30
IRP 2006 North Margin:	1985+70
Photo #:	5047, 5164, 5914

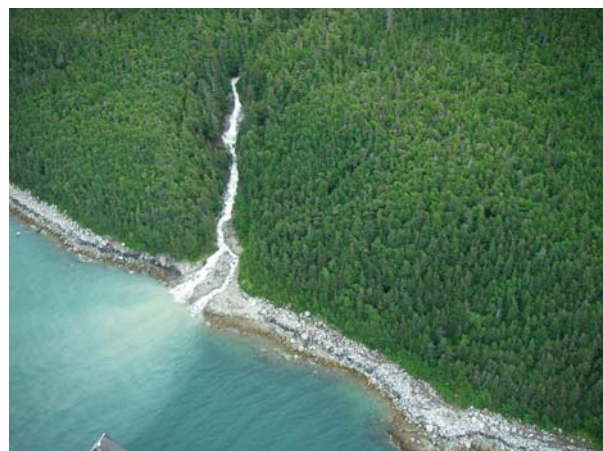
DF22. View east/upslope at debris flow channel.
