FINAL REPORT

**LYNN CANAL HIGHWAY
PHASE I
ZONE 4 GEOTECHNICAL INVESTIGATION**

STATE PROJECT NUMBER: 71100

*Golder Associates Inc.
1750 Abbott Road, Suite 200
Anchorage, Alaska 99507*

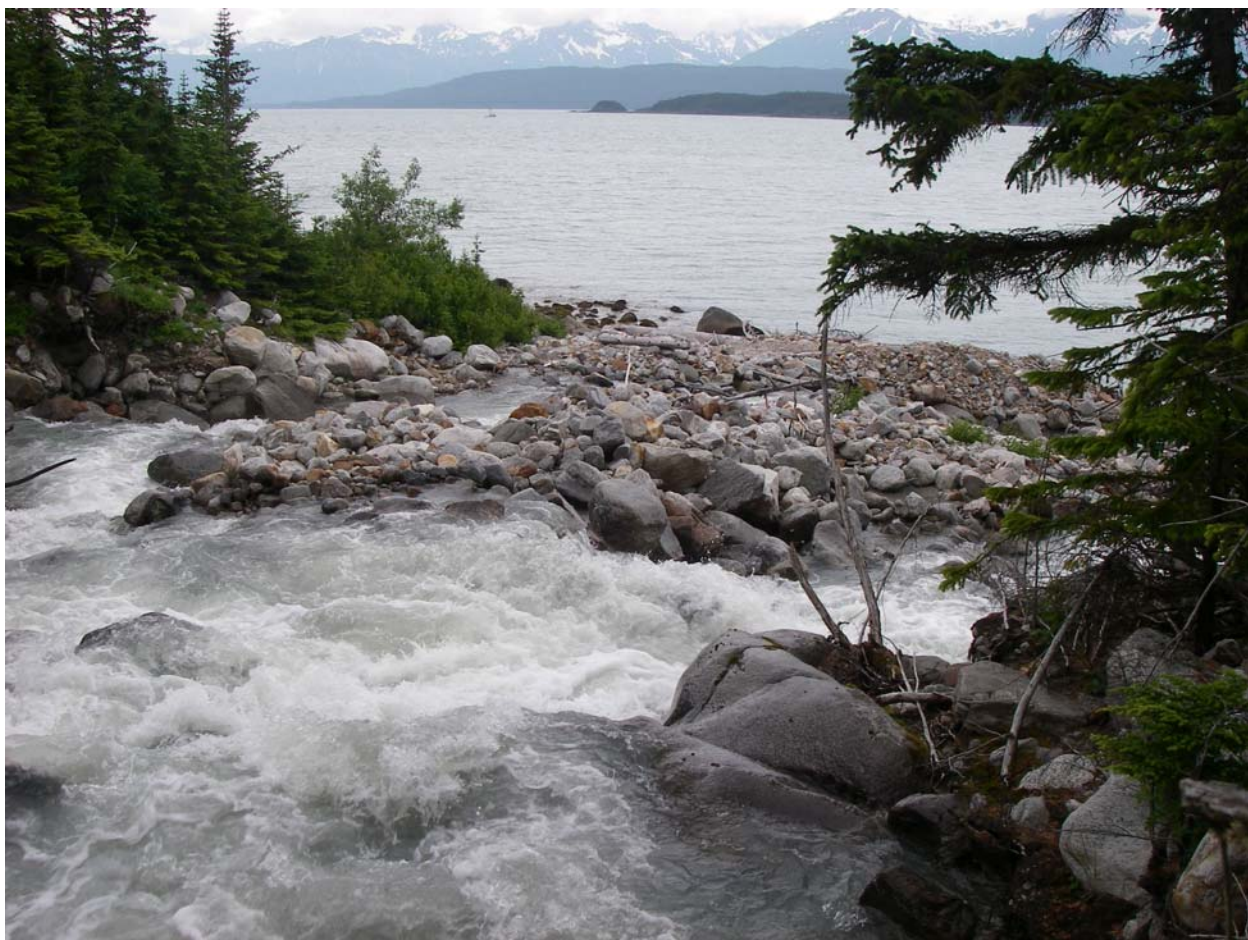
DF22. View southwest (downslope and down alignment) at debris flow fan and avalanche path ELC016. Photo taken 50 ft right of IRP 2006 1984+00.

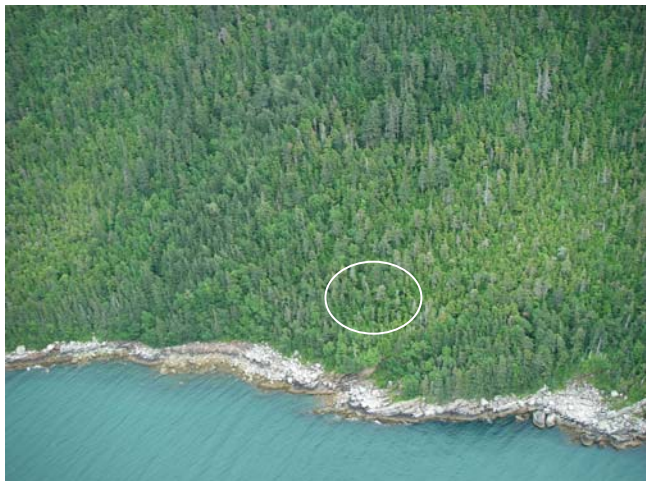
RF16. View east/upslope at rockfall hazard.

Hazard ID #:	RF16
Hazard Type:	rockfall
HIN:	129
Rating:	B
IRP 2006 Location:	2015
Frequency (yrs):	unknown (5-25?)
Predictability:	unpredictable
Material Volume (CY):	<10
Clast Size (ft):	3-4
Source Elev. (ft):	100-500
Centerline Slope:	deciduous_trees
Alignment Location:	below_deposition_zone
Impact Alignment:	yes
Alignment Exposure (ft):	200-500
Vegetation:	disturbed
Deciduous Trees:	yes
IRP 2006 South Margin:	2015+00
IRP 2006 North Margin:	2017+40
Photo #:	5052, 5053, 6240

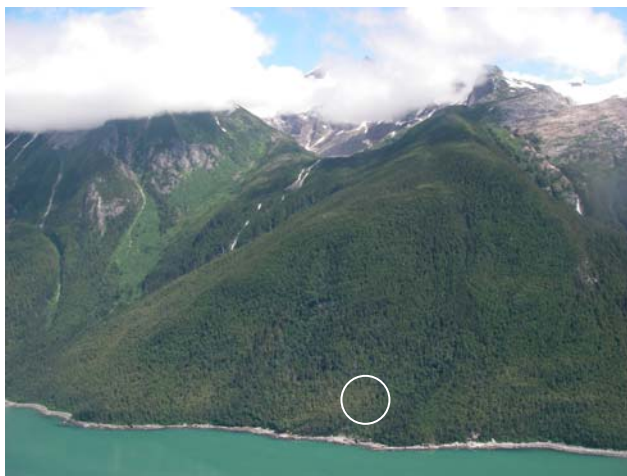
RF16. View east/upslope at rockfall area.

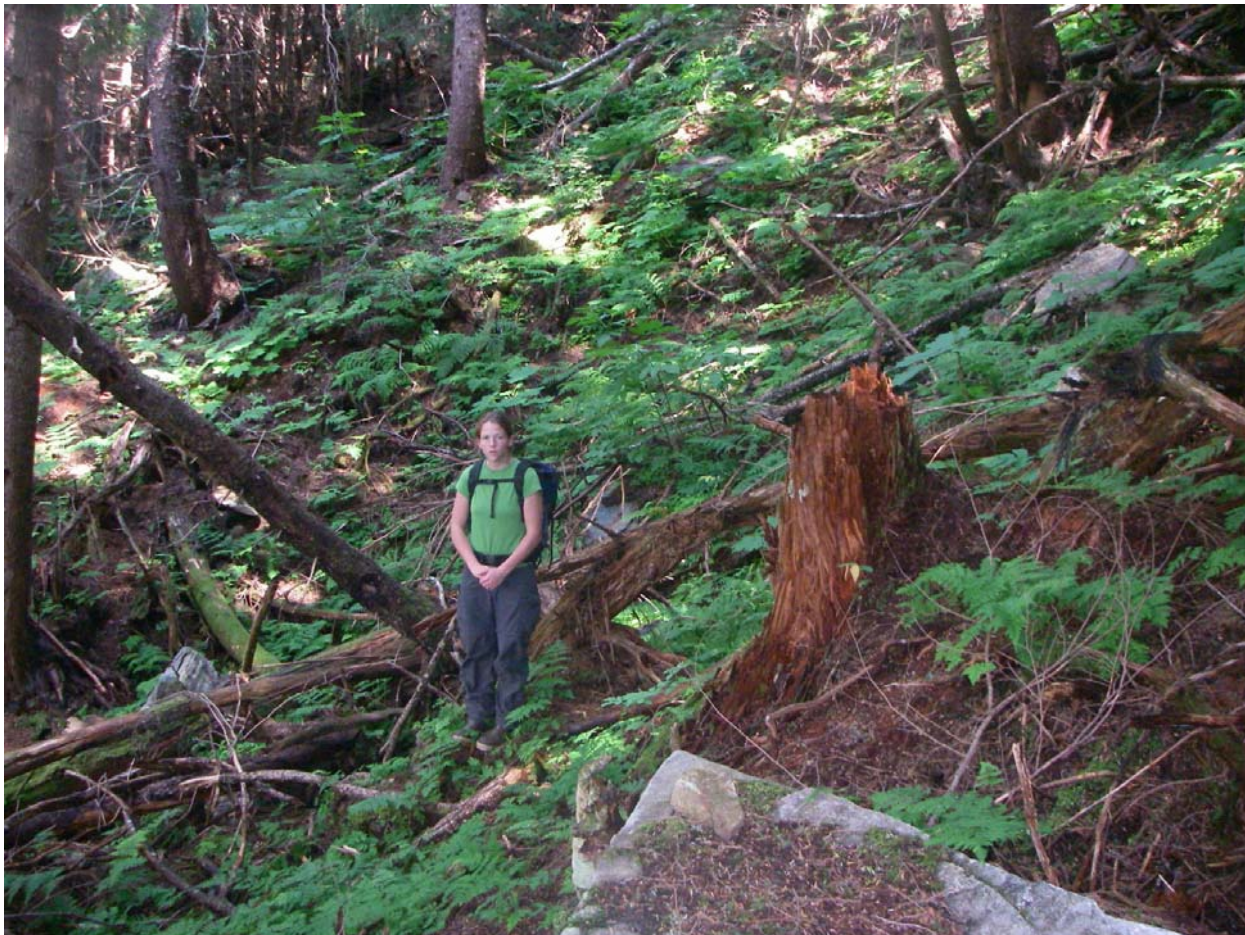
RF16. View north/up alignment across low frequency rockfall area 240 ft east of IRP 2006 2016+20.

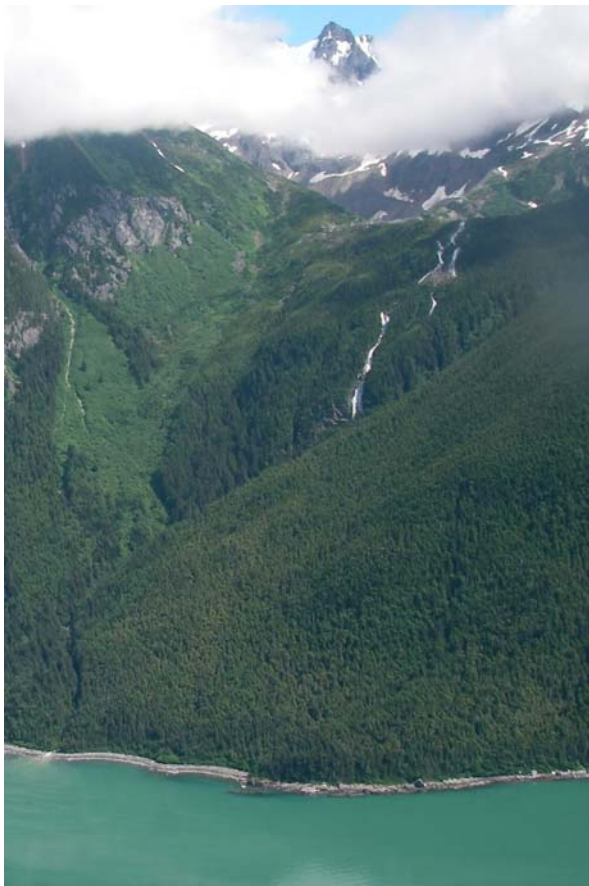
DF23. View east/upslope at debris flow channel and avalanche path ELC017.

Hazard ID #:	DF23
Hazard Type:	debris_flow
HIN:	117
Rating:	A
IRP 2006 Location:	2038
Frequency (yrs):	5-25
Predictability:	moderate
Material Volume (CY):	10-100
Clast Size (ft):	1-2
Source Elev. (ft):	3000+
Centerline Slope:	multi_channel
Alignment Location:	path
Impact Alignment:	yes
Alignment Exposure (ft):	50-200
Vegetation:	disturbed
Deciduous Trees:	yes
IRP 2006 South Margin:	2041+20
IRP 2006 North Margin:	2042+70
Photo #:	5057, 5166

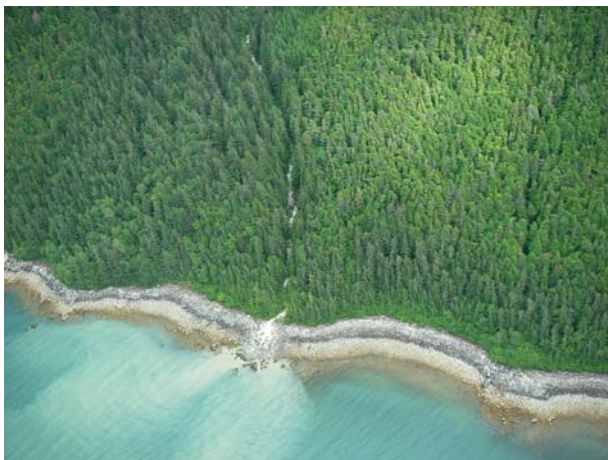
DF23. View east/upslope at debris flow channel and avalanche path ELC017.

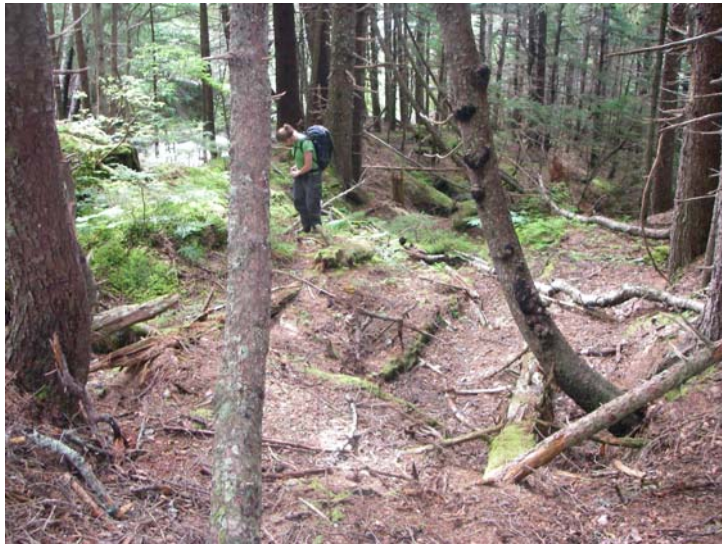
DF23. View southwest (downslope and down alignment) into multi-channel debris flow at centerline. Secondary channel is seen to right of person. Person is located at centerline at IRP 2006 2042+00.

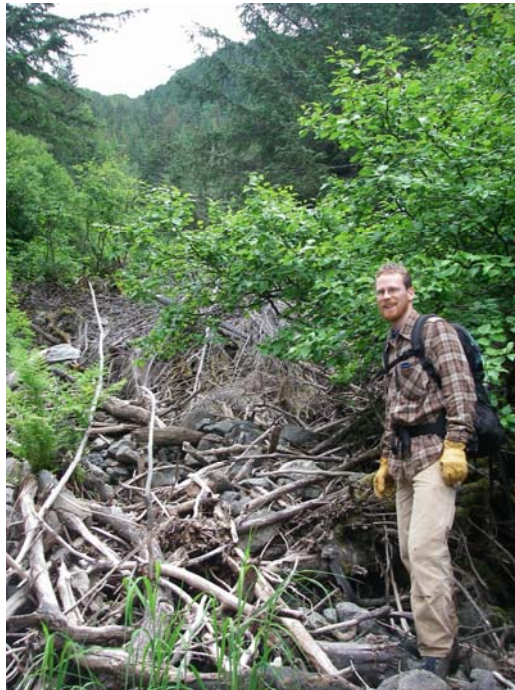
DF23. View east/upslope at debris flow channel and avalanche path ELC017. Photo taken 1,200 ft right of IRP 2006 2042+00.

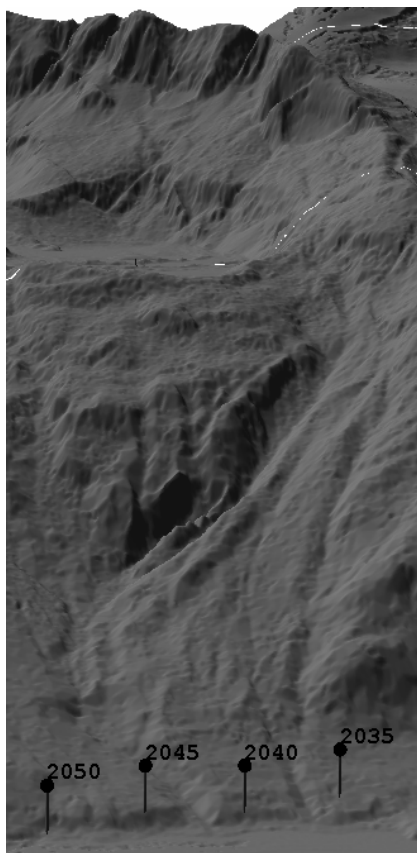
SR01. LIDAR image of soil raveling area.

Hazard ID #:	SR01
Hazard Type:	soil_raveling
HIN:	171
Rating:	B
IRP 2006 Location:	2042
Frequency (yrs):	0-1
Predictability:	high
Material Volume (CY):	<10
Clast Size (ft):	1-2
Source Elev. (ft):	<100
Centerline Slope:	open_soil_slope
Alignment Location:	path
Impact Alignment:	yes
Alignment Exposure (ft):	500+
Vegetation:	disturbed
Deciduous Trees:	yes
IRP 2006 South Margin:	2043+40
IRP 2006 North Margin:	2050+10
Photo #:	5090, 5166, 6244

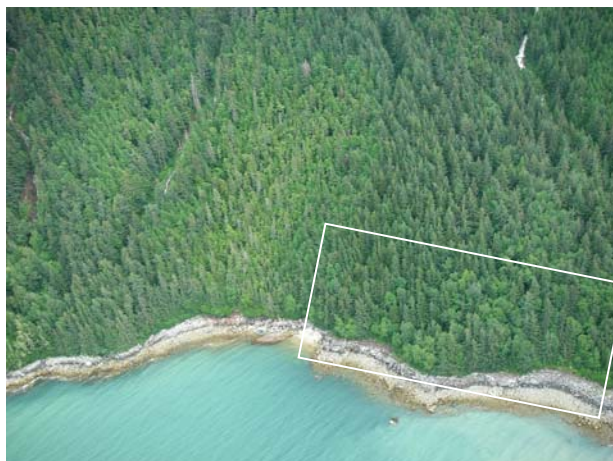
SR01. View east/upslope at soil raveling area.

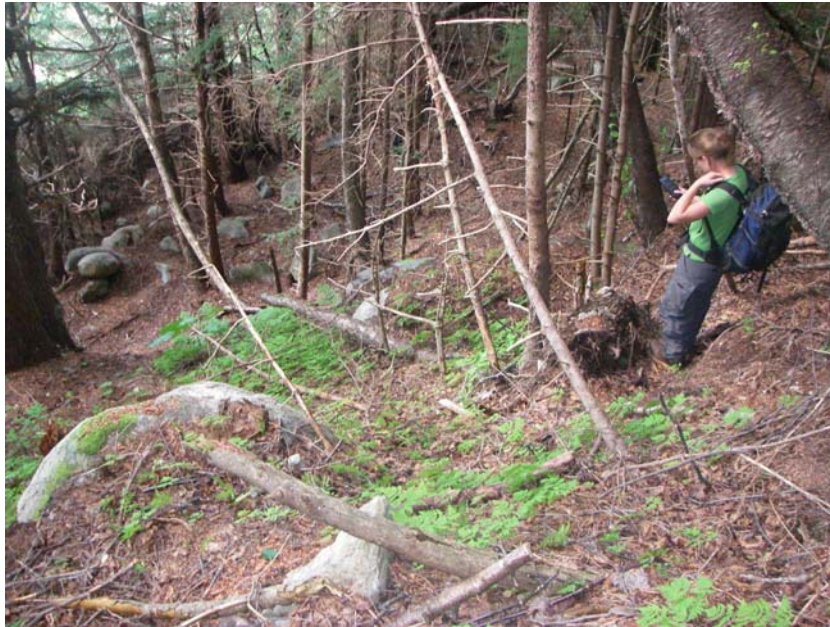
SR01. View northwest (up alignment and downslope) across soil raveling slope with 1-3 ft diameter boulders being deposited 15 ft left of IRP 2006 2047+00.

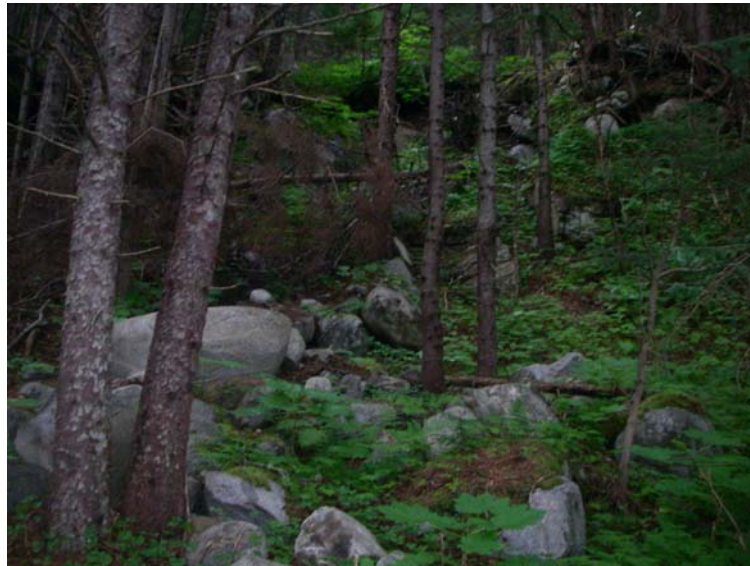
SR01. View east/upslope at soil raveling with 0-3 ft diameter boulders deposited 15 ft left of IRP 2006 alignment.

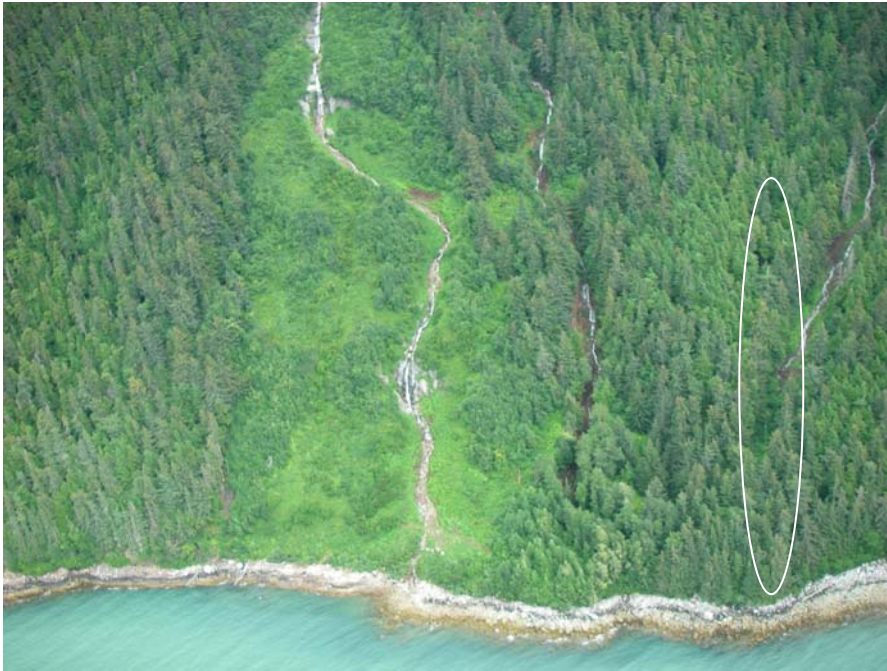
Hazard ID #:	DF24
Hazard Type:	debris_flow
HIN:	207
Rating:	B
IRP 2006 Location:	2054
Frequency (yrs):	1-5
Predictability:	high
Material Volume (CY):	10-100
Clast Size (ft):	1-2
Source Elev. (ft):	3000+
Centerline Slope:	multi_channel
Alignment Location:	deposition_zone
Impact Alignment:	yes
Alignment Exposure (ft):	50-200
Vegetation:	disturbed
Deciduous Trees:	yes
IRP 2006 South Margin:	2054+40
IRP 2006 North Margin:	2056+50
Photo #:	2054, 2239, 3462, 3463, 5093, 6195

DF24. View east/upslope at debris flow channel and avalanche path ELC018 (circled, right) and avalanche path ELC019 (with major stream, center).

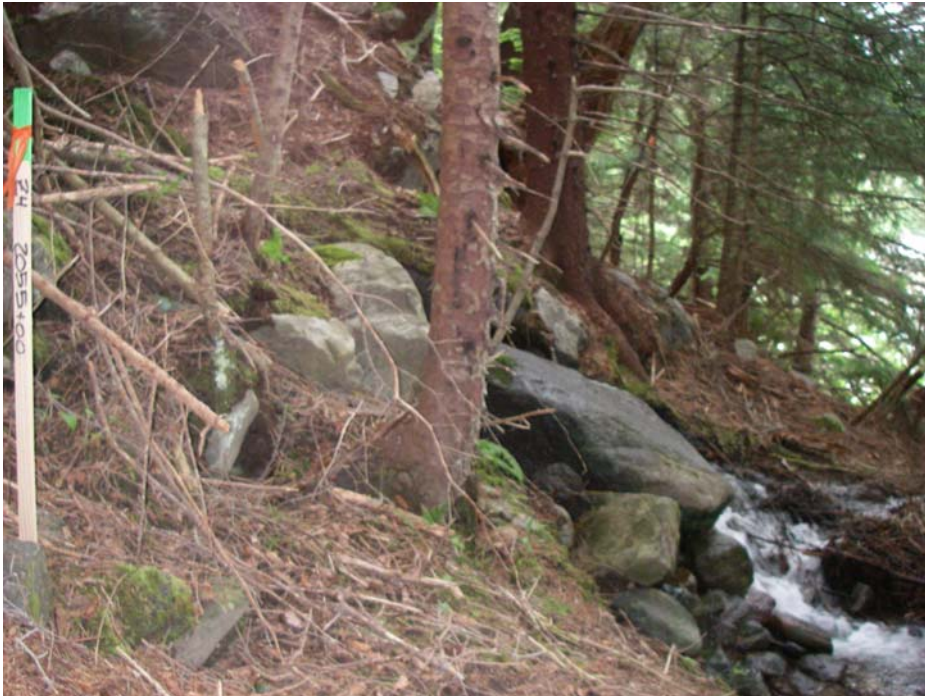
DF24. View south/ down alignment across debris flow fan terminus at IRP 2006 2055+00.

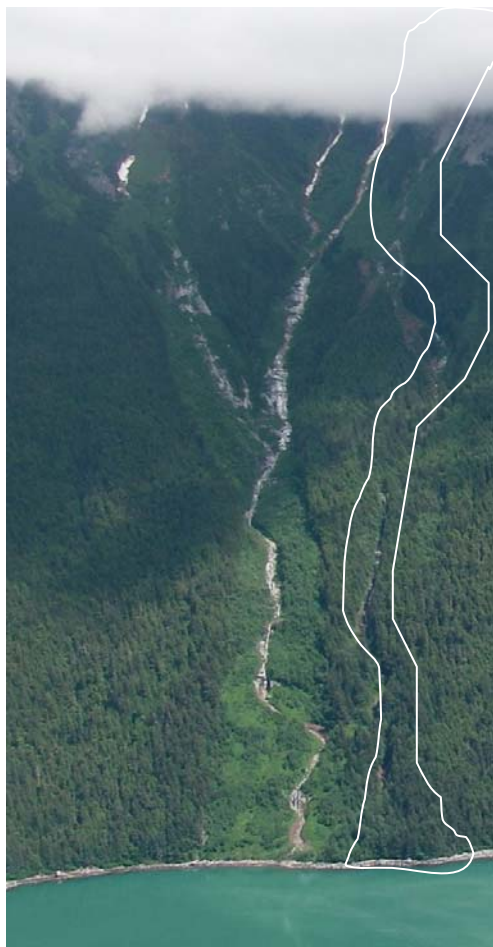
DF25. View east/upslope at debris flow channel.

Hazard ID #:	DF25
Hazard Type:	debris_flow
HIN:	129
Rating:	B
IRP 2006 Location:	2055
Frequency (yrs):	5-25
Predictability:	moderate
Material Volume (CY):	<10
Clast Size (ft):	0-1
Source Elev. (ft):	3000+
Centerline Slope:	fan
Alignment Location:	deposition_zone
Impact Alignment:	yes
Alignment Exposure (ft):	200-500
Vegetation:	disturbed
Deciduous Trees:	no
IRP 2006 South Margin:	2056+50
IRP 2006 North Margin:	2059+00
Photo #:	3462, 3463, 5093, 6195

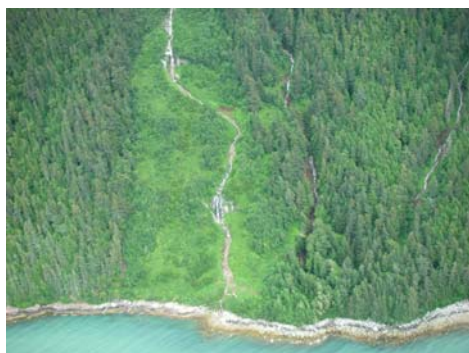
DF25. View east/upslope at debris flow channel.

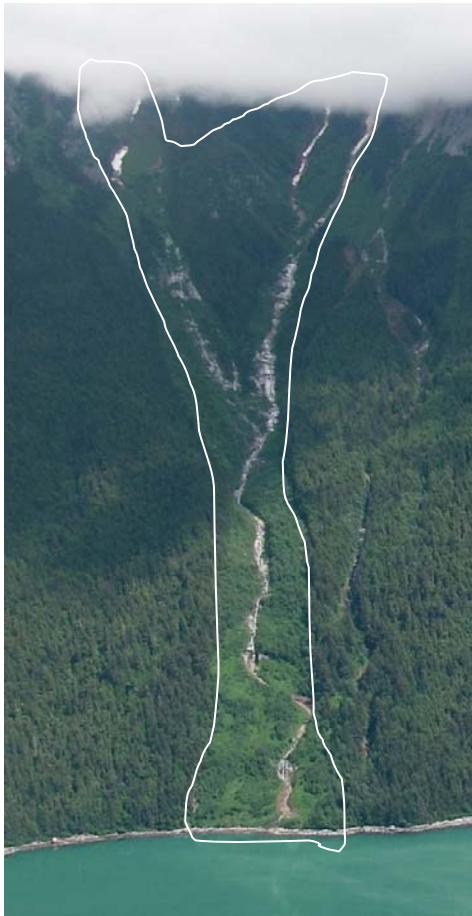
DF26. View east/upslope at debris flow channel and avalanche path ELC019.

Hazard ID #:	DF26
Hazard Type:	debris_flow
HIN:	129
Rating:	B
IRP 2006 Location:	2056
Frequency (yrs):	1-5
Predictability:	high
Material Volume (CY):	10-100
Clast Size (ft):	0-1
Source Elev. (ft):	3000+
Centerline Slope:	fan
Alignment Location:	deposition_zone
Impact Alignment:	yes
Alignment Exposure (ft):	50-200
Vegetation:	disturbed
Deciduous Trees:	yes
IRP 2006 South Margin:	2059+00
IRP 2006 North Margin:	2060+50
Photo #:	2241, 3470, 6195

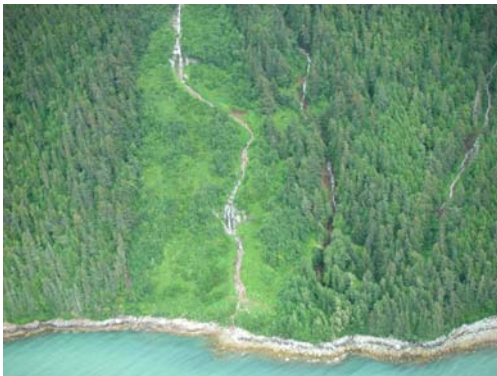
DF26. View east/upslope at debris flow channel and avalanche path ELC019 (center).

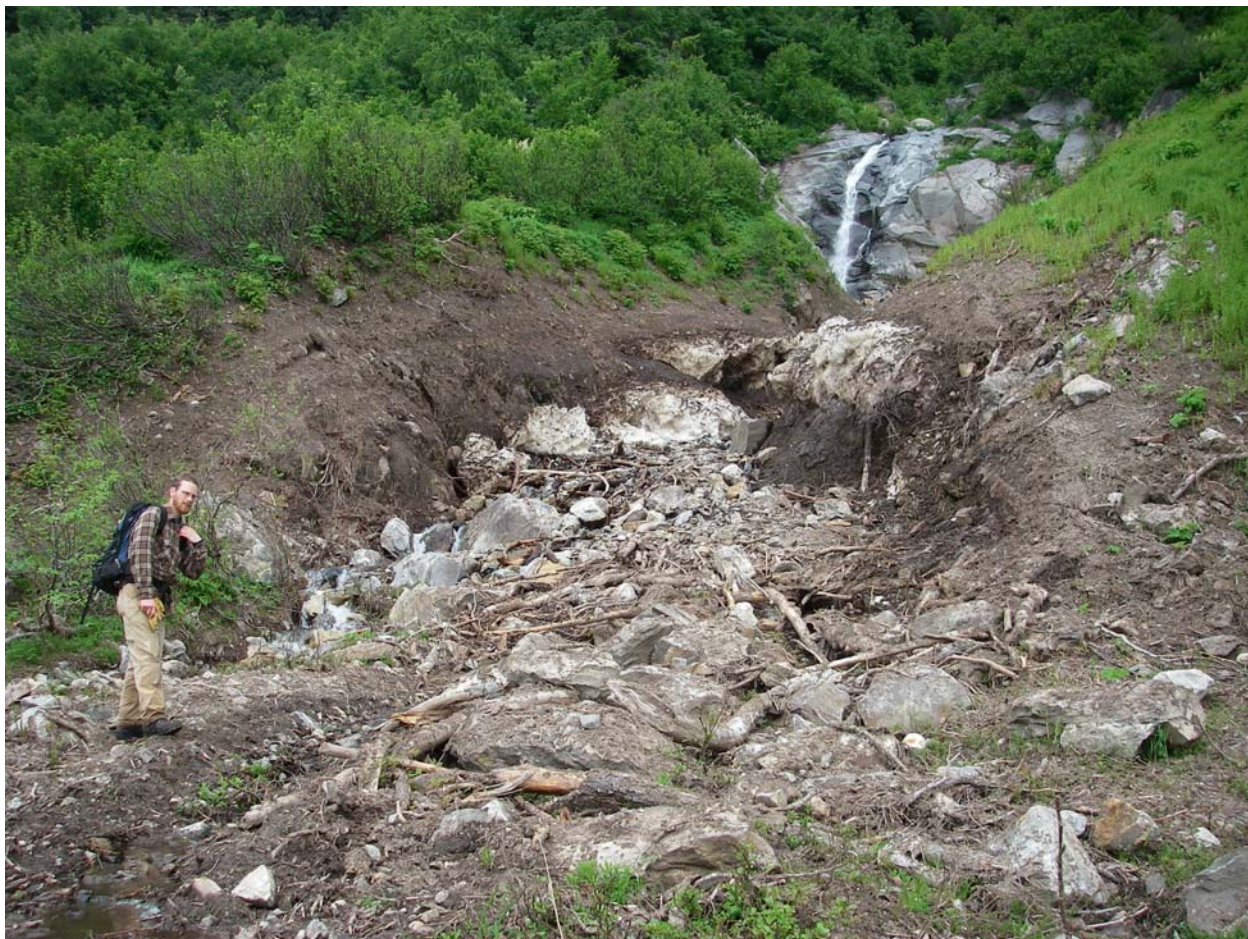
DF26. View east/upslope at debris flow channel and avalanche path ELC019. Photo taken 20 ft left of IRP 2006 2059+50.

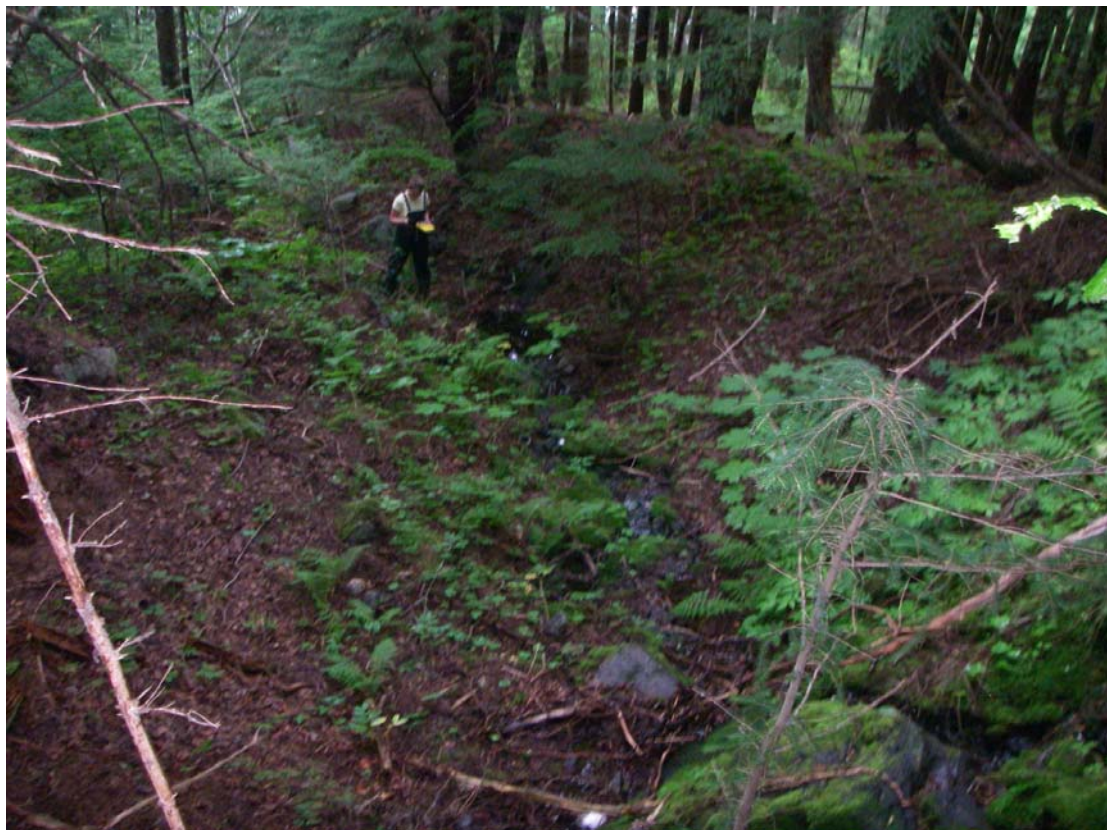
Hazard ID #:	DF27
Hazard Type:	debris_flow
HIN:	129
Rating:	B
IRP 2006 Location:	2088
Frequency (yrs):	5-25
Predictability:	Low
Material Volume (CY):	<10
Clast Size (ft):	0-1
Source Elev. (ft):	2000-3000
Centerline Slope:	open_soil_slope
Alignment Location:	deposition_zone
Impact Alignment:	yes
Alignment Exposure (ft):	50-200
Vegetation:	disturbed
Deciduous Trees:	yes
IRP 2006 South Margin:	2088+00
IRP 2006 North Margin:	2089+00
Photo #:	3885, 5167, 5924, 6247

DF27. View east/upslope at debris flow channel and avalanche path ELC019-1. Photo taken at centerline at IRP 2006 2088+50.

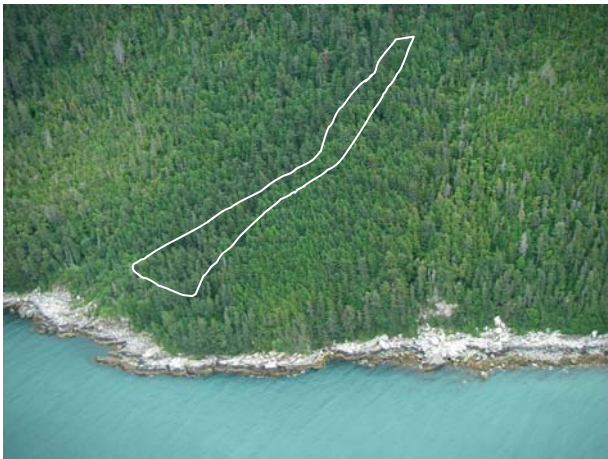
DF28. View east/upslope at debris flow channel.

Hazard ID #:	DF28
Hazard Type:	debris_flow
HIN:	183
Rating:	A
IRP 2006 Location:	2104
Frequency (yrs):	0-1
Predictability:	high
Material Volume (CY):	10-100
Clast Size (ft):	3-4
Source Elev. (ft):	3000+
Centerline Slope:	fan
Alignment Location:	deposition_zone
Impact Alignment:	yes
Alignment Exposure (ft):	50-200
Vegetation:	denuded
Deciduous Trees:	yes
IRP 2006 South Margin:	2102+30
IRP 2006 North Margin:	2103+70
Photo #:	3886, 5916

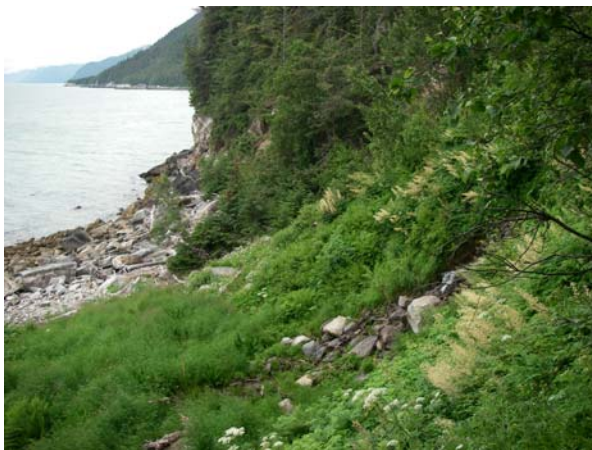
DF28. View northwest (up alignment and downslope) at IRP 2006 2103+00 at deposition fan of debris flow.

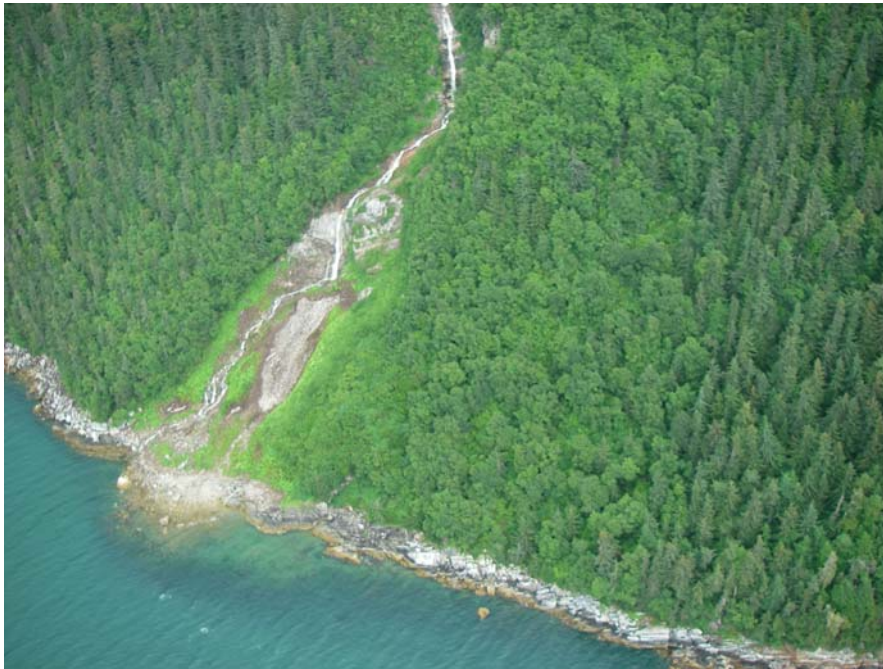
Hazard ID #:	DF29
Hazard Type:	debris_flow
HIN:	153
Rating:	A
IRP 2006 Location:	2114
Frequency (yrs):	1-5
Predictability:	moderate
Material Volume (CY):	10-100
Clast Size (ft):	1-2
Source Elev. (ft):	3000+
Centerline Slope:	fan
Alignment Location:	deposition_zone
Impact Alignment:	yes
Alignment Exposure (ft):	200-500
Vegetation:	denuded
Deciduous Trees:	yes
IRP 2006 South Margin:	2115+00
IRP 2006 North Margin:	2117+40
Photo #:	5125, 5926, 6248

DF29. View northeast (up alignment and upslope) at debris flow deposition zone and avalanche path ELC020.

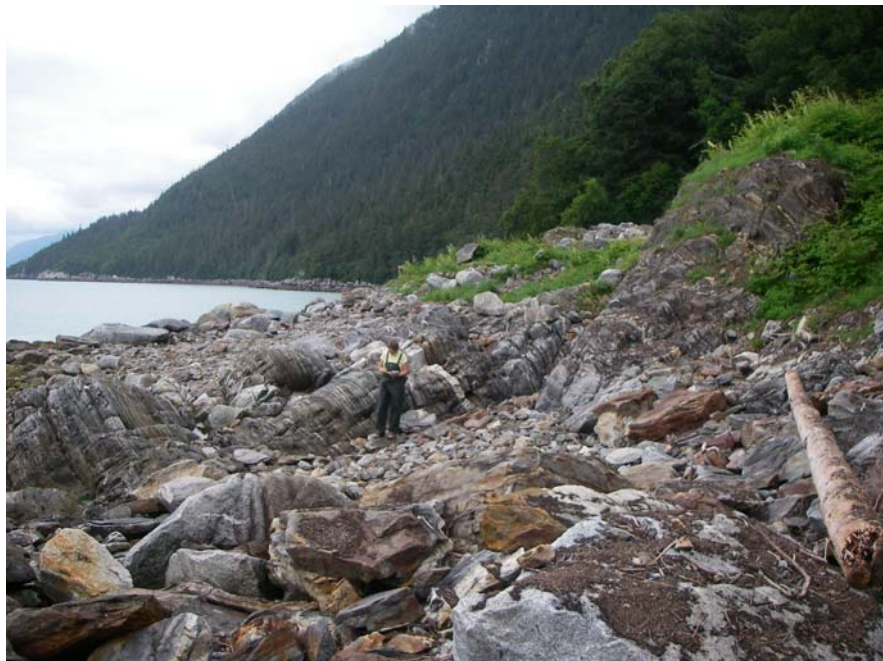
DF29. View north/up alignment across debris flow fan 15 ft left of IRP 2006 2117+00 at base of avalanche path ELC020.

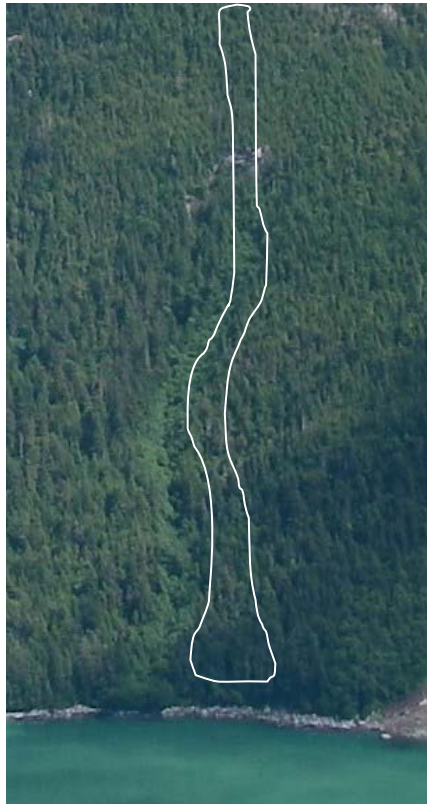
DF30. View east/upslope at debris flow path.

Hazard ID #:	DF30
Hazard Type:	debris_flow
HIN:	135
Rating:	B
IRP 2006 Location:	2123
Frequency (yrs):	5-25
Predictability:	low
Material Volume (CY):	10-100
Clast Size (ft):	0-1
Source Elev. (ft):	1000-2000
Centerline Slope:	single_channel
Alignment Location:	deposition_zone
Impact Alignment:	yes
Alignment Exposure (ft):	50-200
Vegetation:	disturbed
Deciduous Trees:	yes
IRP 2006 South Margin:	2123+00
IRP 2006 North Margin:	2123+90
Photo #:	5168, 5927, 6250

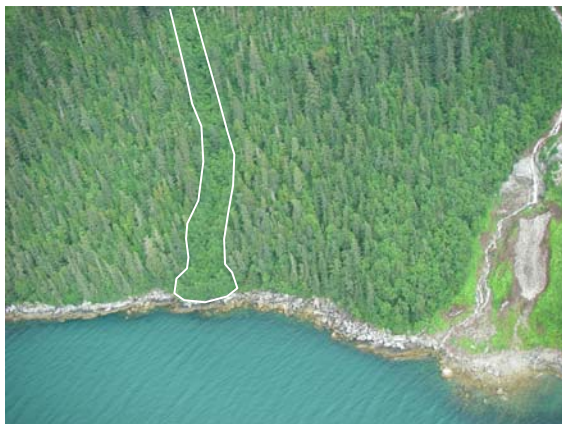
DF30. Disturbed vegetation marks path of debris flow.

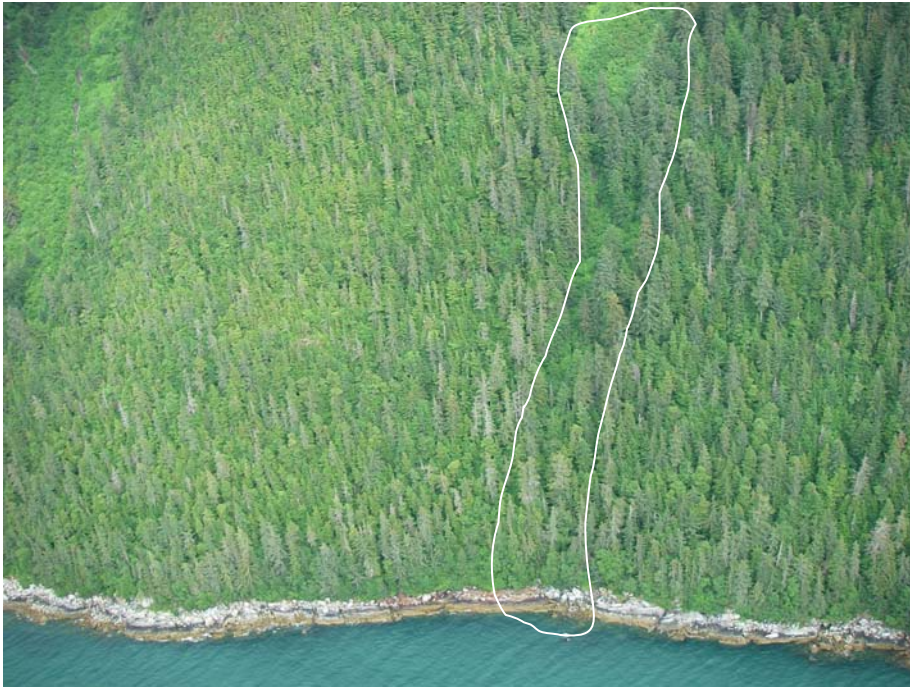
Hazard ID #:	RF17
Hazard Type:	rockfall
HIN:	201
Rating:	A
IRP 2006 Location:	2129
Frequency (yrs):	1-5
Predictability:	unpredictable
Material Volume (CY):	<10
Clast Size (ft):	3-4
Source Elev. (ft):	1000-2000
Centerline Slope:	open_soil_slope
Alignment Location:	path
Impact Alignment:	yes
Alignment Exposure (ft):	50-200
Vegetation:	disturbed
Deciduous Trees:	yes
IRP 2006 South Margin:	2129+00
IRP 2006 North Margin:	2130+00
Photo #:	5928, 6251

RF17. View east/upslope at rockfall path.

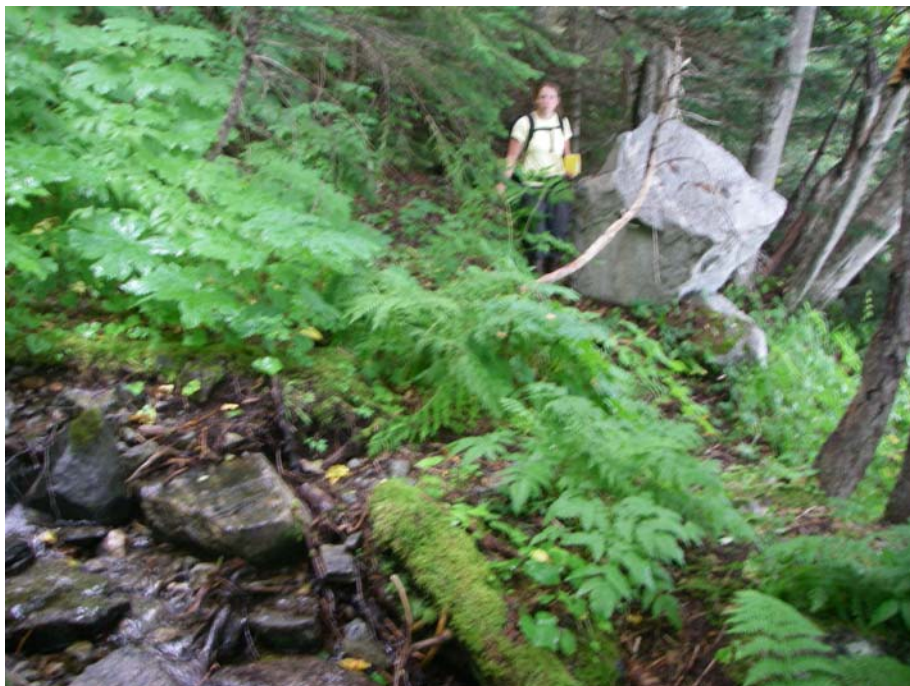
RF17. View south/down alignment across rockfall with 3-5 ft diameter boulders at IRP 2006 2129+50.

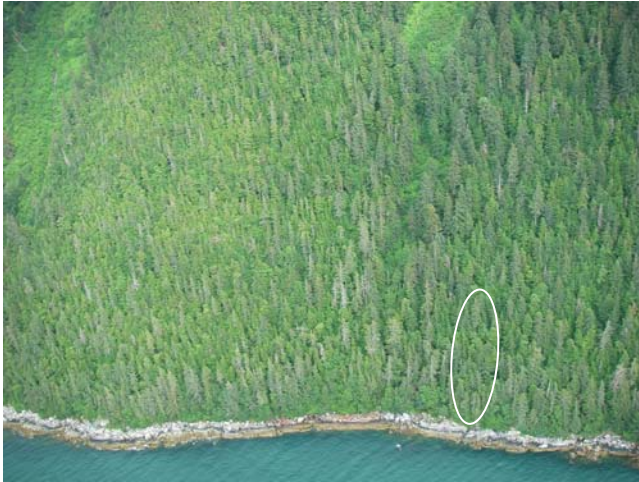
SR02. View east/upslope at soil raveling area.

Hazard ID #:	SR02
Hazard Type:	soil_raveling
HIN:	171
Rating:	B
IRP 2006 Location:	2130
Frequency (yrs):	0-1
Predictability:	unpredictable
Material Volume (CY):	<10
Clast Size (ft):	0-1
Source Elev. (ft):	<100
Centerline Slope:	single_channel
Alignment Location:	deposition_zone
Impact Alignment:	yes
Alignment Exposure (ft):	<50
Vegetation:	disturbed
Deciduous Trees:	yes
IRP 2006 South Margin:	2129+40
IRP 2006 North Margin:	2129+80
Photo #:	3889, 5168

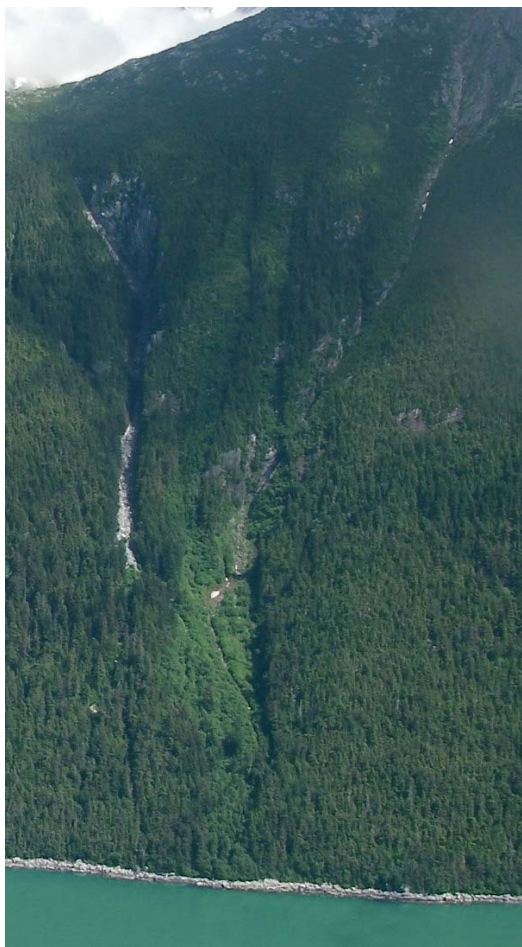
RF18. View east/upslope at rockfall area.

Hazard ID #:	RF18
Hazard Type:	rockfall
HIN:	105
Rating:	C
IRP 2006 Location:	2134
Frequency (yrs):	unknown (5-25?)
Predictability:	unpredictable
Material Volume (CY):	10-100
Clast Size (ft):	1-2
Source Elev. (ft):	<100
Centerline Slope:	open_bedrock_slope
Alignment Location:	starting_zone
Impact Alignment:	no
Alignment Exposure (ft):	<50
Vegetation:	-
Deciduous Trees:	no
IRP 2006 South Margin:	2134+00
IRP 2006 North Margin:	2134+50
Photo #:	1751, 3490, 5169, 5929

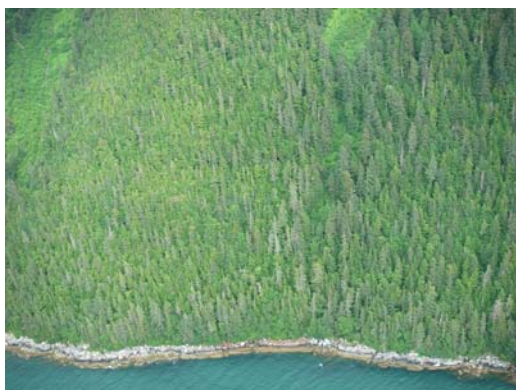
RF18. View east/upslope at rockfall area.

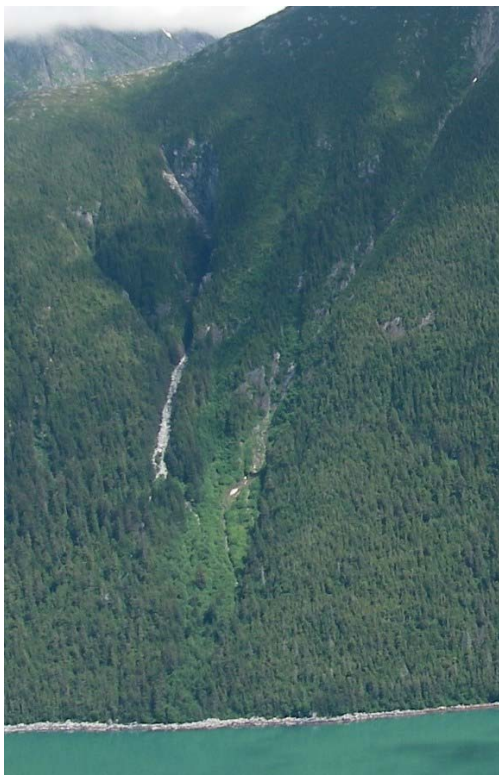
RF19. View east/upslope at large rockfall area.

Hazard ID #:	RF19
Hazard Type:	rockfall
HIN:	273
Rating:	A
IRP 2006 Location:	2144
Frequency (yrs):	1-5
Predictability:	unpredictable
Material Volume (CY):	<10
Clast Size (ft):	4+
Source Elev. (ft):	3000+
Centerline Slope:	fan
Alignment Location:	deposition_zone
Impact Alignment:	yes
Alignment Exposure (ft):	500+
Vegetation:	disturbed
Deciduous Trees:	yes
IRP 2006 South Margin:	2142+70
IRP 2006 North Margin:	2150+30
Photo #:	1357, 3491, 3493, 3495, 3498, 5130, 5168

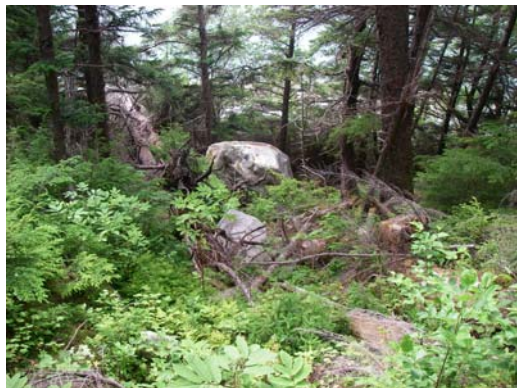
RF19. Fresh 6 ft diameter mega-boulder and related deforestation at centerline at IRP 2006 2144+00.

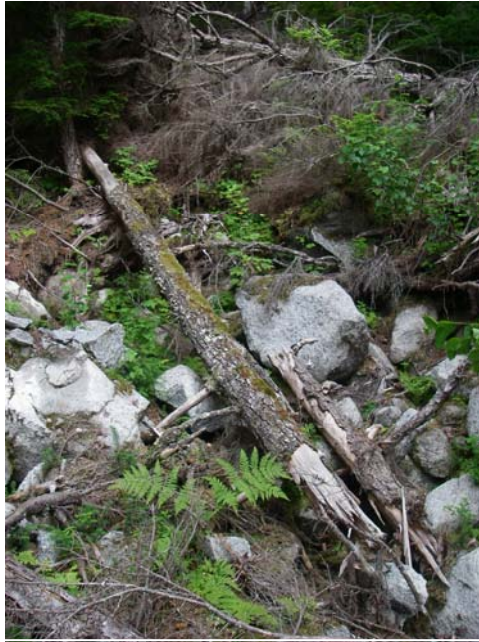
RF19. View west/downslope at rockfall debris deposited at centerline at IRP 2006 2144+00.

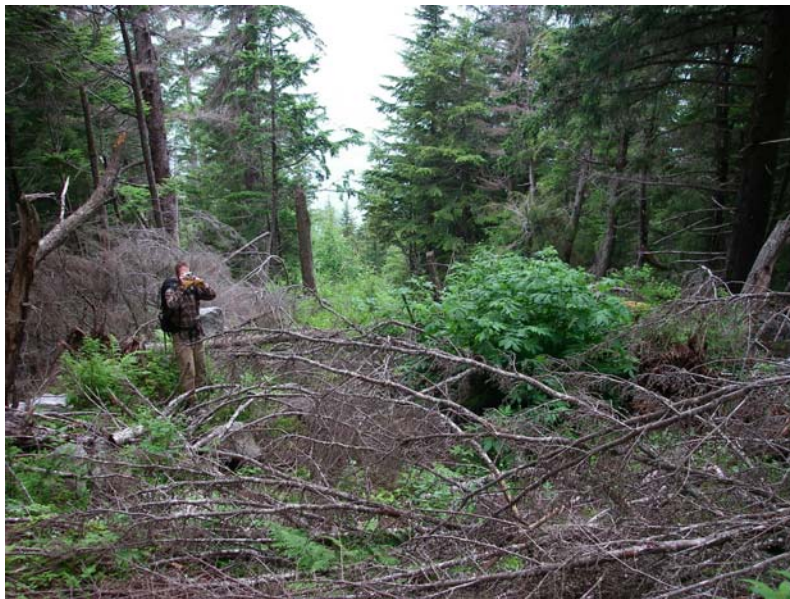
RF19. View west/downslope at rockfall path. Photo taken 400 ft right of IRP 2006 2145+00.

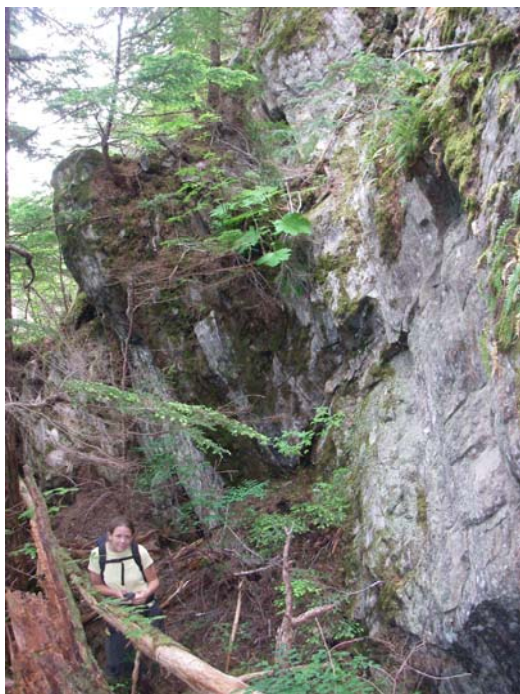
RF21. View north/up alignment at rockfall hazard.

Hazard ID #:	RF21
Hazard Type:	rockfall
HIN:	147
Rating:	C
IRP 2006 Location:	2154
Frequency (yrs):	1-5
Predictability:	unpredictable
Material Volume (CY):	<10
Clast Size (ft):	2-3
Source Elev. (ft):	500-1000
Centerline Slope:	-
Alignment Location:	below_deposition _zone
Impact Alignment:	no
Alignment Exposure (ft):	50-200
Vegetation:	disturbed
Deciduous Trees:	yes
IRP 2006 South Margin:	2154+00
IRP 2006 North Margin:	2155+00
Photo #:	6014

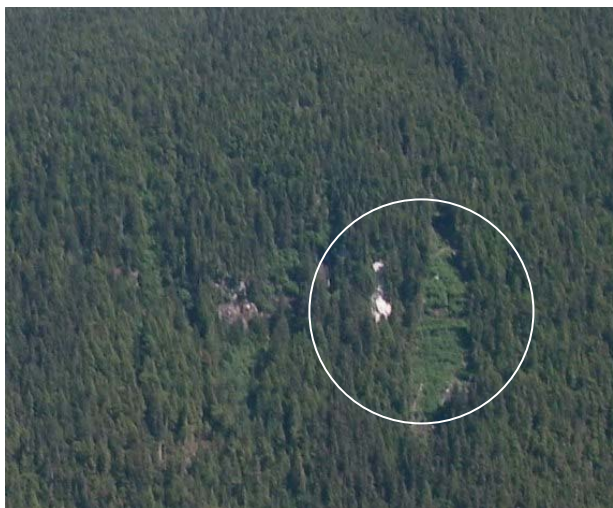
LS01. View east/upslope at landslide area.

Hazard ID #:	LS01
Hazard Type:	landslide
HIN:	183
Rating:	C
IRP 2006 Location:	2205
Frequency (yrs):	unknown (>25?)
Predictability:	unpredictable
Material Volume (CY):	10-100
Clast Size (ft):	-
Source Elev. (ft):	1000-2000
Centerline Slope:	-
Alignment Location:	below_deposition _zone
Impact Alignment:	no
Alignment Exposure (ft):	<50
Vegetation:	disturbed
Deciduous Trees:	no
IRP 2006 South Margin:	2204+00
IRP 2006 North Margin:	2208+00
Photo #:	5171

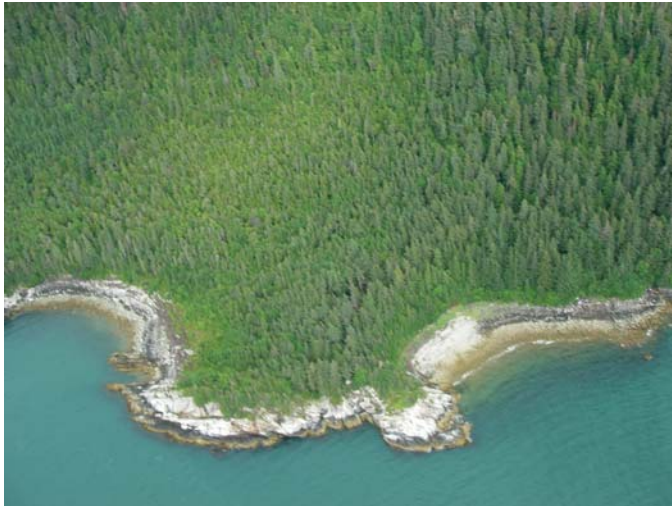
DF32. View east/upslope at outlet of debris flow.

Hazard ID #:	DF32
Hazard Type:	debris_flow
HIN:	51
Rating:	B
IRP 2006 Location:	2207
Frequency (yrs):	5-25
Predictability:	high
Material Volume (CY):	<10
Clast Size (ft):	0-1
Source Elev. (ft):	500-1000
Centerline Slope:	single_channel
Alignment Location:	path
Impact Alignment:	yes
Alignment Exposure (ft):	50-200
Vegetation:	disturbed
Deciduous Trees:	yes
IRP 2006 South Margin:	2206+60
IRP 2006 North Margin:	2207+20
Photo #:	6018

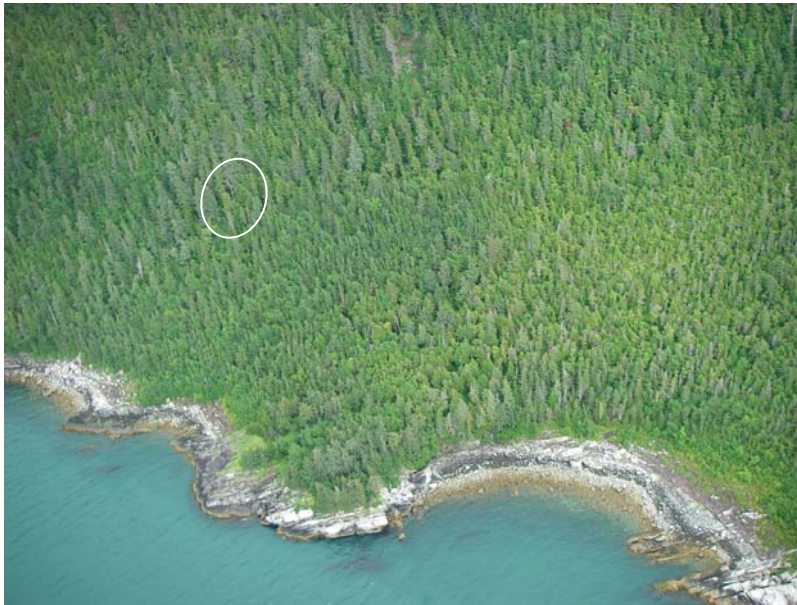
Hazard ID #:	LS02
Hazard Type:	translational_slide
HIN:	135
Rating:	C
IRP 2006 Location:	2220
Frequency (yrs):	1-5
Predictability:	unpredictable
Material Volume (CY):	10-100
Clast Size (ft):	0-1
Source Elev. (ft):	100-500
Centerline Slope:	-
Alignment Location:	below_deposition_ zone
Impact Alignment:	no
Alignment Exposure (ft):	50-200
Vegetation:	denuded
Deciduous Trees:	yes
IRP 2006 South Margin:	2219+60
IRP 2006 North Margin:	2221+00
Photo #:	5000, 5937

LS02. View east/upslope at landslide area.

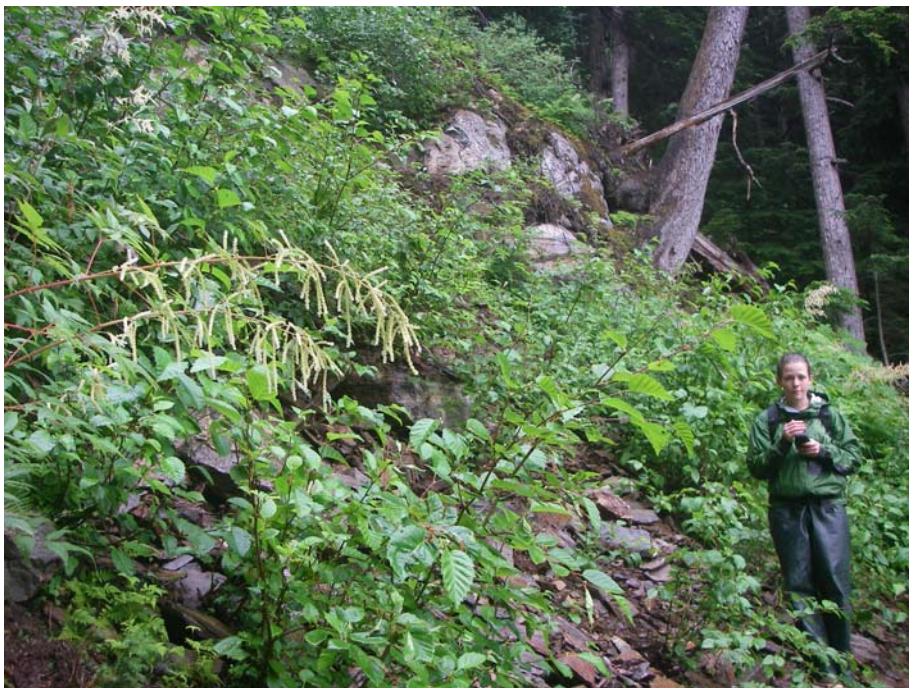
LS02. View south/down alignment at landslide and exposed bedrock. Photo taken 47 ft right of IRP 2006 2221+00.

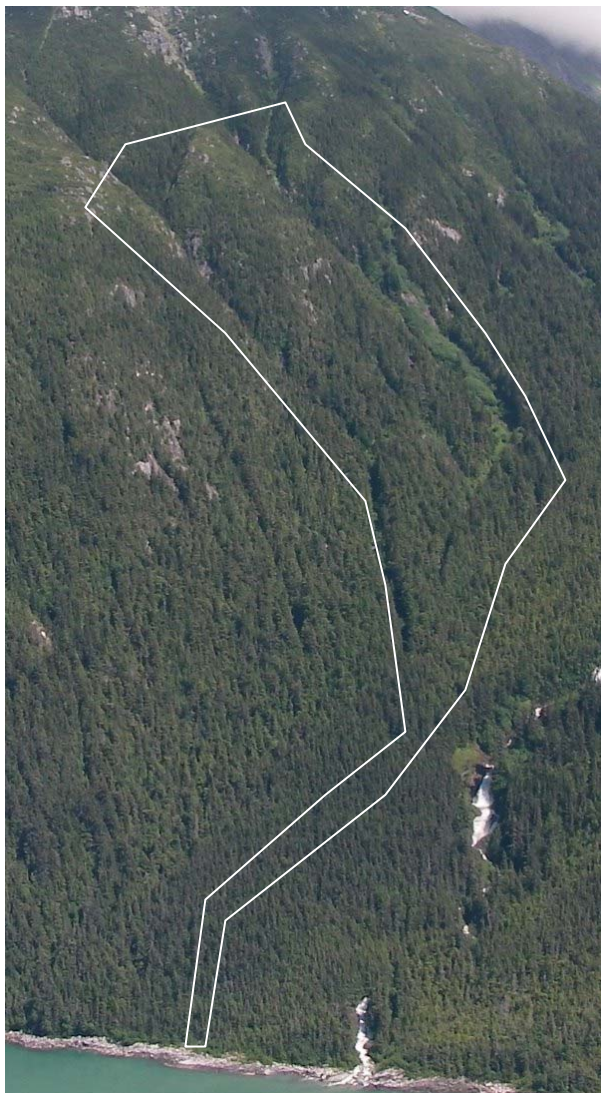
DF33. View east/upslope at debris flow channel.

Hazard ID #:	DF33
Hazard Type:	debris_flow
HIN:	183
Rating:	B
IRP 2006 Location:	2250
Frequency (yrs):	unknown (5-25?)
Predictability:	unpredictable
Material Volume (CY):	10-100
Clast Size (ft):	1-2
Source Elev. (ft):	3000+
Centerline Slope:	single_channel
Alignment Location:	path
Impact Alignment:	yes
Alignment Exposure (ft):	<50
Vegetation:	denuded
Deciduous Trees:	no
IRP 2006 South Margin:	2252+50
IRP 2006 North Margin:	2252+80
Photo #:	6023
