FINAL REPORT

**LYNN CANAL HIGHWAY
PHASE I
ZONE 4 GEOTECHNICAL INVESTIGATION**

STATE PROJECT NUMBER: 71100

*Golder Associates Inc.
1750 Abbott Road, Suite 200
Anchorage, Alaska 99507*

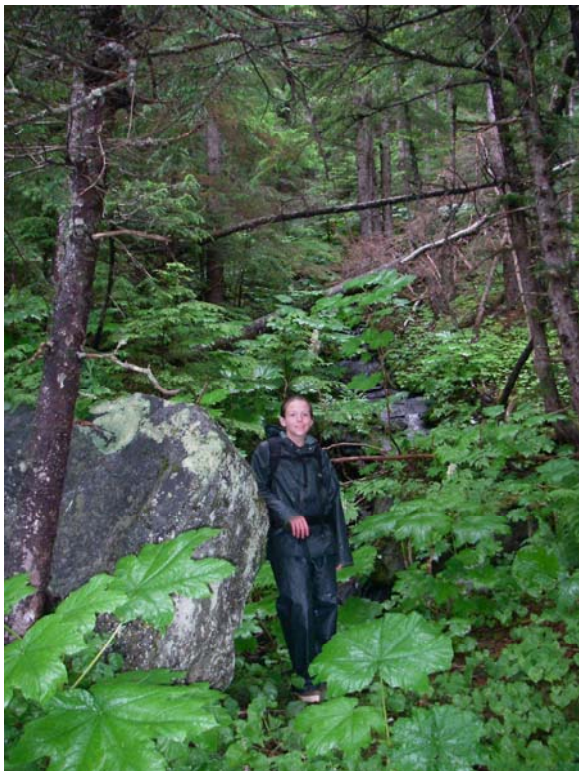
RF22. View east/upslope at fresh rockfall. Photo taken 150 left of IRP 2006 2253+50.

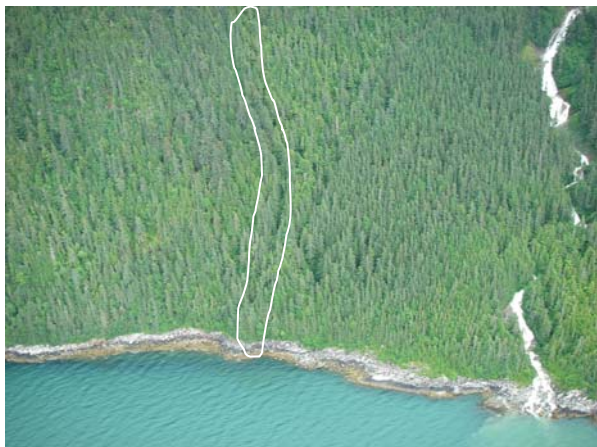
RF22. View east/upslope at rockfall path.

Hazard ID #:	RF22
Hazard Type:	rockfall
HIN:	147
Rating:	B
IRP 2006 Location:	2254
Frequency (yrs):	1-5
Predictability:	unpredictable
Material Volume (CY):	<10
Clast Size (ft):	1-2
Source Elev. (ft):	500-1000
Centerline Slope:	single_channel
Alignment Location:	path
Impact Alignment:	yes
Alignment Exposure (ft):	50-200
Vegetation:	disturbed
Deciduous Trees:	no
IRP 2006 South Margin:	2253+30
IRP 2006 North Margin:	2253+80
Photo #:	5941, 6024

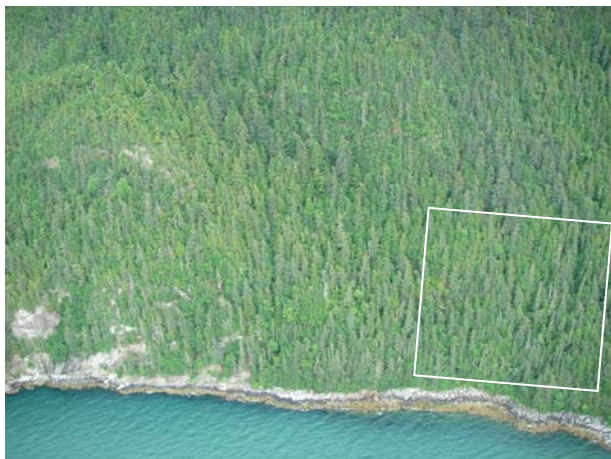
RF23. View east/upslope at rockfall area.

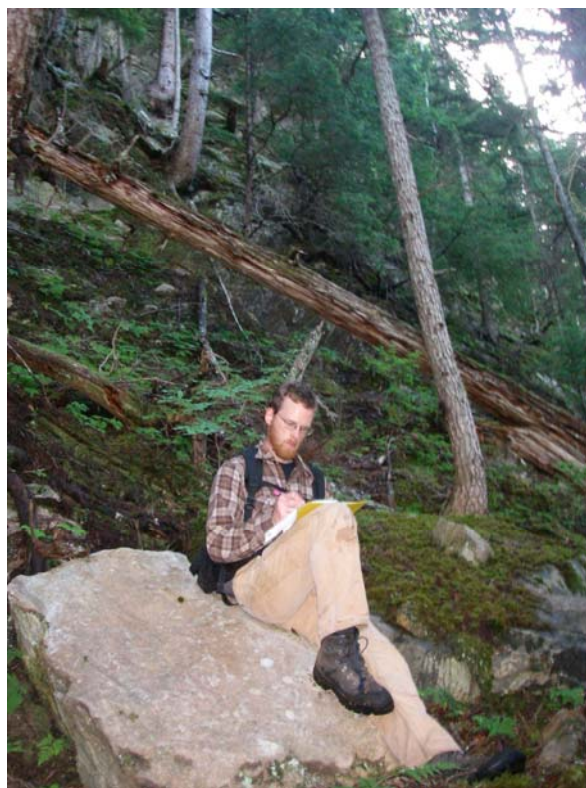
RF23. View south/down alignment at fresh rockfall hazard. Photo taken 100 ft right of IRP 2006 2256+00.

Hazard ID #:	RF23
Hazard Type:	rockfall
HIN:	147
Rating:	B
IRP 2006 Location:	2256
Frequency (yrs):	unknown (1-5?)
Predictability:	unpredictable
Material Volume (CY):	<10
Clast Size (ft):	0-1
Source Elev. (ft):	100-500
Centerline Slope:	other
Alignment Location:	deposition_zone
Impact Alignment:	yes
Alignment Exposure (ft):	200-500
Vegetation:	disturbed
Deciduous Trees:	no
IRP 2006 South Margin:	2254+90
IRP 2006 North Margin:	2258+10
Photo #:	3505

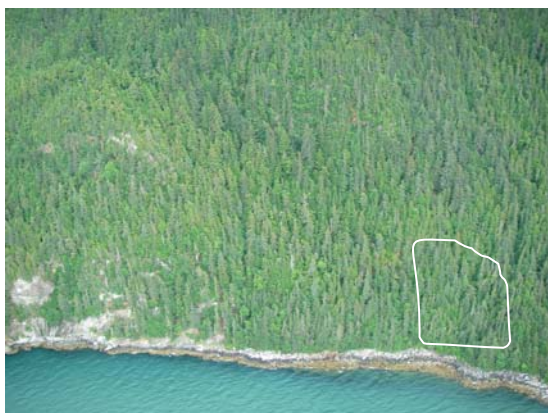
RF24. View east/upslope at rockfall hazard.

Hazard ID #:	RF24
Hazard Type:	rockfall
HIN:	147
Rating:	C
IRP 2006 Location:	2260
Frequency (yrs):	unknown (1-5?)
Predictability:	unpredictable
Material Volume (CY):	<10
Clast Size (ft):	4+
Source Elev. (ft):	100-500
Centerline Slope:	-
Alignment Location:	below_deposition_zone
Impact Alignment:	no
Alignment Exposure (ft):	200-500
Vegetation:	disturbed
Deciduous Trees:	yes
IRP 2006 South Margin:	2258+90
IRP 2006 North Margin:	2261+00
Photo #:	3507

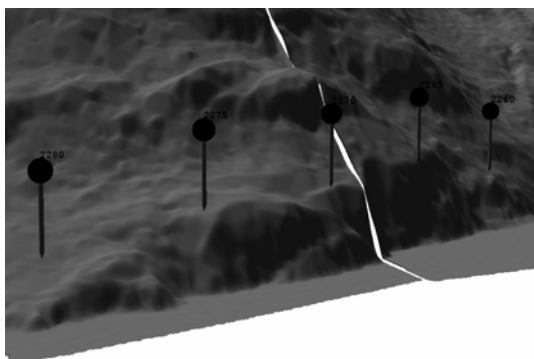
RF24. LIDAR bare earth image of rockfall hazard.

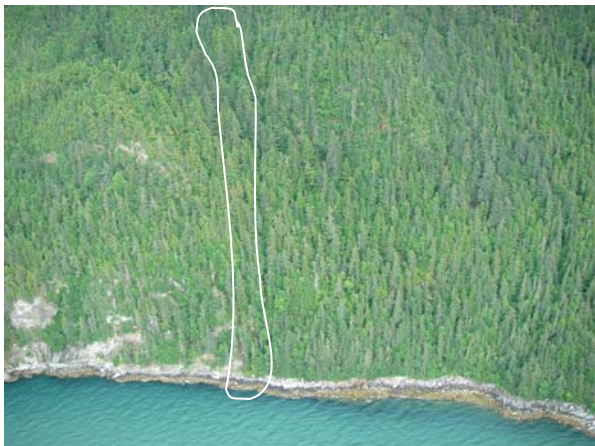
RS02. View east/upslope at rockfall hazard and rockslide.

Hazard ID #:	RS02
Hazard Type:	rock_slide
HIN:	81
Rating:	A
IRP 2006 Location:	2261
Frequency (yrs):	1-5
Predictability:	moderate
Material Volume (CY):	10-100
Clast Size (ft):	1-2
Source Elev. (ft):	500-1000
Centerline Slope:	single_channel
Alignment Location:	path
Impact Alignment:	yes
Alignment Exposure (ft):	50-200
Vegetation:	disturbed
Deciduous Trees:	no
IRP 2006 South Margin:	2261+10
IRP 2006 North Margin:	2261+80
Photo #:	3508, 3510, 3511

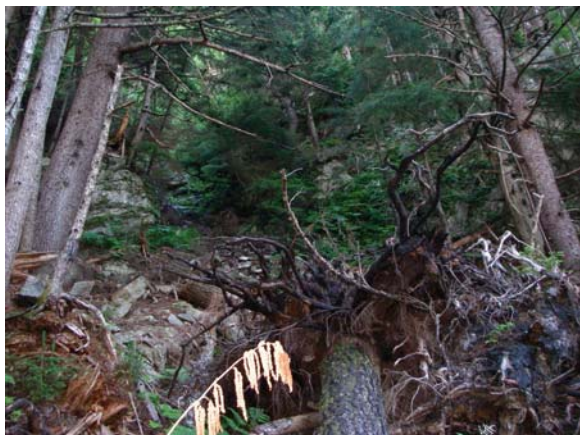
RS02. View east/upslope at rockslide path. Photo taken 270 ft right of IRP 2006 2261+00.

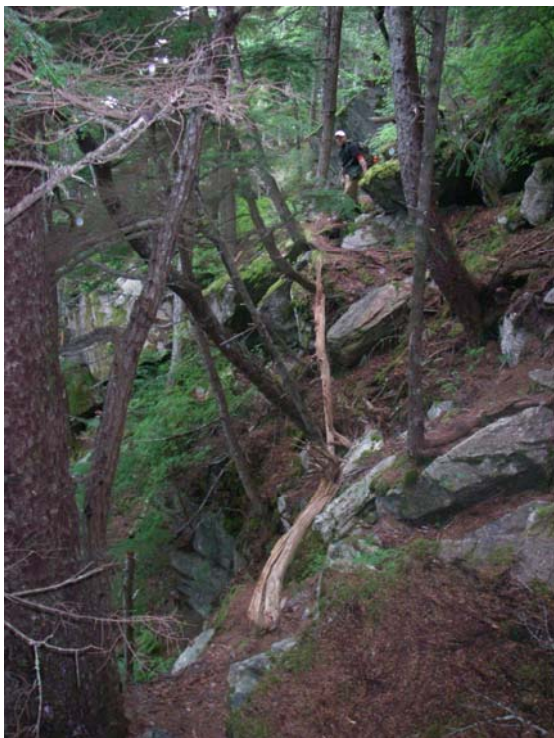
SR03. View north/up alignment at soil raveling. Photo taken at centerline at IRP 2006 2267+00.

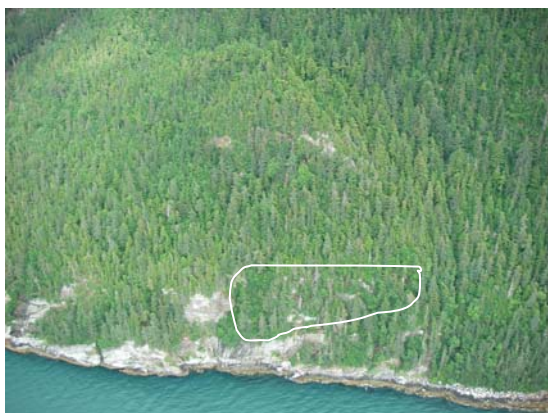
SR03. View east/upslope at soil raveling area.

Hazard ID #:	SR03
Hazard Type:	soil_raveling
HIN:	147
Rating:	B
IRP 2006 Location:	2265
Frequency (yrs):	1-5
Predictability:	unpredictable
Material Volume (CY):	<10
Clast Size (ft):	2-3
Source Elev. (ft):	100-500
Centerline Slope:	open_bedrock_slope
Alignment Location:	path
Impact Alignment:	yes
Alignment Exposure (ft):	200-500
Vegetation:	disturbed
Deciduous Trees:	yes
IRP 2006 South Margin:	2263+50
IRP 2006 North Margin:	2267+40
Photo #:	5579, 5580, 5581

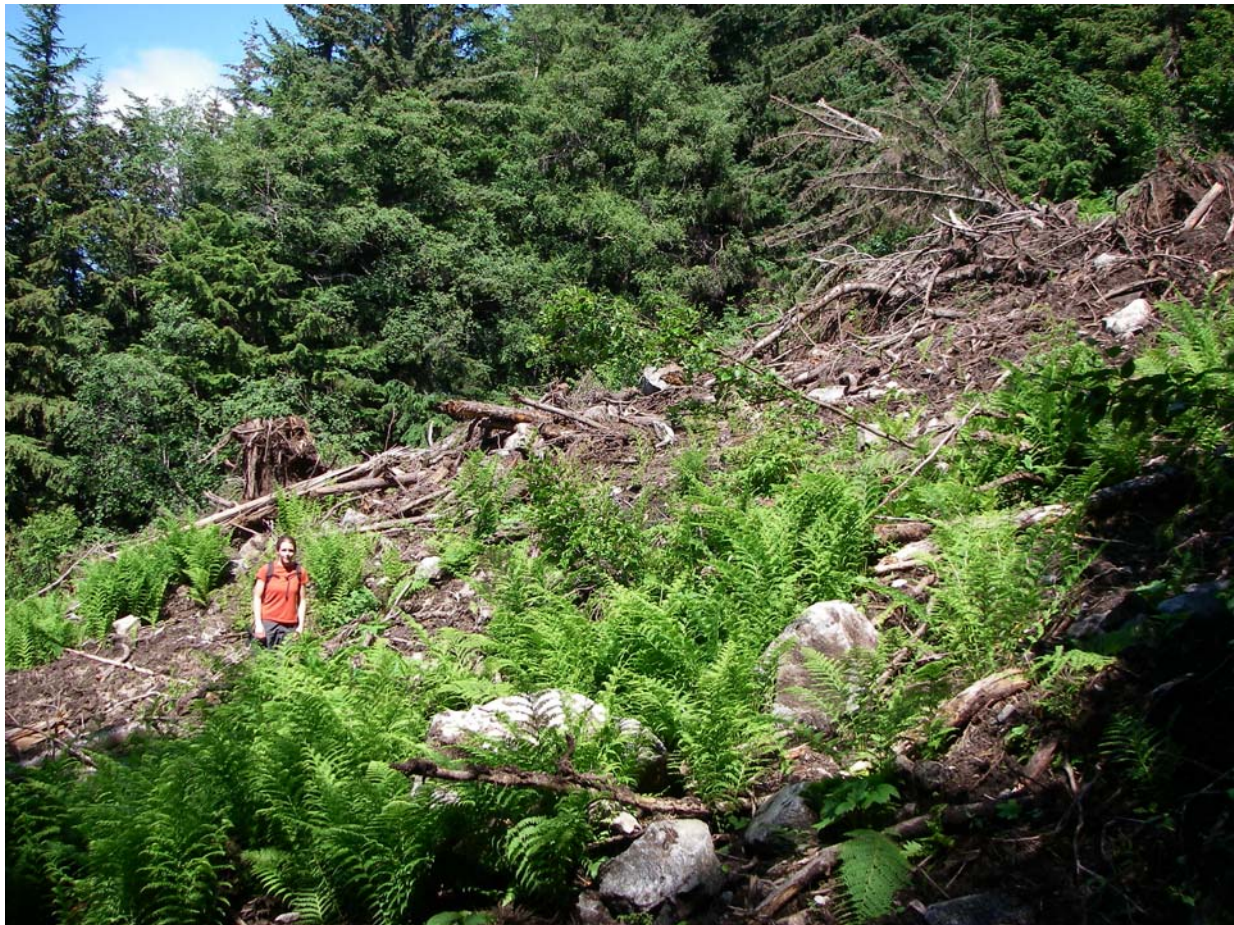
Hazard ID #:	DF34
Hazard Type:	debris_flow
HIN:	147
Rating:	B
IRP 2006 Location:	2281
Frequency (yrs):	1-5
Predictability:	high
Material Volume (CY):	10-100
Clast Size (ft):	1-2
Source Elev. (ft):	3000+
Centerline Slope:	fan
Alignment Location:	deposition_zone
Impact Alignment:	yes
Alignment Exposure (ft):	200-500
Vegetation:	denuded
Deciduous Trees:	yes
IRP 2006 South Margin:	2283+70
IRP 2006 North Margin:	2287+10
Photo #:	3527, 3528

DF34. View north/up alignment at debris flow channel/avalanche path ELC025.
Photo taken 580 ft right of IRP 2006 2284+00.

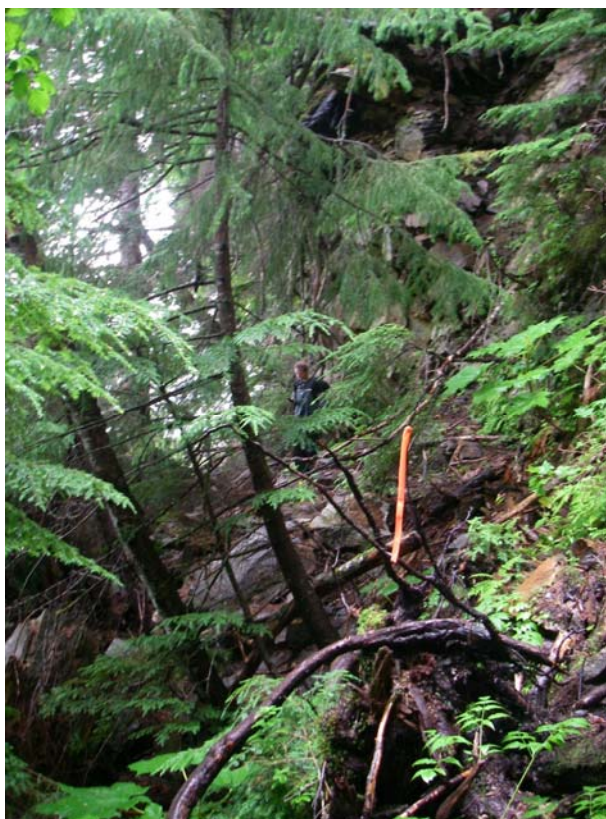
RF25. View north/up alignment at rockfall hazard impacting the alignment. Orange flagging represents alignment at IRP 2006 2291+50.

Hazard ID #:	RF25
Hazard Type:	rockfall
HIN:	123
Rating:	B
IRP 2006 Location:	2291
Frequency (yrs):	unknown (1-5?)
Predictability:	unpredictable
Material Volume (CY):	10-100
Clast Size (ft):	2-3
Source Elev. (ft):	<100
Centerline Slope:	open_bedrock_slope
Alignment Location:	deposition_zone
Impact Alignment:	yes
Alignment Exposure (ft):	<50
Vegetation:	denuded
Deciduous Trees:	yes
IRP 2006 South Margin:	2290+60
IRP 2006 North Margin:	2291+00
Photo #:	3531

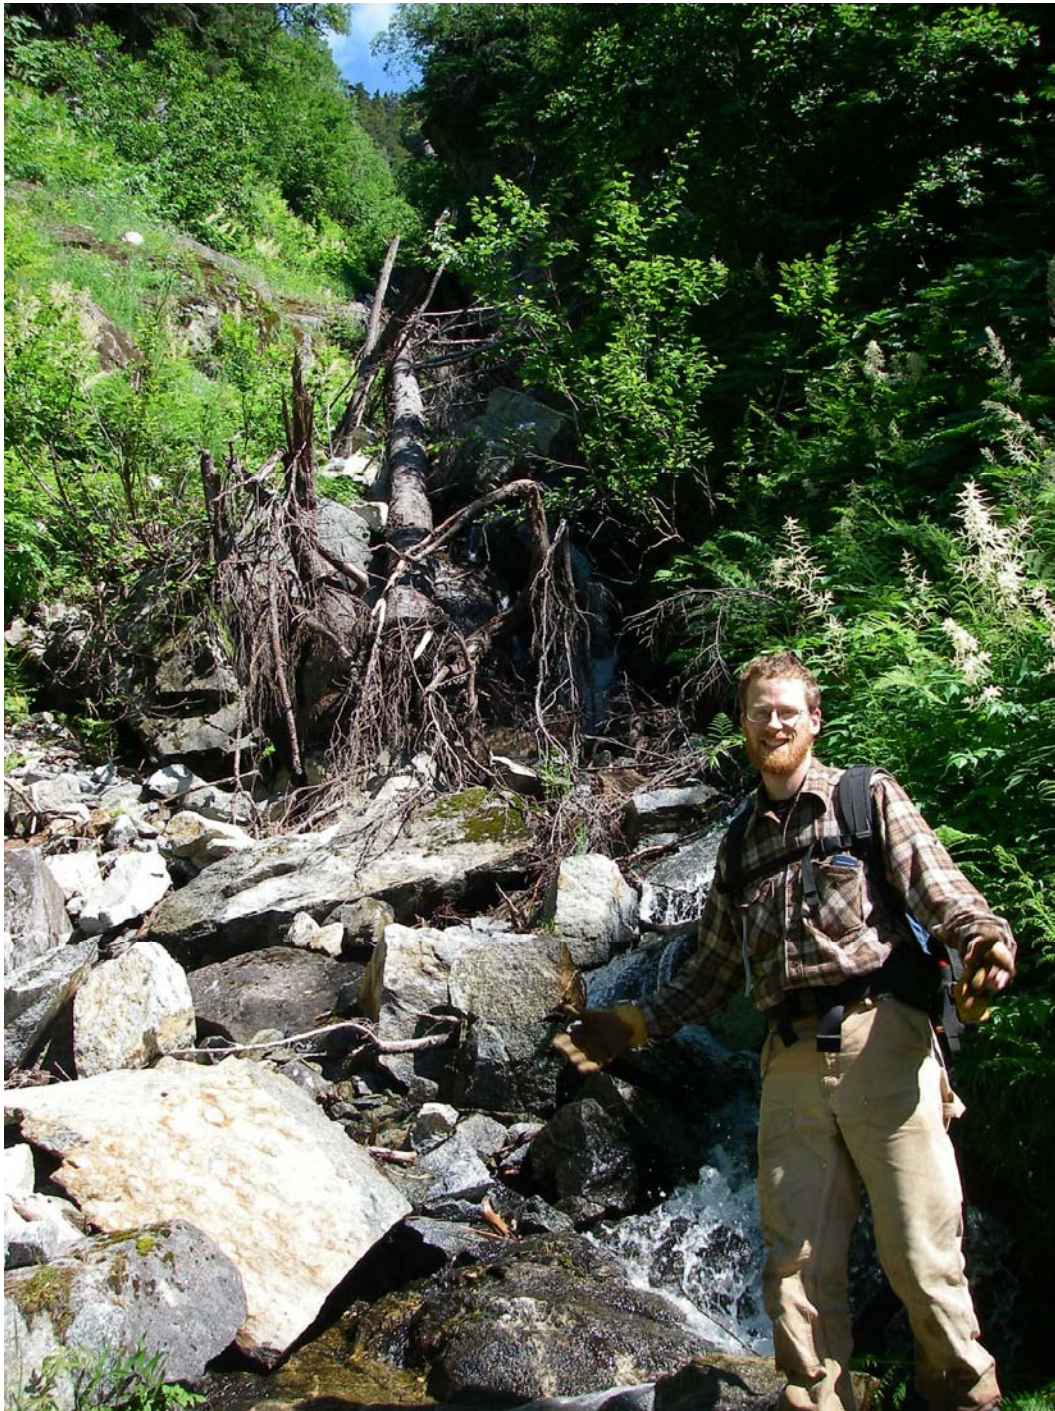
Hazard ID #:	DF35
Hazard Type:	debris_flow
HIN:	207
Rating:	B
IRP 2006 Location:	2296
Frequency (yrs):	unknown (1-5?)
Predictability:	unpredictable
Material Volume (CY):	10-100
Clast Size (ft):	3-4
Source Elev. (ft):	3000+
Centerline Slope:	fan
Alignment Location:	deposition _zone
Impact Alignment:	yes
Alignment Exposure (ft):	50-200
Vegetation:	disturbed
Deciduous Trees:	yes
IRP 2006 South Margin:	2293+80
IRP 2006 North Margin:	2294+90
Photo #:	3535

DF35. View east/upslope of debris flow channel and avalanche path
ELC026. Photo taken 320 ft right of IRP 2006 2295+00.

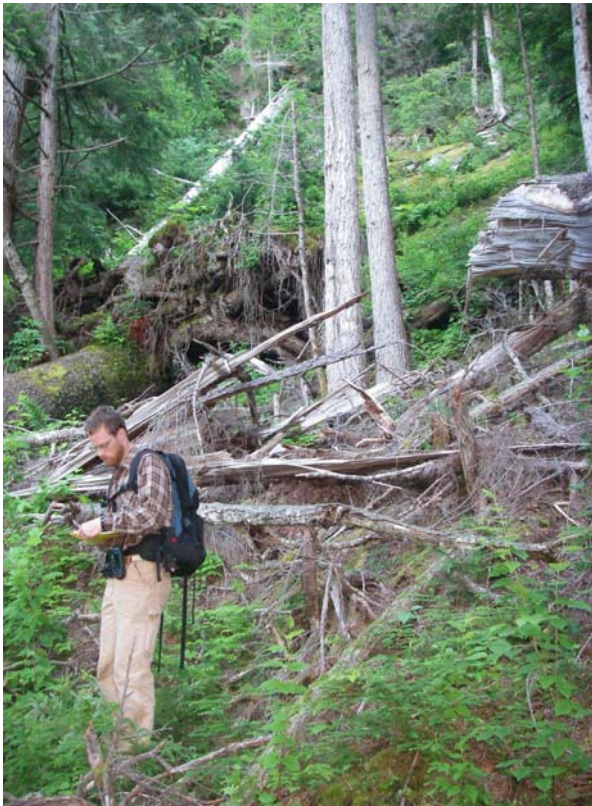
LS03. View north/up alignment at landslide. Photo taken 200 ft right of IRP 2006 2299+50.

Hazard ID #:	LS03
Hazard Type:	translational_slide
HIN:	111
Rating:	C
IRP 2006 Location:	2300
Frequency (yrs):	25+
Predictability:	unpredictable
Material Volume (CY):	10-100
Clast Size (ft):	1-2
Source Elev. (ft):	100-500
Centerline Slope:	-
Alignment Location:	below_deposition_zone
Impact Alignment:	no
Alignment Exposure (ft):	50-200
Vegetation:	disturbed
Deciduous Trees:	yes
IRP 2006 South Margin:	2299+10
IRP 2006 North Margin:	2299+60
Photo #:	5269, 5946

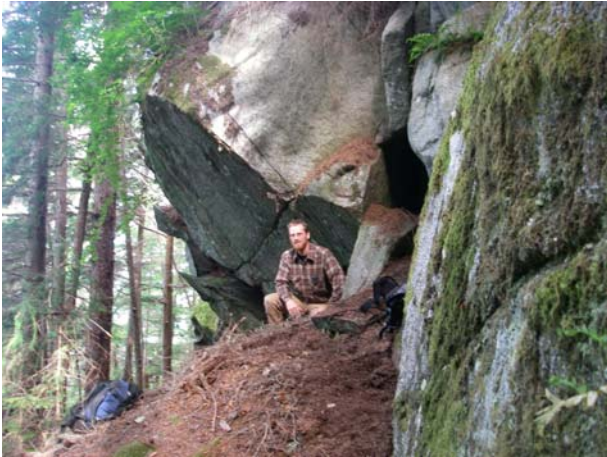
RF26. View north/up alignment at rockfall hazard. Photo taken 100 ft right of IRP 2006 2301+00.

Hazard ID #:	RF26
Hazard Type:	rockfall
HIN:	117
Rating:	B
IRP 2006 Location:	2301
Frequency (yrs):	unknown (5-25?)
Predictability:	unpredictable
Material Volume (CY):	10-100
Clast Size (ft):	4+
Source Elev. (ft):	100-500
Centerline Slope:	other
Alignment Location:	deposition_zone
Impact Alignment:	yes
Alignment Exposure (ft):	50-200
Vegetation:	undisturbed
Deciduous Trees:	no
IRP 2006 South Margin:	2300+20
IRP 2006 North Margin:	2301+10
Photo #:	3559, 3560, 5946

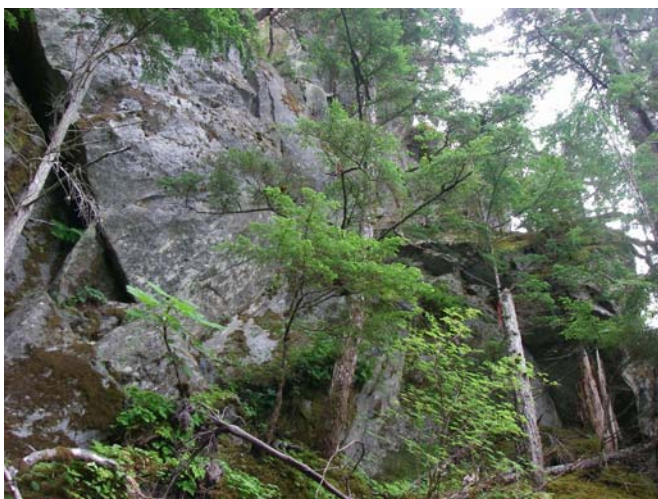
RF27. View south/down alignment at rockfall hazard. Photo taken 300 ft right of IRP 2006 2308+00

Hazard ID #:	RF27
Hazard Type:	rockfall
HIN:	165
Rating:	B
IRP 2006 Location:	2308
Frequency (yrs):	1-5
Predictability:	unpredictable
Material Volume (CY):	<10
Clast Size (ft):	2-3
Source Elev. (ft):	500-1000
Centerline Slope:	fan
Alignment Location:	deposition_zone
Impact Alignment:	yes
Alignment Exposure (ft):	200-500
Vegetation:	disturbed
Deciduous Trees:	yes
IRP 2006 South Margin:	2303+50
IRP 2006 North Margin:	2308+40
Photo #:	3561

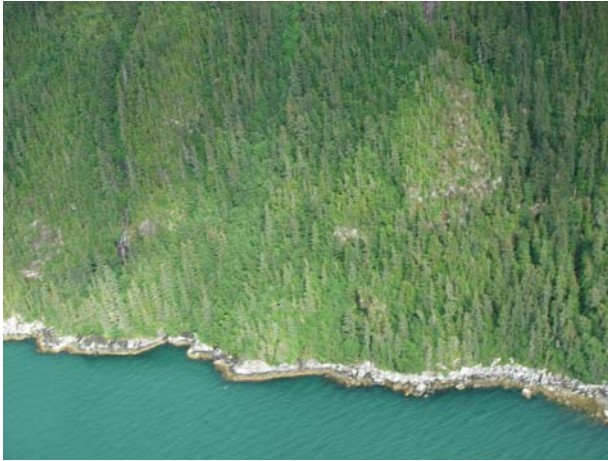
DF36. View east/upslope at debris flow channel.

Hazard ID #:	DF36
Hazard Type:	debris_flow
HIN:	129
Rating:	B
IRP 2006 Location:	2310
Frequency (yrs):	1-5
Predictability:	high
Material Volume (CY):	10-100
Clast Size (ft):	0-1
Source Elev. (ft):	1000-2000
Centerline Slope:	fan
Alignment Location:	path
Impact Alignment:	yes
Alignment Exposure (ft):	50-200
Vegetation:	denuded
Deciduous Trees:	yes
IRP 2006 South Margin:	2311+10
IRP 2006 North Margin:	2311+80
Photo #:	3562

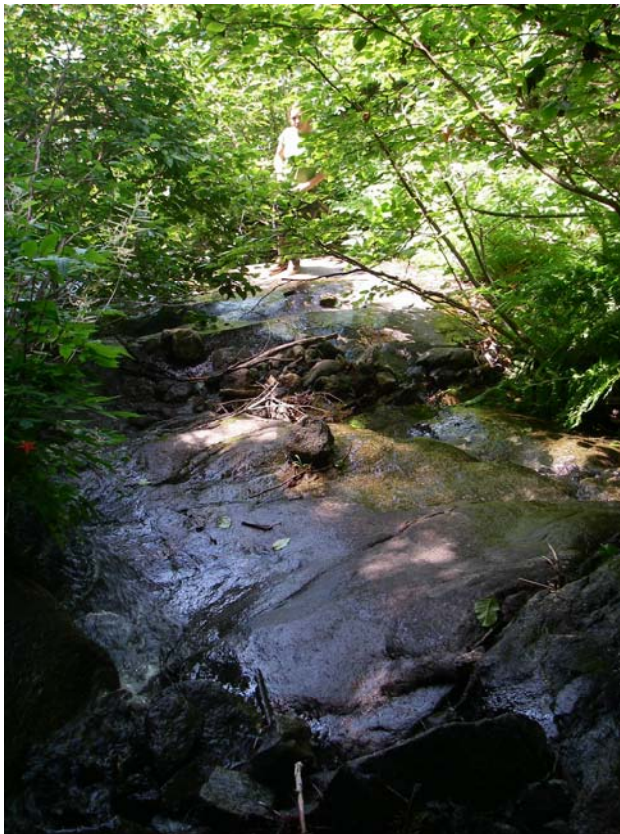
DF36. View west/downslope at debris flow channel scoured to gneiss bedrock. Photo taken 320 ft right of IRP 2006 2311+50.

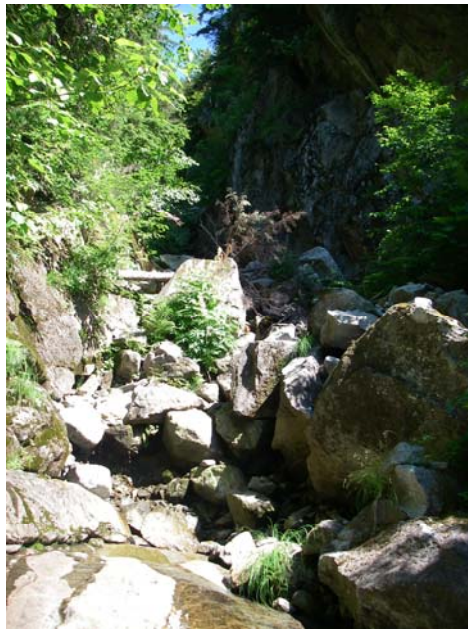
Hazard ID #:	DF37
Hazard Type:	debris_flow
HIN:	129
Rating:	B
IRP 2006 Location:	2321
Frequency (yrs):	1-5
Predictability:	high
Material Volume (CY):	10-100
Clast Size (ft):	1-2
Source Elev. (ft):	1000-2000
Centerline Slope:	fan
Alignment Location:	deposition_zone
Impact Alignment:	yes
Alignment Exposure (ft):	50-200
Vegetation:	denuded
Deciduous Trees:	yes
IRP 2006 South Margin:	2321+20
IRP 2006 North Margin:	2322+10
Photo #:	3564, 3565, 3566

DF37. View east/upslope at debris flow channel with extreme cliffs to south (down alignment). Photo taken 320 ft right of IRP 2006 2320+50.

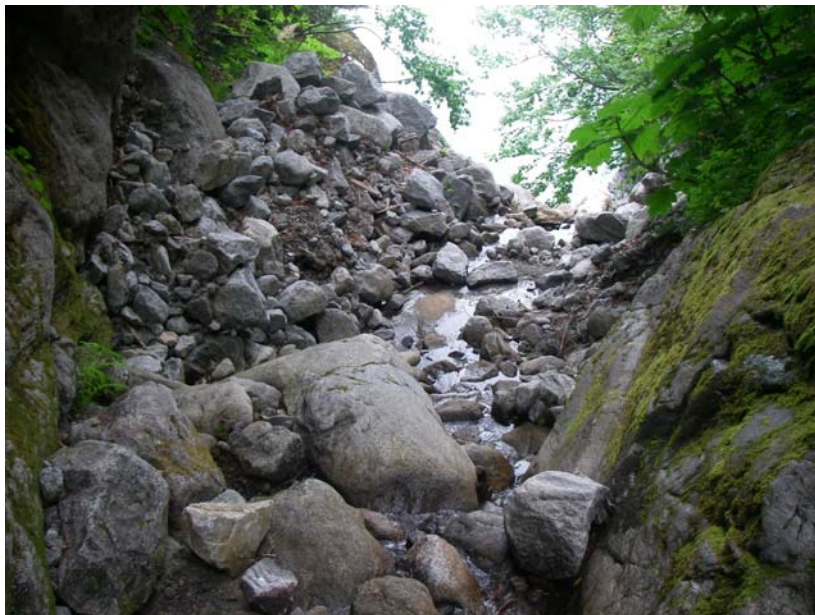
DF37. View east/downslope at boulders deposited by debris flow. Photo taken 320 ft right of IRP 2006 2320+00.

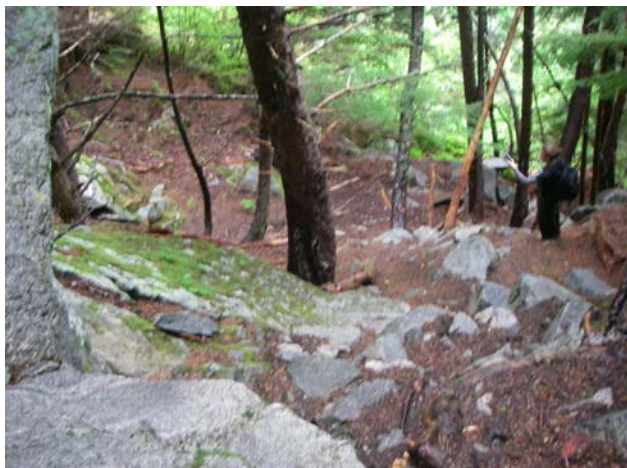
RF28. View east/downslope at rockfall hazard. Photo taken 130 ft right of IRP 2006 2322+00.

Hazard ID #:	RF28
Hazard Type:	rockfall
HIN:	183
Rating:	A
IRP 2006 Location:	2322
Frequency (yrs):	0-1
Predictability:	unpredictable
Material Volume (CY):	<10
Clast Size (ft):	1-2
Source Elev. (ft):	100-500
Centerline Slope:	single_channel
Alignment Location:	path
Impact Alignment:	yes
Alignment Exposure (ft):	50-200
Vegetation:	disturbed
Deciduous Trees:	yes
IRP 2006 South Margin:	2322+10
IRP 2006 North Margin:	2322+70
Photo #:	3891, 5948, 6254

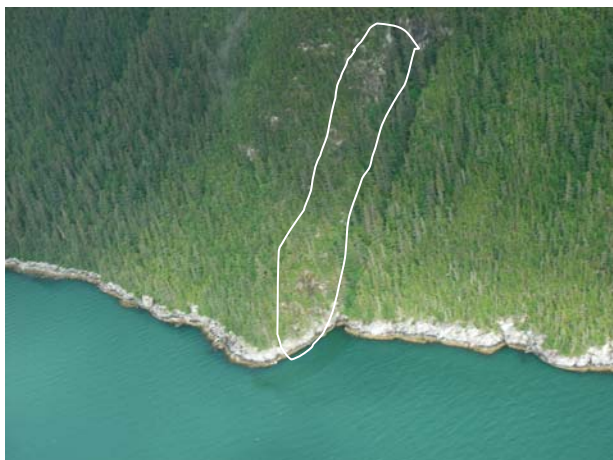
RF28. View east/downslope at rockfall hazard area.

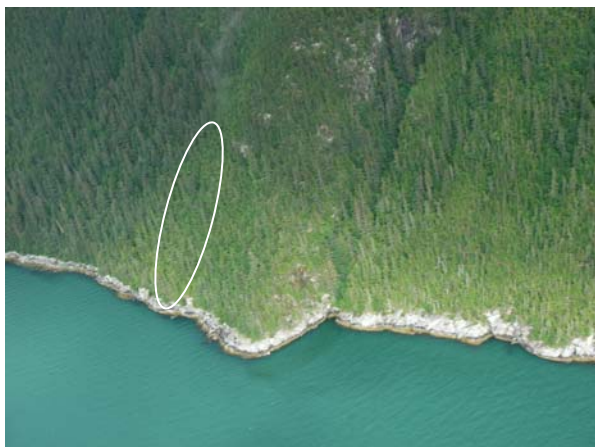
RF29. View northeast (up alignment and upslope) at rockfall area across IRP 2006 alignment.

Hazard ID #:	RF29
Hazard Type:	rockfall
HIN:	105
Rating:	B
IRP 2006 Location:	2328
Frequency (yrs):	25+
Predictability:	unpredictable
Material Volume (CY):	<10
Clast Size (ft):	3-4
Source Elev. (ft):	100-500
Centerline Slope:	open_soil_slope
Alignment Location:	path
Impact Alignment:	yes
Alignment Exposure (ft):	50-200
Vegetation:	disturbed
Deciduous Trees:	no
IRP 2006 South Margin:	2328+10
IRP 2006 North Margin:	2329+10
Photo #:	6140

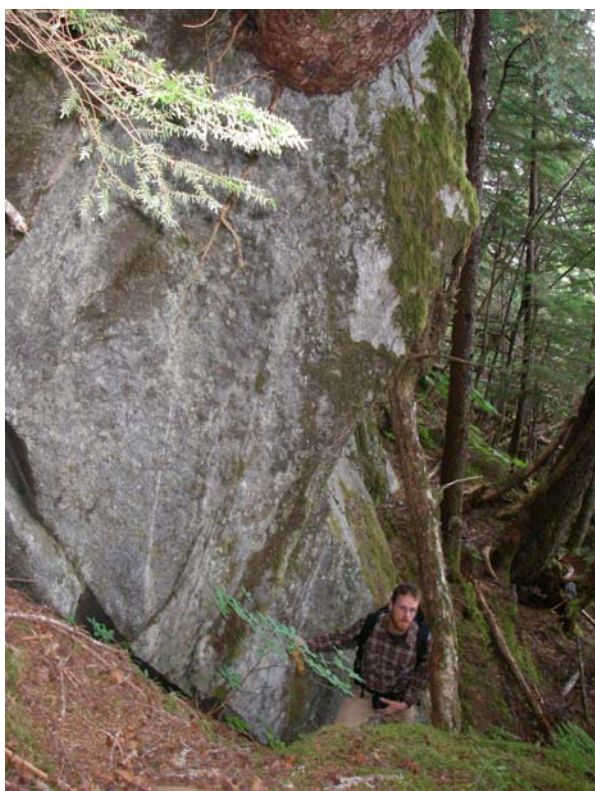
RF20. View west/downslope at rockfall hazard. Photo taken 130 ft right of IRP 2006 2329+00.

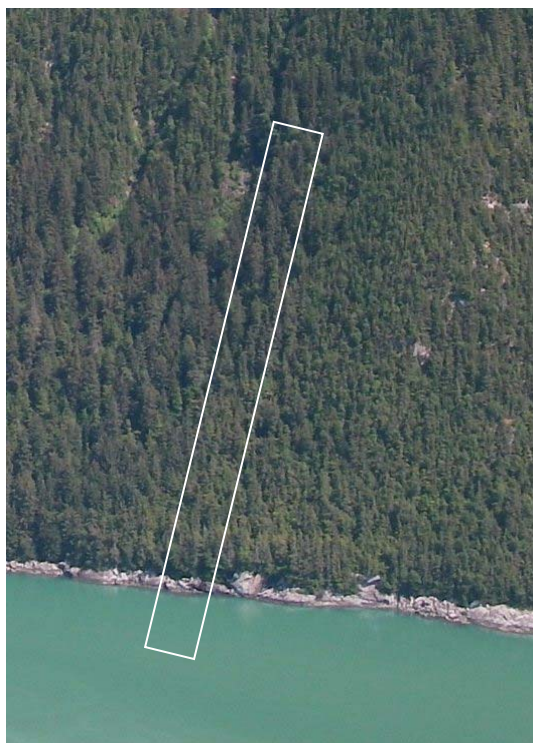
RF30. View east/upslope at rockfall hazard.

Hazard ID #:	RF30
Hazard Type:	rockfall
HIN:	135
Rating:	B
IRP 2006 Location:	2332
Frequency (yrs):	5-25
Predictability:	unpredictable
Material Volume (CY):	10-100
Clast Size (ft):	4+
Source Elev. (ft):	500-1000
Centerline Slope:	open_soil_slope
Alignment Location:	below_deposition_zone
Impact Alignment:	no
Alignment Exposure (ft):	50-200
Vegetation:	disturbed
Deciduous Trees:	no
IRP 2006 South Margin:	2331+40
IRP 2006 North Margin:	2332+80
Photo #:	6142, 6143

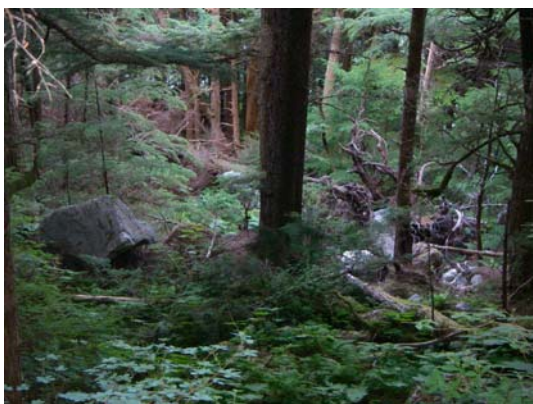
RF30. View west/downslope at rockfall hazard. Photo taken 230 ft right of IRP 2006 2331+50.

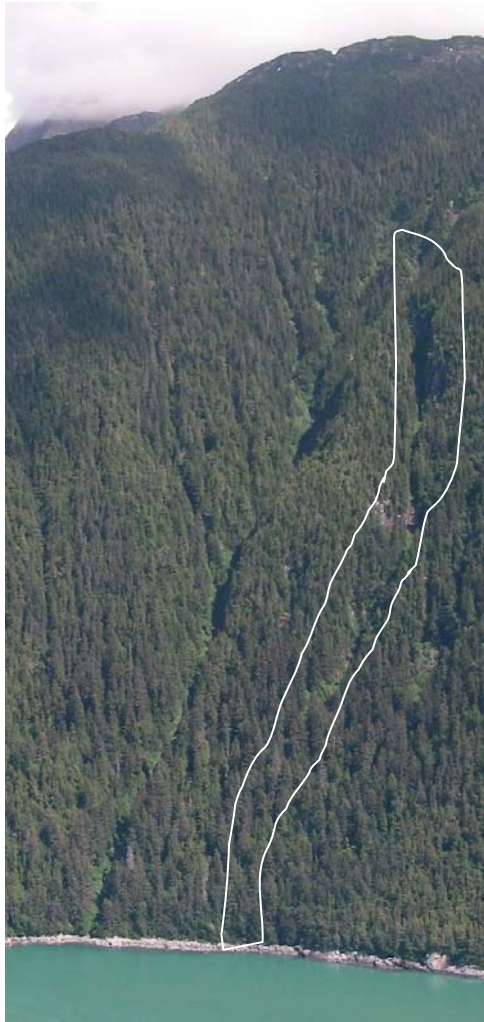
RF31. View east/upslope at rockfall hazard and avalanche path ELC028-2.

Hazard ID #:	RF31
Hazard Type:	rockfall
HIN:	129
Rating:	A
IRP 2006 Location:	2335
Frequency (yrs):	5-25
Predictability:	unpredictable
Material Volume (CY):	<10
Clast Size (ft):	4+
Source Elev. (ft):	500-1000
Centerline Slope:	single_channel
Alignment Location:	deposition_zone
Impact Alignment:	yes
Alignment Exposure (ft):	50-200
Vegetation:	denuded
Deciduous Trees:	yes
IRP 2006 South Margin:	2334+70
IRP 2006 North Margin:	2335+60
Photo #:	6144, 6145

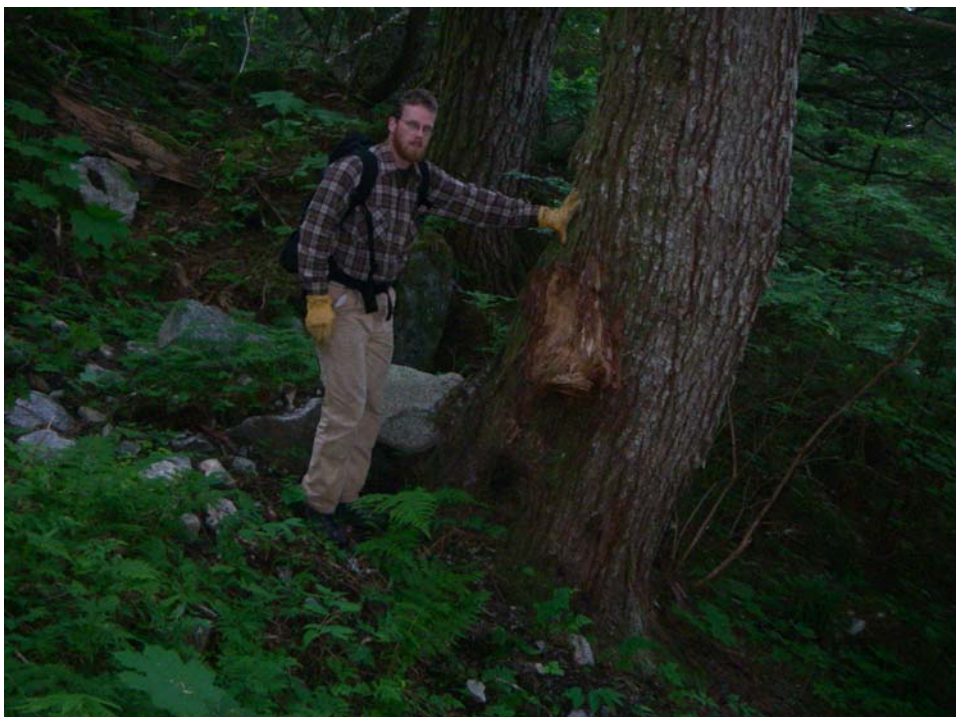
G-131

RF31. View south/down alignment at rockfall with freshly gouged trees. Photo taken 350 ft right of IRP 2006 2335+00.

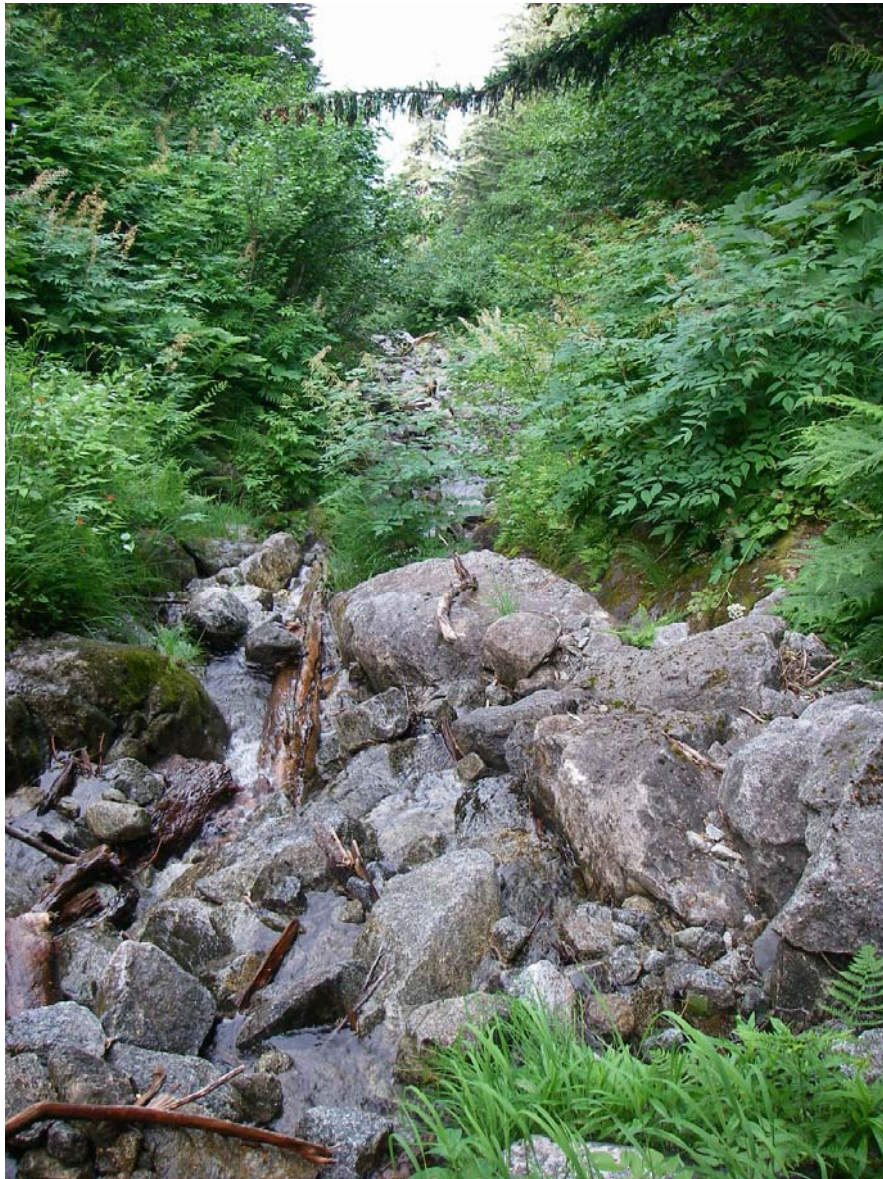
G-133

Hazard ID #:	DF38
Hazard Type:	debris_flow
HIN:	129
Rating:	A
IRP 2006 Location:	2338
Frequency (yrs):	1-5
Predictability:	high
Material Volume (CY):	10-100
Clast Size (ft):	0-1
Source Elev. (ft):	2000-3000
Centerline Slope:	single_channel
Alignment Location:	path
Impact Alignment:	yes
Alignment Exposure (ft):	50-200
Vegetation:	denuded
Deciduous Trees:	no
IRP 2006 South Margin:	2338+00
IRP 2006 North Margin:	2338+90
Photo #:	6146

DF38. View west/downslope at debris flow channel. Photo taken 490 ft right of IRP 2006 2338+50.

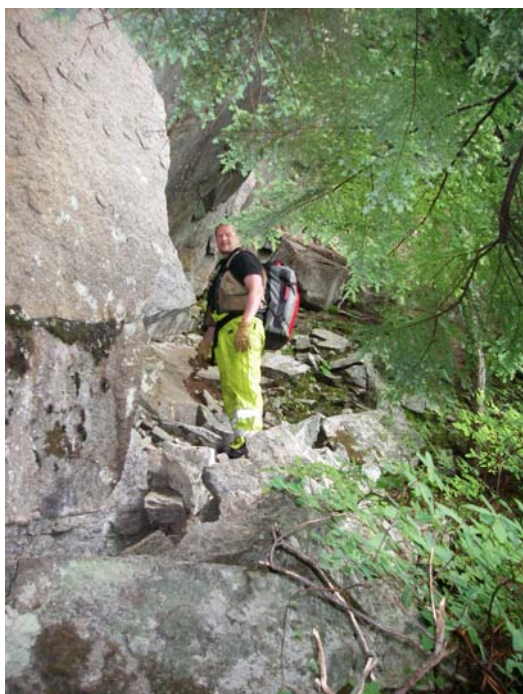
RF32. View south/down alignment at rockfall hazard. Photo taken 100 ft right of IRP 2006 2364+00.

Hazard ID #:	RF32
Hazard Type:	rockfall
HIN:	201
Rating:	B
IRP 2006 Location:	2370
Frequency (yrs):	0-1
Predictability:	unpredictable
Material Volume (CY):	<10
Clast Size (ft):	1-2
Source Elevation (ft):	100-500
Centerline Slope:	open_soil_slope
Alignment Location:	deposition_zone
Impact Alignment:	yes
Alignment Exposure (ft):	200-500
Vegetation:	disturbed
Deciduous Trees:	yes
IRP 2006 South Margin:	2361+10
IRP 2006 North Margin:	2364+20
Photo #:	3724, 3725

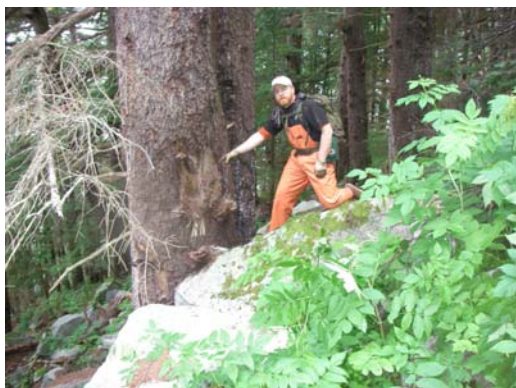
RF32. View north/up alignment at scar on tree from rockfall/boulder striking tree. Photo taken at centerline at IRP 2006 2364+50.

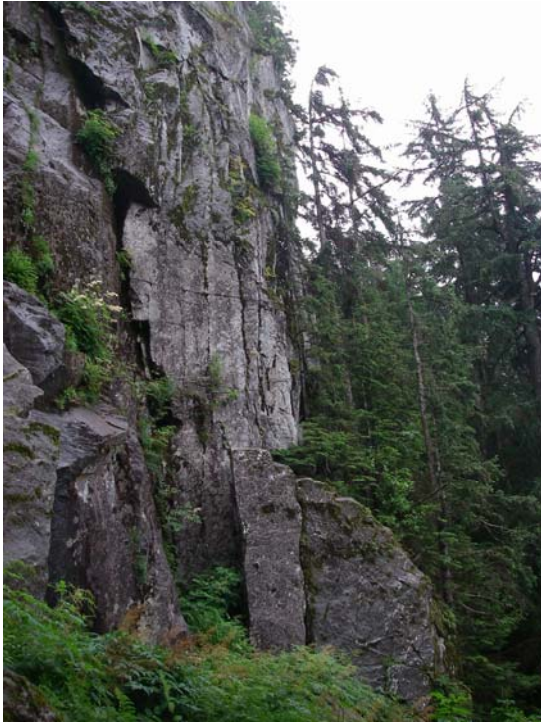
G-136

RF33. View south/down alignment at tabular blocks creating rockfall hazard. Photo taken 90 ft right of IRP 2006 2367+00.

Hazard ID #:	RF33
Hazard Type:	rockfall
HIN:	255
Rating:	B
IRP 2006 Location:	2365
Frequency (yrs):	0-1
Predictability:	unpredictable
Material Volume (CY):	<10
Clast Size (ft):	1-2
Source Elevation (ft):	100-500
Centerline Slope:	open_soil_slope
Alignment Location:	deposition_zone
Impact Alignment:	yes
Alignment Exposure (ft):	500+
Vegetation:	disturbed
Deciduous Trees:	yes
IRP 2006 South Margin:	2364+20
IRP 2006 North Margin:	2370+50
Photo #:	3724, 3725

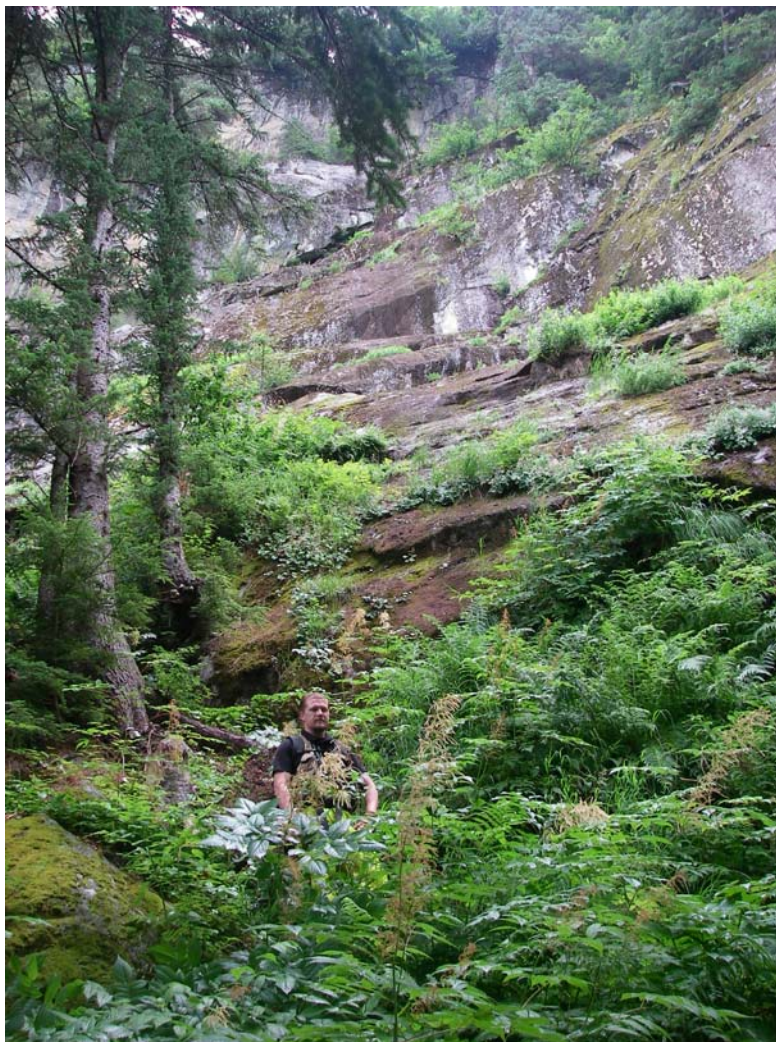
G-137

RF33. View east/upslope at freshly scarred cliffs.
Photo taken 135 ft right of IRP 2006 2367+50.

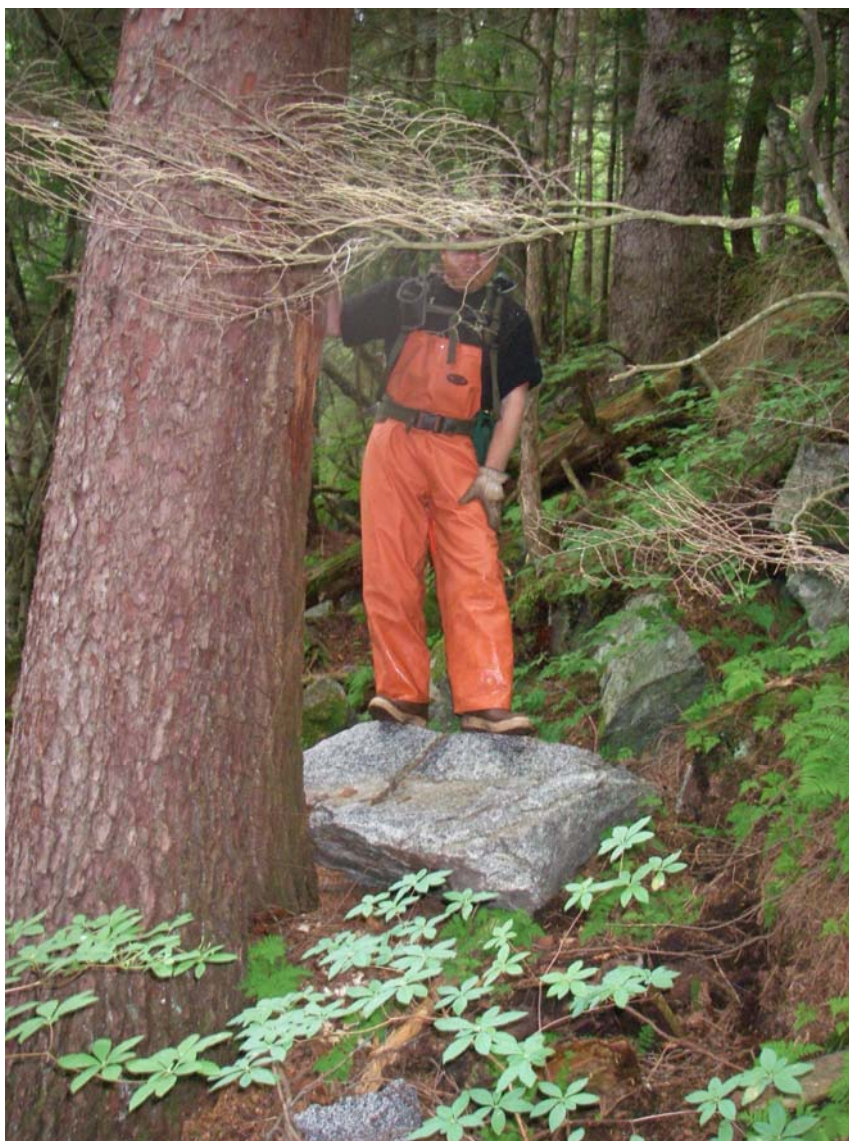
G-138

RF33. View north/up alignment at a 300-500 lb boulder/rockfall (fresh) from cliffs above, stopped by a tree. Photo taken at centerline at IRP 2006 2367+00.

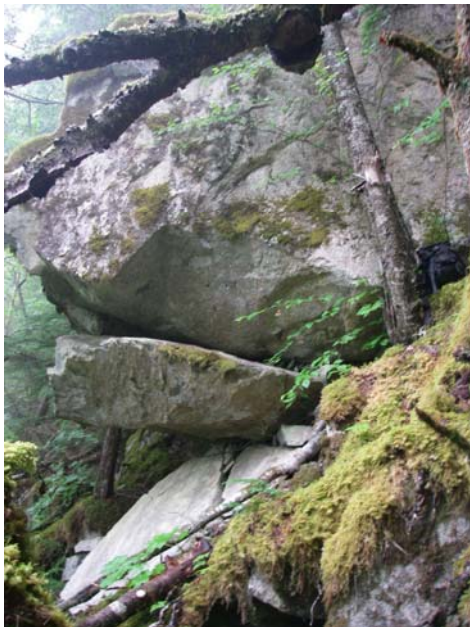
G-139

HR01. View north/up alignment at hazard rock perched 50 ft left of IRP 2006 2374+90.

Hazard ID #:	HR01
Hazard Type:	hazard_rocks
HIN:	99
Rating:	C
IRP 2006 Location:	2374
Frequency (yrs):	unknown (>25?)
Predictability:	unpredictable
Material Volume (CY):	10-100
Clast Size (ft):	4+
Source Elev. (ft):	<100
Centerline Slope:	open_soil_slope
Alignment Location:	below_deposition_zone
Impact Alignment:	yes
Alignment Exposure (ft):	<50
Vegetation:	undisturbed
Deciduous Trees:	no
IRP 2006 South Margin:	2374+90
IRP 2006 North Margin:	-
Photo #:	3722

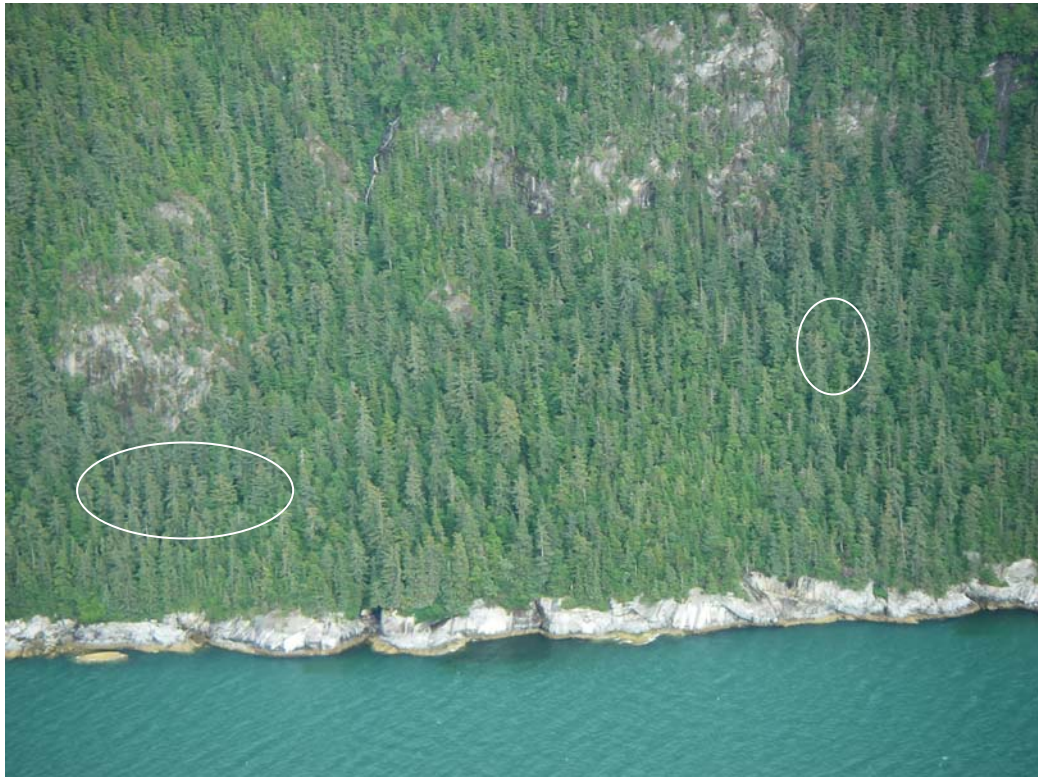
G-140

HR01 & HR02. View east/upslope at hazard rocks HR01 (right) and HR02 (left).

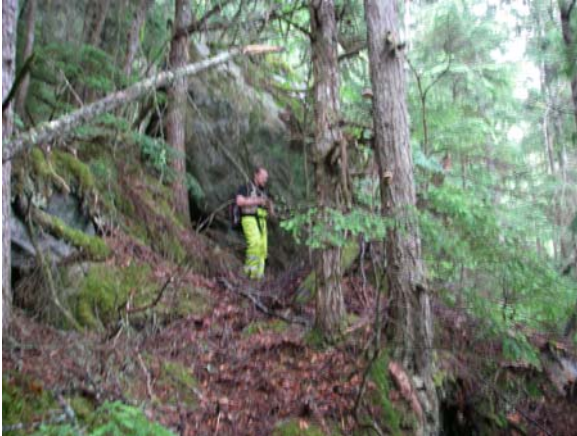
G-141

HR02. View south/down alignment at hazard rock 75 ft right of IRP 2006 2379+40.

Hazard ID #:	HR02
Hazard Type:	hazard_rocks
HIN:	99
Rating:	C
IRP 2006 Location:	2380
Frequency (yrs):	unknown (>25?)
Predictability:	unpredictable
Material Volume (CY):	<10
Clast Size (ft):	4+
Source Elev. (ft):	<100
Centerline Slope:	open_soil_slope
Alignment Location:	deposition_zone
Impact Alignment:	yes
Alignment Exposure (ft):	50-200
Vegetation:	disturbed
Deciduous Trees:	no
IRP 2006 South Margin:	2379+40
IRP 2006 North Margin:	2380+90
Photo #:	3719

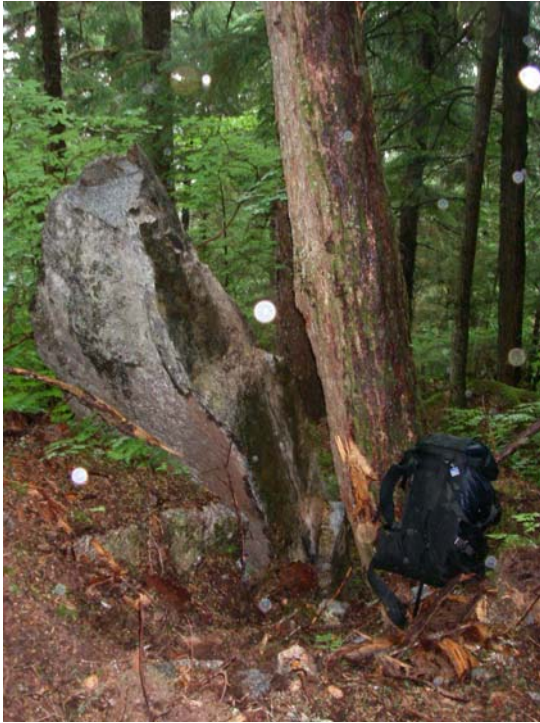
RF34. View west/downslope at rockfall hazard. Fresh scarring of spruce tree next to backpack. Photo taken 75 ft right of IRP 2006 2383+00.

Hazard ID #:	RF34
Hazard Type:	rockfall
HIN:	177
Rating:	B
IRP 2006 Location:	2383
Frequency (yrs):	25+
Predictability:	unpredictable
Material Volume (CY):	<10
Clast Size (ft):	4+
Source Elev. (ft):	100-500
Centerline Slope:	open_soil_slope
Alignment Location:	below_deposition_zone
Impact Alignment:	no
Alignment Exposure (ft):	500+
Vegetation:	undisturbed
Deciduous Trees:	yes
IRP 2006 South Margin:	2382+50
IRP 2006 North Margin:	2388+50
Photo #:	3712, 3715

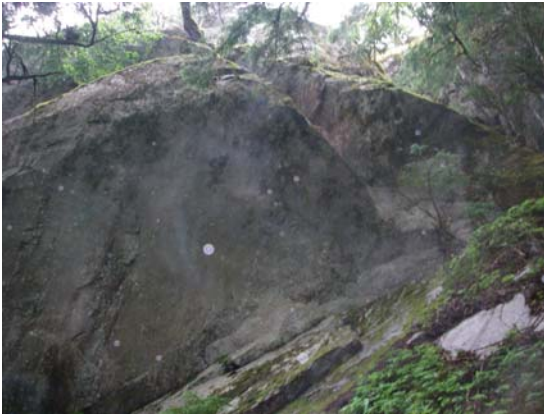
RF35. View west/upslope at 15 foot overhanging cliffs with fresh rockfall. Photo taken 75 ft right of IRP 2006 2388+00.

Hazard ID #:	RF35
Hazard Type:	rockfall
HIN:	183
Rating:	B
IRP 2006 Location:	2388
Frequency (yrs):	0-1
Predictability:	unpredictable
Material Volume (CY):	<10
Clast Size (ft):	0-1
Source Elev. (ft):	100-500
Centerline Slope:	open_soil_slope
Alignment Location:	deposition_zone
Impact Alignment:	yes
Alignment Exposure (ft):	50-200
Vegetation:	disturbed
Deciduous Trees:	yes
IRP 2006 South Margin:	2388+00
IRP 2006 North Margin:	2388+80
Photo #:	3706

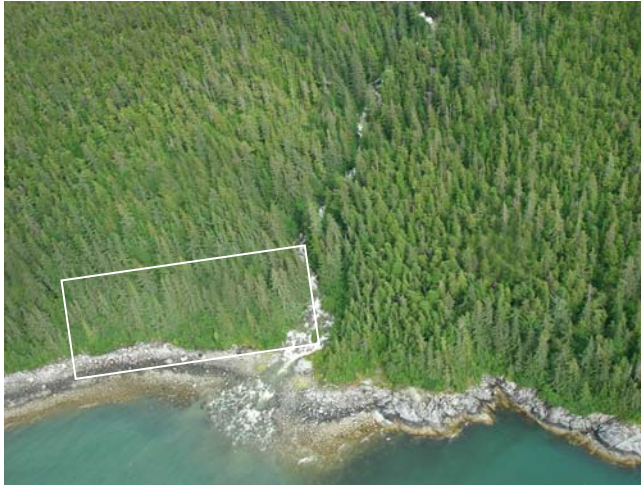
SR04. View east/upslope at soil raveling hazard.

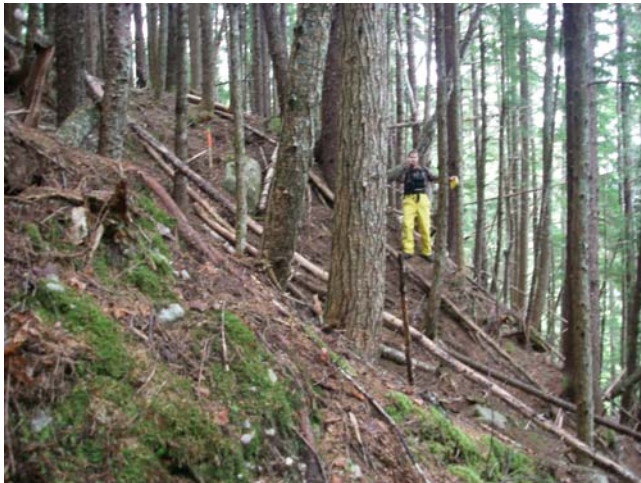
SR04. View south/down alignment at soil raveling in glacial outwash. Photo taken 30 ft left of IRP 2006 2424+00.

Hazard ID #:	SR04
Hazard Type:	soil_raveling
HIN:	105
Rating:	B
IRP 2006 Location:	2420
Frequency (yrs):	5-25
Predictability:	moderate
Material Volume (CY):	<10
Clast Size (ft):	3-4
Source Elev. (ft):	<100
Centerline Slope:	open_soil_slope
Alignment Location:	path
Impact Alignment:	yes
Alignment Exposure (ft):	500+
Vegetation:	disturbed
Deciduous Trees:	no
IRP 2006 South Margin:	2420+70
IRP 2006 North Margin:	2426+80
Photo #:	3595-3598, 5957, 6061
