FINAL REPORT

**LYNN CANAL HIGHWAY
PHASE I
ZONE 4 GEOTECHNICAL INVESTIGATION**

STATE PROJECT NUMBER: 71100

*Golder Associates Inc.
1750 Abbott Road, Suite 200
Anchorage, Alaska 99507*

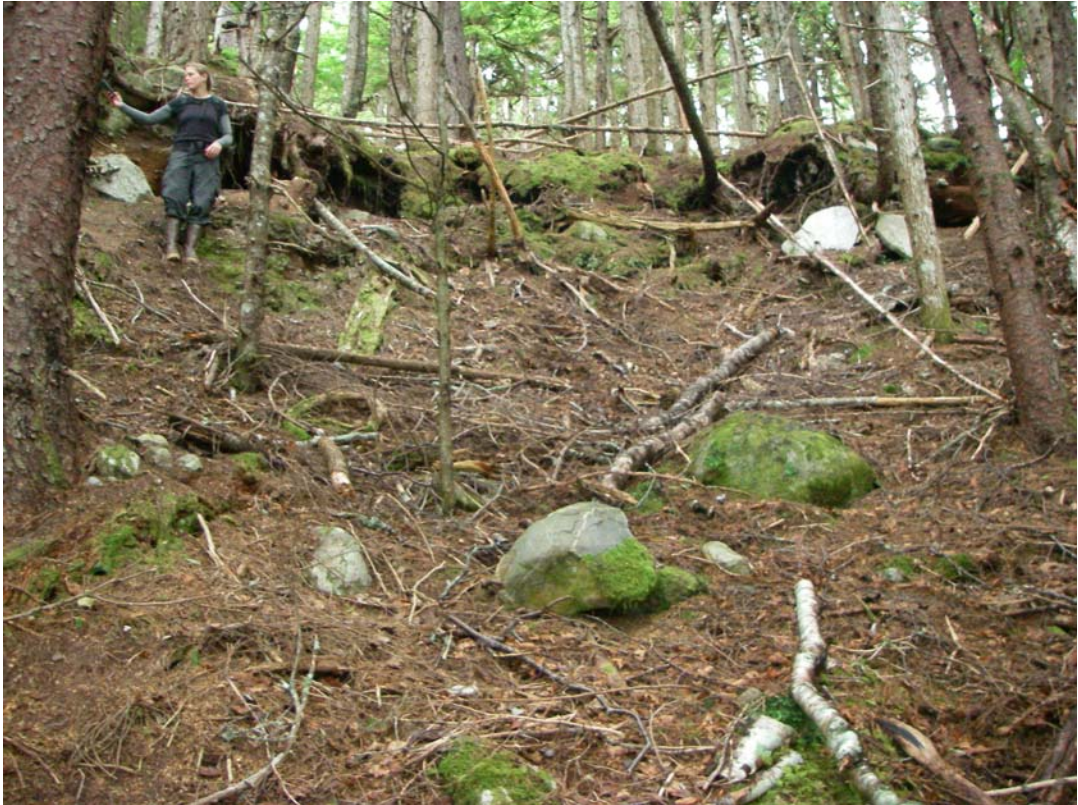
G-146

SR04. View east/upslope at slope releasing 1-3 ft diameter rocks. IRP 2006 2426+20 is located where person is standing.

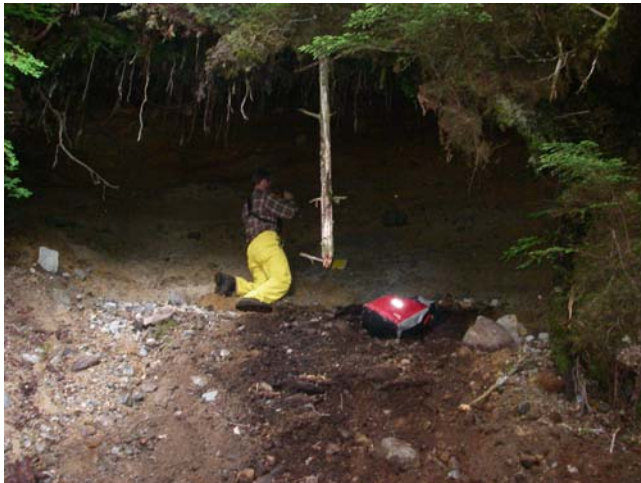
LS04. View east/upslope at recent landslide. Photo taken 70 ft right of IRP 2006 2427+00.

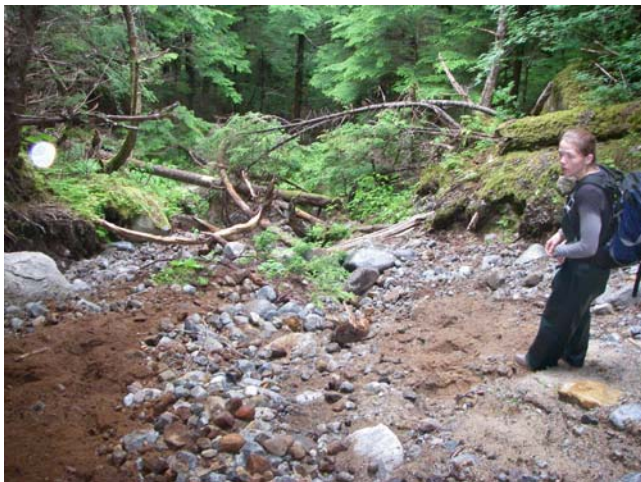
LS04. View west/downslope at slope failure in glacial outwash material. Photo taken 75 ft right of IRP 2006 2427+10.

Hazard ID #:	LS04
Hazard Type:	translational_slide
HIN:	33
Rating:	B
IRP 2006 Location:	2426
Frequency (yrs):	5-25
Predictability:	moderate
Material Volume (CY):	<10
Clast Size (ft):	3-4
Source Elev. (ft):	<100
Centerline Slope:	open_soil_slope
Alignment Location:	path
Impact Alignment:	yes
Alignment Exposure (ft):	50-200
Vegetation:	disturbed
Deciduous Trees:	no
IRP 2006 South Margin:	2426+80
IRP 2006 North Margin:	2427+40
Photo #:	3595, 3597, 3598, 6074

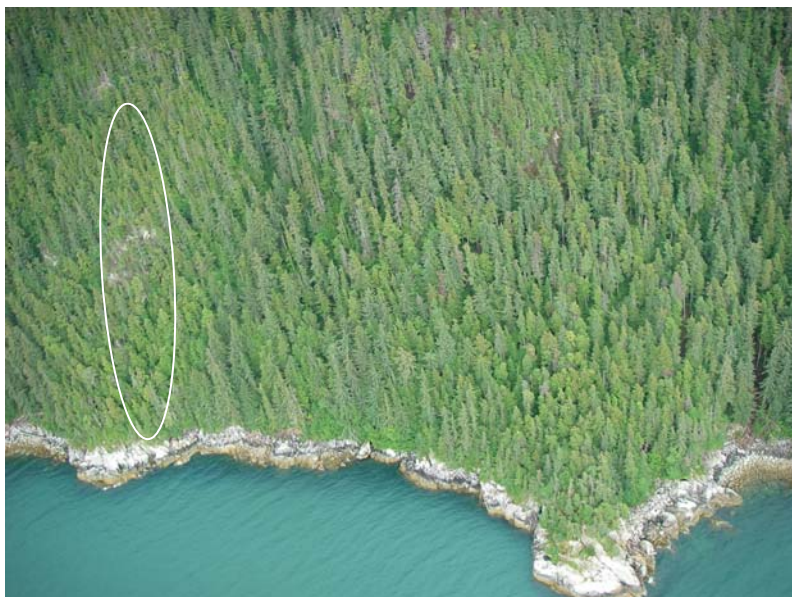
Hazard ID #:	RF36
Hazard Type:	rockfall
HIN:	129
Rating:	B
IRP 2006 Location:	2454
Frequency (yrs):	1-5
Predictability:	unpredictable
Material Volume (CY):	<10
Clast Size (ft):	3-4
Source Elev. (ft):	100-500
Centerline Slope:	-
Alignment Location:	below_deposition_zone
Impact Alignment:	yes
Alignment Exposure (ft):	50-200
Vegetation:	denuded
Deciduous Trees:	yes
IRP 2006 South Margin:	2454+50
IRP 2006 North Margin:	2455+00
Photo #:	3609, 5960

RF36. View east/upslope at rockfall hazard.

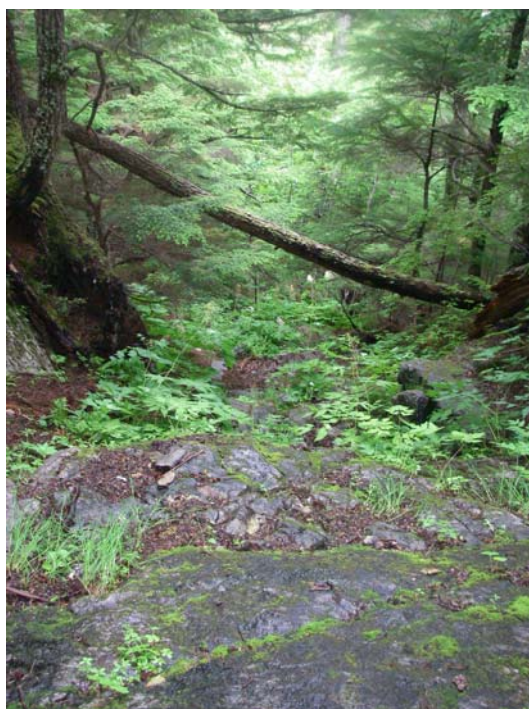
RF36. View west/downslope at rockfall chute. Photo taken 90 ft right of IRP 2006 2454+60.

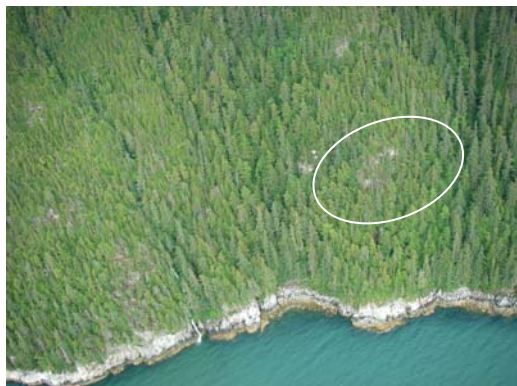
LS05. View east/upslope at landslide.

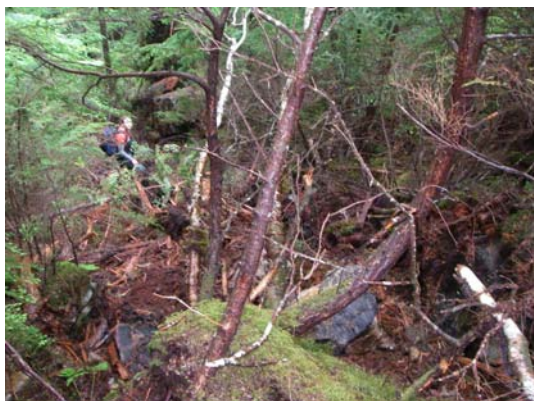
LS05. View west/downslope at landslide. Photo taken 230 ft right of IRP 2006 2457+00.

Hazard ID #:	LS05
Hazard Type:	translational_slide
HIN:	129
Rating:	C
IRP 2006 Location:	2457
Frequency (yrs):	5-25
Predictability:	unpredictable
Material Volume (CY):	<10
Clast Size (ft):	3-4
Source Elev. (ft):	100-500
Centerline Slope:	-
Alignment Location:	below_deposition_zone
Impact Alignment:	no
Alignment Exposure (ft):	200-500
Vegetation:	disturbed
Deciduous Trees:	yes
IRP 2006 South Margin:	2456+00
IRP 2006 North Margin:	2458+00
Photo #:	3615, 5961, 6077

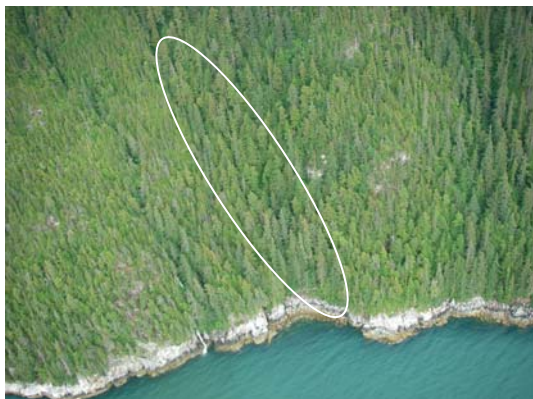
DF40. View east/upslope at debris flow channel.

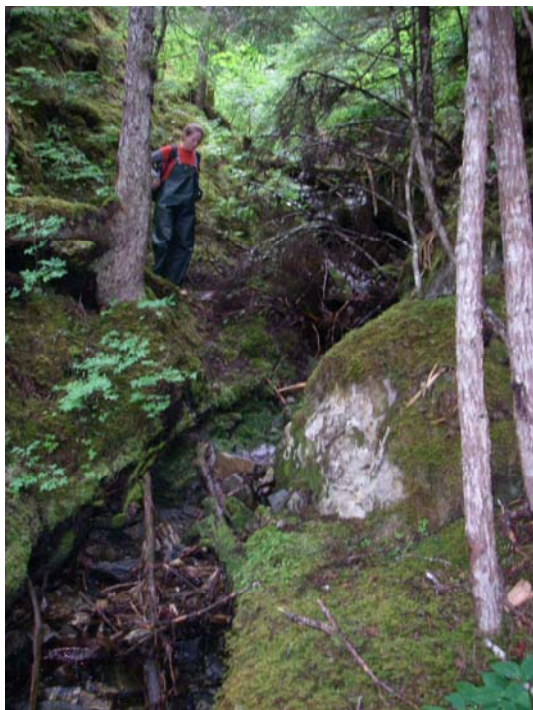
DF40. View west/upslope at debris flow channel. Photo taken 315 ft right of IRP 2006 2459+00.

Hazard ID #:	DF40
Hazard Type:	debris_flow
HIN:	135
Rating:	B
IRP 2006 Location:	2459
Frequency (yrs):	5-25
Predictability:	low
Material Volume (CY):	10-100
Clast Size (ft):	0-1
Source Elev. (ft):	2000-3000
Centerline Slope:	fan
Alignment Location:	deposition_zone
Impact Alignment:	yes
Alignment Exposure (ft):	50-200
Vegetation:	denuded
Deciduous Trees:	no
IRP 2006 South Margin:	2459+00
IRP 2006 North Margin:	2459+90
Photo #:	3616, 5180, 5961

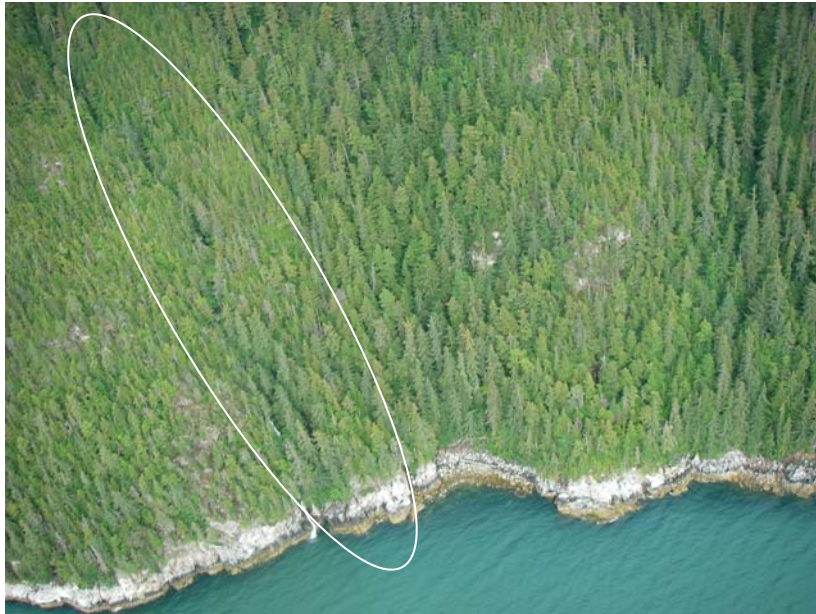
Hazard ID #:	DF41
Hazard Type:	debris_flow
HIN:	129
Rating:	B
IRP 2006 Location:	2460
Frequency (yrs):	1-5
Predictability:	high
Material Volume (CY):	10-100
Clast Size (ft):	0-1
Source Elev. (ft):	3000+
Centerline Slope:	fan
Alignment Location:	deposition_zone
Impact Alignment:	yes
Alignment Exposure (ft):	50-200
Vegetation:	denuded
Deciduous Trees:	yes
IRP 2006 South Margin:	2460+40
IRP 2006 North Margin:	2461+00
Photo #:	3616

DF41. View east/upslope at debris flow channel.

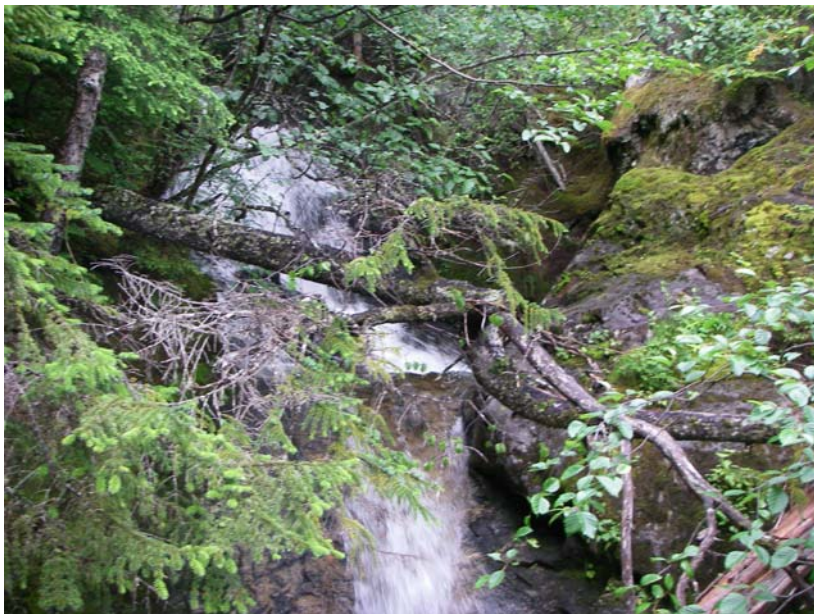
DF41. View east/upslope at debris flow chute with active stream. Photo taken 130 ft right of IRP 2006 2461+00.

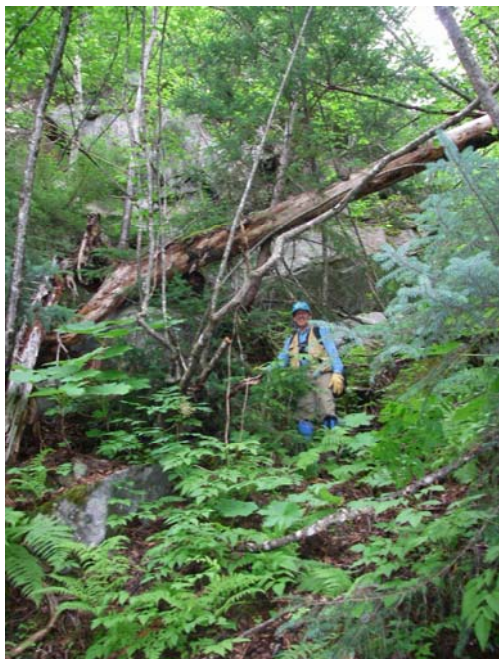
RF37. View east/upslope at rockfall area. Photo taken at centerline at IRP 2006 2468+80.

Hazard ID #:	RF37
Hazard Type:	rockfall
HIN:	69
Rating:	B
IRP 2006 Location:	2467
Frequency (yrs):	1-5
Predictability:	high
Material Volume (CY):	<10
Clast Size (ft):	4+
Source Elev. (ft):	100-500
Centerline Slope:	open_soil_slope
Alignment Location:	path
Impact Alignment:	yes
Alignment Exposure (ft):	200-500
Vegetation:	disturbed
Deciduous Trees:	yes
IRP 2006 South Margin:	2466+10
IRP 2006 North Margin:	2470+00
Photo #:	3637, 5181, 5962

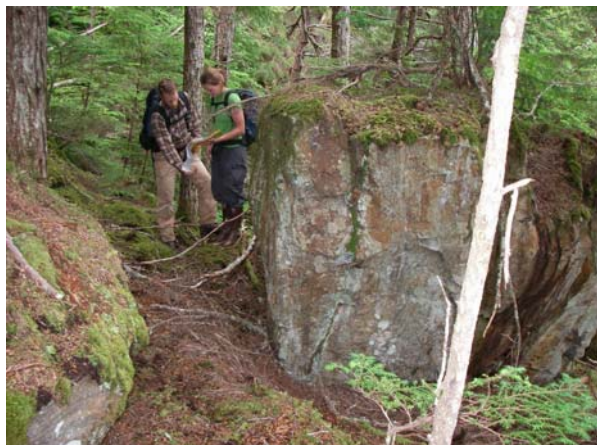
G-156

RF38. View south/down alignment at typical talus field within rockfall hazard. Photo taken 10 ft left of IRP 2006 2473+50.

Hazard ID #:	RF38
Hazard Type:	rockfall
HIN:	33
Rating:	B
IRP 2006 Location:	2473
Frequency (yrs):	5-25
Predictability:	high
Material Volume (CY):	<10
Clast Size (ft):	1-2
Source Elev. (ft):	100-500
Centerline Slope:	single_channel
Alignment Location:	path
Impact Alignment:	yes
Alignment Exposure (ft):	50-200
Vegetation:	disturbed
Deciduous Trees:	yes
IRP 2006 South Margin:	2473+00
IRP 2006 North Margin:	2474+00
Photo #:	6092

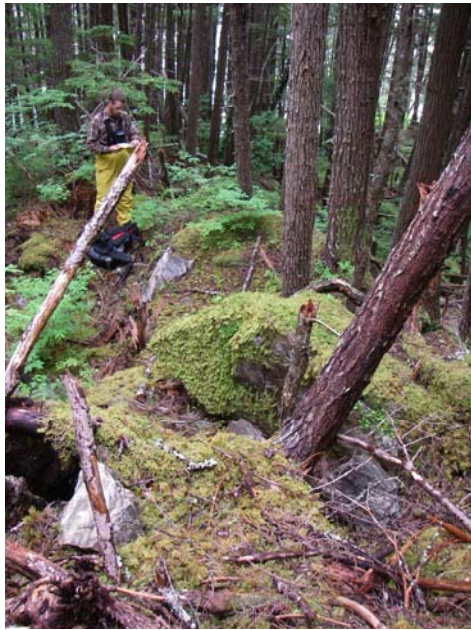
RF39. View south/down alignment at rockfall hazard. Photo taken at centerline at IRP 2006 2481+00.

Hazard ID #:	RF39
Hazard Type:	rockfall
HIN:	129
Rating:	B
IRP 2006 Location:	2481
Frequency (yrs):	1-5
Predictability:	unpredictable
Material Volume (CY):	<10
Clast Size (ft):	3-4
Source Elev. (ft):	100-500
Centerline Slope:	other
Alignment Location:	deposition_zone
Impact Alignment:	yes
Alignment Exposure (ft):	50-200
Vegetation:	disturbed
Deciduous Trees:	yes
IRP 2006 South Margin:	2480+30
IRP 2006 North Margin:	2481+50
Photo #:	6083, 6084

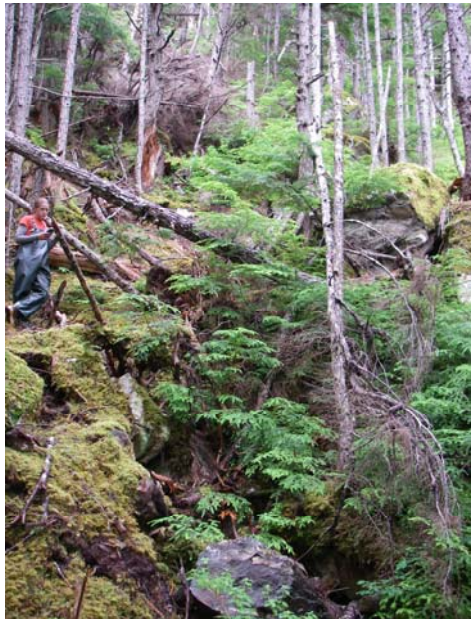
RF39. View east/upslope at rockfall. Photo taken at centerline at IRP 2006 2481+00.

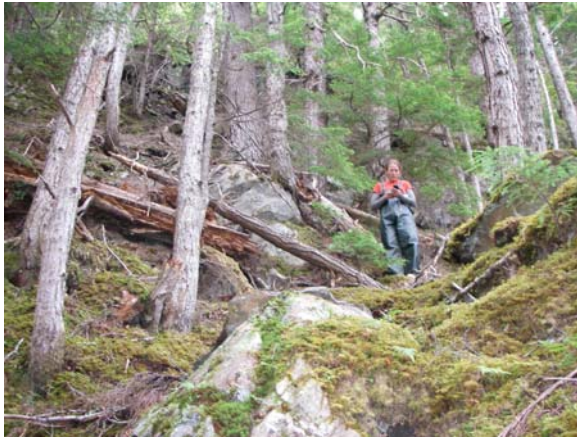
RF40. View west/upslope at rockfall hazard. Photo taken 80 ft right of IRP 2006 2487+00.

Hazard ID #:	RF40
Hazard Type:	rockfall
HIN:	147
Rating:	B
IRP 2006 Location:	2487
Frequency (yrs):	1-5
Predictability:	unpredictable
Material Volume (CY):	<10
Clast Size (ft):	3-4
Source Elev. (ft):	100-500
Centerline Slope:	-
Alignment Location:	below_deposition _zone
Impact Alignment:	yes
Alignment Exposure (ft):	200-500
Vegetation:	disturbed
Deciduous Trees:	no
IRP 2006 South Margin:	2484+00
IRP 2006 North Margin:	2488+70
Photo #:	5182, 5964, 6085

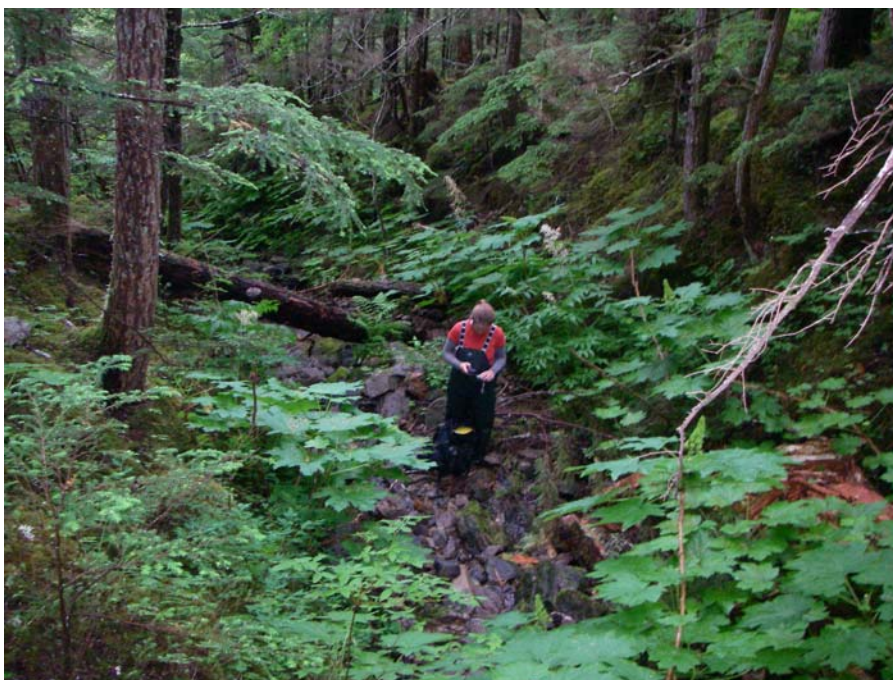
Hazard ID #:	DF42
Hazard Type:	debris_flow
HIN:	117
Rating:	B
IRP 2006 Location:	2491
Frequency (yrs):	5-25
Predictability:	moderate
Material Volume (CY):	10-100
Clast Size (ft):	1-2
Source Elev. (ft):	1000-2000
Centerline Slope:	single_channel
Alignment Location:	path
Impact Alignment:	yes
Alignment Exposure (ft):	50-200
Vegetation:	disturbed
Deciduous Trees:	yes
IRP 2006 South Margin:	2490+70
IRP 2006 North Margin:	2491+30
Photo #:	6086

DF42. View west/downslope at debris flow channel. Photo taken 115 ft right of IRP 2006 2490+50.

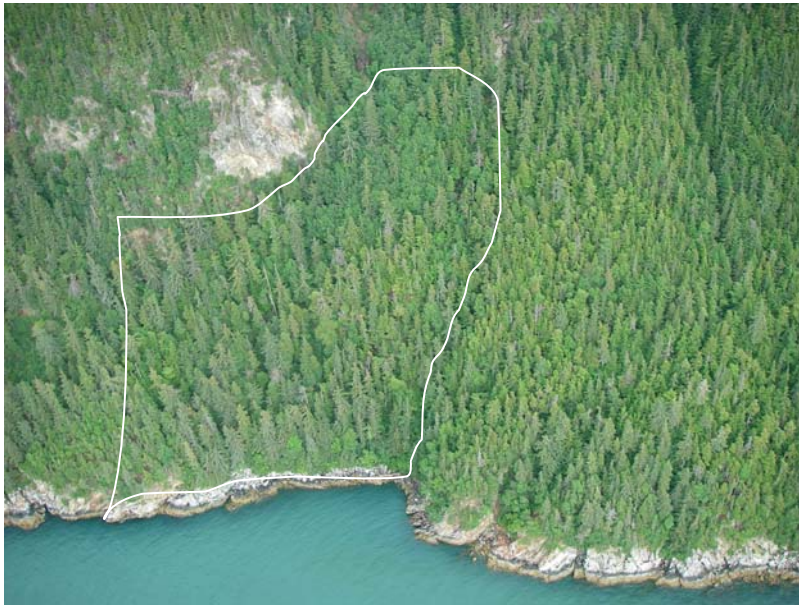
Hazard ID #:	RF41
Hazard Type:	rockfall
HIN:	129
Rating:	C
IRP 2006 Location:	2495
Frequency (yrs):	1-5
Predictability:	moderate
Material Volume (CY):	<10
Clast Size (ft):	2-3
Source Elev. (ft):	100-500
Centerline Slope:	open_soil_slope
Alignment Location:	path
Impact Alignment:	yes
Alignment Exposure (ft):	500+
Vegetation:	disturbed
Deciduous Trees:	yes
IRP 2006 South Margin:	2495+00
IRP 2006 North Margin:	2505+00
Photo #:	5965, 6094, 6095

RF41. View east/upslope at rockfall hazard.

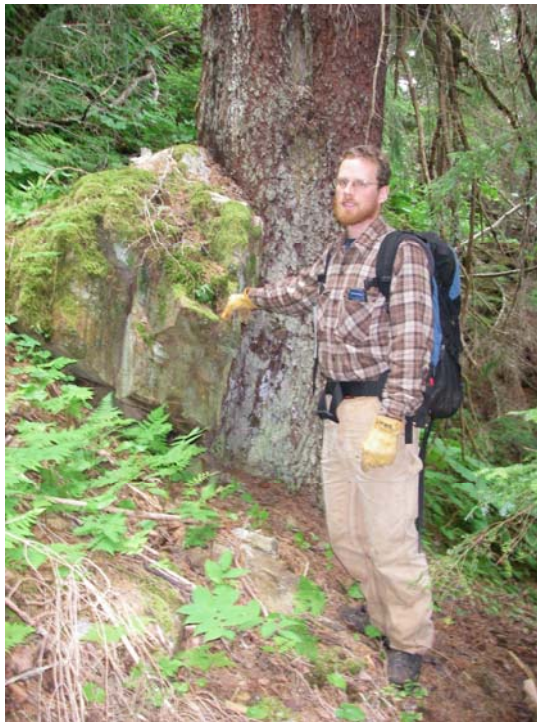
RF41. View south/down alignment at rockfall stopped by a spruce tree.
Photo taken 60 ft right of IRP 2006
2499+50.

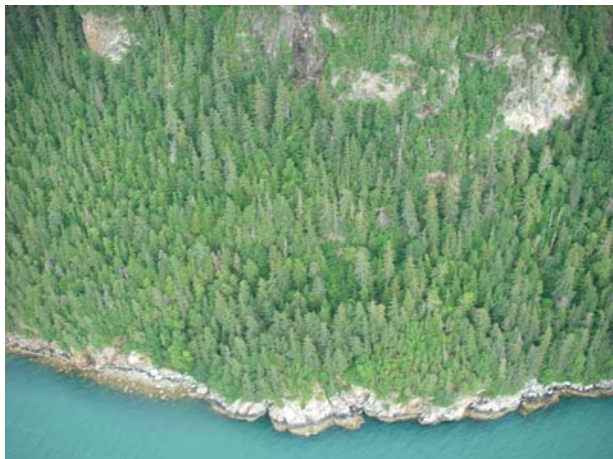
RF42. View east/upslope at rockfall hazard.

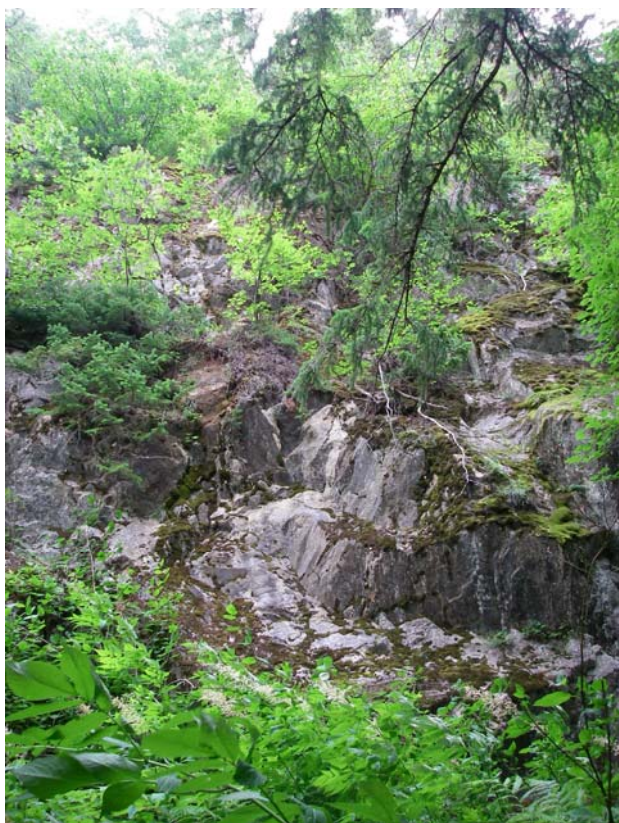
RF42. View east/upslope at rockfall hazard.
Photo taken 60 ft right of IRP 2006 2500+00.

Hazard ID #:	RF42
Hazard Type:	rockfall
HIN:	105
Rating:	B
IRP 2006 Location:	2502
Frequency (yrs):	unknown (5-25?)
Predictability:	moderate
Material Volume (CY):	<10
Clast Size (ft):	0-1
Source Elev. (ft):	<100
Centerline Slope:	deciduous_trees
Alignment Location:	path
Impact Alignment:	yes
Alignment Exposure (ft):	500+
Vegetation:	denuded
Deciduous Trees:	yes
IRP 2006 South Margin:	2499+50
IRP 2006 North Margin:	2505+00
Photo #:	6094, 6095

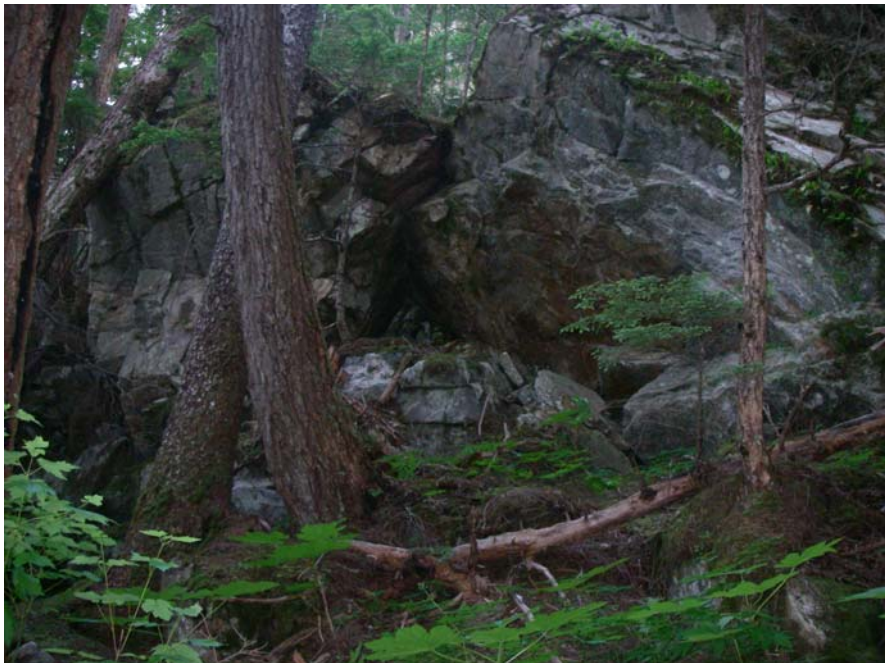
Hazard ID #:	HR03
Hazard Type:	hazard_rocks
HIN:	93
Rating:	C
IRP 2006 Location:	2518
Frequency (yrs):	unknown (>25?)
Predictability:	unpredictable
Material Volume (CY):	<10
Clast Size (ft):	4+
Source Elev. (ft):	<100
Centerline Slope:	-
Alignment Location:	below_deposition_zone
Impact Alignment:	yes
Alignment Exposure (ft):	<50
Vegetation:	-
Deciduous Trees:	no
IRP 2006 South Margin:	2517+80
IRP 2006 North Margin:	-
Photo #:	5311, 5312

HR03. View east/upslope at hazard rock. Photo taken 75 ft right of IRP 2006 2517+80.

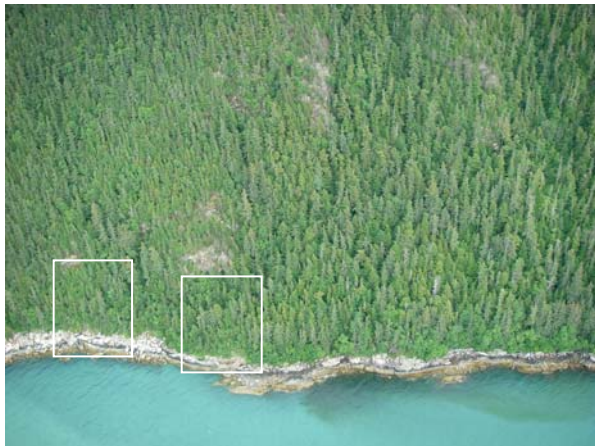
RF43 & RF44. View east/upslope at rockfall areas RF43 (right) and RF44 (left).

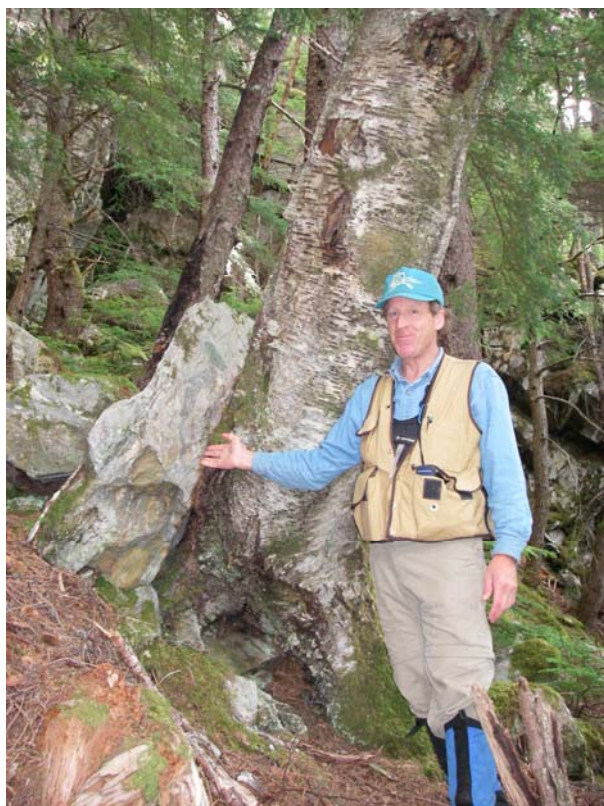
RF43. View south/down alignment at rockfall hazard, recently deposited boulder embedded into 2 ft diameter birch tree. Photo taken 30 ft right of IRP 2006 2529+00.

Hazard ID #:	RF43
Hazard Type:	rockfall
HIN:	129
Rating:	A
IRP 2006 Location:	2529
Frequency (yrs):	1-5
Predictability:	unpredictable
Material Volume (CY):	<10
Clast Size (ft):	2-3
Source Elev. (ft):	100-500
Centerline Slope:	open_soil_slope
Alignment Location:	deposition_zone
Impact Alignment:	yes
Alignment Exposure (ft):	50-200
Vegetation:	disturbed
Deciduous Trees:	yes
IRP 2006 South Margin:	2528+00
IRP 2006 North Margin:	2529+70
Photo #:	3648, 5969

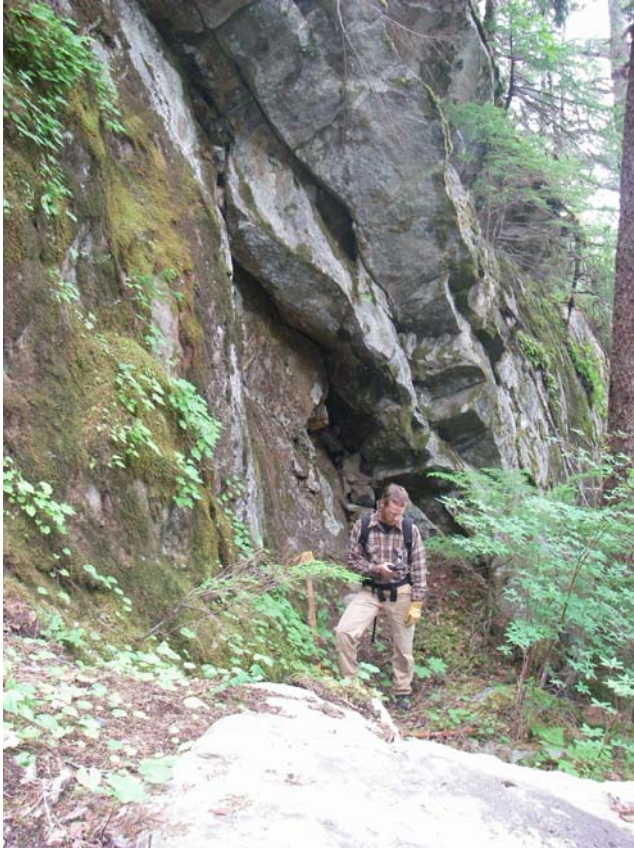
RF44. View south/down alignment at rockfall hazard. Photo taken 10 ft left of IRP 2006 2531+20.

Hazard ID #:	RF44
Hazard Type:	rockfall
HIN:	147
Rating:	B
IRP 2006 Location:	2531
Frequency (yrs):	1-5
Predictability:	unpredictable
Material Volume (CY):	<10
Clast Size (ft):	1-2
Source Elev. (ft):	100-500
Centerline Slope:	open_soil_slope
Alignment Location:	deposition_zone
Impact Alignment:	yes
Alignment Exposure (ft):	200-500
Vegetation:	disturbed
Deciduous Trees:	no
IRP 2006 South Margin:	2531+00
IRP 2006 North Margin:	2533+20
Photo #:	1565, 5326, 5327

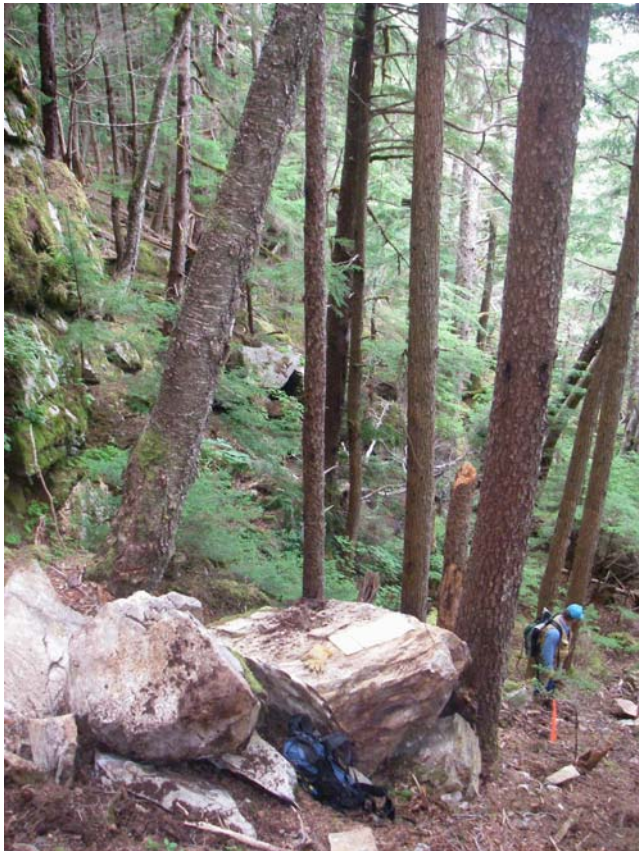
RF45. View west/downslope at rockfall with fresh rockfall stopped by spruce trees. Photo taken 20 ft right of IRP 2006 2537+00.

Hazard ID #:	RF45
Hazard Type:	rockfall
HIN:	129
Rating:	A
IRP 2006 Location:	2537
Frequency (yrs):	1-5
Predictability:	unpredictable
Material Volume (CY):	<10
Clast Size (ft):	1-2
Source Elev. (ft):	100-500
Centerline Slope:	-
Alignment Location:	deposition_zone
Impact Alignment:	yes
Alignment Exposure (ft):	50-200
Vegetation:	-
Deciduous Trees:	no
IRP 2006 South Margin:	2536+10
IRP 2006 North Margin:	2537+80
Photo #:	6098, 6099

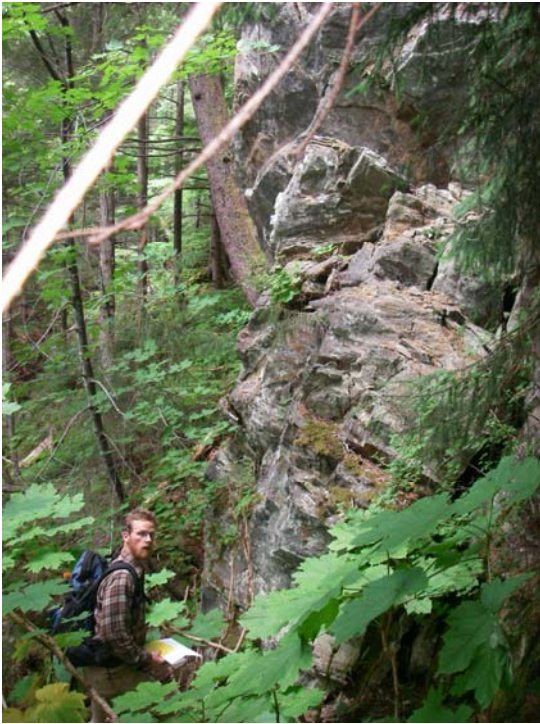
RF46. View north/up alignment at rockfall hazard cliffs. Photo taken 150 ft right of IRP 2006 2546+00.

Hazard ID #:	RF46
Hazard Type:	rockfall
HIN:	111
Rating:	A
IRP 2006 Location:	2548
Frequency (yrs):	5-25
Predictability:	unpredictable
Material Volume (CY):	<10
Clast Size (ft):	2-3
Source Elev. (ft):	100-500
Centerline Slope:	open_soil_slope
Alignment Location:	deposition_zone
Impact Alignment:	yes
Alignment Exposure (ft):	50-200
Vegetation:	disturbed
Deciduous Trees:	yes
IRP 2006 South Margin:	2546+70
IRP 2006 North Margin:	2548+30
Photo #:	5338, 5339

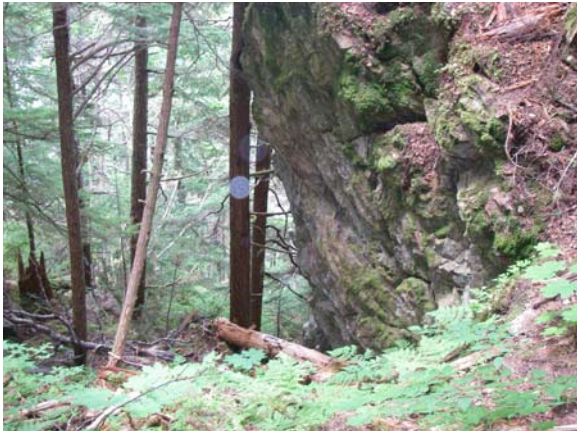
RF46. View northwest (up alignment and downslope) at rockfall hazard area. Photo taken 150 ft right of IRP 2006 2546+00.

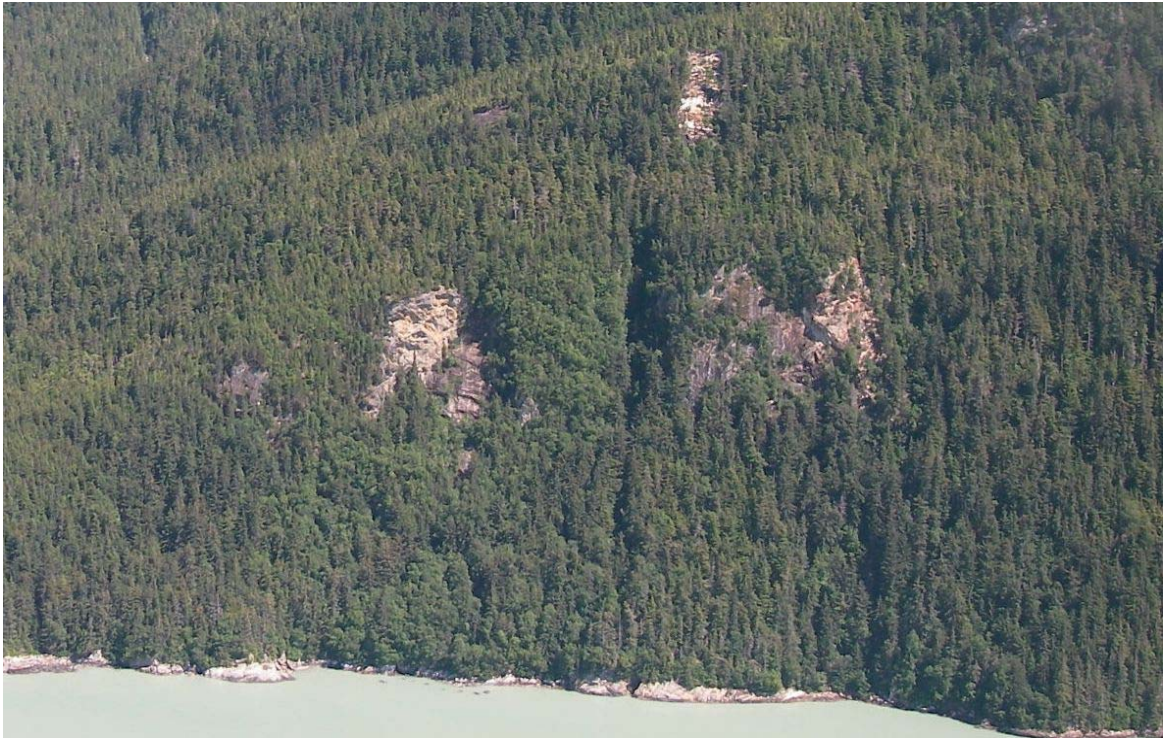
View east/upslope at approximate IRP 2006 range 2550+00 to 2570+00. Regional photo for hazards listed below. Local photos and details for individual hazards follow.

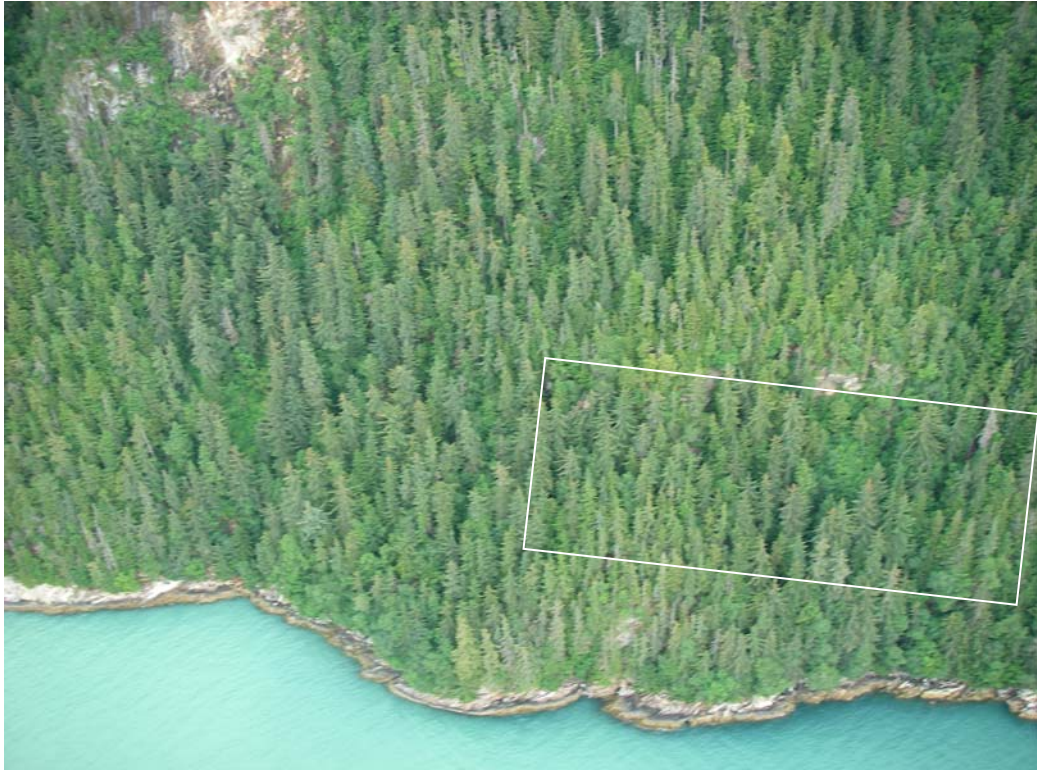
Hazard ID #:	RF47
Hazard Type:	rockfall
HIN:	183
Rating:	B
IRP 2006 Location:	2550
Frequency (yrs):	5-25
Predictability:	unpredictable
Material Volume (CY):	<10
Clast Size (ft):	2-3
Source Elevation (ft):	100-500
Centerline Slope:	open_soil_slope
Alignment Location:	deposition_zone
Impact Alignment:	yes
Alignment Exposure (ft):	500+
Vegetation:	disturbed
Deciduous Trees:	yes
IRP 2006 South Margin:	2549+80
IRP 2006 North Margin:	2556+30
Photo #:	3660

RF47. View east/upslope at rockfall hazard area.

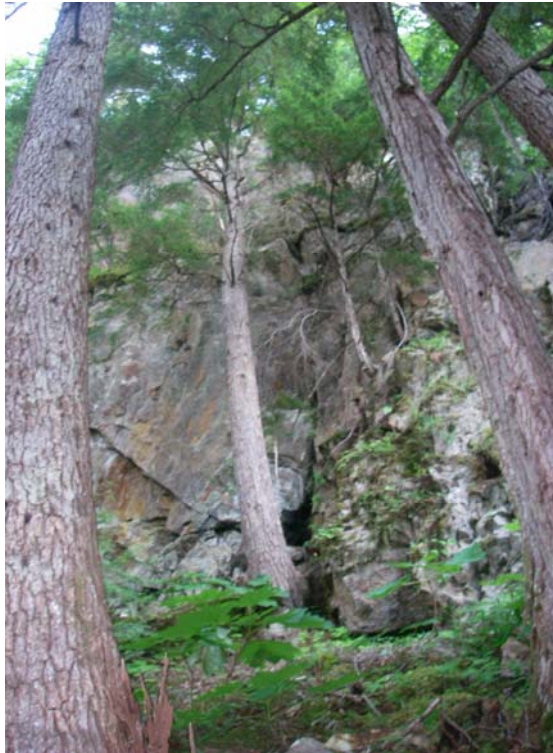
RF47. View east/upslope at rockfall.
Photo taken 220 ft right of IRP 2006
2557+00.

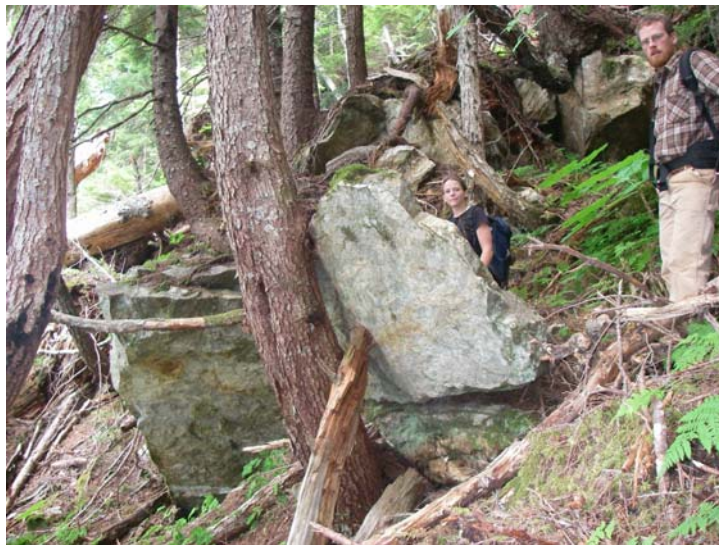
RF47. View north/up alignment at rockfall stopped
by tree trunk. Photo taken 30 ft right of IRP 2006
2554+00.

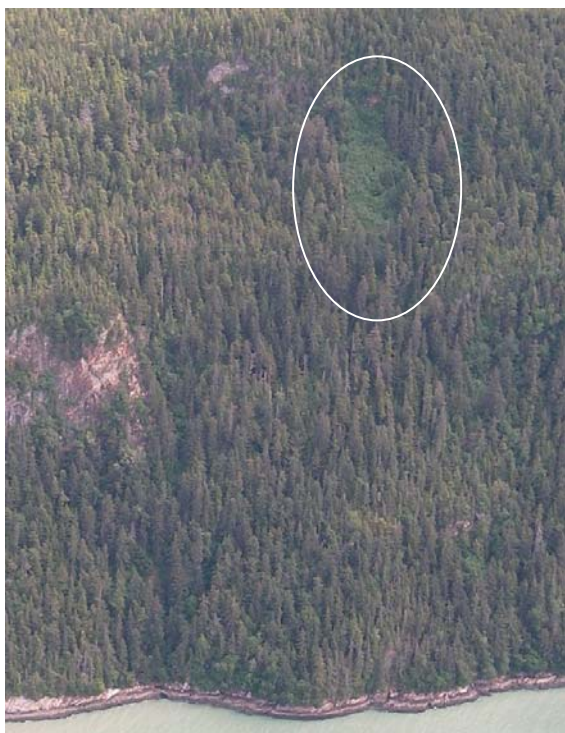
LS06. View east/upslope at landslide area (green patch of disturbed vegetation in upper right photo).

Hazard ID #:	LS06
Hazard Type:	landslide
HIN:	129
Rating:	C
IRP 2006 Location:	2552
Frequency (yrs):	unknown (>25?)
Predictability:	unpredictable
Material Volume (CY):	10-100
Clast Size (ft):	-
Source Elevation (ft):	500-1000
Centerline Slope:	open_soil_slope
Alignment Location:	below_deposition _zone
Impact Alignment:	no
Alignment Exposure (ft):	50-200
Vegetation:	disturbed
Deciduous Trees:	no
IRP 2006 South Margin:	2552+80
IRP 2006 North Margin:	2554+00
Photo #:	5185, 5341, 5342

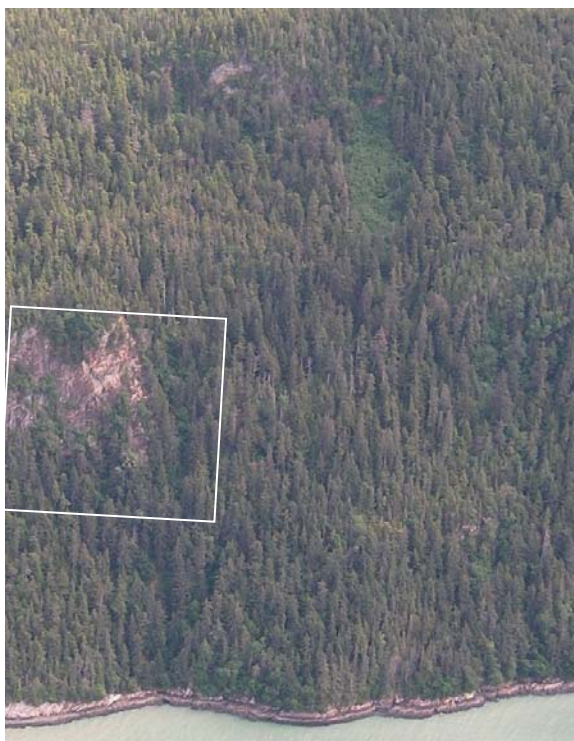
RF49. View east/upslope at rockfall hazard below cliffs and above IRP 2006 alignment.

Hazard ID #:	RF49
Hazard Type:	rockfall
HIN:	201
Rating:	C
IRP 2006 Location:	2557
Frequency (yrs):	1-5
Predictability:	unpredictable
Material Volume (CY):	<10
Clast Size (ft):	2-3
Source Elevation (ft):	100-500
Centerline Slope:	open_soil_slope
Alignment Location:	below_deposition_zone
Impact Alignment:	no
Alignment Exposure (ft):	500+
Vegetation:	disturbed
Deciduous Trees:	yes
IRP 2006 South Margin:	2556+50
IRP 2006 North Margin:	2562+00
Photo #:	3661, 3662, 3664

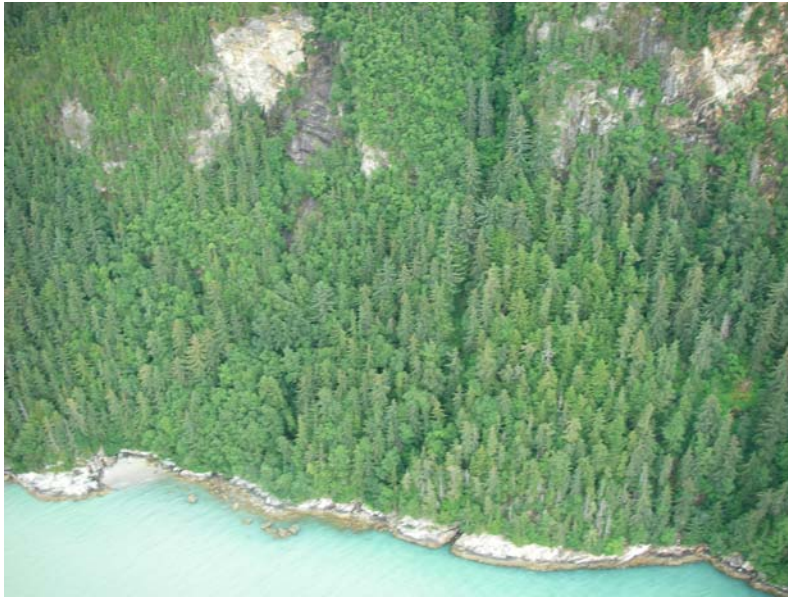
RF49. View east/upslope at the north half of rockfall area.

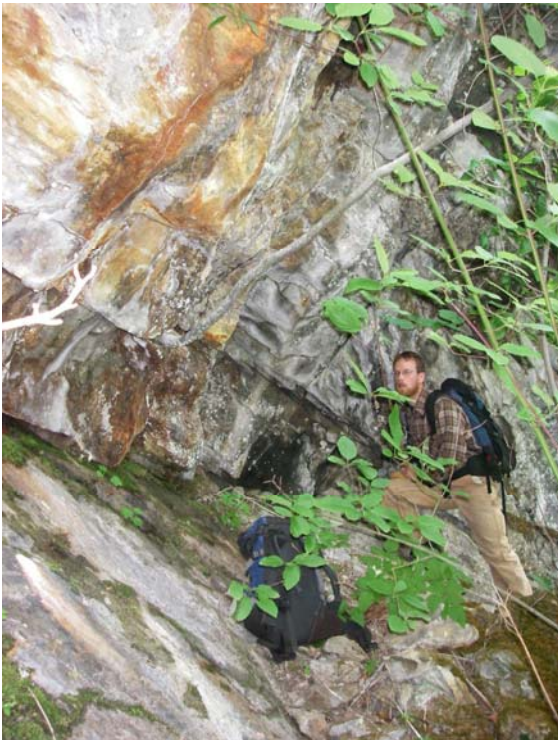
RF49. View south/down alignment across rockfall hazard. Photo taken 130 ft right of IRP 2006 2560+00.

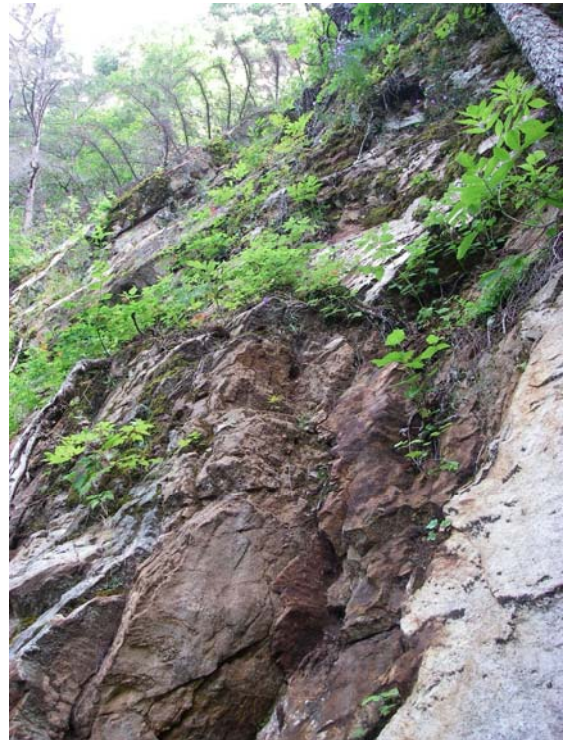
RF49. View north/up alignment across rockfall hazard. Photo taken 110 ft right of IRP 2006 2565+50.

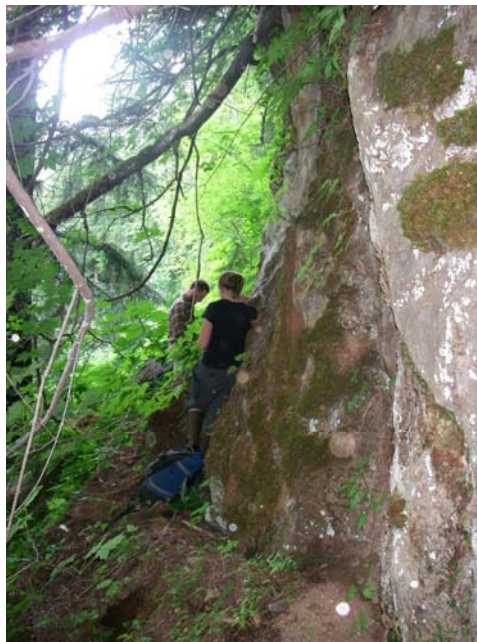
Hazard ID #:	RF50
Hazard Type:	rockfall
HIN:	147
Rating:	B
IRP 2006 Location:	2558
Frequency (yrs):	1-5
Predictability:	unpredictable
Material Volume (CY):	<10
Clast Size (ft):	2-3
Source Elevation (ft):	500-1000
Centerline Slope:	open_soil_slope
Alignment Location:	path
Impact Alignment:	yes
Alignment Exposure (ft):	50-200
Vegetation:	disturbed
Deciduous Trees:	yes
IRP 2006 South Margin:	2557+80
IRP 2006 North Margin:	2558+40
Photo #:	3661, 3662, 3664

RF50. View north/up alignment
at margin of rockfall hazard.
Photo taken 40 ft right of IRP
2006 2558+30.

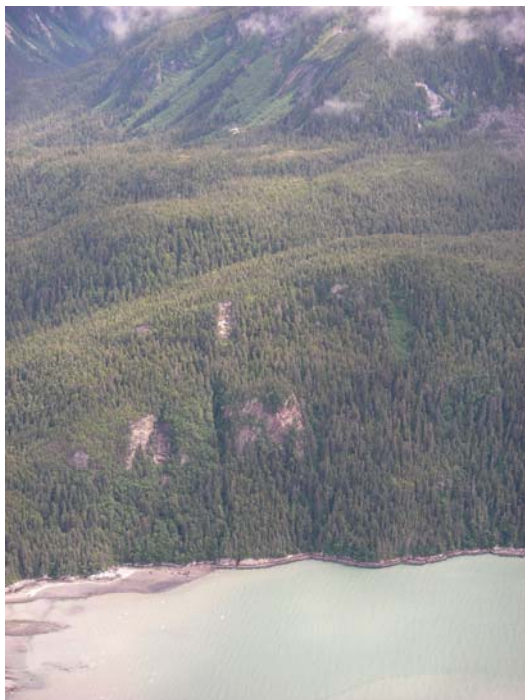
LS07. View east/upslope at landslide.

Hazard ID #:	LS07
Hazard Type:	landslide
HIN:	129
Rating:	C
IRP 2006 Location:	2561
Frequency (yrs):	unknown (>25?)
Predictability:	unpredictable
Material Volume (CY):	10-100
Clast Size (ft):	-
Source Elevation (ft):	500-1000
Centerline Slope:	open_soil_slope
Alignment Location:	below_deposition_zone
Impact Alignment:	no
Alignment Exposure (ft):	50-200
Vegetation:	disturbed
Deciduous Trees:	no
IRP 2006 South Margin:	2561+80
IRP 2006 North Margin:	2562+80
Photo #:	5024

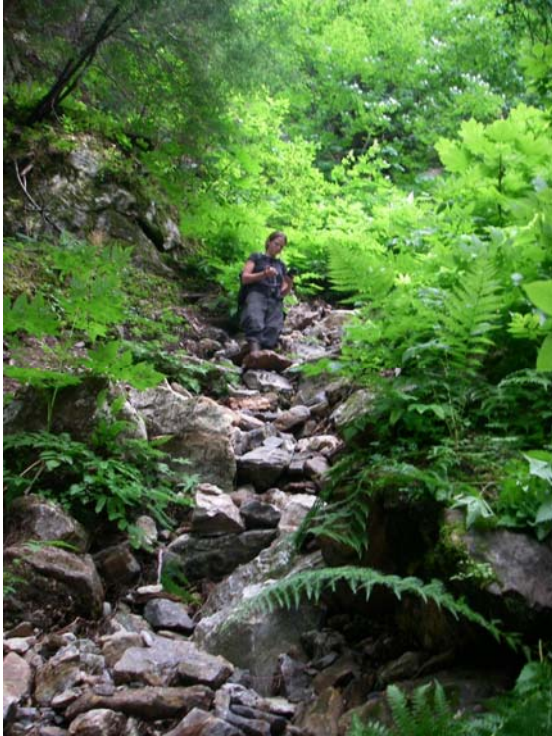
DF43. View north/upslope at debris flow channel. Photo taken 160 ft right of IRP 2006 2563+40.

Hazard ID #:	DF43
Hazard Type:	debris_flow
HIN:	63
Rating:	A
IRP 2006 Location:	2563
Frequency (yrs):	5-25
Predictability:	moderate
Material Volume (CY):	10-100
Clast Size (ft):	1-2
Source Elevation (ft):	500-1000
Centerline Slope:	single_channel
Alignment Location:	path
Impact Alignment:	yes
Alignment Exposure (ft):	50-200
Vegetation:	denuded
Deciduous Trees:	yes
IRP 2006 South Margin:	2563+30
IRP 2006 North Margin:	2564+10
Photo #:	5356

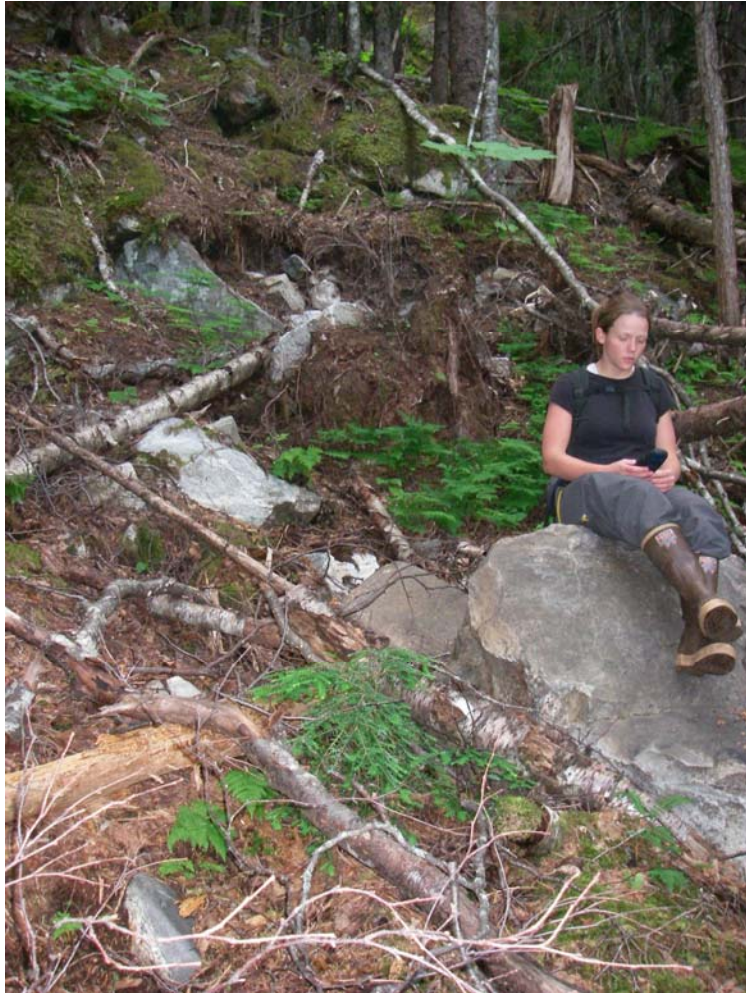
RF52. View south/down alignment at recent rockfall.
Photo taken 170 ft right of IRP 2006 2565+00.

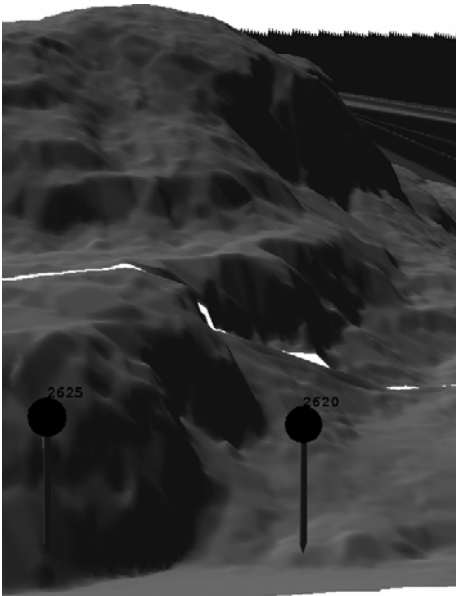
RF53. LIDAR bare earth image of local topography surrounding rockfall hazard. IRP 2006 alignment location 2620+00.
