Routine Inspection Report

Date: 7/14/2017

Br No 574

GULKANA RIVER

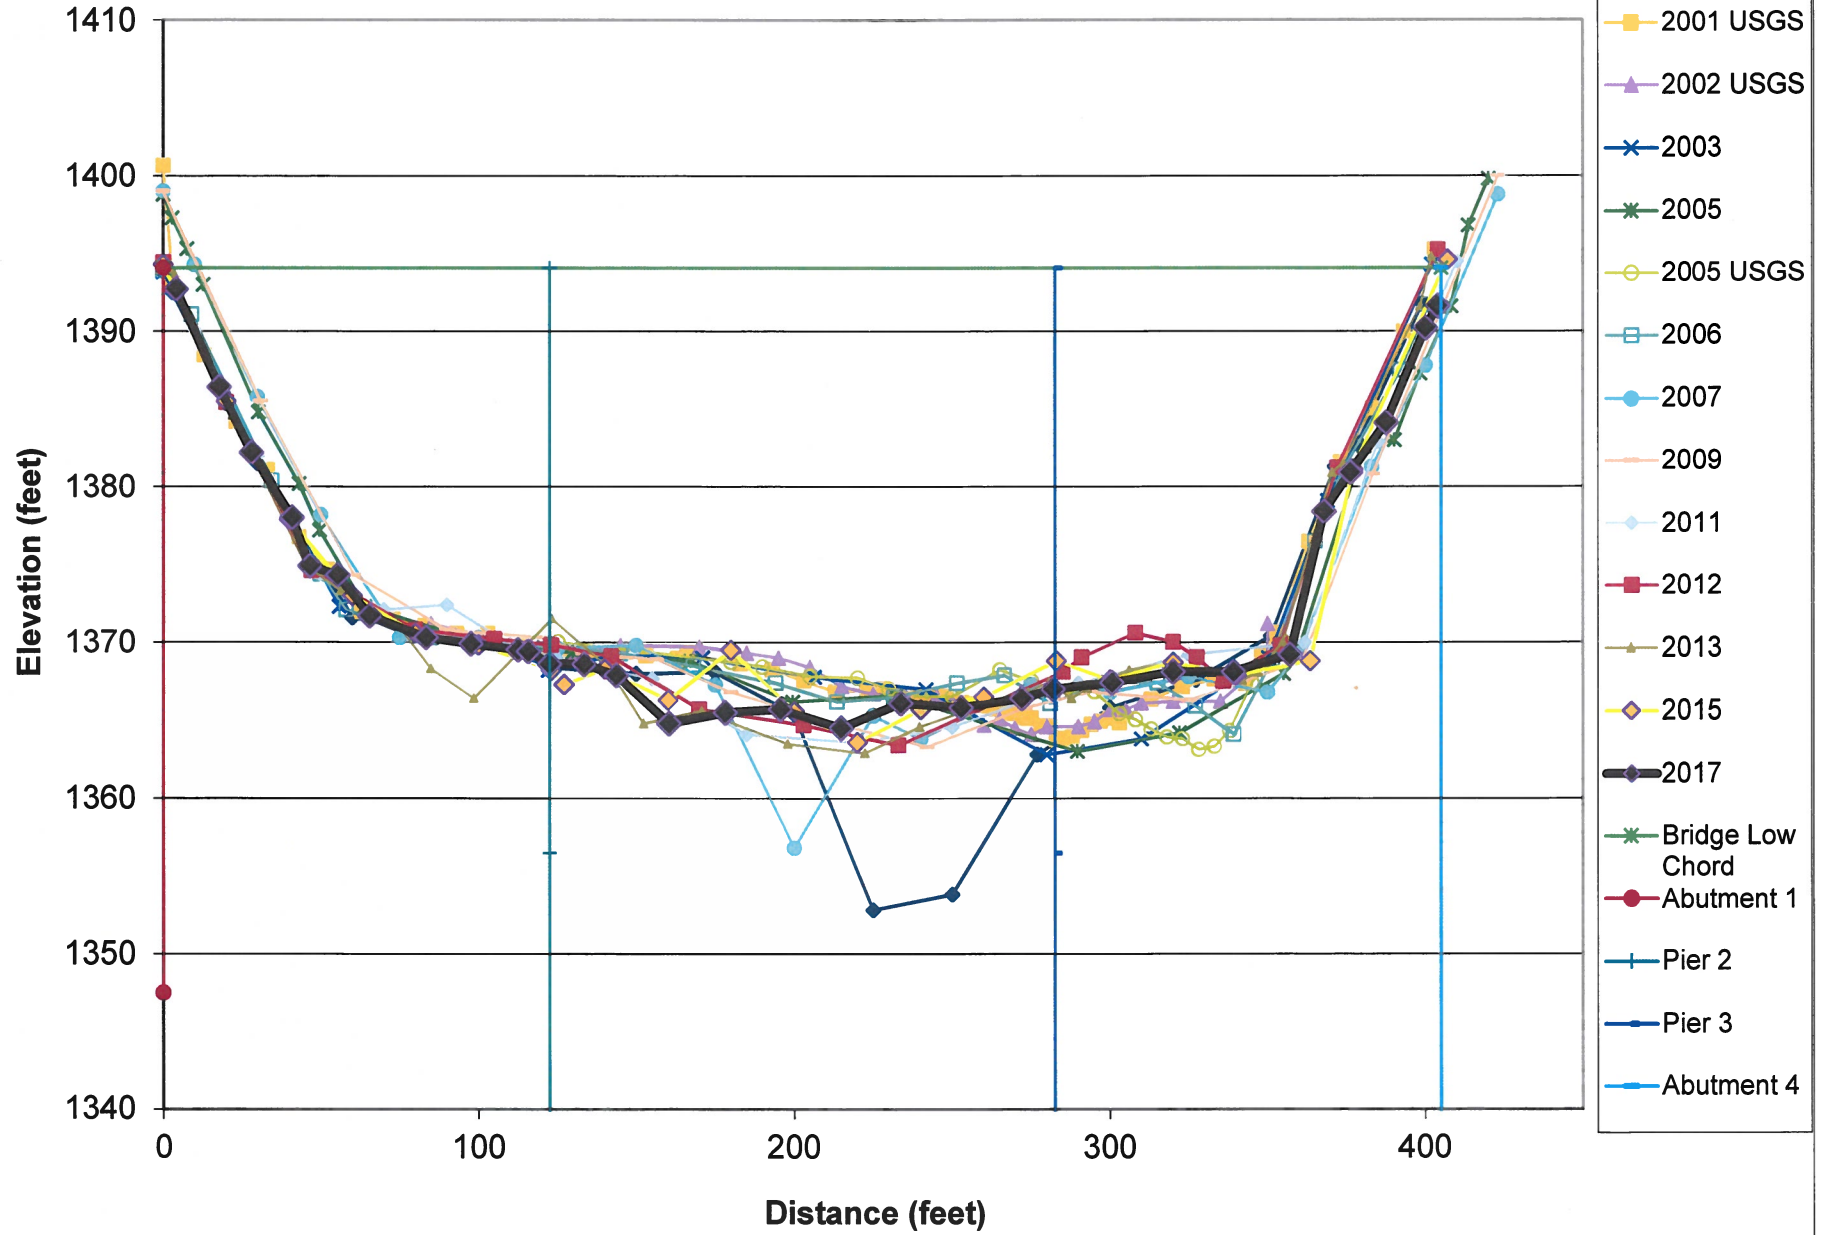
BN574 Gulkana River Soundings

Horiz Dist from NE	Substr Unit No.	Vert Dist to Water Surface	Vert Dist to Stream Bottom	Remarks
4.10	1	0.0	10.1	NE face of backwall, river-right
17.80	1	0.0	16.4	
28.00	1	0.0	20.6	
40.90	1	0.0	24.8	
46.60	1	0.0	27.9	
55.30	1	0.0	28.5	
65.50	1	0.0	31.1	
83.40	1	0.0	32.5	
97.60	1	0.0	32.9	
112.50	1	0.0	33.3	
115.70	1	0.0	33.4	EOW
122.40	1	0.0	34.2	Pier 2
133.40	1	0.0	34.2	
143.70	1	0.0	34.9	
160.30	1	0.0	38.0	
178.20	1	0.0	37.3	
195.60	1	0.0	37.1	
214.80	1	0.0	38.3	
233.70	1	0.0	36.7	
252.80	1	0.0	37.0	
272.10	1	0.0	36.4	
281.90	1	0.0	35.8	Pier 3
300.60	1	0.0	35.4	
320.00	1	0.0	34.7	
339.20	1	0.0	34.7	
357.10	1	0.0	33.6	EOW
367.80	1	0.0	24.4	
376.20	1	0.0	21.9	
387.50	1	0.0	18.7	
400.00	1	0.0	12.6

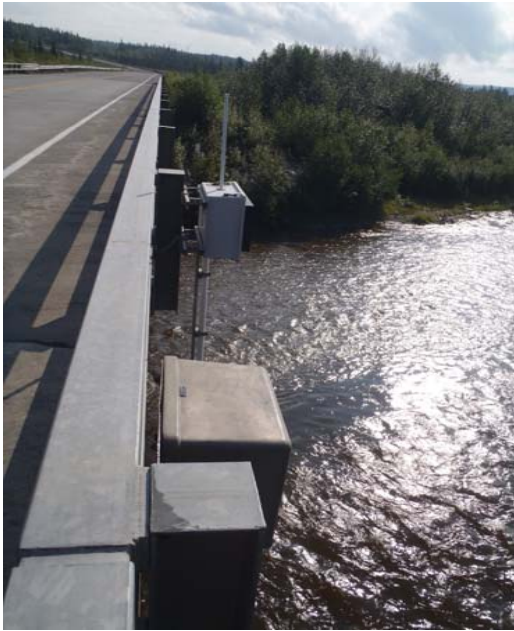
Bridge No. **0574** Br. Name **Gulkana River** Date **07/14/17**
 Inspector **Murray / Knapp** Frame **9**
Hydrologic monitoring on bridge

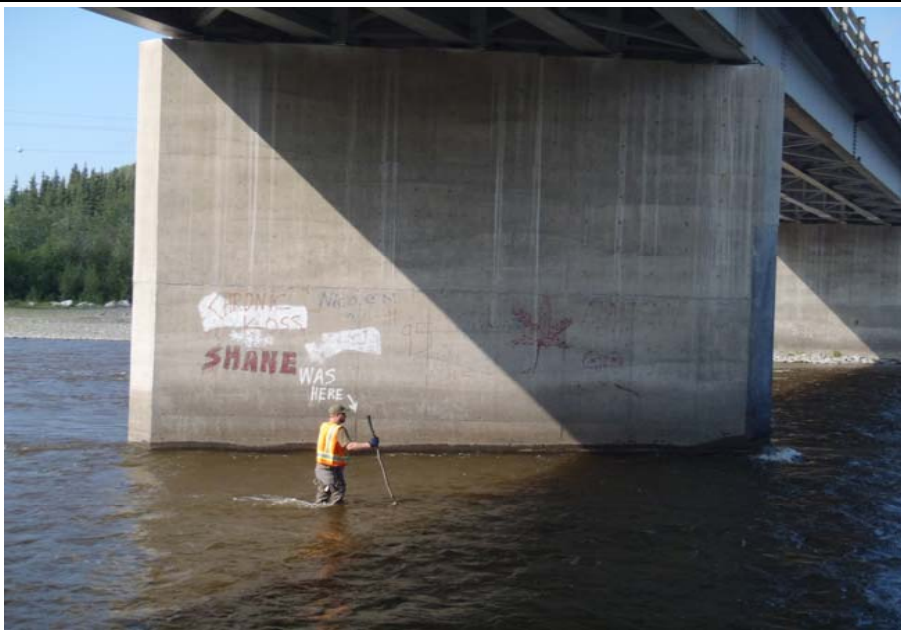
<i>Element</i>	<i>Description</i>	<i>Observations</i>
12	Reinforced Concrete Deck	Most delaminations are near highway centerline and around previously patched areas especially at the FE of the bridge. About 25% delams in the SB and minimal delams in the NB lane. Deck cracking is prevalent and many patches are cracked. About 15 spalls have been filled with asphalt. Minor amount of transverse cracking with efflorescence in soffit overhangs.
> 1120	<i>Efflorescence/Rust Staining</i>	
> 1130	<i>Cracking (RC and Other)</i>	
107	Steel Open Girder/Beam	Minor rust freckles on girders, cross frames, and lateral bracing with combined area less than 1% of total painted area. Second and sixth transverse stiffeners from the NE on the US girder are bent. Swallows nests on the lateral bracing connection plates.
> 515	<i>Steel Protective Coating</i>	
210	Reinforced Concrete Pier Wall	Vertical cracks on both faces of both piers. Crack width of about 1/16 inch for the full height of the pier at about centerline. Some locations behind steel nosing armor sound hollow as if it is not in direct contact with concrete. Pier 3 has a tight horizontal crack about 6 feet above the waterline.

Bridge No. **0574** Br. Name **Gulkana River** Date **07/14/17**
 Inspector **Murray / Knapp** Frame **23**
Probing pier 3
