Routine Inspection Report

Date: 7/14/2017

Br No 684 ROCK CREEK

Bridge No. 0684, ROCK CREEK

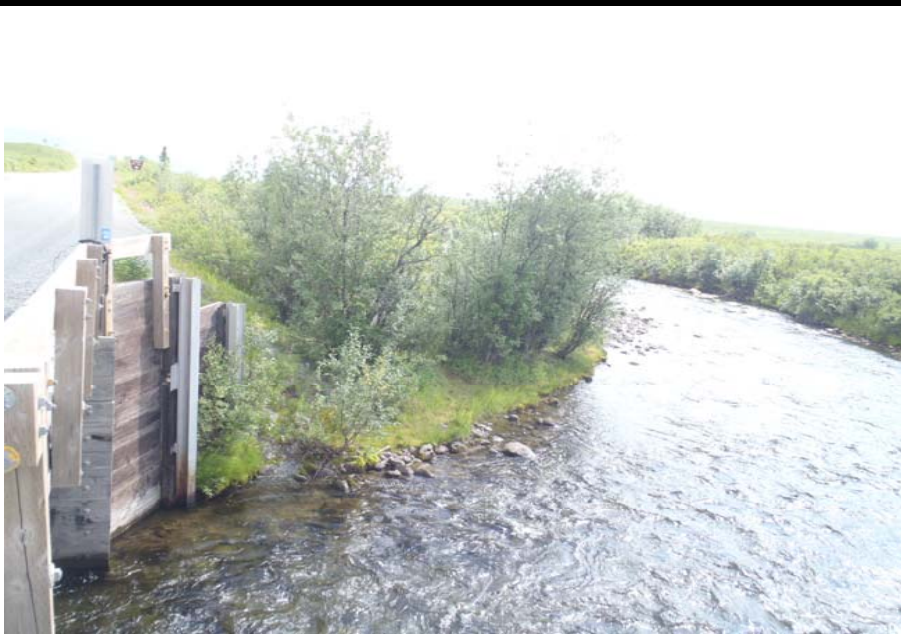
Bridge No. **0684** Br. Name **Rock Creek** Date **07/14/17**
 Inspector **Murray / Knapp** Frame **7**
DS FE Bank

Probing at FE abutment found ~1 ft gap at bottom of lagging to streambed; smaller gap visible at NE abutment;

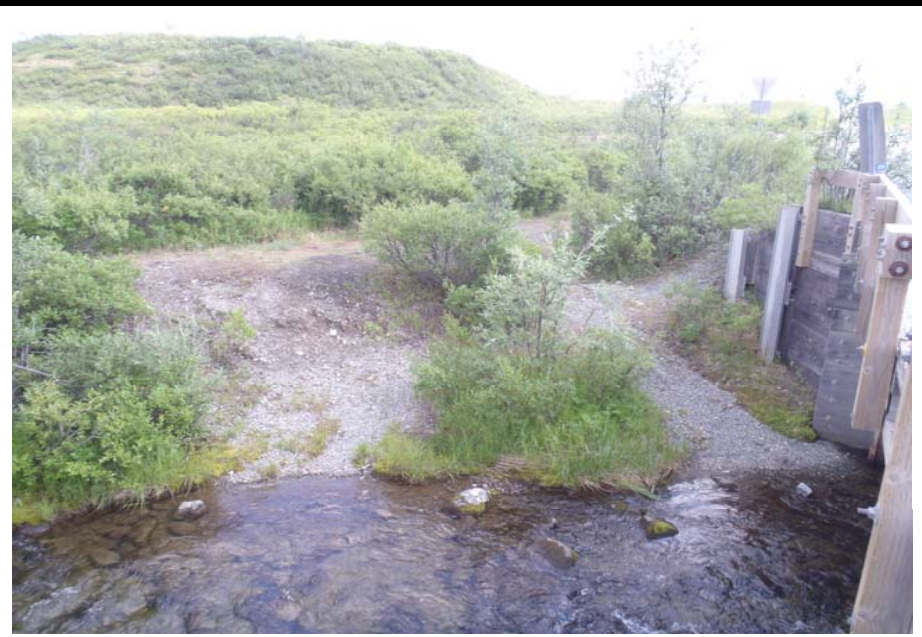
Bridge No. **0684** Br. Name **Rock Creek** Date **07/14/17**
 Inspector **Murray / Knapp** Frame **8**
US FE Bank

FE US wingwall and end of lagging wall are getting 'punky'.
FE US wingwall pile has a crack in a vertical weld.
