Routine Inspection Report

Date: 8/9/2017

Br No 605 SNOW RIVER CNTR CHANNEL

Bridge No. 0605, SNOW RIVER CNTR CHANNEL

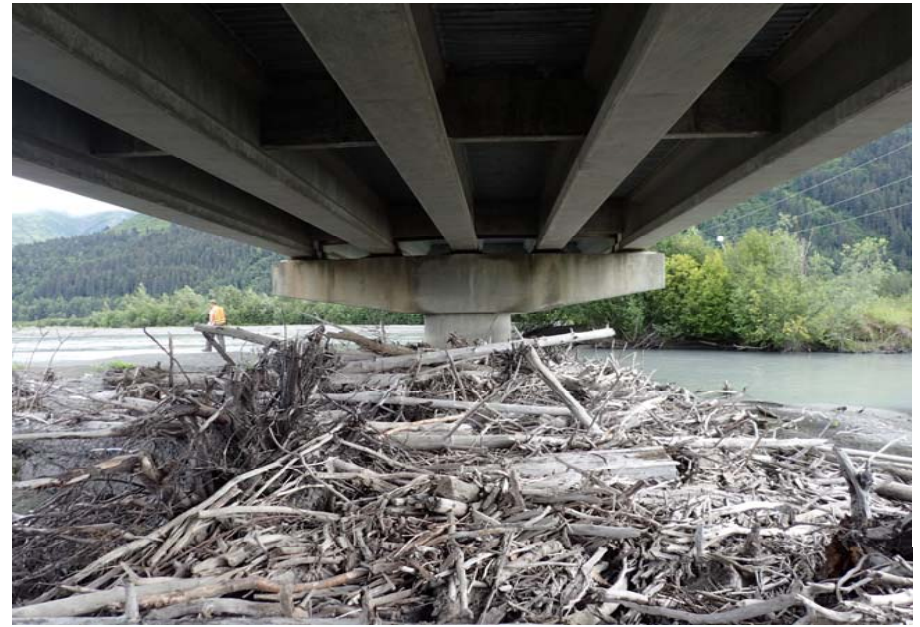
Bridge No. **0605** Br. Name **Snow River Cntr Channel** Date **08/09/17**
 Inspector **Murray / Murph** Frame **30**
Pier 3 NE face

Large build up of trees, logs, etc. at every
pier except for pier 5. Scour holes 2-3ft
deep at all piers in the dry, particularly
pier 2.

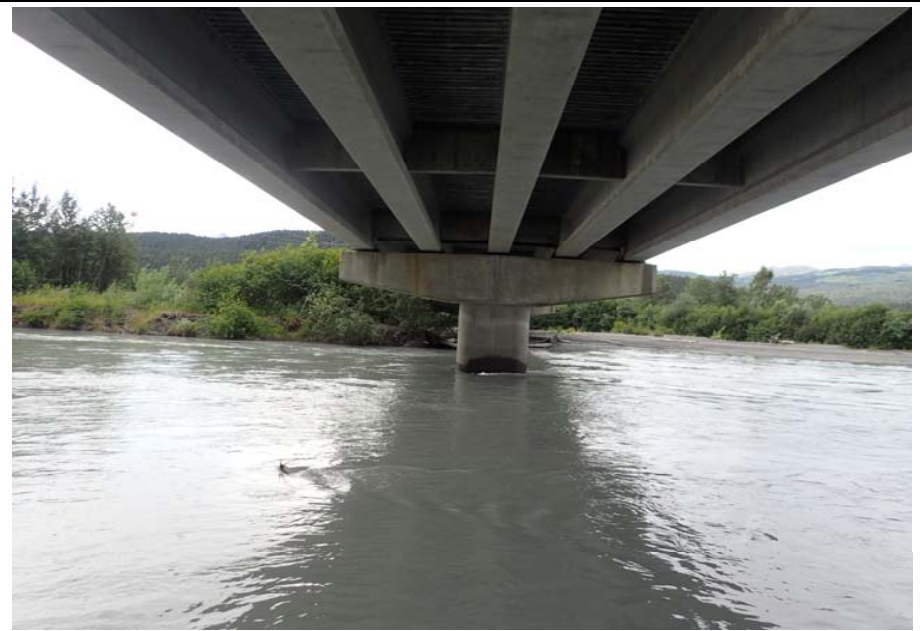
Bridge No. **0605** Br. Name **Snow River Cntr Channel** Date **08/09/17**
 Inspector **Murray / Murph** Frame **32**
FE pier 5

Pier 4 is mostly in the dry but
unaccessible. Pier 5 is deep, murky and
silty.
