Routine Inspection Report

Date: 8/9/2017

Br No 607

VICTOR CREEK

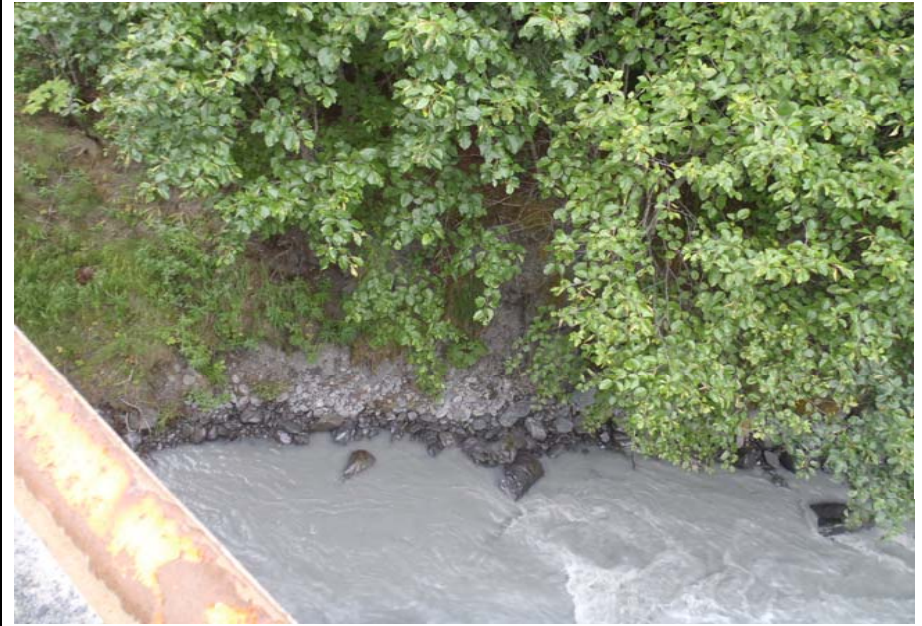
Bridge No. **0607** Br. Name **Victor Creek** Date **08/09/17**
 Inspector **Murray / Murph** Frame **6**
Looking NE DS

8 ft vertical banks NE DS for 200+ feet
as well as FE US for 200+ ft.

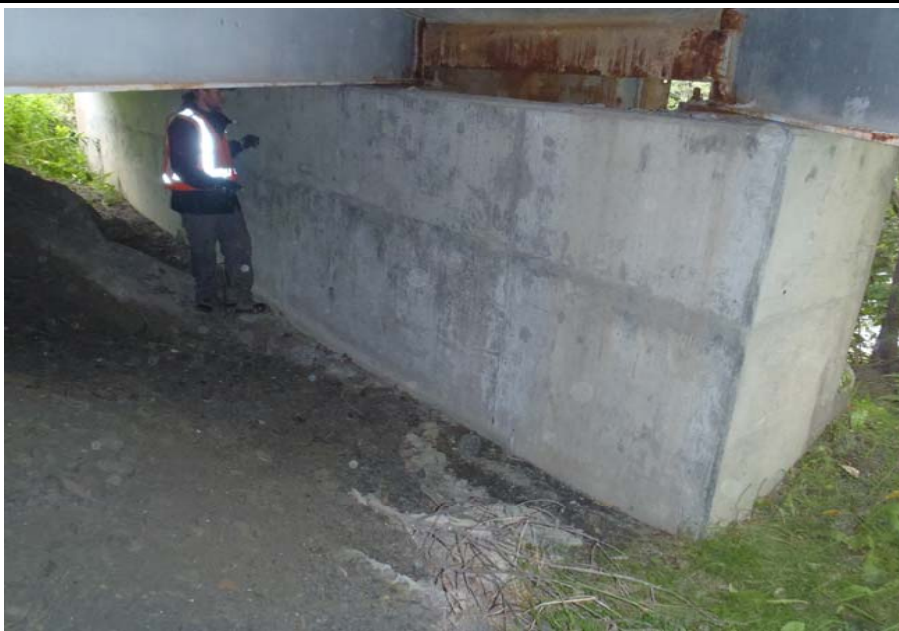
Bridge No.	0607	Br. Name	Victor Creek	Date	08/09/17
Inspector	Murray / Murph		Frame	27	
NE face Pier 2

> 515	Steel Protective Coating	
210	Reinforced Concrete Pier Wall	<p>Pier 2 NE face multiple hairline cracks half height. One full height cracked measured at 0.040in. Pier 3 NE, two hairline cracks full-width about mid-height and 1 full-height hairline crack. Pier 3 NEDS, 2SF spall with exposed rebar at footing. Pier 3 FE, two cracks full width about mid-height. US side is 3/16 inch wide for about 6ft. Pier 3 FE, one full-height hairline crack. Pier 3 US footing exposed about 3ft deep and 4ft wide. Remaining length 1.5 feet deep. As-builts indicate footing is pile supported. Pier 4 NE, 1SF spall near mudline. Pier 4 FE, full-width hairline crack at construction joint. US side is about 0.3 inches wide for about 5ft.</p>
> 6000	Scour	
215	Reinforced Concrete Abutment	<p>NEDS, minor wingwall spall. 40 inch long x 5 inch high x 40 inch deep void under NE cap near centerline. NEDS and FEUS 8ft vertical banks for about 200ft starting at bridge.</p>
