Routine Inspection Report

Date: 6/25/2017

Br No 253

HERRING COVE

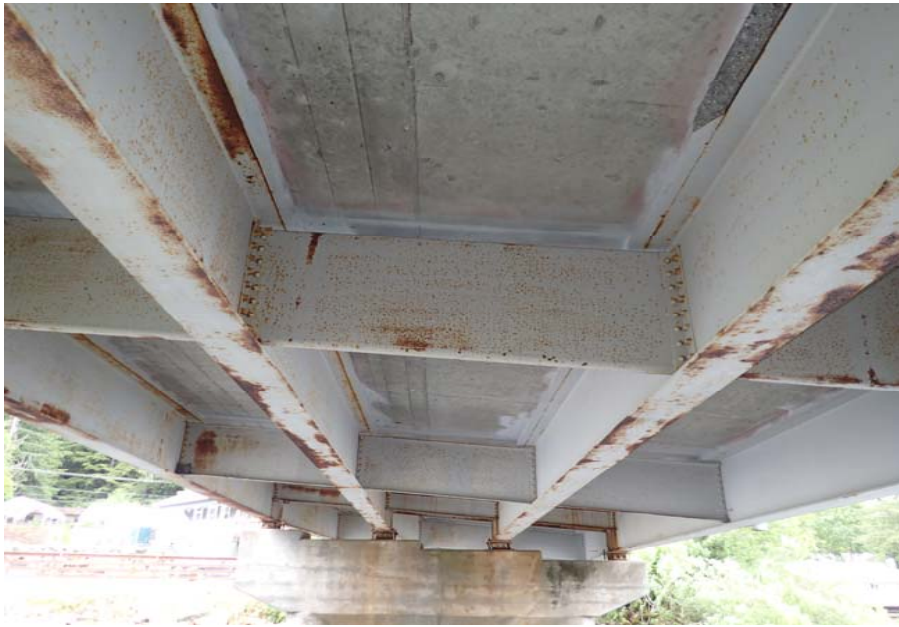
Bridge No.	0253	Br. Name	Herring Cove	Date	06/25/17
Inspector		Manning / Escamilla		Frame	21
Underside of deck typical

Element	Description	Observations
12	Reinforced Concrete Deck	<p>Scale and abrasion throughout. Numerous spalls, popouts, and several exposed rebar.</p> <p>Delaminations and Spalls: Span 1 LT - Approximately 50% of total area Span 1 RT - Approximately 40% of total area Span 2 LT - Approximately 20% of total area Span 2 RT - Approximately 50% of total area</p> <p>Exposed Rebar: Span 1 LT - 16SF; 3ft x 8ft section (14SF of total) with 6 transverse and 1 longitudinal bar(s) exposed, partially patched with asphalt, rebar still exposed Span 1 RT - 3SF; 1 section mostly covered with asphalt patch material Span 2 LT - 1SF FE, patched Span 2 RT - 10SF; 2SF at midspan, remaining in 1SF increments; 1SF found, 9 SF patched with asphalt</p> <p>Soffit: Minor cracking with efflorescence typical near rail post anchor plates and drains. Span 1 G2 DS haunch spalled 15ft near NE abutment Span 1 G3 US haunch spalled 20ft near NE abutment; both haunches spalled 5ft US and 10ft DS near Pier 2 Span 1 G4 haunch spalled 12ft US near Pier 2 Span 2 G2 US haunch spalled 4ft near Pier 2 Span 2 G2 DS haunch spalled 1ft near Pier 2 Span 2 G2 DS haunch spalled 1ft near Abutment 3 Span 2 G3 DS haunch spalled 2 ft with delamination near Abutment 3 Span 2 G3 DS haunch delaminated 1ft near Pier 3 Span 2 G4 US haunch spalled 0.5 ft near Abutment 3</p>

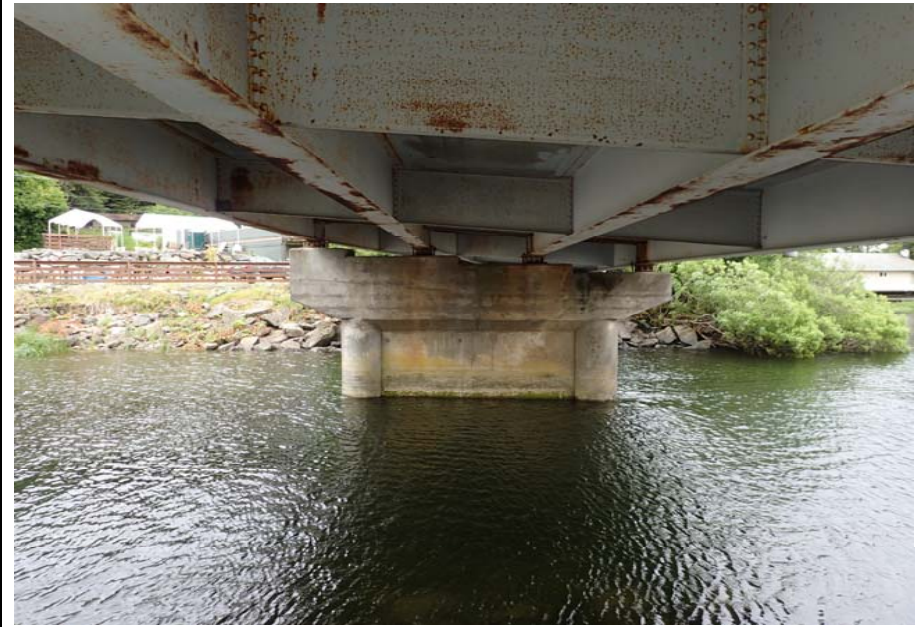
Bridge No.	0253	Br. Name	Herring Cove	Date	06/25/17
Inspector		Manning / Escamilla		Frame	22
NE Pier 2

> 1080	Delamination/Spall/Patched Area
	> 1120	Efflorescence/Rust Staining
	> 1130	Cracking (RC and Other)
107	Steel Open Girder/Beam	
	> 515	Steel Protective Coating
210	Reinforced Concrete Pier Wall	<p>Marine growth in tidal zone. NE face, top of footing slightly exposed. FELT of footing exposed for about 2ft; streambed approximately 3 inches below top of footing. RT face minor crack with efflorescence. One LT face 1 SF spall. NELT spall has exposed rebar.</p>
