ANALYSIS OF RUTTING FOR ANCHORAGE PAVEMENTS

PURPOSE

Understand Rutting Mechanisms and Recommend Methods to Reduce Rutting in Anchorage.

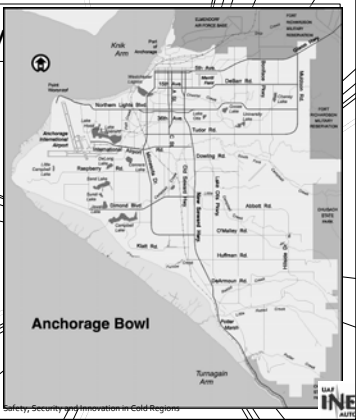
Field Study

- Inbound Glen Highway at Muldoon exit
- Diamond Blvd. at Old Seward
- Tudor Road at Bragaw
- Gamble Street at 13th Ave.
- Benson at Seward Hwy.
- Bragaw at 6th Ave.
- C-Street at 8th Ave
