The Effects of a Winter Ice Jam Event On Bioengineered Bank Stabilization Along The Kenai River

Prepared by: Kenneth F. Karle, P.E.
Hydraulic Mapping and Modeling

Date
October 2007

FHWA-AK-RD-07-03

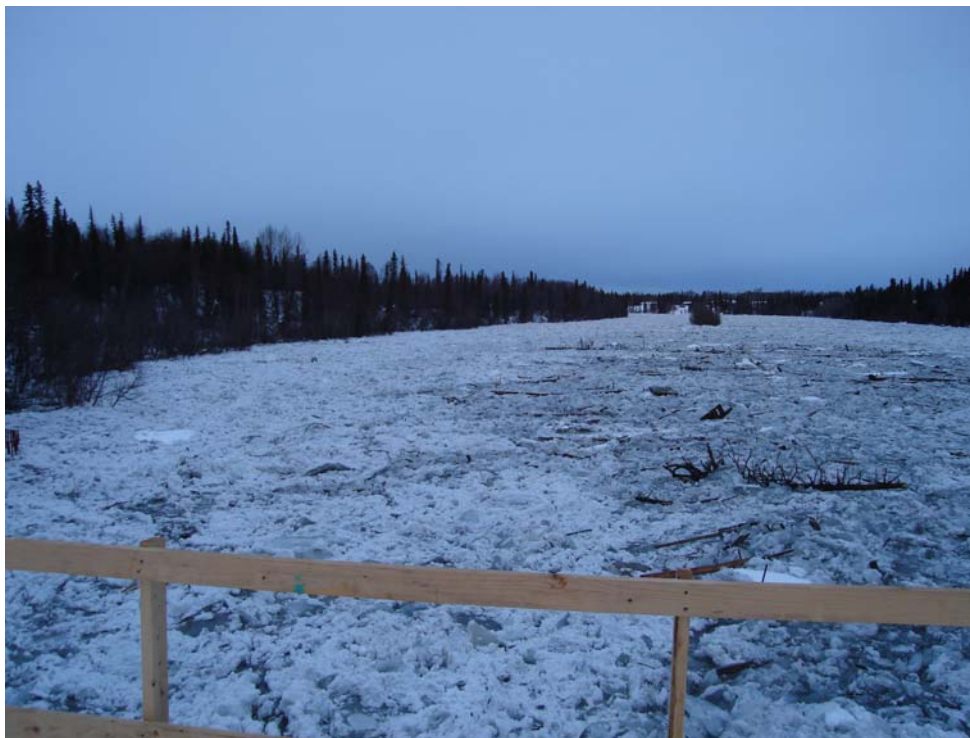
The lake began releasing around January 16. The Kenai River at Skilak Lake rose about 3.8 feet beginning on January 18, and experienced a broad crest below Skilak Lake on January 27 (Kenai Borough, 2007). The rise in water levels caused the existing ice cover on the Kenai River to break up and form a series of ice jams that moved downstream over a period of several days, causing localized flooding in the Soldotna vicinity. Ice jams were noted upstream of the Sterling Highway Bridge near the confluence of Soldotna Creek; that ice moved downstream and jammed at the Sterling Highway Bridge by January 29. The bridge jam broke loose and moved downstream early January 30, allowing the water level at the bridge to decrease from 20 feet to 11.20 feet, which is just under flood stage. Ice was jammed at Centennial Park on the morning of January 30, but open channels allowed water to flow through and not back up behind the jam (Peninsula Clarion, 2007). By the afternoon of January 30, the Centennial Park jam cleared and reformed downstream near Slikok Creek, two miles below the Sterling Highway Bridge; this jam was over a mile in length (DHS, 2007). See Figure 2.

Figure 2. Ice jam on the Kenai River January 28, 2007. ADOT&PF photo.

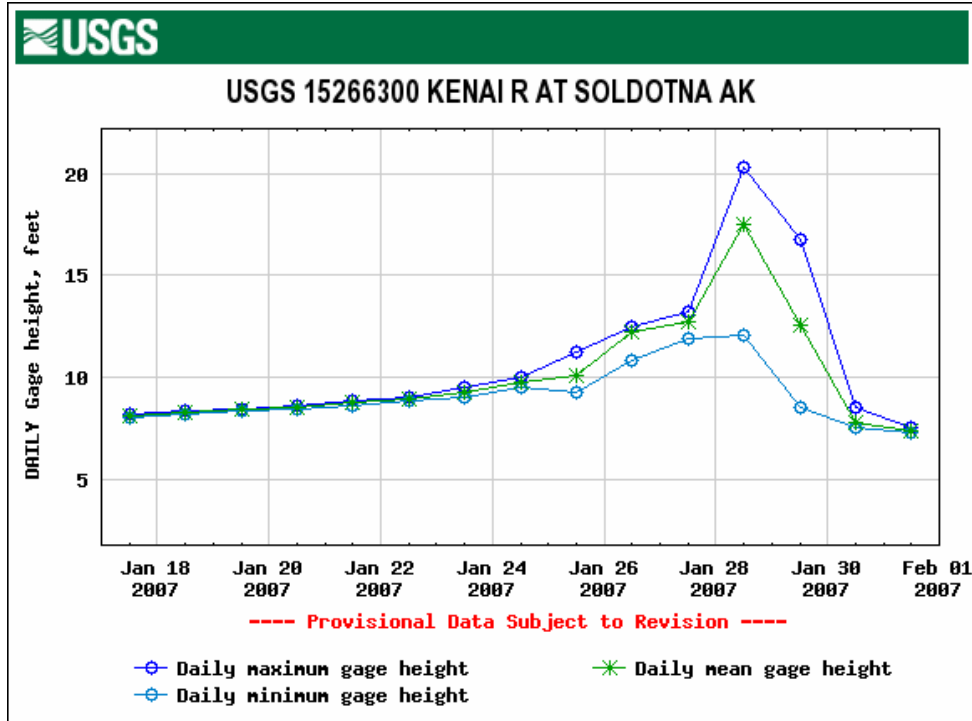
A USGS gaging station is located adjacent to the Sterling Highway Bridge, just upstream of the large ice jam location. The hydrograph at that station for a 14-day period surrounding the event is found in Figure 3. The flood peaked at 20.26 feet. The generally accepted elevation of ordinary high water in this reach is 9.1 feet.

Figure 3. USGS hydrograph for the January 2007 flood and ice jam event.

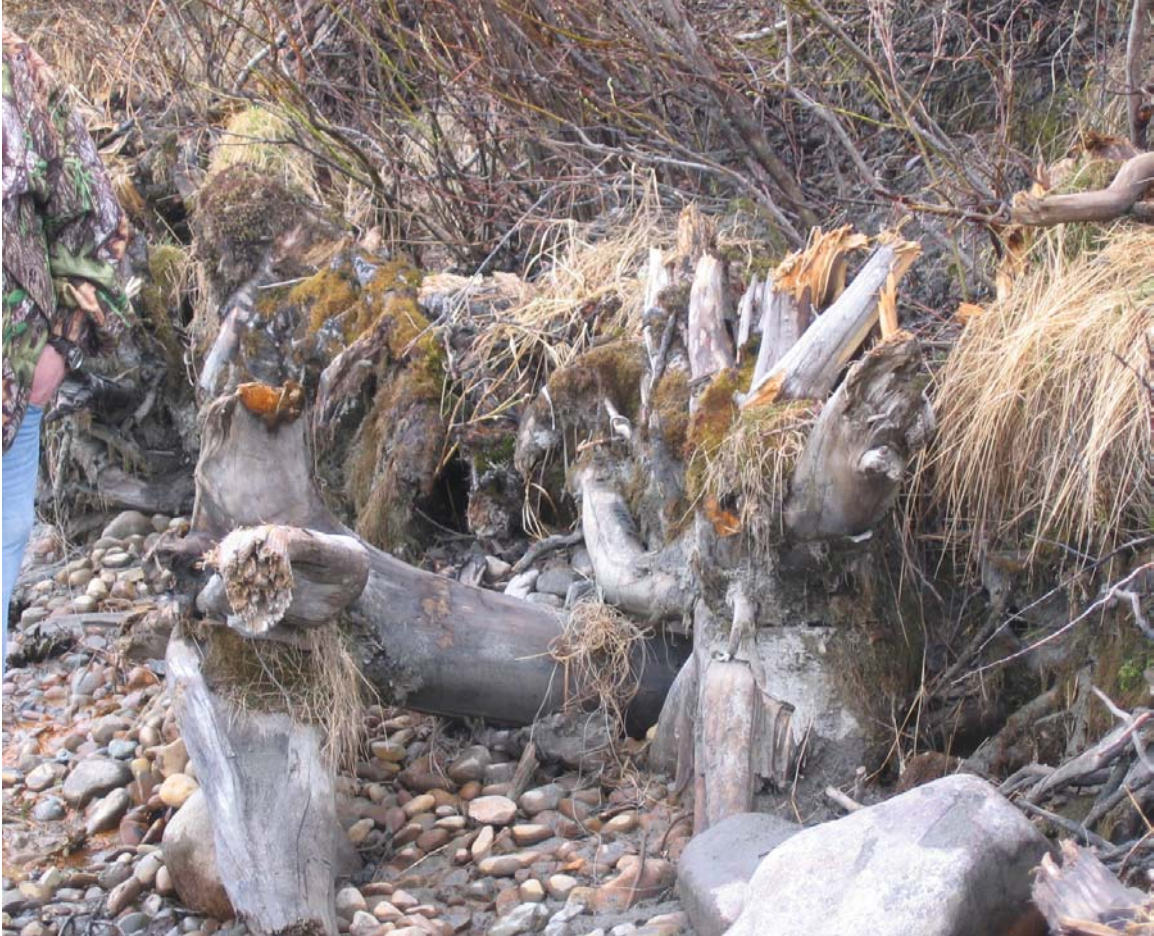
B-Soldotna Park. A 650 foot section of streambank at Soldotna Creek Park was stabilized in 1994 using several bioengineering methods. A live cribwall was constructed up to 3 feet in height, and live siltation techniques were used to provide over-hanging cover. In wet areas, native sod rolls and live fascines were used to stabilize the bank line and reestablish vegetation. Large rocks, placed randomly in the shallow water in front of the live cribwalls, and small rootwads, anchored further out, were used to create additional fish cover. In the spring of 2006, a long section of root wads was installed downstream of the cribwall section. Fabric encapsulated soil lifts with willow brushlayering were used to protect the upper bank.
