THERMAL EROSION OF CUT SLOPES IN ICE-RICH SOIL

FINAL REPORT

Daniel W. Mageau
and
James W. Rooney

April 1984

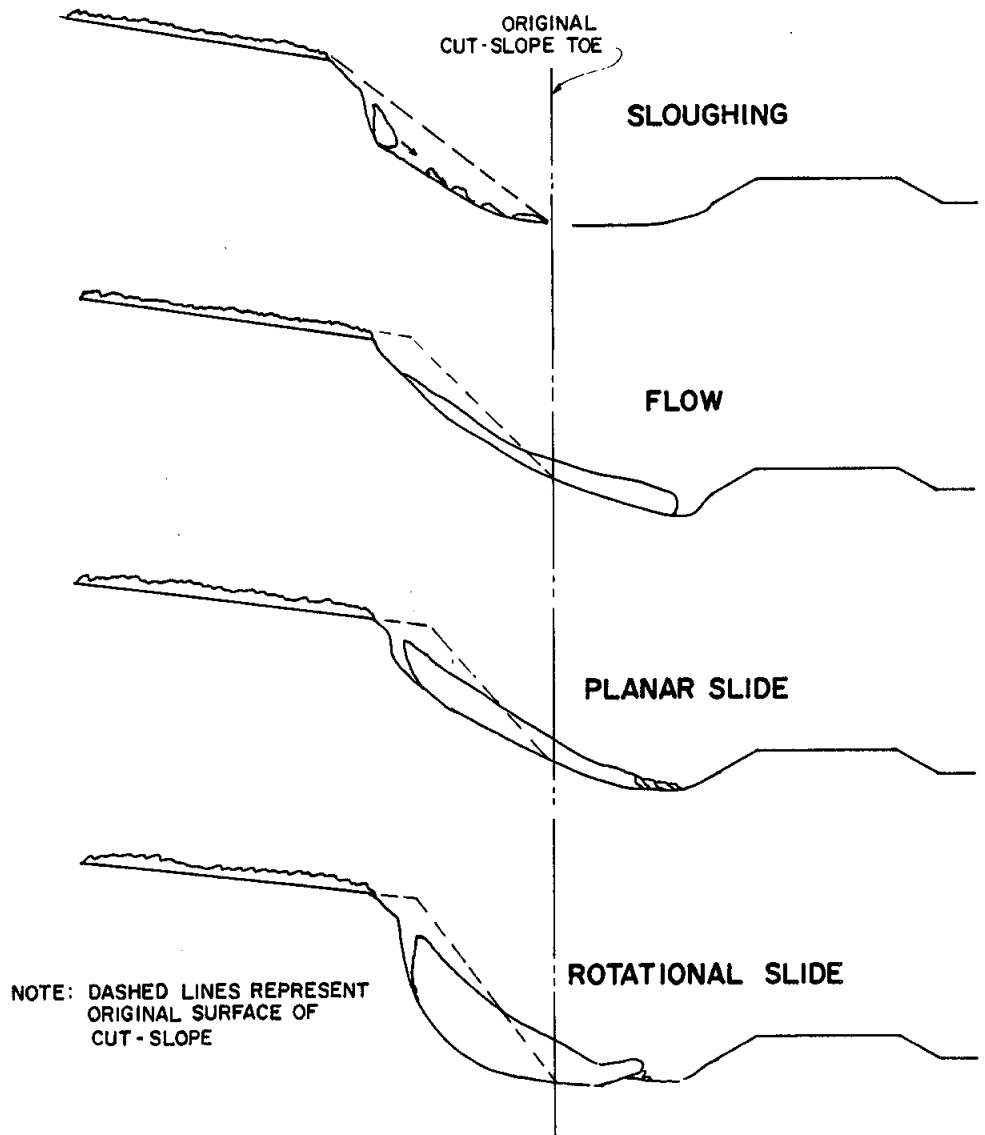
**FIGURE 3
TYPES OF CUT-SLOPE INSTABILITY**

A serious concern related to cut-slopes in frozen soil is slope instability. Slope instability is a generalized term to describe all forms of downslope movement involving moderate to large volumes of soil. Various types of instability within a thawing slope include sloughing, flows, planar slide, and rotational slides. The term "thermal erosion" is sometimes used to describe the general process of thawing within the slope surface and subsequent transport of soil downslope. The primary differences between the various forms of slope instability are; (1) the volume of soil displaced, (2) physical form of the failure, and (3) rate of soil movement. Sloughing, and flows typically involve smaller quantities of soil over a longer period of time than planar and rotational slides, although the volume of soil involved with some flows can be significant (McRoberts and Morgenstern, 1974). A schematic diagram is presented in Figure 3 showing typical physical appearances of the various types of cut-slope instability.

The speed at which a failed mass of soil moves down a slope depends primarily on slope angle, shear strength of the failed soil, and water content of the failed soil. Some types of failure, such as sloughing and flows, occur during the thawing process. Planar and rotational slides generally do not occur until thaw penetration reaches a depth at which the shear strength of the soil cannot support the weight of the thawed soil mass.

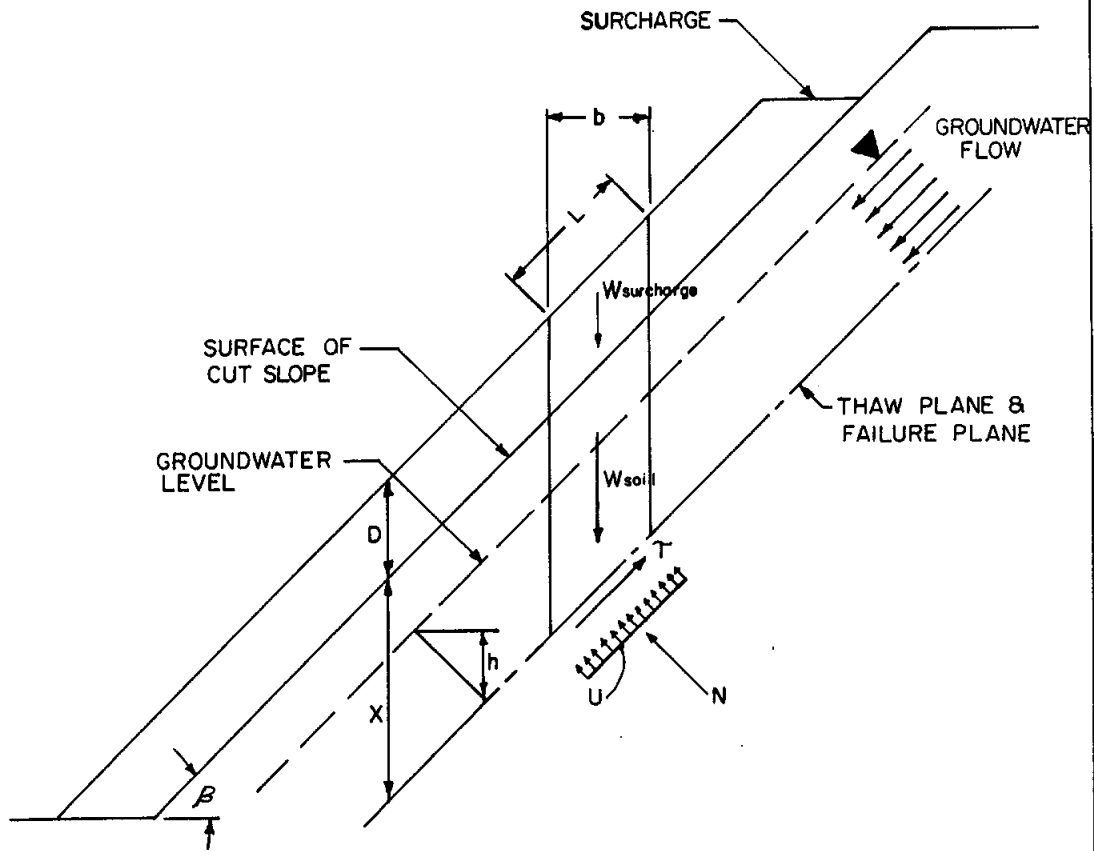
FIGURE 4
SCHEMATIC DIAGRAM
INFINITE SLOPE ANALYSIS

Referring to infinite slope conditions, such as illustrated in Figure 4, the forces which "cause" soil movement result from the bulk weight of the thawed soil and any surcharge (if applicable). "Resisting" forces result from shearing resistance between soil particles. From classical soil mechanics the shear strength of the soil along a potential failure plane parallel to the slope surface may be expressed by:

It can be shown that when U_s and U_o are zero (i.e., no excess pore pressures during thaw) equation 6.2 becomes identical to the conventional "infinite slope" stability equation for unfrozen slopes.

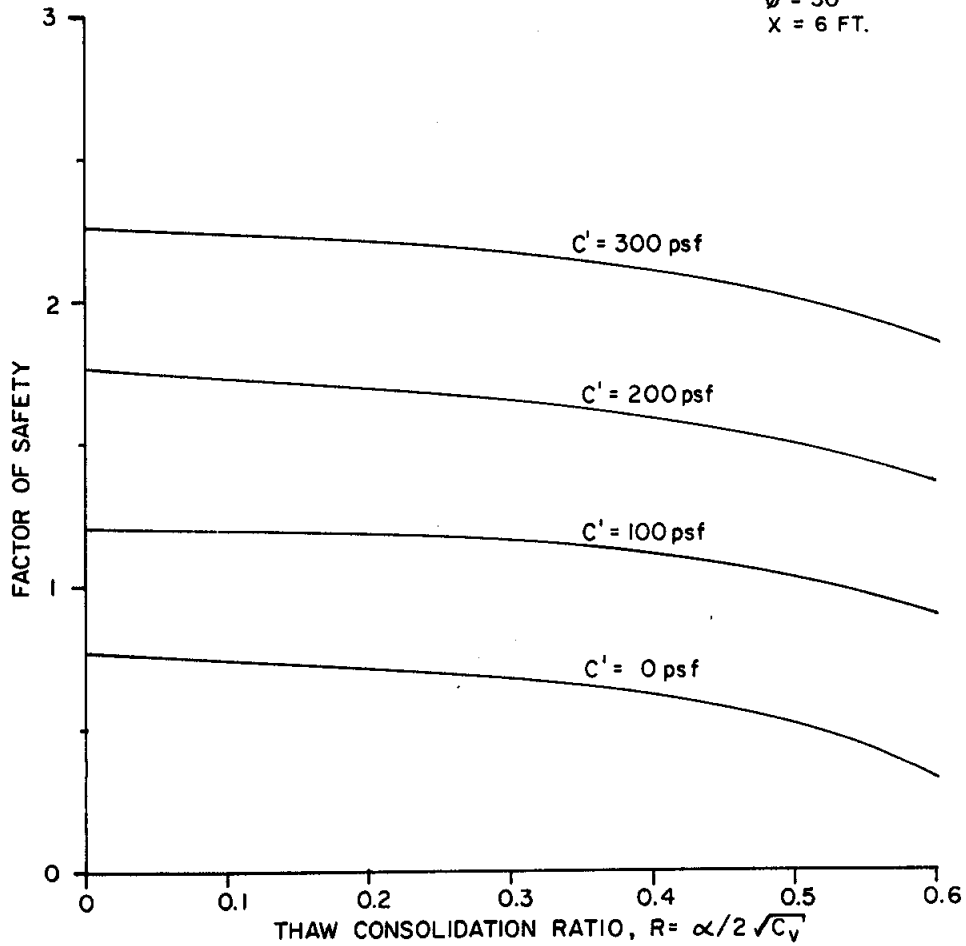
FIGURE 5

From Figure 5, it is seen that, as expected, higher excess pore pressures result in lower factors of safety. The magnitude of the effect, however, is relatively insignificant for R values less than about 0.3. For a typical clayey silt ($C_v = 500 \text{ ft/yr}$) and a moderate thaw rate (10 ft/yr) for "naturally" thawing slopes, the thaw consolidation ratio R , is only 0.22. The reduction in F.S. at this R value is less than 0.1 for all values of cohesion. The effect of excess pore pressures on stability, however, becomes more pronounced at higher values of R .

- 1) Excess pore pressures due to thawing have only a limited effect on F.S. for values of R less than about 0.3. For naturally thawing silts typically encountered in Interior Alaska, values of R are typically not expected to exceed about 0.25. Excess pore pressures can be important, when considering R values greater than 0.3. The presence of low compressible soils such as clays, particularly in combination with high thaw rates, could result in R values greater than 0.3 (Figure 5).

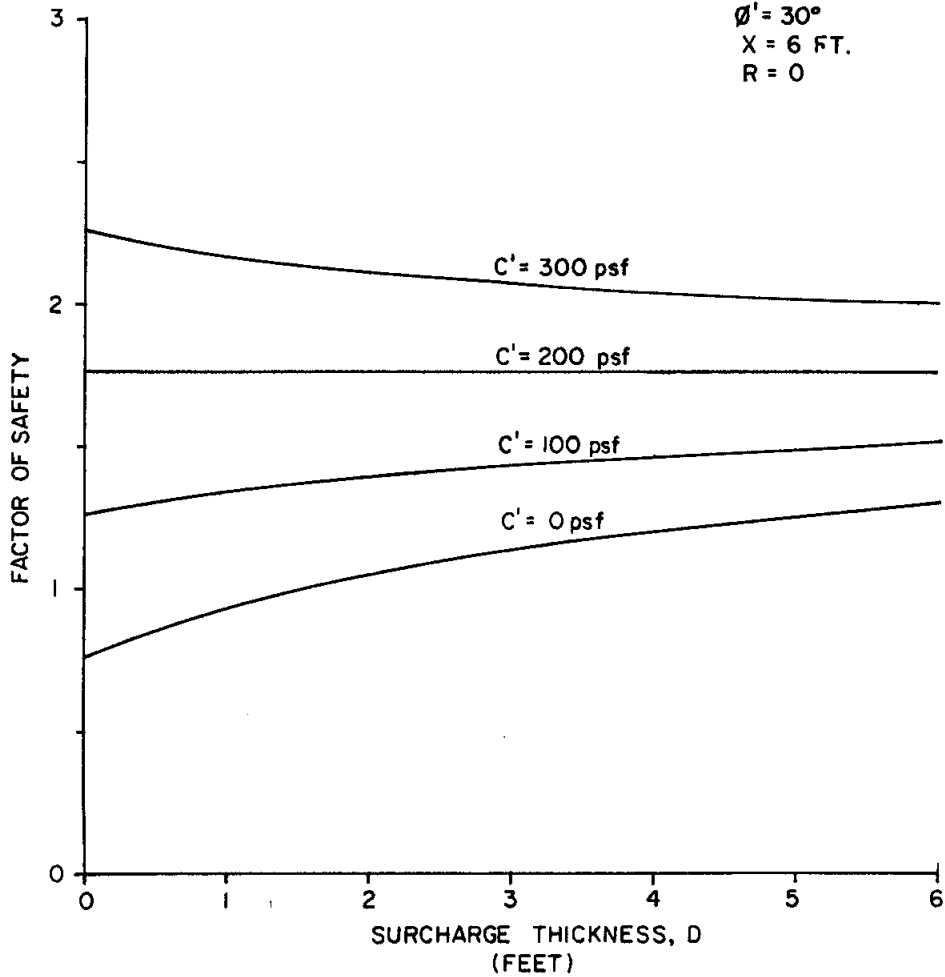
FIGURE 6

While this is true to some extent in the cohesionless soils investigated by Pufahl and Morgenstern, it is cautioned that, as seen in Figure 6, the opposite effect is attained in cohesive soils for certain conditions. For this particular case, the factor of safety of a slope - composed of soil with a friction angle of 30° and a cohesion of 300 psf - decreases approximately 14 percent (from 2.26 to 1.95) when a six foot surcharge is placed on the slope. The relationship between surcharge thickness and factor of safety is also influenced by groundwater level, slope angle, surcharge density and thaw depth.

- 2) Placement of a free-draining surcharge does increase short term stability of thawing slopes composed of low-cohesion soil. As cohesion decreases and/or depth of thaw increases the effect of a surcharge can be to decrease stability (Figure 6).

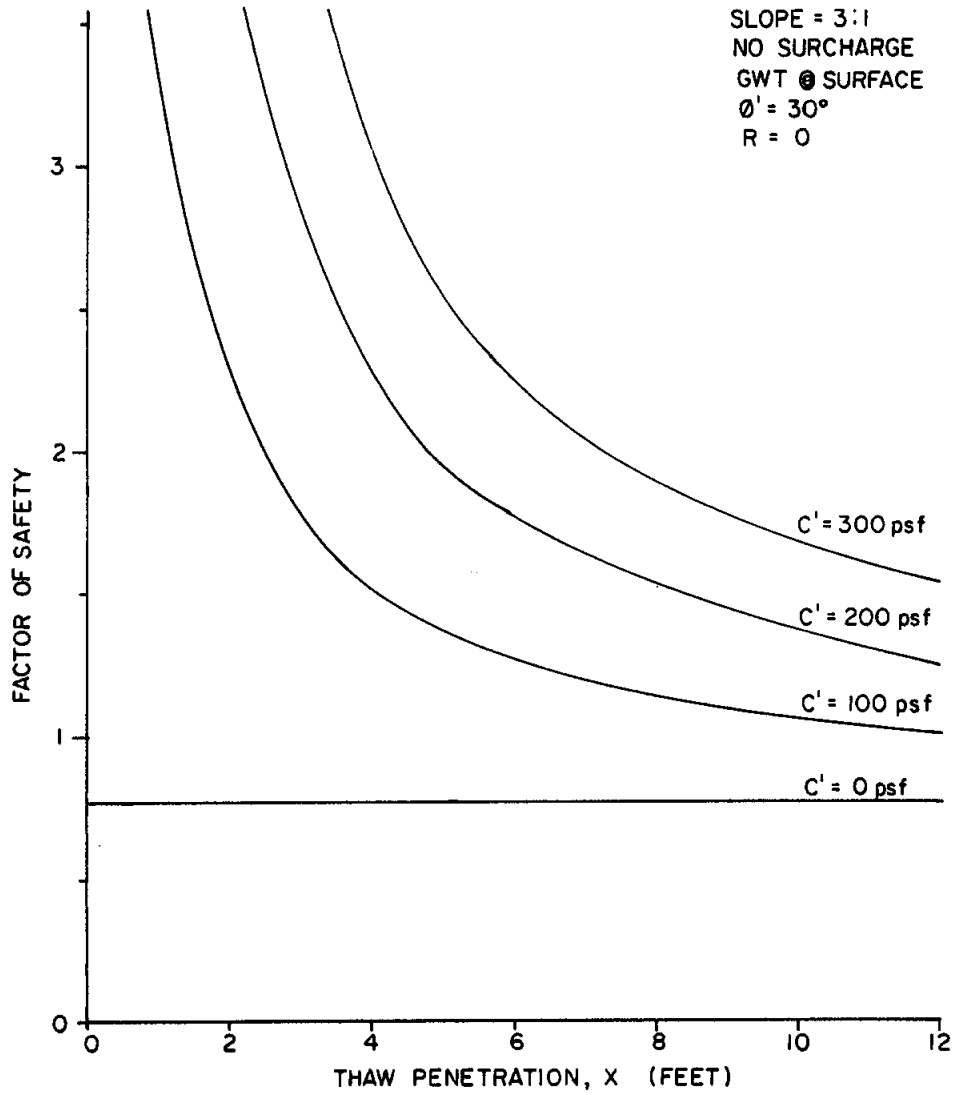
FIGURE 7
THAW PENETRATION vs. FACTOR OF SAFETY

Another important parameter of stability analysis is the depth of thaw X . While X has no influence on F.S. for cohesionless soils, it has considerable effect for cohesive soils as is evident in Figure 7. The inclusion of cohesion in stability analysis at shallow depths results in very high factors of safety. The effect diminishes significantly as the depth of thaw progresses. Since thaw depths at the end of the first thaw season for more ice rich material generally do not exceed several feet, it is seen in Figures 5, 6, and 7 that the influence of effective cohesion on a thawing slope is very important. Moreover, it appears that the influence of cohesion on stability of thawing slopes is greater than that of excess pore pressures, particularly for R values less than about 0.3.

- 3) For slopes composed of cohesive soils, the factor of safety decreases with increasing thaw depth (Figure 7).
- 4) In general, effective cohesion and groundwater level are the two factors which appear to dominate stability of thawing slopes when thaw depths are small. As thaw depths increase, the effect of cohesion diminishes. The influence of the groundwater level remains important at any thaw depth.

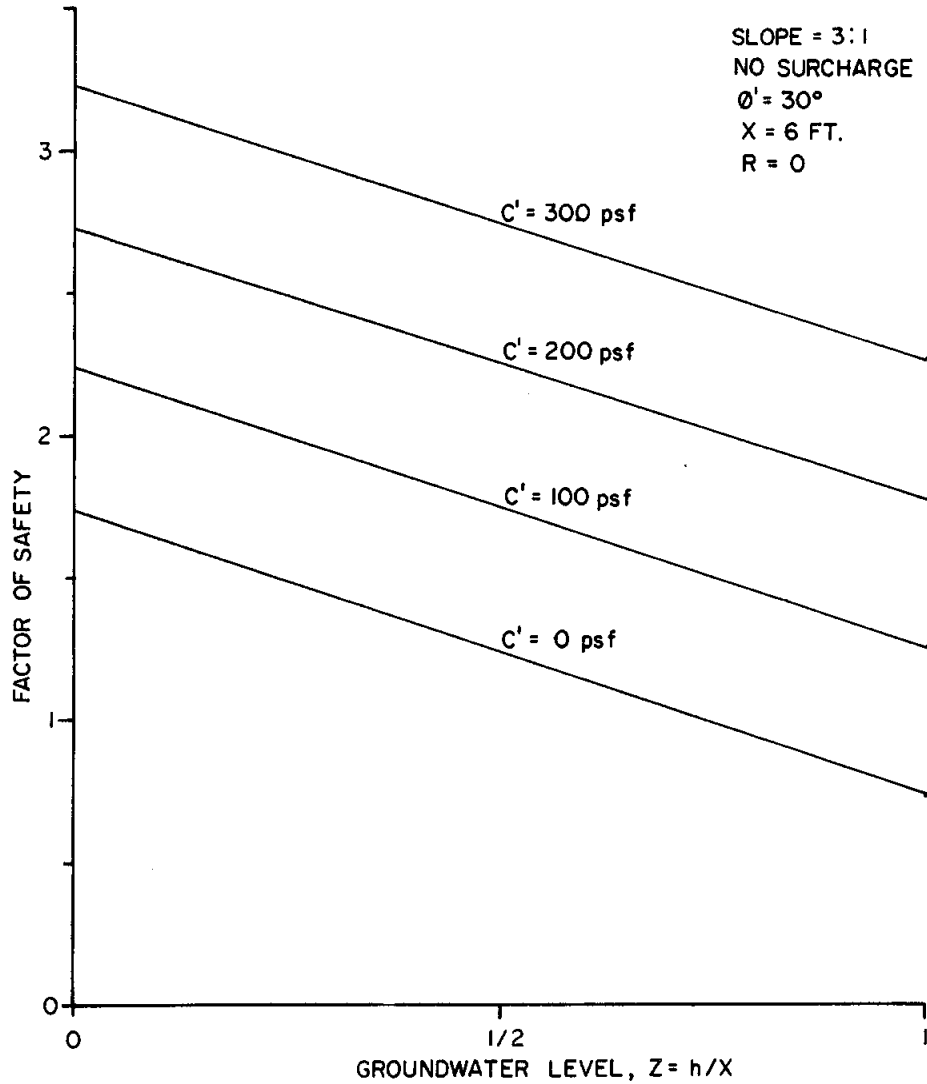
FIGURE 8
GROUNDWATER LEVEL vs. FACTOR OF SAFETY

In order to investigate the relative importance of groundwater level on factor of safety, several computer runs were made using different values of Z as input (Z being the ratio of hydrostatic pressure, h , to thaw depth, X). Typical results are presented in Figure 8. As seen in Figure 8, the factor of safety is significantly reduced when the groundwater level is near ground surface (Z is approximately 0.9). Again, the importance of effective cohesion is seen in Figure 8. For this particular example, a slope composed of cohesionless soil would be considered to be unstable when the groundwater level rises to within the upper third portion of the thaw depth. If the effective cohesion of the soil is 100 psf, then, the factor of safety for the same slope conditions would be about 1.2, and would be considered to be marginally stable.

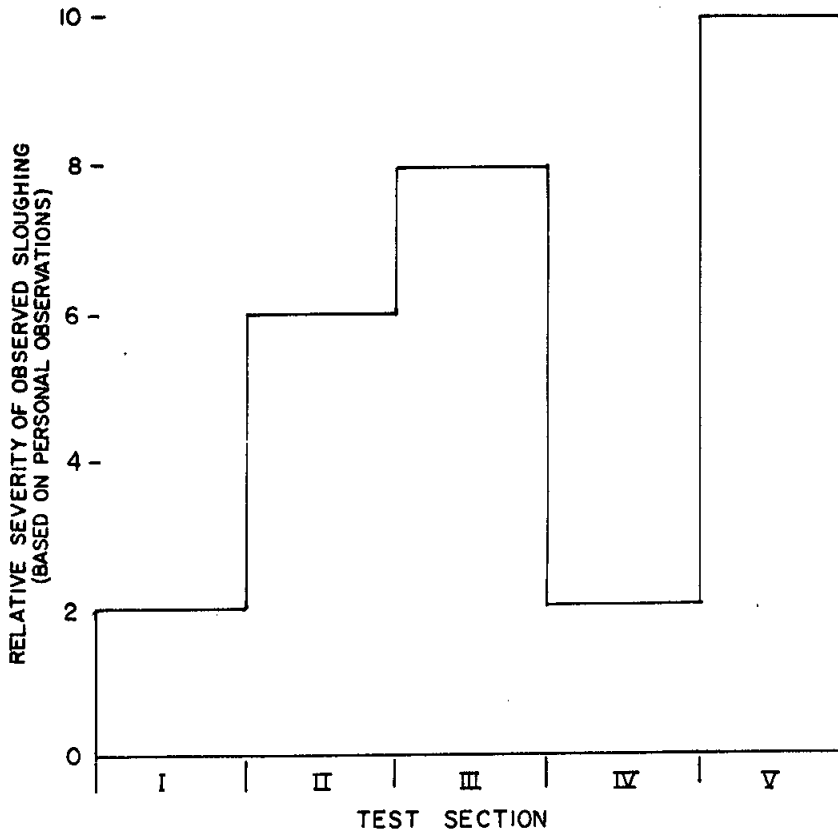
FIGURE 9

The relative degree of observed sloughing during the first thaw season (1973) was determined by APSC (1974) by visually examining the amount of sloughing for each test site and assigning a number to each section from one to ten. The results for each test section are shown in Figure 9. In Figure 10, thaw penetration is presented as a function of time for each test section. From these two figures, it can be seen that slopes with the lowest thaw penetration experienced the least amount of observable deterioration during the first thaw season.

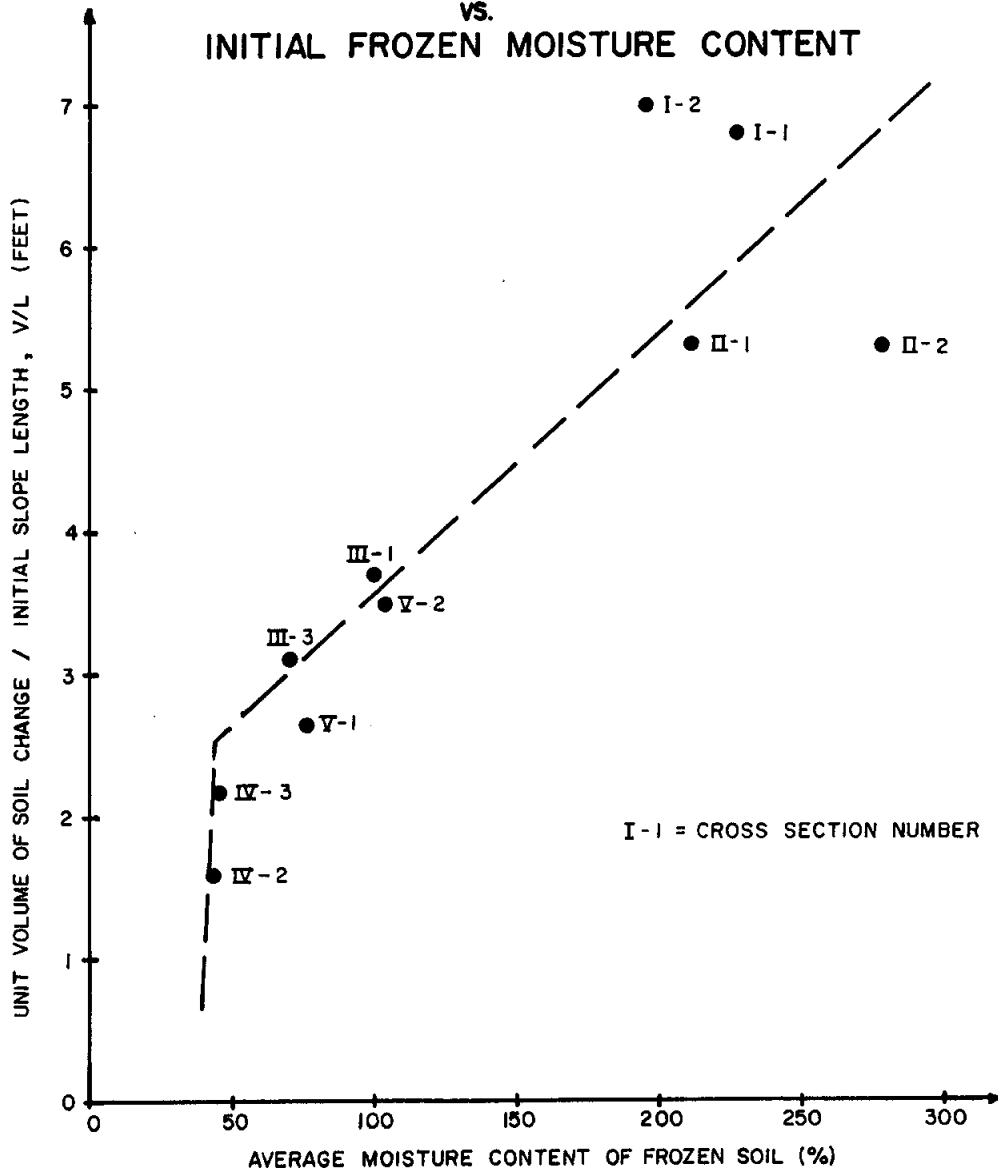
FIGURE 11
SLOPE VOLUME CHANGE
vs.
INITIAL FROZEN MOISTURE CONTENT

It is apparent from Figure 11 that the amount of long-term slope volume change can at least partially be related to moisture content of the frozen soil. Although there is some scatter in data due to inherent variability of natural soils and statistical uncertainty, the relationship between the amount of slope volume change and the amount of ice (frozen moisture) in

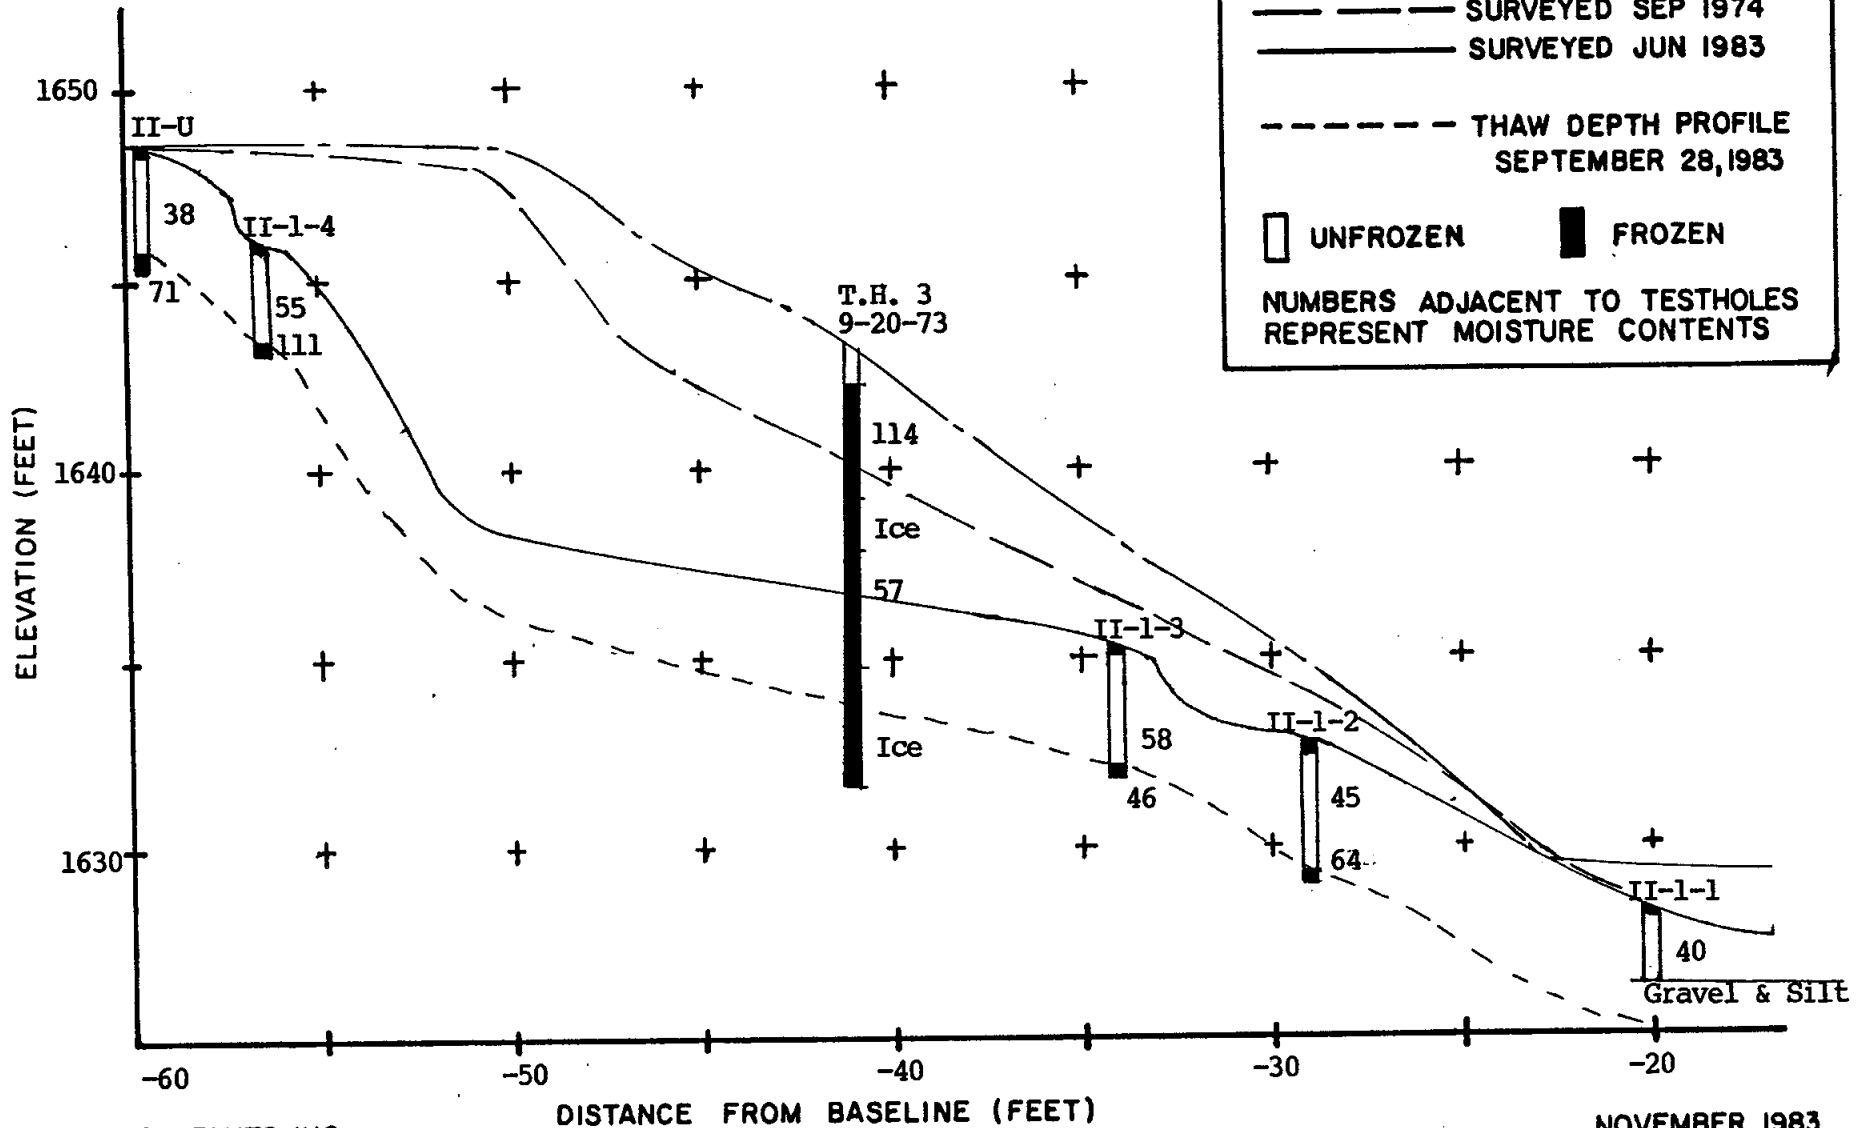
FIGURE A-5

As seen from Figures A-4 through A-6, the 1983 slope configuration had changed significantly from that measured in 1974. The 1983 slope angle was very high at the top while the central portion of the slope in this test section had a more gentle, almost flat grade which transitioned to a steeper grade near the toe of the slope. Very little of the excelsior blanket could be identified due to degradation of the material and vegetation growth. The topography of the slope in Test Section II was irregular with many scarps and small fracture zones.

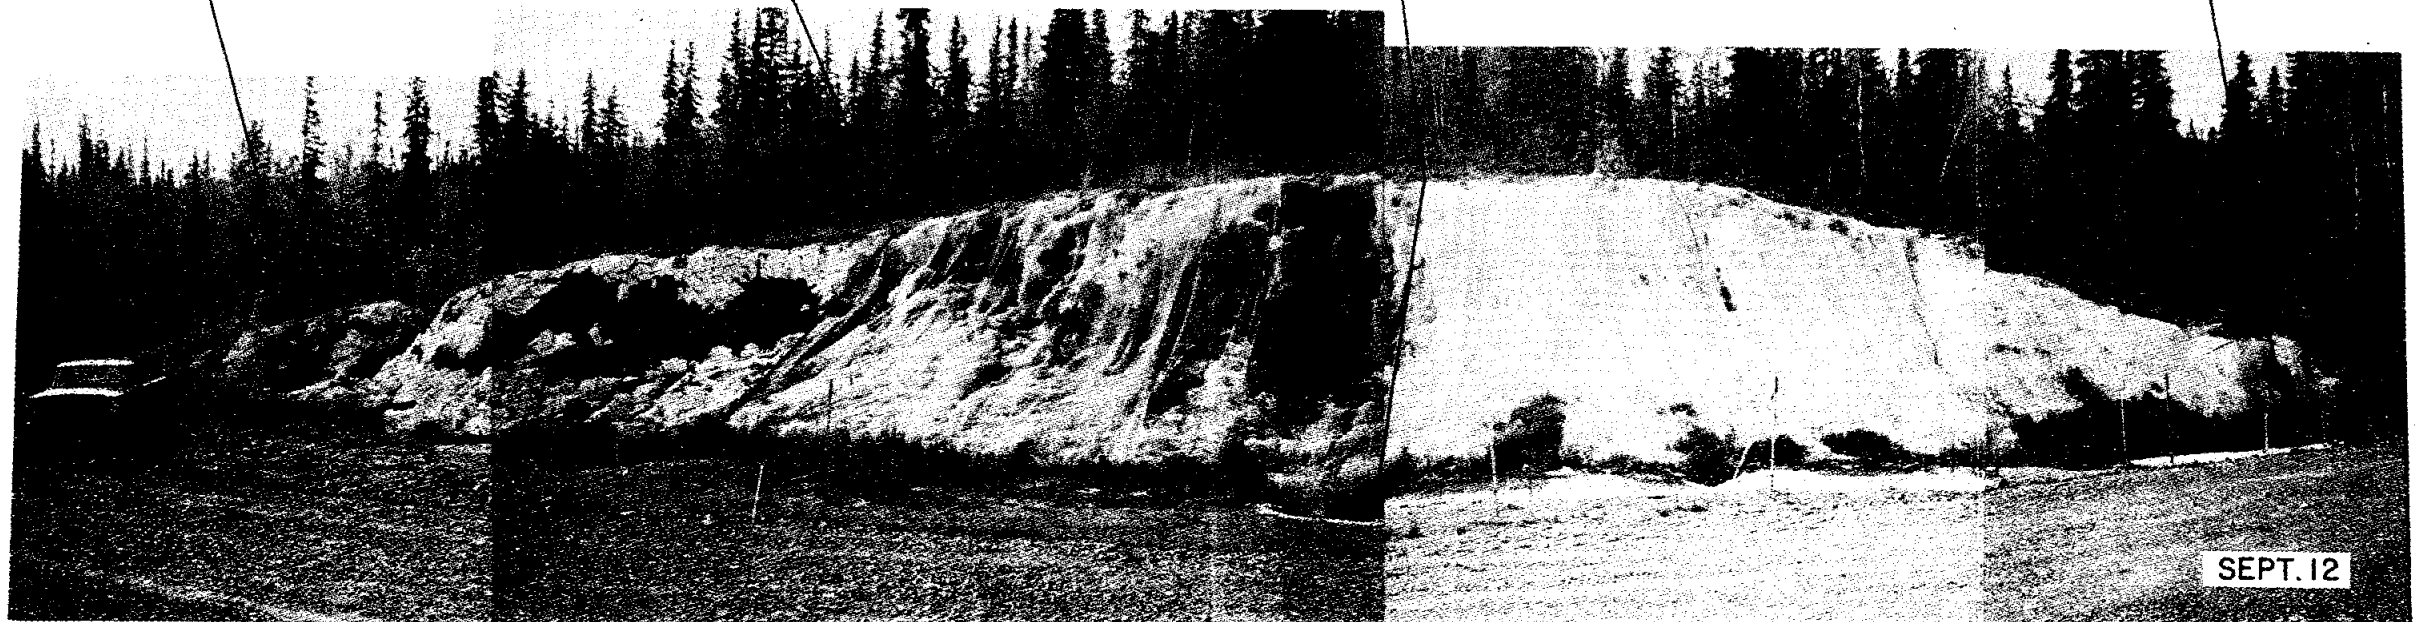
SEPT 1974

Excelsior Blanket over High Reflectivity Fabric

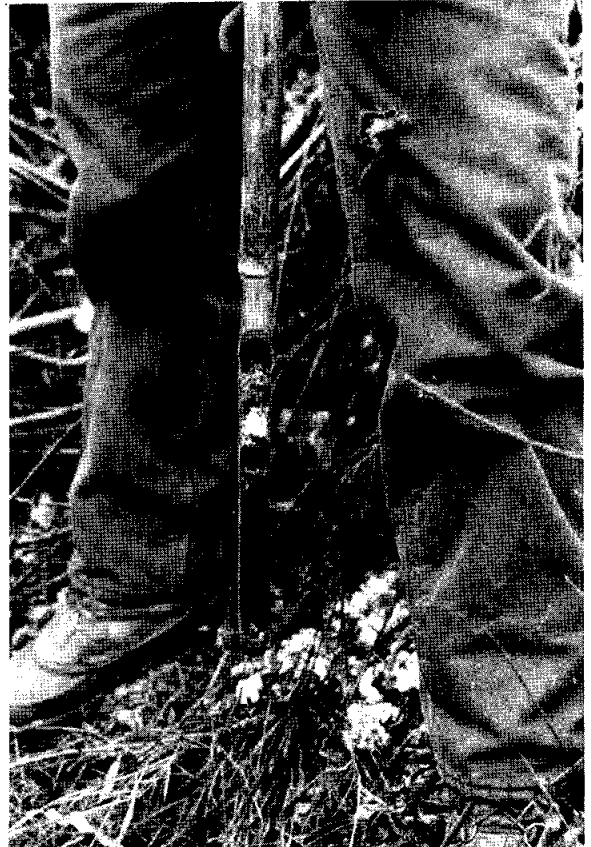
TEST SECTION II

TEST PROBE USED TO OBTAIN
SOIL SAMPLES TO 5 FT.
