**ALASKA DEPARTMENT OF TRANSPORTATION &
PUBLIC FACILITIES - CENTRAL REGION**

HSIP SIGN INVENTORY

FINAL PROJECT REPORT

March 2013

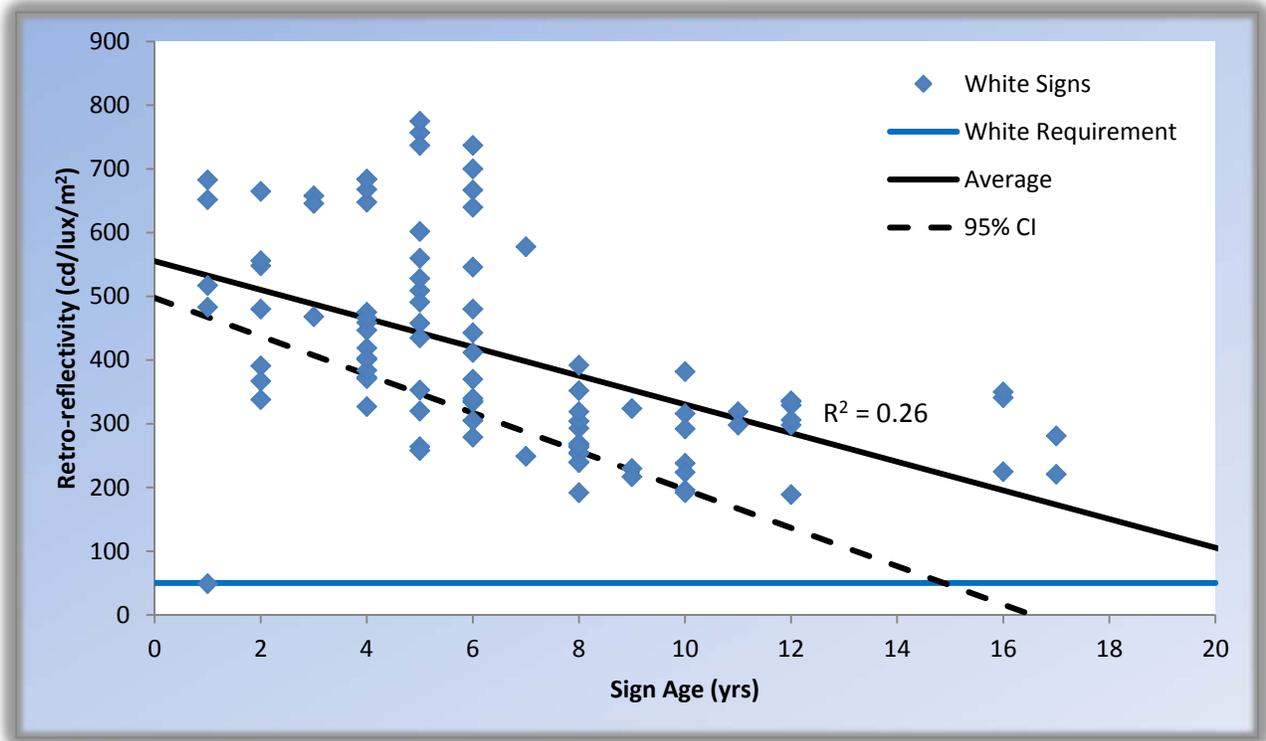
Figure 15 - Retro-reflectivity versus Age for White Signs

Figure 14 through Figure 17 shows plots of retro-reflectivity versus sign age for the various colored signs. The MUTCD minimum retro-reflectivity values are displayed as horizontal lines near the bottom of the figures. The R-squared values for the regression line vary across the colors and range from 0.06 to 0.52. Overall this indicates a fairly poor correlation between age and retroreflectivity. Additionally, the actual values of retro-reflectivity vary depending on the color of the sign. This may be a result of the colorant both blocking some of the retro-reflectivity of the underlying material and protecting it from degradation.
